Purpose: RCRA Compliance Evaluation Inspection

Facility: **Consolidated Tire Recyclers, Inc.**

Date of Investigation: August 17, 2011

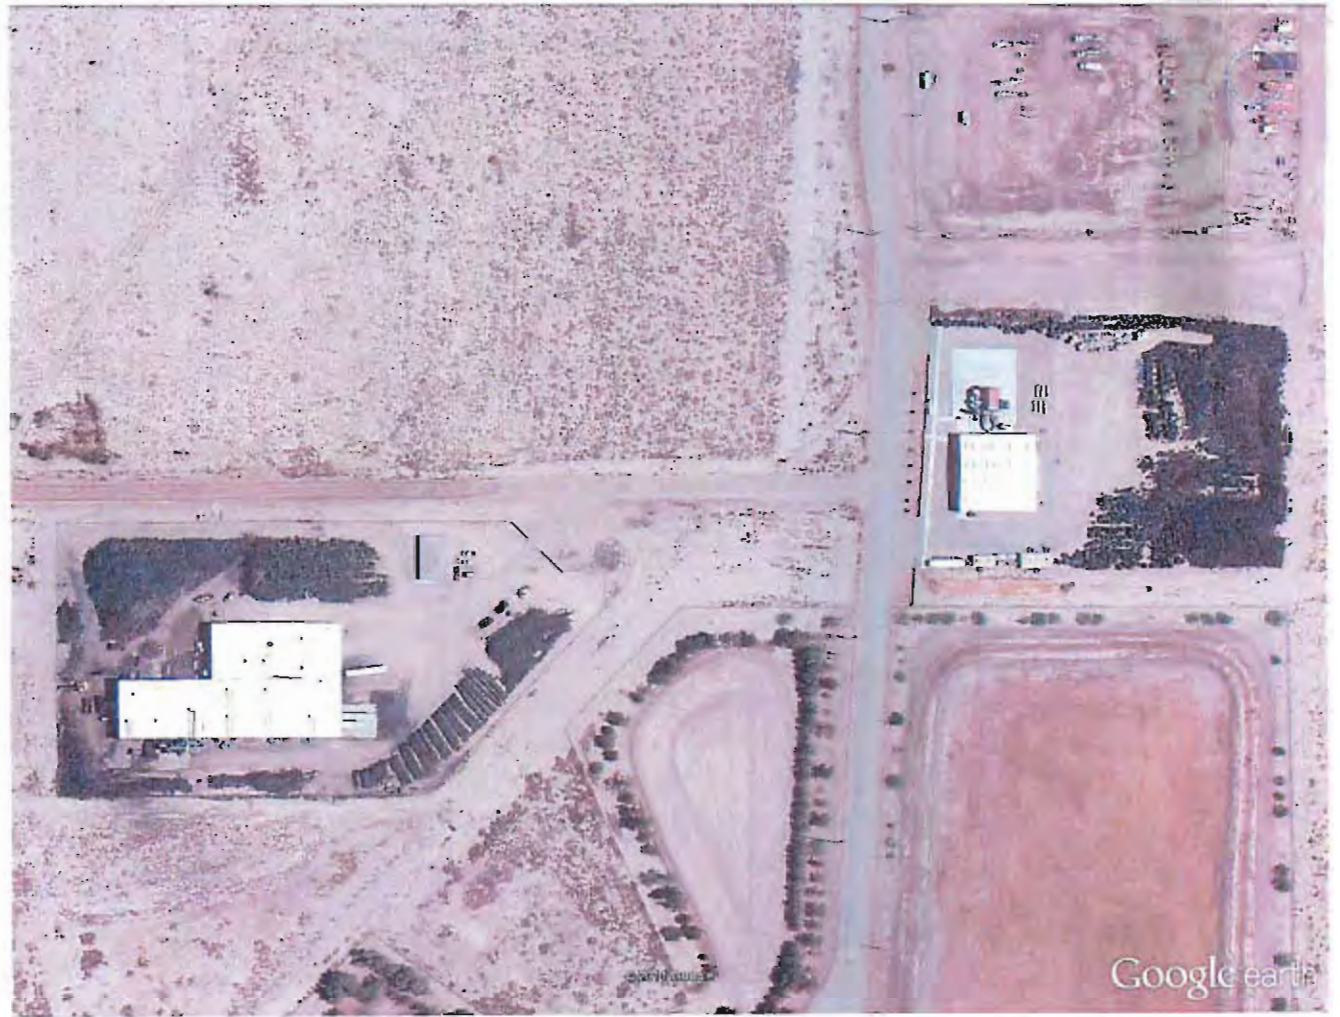
Google Earth view dated June 23, 2011.
