**U.S. Environmental Protection Agency, Region IX
CWA Compliance Office
Report of Clean Water Act Inspection**

Site Location: State Route 179 Improvement Project
Between Mile Posts 310.5 and 313.8
Oak Creek/Sedona, AZ

Date and Time of Visit: February 5, 2010, 8:30 a.m. – 1:30 p.m.

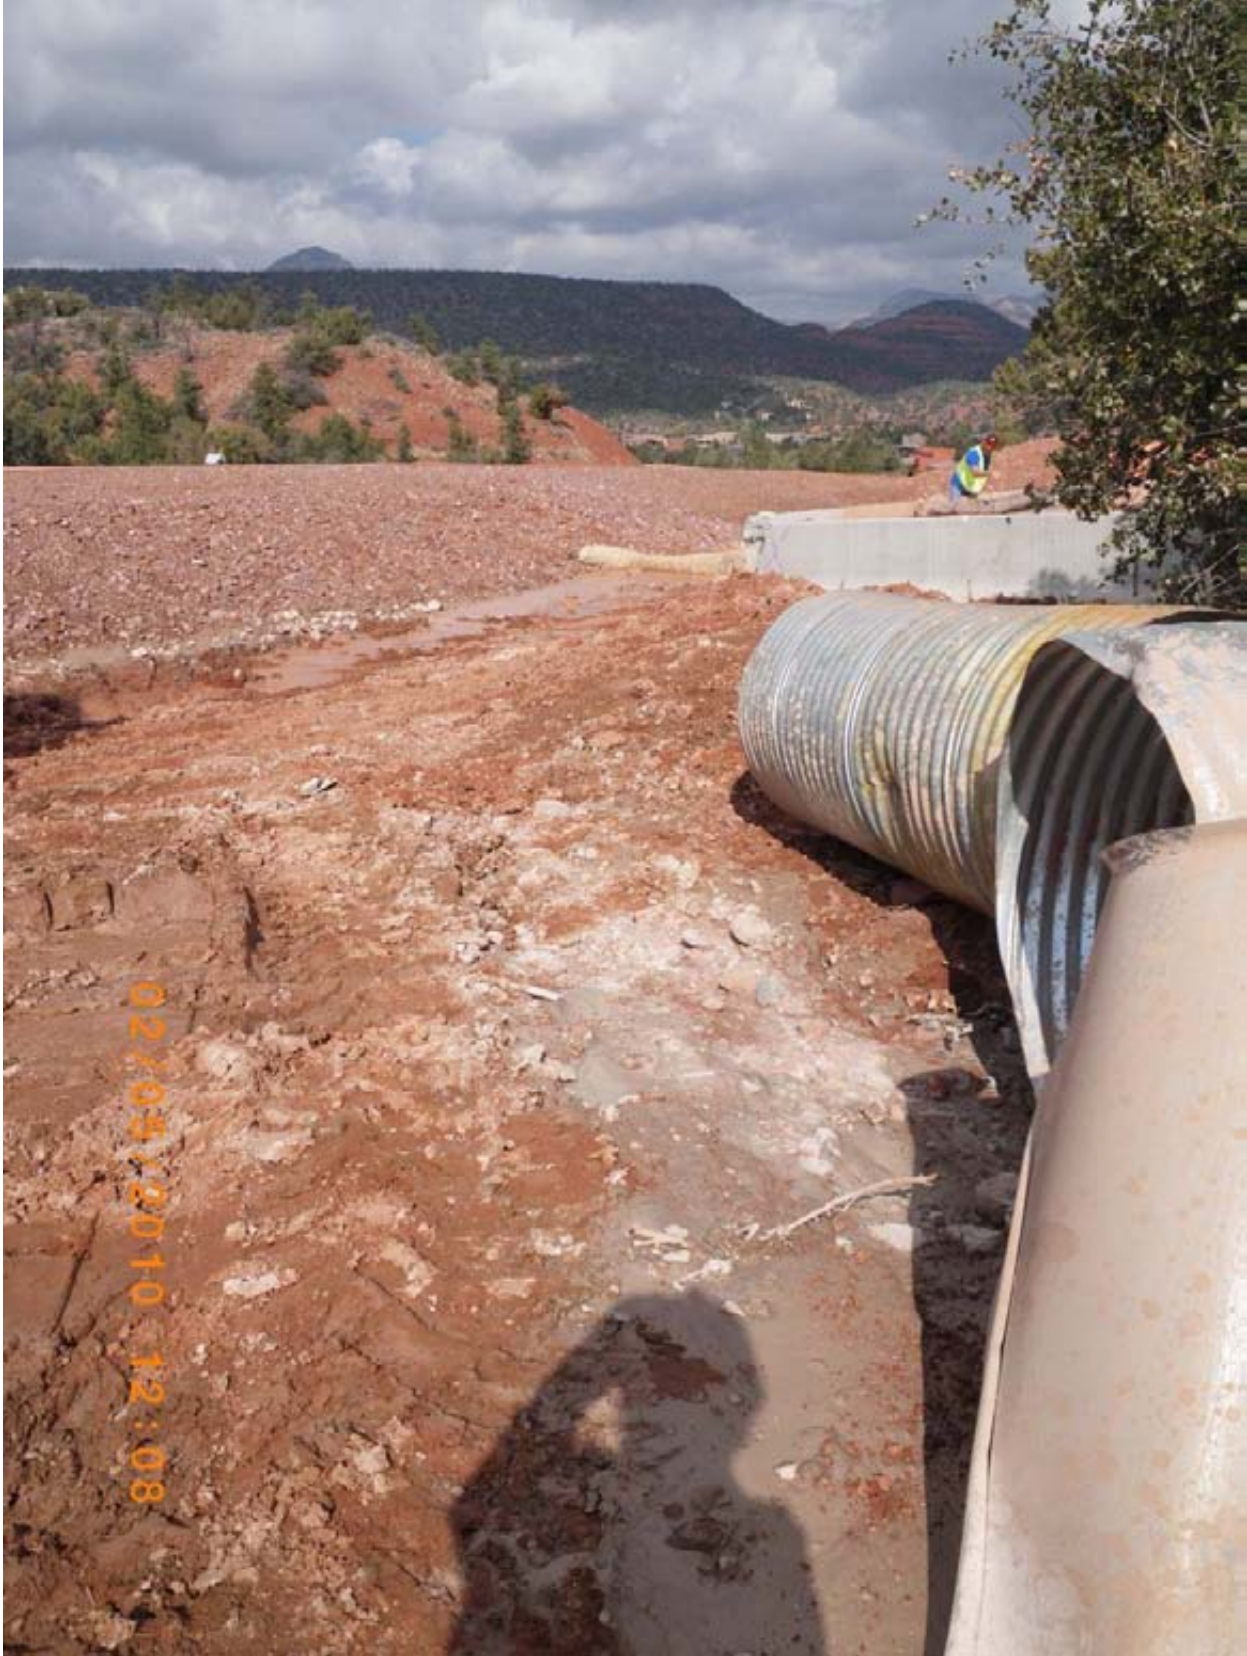
IMGP0053

The BMP in use during the inspection for this pump water discharge at the Chapel staging yard was a poorly designed settling basin (see Photos 0047, 0053, 0055, 0062, and 0064) that discharged to the sediment-laden drainage ditch described above. The basin was made of three K-rails and lined with filter-fabric wrapped sediment logs. However, the basin was over 90% full and sediment covered the sediment logs (see Photo 0055). According to Fisher, another pump delivery was scheduled for that afternoon, before the basin could be cleaned out and repaired. On February 5, 2010 (the day of the inspection) a BMP update sheet was placed in the SWPPP, describing this BMP. This could indicate that the SWPPP was not being updated in a timely fashion. As described above, this BMP is undersized and inadequate. I instructed ADOT/Fisher representatives

on site to clean it out and suggested a range of options to repair the BMP before using it again. We also discussed moving this BMP to an upland area above the drainage ditch.
