Guam Waterworks Authority (VP0989)

SDWA Sanitary Survey

Northern System

NEIC Field Investigation Photographs

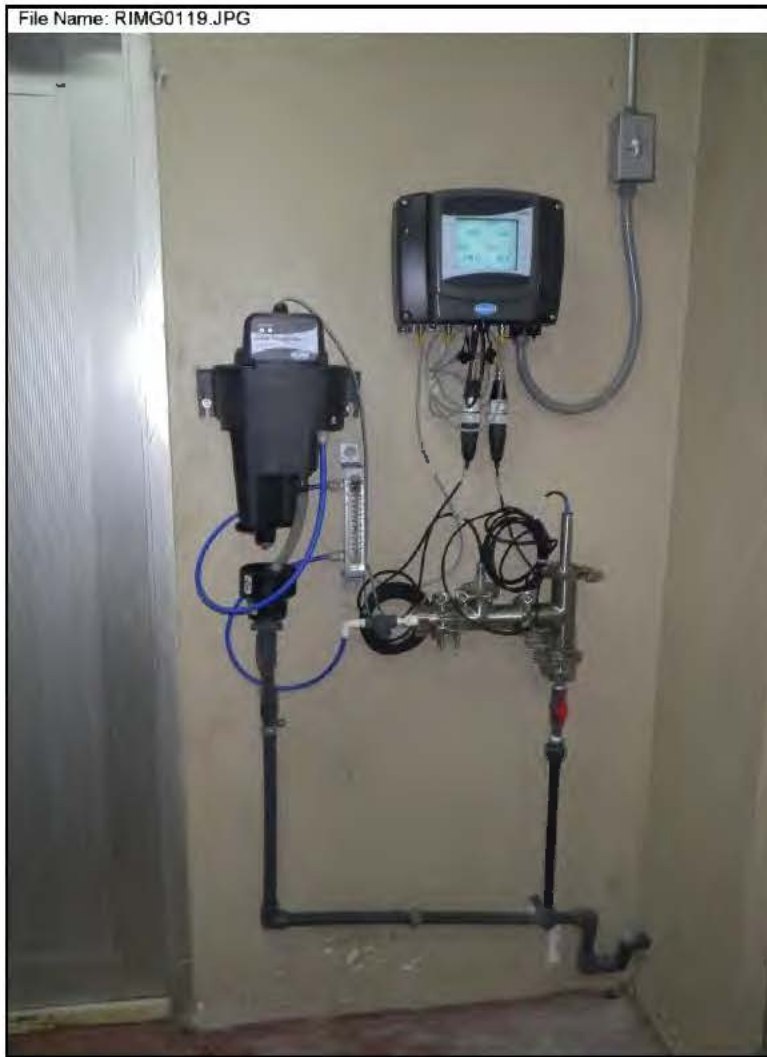
Attributes	
Title	Guam Waterworks Authority (VP0989)
Subject	Northern System
Latitude	[REDACTED]
Longitude	[REDACTED]
Photo Direction	[REDACTED]
[REDACTED]	[REDACTED]
Date Time Stamp	4/27/2012 10:12:55 AM
Photographer	K. Sable
Comment	Y 15 Well
Description	Turbidimeter

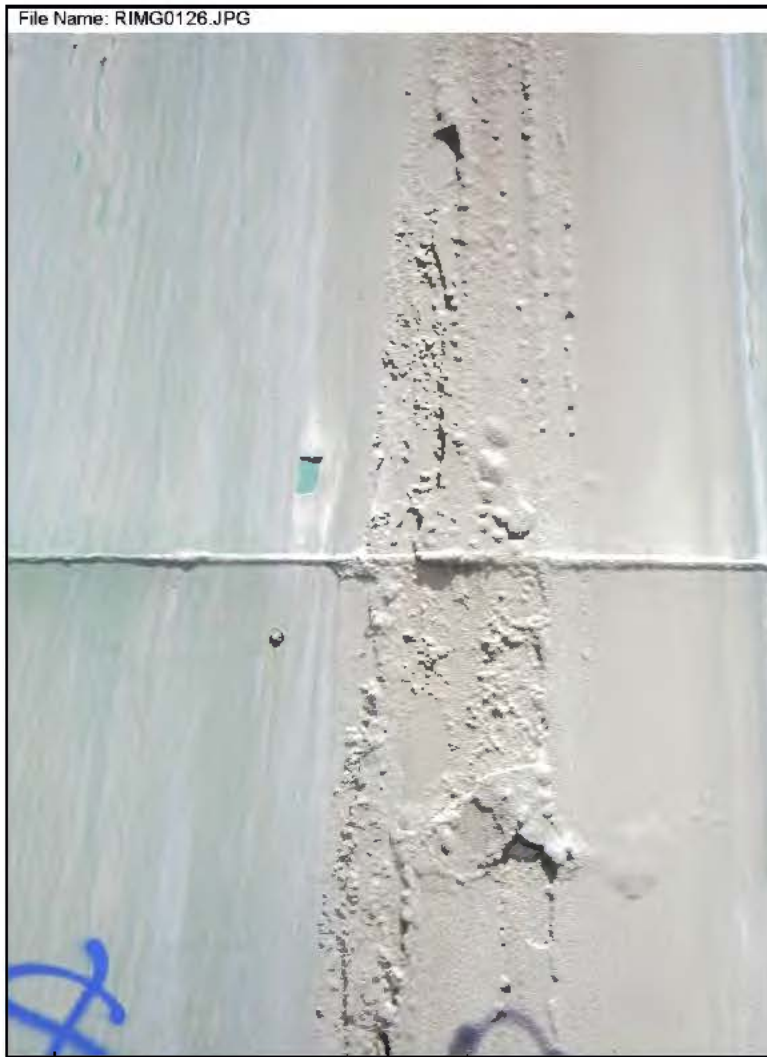
Attributes	
Title	Guam Waterworks Authority (VP0989)
Subject	Northern System
Latitude	[REDACTED]
Longitude	[REDACTED]
Photo Direction	[REDACTED]
Elevation	[REDACTED]
Date Time Stamp	4/27/2012 10:39:46 AM
Photographer	K. Sable
Comment	Santa Rosa Tank
Description	Close-up of previously patched area with build-up of precipitate

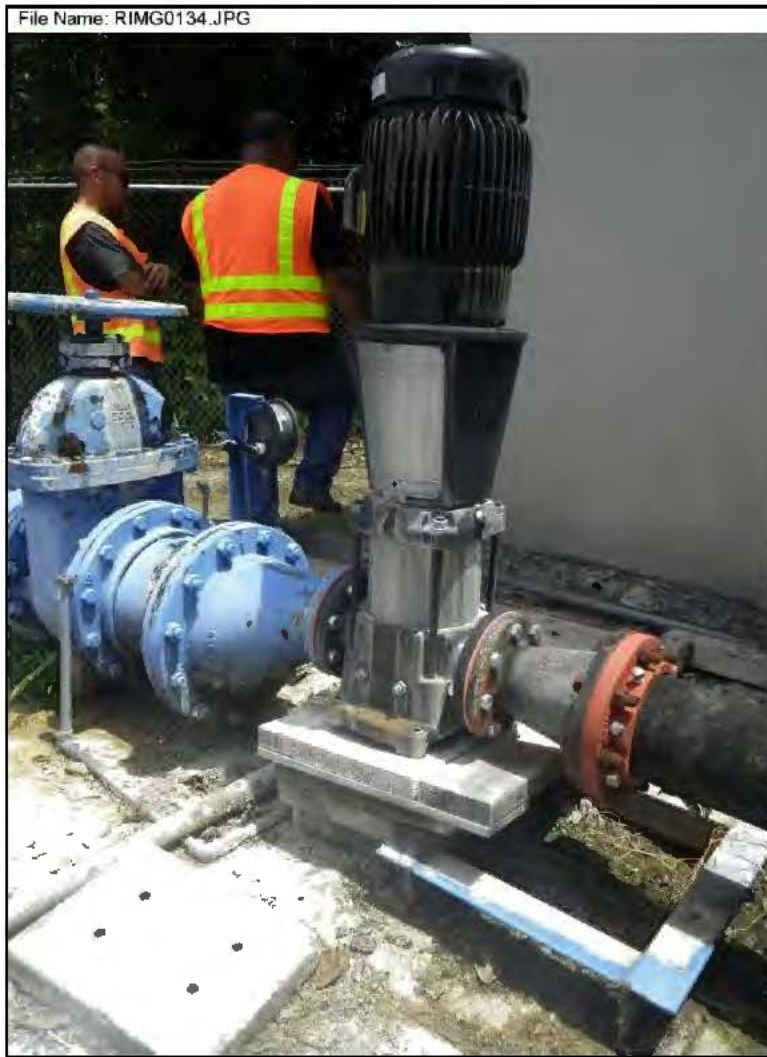
Attributes	
Title	Guam Waterworks Authority (VP0989)
Subject	Northern System
Latitude	[REDACTED]
Longitude	[REDACTED]
Photo Direction	[REDACTED]
Elevation	[REDACTED]
Date Time Stamp	4/27/2012 11:17:56 AM
Photographer	K. Sable
Comment	Gayinero Pump Station
Description	Pump # 1

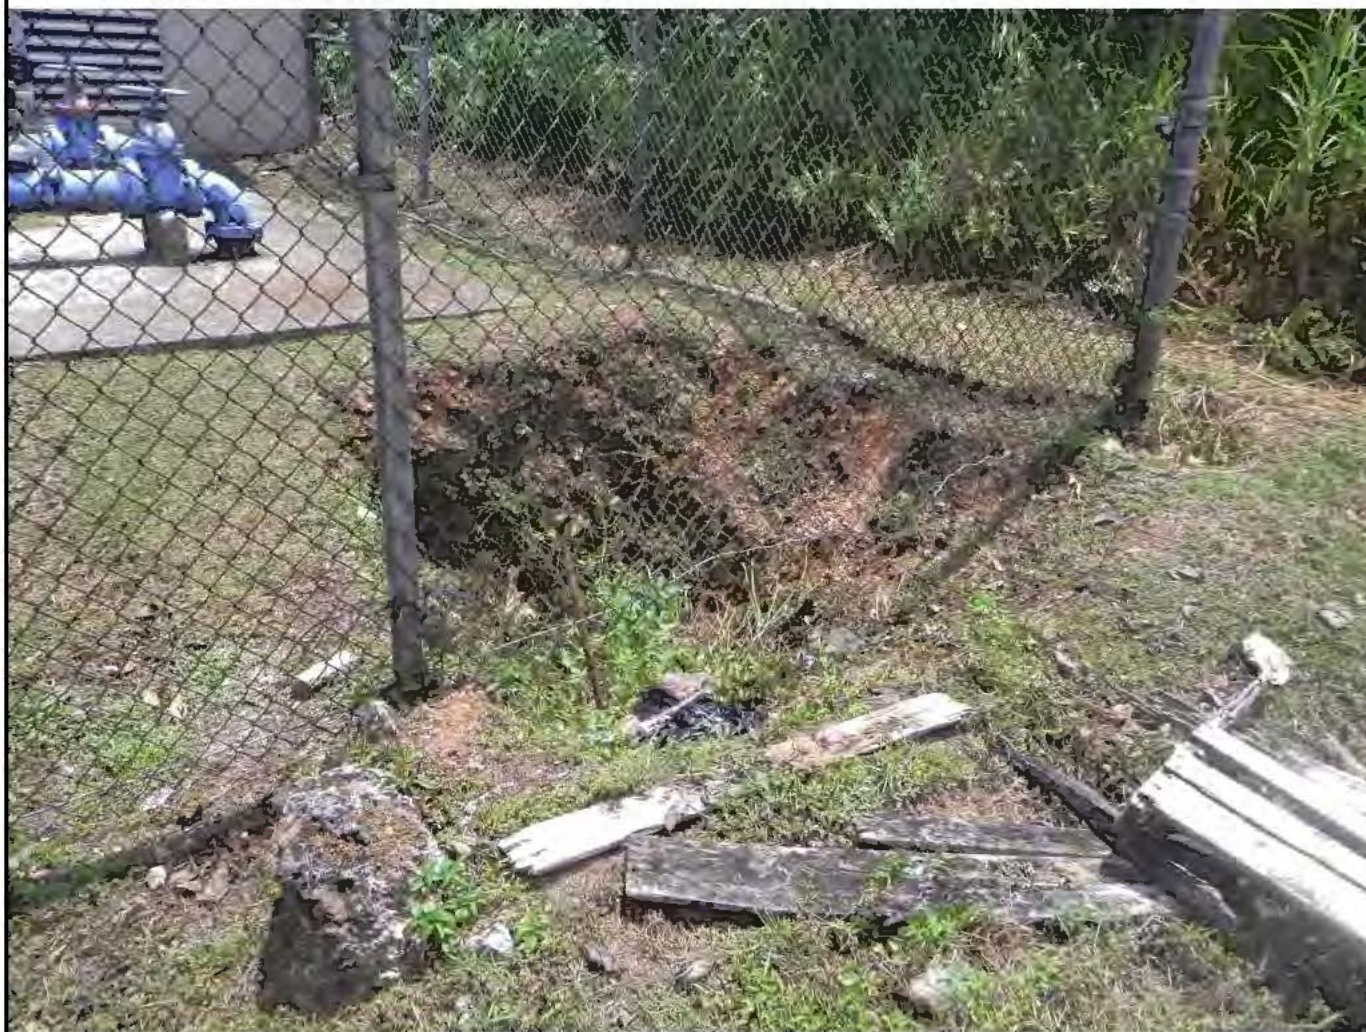
File Name: RIMG0138.JPG

Title	Guam Waterworks Authority (VP0989)
Subject	Northern System
Latitude	██████████
Longitude	██████████
Photo Direction	██████
Elevation	██████
Date Time Stamp	4/27/2012 11:27:48 AM
Photographer	K. Sable
Comment	Gayinero Pump Station
Description	Hole under fence

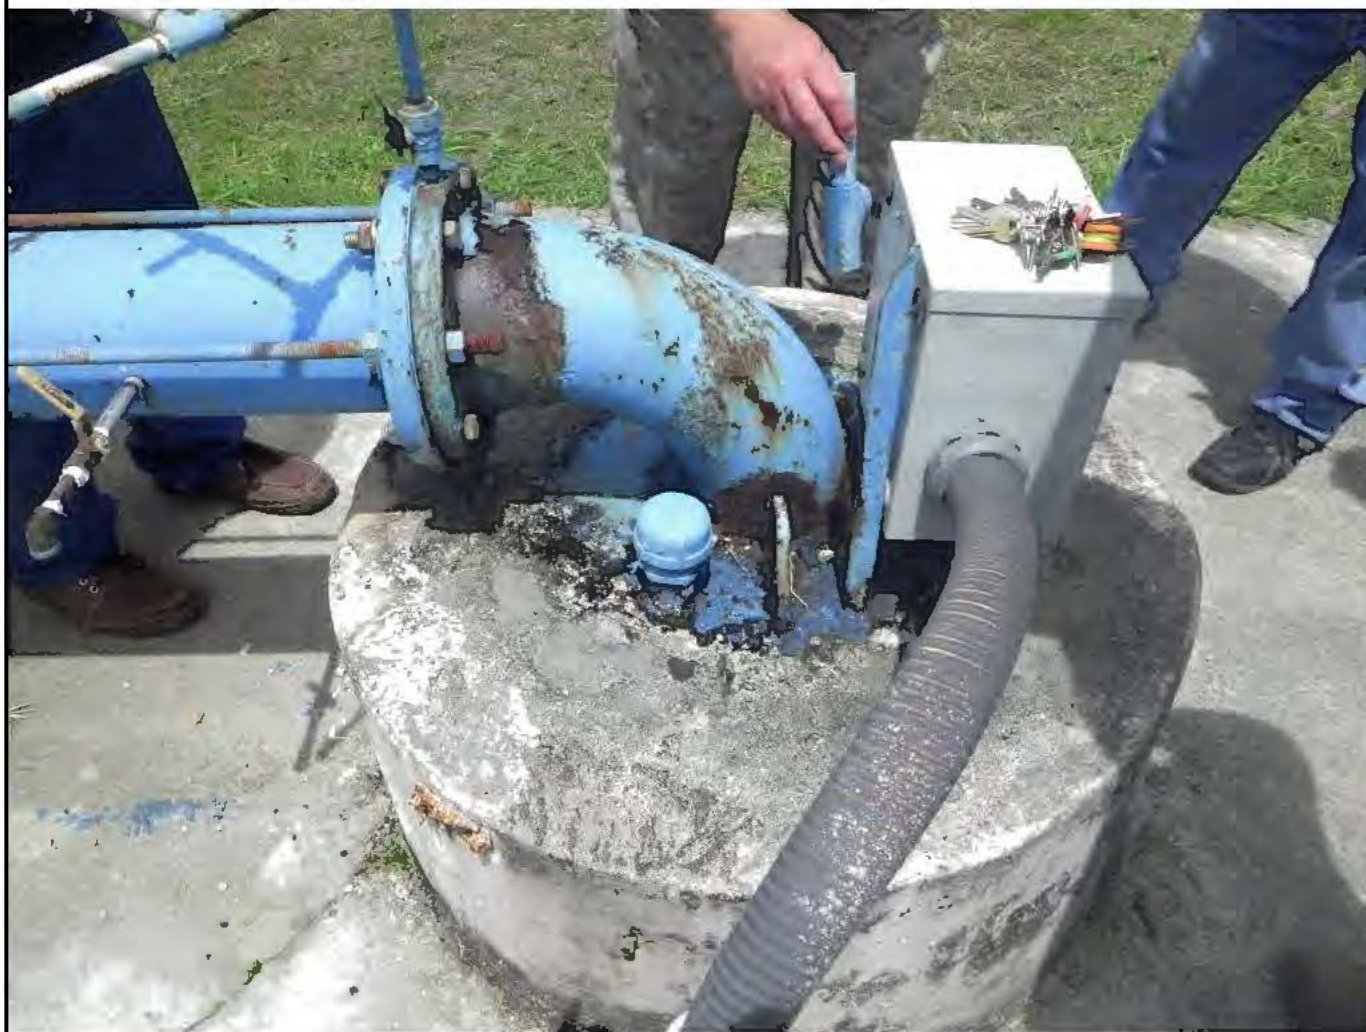
File Name: RIMG0141.JPG

Title	Guam Waterworks Authority (VP0989)
Subject	Northern System
Latitude	██████████
Longitude	██████████
Photo Direction	██████
Elevation	██████
Date Time Stamp	4/27/2012 1:39:52 PM
Photographer	K. Sable
Comment	Y 9 Well
Description	Sounding tube

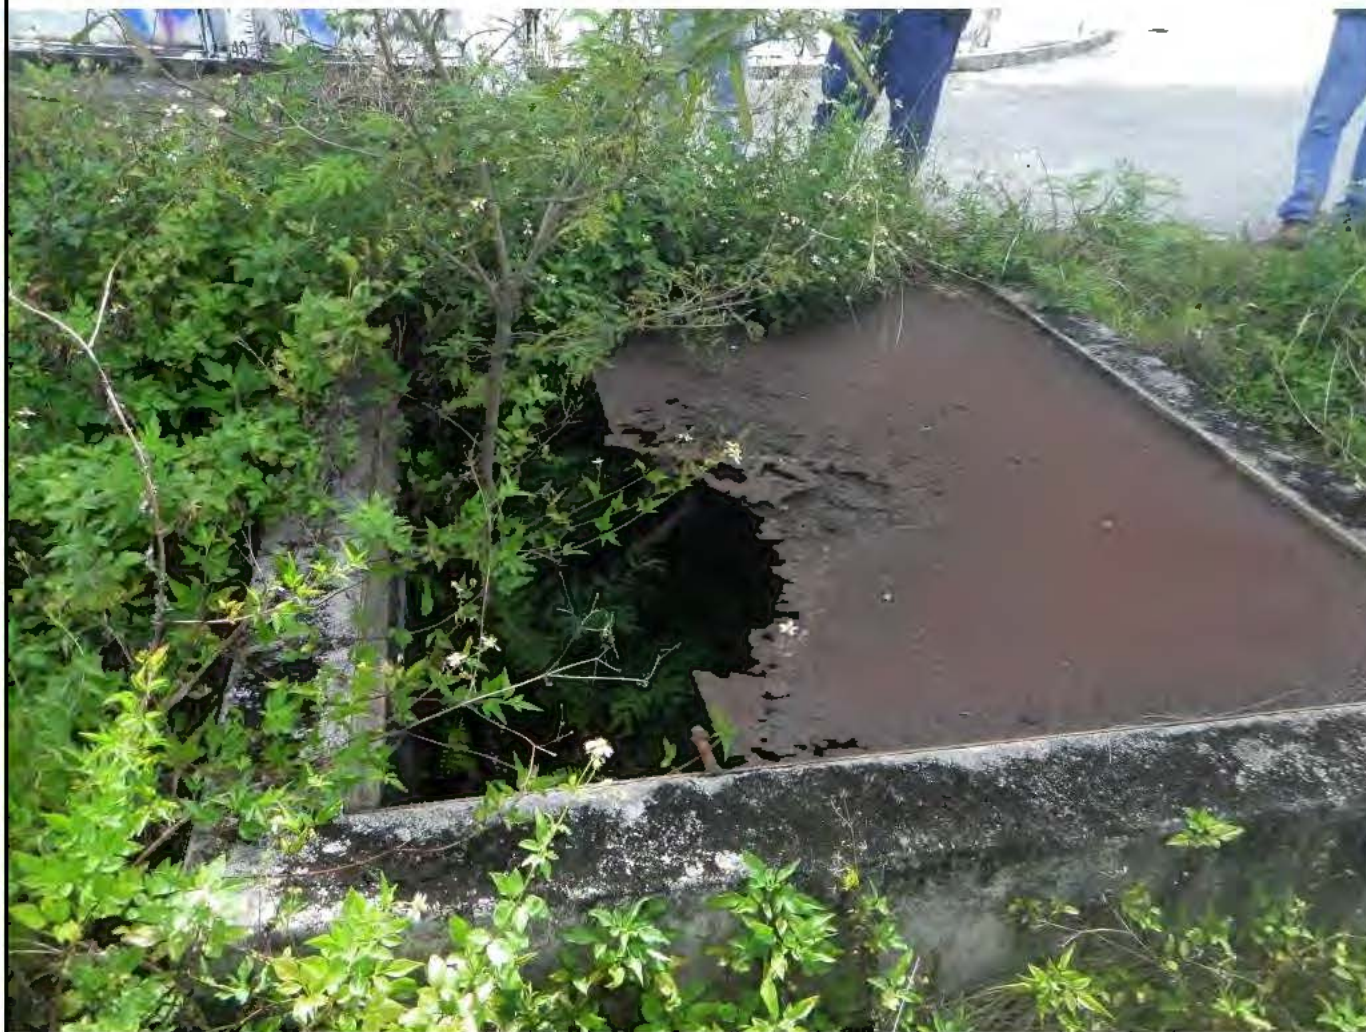
File Name: RIMG0148.JPG

Title	Guam Waterworks Authority (VP0989)
Subject	Northern System
Latitude	[REDACTED]
Longitude	[REDACTED]
Photo Direction	[REDACTED]
Elevation	[REDACTED]
Date Time Stamp	4/27/2012 2:21:25 PM
Photographer	K. Sable
Comment	Yigo # 1 Tank
Description	Valve pit

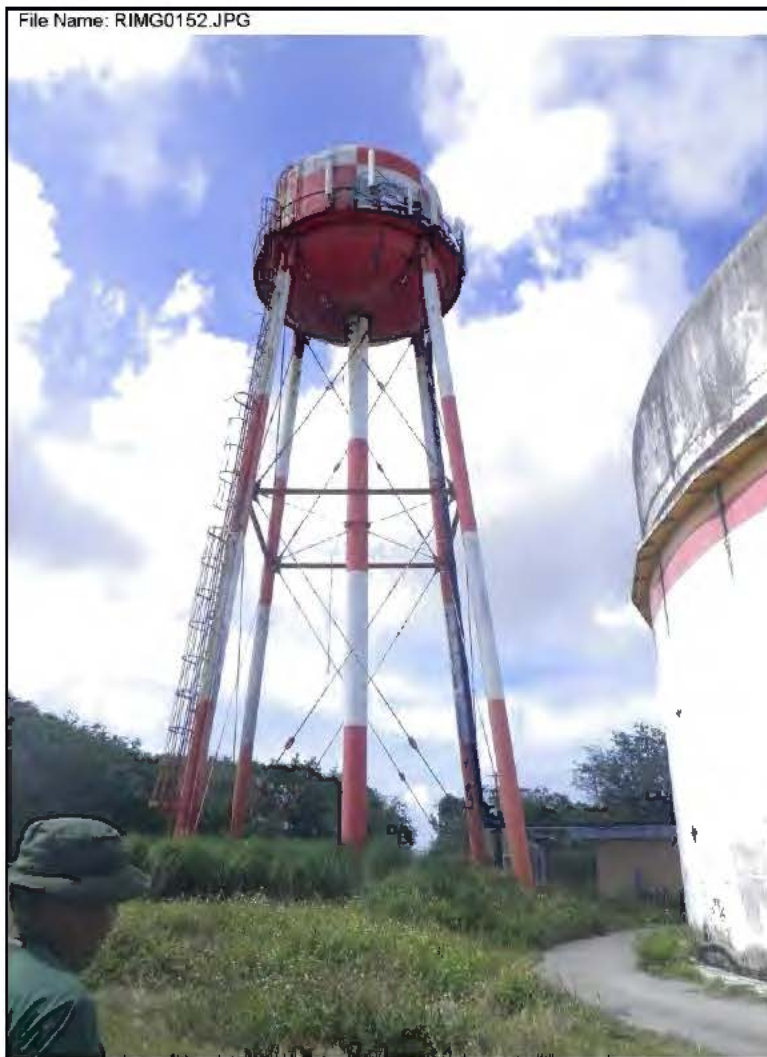
Attributes	
Title	Guam Waterworks Authority (VP0989)
Subject	Northern System
Latitude	[REDACTED]
Longitude	[REDACTED]
Photo Direction	[REDACTED]
Elevation	[REDACTED]
Date Time Stamp	4/27/2012 2:36:25 PM
Photographer	K. Sable
Comment	Yigo # 3 Elevated Tank
Description	Overview of tank

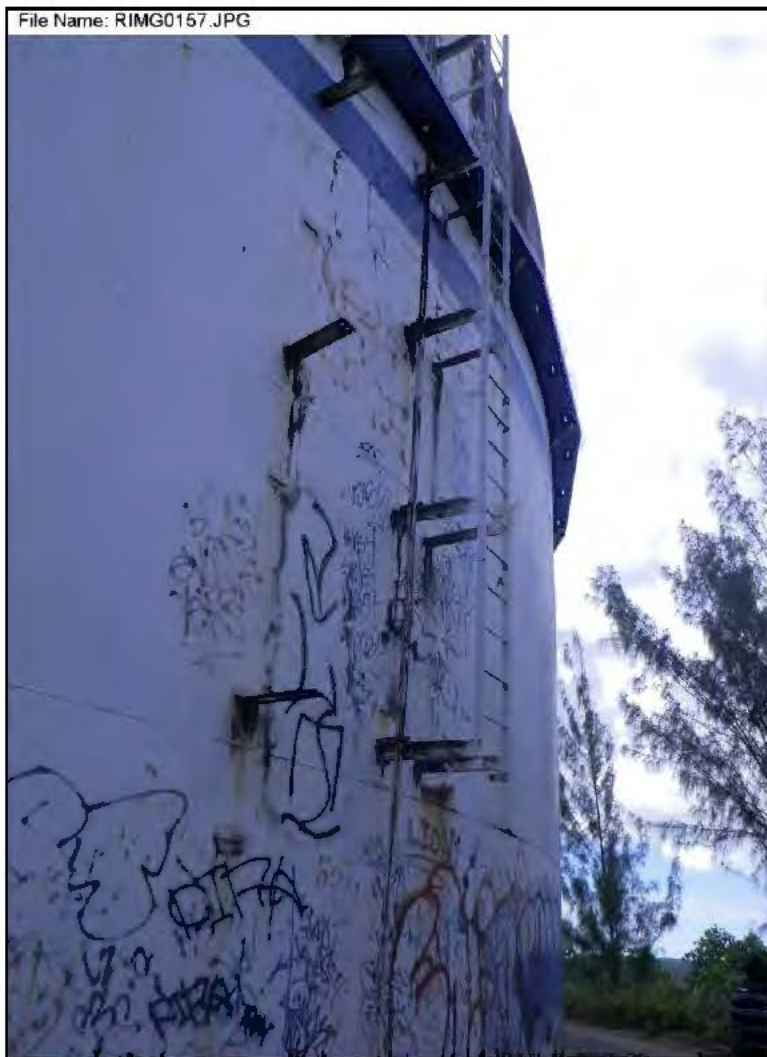
Attributes	
Title	Guam Waterworks Authority (VP0989)
Subject	Northern System
Latitude	[REDACTED]
Longitude	[REDACTED]
Photo Direction	[REDACTED]
Elevation	[REDACTED]
Date Time Stamp	4/27/2012 3:20:28 PM
Photographer	K. Sable
Comment	Barrigada # 3 Tank
Description	Ladder with no cage

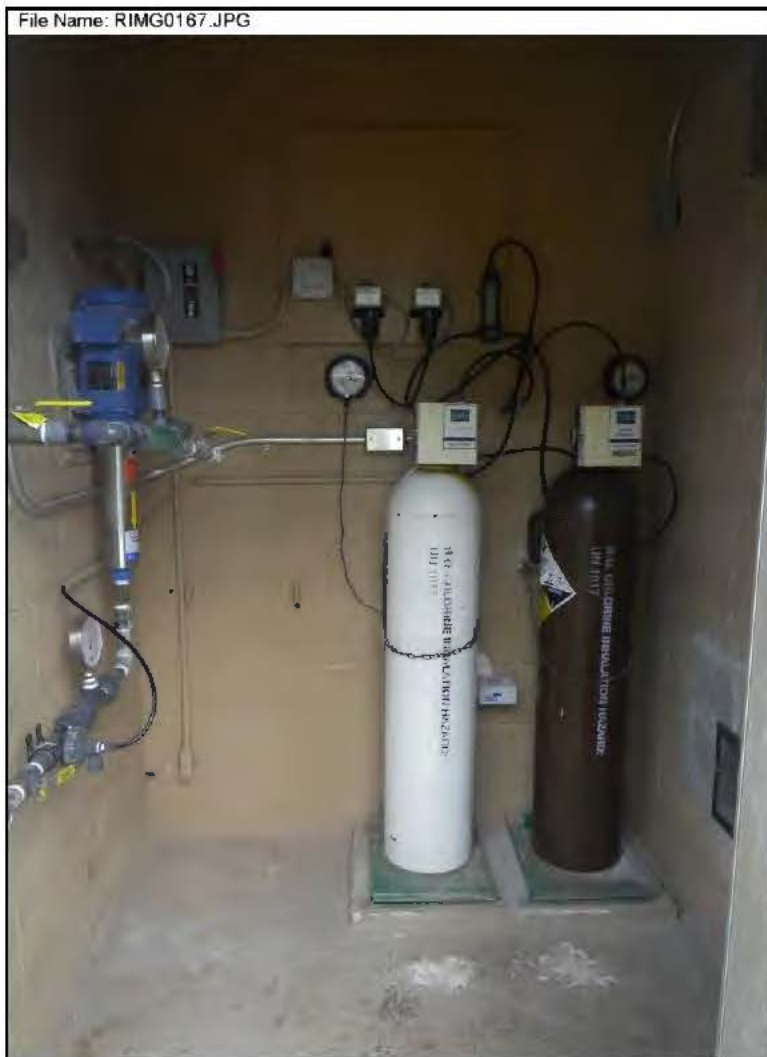
Attributes	
Title	Guam Waterworks Authority (VP0989)
Subject	Northern System
Latitude	[REDACTED]
Longitude	[REDACTED]
Photo Direction	[REDACTED]
Elevation	[REDACTED]
Date Time Stamp	4/30/2012 9:42:43 AM
Photographer	K. Sable
Comment	A 31 Well
Description	Chlorine room

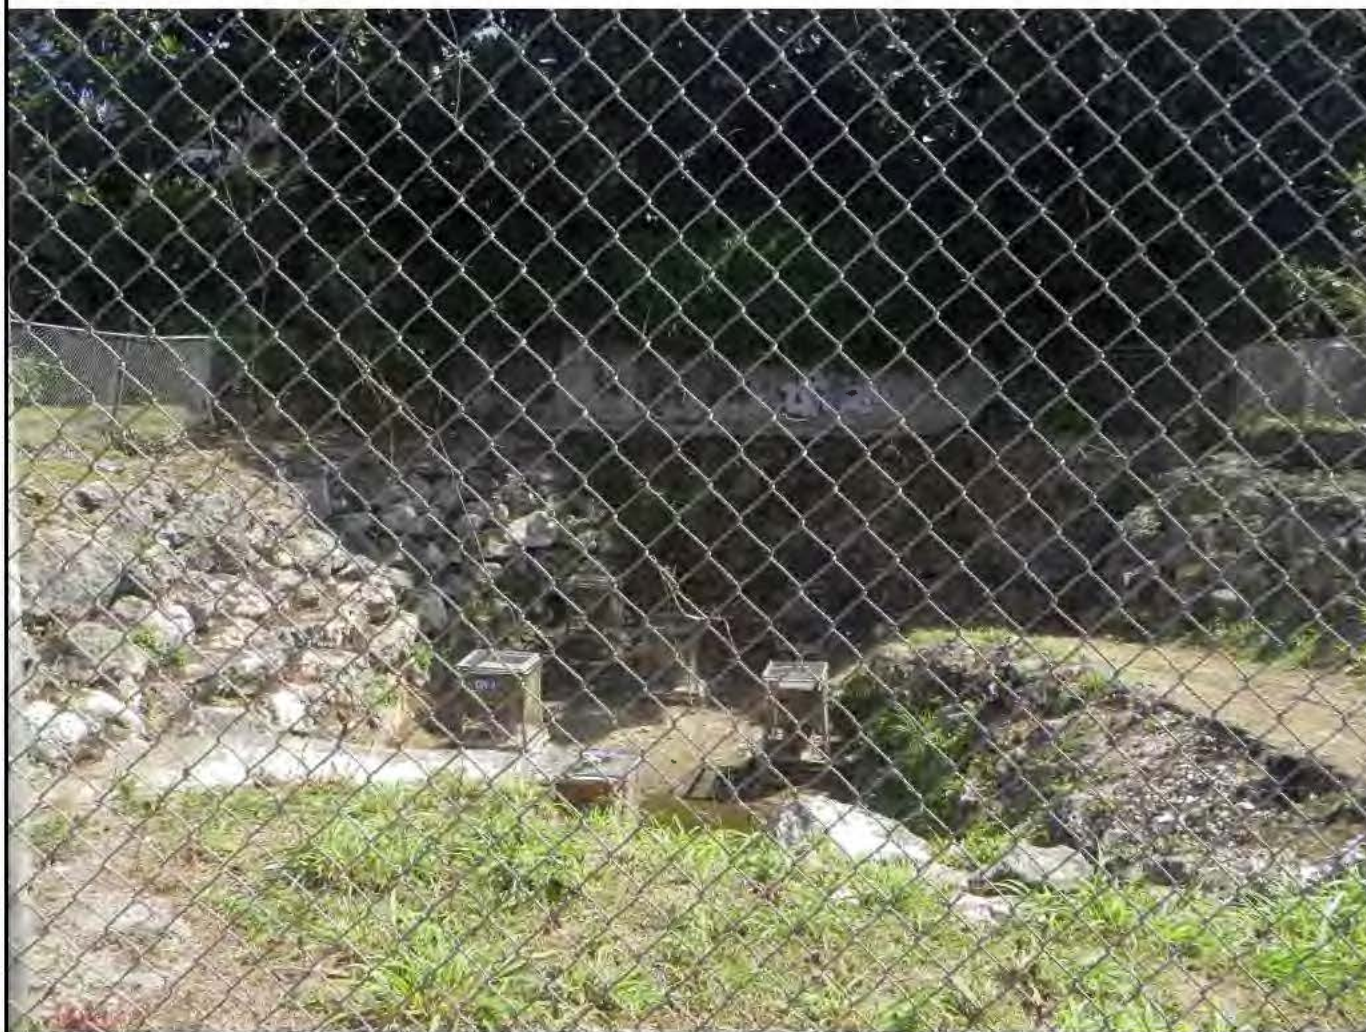
File Name: RIMG0169.JPG

Title	Guam Waterworks Authority (VP0989)
Subject	Northern System
Latitude	[REDACTED]
Longitude	[REDACTED]
Photo Direction	[REDACTED]
Elevation	[REDACTED]
Date Time Stamp	4/30/2012 9:55:10 AM
Photographer	K. Sable
Comment	UIC Ponding Basin
Description	Overview

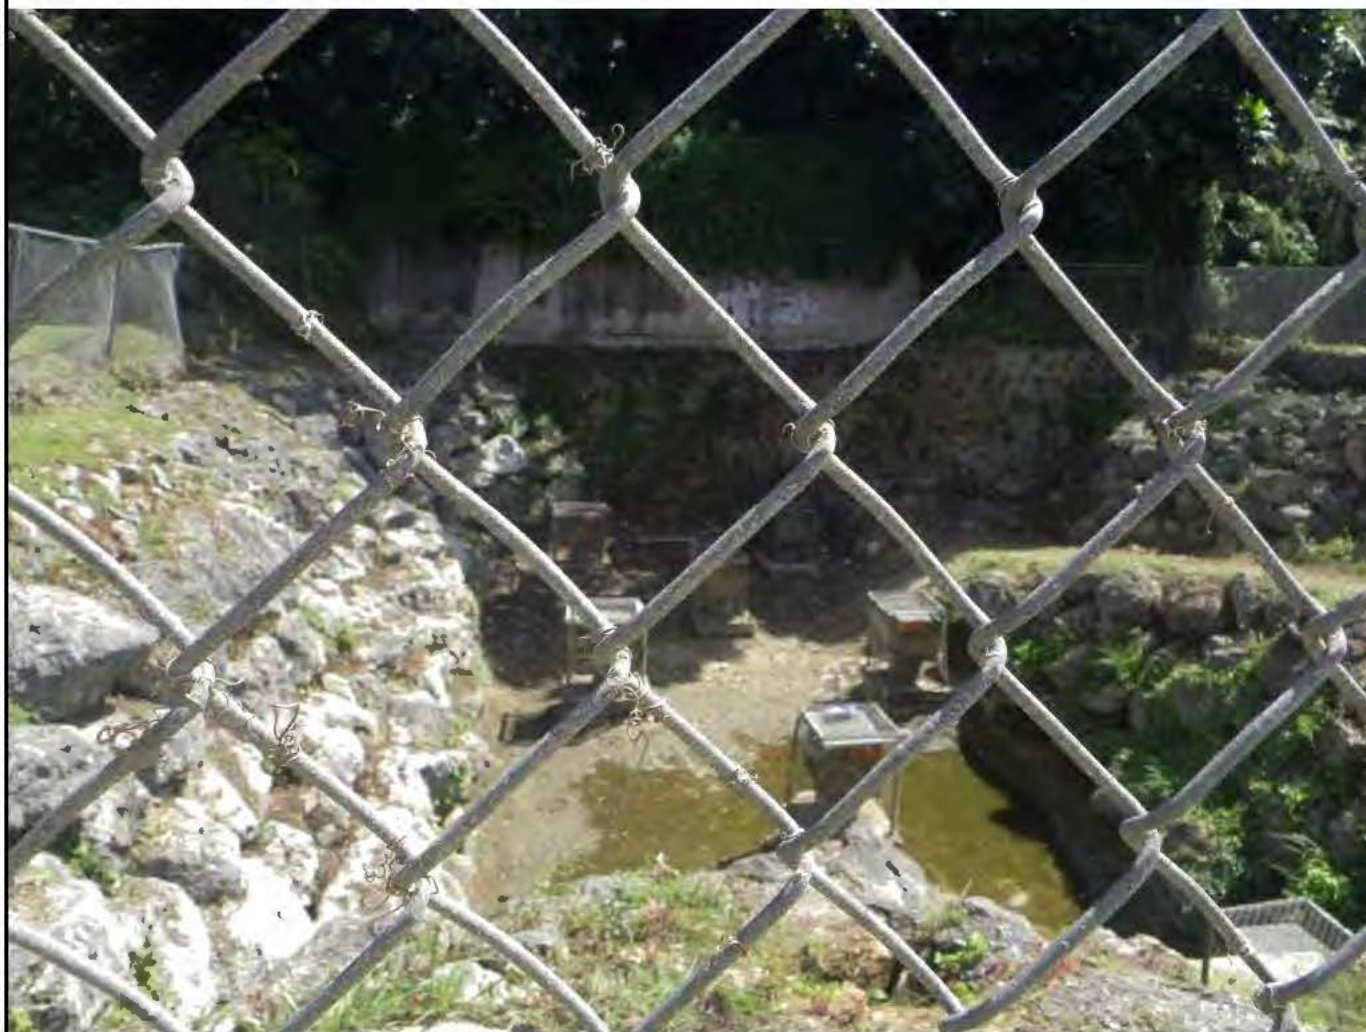
File Name: RIMG0170.JPG

Title	Guam Waterworks Authority (VP0989)
Subject	Northern System
Latitude	[REDACTED]
Longitude	[REDACTED]
Photo Direction	[REDACTED]
[REDACTED]	[REDACTED]
Date Time Stamp	4/30/2012 9:58:18 AM
Photographer	K. Sable
Comment	UIC Ponding Basin
Description	Overview

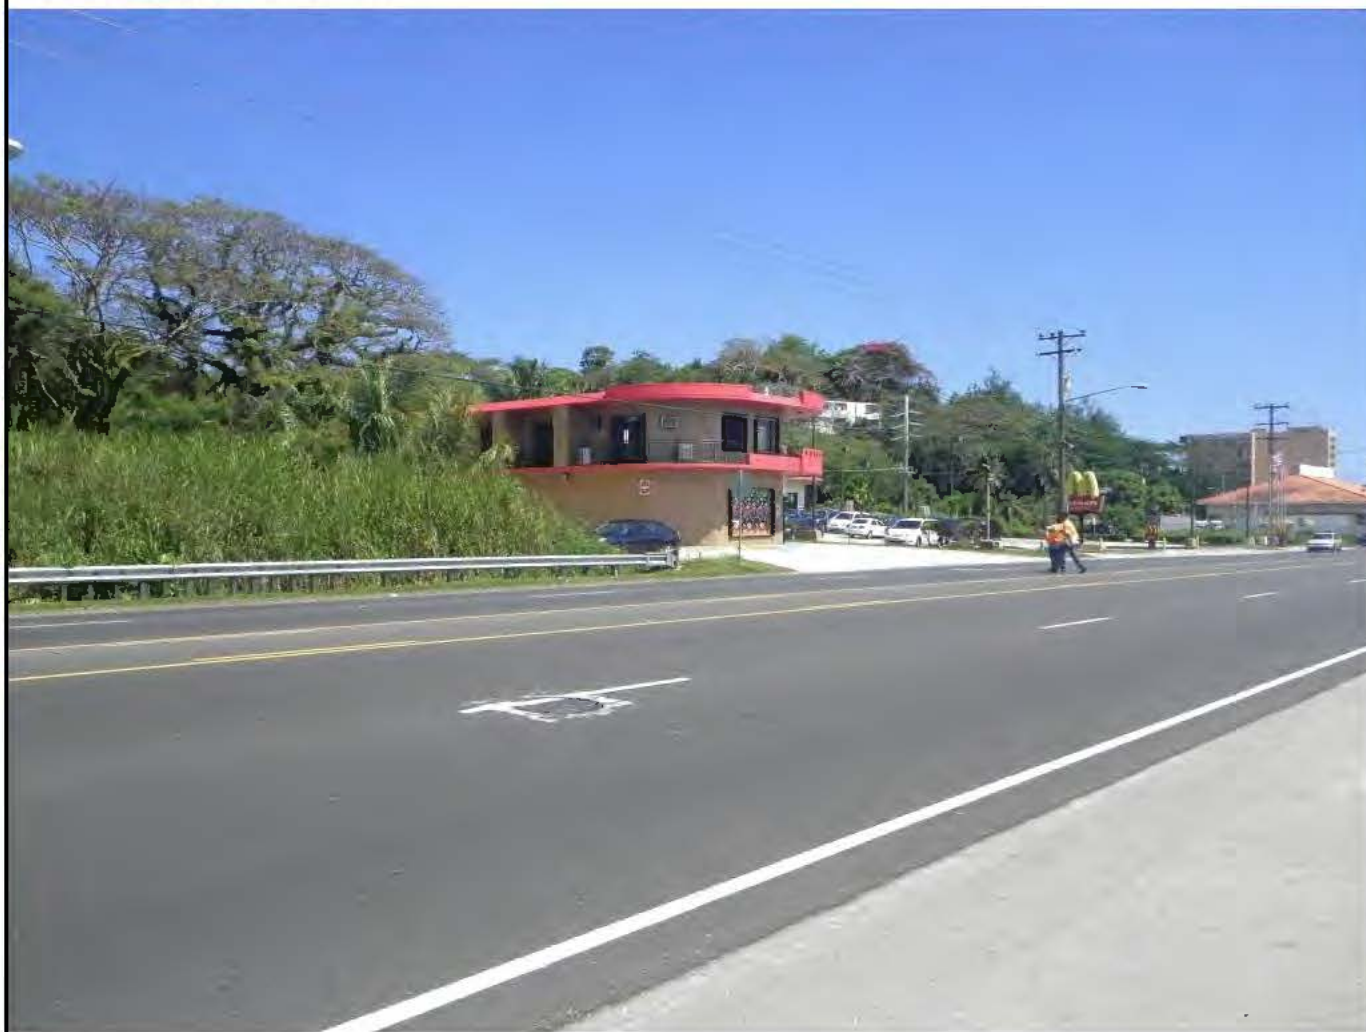
File Name: RIMG0172.JPG

Title	Guam Waterworks Authority (VP0989)
Subject	Northern System
Latitude	[REDACTED]
Longitude	[REDACTED]
Photo Direction	[REDACTED]
Elevation	[REDACTED]
Date Time Stamp	4/30/2012 10:19:17 AM
Photographer	K. Sable
Comment	Previous SSO Manhole Location
Description	Manhole on Route 4 near McDonalds

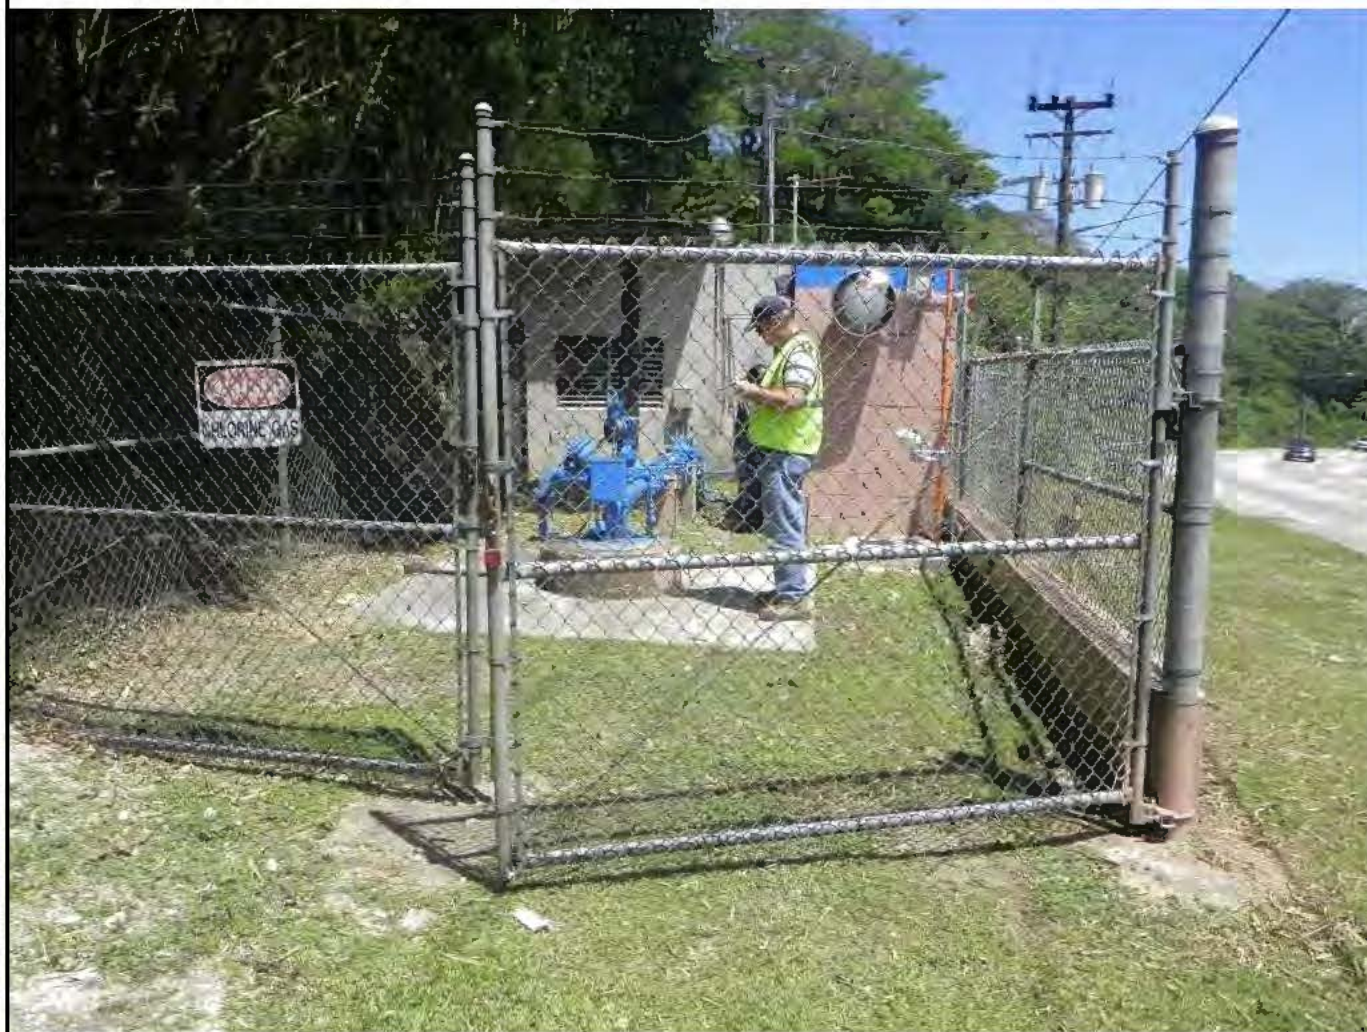
File Name: RIMG0176.JPG

Title	Guam Waterworks Authority (VP0989)
Subject	Northern System
Latitude	[REDACTED]
Longitude	[REDACTED]
Photo Direction	[REDACTED]
Elevation	[REDACTED]
Date Time Stamp	4/30/2012 10:53:51 AM
Photographer	K. Sable
Comment	A 25 Well
Description	Overview of well

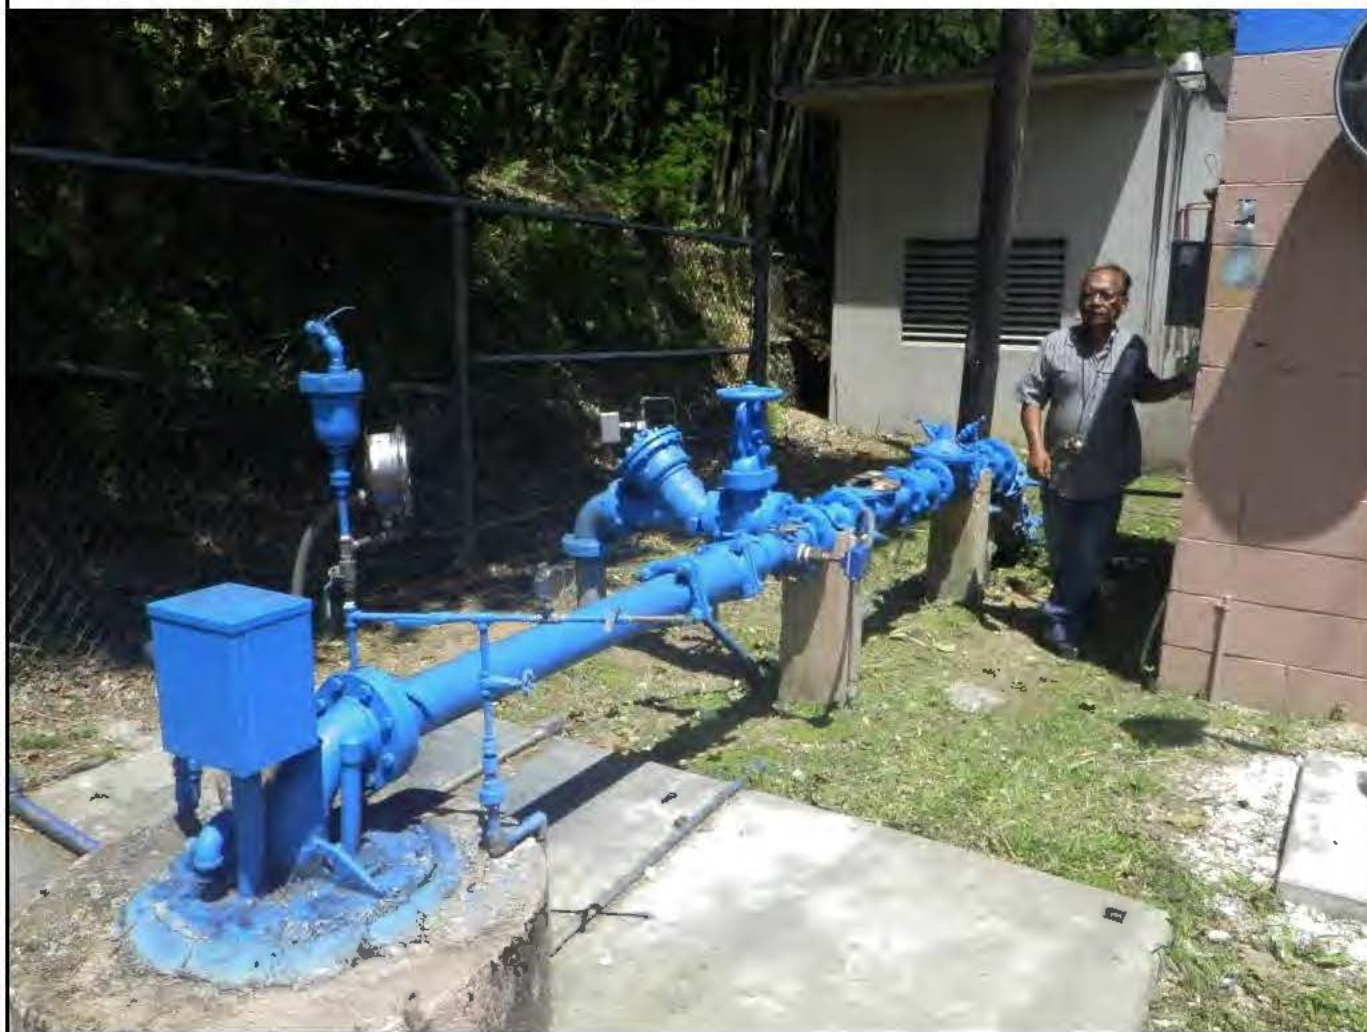
File Name: RIMG0177.JPG

Title	Guam Waterworks Authority (VP0989)
Subject	Northern System
Latitude	██████████
Longitude	██████████
Photo Direction	██████ /
Elevation	████
Date Time Stamp	4/30/2012 10:54:07 AM
Photographer	K. Sable
Comment	A 25 Well
Description	Well assembly

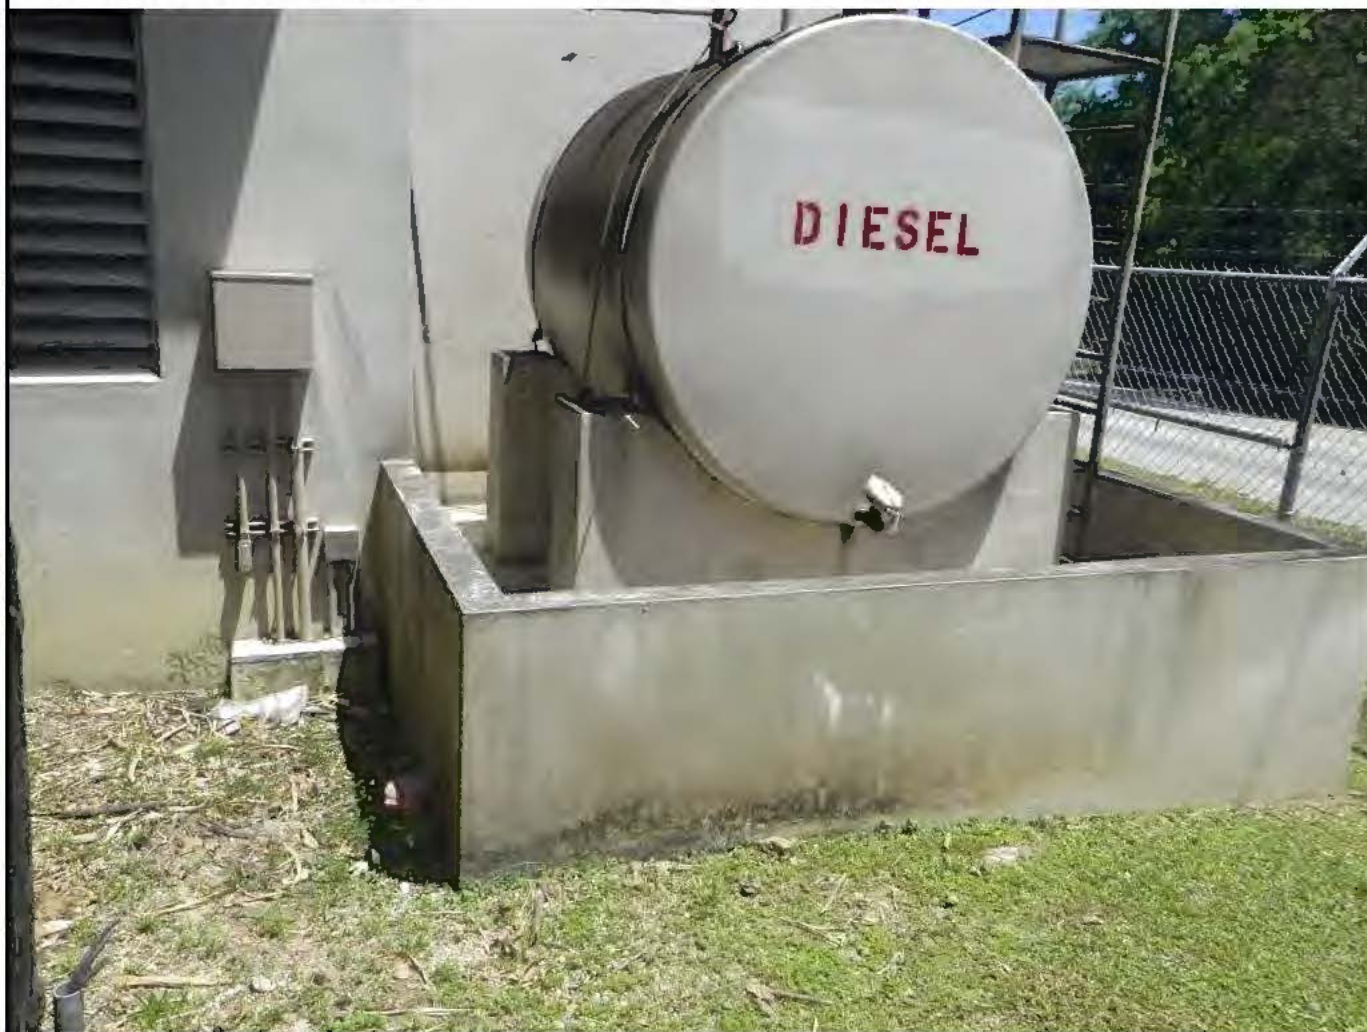
File Name: RIMG0178.JPG

Title	Guam Waterworks Authority (VP0989)
Subject	Northern System
Latitude	[REDACTED]
Longitude	[REDACTED]
Photo Direction	[REDACTED]
[REDACTED]	[REDACTED]
Date Time Stamp	4/30/2012 11:00:22 AM
Photographer	K. Sable
Comment	A 25 Well
Description	Deisel fuel tank with discharge to ground near well head

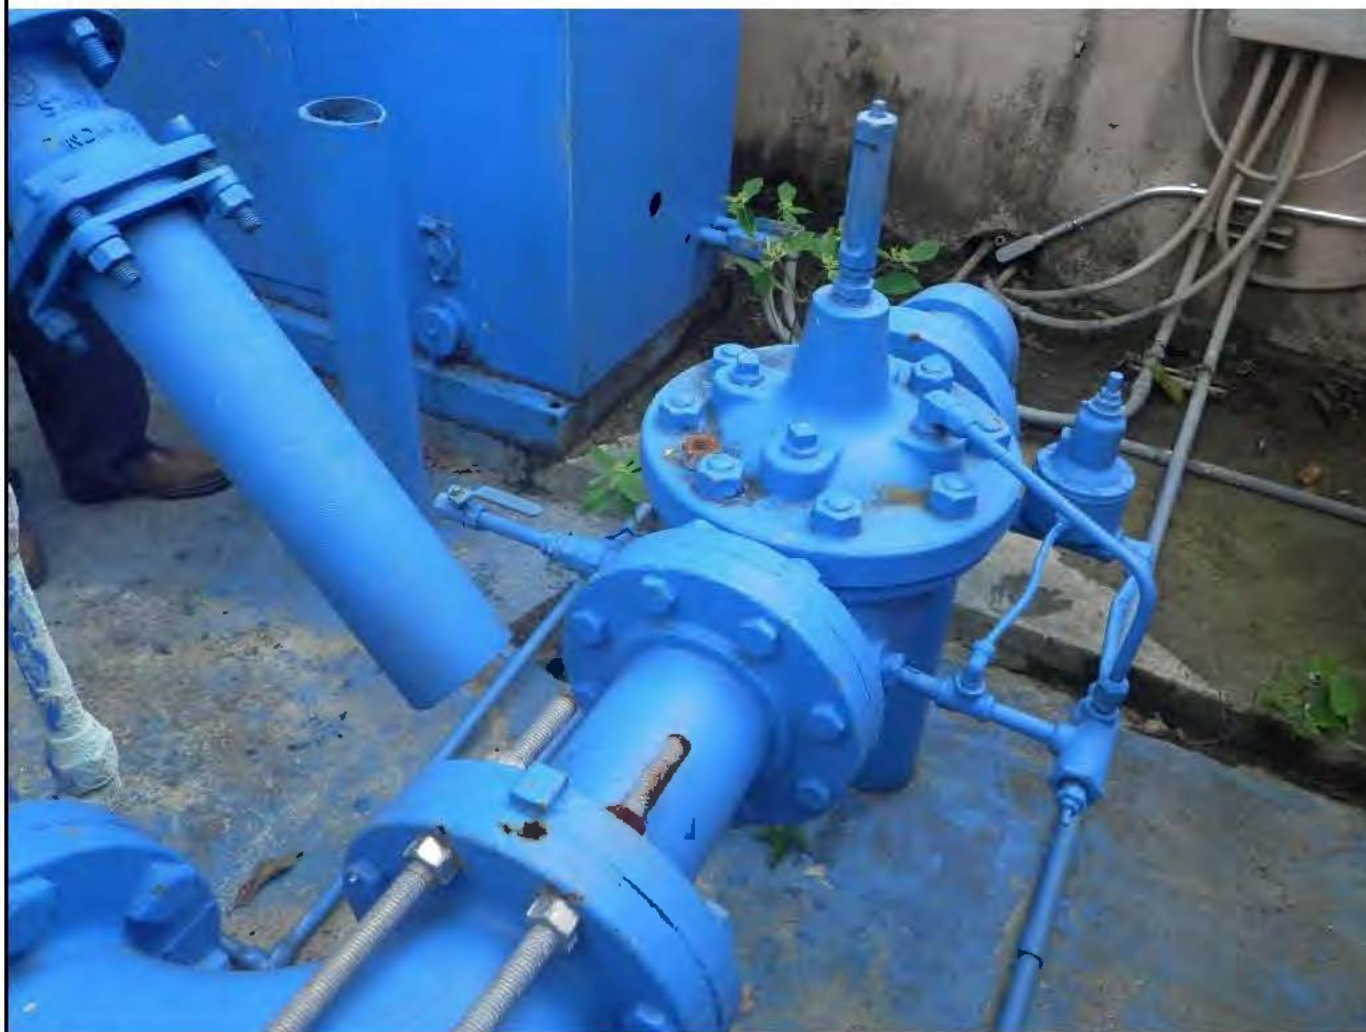
File Name: RIMG0182.JPG

Title	Guam Waterworks Authority (VP0989)
Subject	Northern System
Latitude	██████████
Longitude	██████████
Photo Direction	██████████
Elevation	██████████
Date Time Stamp	4/30/2012 1:32:49 PM
Photographer	K. Sable
Comment	A 1 Well
Description	Bypass and check valves

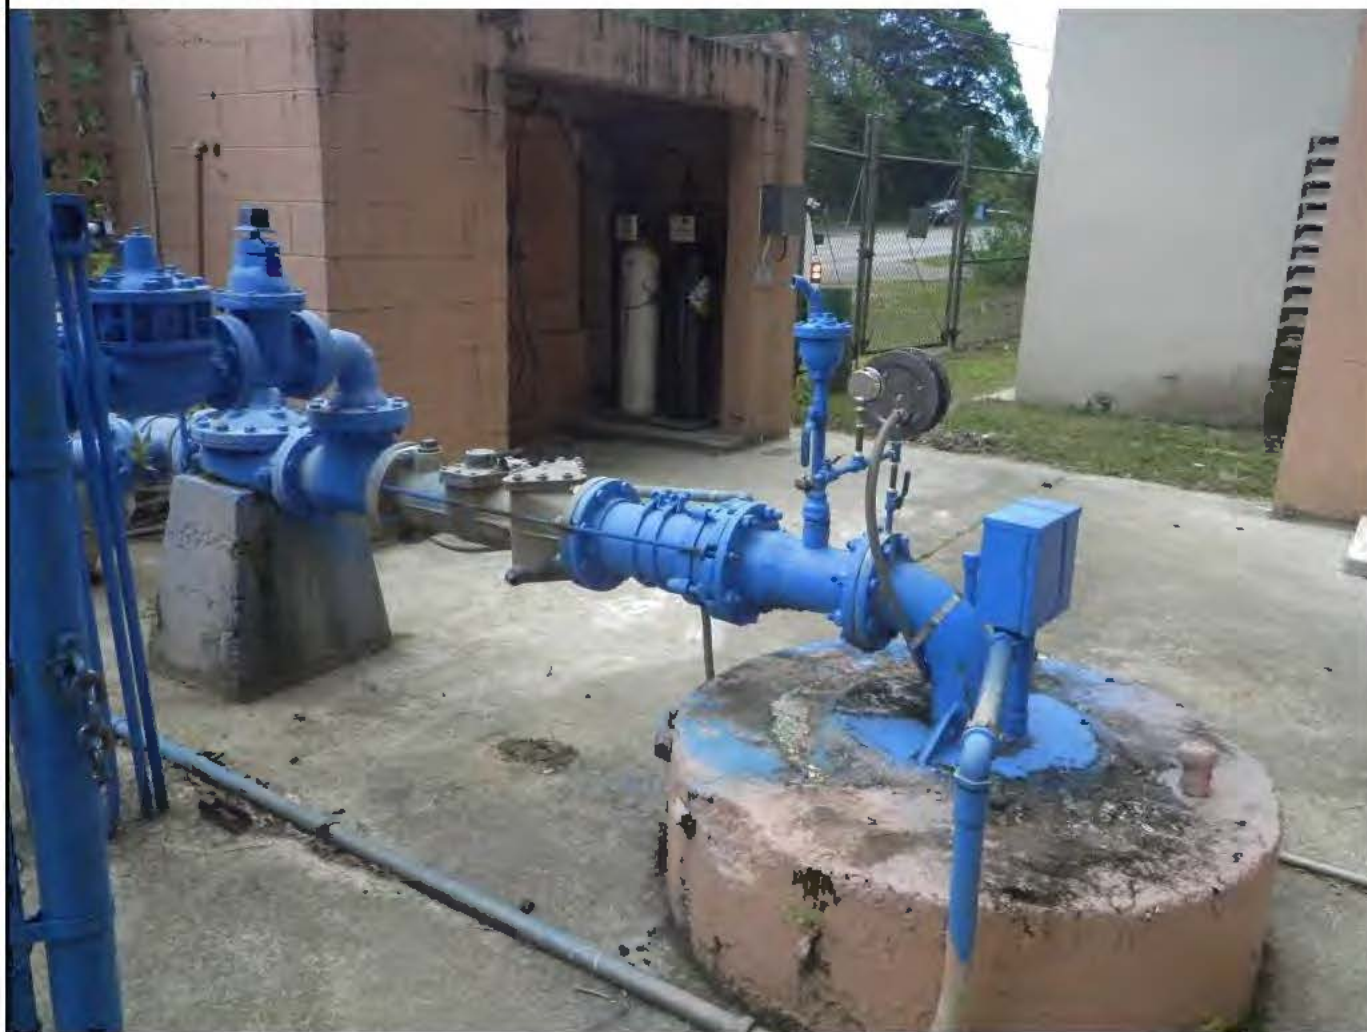
File Name: RIMG0184.JPG

Title	Guam Waterworks Authority (VP0989)
Subject	Northern System
Latitude	██████████
Longitude	██████████
Photo Direction	██████████
Elevation	██████████
Date Time Stamp	4/30/2012 1:49:44 PM
Photographer	K. Sable
Comment	A 3 Well
Description	Well assembly

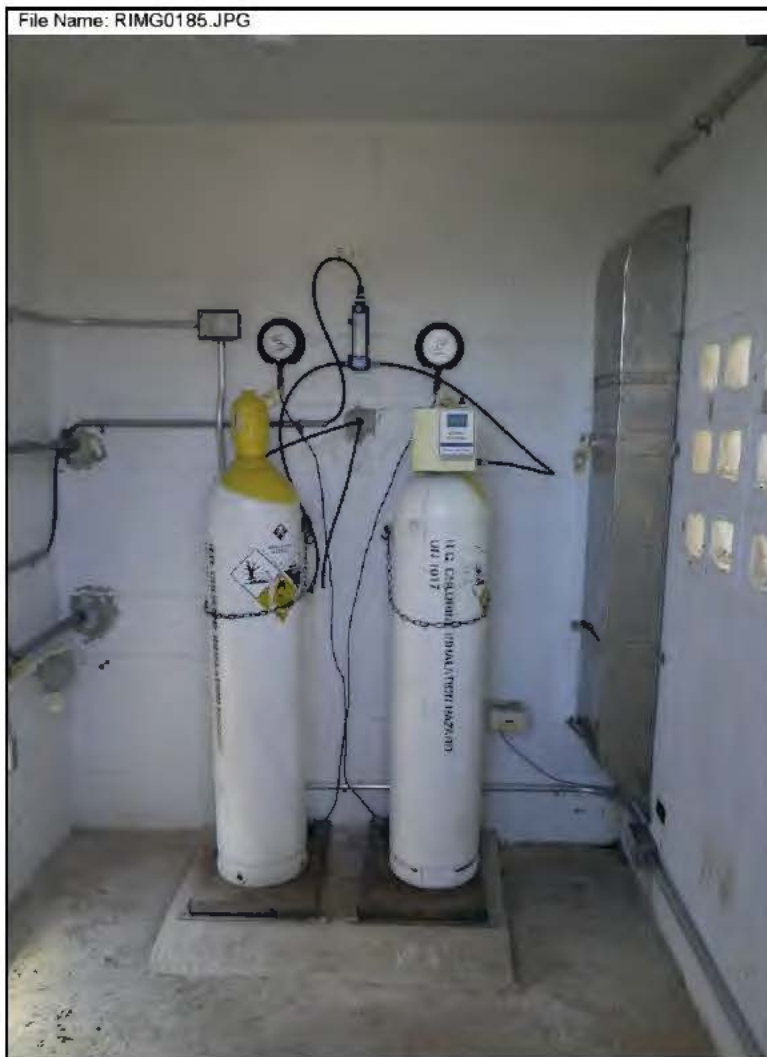
Attributes	
Title	Guam Waterworks Authority (VP0989)
Subject	Northern System
Latitude	[REDACTED]
Longitude	[REDACTED]
Photo Direction	[REDACTED]
Elevation	[REDACTED]
Date Time Stamp	4/30/2012 2:45:00 PM
Photographer	K. Sable
Comment	A 9 Well
Description	Chlorine tanks
