Guam Waterworks Authority (VP0989)

SDWA Sanitary Survey

Northern System

NEIC Field Investigation Photographs

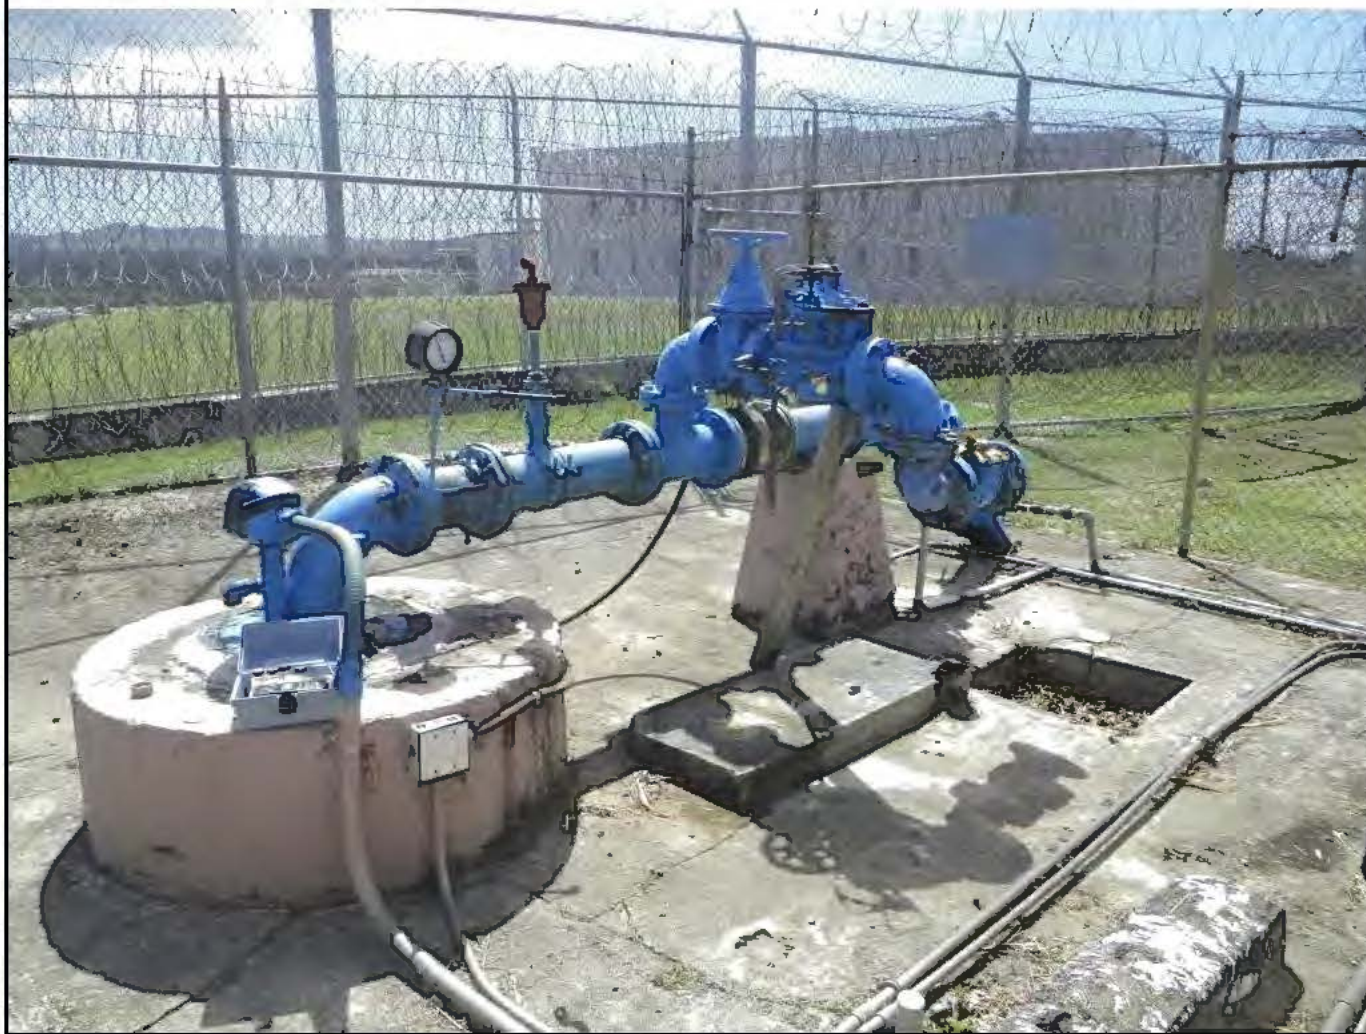
File Name: RIMG0186.JPG

Title	Guam Waterworks Authority (VP0989)
Subject	Northern System
Latitude	[REDACTED]
Longitude	[REDACTED]
Photo Direction	[REDACTED]
Elevation	[REDACTED]
Date Time Stamp	4/30/2012 2:46:02 PM
Photographer	K. Sable
Comment	A 9 Well
Description	Well assembly

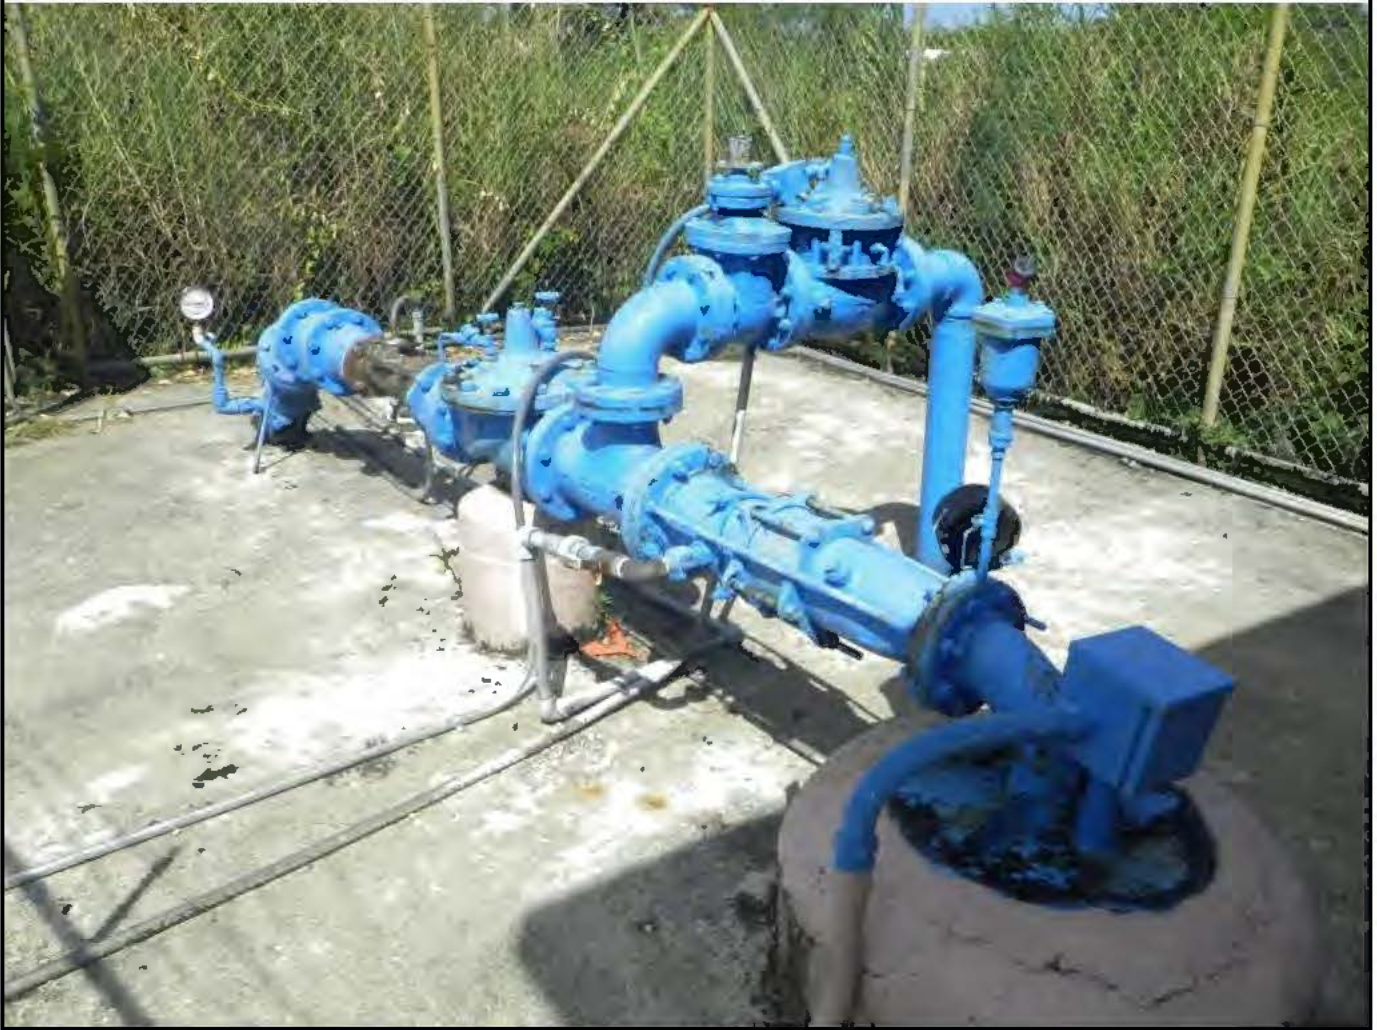
File Name: RIMG0187.JPG

Title	Guam Waterworks Authority (VP0989)
Subject	Northern System
Latitude	██████████
Longitude	██████████
Photo Direction	██████████
Elevation	██████████
Date Time Stamp	4/30/2012 2:54:42 PM
Photographer	K. Sable
Comment	A 10 Well
Description	Overview of well assembly (not in operation)

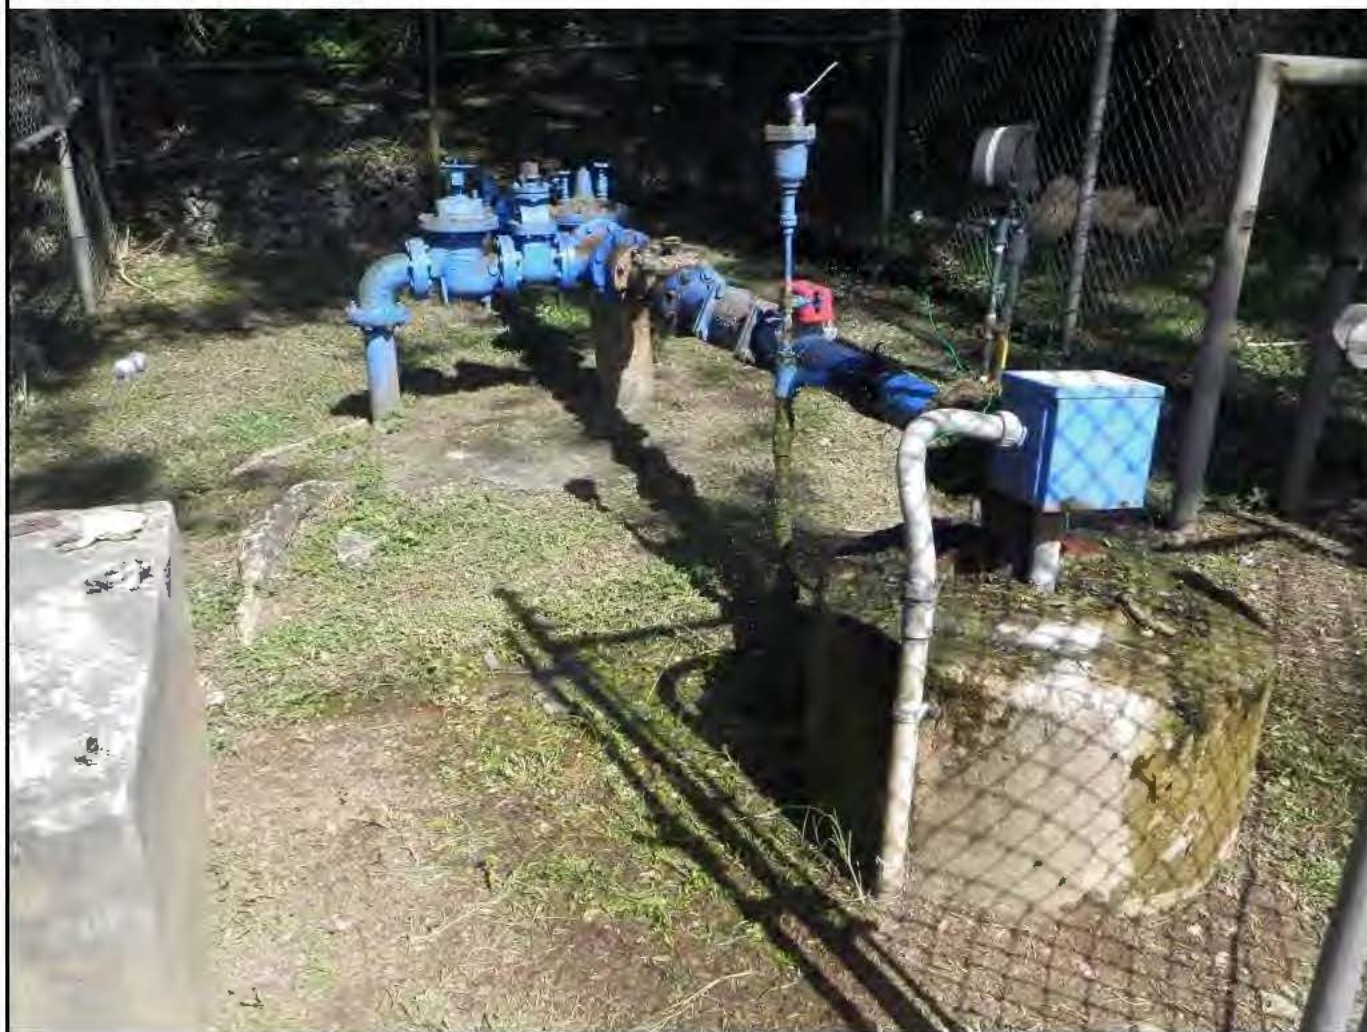
File Name: RIMG0188.JPG

Title	Guam Waterworks Authority (VP0989)
Subject	Northern System
Latitude	██████████
Longitude	██████████
Photo Direction	██████
Elevation	████
Date Time Stamp	4/30/2012 3:19:58 PM
Photographer	K. Sable
Comment	A 21 Well
Description	Well assembly

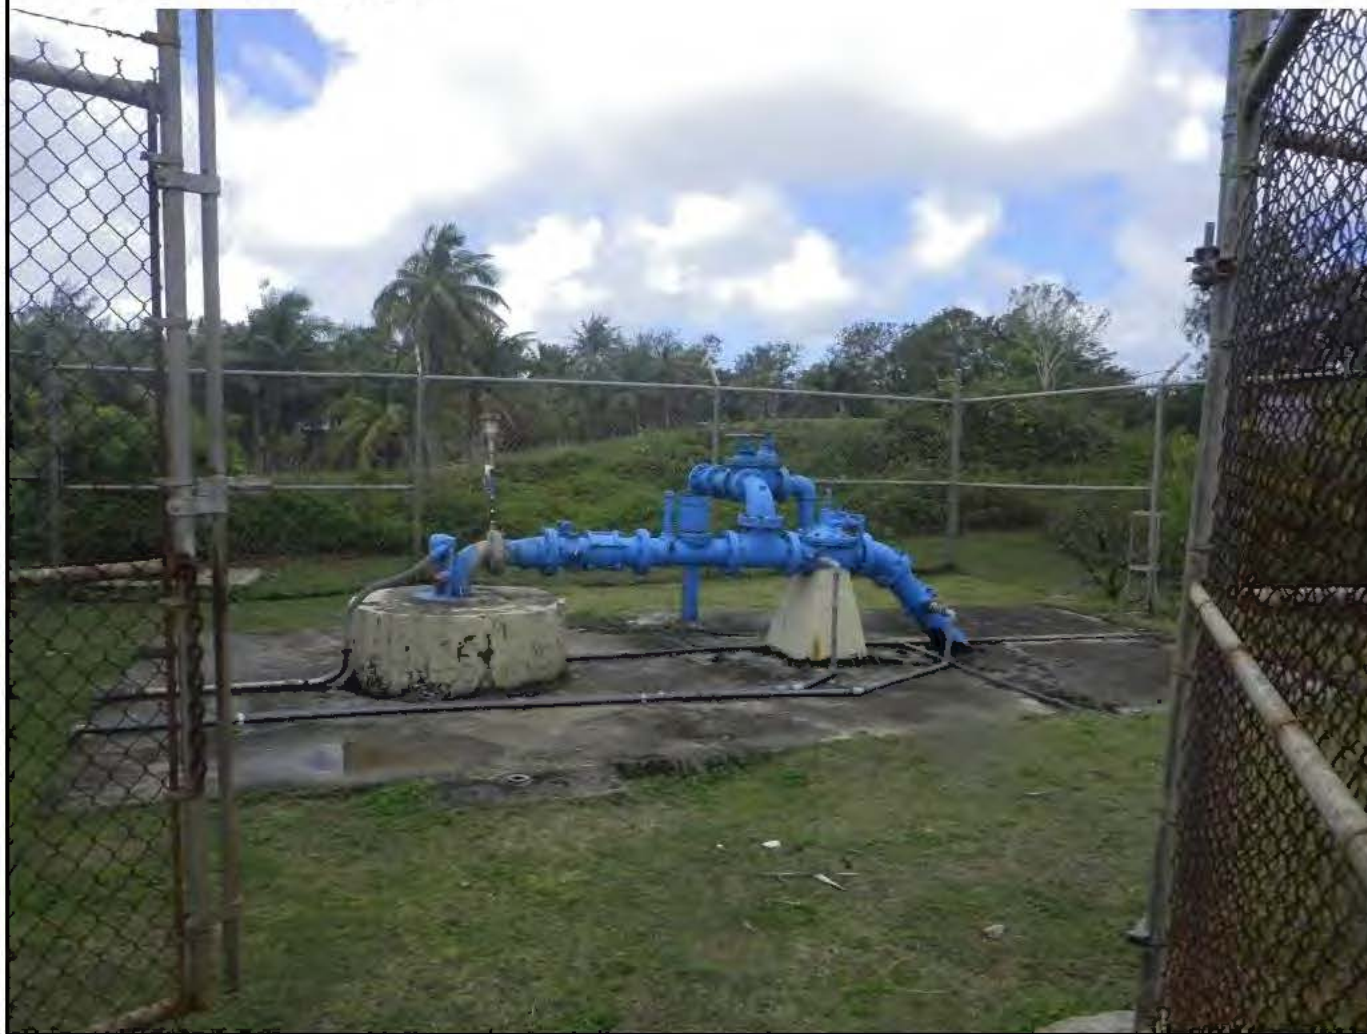
File Name: RIMG0190.JPG

Title	Guam Waterworks Authority (VP0989)
Subject	Northern System
Latitude	[REDACTED]
Longitude	[REDACTED]
Photo Direction	[REDACTED]
Elevation	[REDACTED]
Date Time Stamp	5/1/2012 10:19:07 AM
Photographer	K. Sable
Comment	D 5 Well
Description	Well assembly

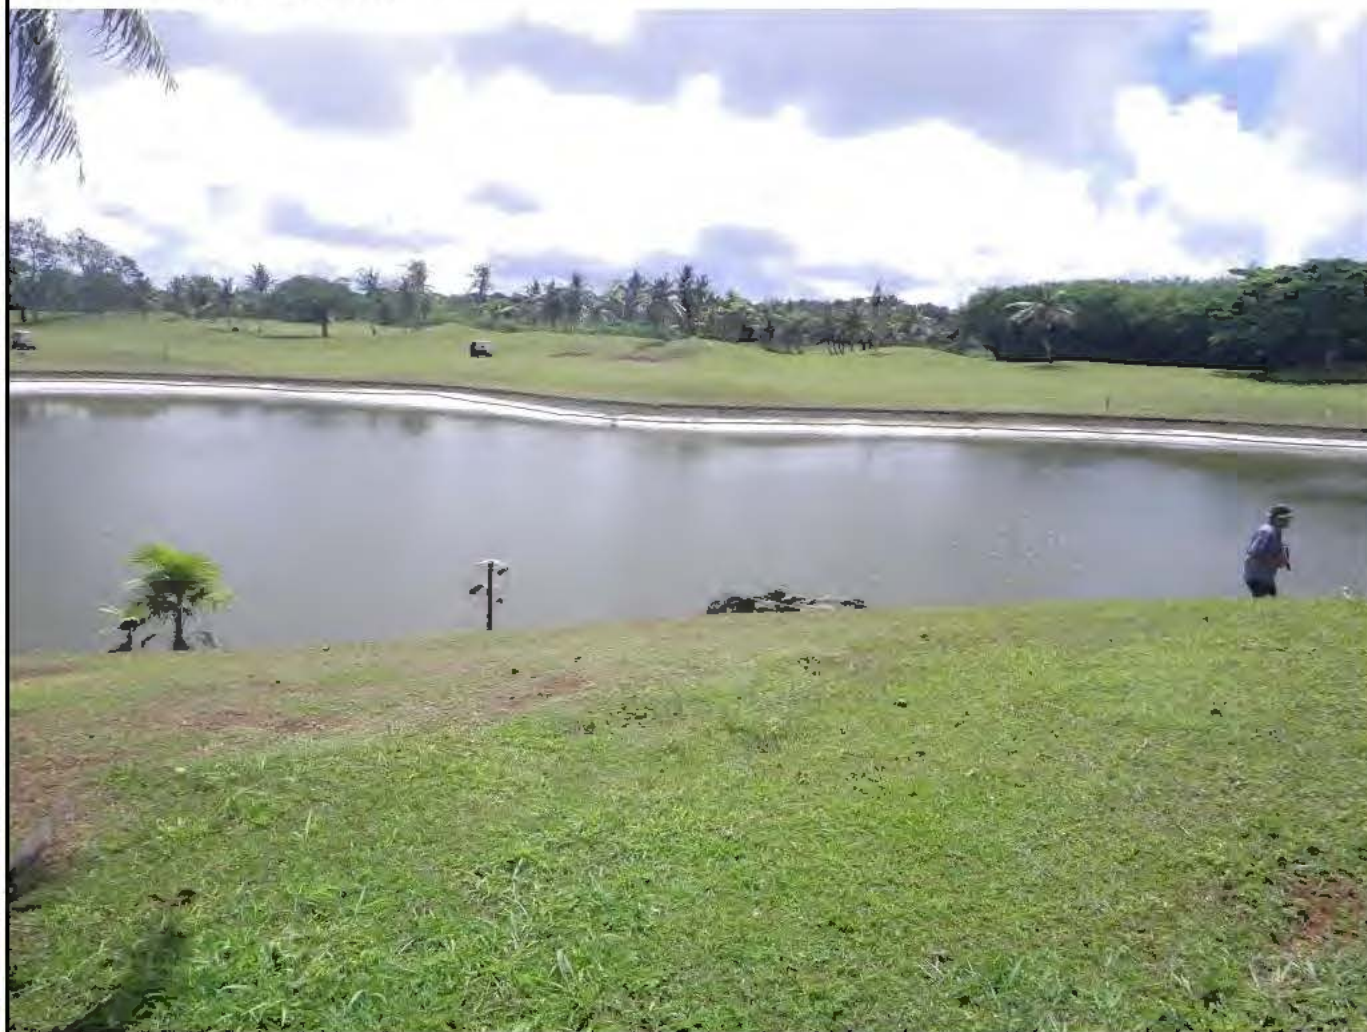
File Name: RIMG0191.JPG

Title	Guam Waterworks Authority (VP0989)
Subject	Northern System
Latitude	[REDACTED]
Longitude	[REDACTED]
Photo Direction	[REDACTED]
Elevation	[REDACTED]
Date Time Stamp	5/1/2012 10:31:52 AM
Photographer	K. Sable
Comment	D 5 Well
Description	From well fence line to lake at discharge location

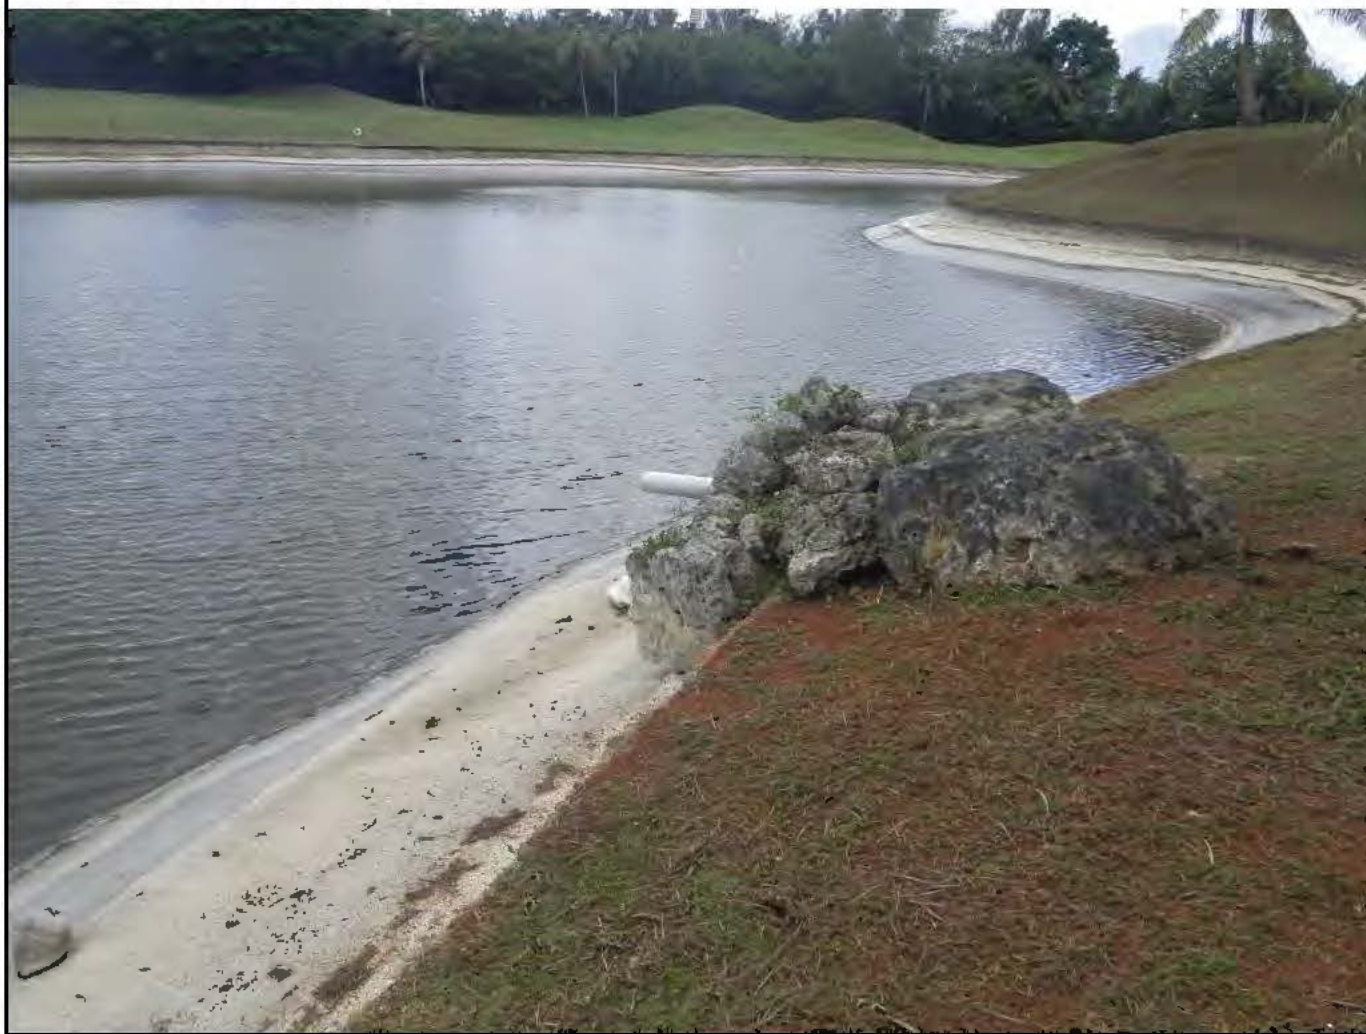
File Name: RIMG0192.JPG

Title	Guam Waterworks Authority (VP0989)
Subject	Northern System
Latitude	[REDACTED]
Longitude	[REDACTED]
Photo Direction	[REDACTED]
Elevation	[REDACTED]
Date Time Stamp	5/1/2012 10:33:36 AM
Photographer	K. Sable
Comment	D 5 Well
Description	Lake at discharge location

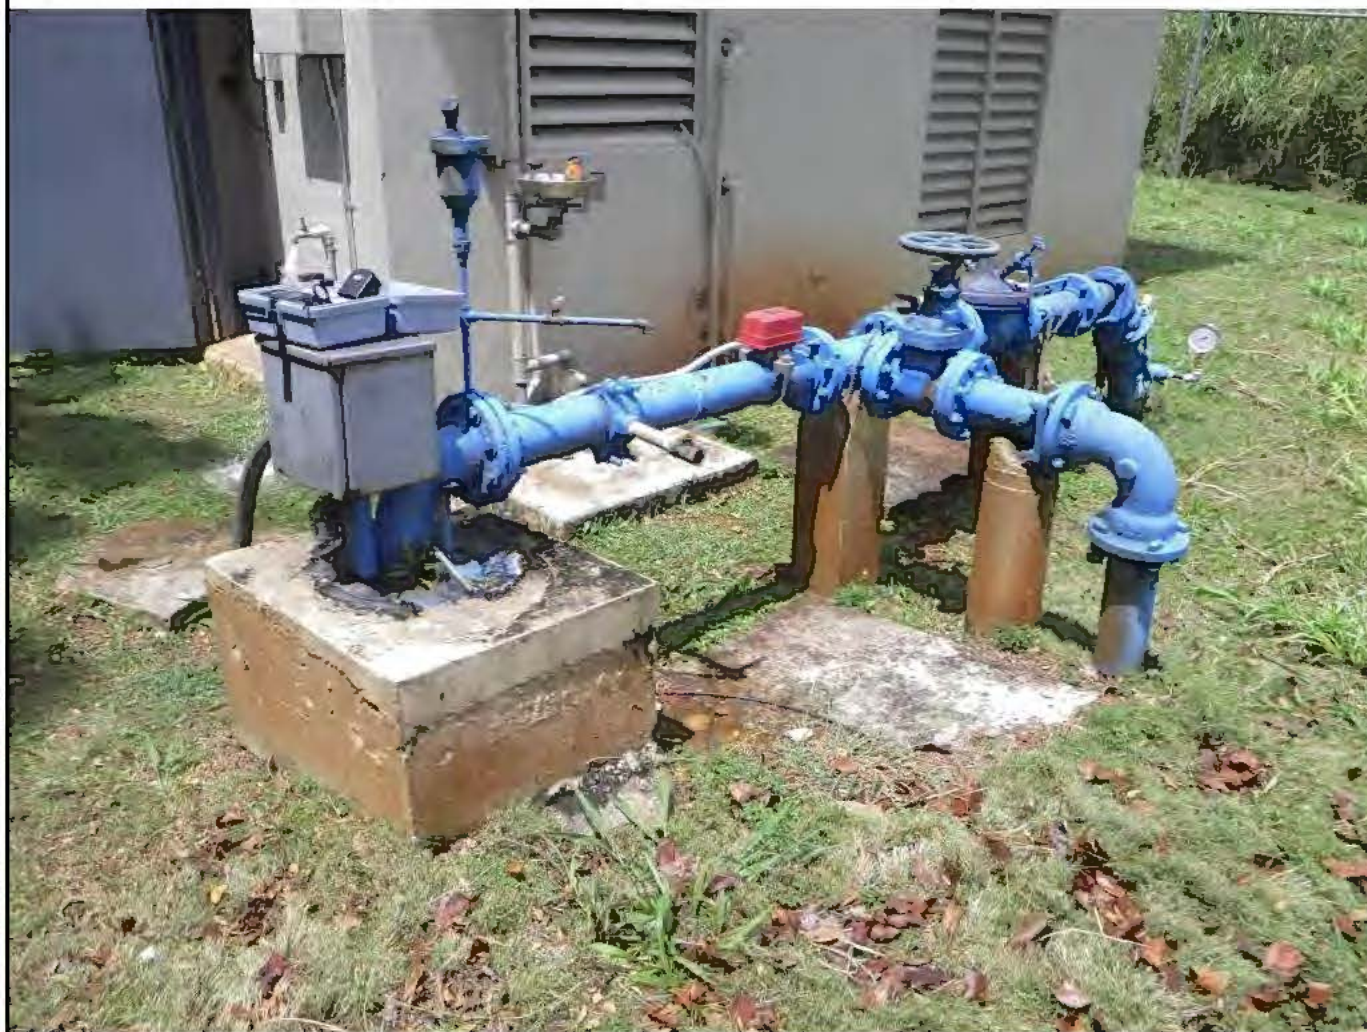
File Name: RIMG0193.JPG

Title	Guam Waterworks Authority (VP0989)
Subject	Northern System
Latitude	[REDACTED]
Longitude	[REDACTED]
Photo Direction	[REDACTED]
Elevation	[REDACTED]
Date Time Stamp	5/1/2012 10:49:26 AM
Photographer	K. Sable
Comment	EX 5 Well
Description	Minimal concrete pad not under well casement

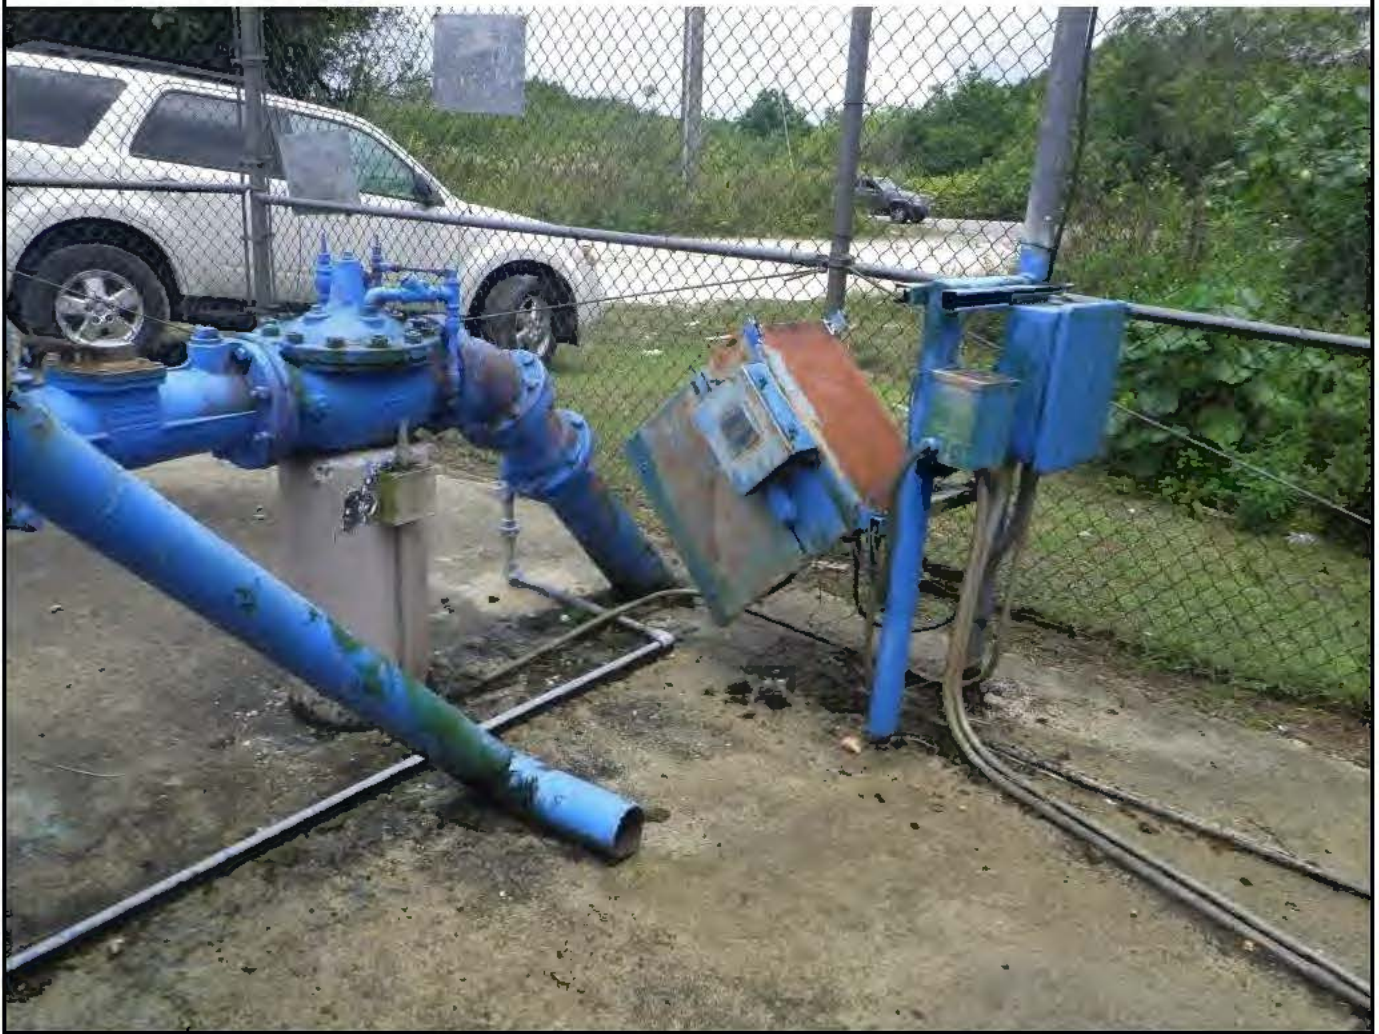
File Name: RIMG0194.JPG

Title	Guam Waterworks Authority (VP0989)
Subject	Northern System
Latitude	[REDACTED]
Longitude	[REDACTED]
Photo Direction	[REDACTED]
Elevation	[REDACTED]
Date Time Stamp	5/1/2012 11:32:22 AM
Photographer	K. Sable
Comment	D 7 Well
Description	Remote telemetry unit for previous SCADA system

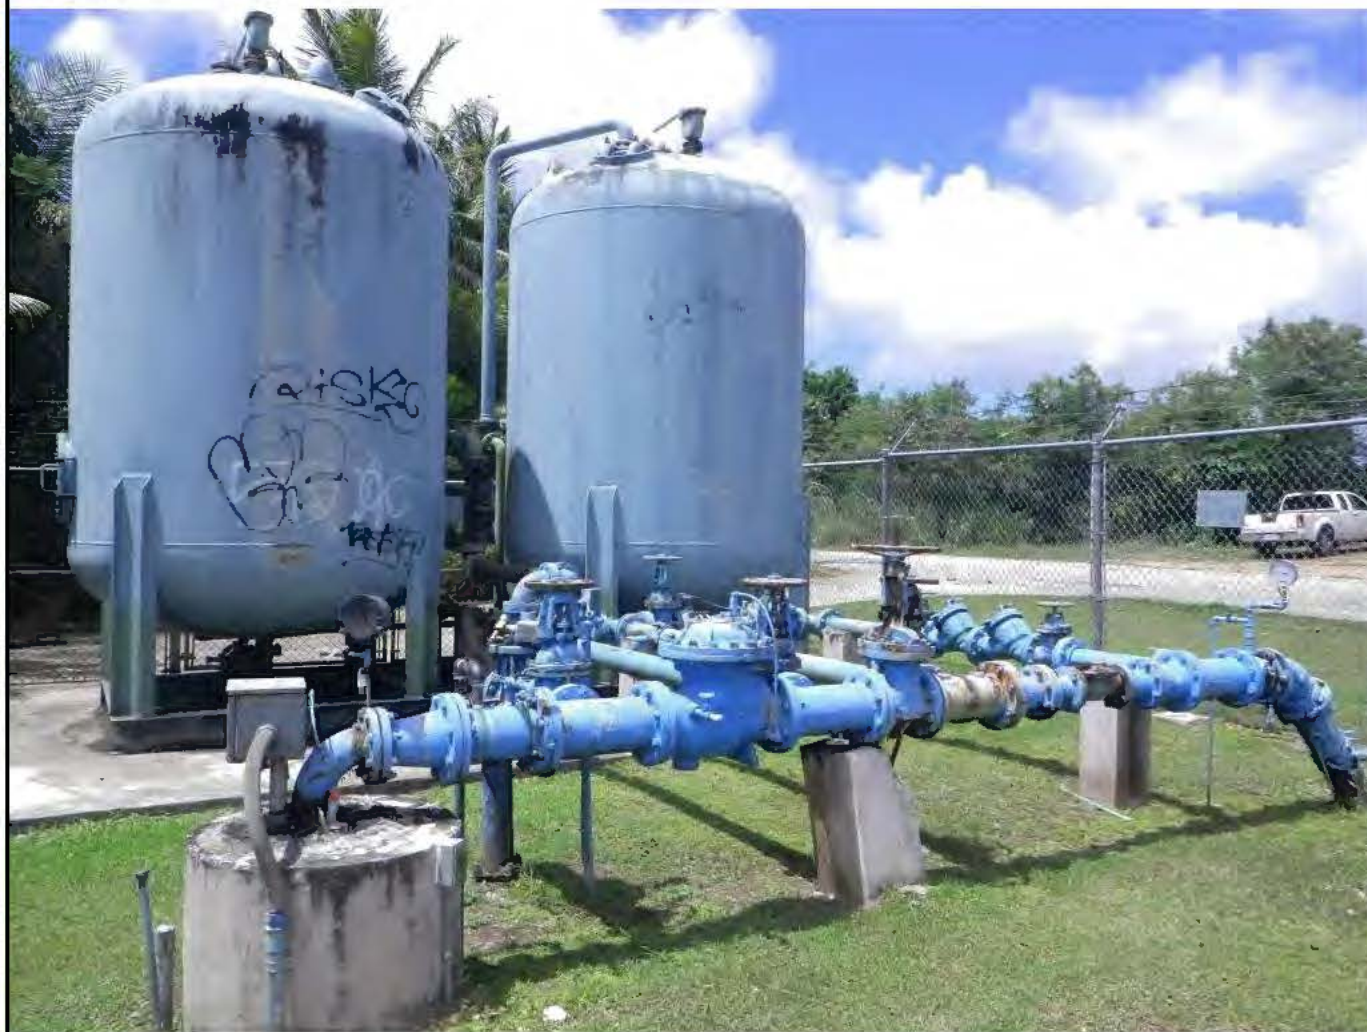
File Name: RIMG0196.JPG

Title	Guam Waterworks Authority (VP0989)
Subject	Northern System
Latitude	██████████
Longitude	██████████
Photo Direction	██████
Elevation	██████
Date Time Stamp	5/1/2012 1:32:54 PM
Photographer	K. Sable
Comment	F 8 Well
Description	Granular activated carbon (GAC) tanks and well assembly

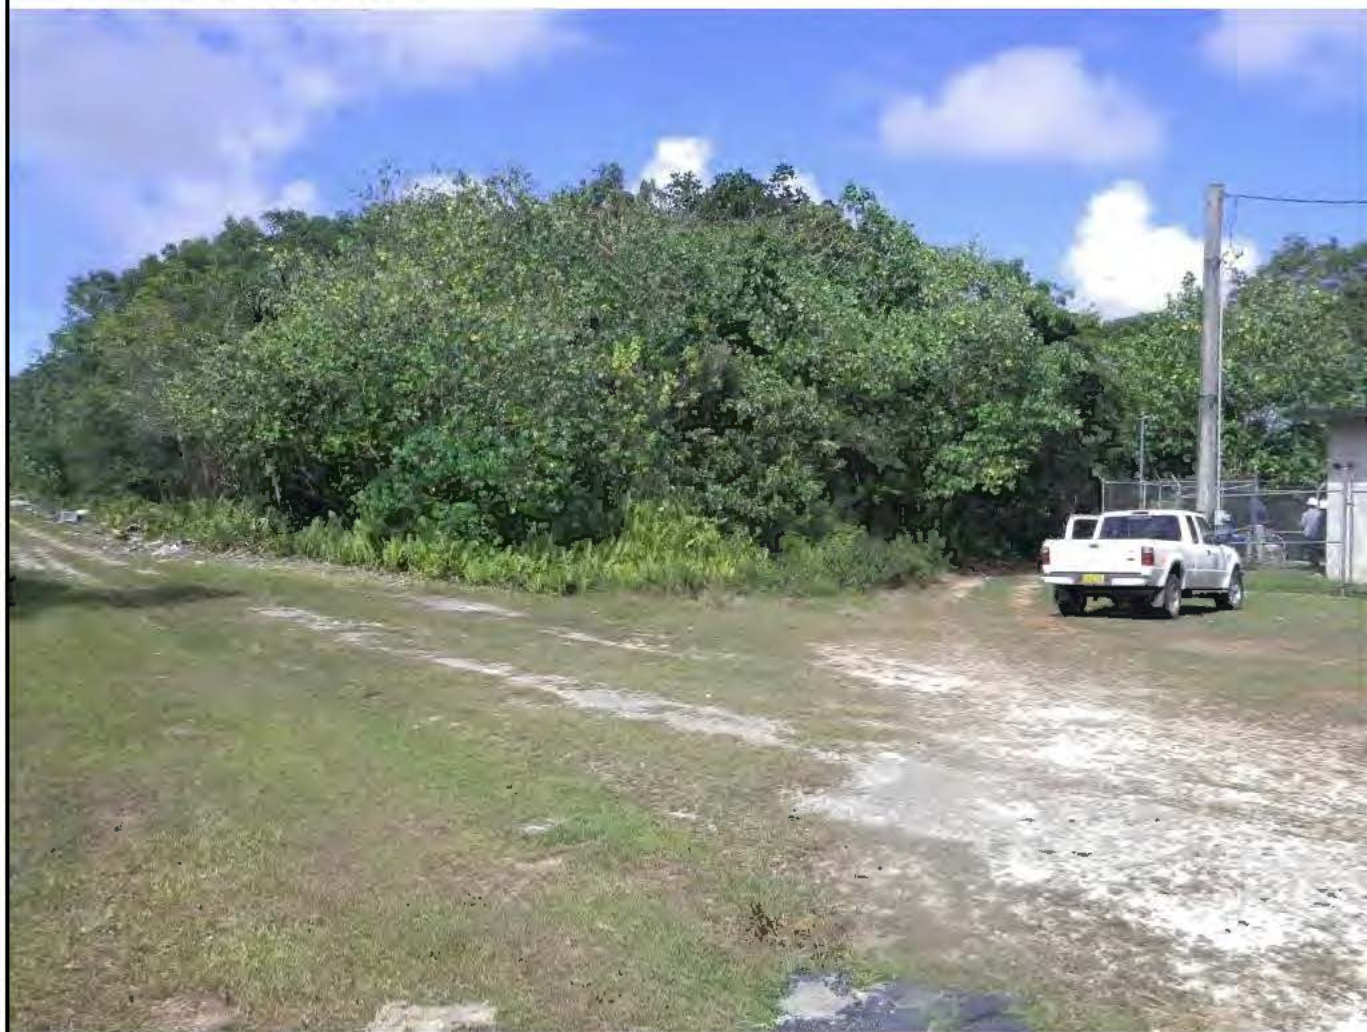
File Name: RIMG0198.JPG

Title	Guam Waterworks Authority (VP0989)
Subject	Northern System
Latitude	[REDACTED]
Longitude	[REDACTED]
Photo Direction	[REDACTED]
Elevation	[REDACTED]
Date Time Stamp	5/1/2012 2:45:05 PM
Photographer	K. Sable
Comment	F 3 Well
Description	Well pad to right with spilt in road that contained trash

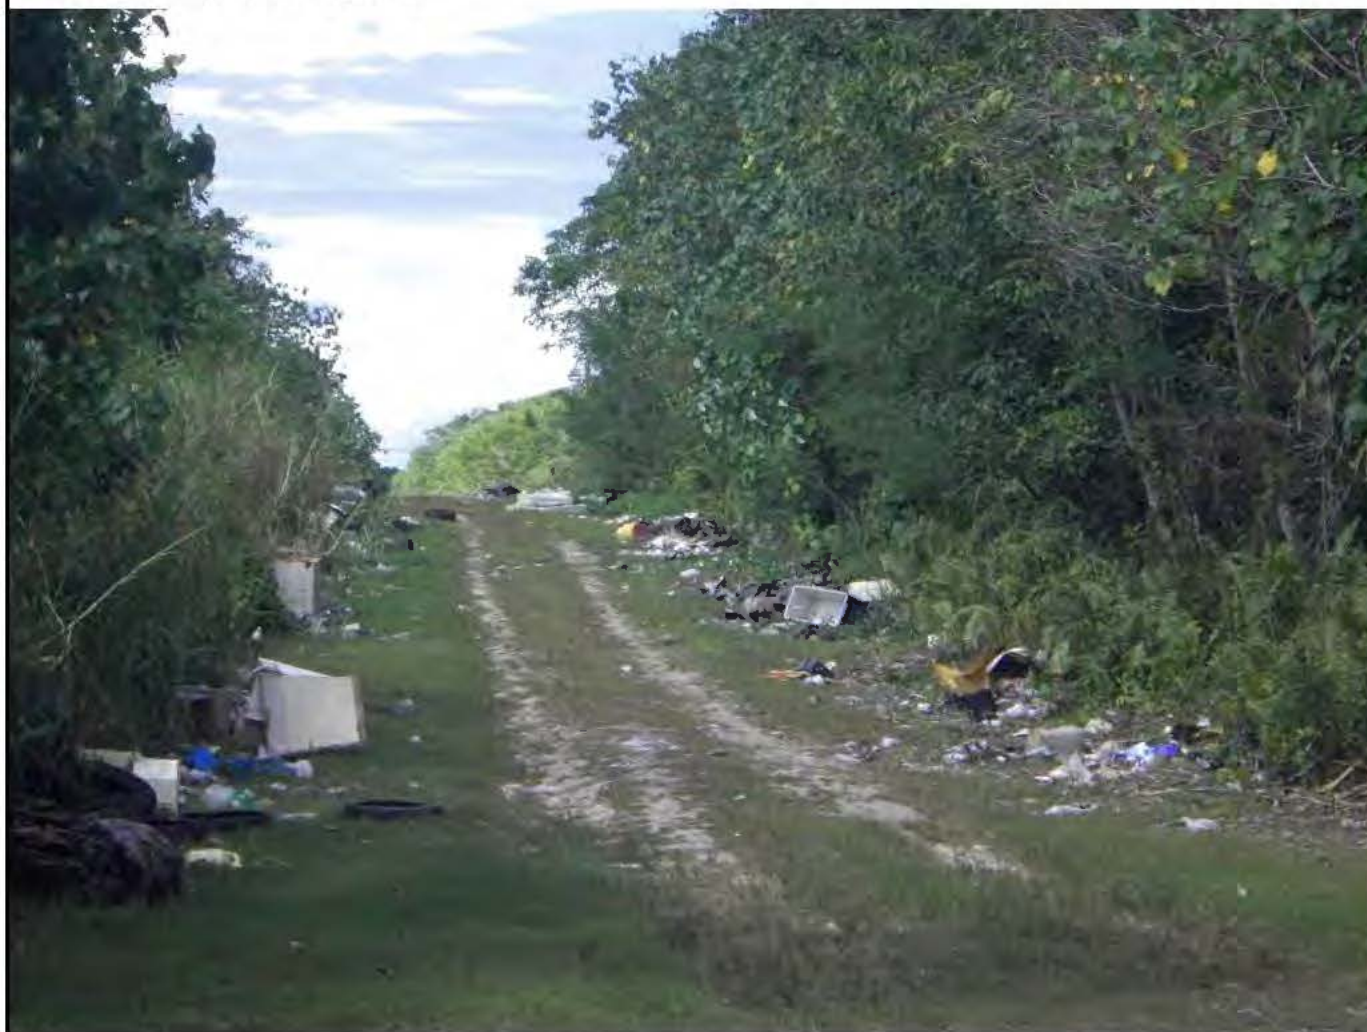
File Name: RIMG0199.JPG

Title	Guam Waterworks Authority (VP0989)
Subject	Northern System
Latitude	██████████
Longitude	██████████
Photo Direction	██████
Elevation	██████
Date Time Stamp	5/1/2012 2:45:26 PM
Photographer	K. Sable
Comment	F 3 Well
Description	Close-up of road next to well pad with trash

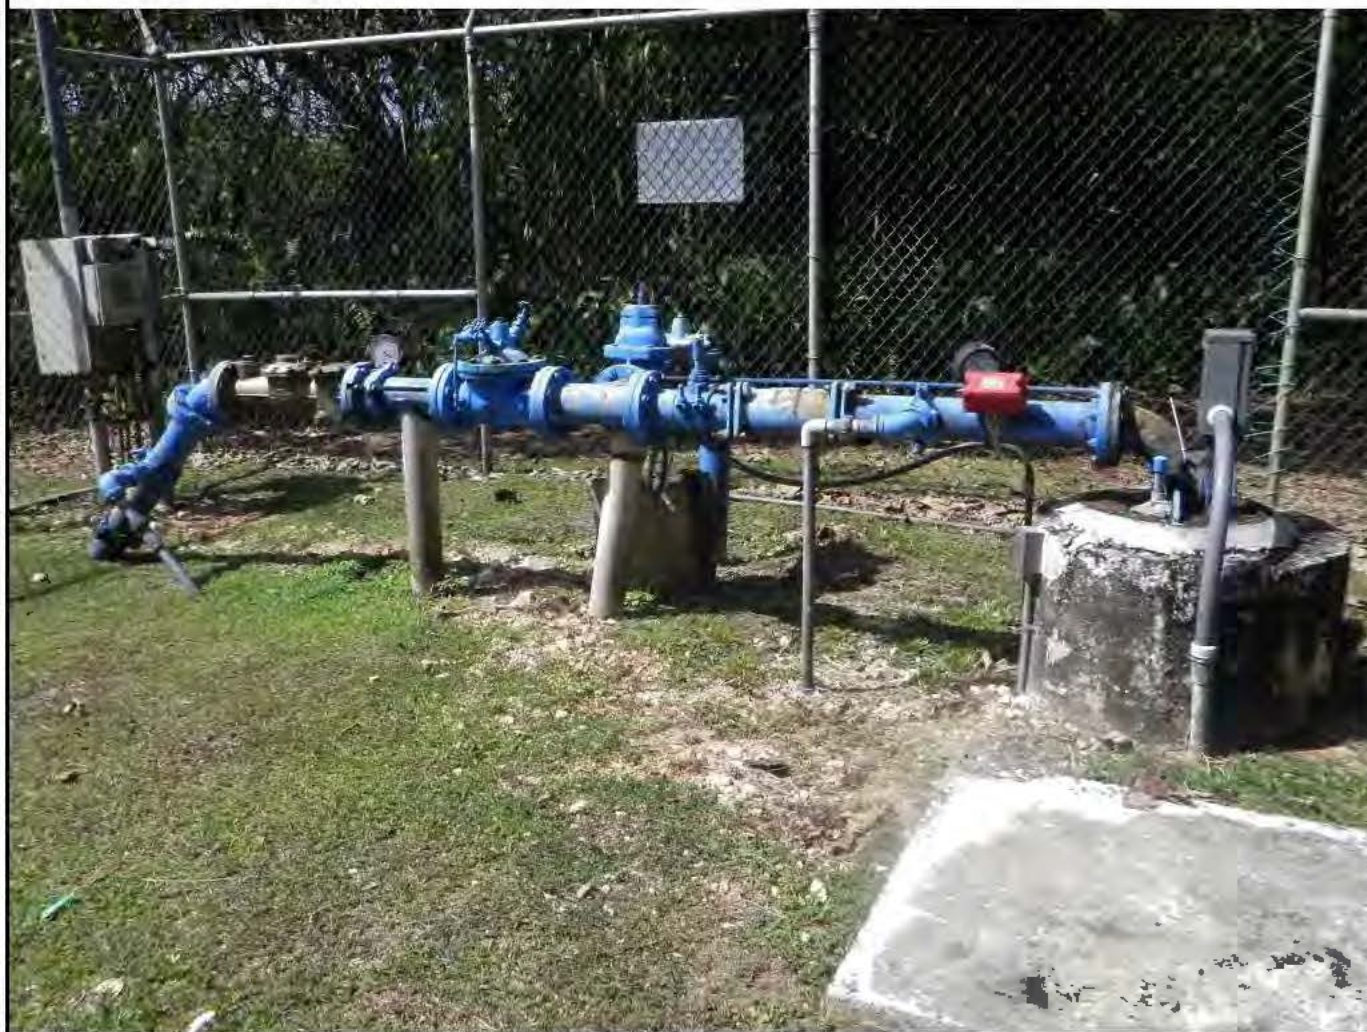
File Name: RIMG0200.JPG

Title	Guam Waterworks Authority (VP0989)
Subject	Northern System
Latitude	██████████
██████████	██████████
Photo Direction	██████
Elevation	██████t
Date Time Stamp	5/1/2012 2:50:28 PM
Photographer	K. Sable
Comment	F 3 Well
Description	Well assembly

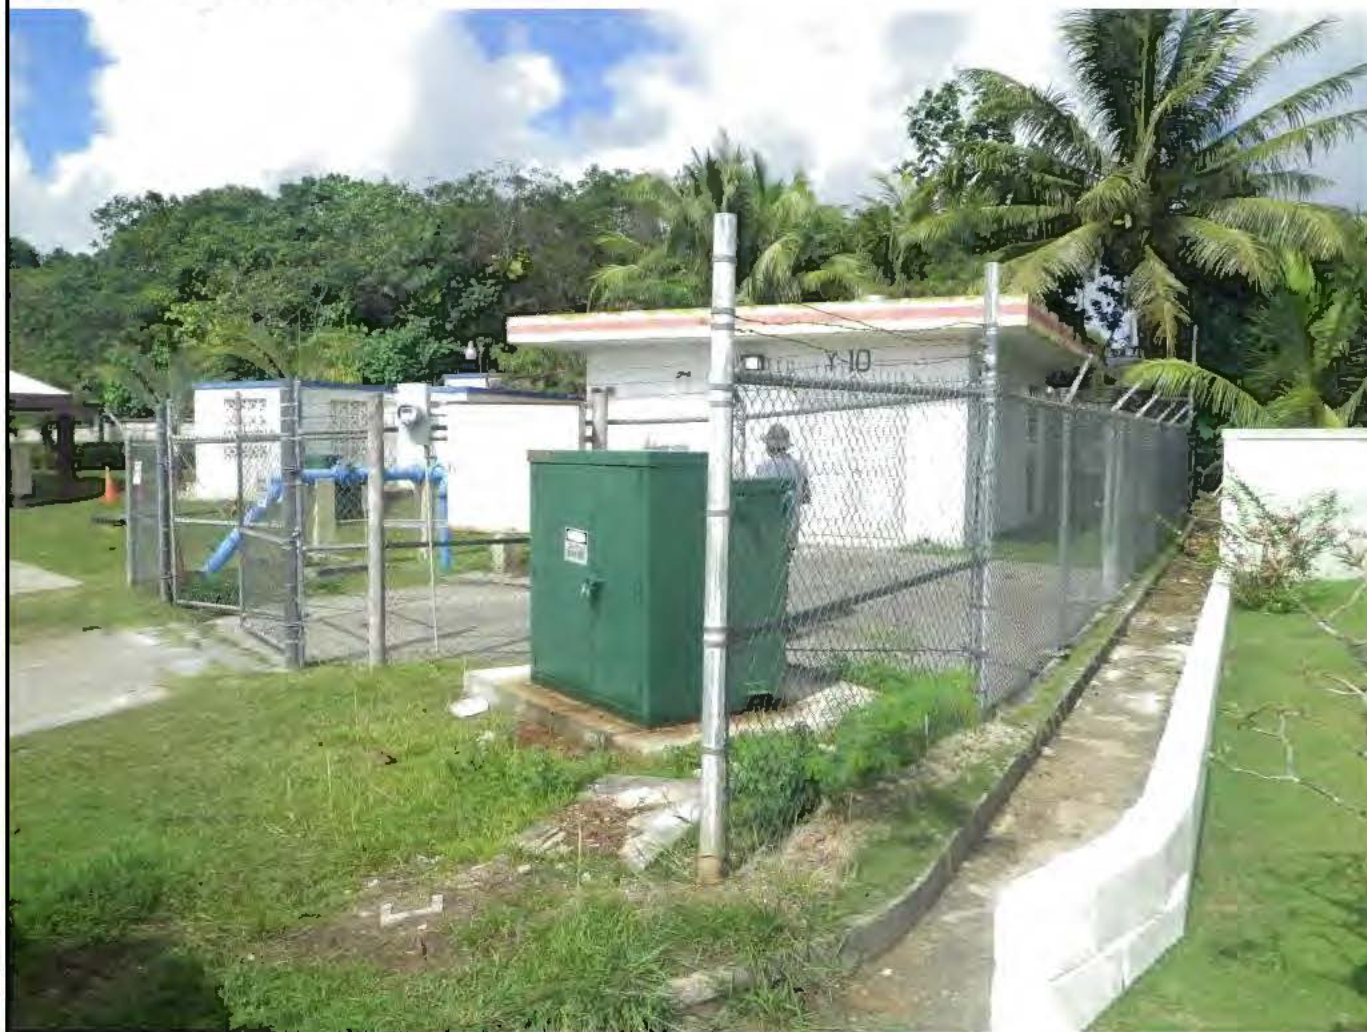
File Name: RIMG0201.JPG

Title	Guam Waterworks Authority (VP0989)
Subject	Northern System
Latitude	██████████
Longitude	██████████
Photo Direction	██████
Elevation	██████
Date Time Stamp	5/1/2012 3:17:58 PM
Photographer	K. Sable
Comment	Y 10 Well
Description	Storm sewer ditch adjacent to well pad

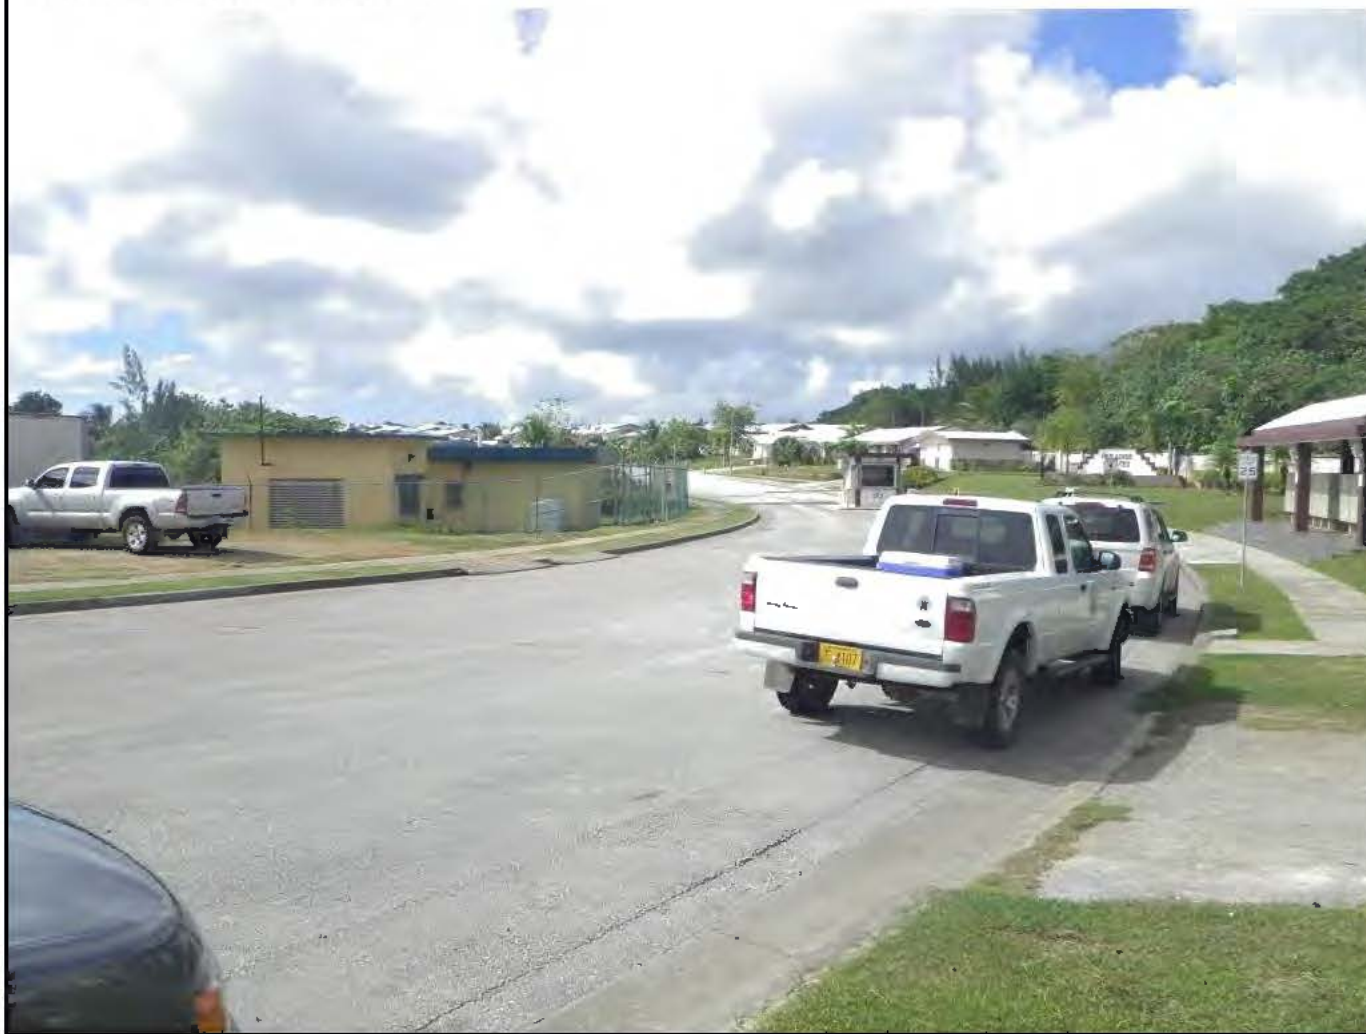
File Name: RIMG0202.JPG

Title	Guam Waterworks Authority (VP0989)
Subject	Northern System
Latitude	[REDACTED]
Longitude	[REDACTED]
Photo Direction	[REDACTED]
Elevation	[REDACTED]
Date Time Stamp	5/1/2012 3:18:08 PM
Photographer	K. Sable
Comment	Y 10 Well
Description	From well toward nearby Ypaopao wastewater pump station

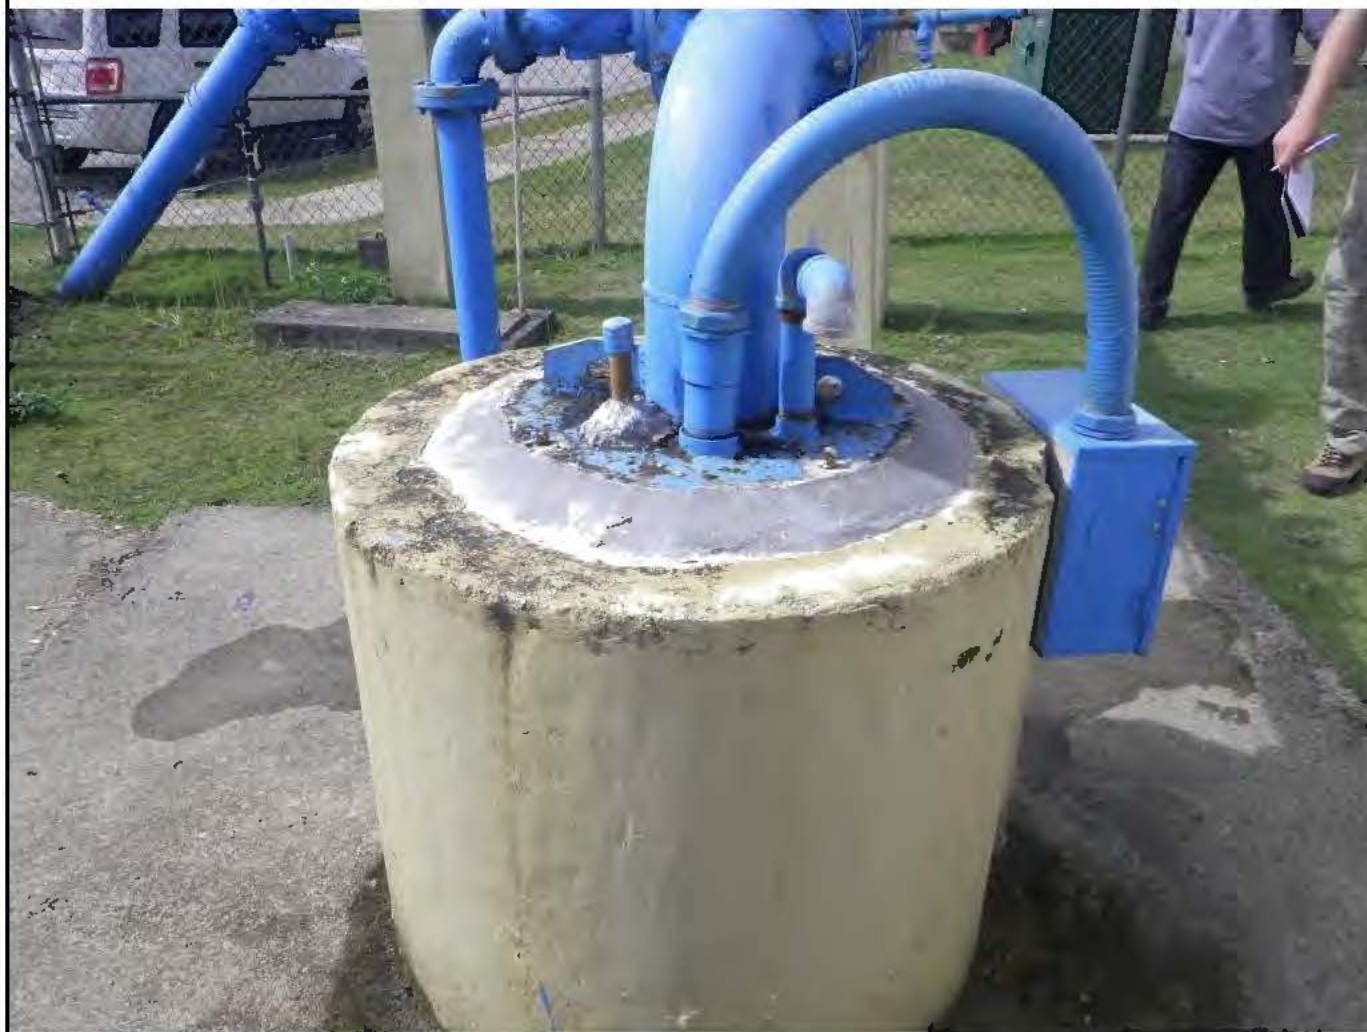
File Name: RIMG0203.JPG

Title	Guam Waterworks Authority (VP0989)
Subject	Northern System
Latitude	[REDACTED]
Longitude	[REDACTED]
Photo Direction	[REDACTED]
Elevation	[REDACTED]
Date Time Stamp	5/1/2012 3:21:24 PM
Photographer	K. Sable
Comment	Y 10 Well
Description	Well casing with holes
