Guam Waterworks Authority (VP0989)

SDWA Sanitary Survey

Northern System

NEIC Field Investigation Photographs

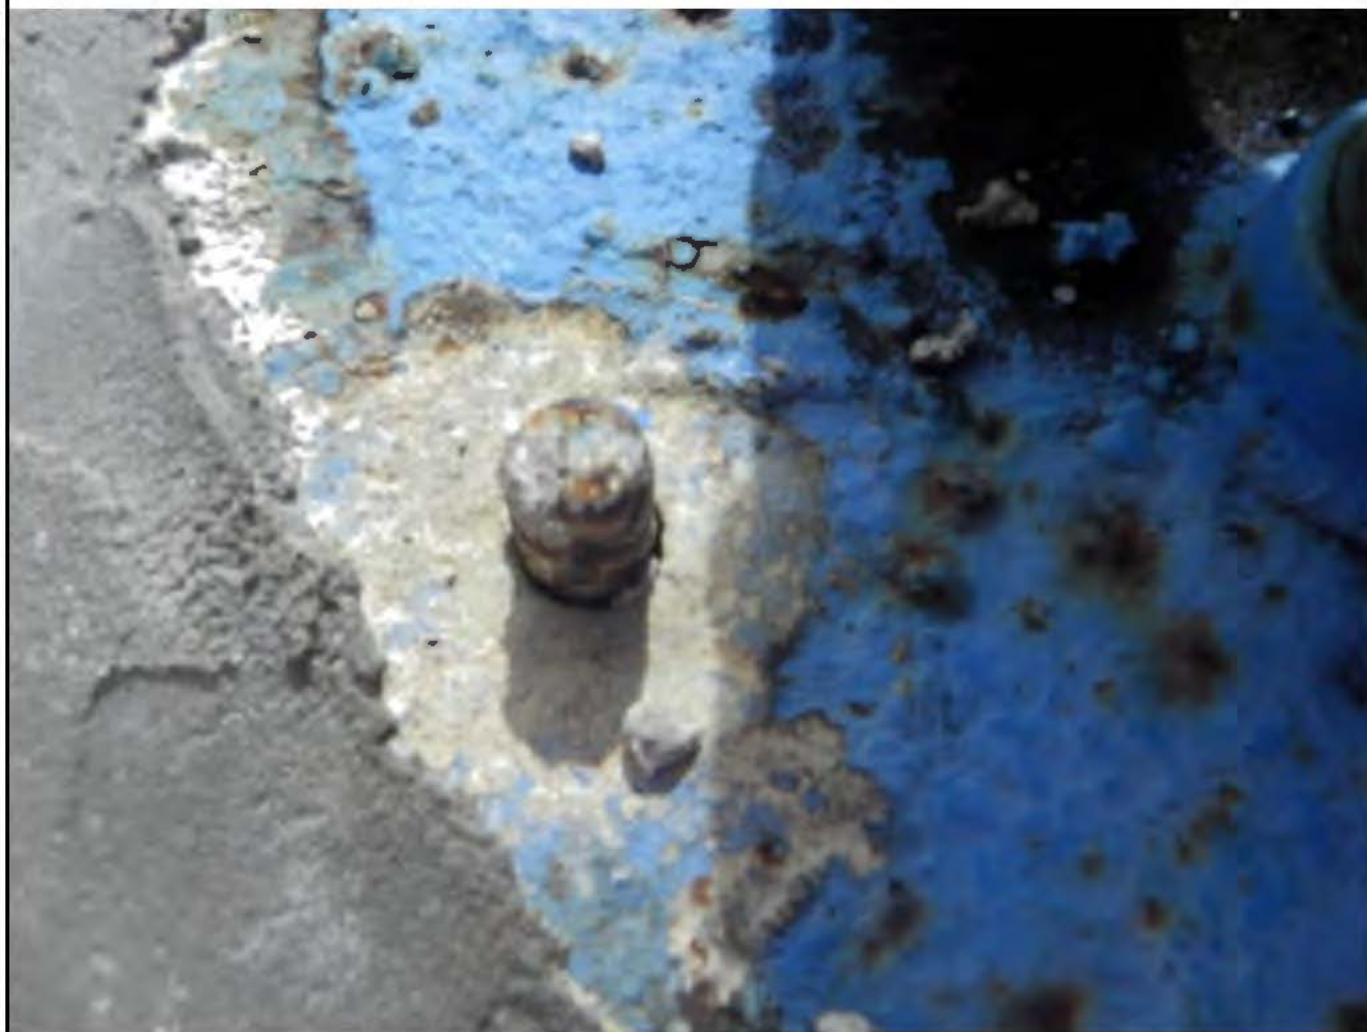
File Name: RIMG0204.JPG

Title	Guam Waterworks Authority (VP0989)
Subject	Northern System
Latitude	[REDACTED]
Longitude	[REDACTED]
Photo Direction	[REDACTED]
Elevation	[REDACTED]
Date Time Stamp	5/1/2012 3:21:44 PM
Photographer	K. Sable
Comment	Y 10 Well
Description	Close-up of alignment pins with holes in casing

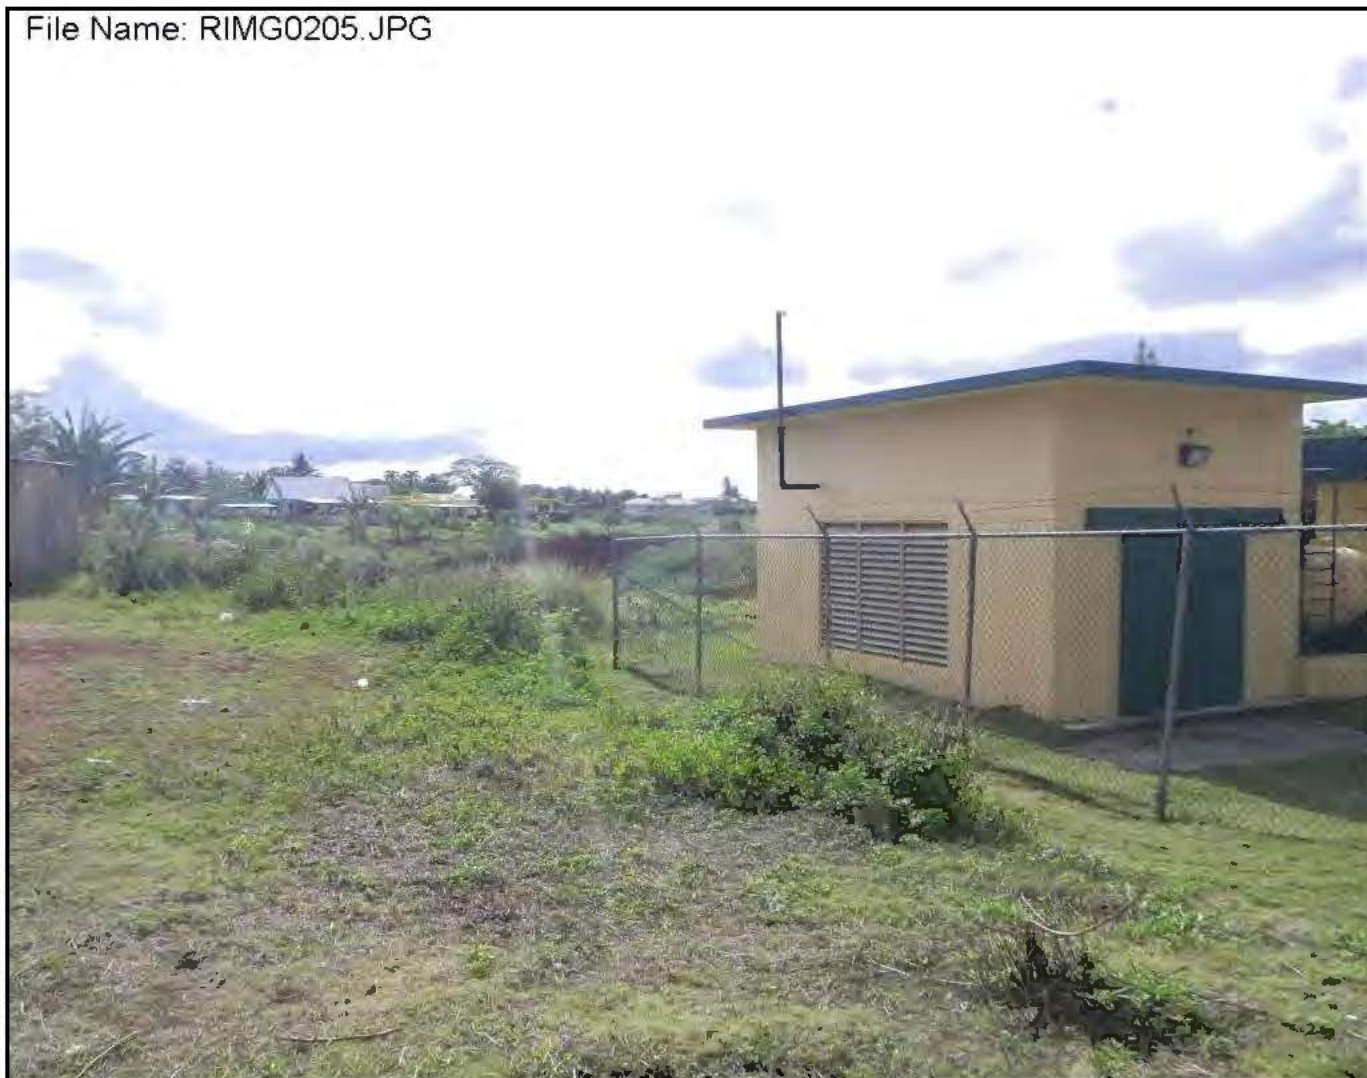
File Name: RIMG0205.JPG

Title	Guam Waterworks Authority (VP0989)
Subject	Northern System
Latitude	██████████
Longitude	██████████
Photo Direction	██████████
Elevation	██████
Date Time Stamp	5/1/2012 3:26:42 PM
Photographer	K. Sable
Comment	Y 10 Well
Description	Ypaopao wastewater pump station near well with sink hole and storm water detention basin behind

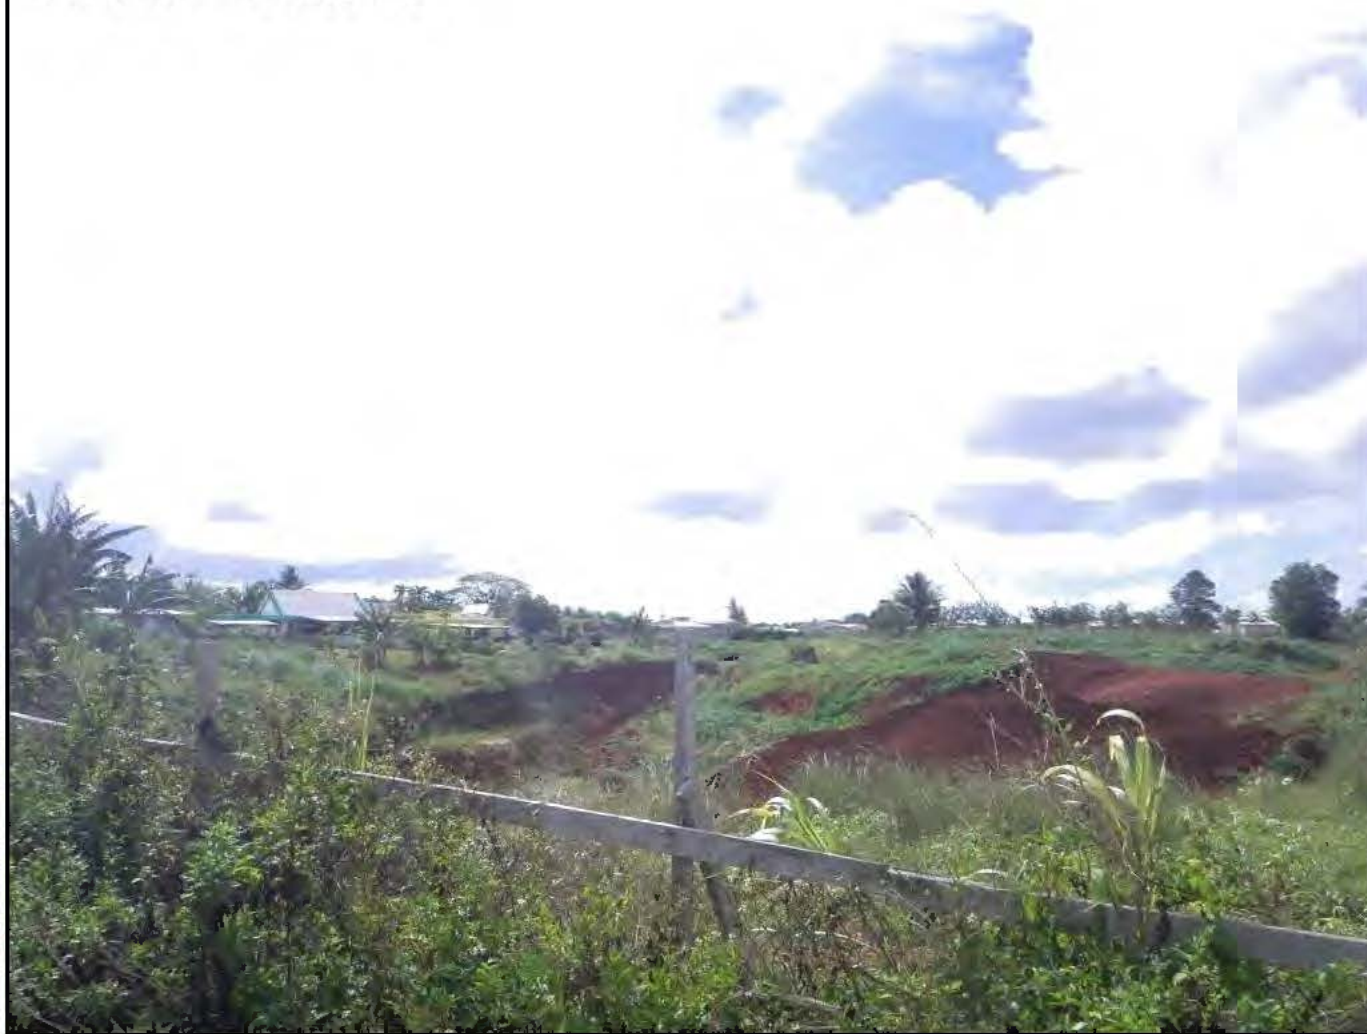
File Name: RIMG0206.JPG

Title	Guam Waterworks Authority (VP0989)
Subject	Northern System
Latitude	[REDACTED]
Longitude	[REDACTED]
Photo Direction	[REDACTED]
Elevation	[REDACTED]
Date Time Stamp	5/1/2012 3:29:02 PM
Photographer	K. Sable
Comment	Y 10 Well
Description	Sink hole and storm water detention basin
