Appendix D
Construction Program Site Visit Reports

Thomes Creek Bridge Project
Site Visit Date: 10/13/2009

**Caltrans MS4 (SWRCB Order No. 99-06-DWQ)
Thomes Creek Bridge Project
Caltrans District 2**

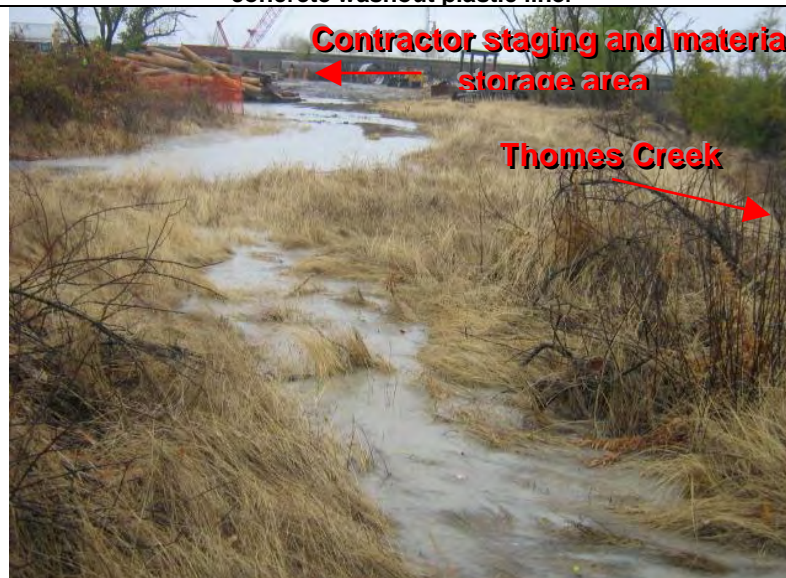
Prohibition A.1 of the Permit states the “discharge of runoff from construction sites containing pollutants which have not been reduced using BAT for toxic pollutants and BCT for conventional pollutants to waters of the United States is prohibited.” Adequate BMPs were not implemented for the contractor’s staging and material storage areas located up-gradient and adjacent to Thomes Creek. Specifically, adequate BMPs or perimeter controls had not been implemented for the areas of disturbance associated with the contractor staging and material storage areas. For example, a concrete washout was improperly implemented and lined with plastic that had been torn and badly deteriorated (see Photographs 1 and 2), and uncontained concrete waste was observed on the ground surface directly adjacent to the concrete washout (see Photograph 3). Jeff Blin (Caltrans District 2, Resident Engineer), explained that the concrete washout area had been present for a long period of time and was not identified in the project SWPPP. Moreover, a visible discharge of sediment and/or other pollutants was observed leading from the contractor staging and material storage areas to Thomes Creek (see Photographs 4 through 7).

Photograph 4 – Evidence of the discharge of pollutants from the contractor staging and material storage areas

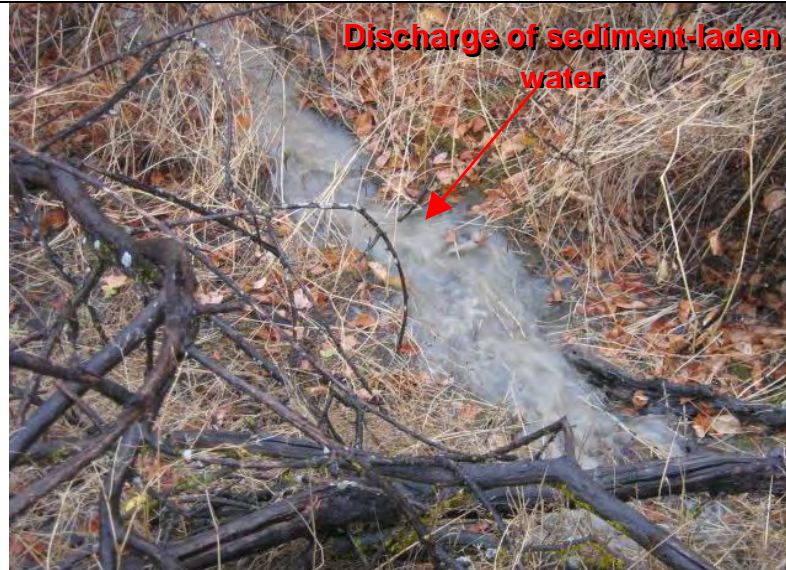
Photograph 6 – Close-up of Photograph 5 depicting the discharge of pollutants flowing to Thomes Creek

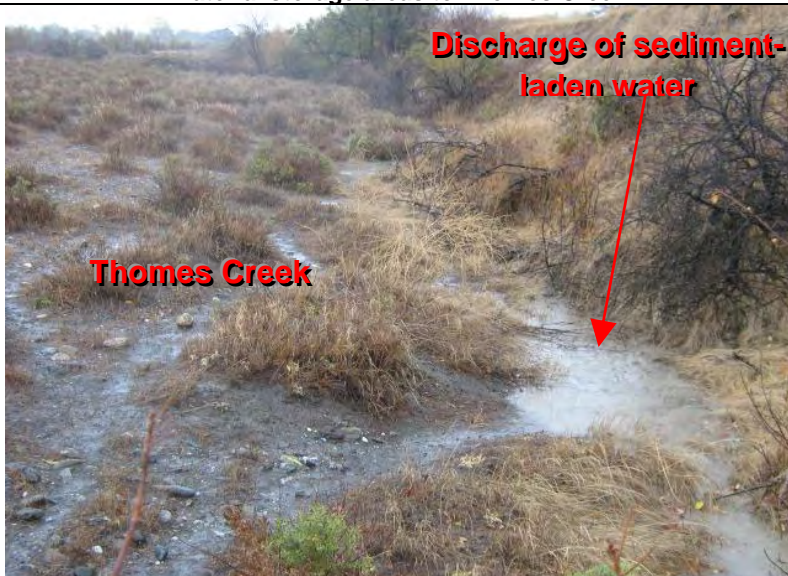
Photograph 7—Discharge of pollutants entering the receiving water, Thomes Creek

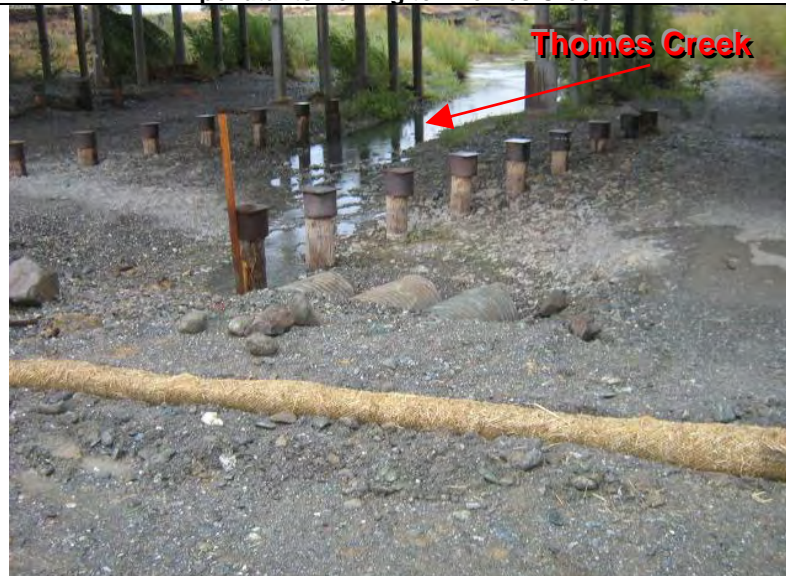
Additionally, adequate BMPs had not been implemented for areas of disturbance located directly adjacent to the flowing Thomes Creek. Although erosion log BMPs had been implemented, the erosion logs were not staked and a discharge of sediment was observed bypassing the BMPs and leading to Thomes Creek (see Photographs 8 and 9).

Photograph 8 – Erosion log BMPs were not adequately installed (e.g., not properly staked) adjacent to the flowing Thomes Creek

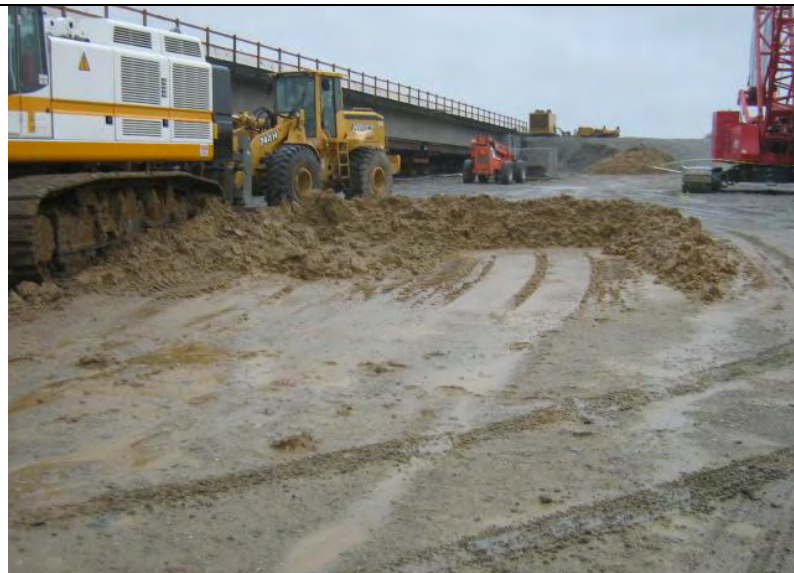
Photograph 10 – Unconsolidated soils without BMPs

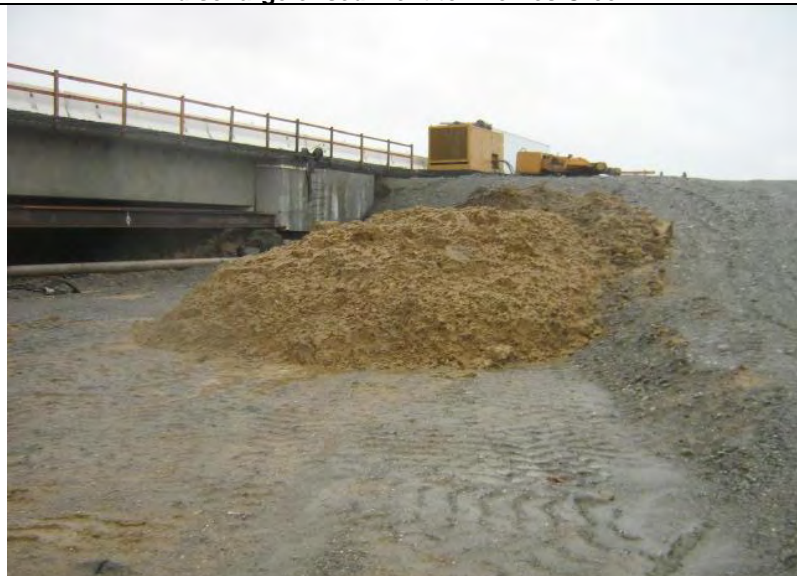
Photograph 11— Soil stockpile without BMPs

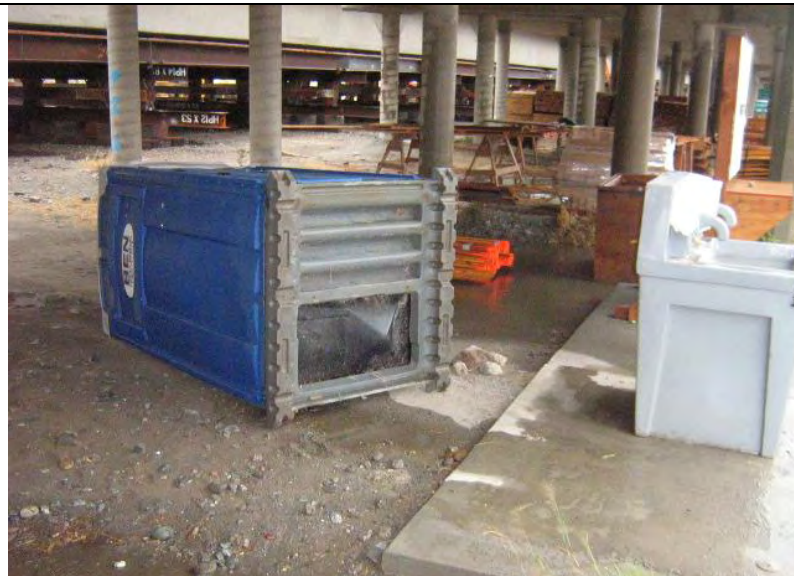
Photograph 12 – View of portable toilet blown over under Thomes Creek bridge

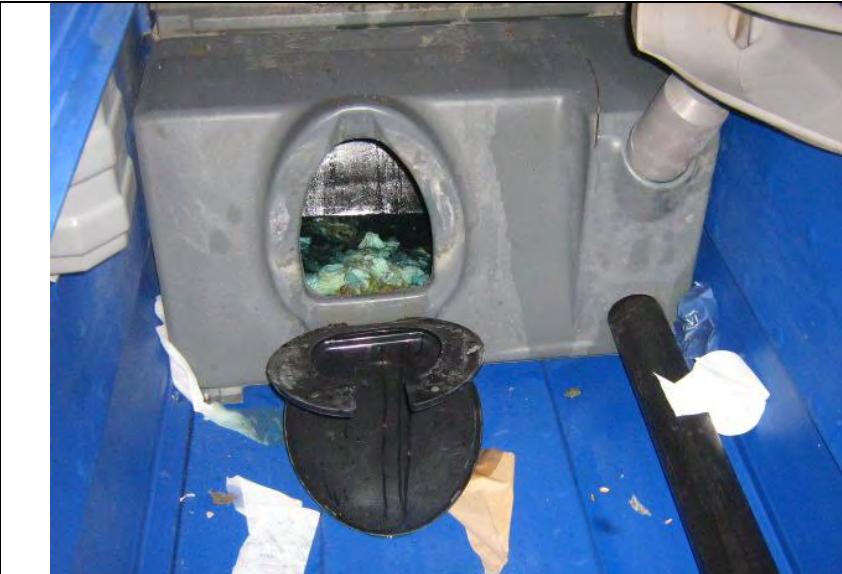
Photograph 13—View inside of overturned portable toilet with visible chemical and sanitary waste present

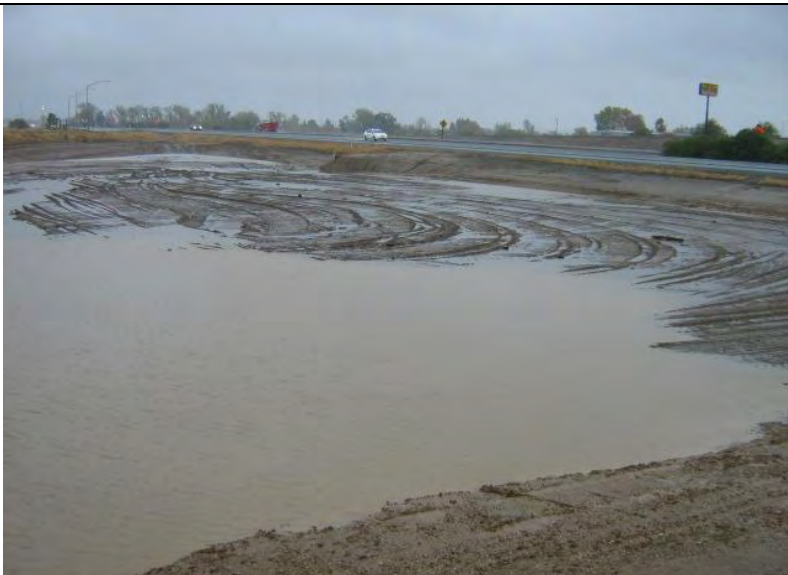
Photograph 1 – View of unstabilized sediment basin and embankment slopes

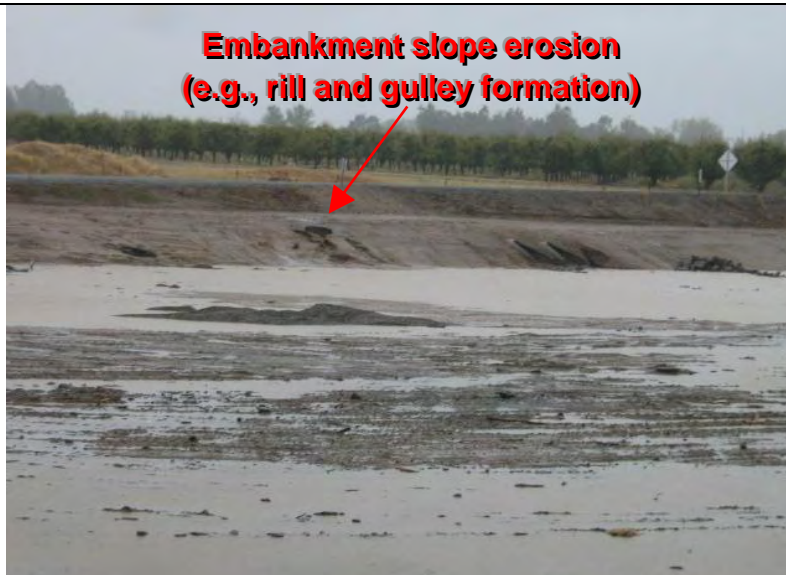
Photograph 2 – Erosion of unstabilized sediment basin and associated embankment slopes

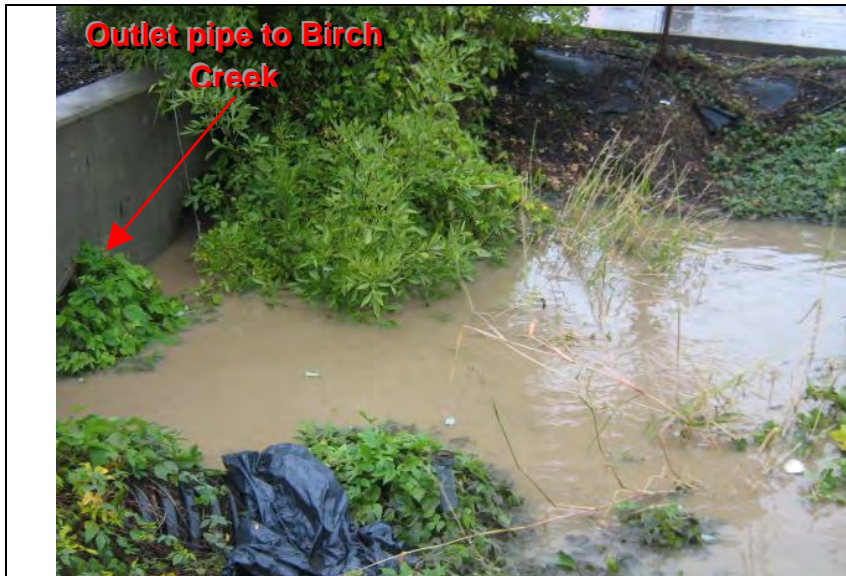
Additionally, inappropriate and inadequate BMPs had been implemented for the interconnected sediment basin discharge point, a culvert pipe inlet and drainage pipe leading to Birch Creek. Specifically, a silt fence BMP had been implemented in an area of concentrated flow at the culvert inlet, and had therefore collapsed (see Photographs 9 through 11). As a result, there was a discharge of sediment from the unstabilized up-gradient areas (e.g., sediment basins and disturbed slope areas) to the culvert pipe inlet and discharge pipe which ultimately flows to Birch Creek (see Photographs 12 through 14).

Photograph 13—Evidence of the discharge of sediment leading to Birch Creek

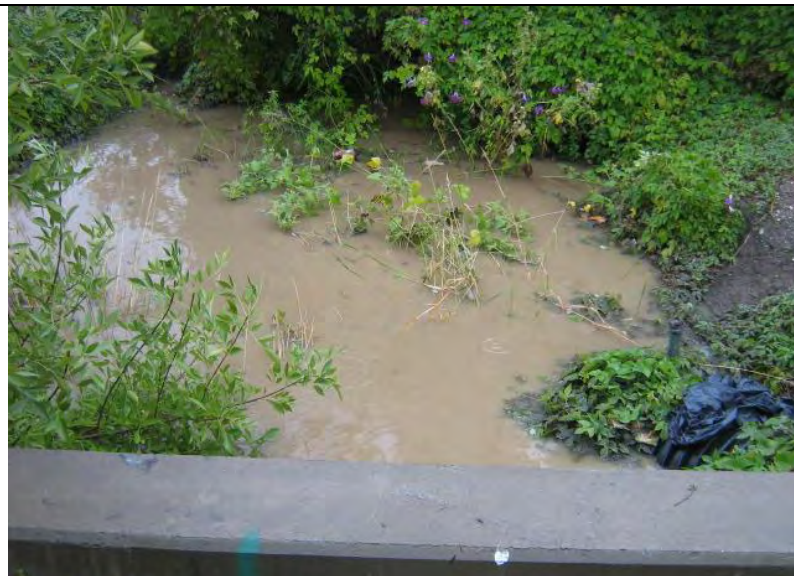
Photograph 14 – Evidence of the discharge of sediment leading to Birch Creek

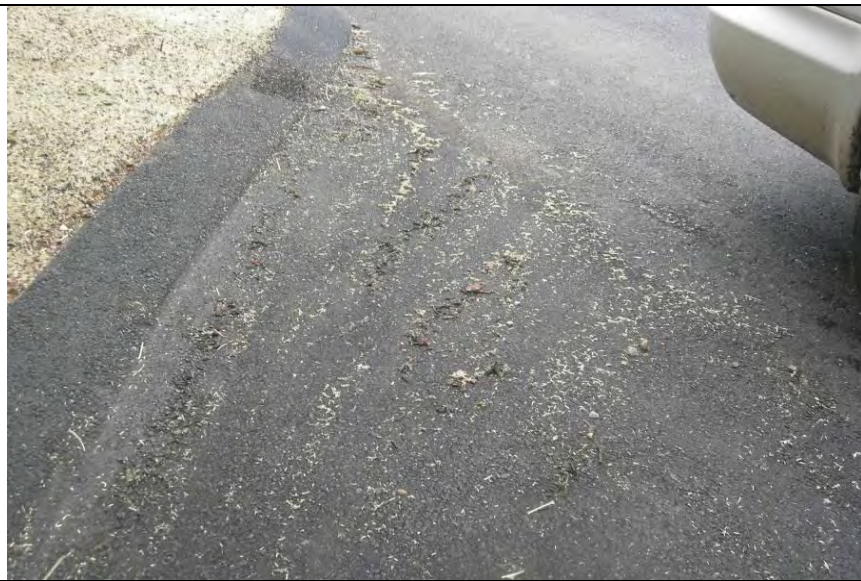
Specifically, BMPs were not adequately implemented and maintained along the perimeter of the disturbed area associated with the former construction site staging area. The Audit Team observed a visible flow path and erosion causing sediment and debris accumulation to surpass the straw wattles utilized along the southern perimeter of the former staging area (see Photograph 1). Erosion had caused the discharge of sediment and debris from several portions of the roadway drainage area adjacent to the sound wall into a storm drain inlet located along the west side of the highway shoulder (see Photographs 2, 3, and 4).

Photograph 3 – Sediment and debris from Photograph 2

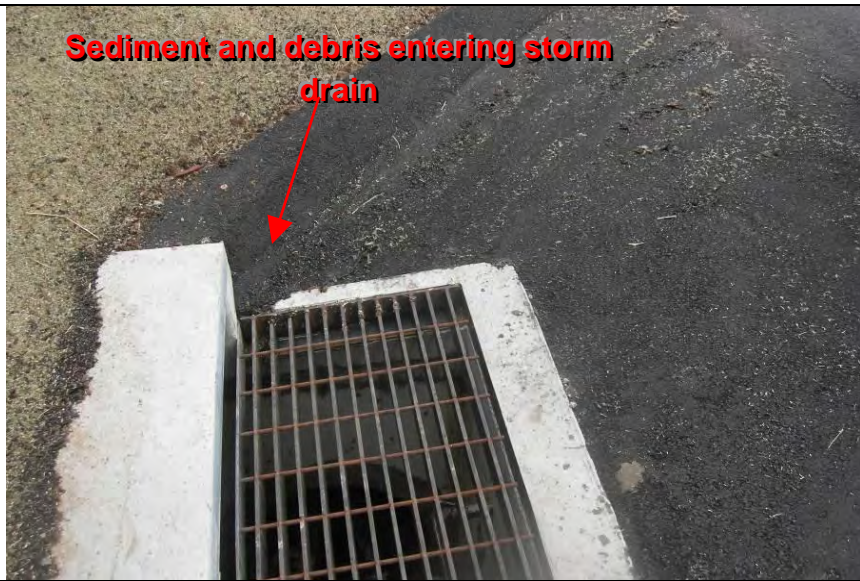
Photograph 4 – Storm drain located on the west side of Highway 299

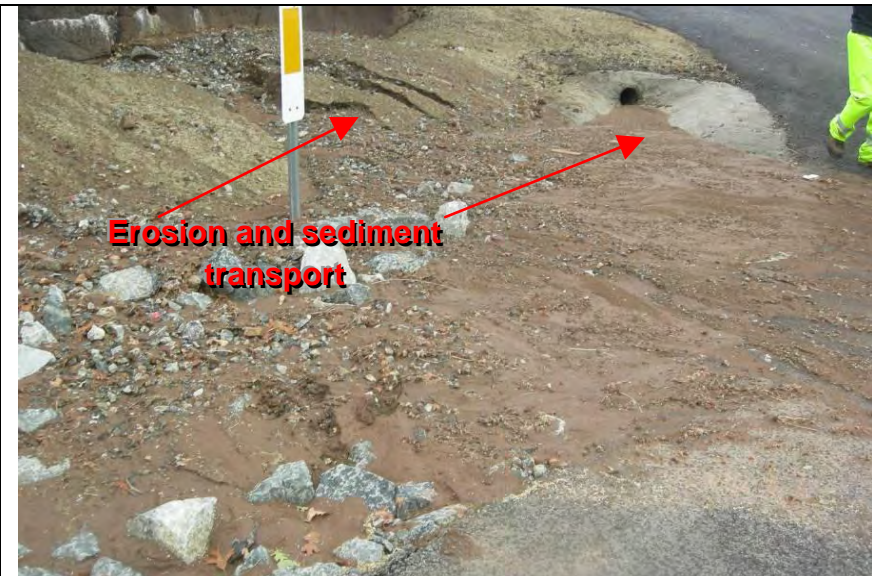
In addition, BMPs were not adequately implemented on the disturbed slope along the south side of the sound wall to prevent sediment discharge (see Photographs 5 and 6). Furthermore, sediment accumulation was observed along the flow path of a rock lined drainage swale leading to a down-gradient drainage pipe (see Photographs 7 and 8). The straw wattles utilized at the down-gradient drainage pipe inlet were not adequately maintained.

Photograph 5 – Lack of adequate BMPs to prevent discharge of sediment to the roadway

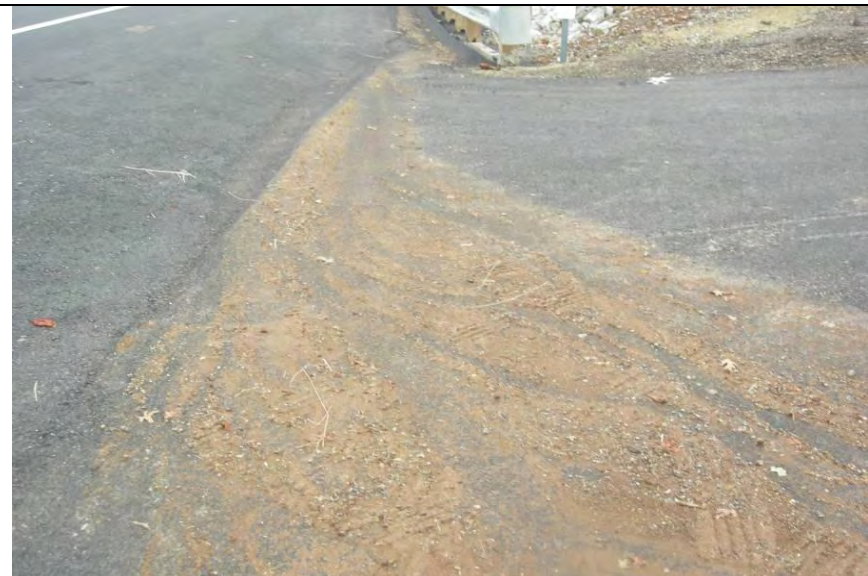
Photograph 6 – Sediment discharge along the highway from Photograph 5

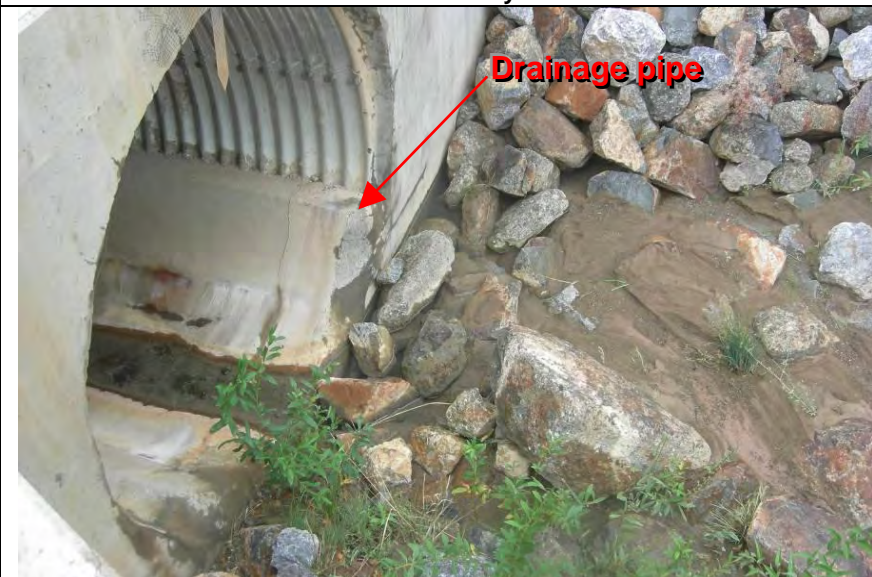
Photograph 7 – Sediment accumulation at down-gradient drainage pipe inlet

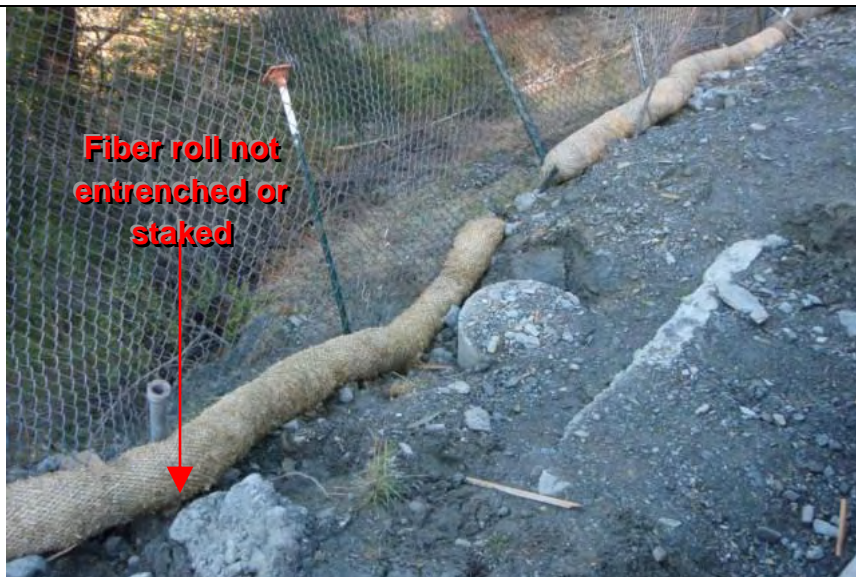
Photograph 3 – Example of fiber roll not entrenched or staked into the ground

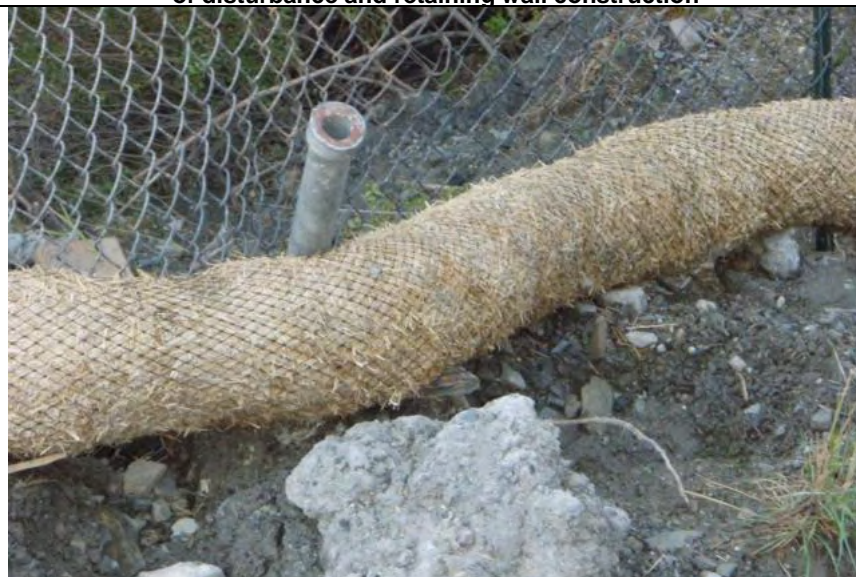
Photograph 4 – Close-up view of fiber roll not entrenched or staked into the ground

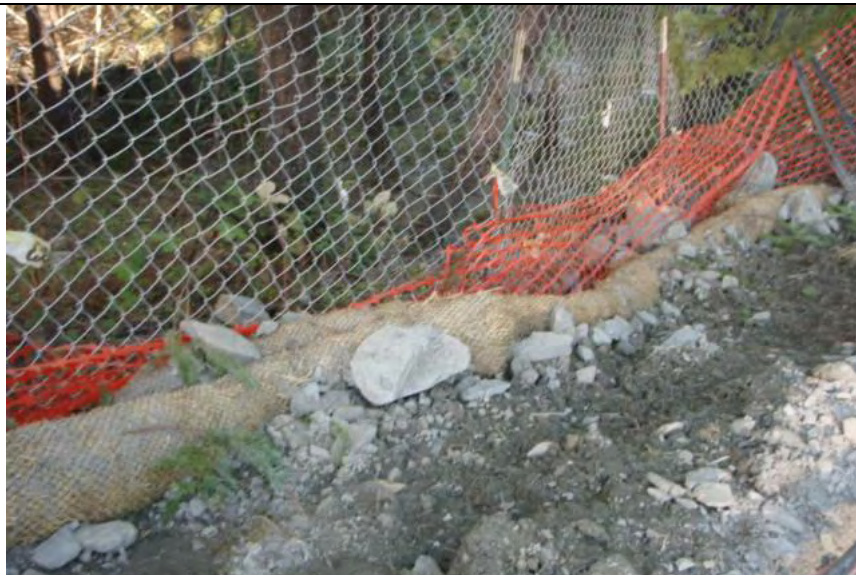
Photograph 5— Example of sediment and debris accumulation against straw wattle BMP

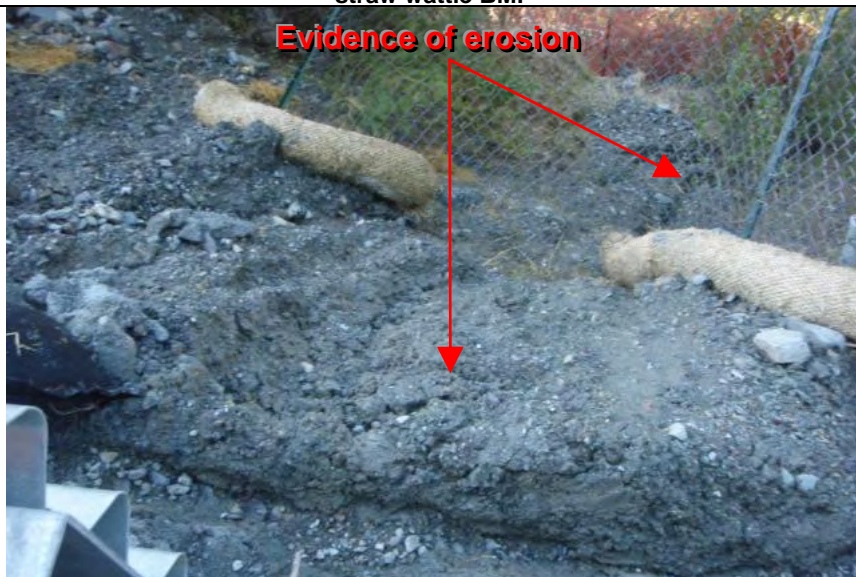
Photograph 7— Undercut section of straw wattle BMP and evidence of erosion

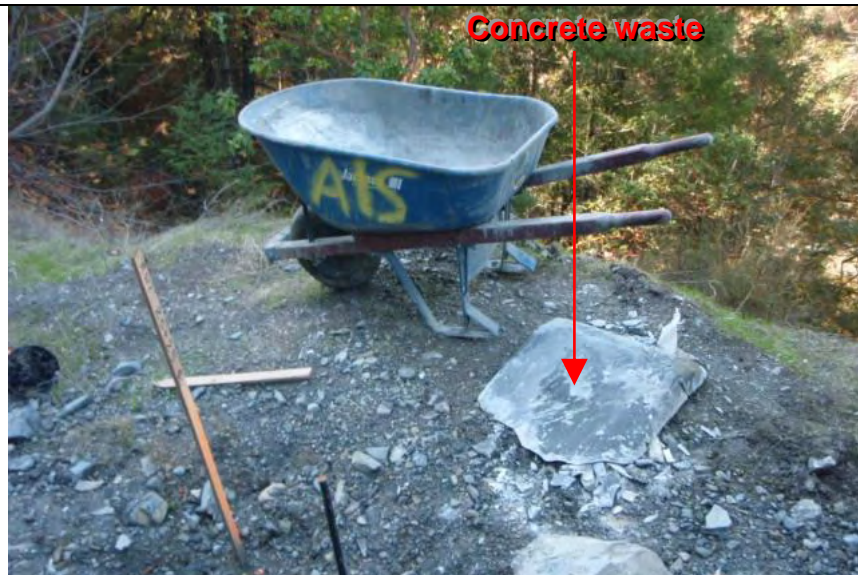
Photograph 9— Concrete waste on ground surface adjacent to steep slope

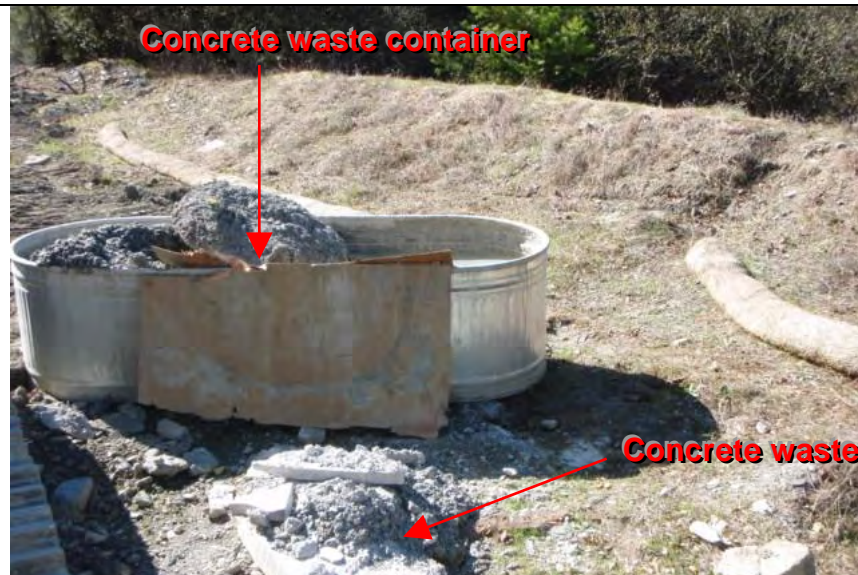
Photograph 10— Concrete waste and container in staging area (Note: Straw wattle BMP not staked or entrenched into ground)

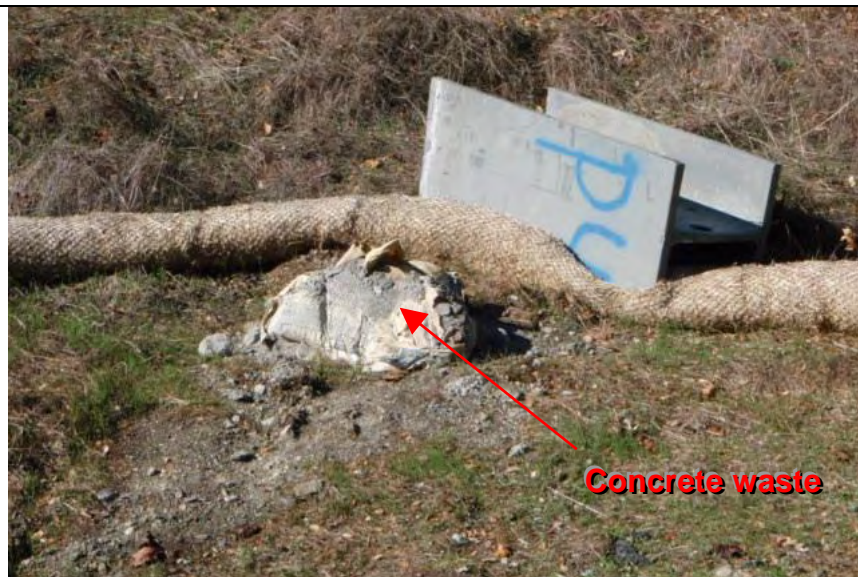
Photograph 11— Concrete waste near concrete waste container in staging area (Note: Straw wattle BMP not staked or entrenched into ground)

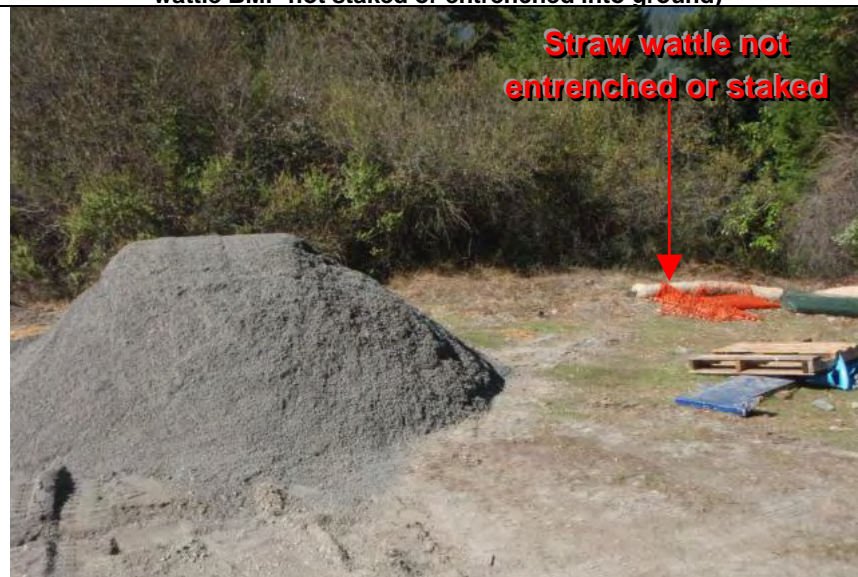
Photograph 12— Stockpile in staging area without BMPs for containment or coverage

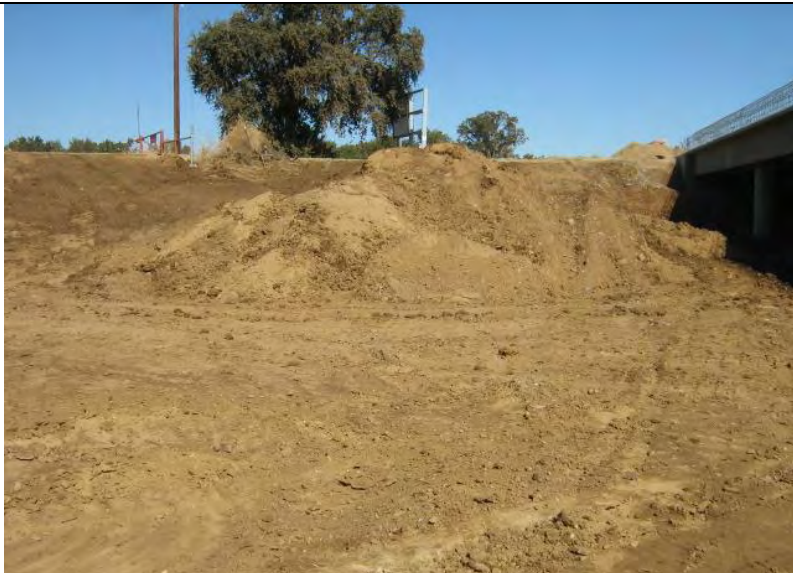
Photograph 5 – Soil stockpile with no perimeter controls or temporary stabilization located just upgradient of Bear River crossing.

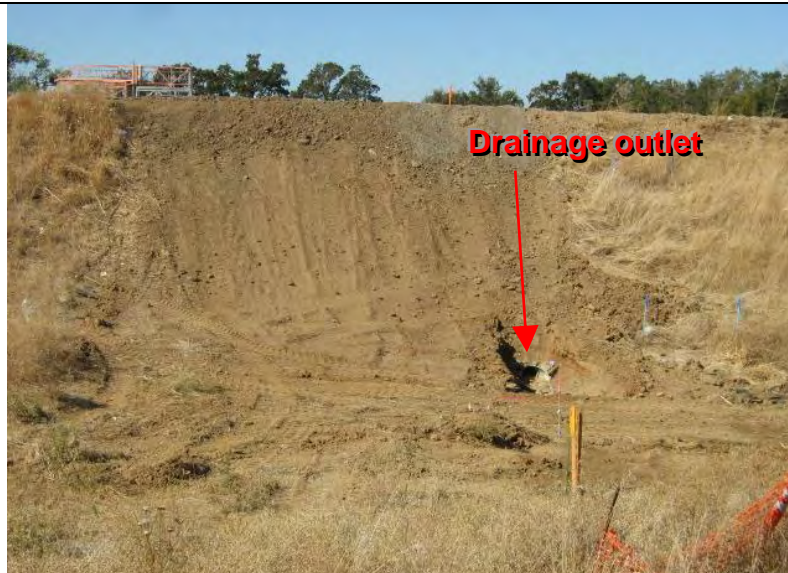
Photograph 6 – Drainage outlet below unstabilized embankment slope adjacent to the highway.

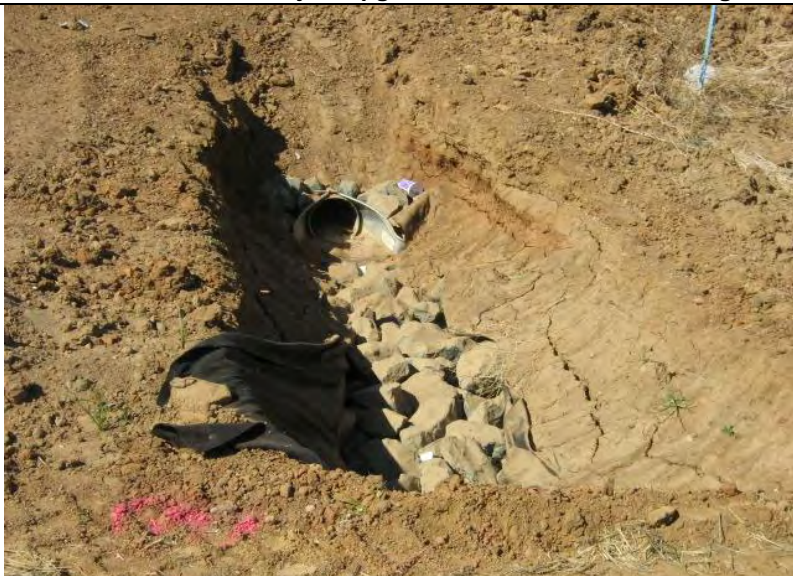
Photograph 7 – Drainage outlet at base of unstabilized slope shown in Photograph 6.

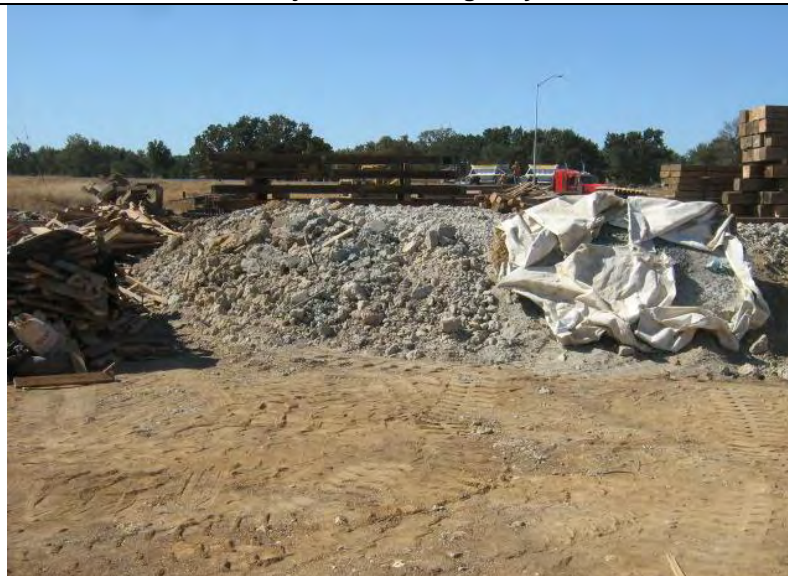
Photograph 8 – Uncontrolled/uncontained concrete waste

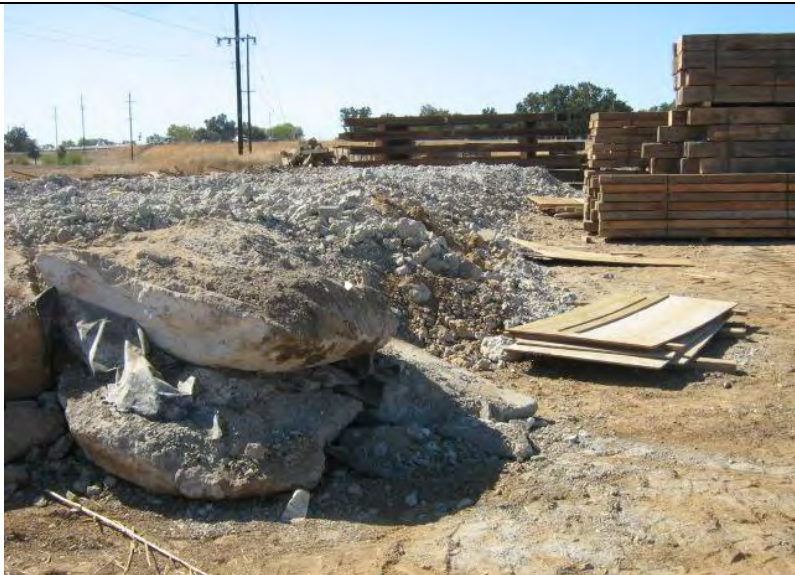
Photograph 9 – Uncontrolled/uncontained concrete waste

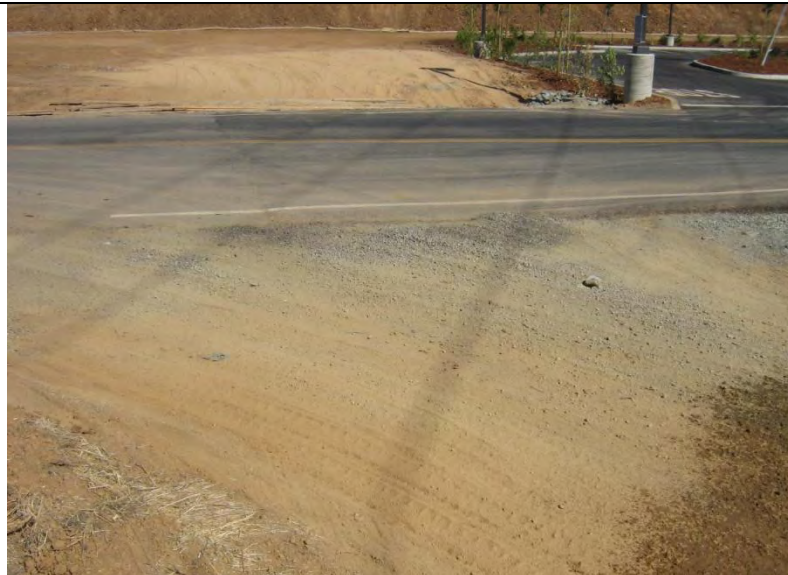
Photograph 10 – Tracking control BMPs not adequately maintained (e.g., sediment in rock pad and rock sparse in areas)

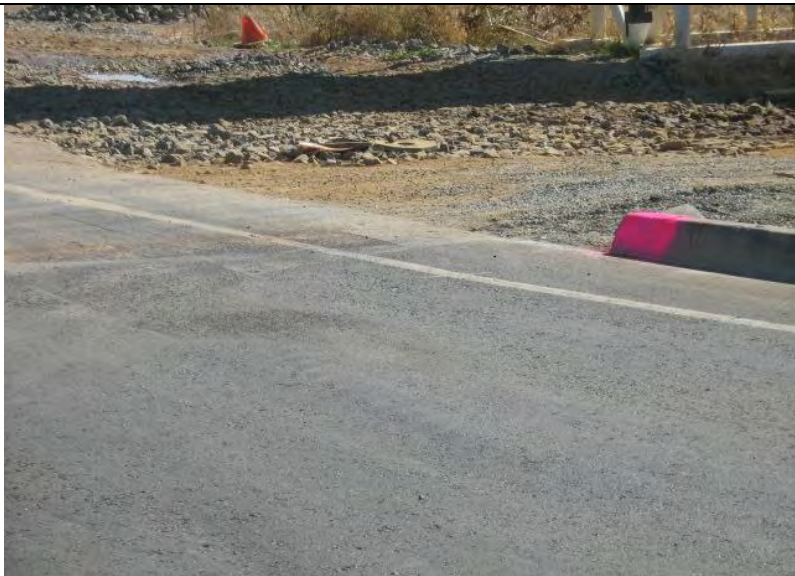
Photograph 11 – Tracking control BMPs not adequately maintained (e.g., sediment in rock pad and rock sparse in areas)

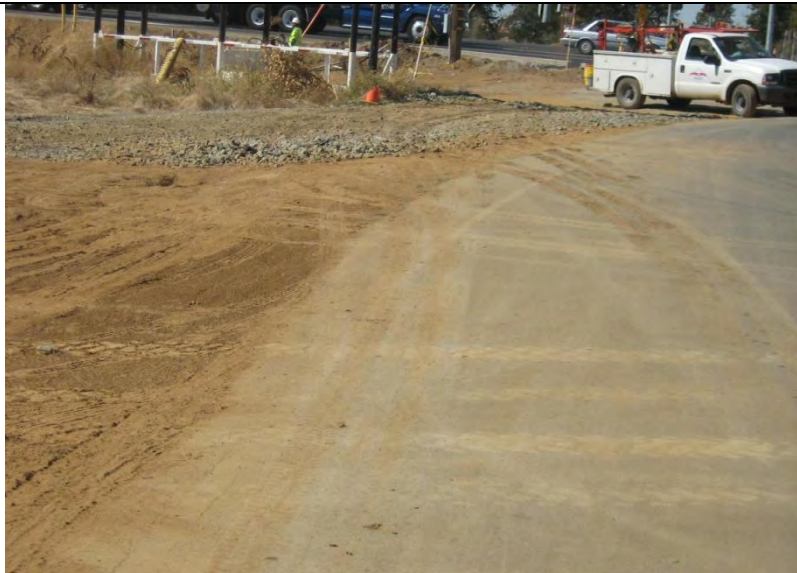
Photograph 13 – Sediment transport from areas of disturbance onto Feather River Boulevard, a public roadway.

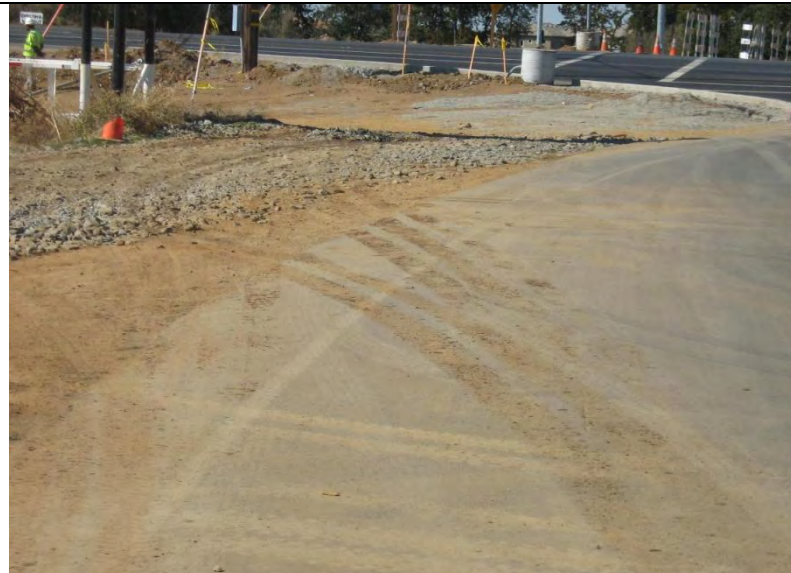
Photograph 14 – Sediment transport from areas of disturbance onto Feather River Boulevard, a public roadway.

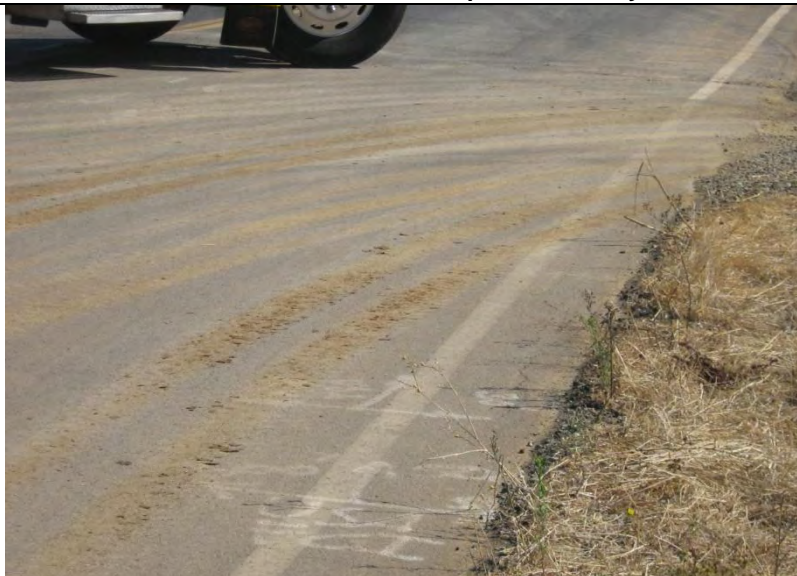
Photograph 15 – Sediment transport from areas of disturbance onto Feather River Boulevard, a public roadway.

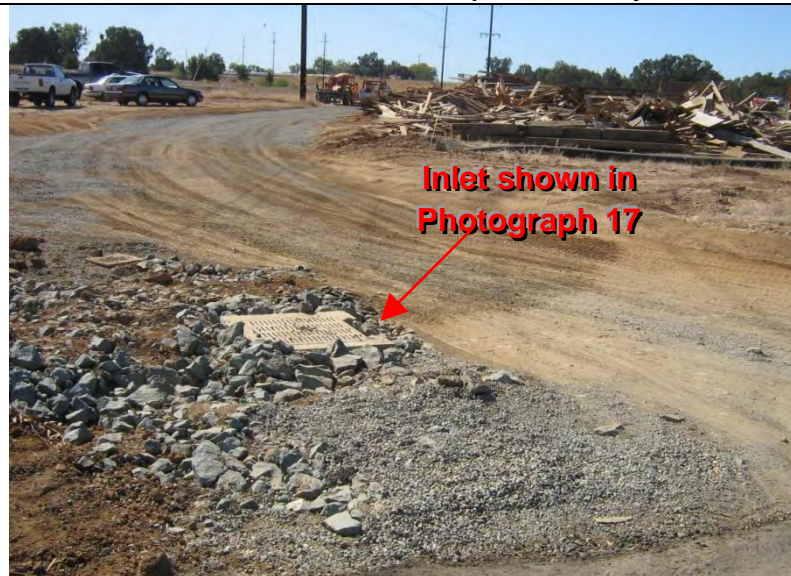
Photographs 16 – Adequate inlet protection and vehicle tracking control BMPs had not been implemented adj. to entrance off Feather River Blvd.

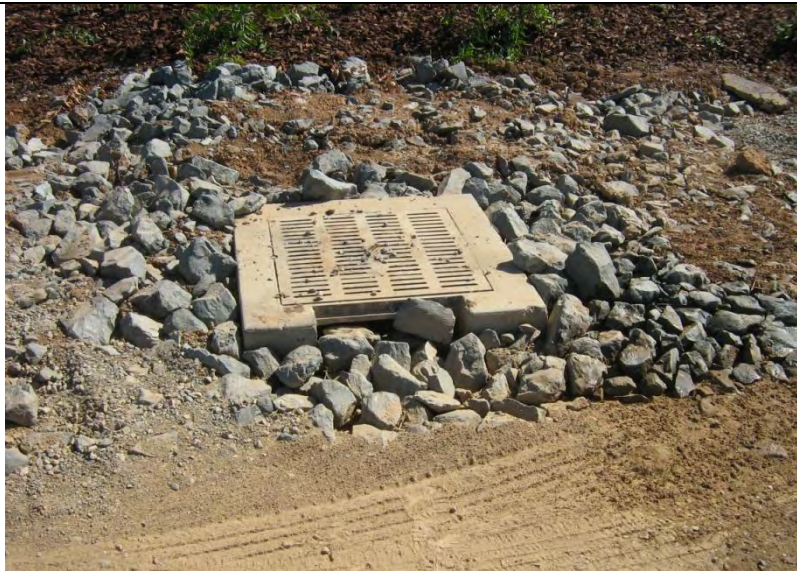
Photograph 17 – Close-up of Photograph 16. Adequate inlet protection had not been implemented.

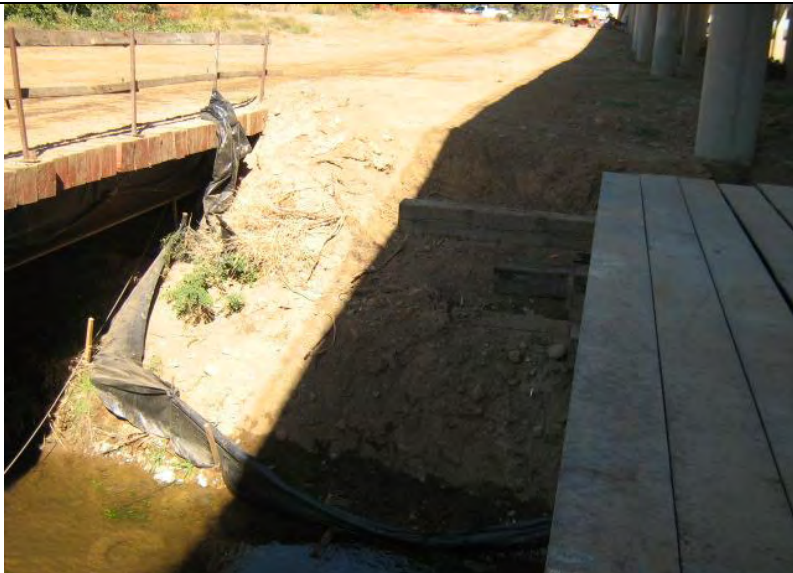
Photograph 21 – Silt Fence BMP not properly maintained (e.g., collapsed) adjacent to Yankee Slough. Note area of disturbance up-gradient.

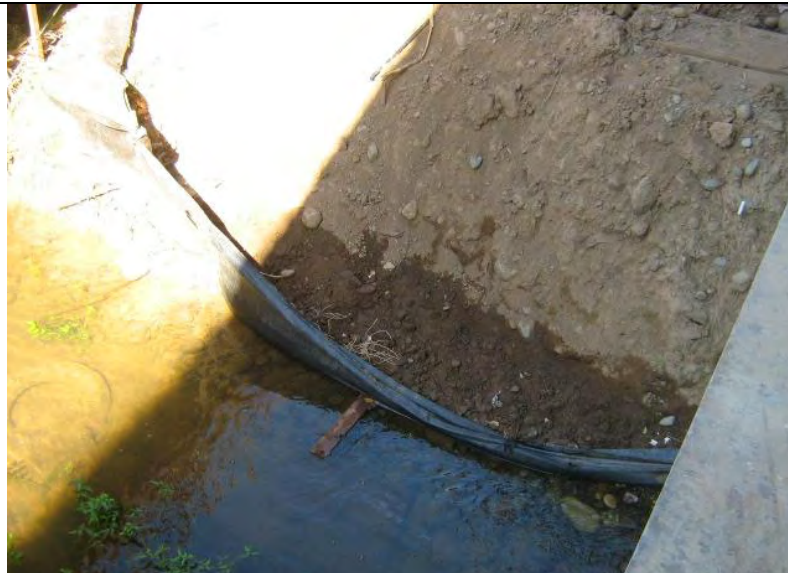
Photograph 22 – Close-up view of Photograph 21.

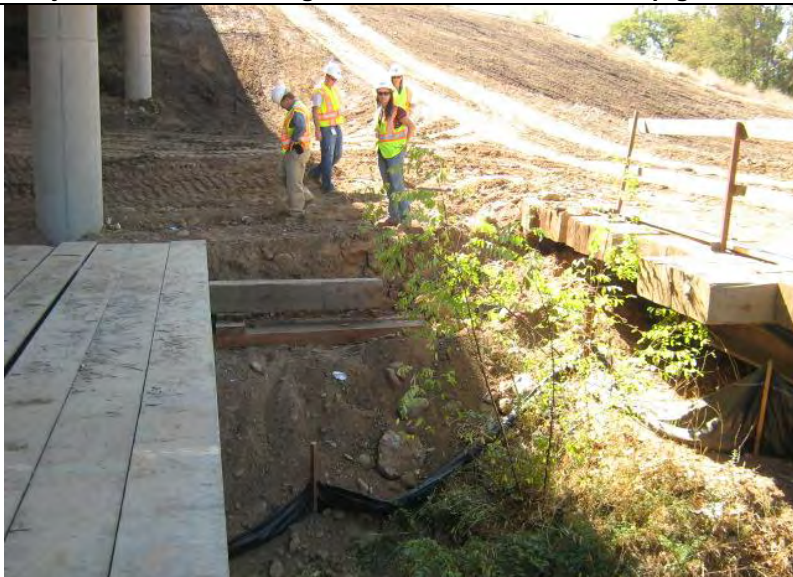
Photograph 23 – Silt Fence collapsed in areas and not properly maintained. Note large unstabilized slope area upgradient.

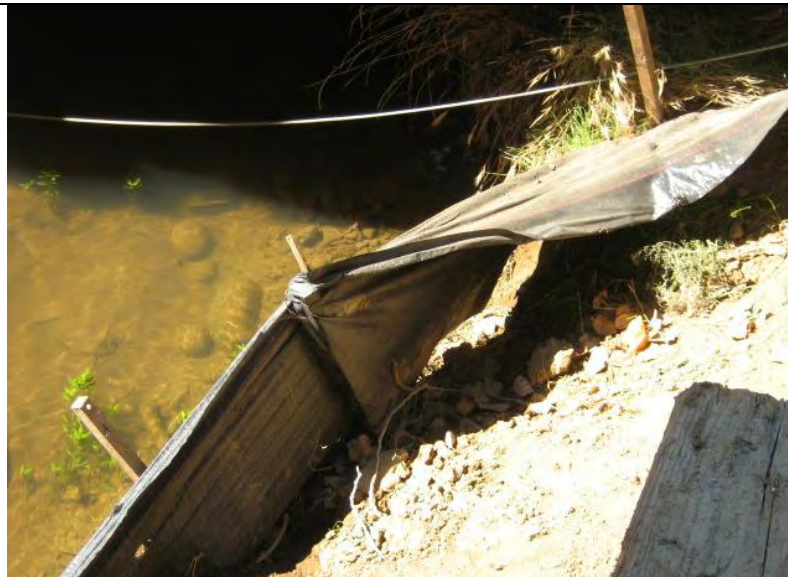
Photograph 24 – Silt Fence not properly entrenched to retain sediment adjacent to Yankee Slough waterway

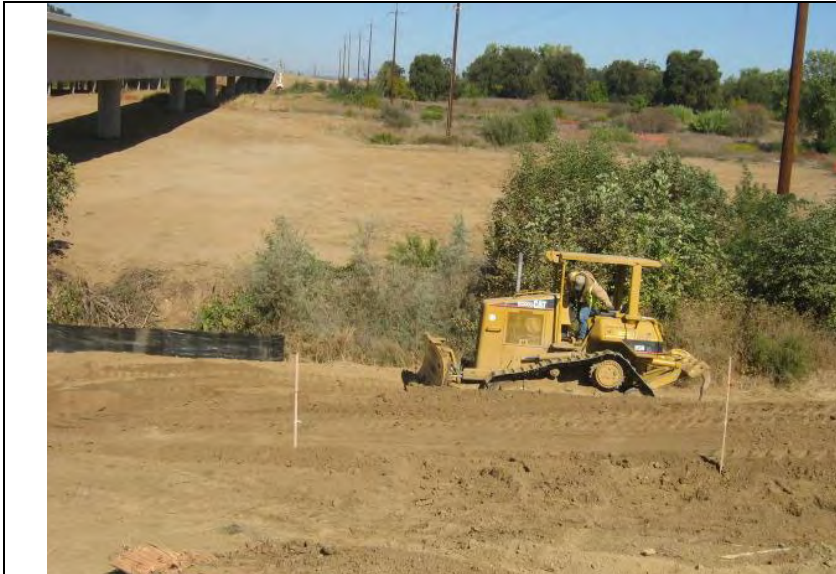
Photograph 25 – SF not adequately implemented for all land disturbing activities to prevent the discharge of sediment to Yankee Slough

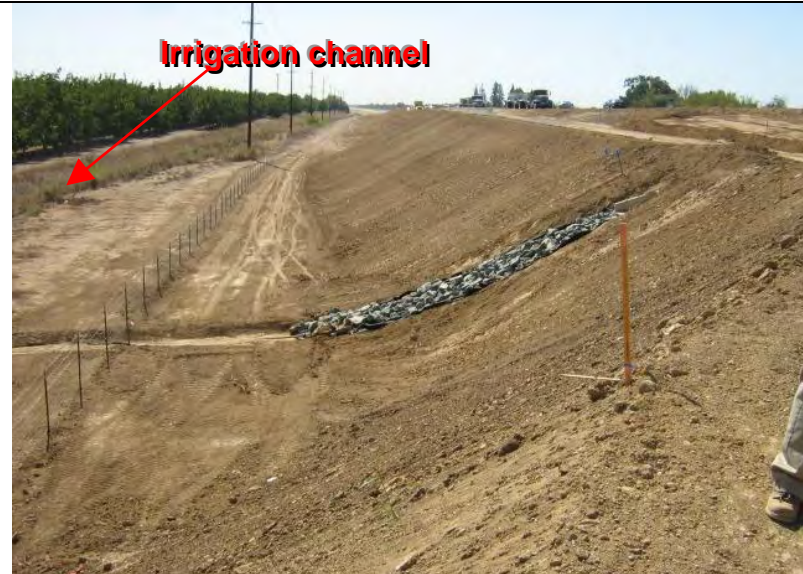
Photograph 26 – Large expanse of disturbed slope area with only rock and no perimeter BMPs.

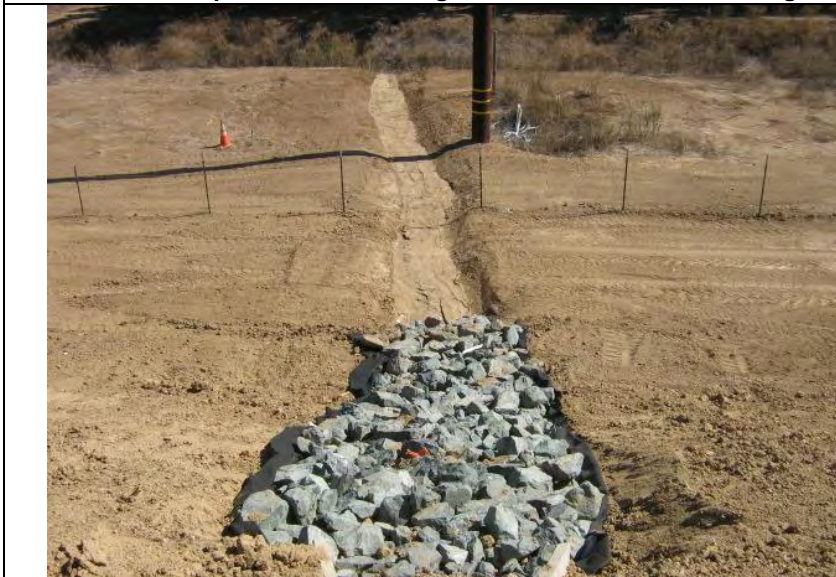
Photograph 27 – Slope drainage channel which drains to irrigation channel
