Appendix D
Construction Program Site Visit Reports

Thomes Creek Bridge Project
Site Visit Date: 10/13/2009

**Caltrans MS4 (SWRCB Order No. 99-06-DWQ)
Thomes Creek Bridge Project
Caltrans District 2**

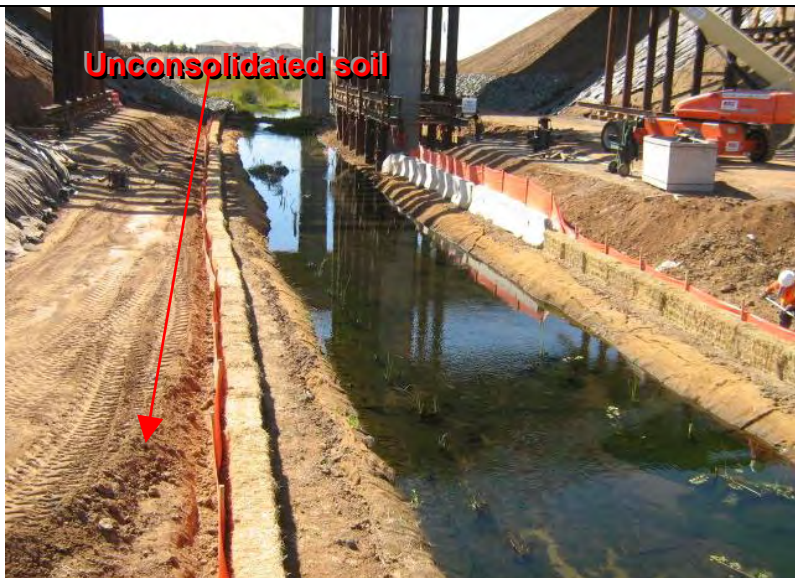
Photograph 3 – Unconsolidated soil placed between the toe of the slope and the perimeter control BMPs along the waterway

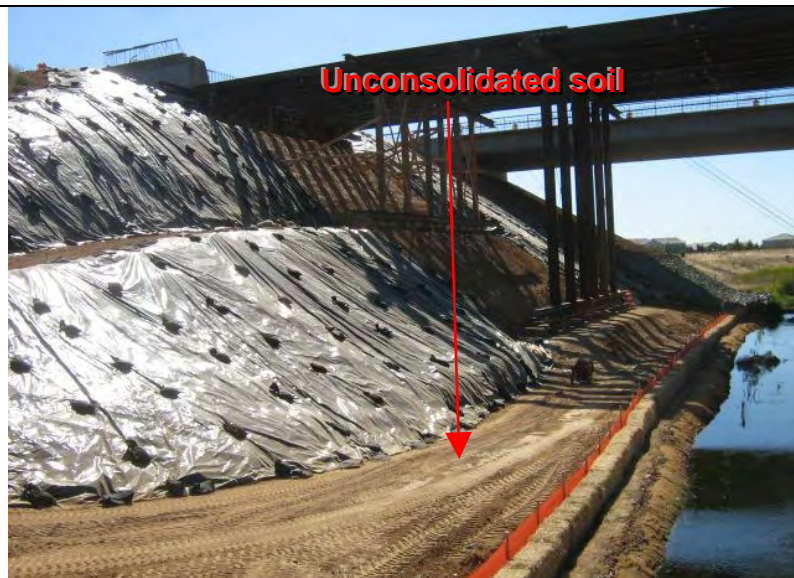
Photograph 4 – No BMPs to control concentrated flow off of the plastic and across the unconsolidated material at the toe of the slope

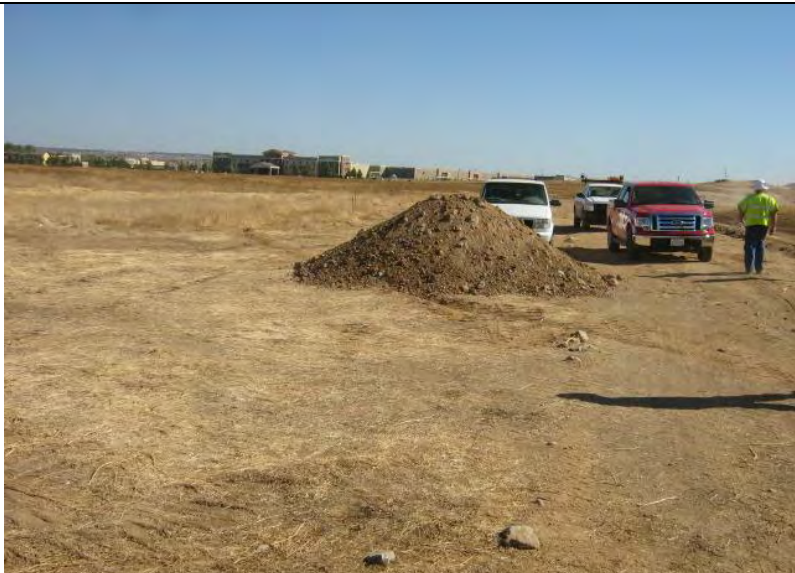
Photograph 9 – No BMPs implemented for stockpile management near the North Ingram Slough bridge crossing

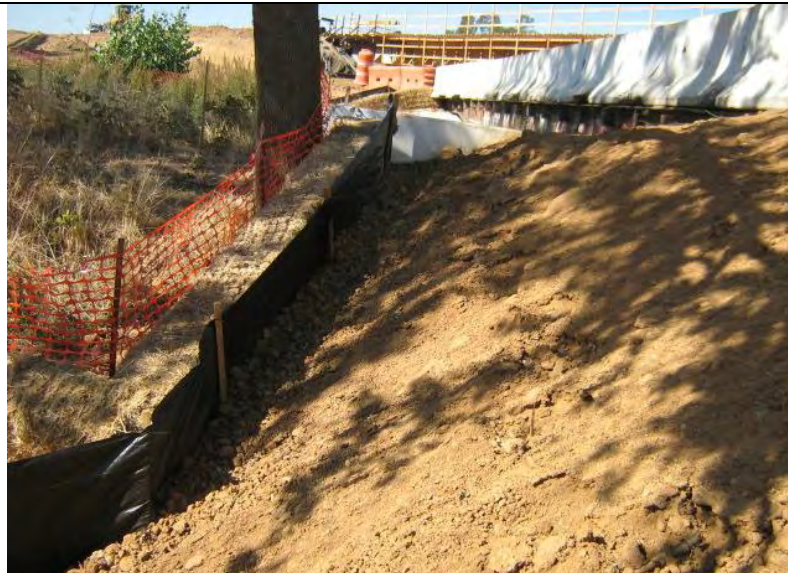
Photograph 10 – Silt fence BMPs installed backwards (e.g., stakes on the upgradient side of the fabric)

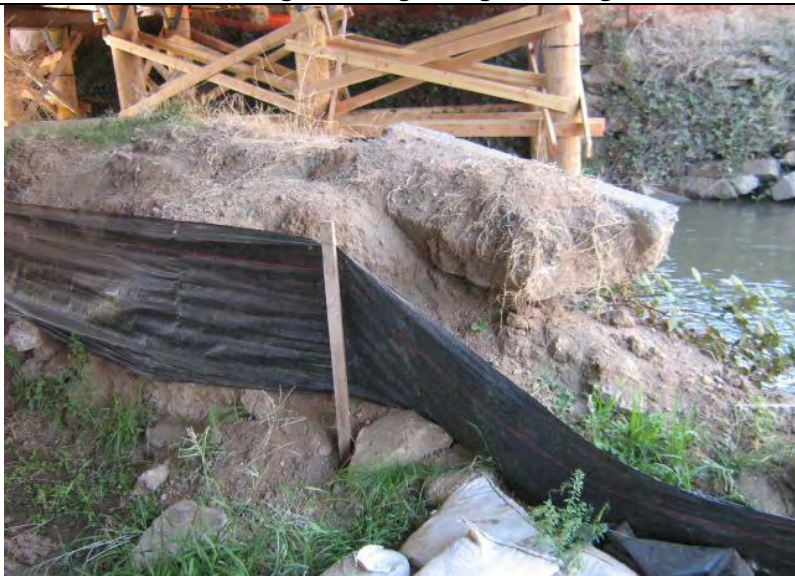
Photograph 11 – Silt Fence BMPs not properly installed (e.g., not entrenched) or maintained (e.g., collapsed) adjacent to Auburn Ravine

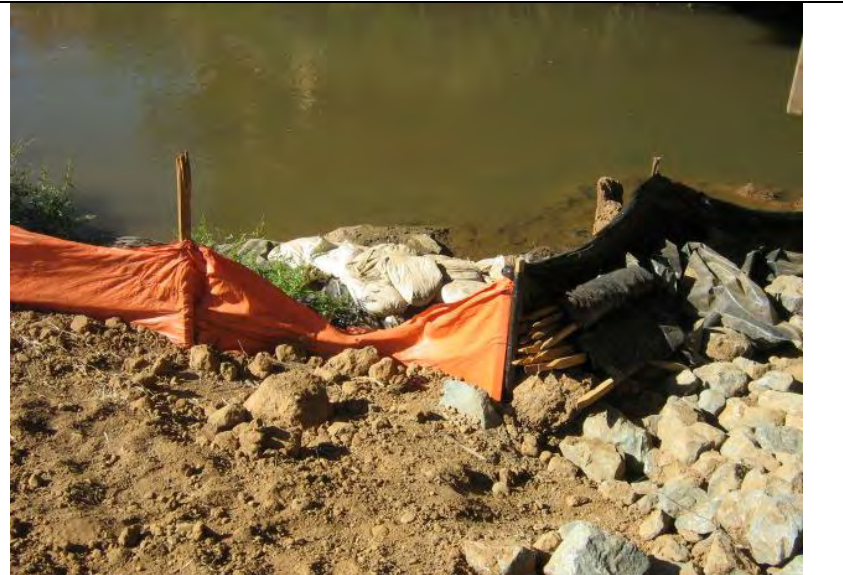
Photograph 14 – Silt Fence BMP not adequately maintained (e.g., down in areas) adjacent to Auburn Ravine

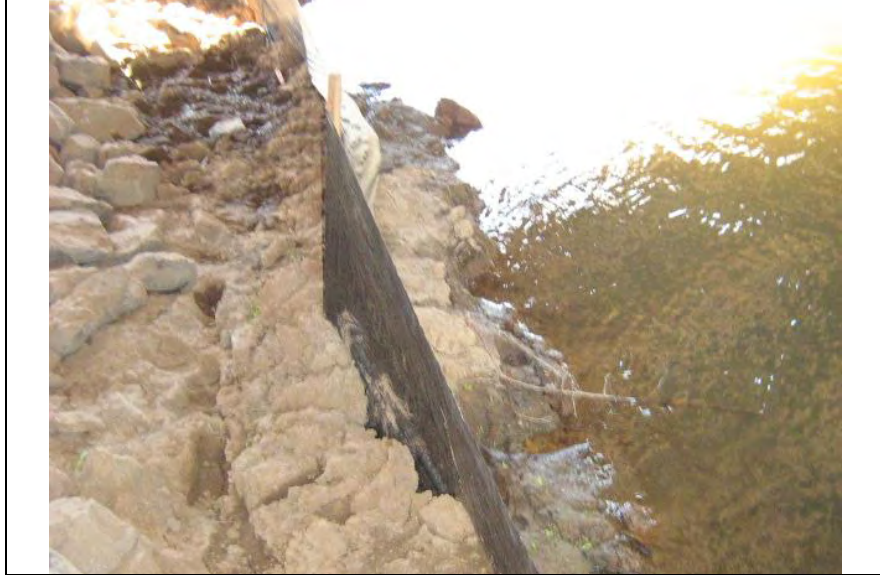
Photograph 15 – SF BMP not adequately maintained (e.g., sediment placement over ½ the effective height) adjacent to Auburn Ravine

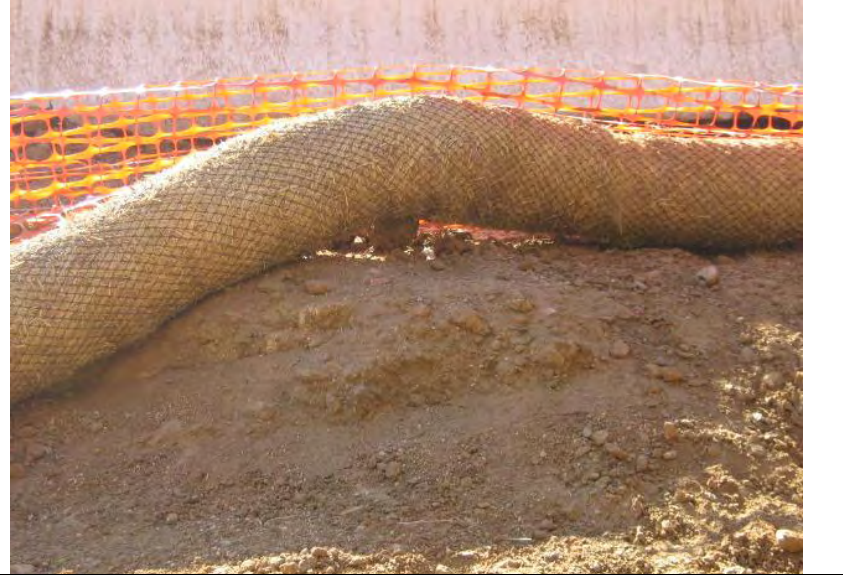
Photographs 16 – Straw wattle BMP not properly installed (e.g., not entrenched) up-gradient of Auburn Ravine

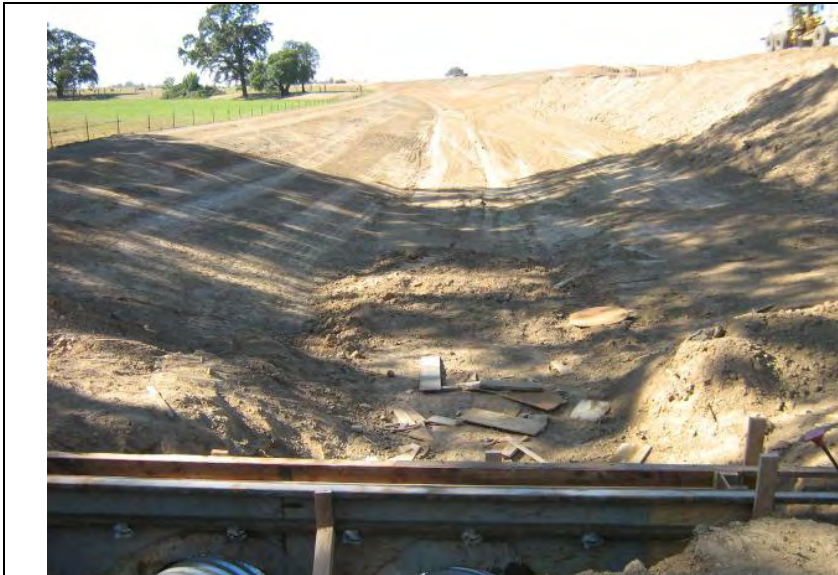
Adequate structural and non-structural BMPs were not implemented in the drainage swale conveyance channels located up-gradient of South Ingram Slough (see [Photograph 8](#)) and Auburn Ravine (see [Photograph 17](#)). BMPs had not been implemented to prevent erosion from run-on to the swale slopes, and concentrated flow along the bottom of the swale. As a result, there was a potential for erosion and subsequent discharge from these drainage swale conveyance channels to South Ingram Slough and Auburn Ravine, respectively.

Photograph 17 – Upgradient areas of disturbance associated with pollution prevention BMP unstabilized. Drains to Auburn Ravine.

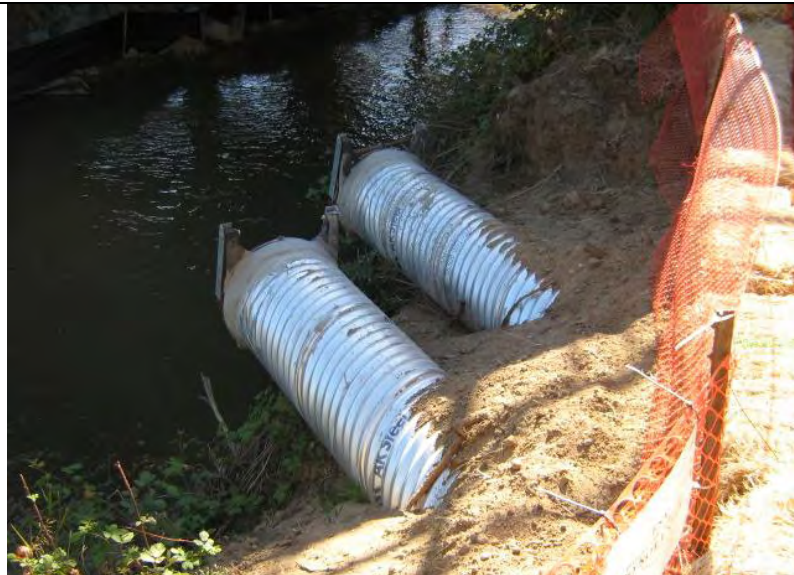
Photograph 18 – Disturbed slope area adjacent to pollution prevention BMP outlet pipes adjacent to Auburn Ravine.

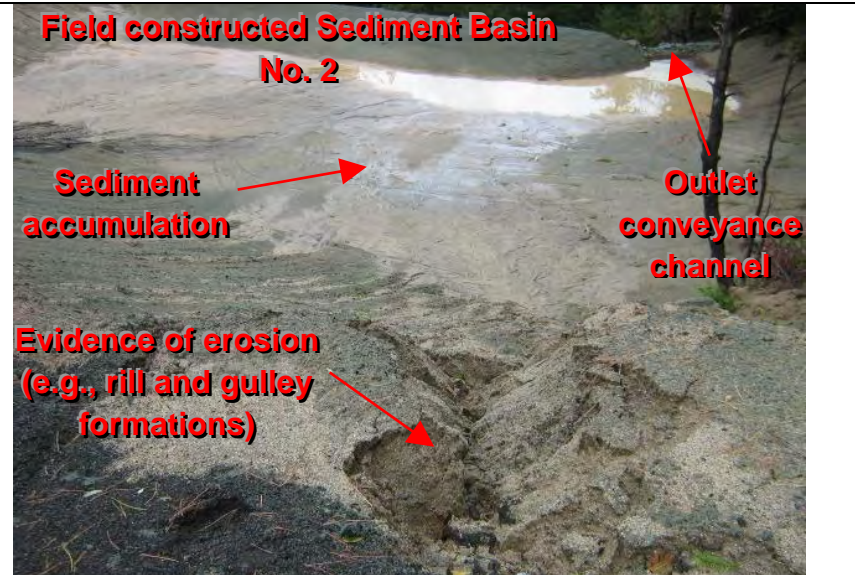
Photograph 10 – Evidence of the discharge of sediment to the basin and sediment accumulation in the basin which drains to unnamed tributary

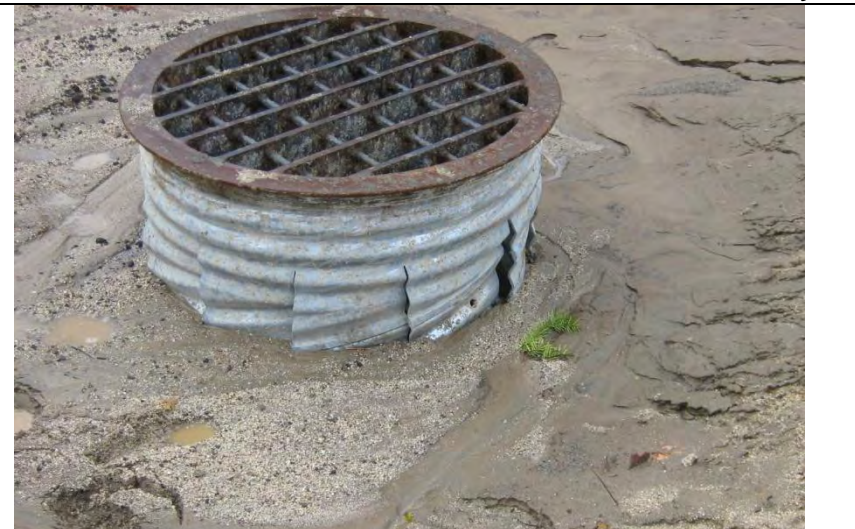
Photograph 12 – Close-up view of sediment basin No. 1 outlet structure with sediment accumulation

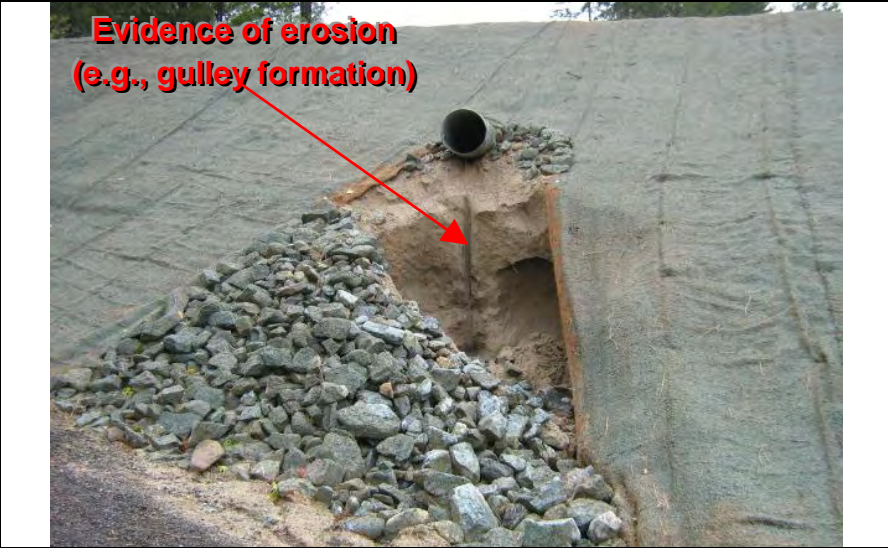
Photographs 16 – Adequate BMPs were not implemented below field constructed sediment basin No. 1 culvert outlet pipe.

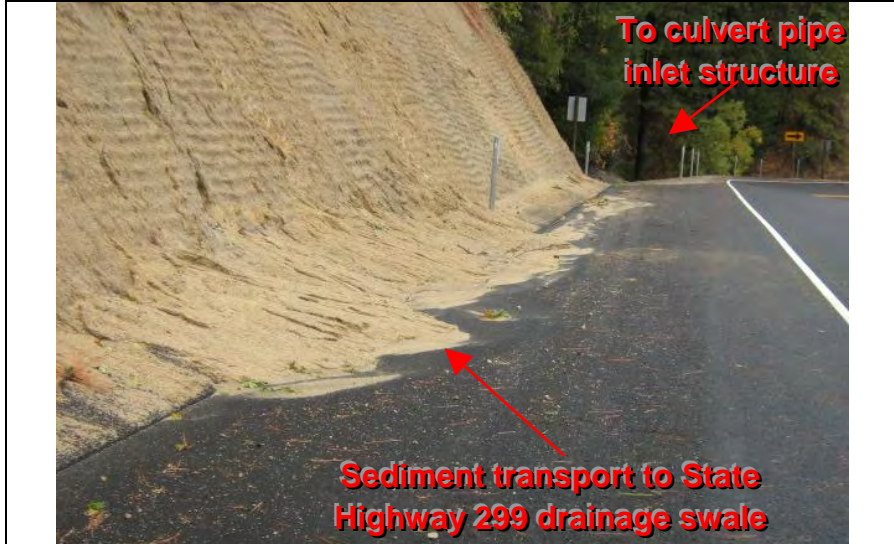
Photograph 19—Evidence of sediment transport to State Highway 299 drainage swale from the adjacent unstabilized disturbed cut slope area.

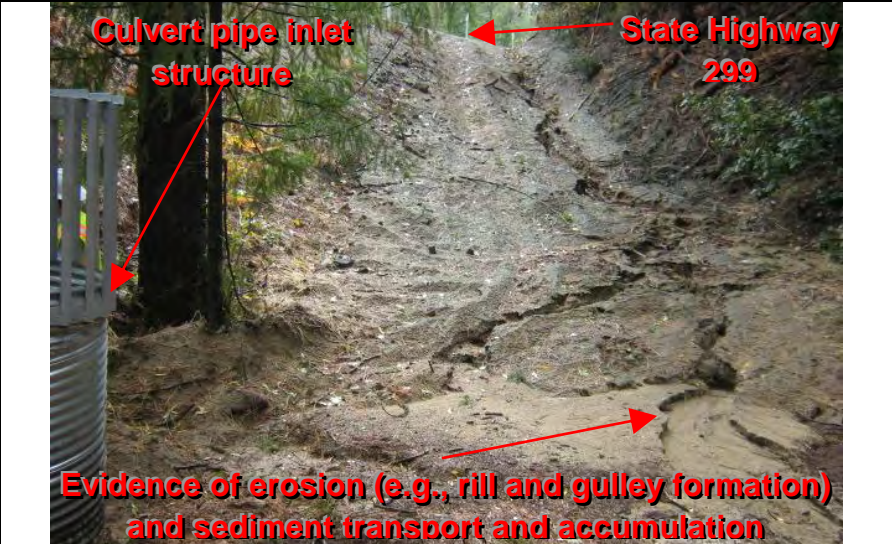
Adequate BMPs were not implemented for disturbed cut slope areas located adjacent to State Highway 299, which ultimately drain offsite via a culvert pipe inlet and drainage pipe leading to unnamed tributary to Crystal Creek. Specifically, adequate structural and non-structural BMPs had not been implemented for the disturbed cut slope areas (see [Photograph 18](#)), and evidence of erosion, cut slope failure and sediment transport were observed (see [Photographs 18 through 20](#)). As a result, there was evidence of sediment transport from the disturbed cut slope area to the adjacent State Highway 299 drainage swale which drains to the culvert pipe inlet area (see [Photograph 20](#)).

Photographs 20 – Evidence of erosion (e.g. rill and gully formation) and sediment transport from upgradient disturbed slope area (see Photo 18+19)

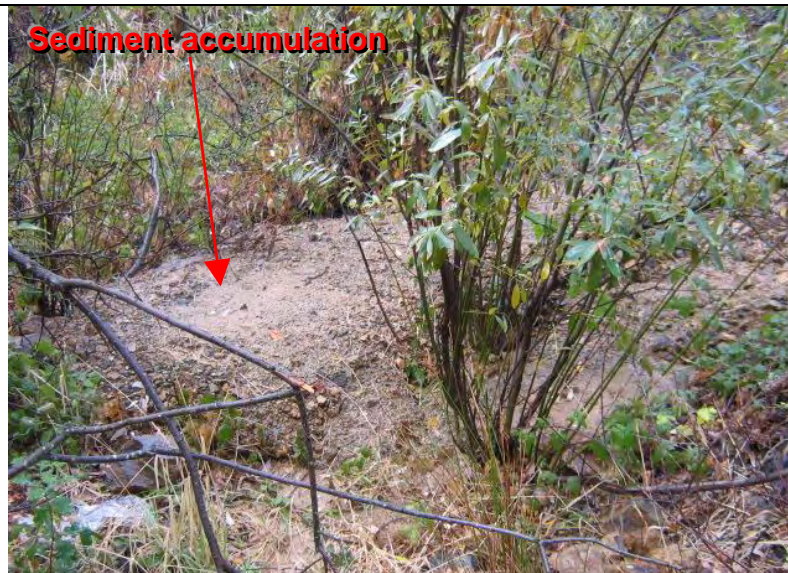
Photograph 6 – Close-up of sediment accumulation shown in Photograph 5

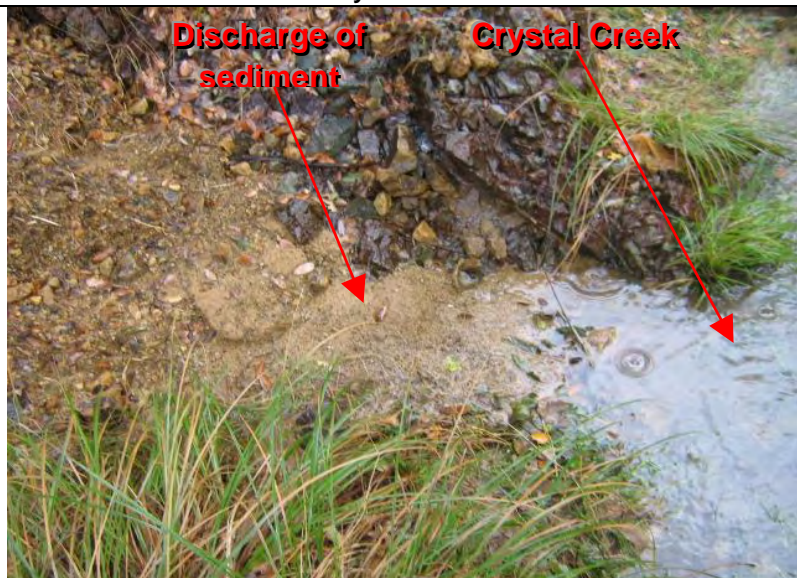
Photograph 7—Visible evidence of the discharge of sediment from the upgradient disturbed slope areas to Crystal Creek

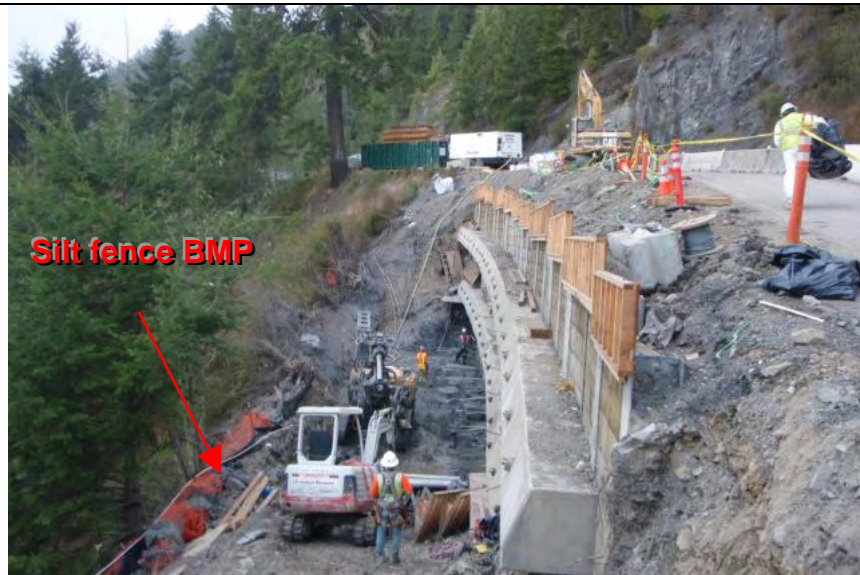
Photograph 2 – Example of silt fence BMP implemented down-gradient of disturbance and retaining wall construction

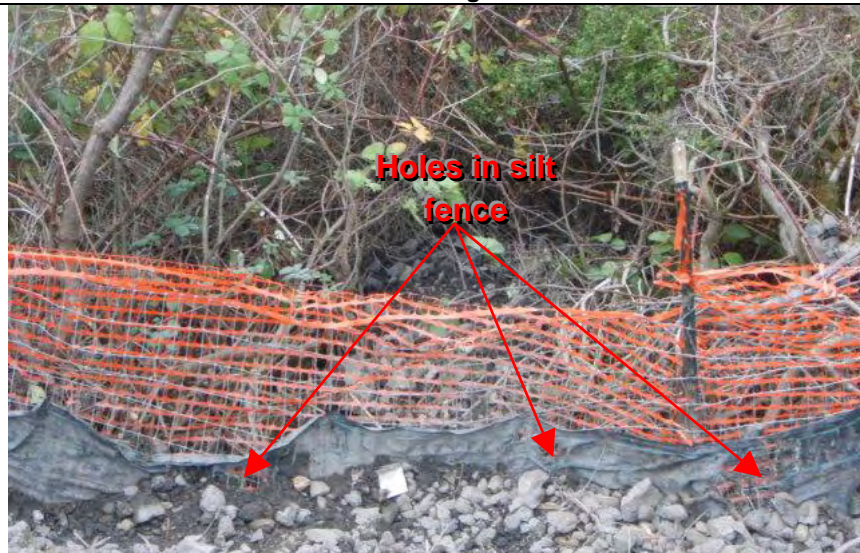
Photograph 4 – Another example of sediment accumulation and unmaintained silt fence

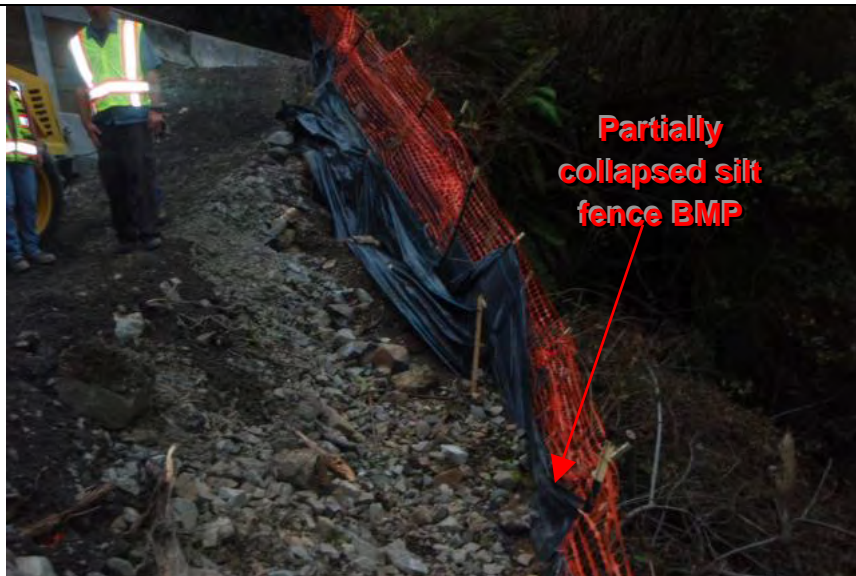
Photograph 5— Another example of sediment accumulation and unmaintained silt fence

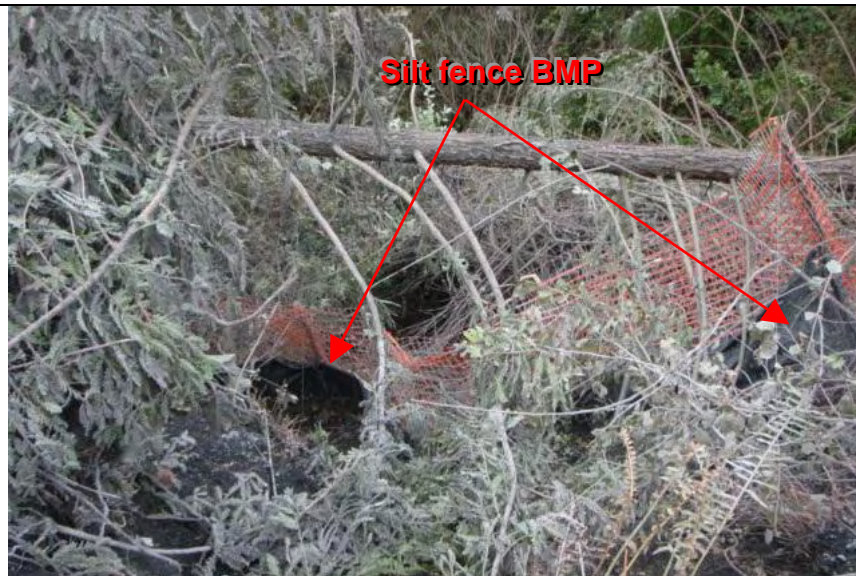
Photograph 6 – Example of silt fence BMP partially covered by collapsed vegetation

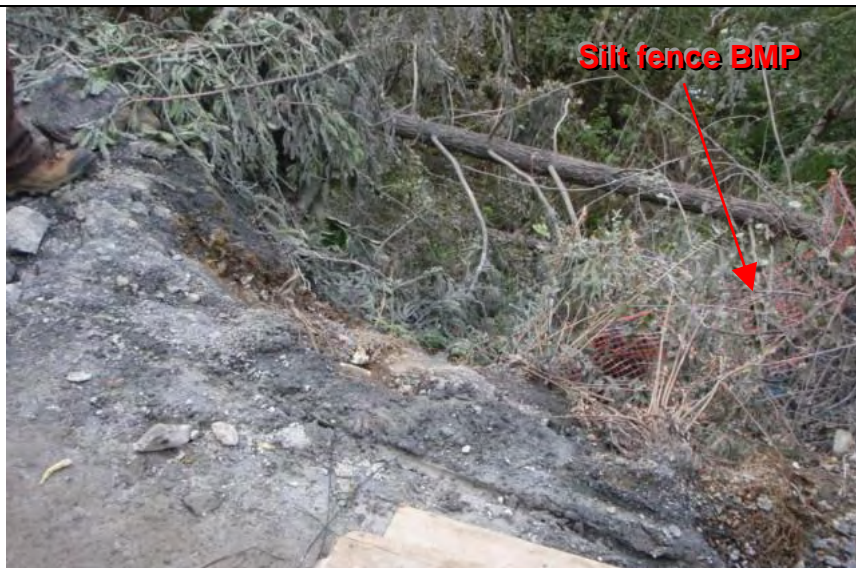
Photograph 7— Another example of silt fence BMP partially covered by collapsed vegetation - view down slope to silt fence BMP

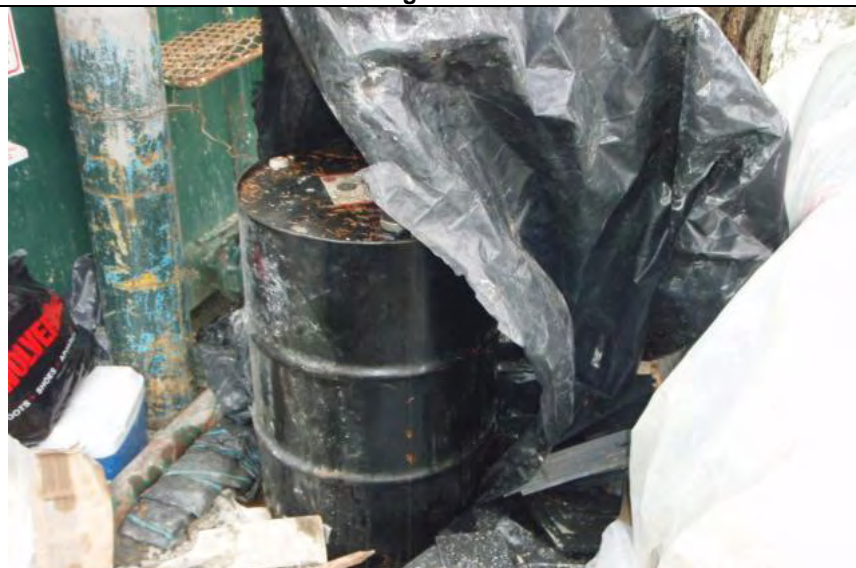
Photograph 8 – 55-gallon drum of “Rock Drill 150” that is partially covered and not within adequate secondary containment

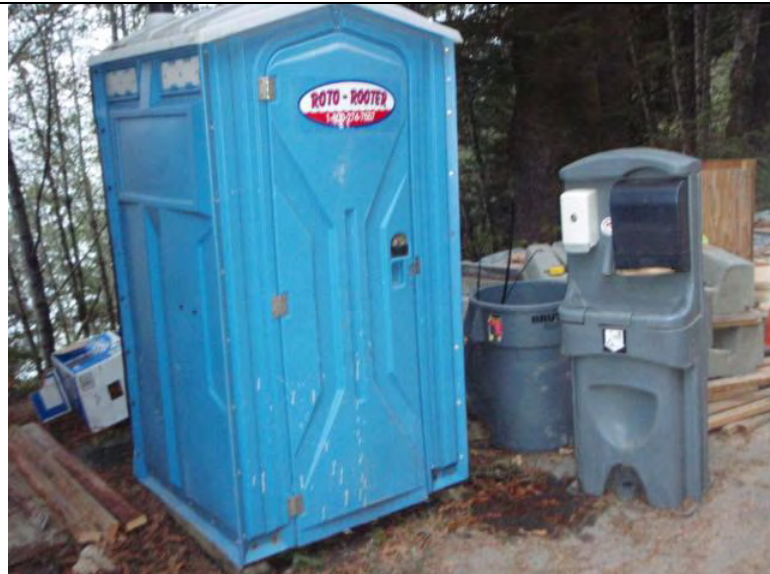
Photograph 12— Portable toilet adjacent to steep slope

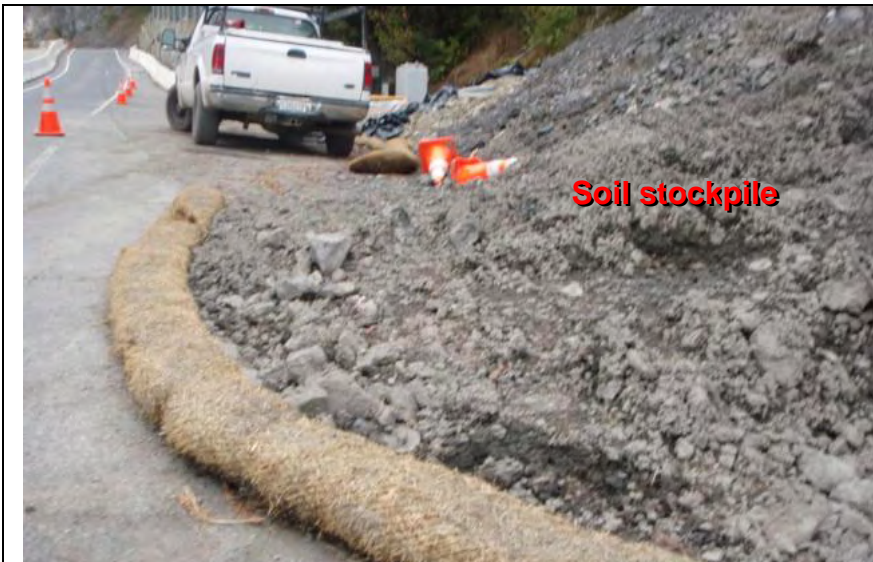
In addition, straw wattle BMPs used for stockpile management were improperly installed on impervious surfaces at the facility, and therefore were not properly entrenched in the ground to retain the stockpiled materials (see Photographs 13 and 14). As a result, there was a potential for the discharge of sediment to the roadway and off-site to the west. The Resident Engineer explained that the SWPPP had been amended to include the use of straw wattle BMPs on impervious surfaces; however, this was not confirmed by the EPA Audit Team.

Photograph 13— Straw wattle not staked or entrenched into ground. Inappropriate application of wattles on impervious surface

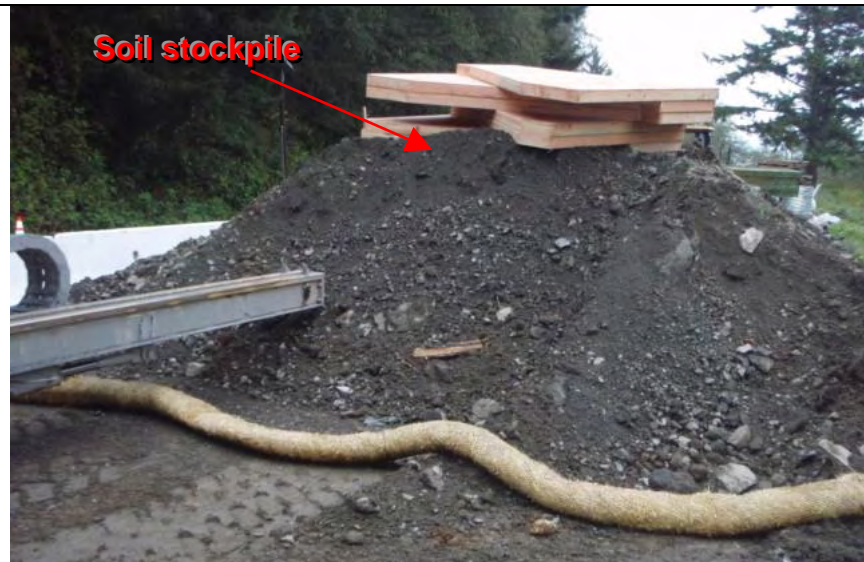
Photograph 14— Another example of straw wattle not staked or entrenched into ground. Inappropriate application of wattles on impervious surface.

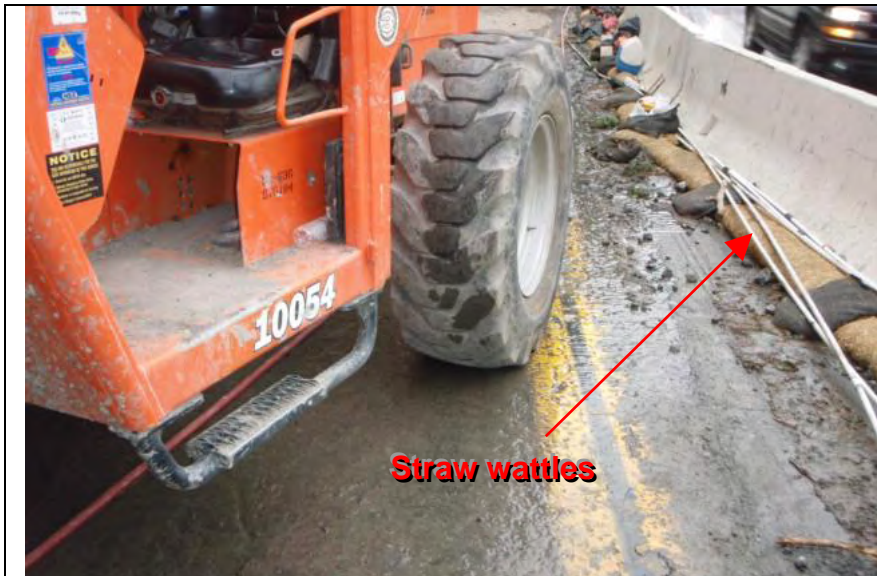
Photograph 17— View down-gradient from water container (Note: Wetness on impervious surface and placement of straw wattles)

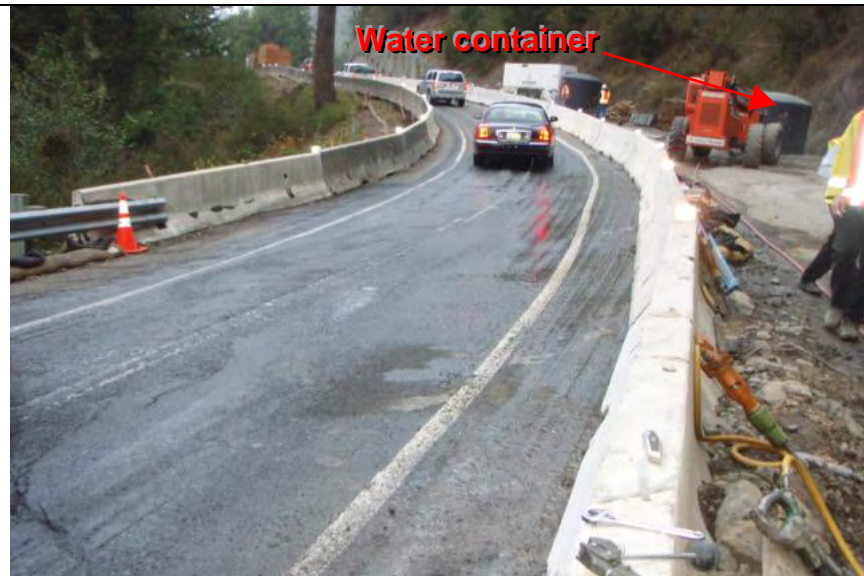
The EPA Audit Team observed that a water storage tank (approximately 1,000-gallon capacity) located up-gradient had been punctured by a forklift and was leaking (see Photographs 15 and 16). Water was observed slowly flowing underneath the straw wattle BMPs that been placed on the impervious roadway surface adjacent to K-rail barriers near the southern end of the construction project (see Photograph 17). The straw wattle BMPs had been installed prior to the puncture incident. Water had flowed underneath the straw wattles and jersey barriers and was observed on the adjacent roadway (see Photograph 18).

Photograph 18— View up-gradient to water container (Note: Wetness on roadway surface down-gradient of water container)

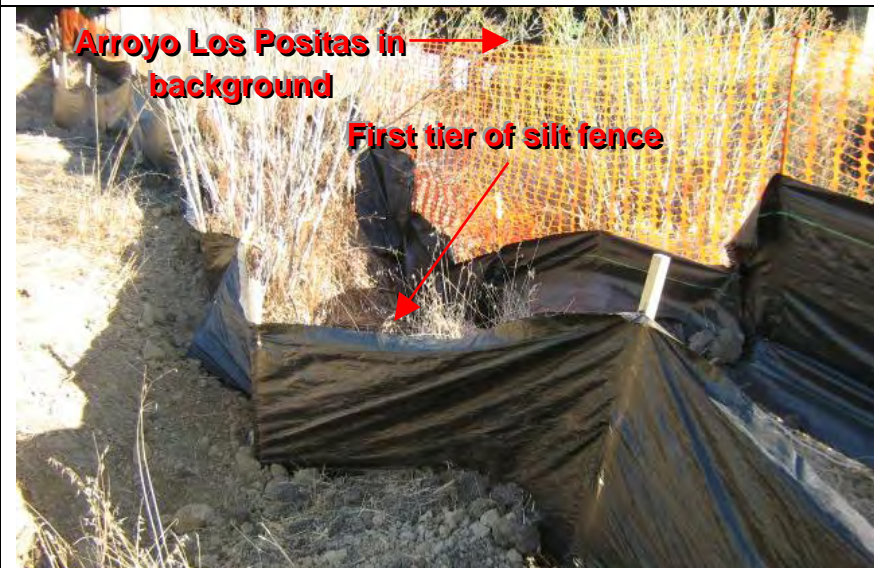
In an area located upstream of the constructed diversion near the entrance to the construction access road, a silt fence BMP was improperly installed in a drainage depression leading to Arroyo Los Positas and had partially collapsed. Although two tiers of silt fence had been installed for BMP redundancy, both tiers were in need of maintenance and the first tier of silt fence had failed (see Photographs 4 and 5). As a result, there was a potential for the discharge of sediment to Arroyo Los Positas.

Photograph 4 – Silt fence BMP installed in a drainage depression

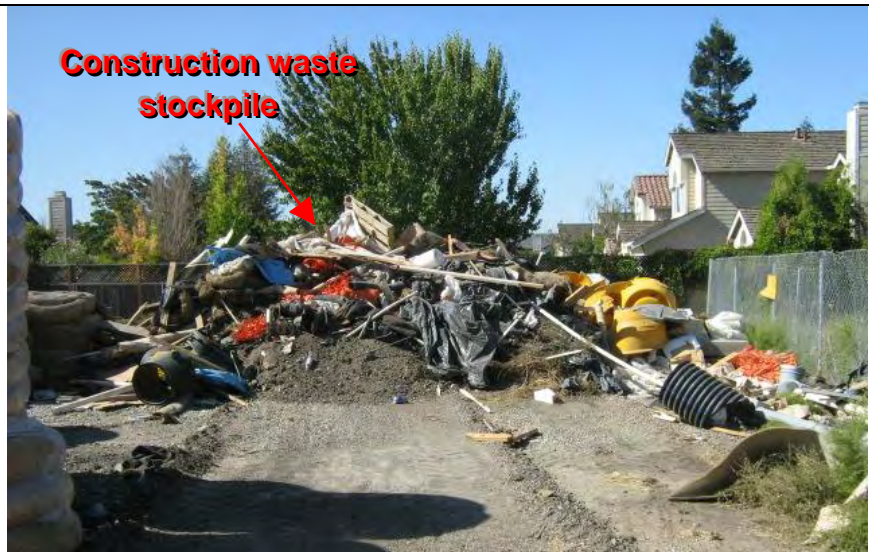
Photograph 5— Uncovered and uncontained construction waste

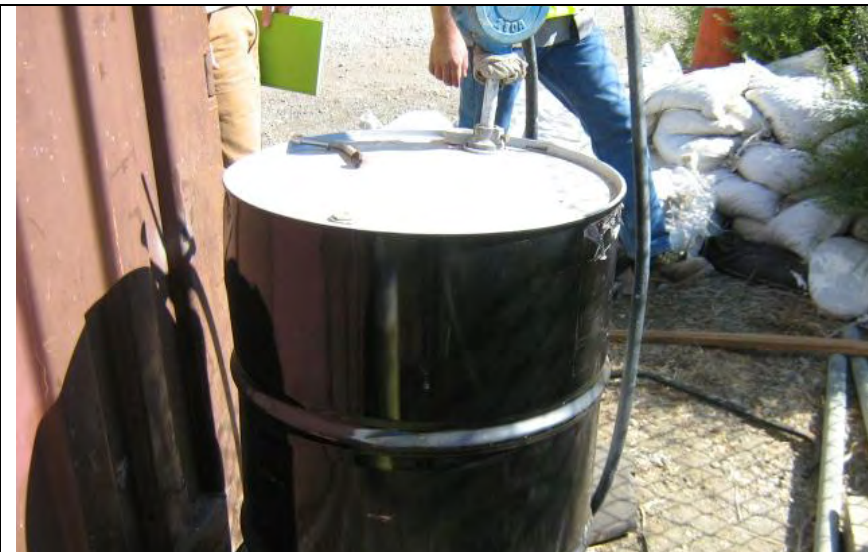
Photograph 6 – Asphalt release agent without secondary containment

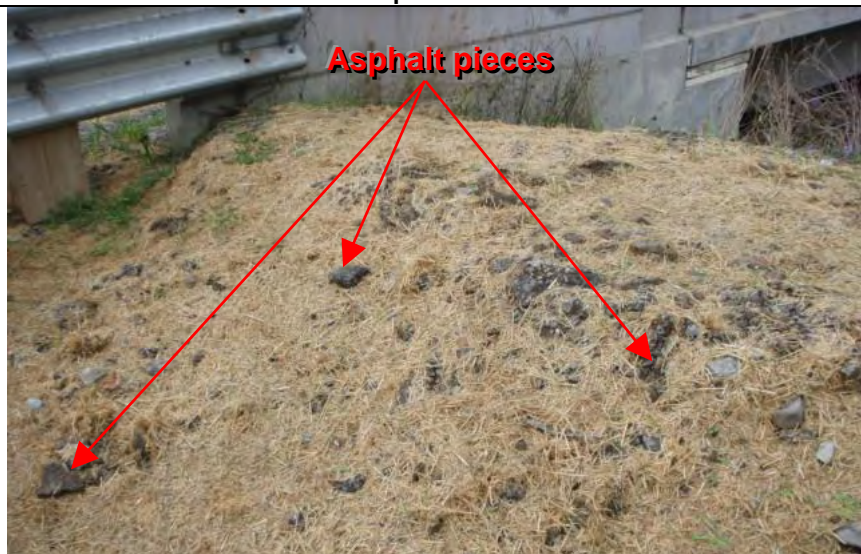
Moreover, evidence of sidecast asphalt pieces in areas adjacent to the roadway were observed near the northern end of the construction project (see [Photograph 11](#)).

Photograph 11— Sidecast asphalt pieces along side of roadway at northern end of construction project

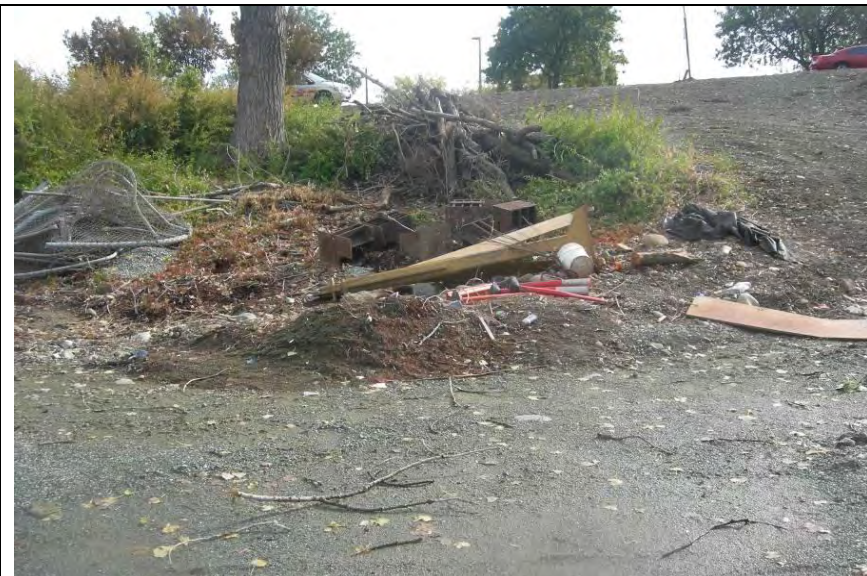
Photograph 5 – Lack of perimeter control BMPs around a construction material disposal stockpile

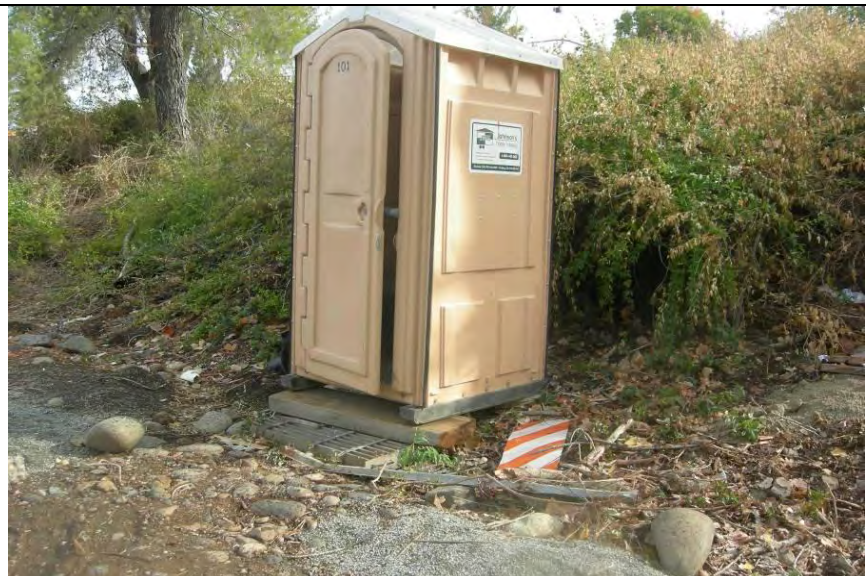
Photograph 6 – View of unsecured portable toilet

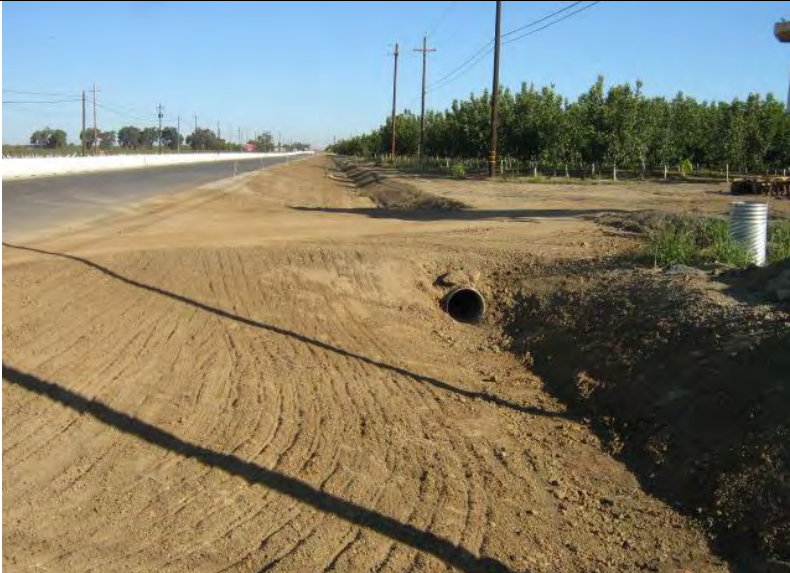
Photograph 1 – Drainage swale adjacent to roadway without adequate BMPs implemented (Drill seeding only)

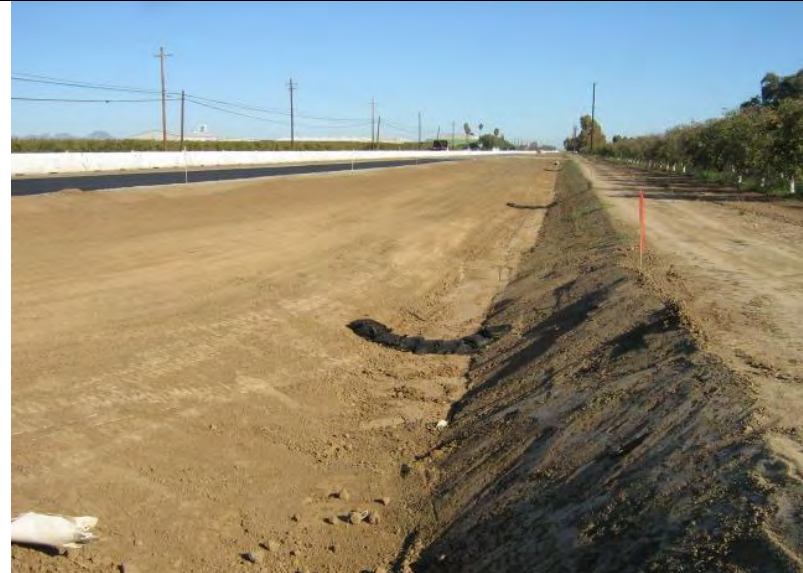
Photograph 2 – Unstabilized drainage swale and slope adjacent to roadway

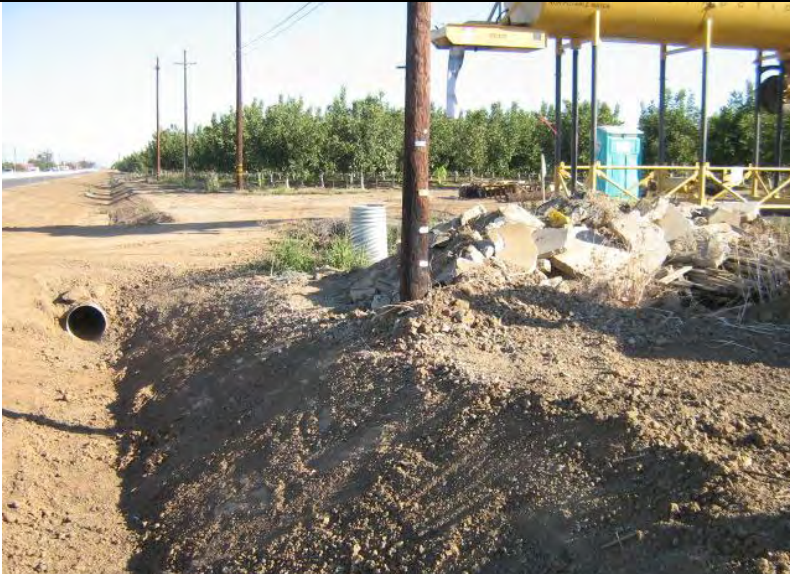
Photograph 3 – Uncontained concrete waste adjacent to roadway drainage swale

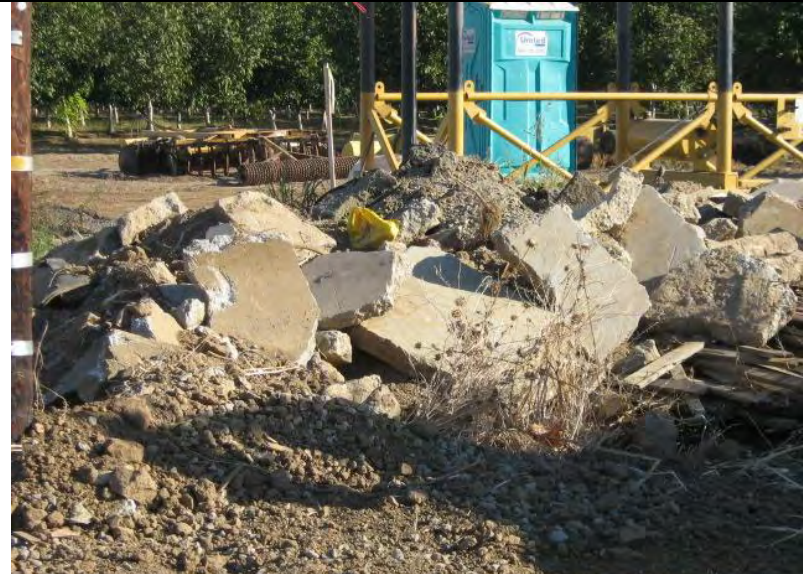
Photograph 4 – Close-up of Photograph 3 and concrete waste

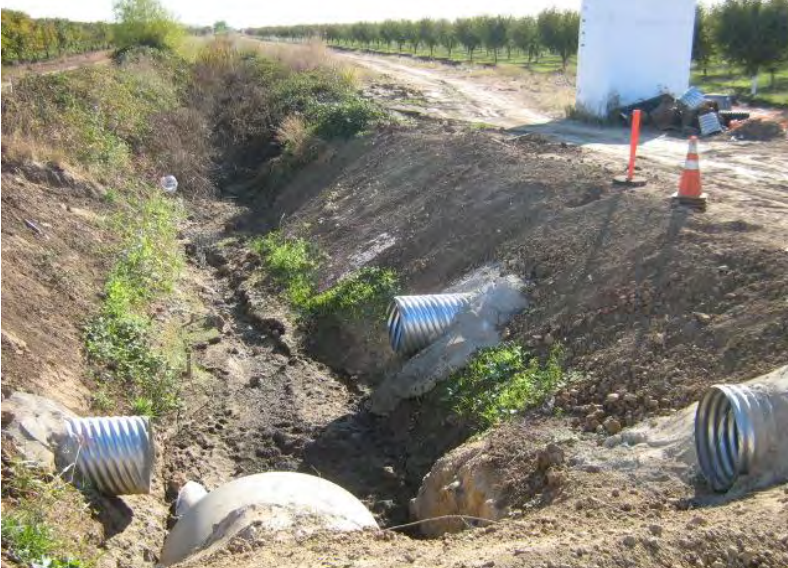
Photograph 5 – View looking upgradient on irrigation channel located adjacent to project. Note unstabilized slopes adj. to irrigation channel.

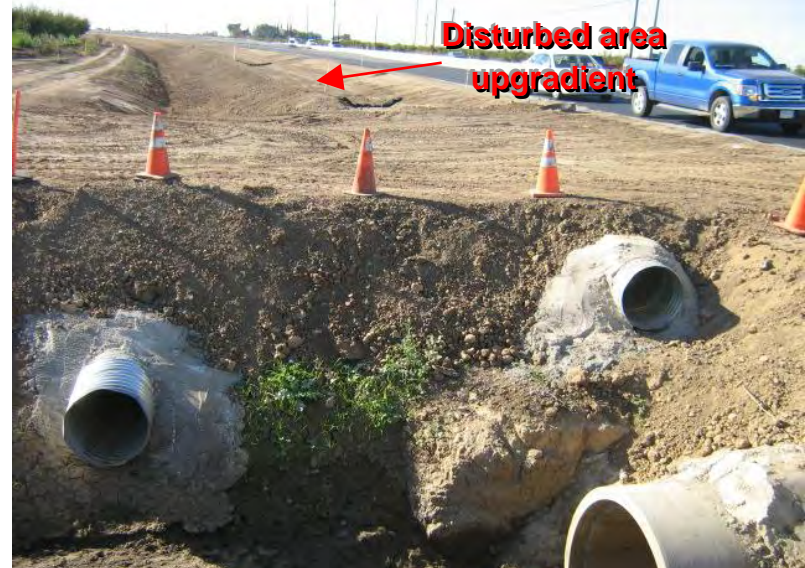
Photograph 6 – Culvert outlet pipes and disturbed embankment slope in irrigation ditch

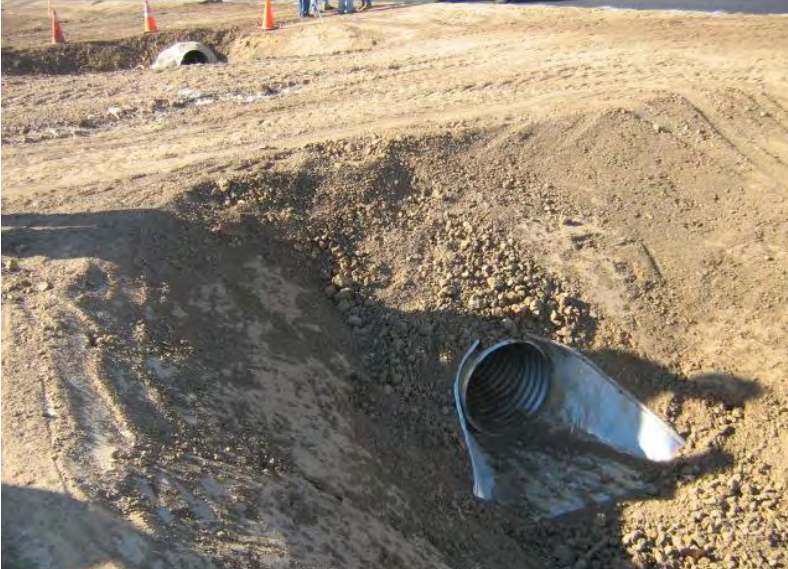
Photograph 7 – Culvert pipe inlet with no BMPs implemented – drains to irrigation ditch.

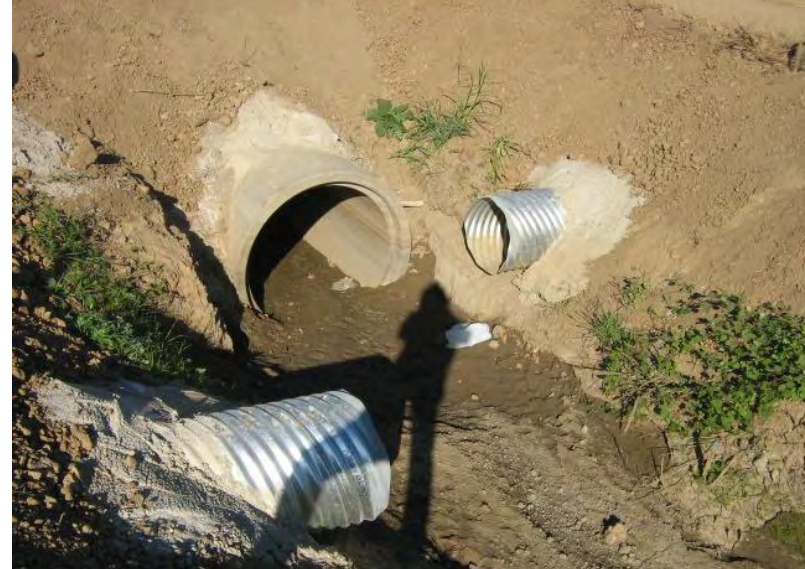
Photograph 8 – Culvert pipe outlet from Photograph 7 to irrigation channel.

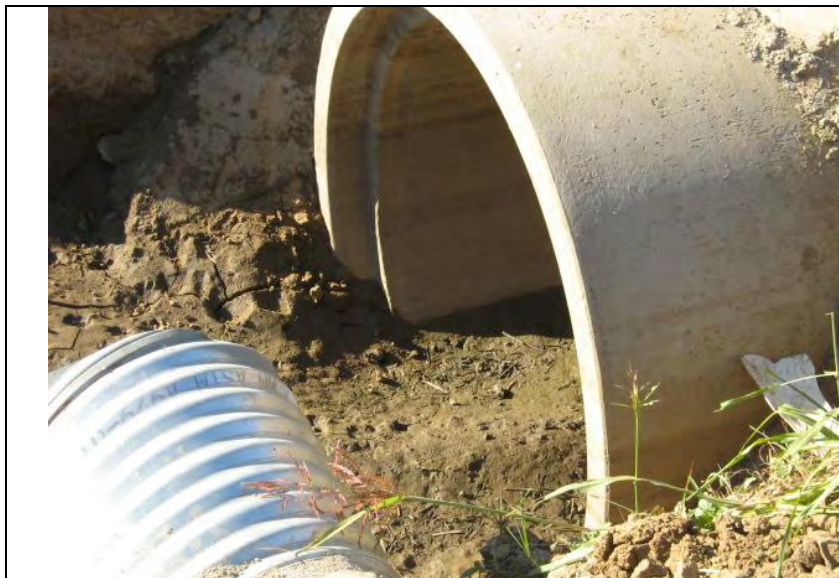
Photograph 9 – Visible sediment accumulation in the irrigation channel and associated culvert pipe

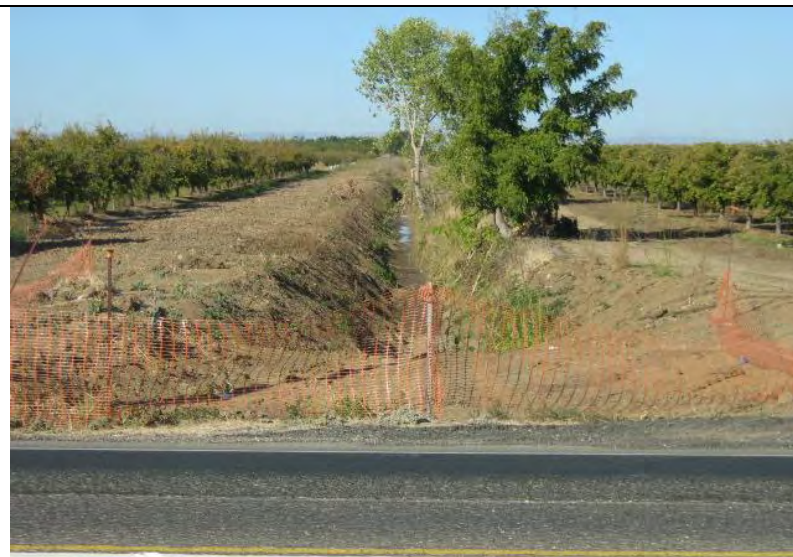
**Photograph 10- View of down-gradient irrigation channel below outlet.
 Note: Inlet to this area is shown in Photograph 9.**
