Appendix D
Construction Program Site Visit Reports

Thomes Creek Bridge Project
Site Visit Date: 10/13/2009

**Caltrans MS4 (SWRCB Order No. 99-06-DWQ)
Thomes Creek Bridge Project
Caltrans District 2**

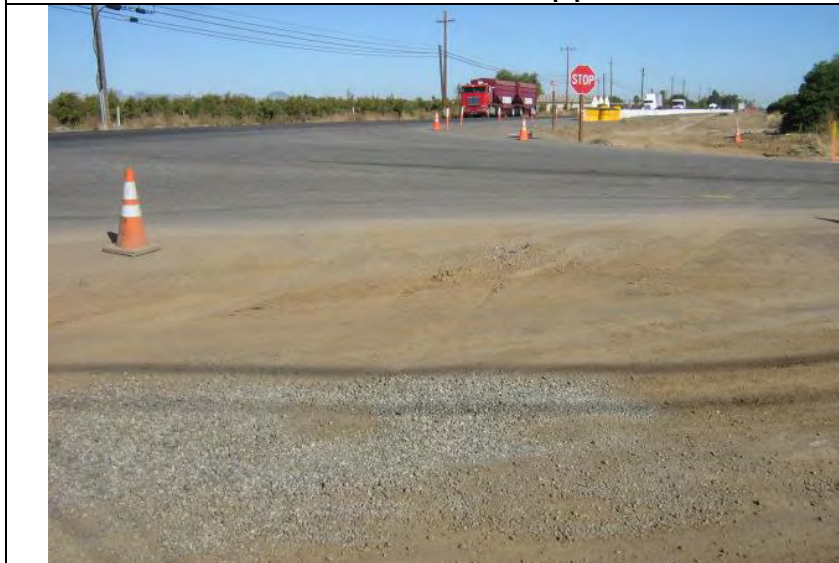
Photograph 11 –Tracking control BMPs were not implemented near Station 346 + 70.

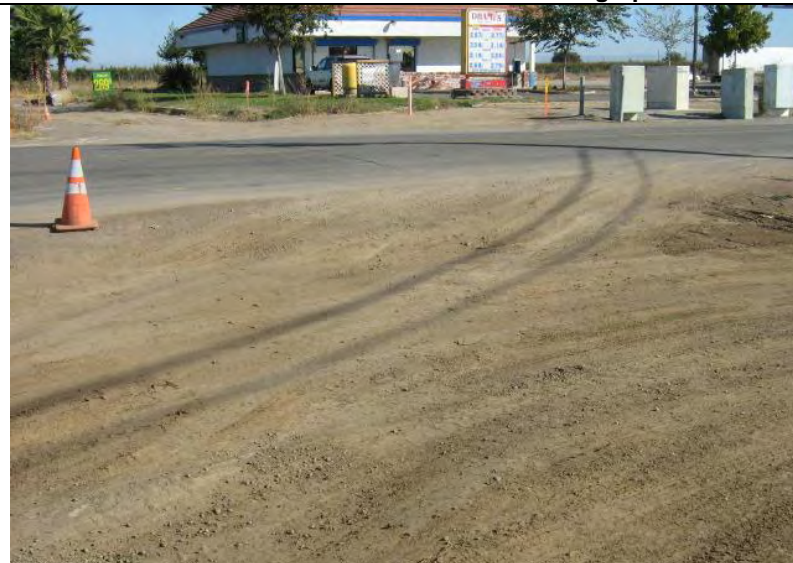
Photograph 12 – No tracking control BMPs implemented at Sta. 346 + 70.

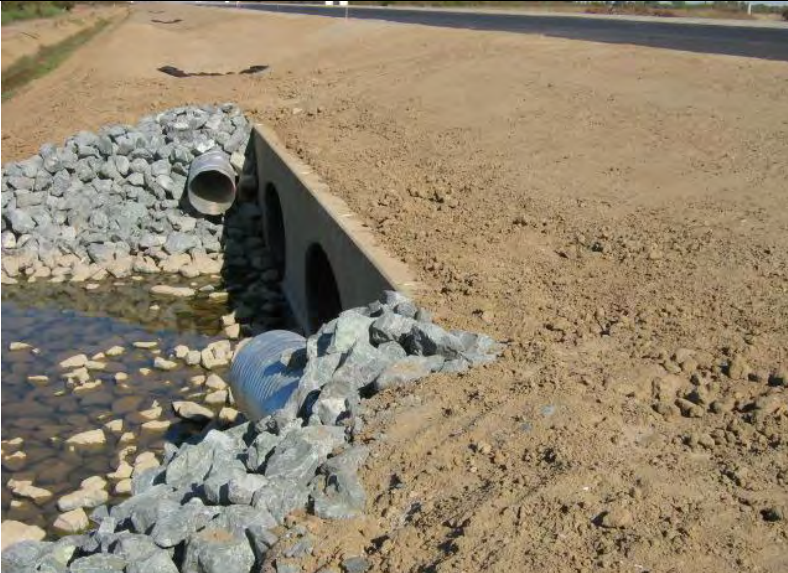
Adequate structural and non-structural BMPs had not been implemented for up-gradient areas of disturbance located directly adjacent to an irrigation channel located at Station 300 + 00 (see Photographs 13 through 16). Specifically, erosion and sediment controls had not been implemented for disturbed slope areas and no inlet protection BMPs had been implemented. As a result, there was a potential for the discharge of sediment from the up-gradient areas of disturbance to the irrigation channel which subsequently drains to levees at Sutter Bypass and ultimately to the Sacramento River.

Photograph 13 – Adequate E&S controls were not implemented for areas of disturbance up-gradient of irrigation channel (East side)

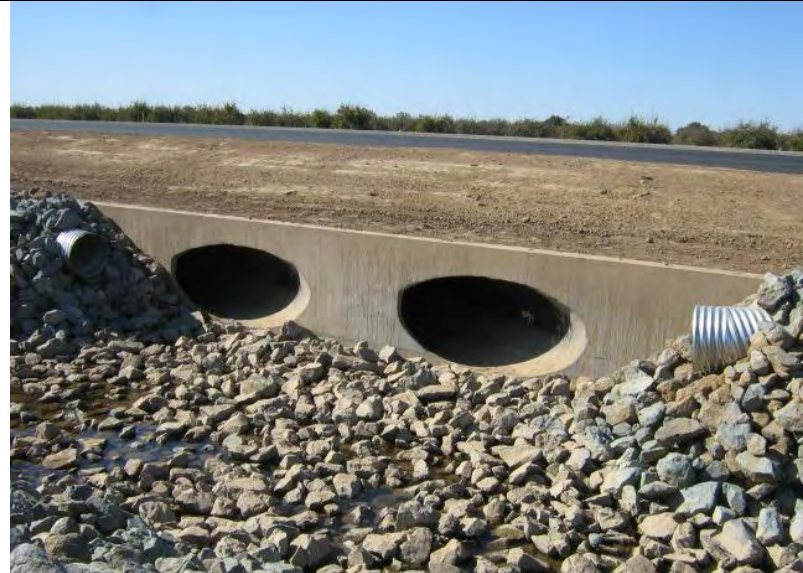
Photograph 14 - Adequate E&S controls were not implemented for areas of disturbance up-gradient of irrigation channel (West side)

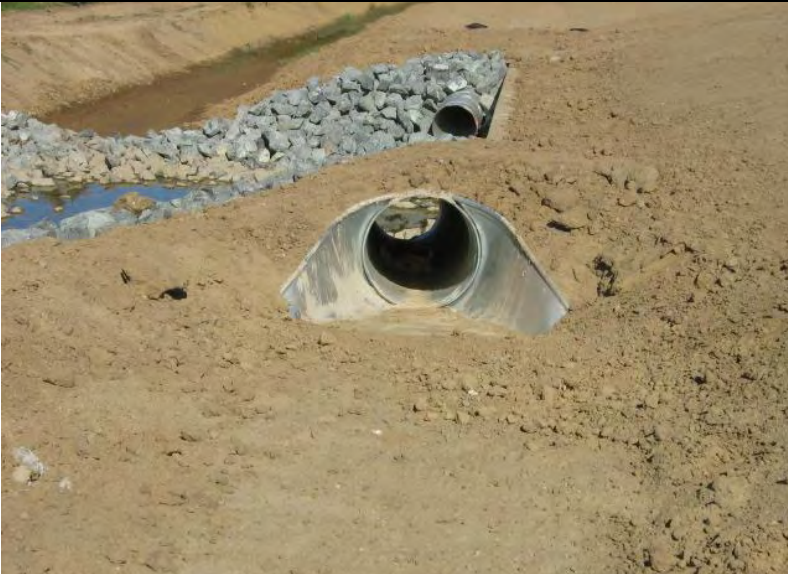
Photograph 15 – Inlet protection BMPs were not implemented for a culvert inlet draining to the irrigation channel.

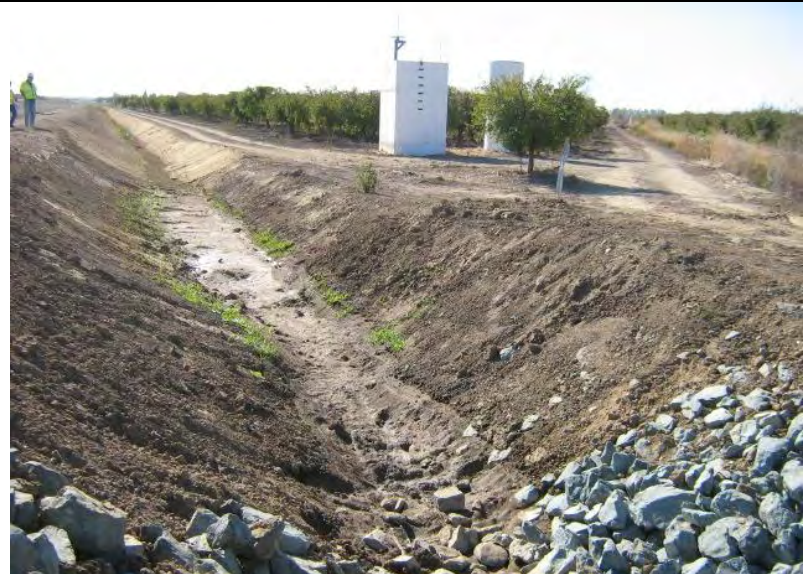
Photographs 16 – BMPs were not implemented for the entire disturbed slope areas of the adjacent roadway drainage swale (East side).

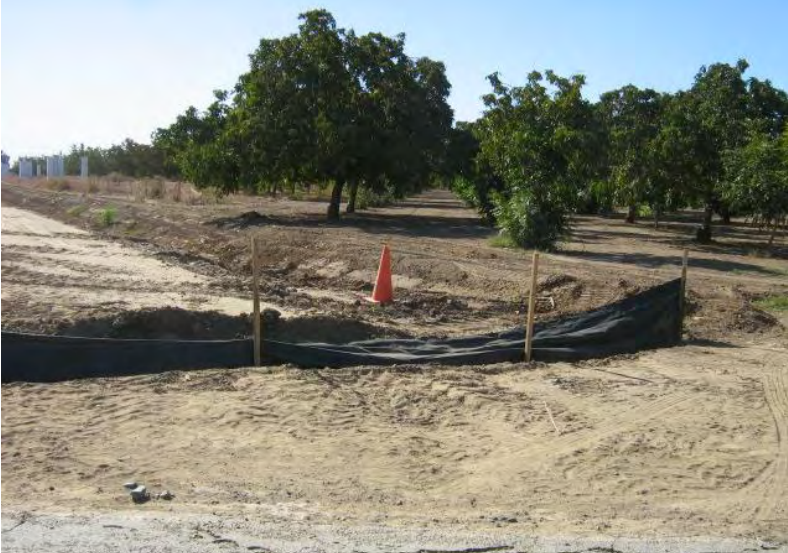
Photograph 19 – Silt fence not adequately maintained (e.g., collapsed in areas) near the new Hwy 99 and Wilson Road intersection.

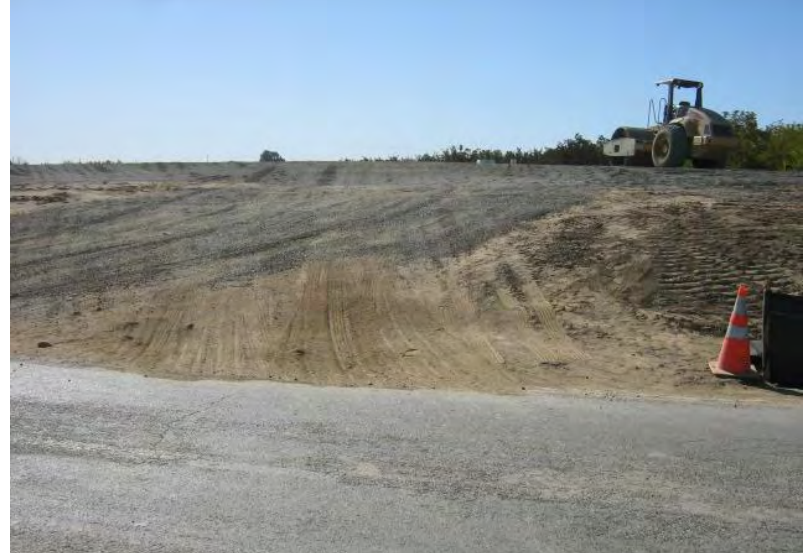
Photograph 20 – Adequate tracking control BMPs had not been implemented at the Wilson Road intersection.

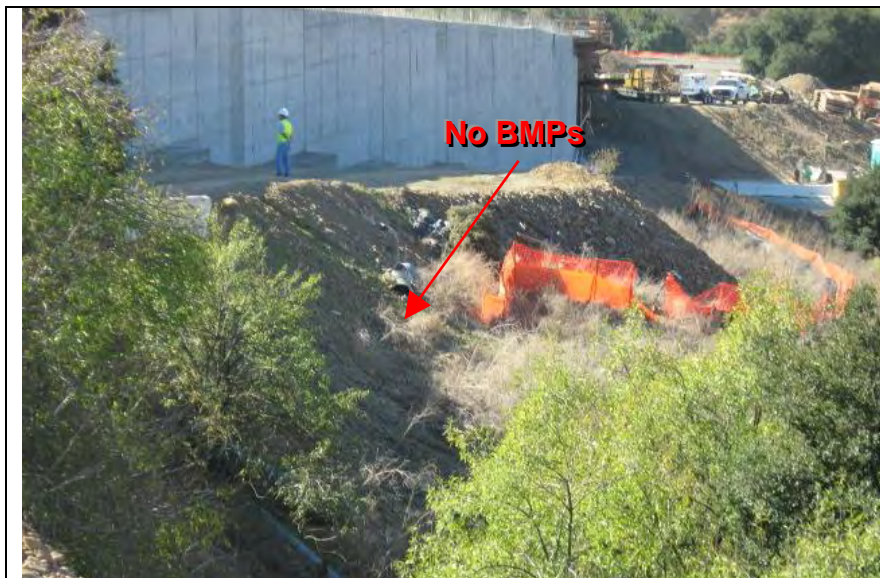
Photograph 5— Fill slope along access road without BMPs

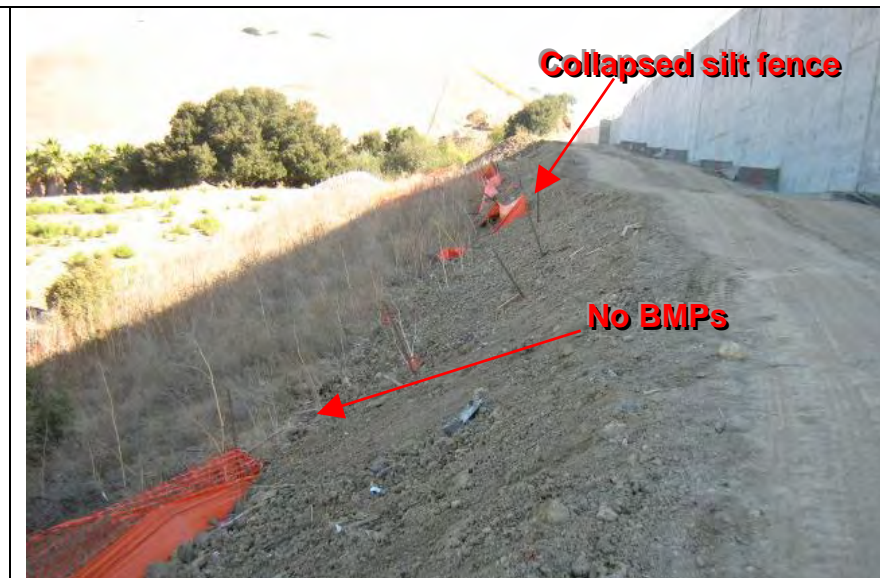
Photograph 6 – Fill slope along access road without BMPs

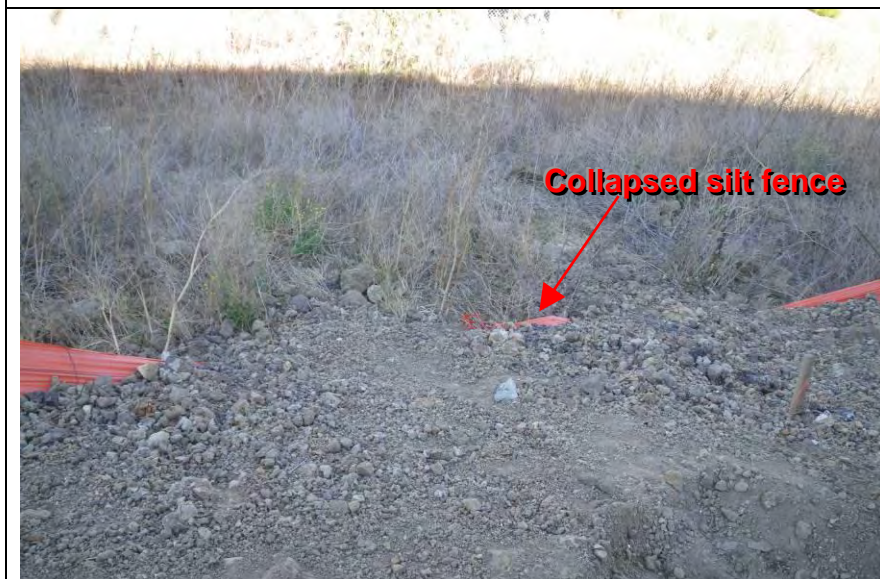
Photograph 7— Collapsed silt fence due to slide

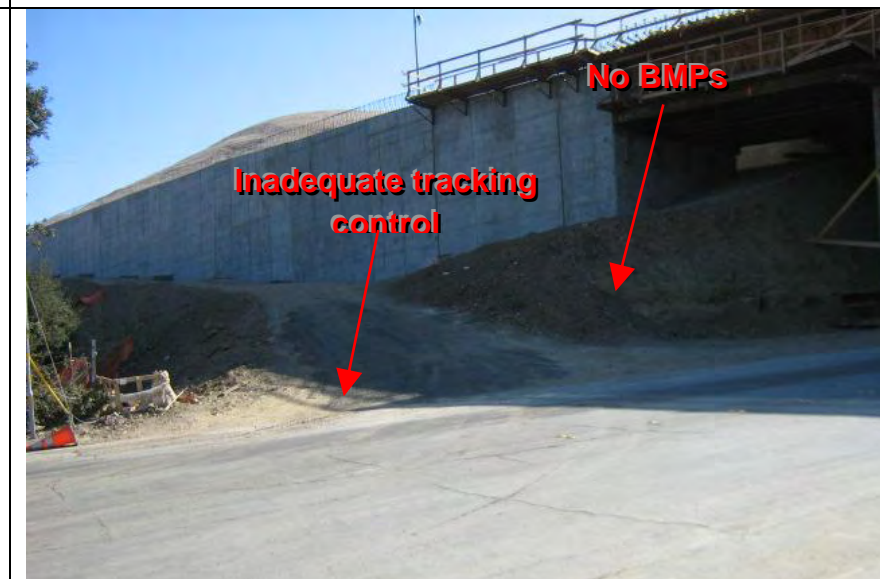
Photograph 8 – View of fill slope along access road without BMPs and vehicle tracking control pad
