Appendix E

Maintenance Program Site Visit Reports

Site Visit No. 16

Willow Creek Highway Maintenance Facility
Site Visit Date: 10/22/2009

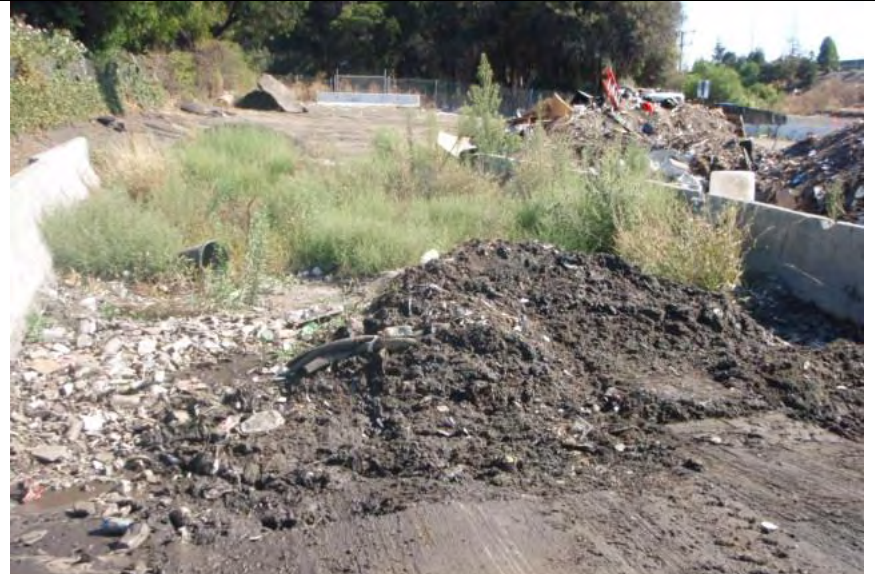
Photograph 2 – Close-up view of excavated vactor waste dump site at the facility

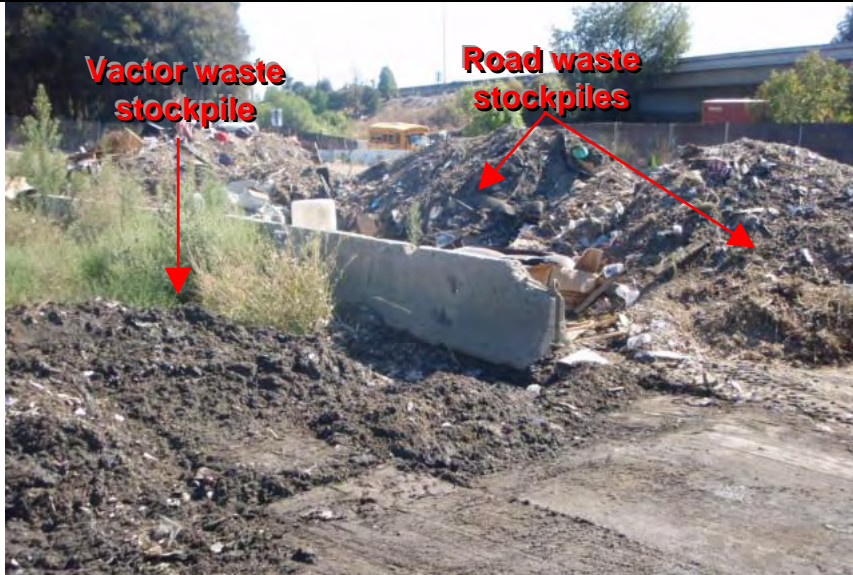
Photograph 3 – Lack of BMPs for containment or coverage of road waste stockpiles

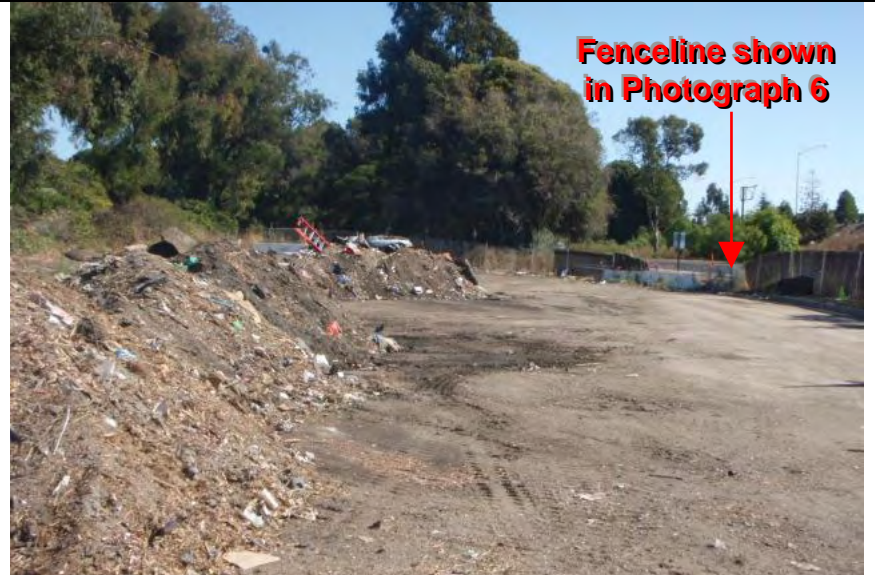
Photograph 4 – View of waste stockpiles and proximity to fenceline

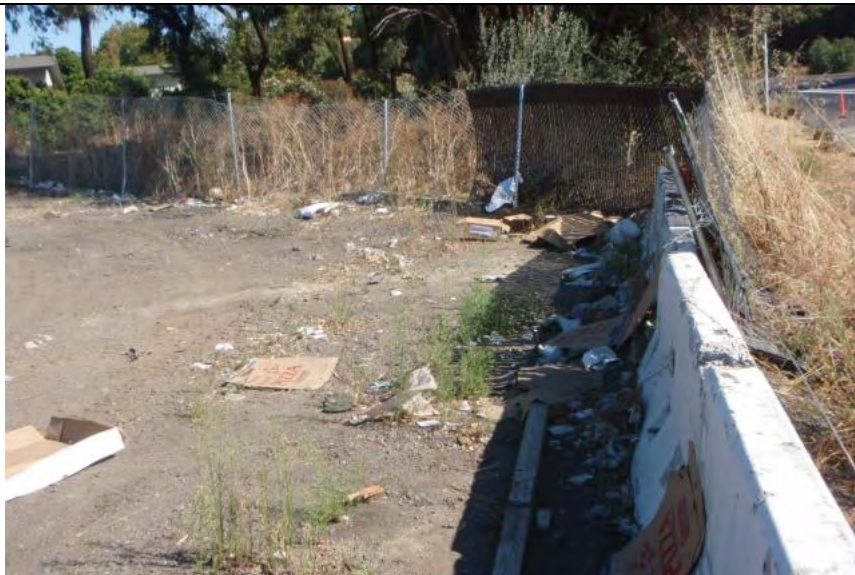
Photograph 5 – Example of fugitive trash and debris

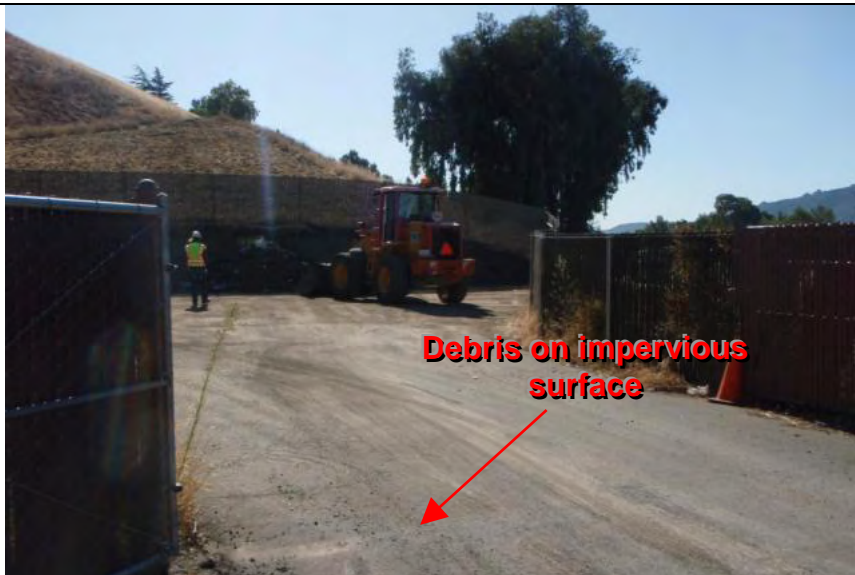
Photograph 1 – Entrance to temporary storage site. (Note: Impervious roadway entrance and tracking of debris)

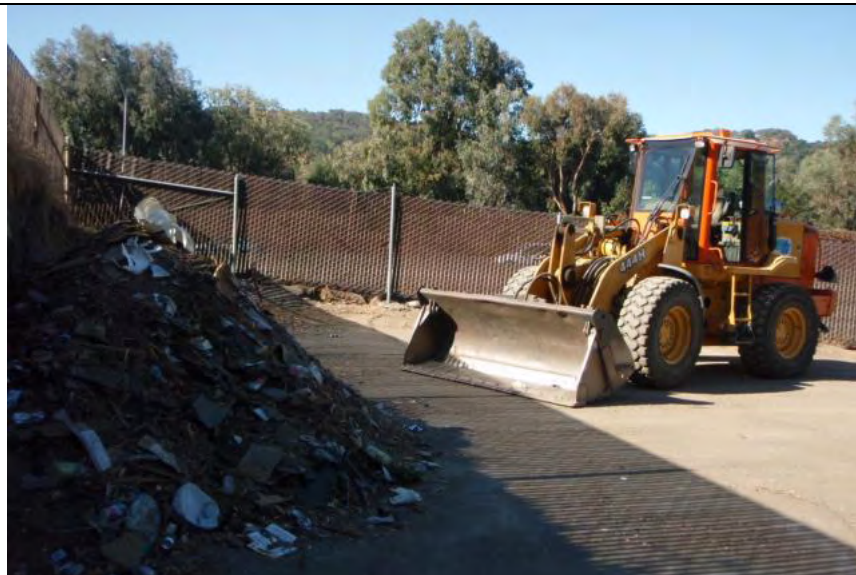
Because collected road sweepings and debris contain fine pollutant particles and non-visible pollutants, the stockpile management techniques outlined in the Maintenance Staff Guide are not adequate to contain the collected waste. In addition, the EPA Audit Team noted that BMPs were not stored at the facility for implementation in the event of precipitation prior to October 15th.

Photograph 2 – Waste from road sweeping and other road cleaning activities

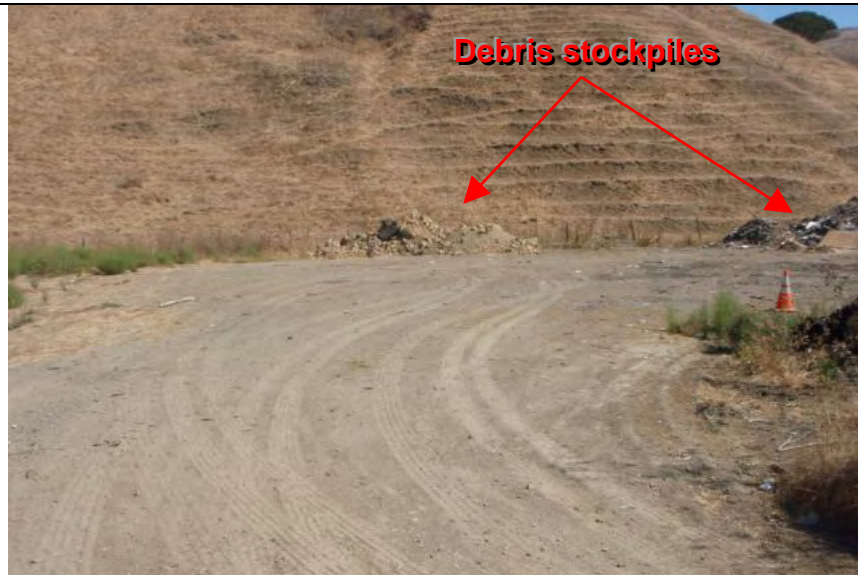
Photograph 1 – Entrance to temporary storage site

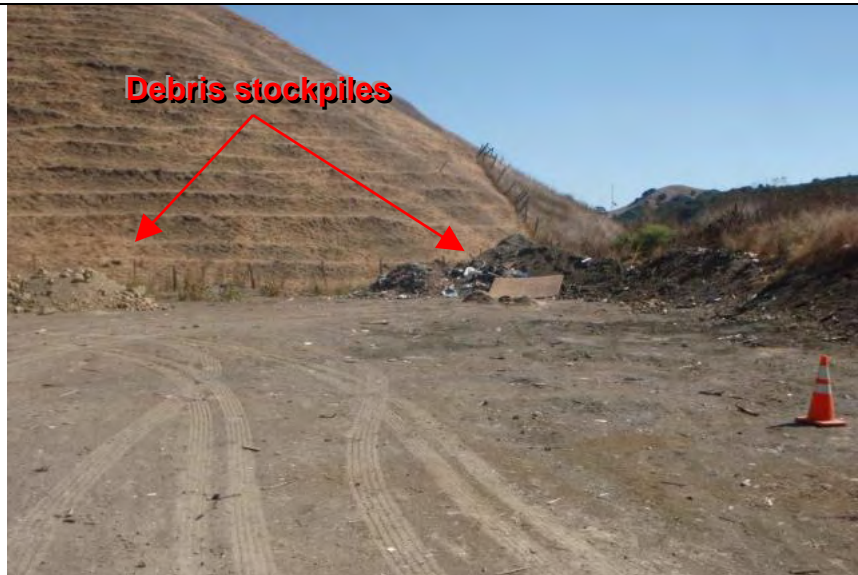
Additionally, coverage and containment BMPs had not been implemented for a sweeper and roadway waste stockpile at the Schaefer Ranch Waste Storage site and there was a potential for the contribution of pollutants to storm water runoff (see Photographs 3, 4, and 5). Specifically, the EPA Audit Team observed a culvert in the northwestern part of the site which a Caltrans staff member stated is connected to Caltrans’ storm water conveyance system (see Photograph 6). An unmaintained, collapsed silt fence BMP was observed up-gradient of the culvert inlet (see Photograph 7). A Caltrans staff member explained that perimeter control BMPs had not yet been implemented for the stockpile because at the time of the audit it was prior to the October 15th start of the rainy season. He added that straw wattles would be placed around the debris pile on the ground surface in accordance with the stockpile management techniques outlined in the Caltrans Stormwater Quality Handbook – Maintenance Staff Guide.

Photograph 2 –Lack of BMPs for containment or coverage of stockpiles

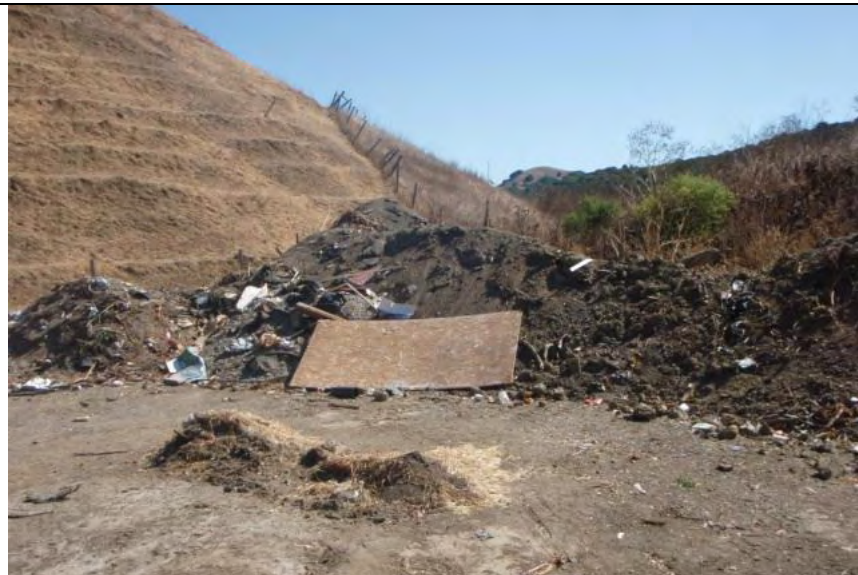
Photograph 3 – Close-up view of debris stockpile from road sweeping and other road cleaning activity

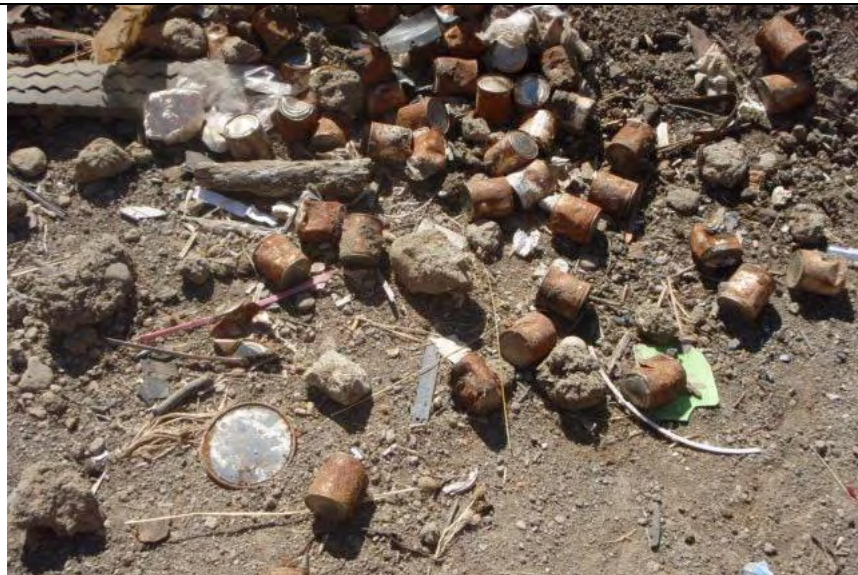
Photograph 4 – Close-up view of debris in stockpile pictured in Photograph 3. The metal cans appeared to contain a liquid milk substance.

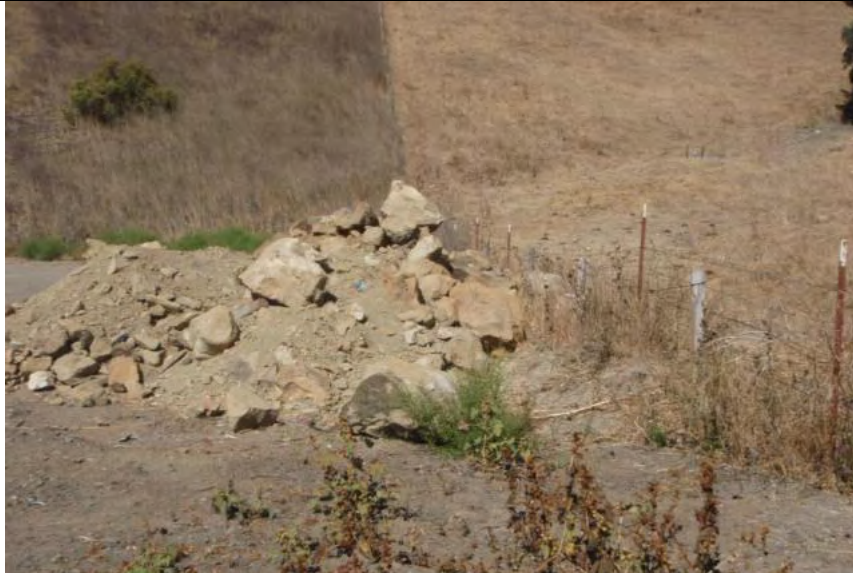
Photograph 5 – Note lack of BMPs for containment around stockpile and the stockpile's proximity to the fenceline

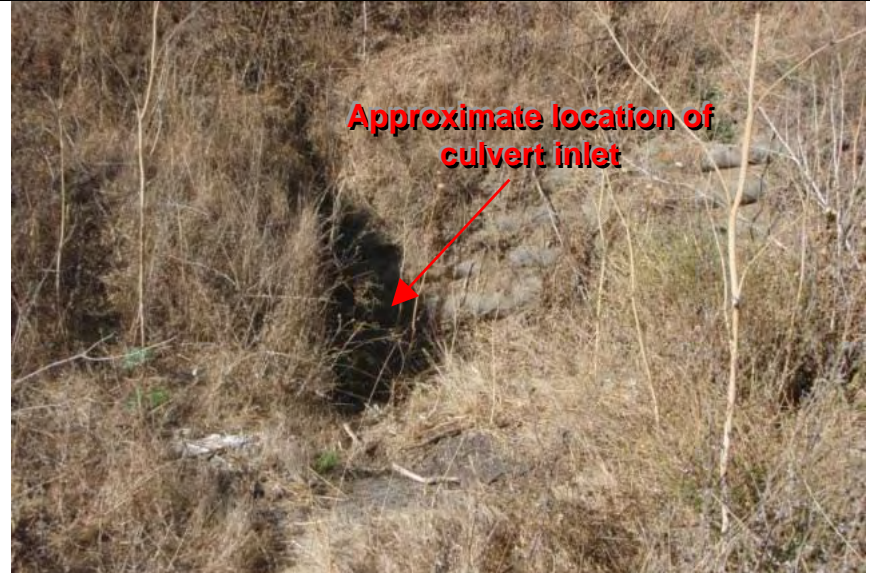
Photograph 6 – Location of culvert inlet in the northwestern portion of the waste storage site

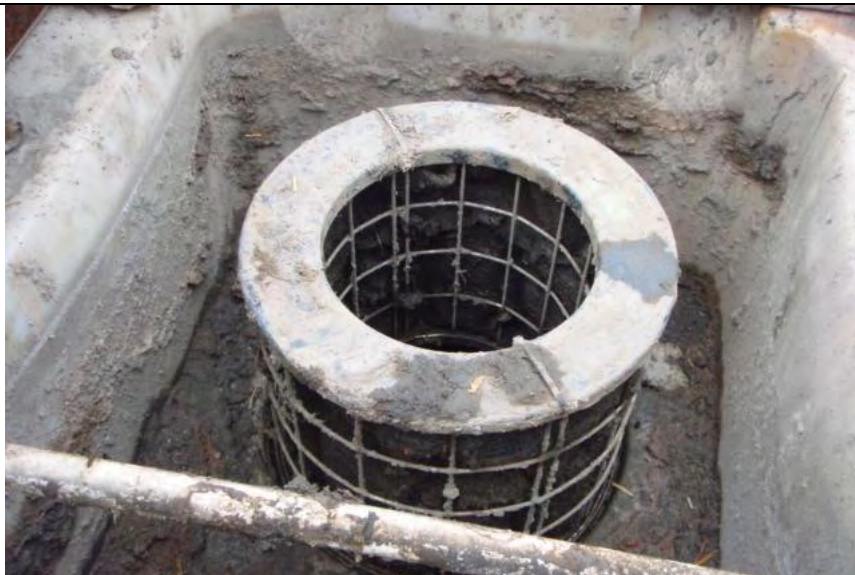
Additional storm drain inlet filters at the facility (see [Photograph 8](#)) did not appear to have been recently cleaned or maintained and debris accumulation was observed in the filter units and inlets (see [Photograph 9](#)). It was not clear when maintenance had been last performed on the filters.

Photograph 9— Closer view of filter shown in Photograph 8.
(Note: Pollutant accumulation within filter and inlet)

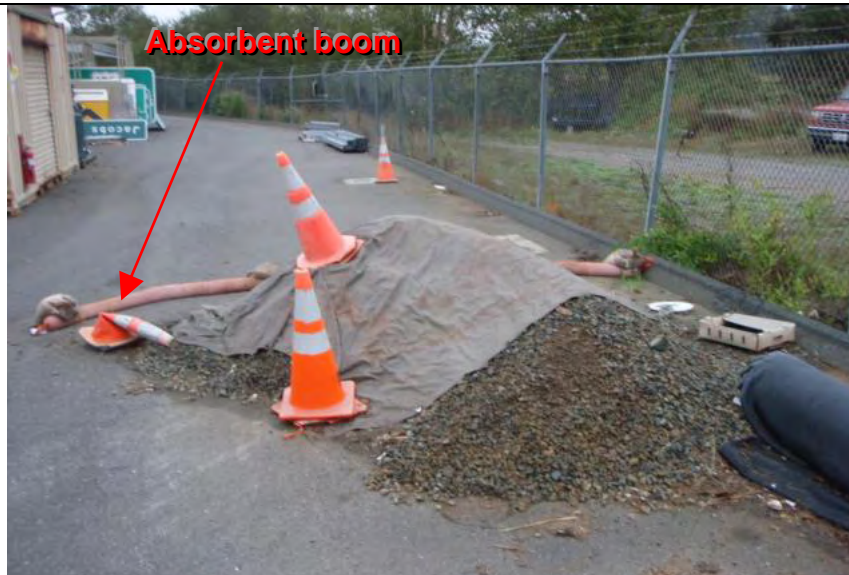
In a separate location along the eastern edge of the facility, a stockpile of gravel and sediment did not have properly selected and implemented BMPs for stockpile management (see [Photograph 10](#)). Specifically, the stockpile was only partially covered and perimeter controls had only been implemented around a portion of the stockpile. Furthermore, absorbent booms are not intended to be used on impervious surfaces as sediment control.

Photograph 10 – Partially covered and contained stockpile along eastern edge of facility

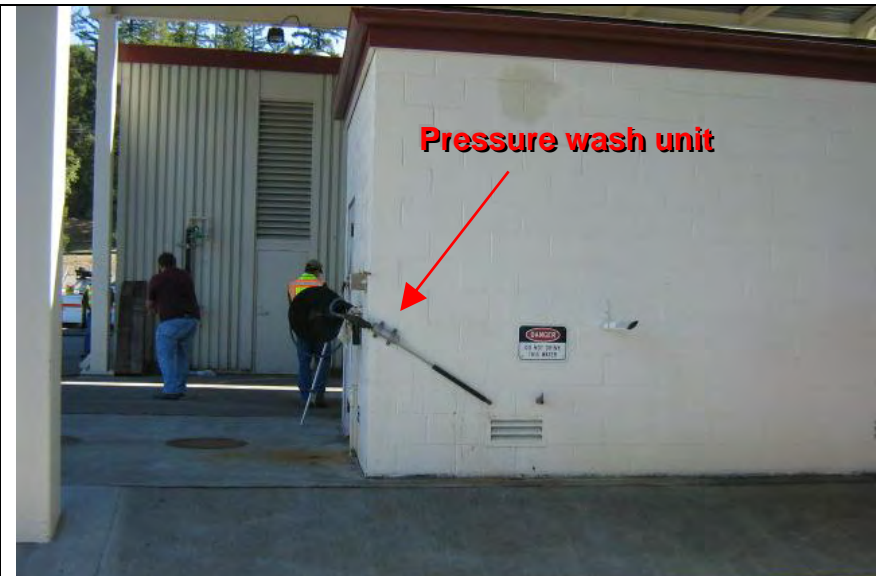
Photograph 1 – Covered wash rack

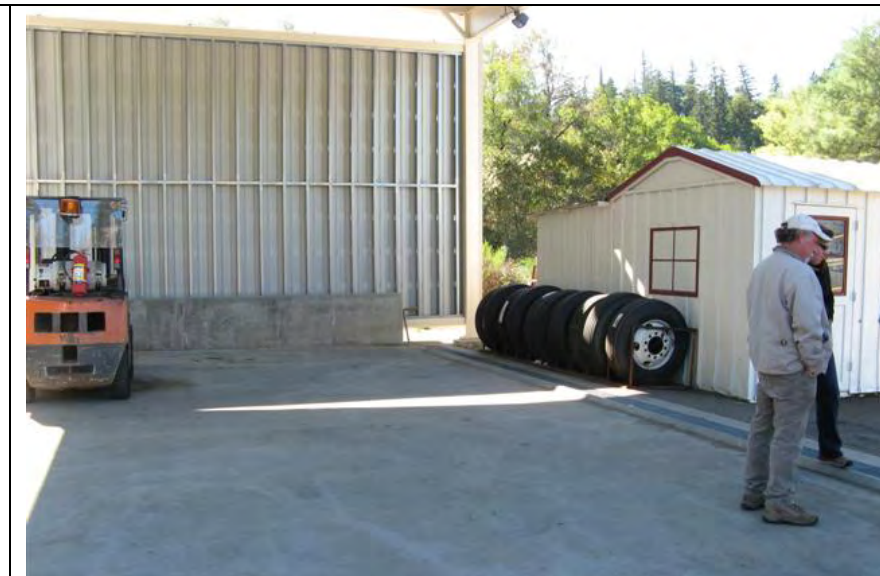
Photograph 2 – Covered wash rack

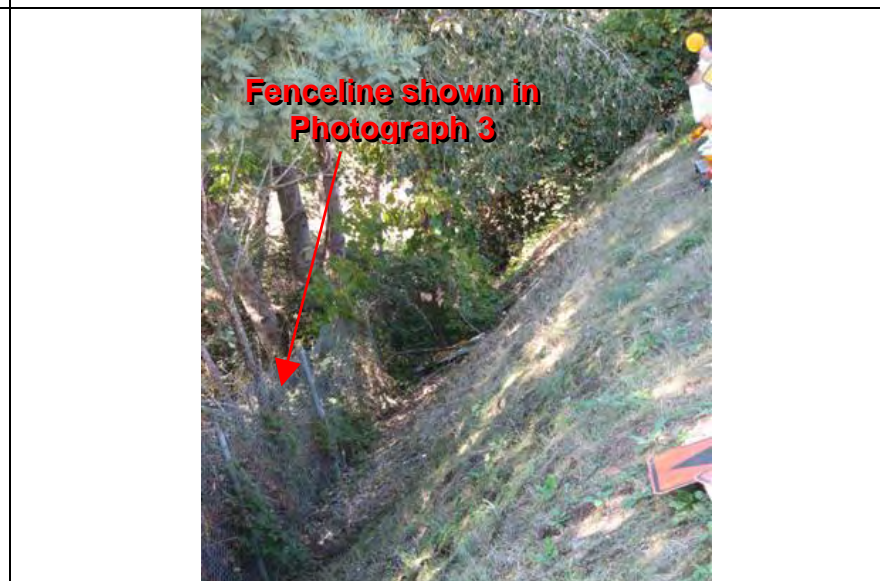
Photograph 4 – View of drainage ditch leading toward South Fork Eel River

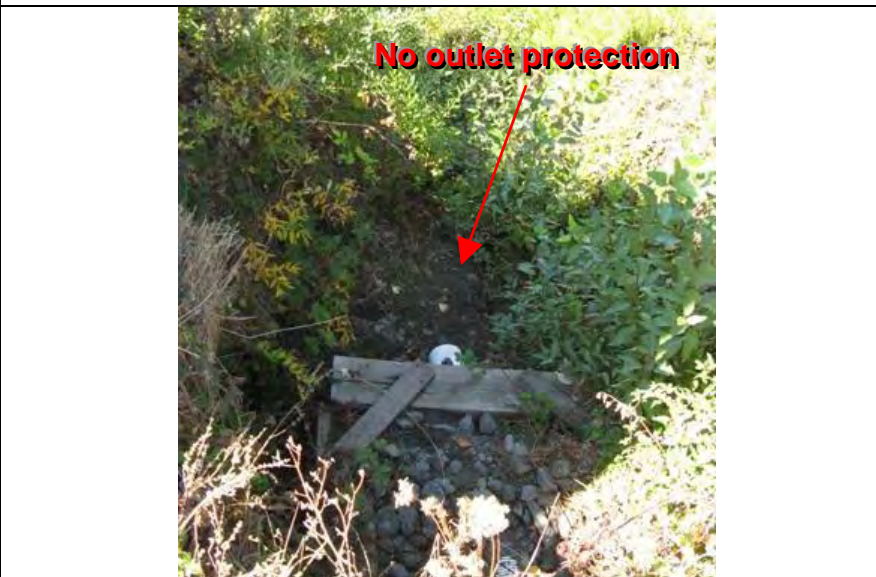
Photograph 11— Outlet pipe down-gradient of facility outfall

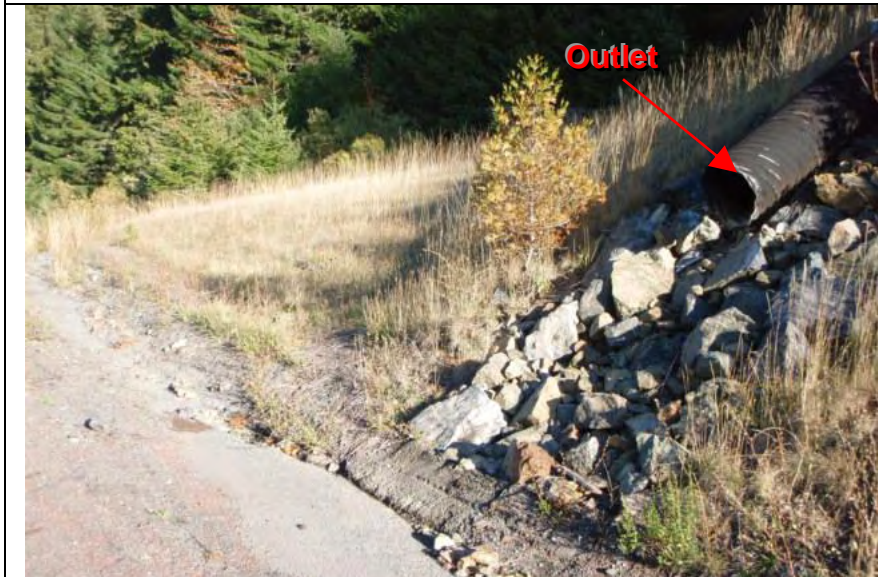
Photograph 3 – Discharge location from inlet shown in Photograph 2

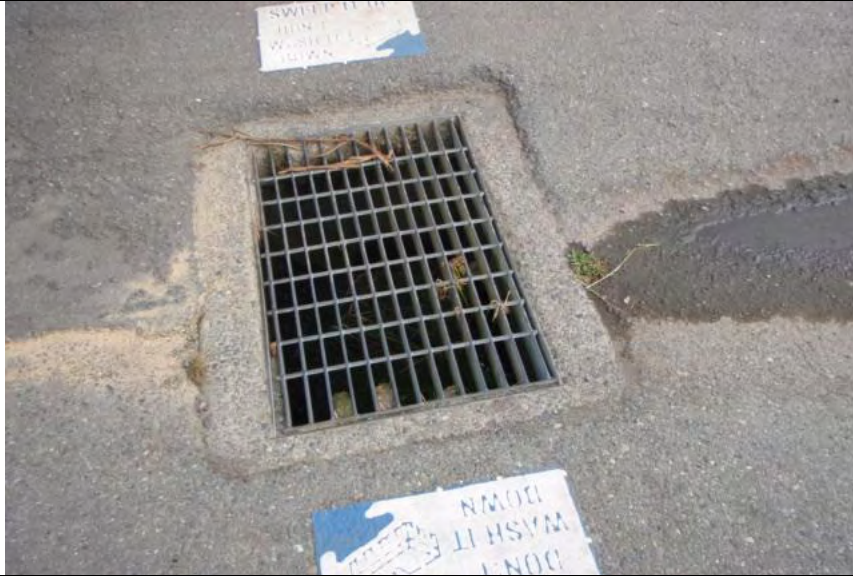
Provision I.3.b of the Permit requires Caltrans to provide appropriate site-specific BMPs for all maintenance facilities. A significant amount of sediment accumulation was observed within a storm drain inlet at the facility that did not appear to have been recently cleaned (see Photographs 1 and 2). As explained by the Highway Maintenance Supervisor, storm drain inlets at the facility flow to the drainage ditch in the southeast corner of the facility (see Photograph 3). He added that storm water runoff does not generally discharge off-site from this location but rather ponds and remains as standing water until it infiltrates into the ground. Nonetheless, evidence of sediment discharged to the drainage ditch as well as sediment accumulation within the culvert pipe that discharges to the southeast corner of the facility was observed (see Photograph 5). Furthermore, a silt fence BMP had been installed in the flow pathway of the culvert outlet and was not entrenched into the ground to retain sediment and prevent failure (see Photograph 3).

Photograph 1 – Storm drain inlet at facility

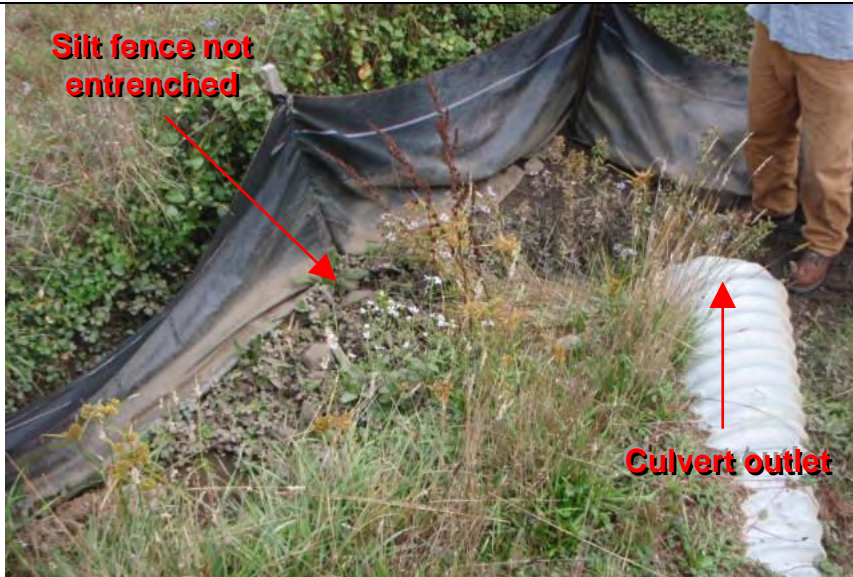
Photograph 3 – Storm drain outlet to drainage ditch in southeast corner of facility

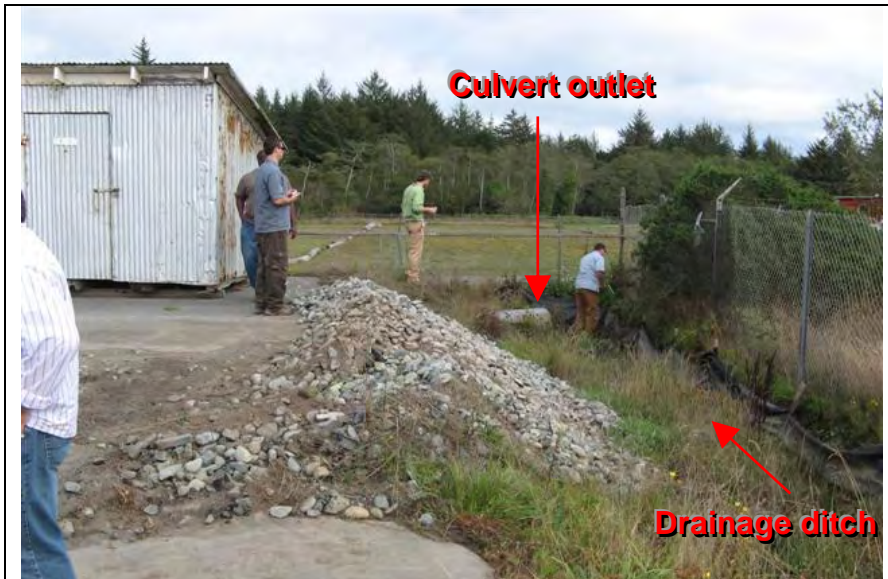
In addition, a significant amount of sediment accumulation was observed on the impervious ground surface near the southeast corner of the facility (see Photographs 6 and 7). As explained by the Highway Maintenance Supervisor, the area was used as a temporary stockpile location for washout material from front loaders and dump trucks. Whether the equipment washout operation was conducted with dry or wet processes was unclear. Appendix D of the Caltrans SWMP, Section 2.15.1, Vehicle and Equipment Cleaning, states “when possible, truck beds should be cleaned using dry cleanup technique (sweep up or shovel out).” It should also be noted that the stockpile area was located directly in the flow pathway of the surface drainage system at the facility (see Photograph 8). As a result, there was a potential for the discharge of sediment and other pollutants to the drainage ditch along the southern edge of the facility (see Photograph 9).

Photograph 9— View of drainage ditch and storm drain system culvert outlet

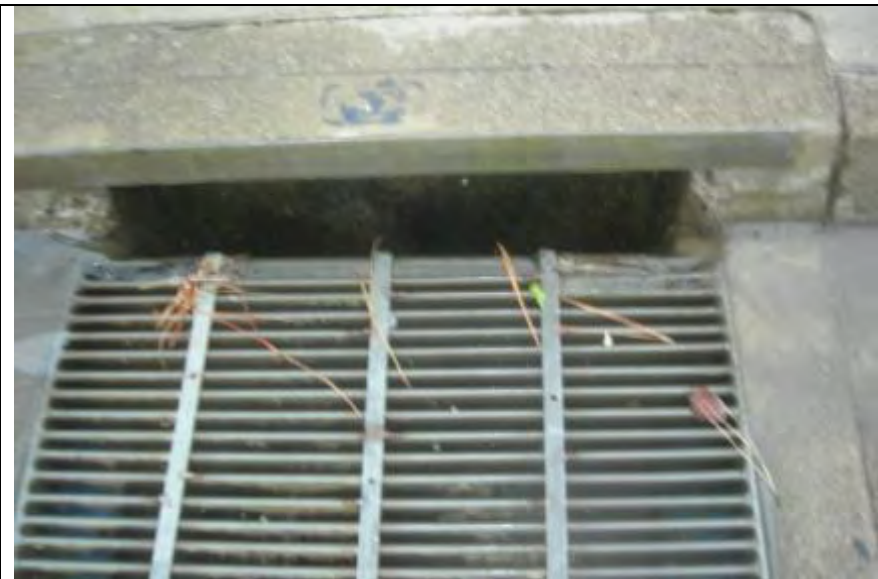
Photograph 2 – Storm drain from Photograph 1

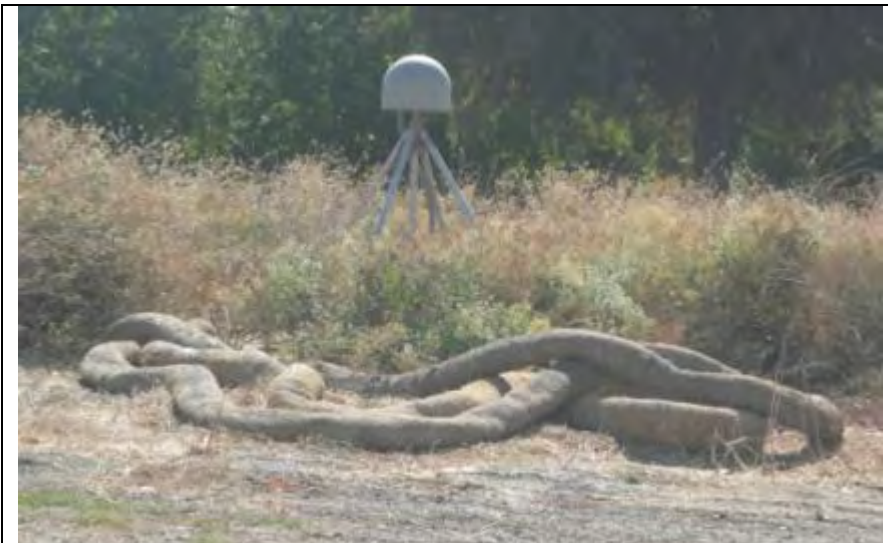
Photograph 1 – View of BMP stockpile

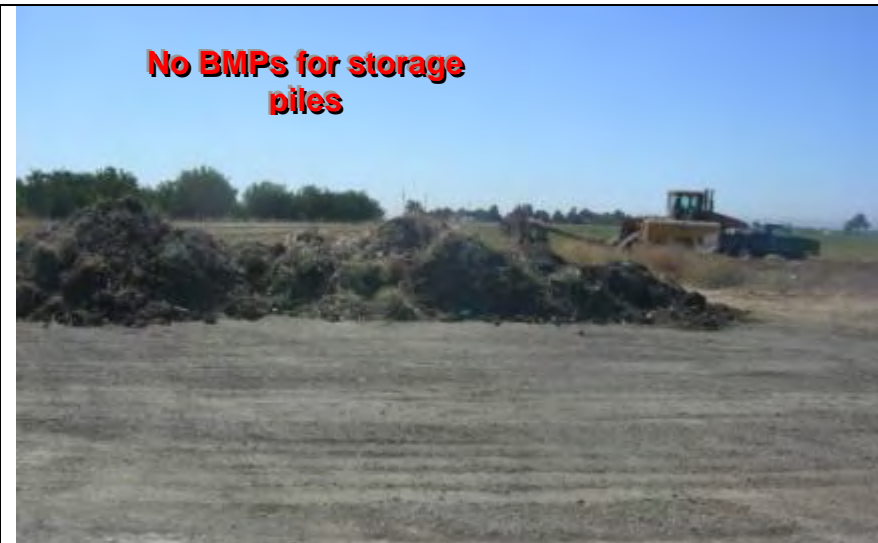
Photograph 2 – Lack of BMPs to contain stockpiled soils from tree removal
