Attachment 1

**Attachment 3
Photograph Log**

Photograph Log for EPA's December 3, 2010 Electrochem Solutions RCRA and CWA Inspection

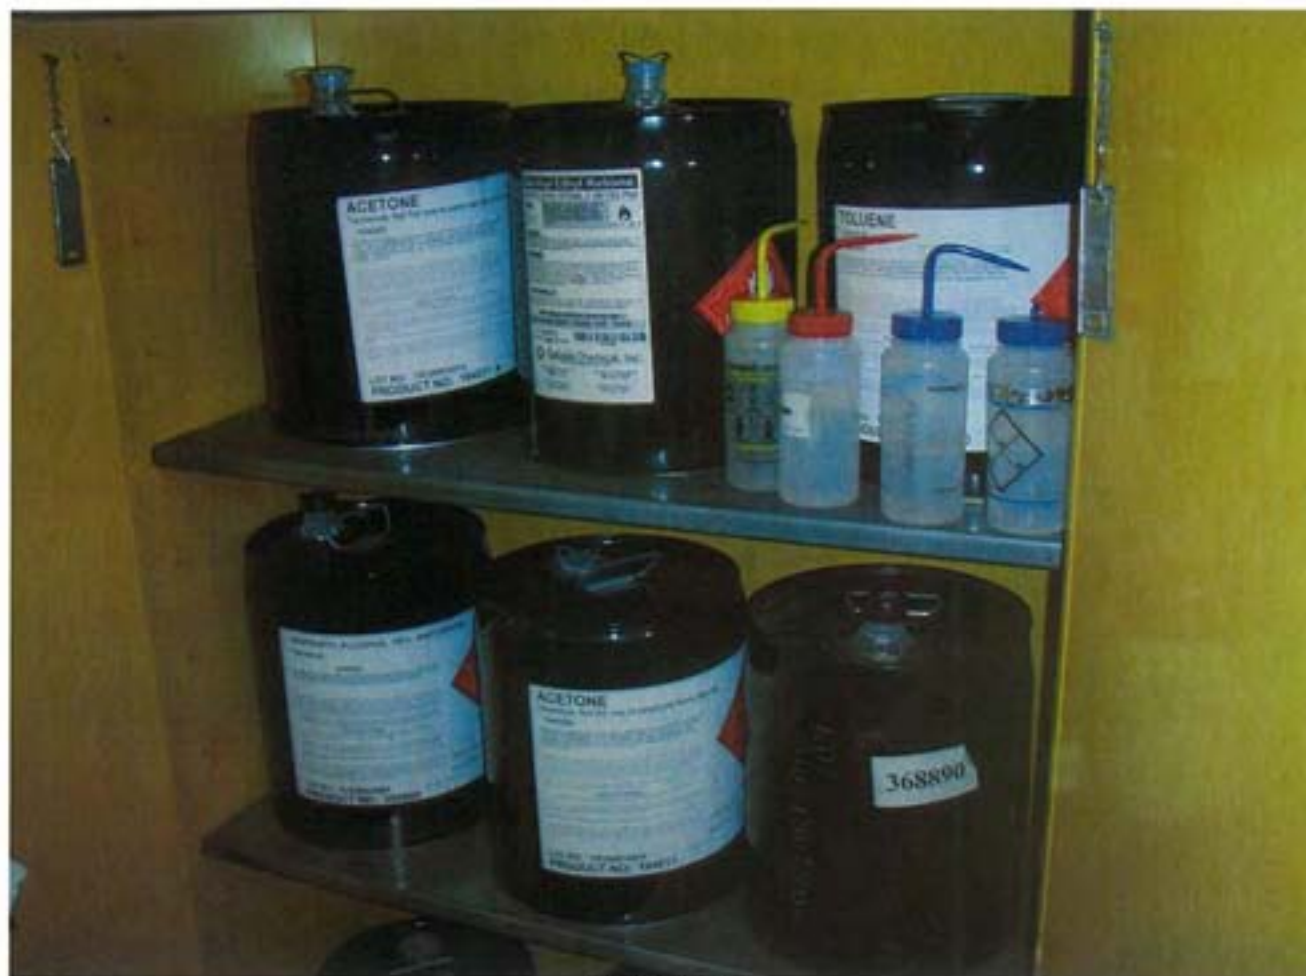
PC030001

001. Outdoor sign for Electrochem Solutions.
002. Production Room: All of the contents in the flammable cabinet are solvents used in the production process.

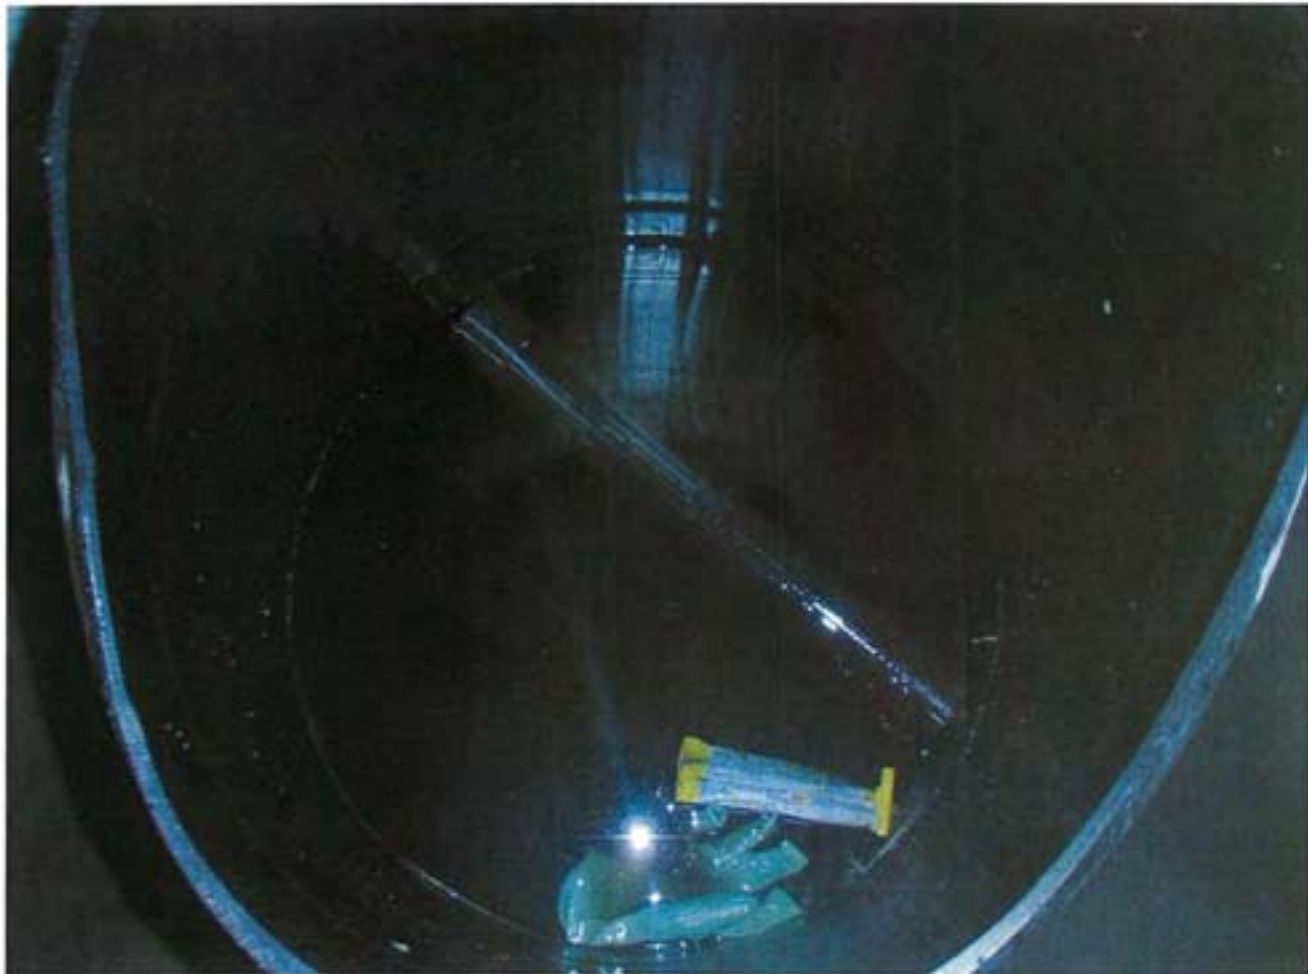
PC030022

022. Anodizing Area: An open 5-gallon container of unknown substance.
023. Anodizing Area: Open cut top 55-gallon container labeled "waste water." Facility representative stated it was placed in the location to collect rain water from a leak in the roof.

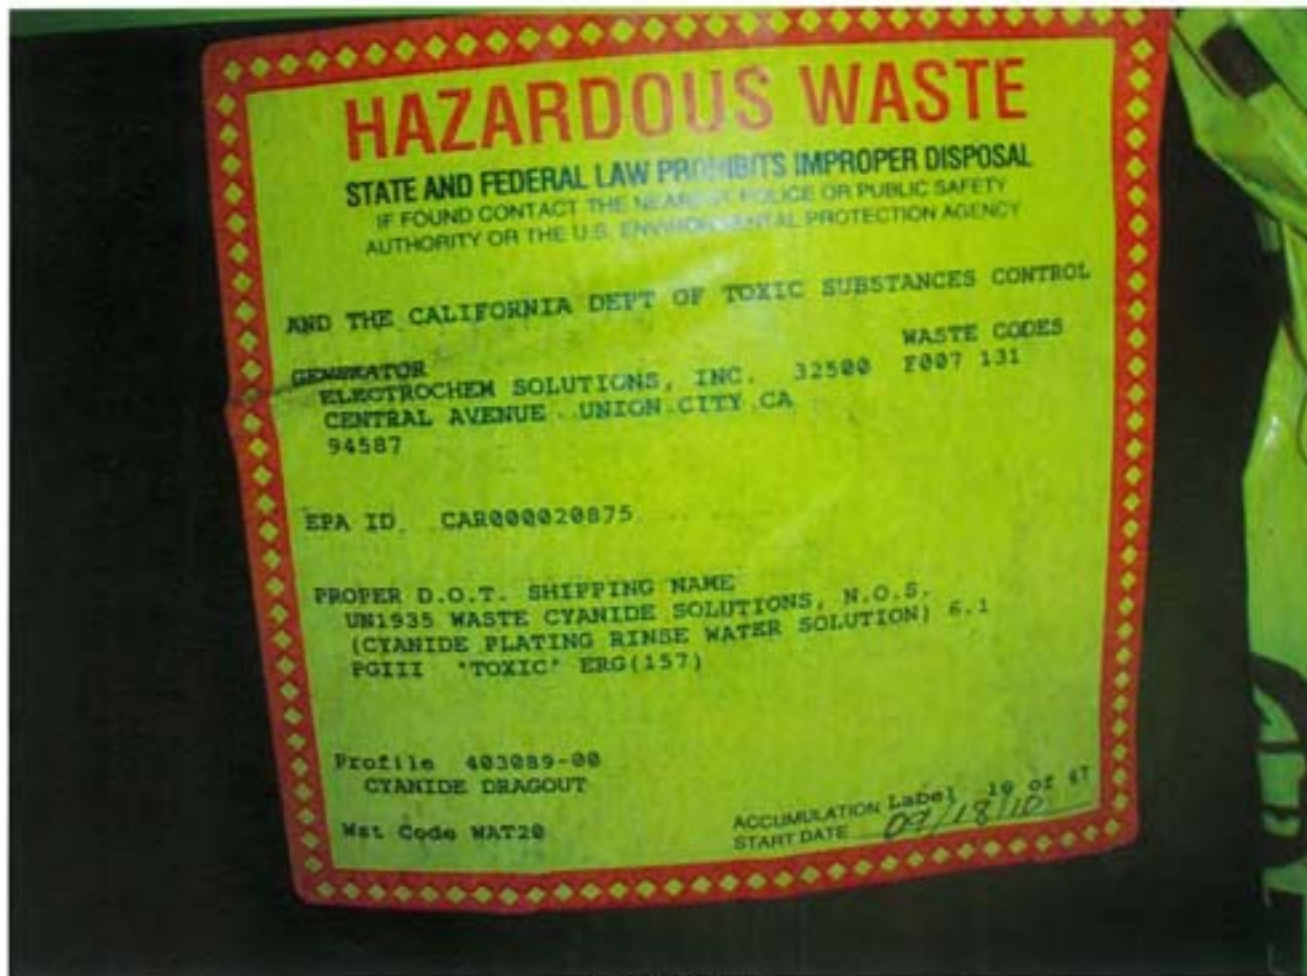
PC030027

027. Water Treatment and Equipment Area: Three 55-gallon containers of cyanide solution waste with hazardous waste labels.

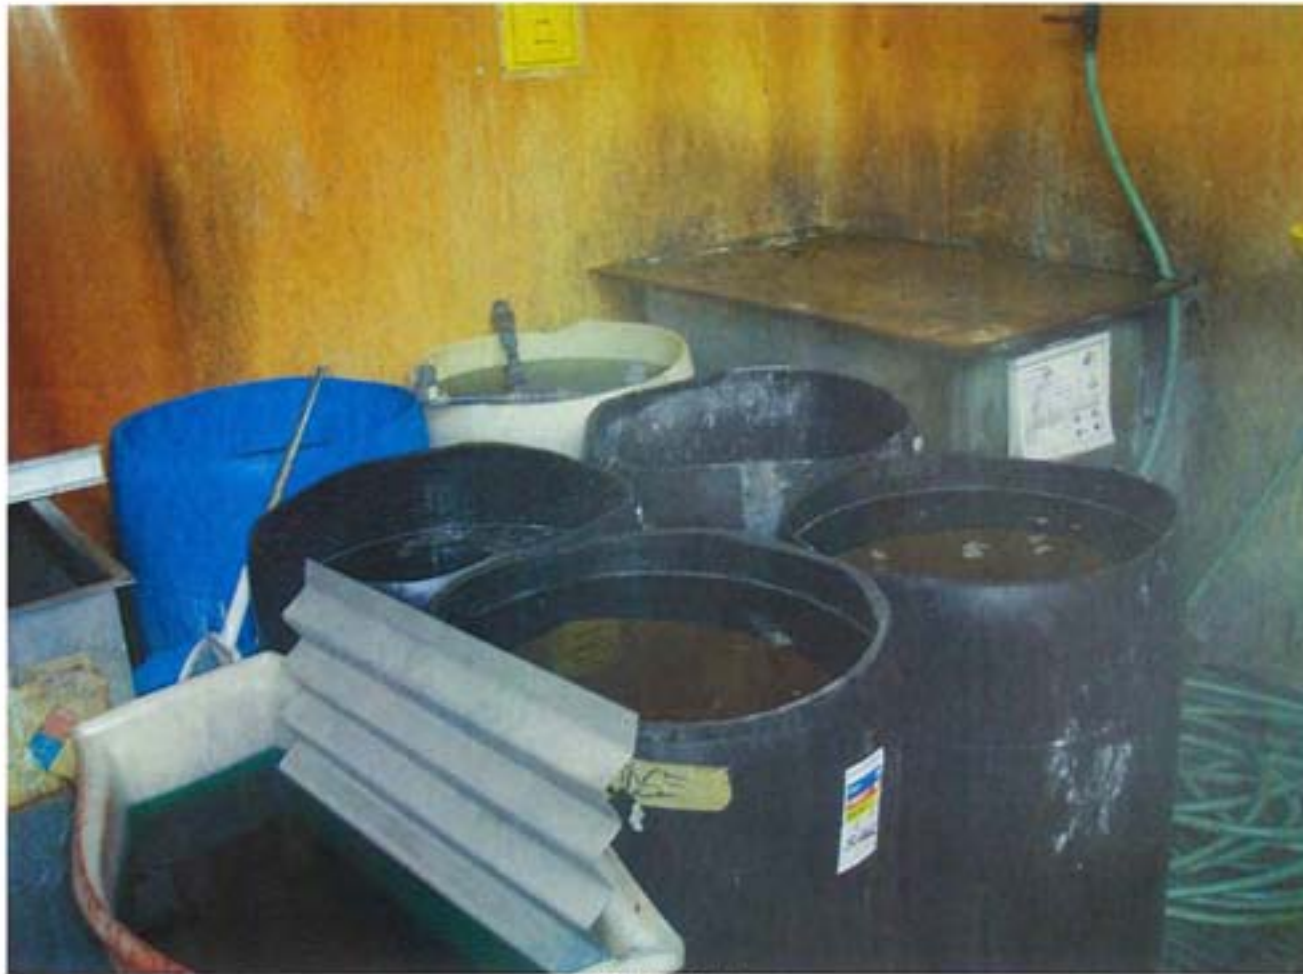
PC030035

035. Bulk Waste Processing Area: The roof corroded off this portion of the building.
036. Bulk Waste Processing Area: Six open top 55-gallon containers and one long rectangular container. One of the containers is labeled "sludge."

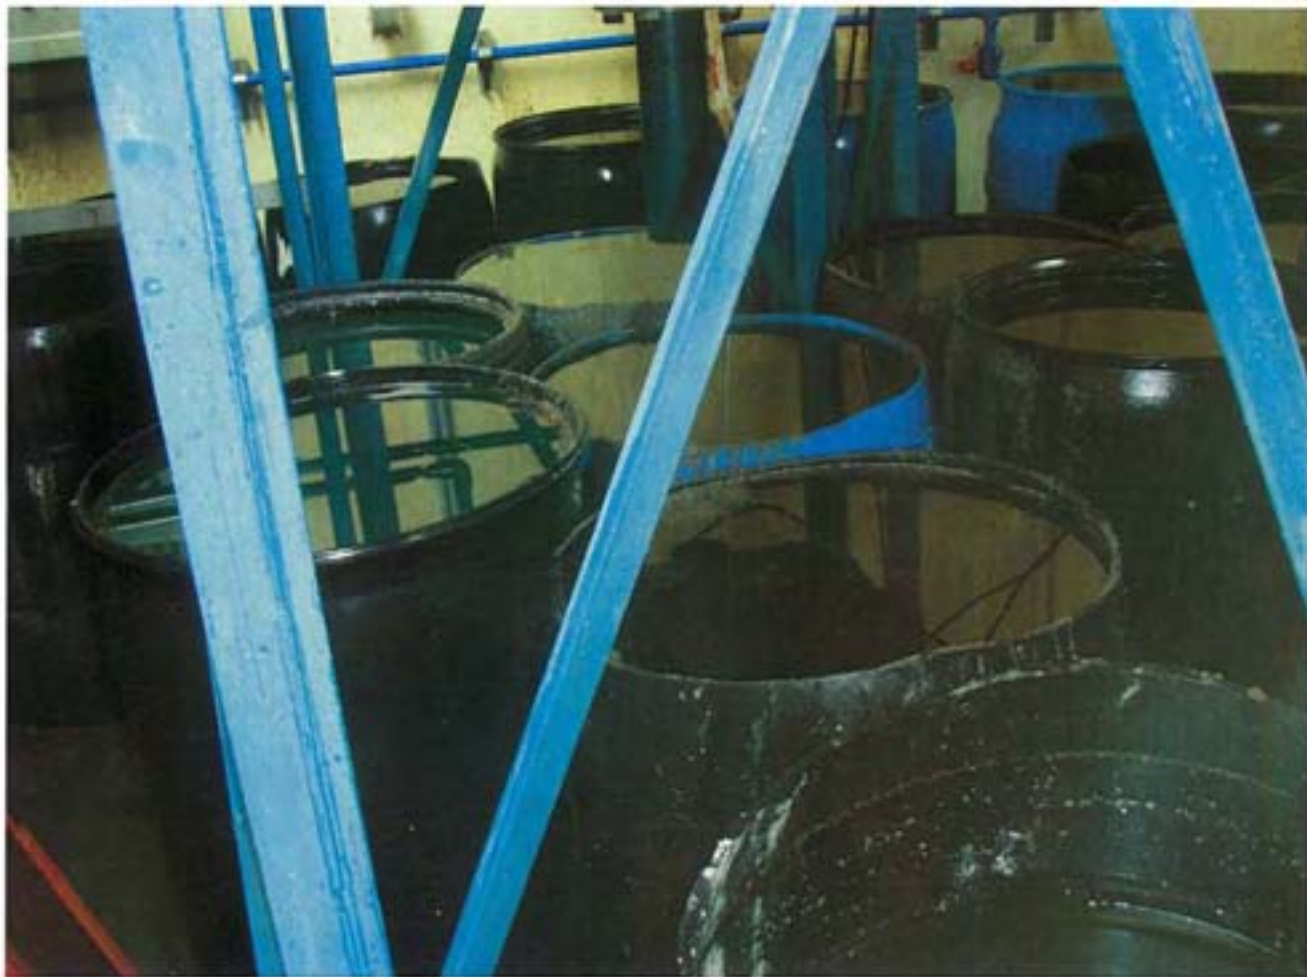
PC030042

041. Bulk Waste Processing Area: Approximately fourteen open top 55-gallon containers.
042. Bulk Waste Processing Area: Liquid observed on the floor in the area. The floor is lined, although torn in some locations.

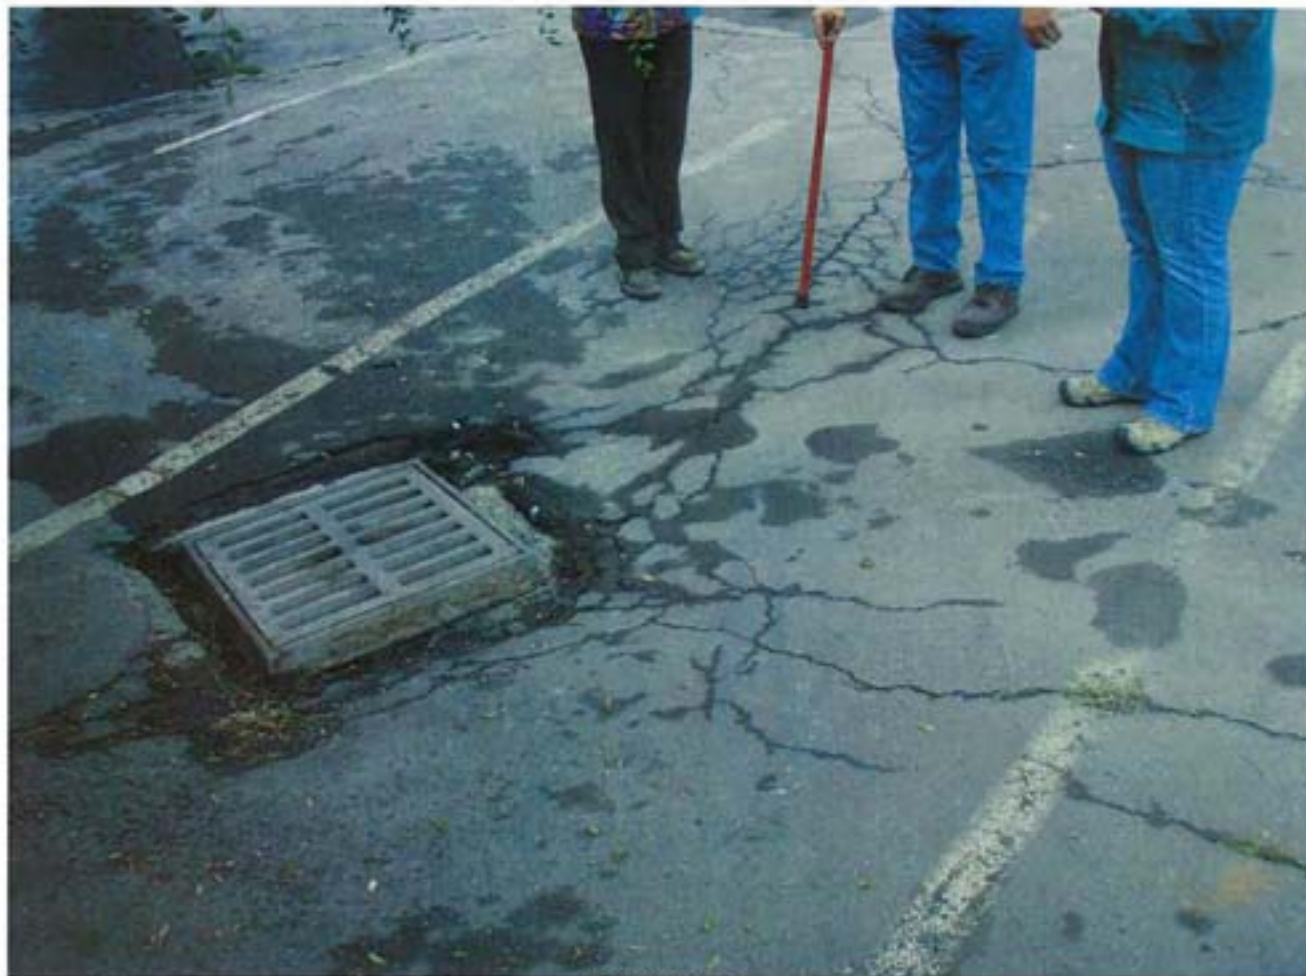
PC030057

058. Outdoor Area: storm drain approximately 30 feet from the back of the building.
059. Outdoor Area: View of storm drain in relationship to the building. Closest part of the building is the Less than 90-day Hazardous Waste Accumulation Area (Waste Chemical Storage).
