UNITED STATES ENVIRONMENTAL PROTECTION AGENCY
REGION IX
75 Hawthorne Street
San Francisco, CA 94105-3901

Subject: Findings of Violations and Order for Compliance
EPA Docket No. CWA-309(a)-11-006

On December 3, 2010, the U.S. Environmental Protection Agency (EPA) conducted a Clean Water Act compliance inspection at Electrochem Solutions' facility located at 32500 Central Avenue in Union City, CA. A copy of the inspection report is enclosed.

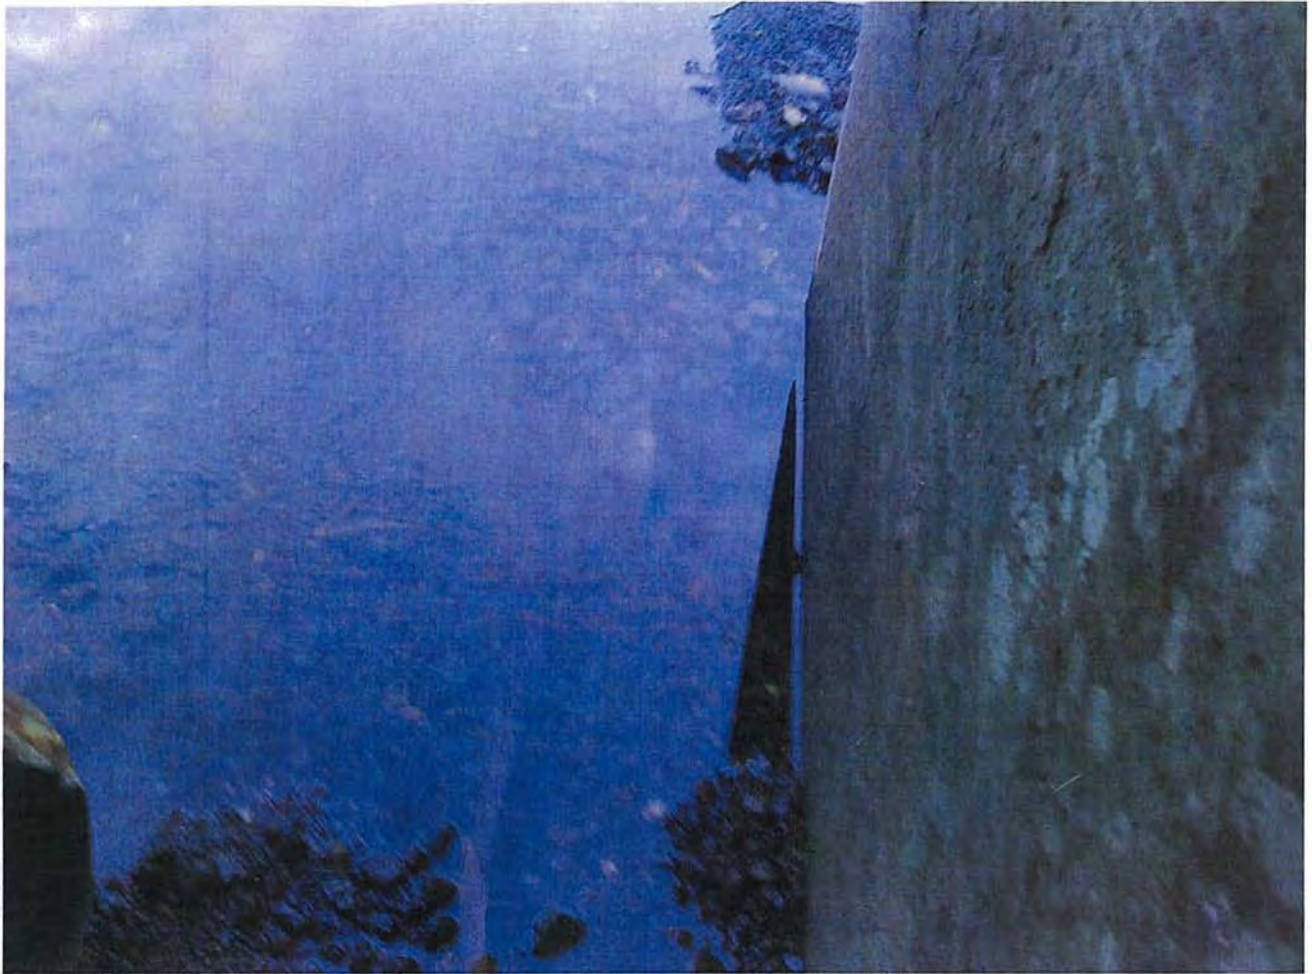
Electrochem cut storm drain 12-9-10

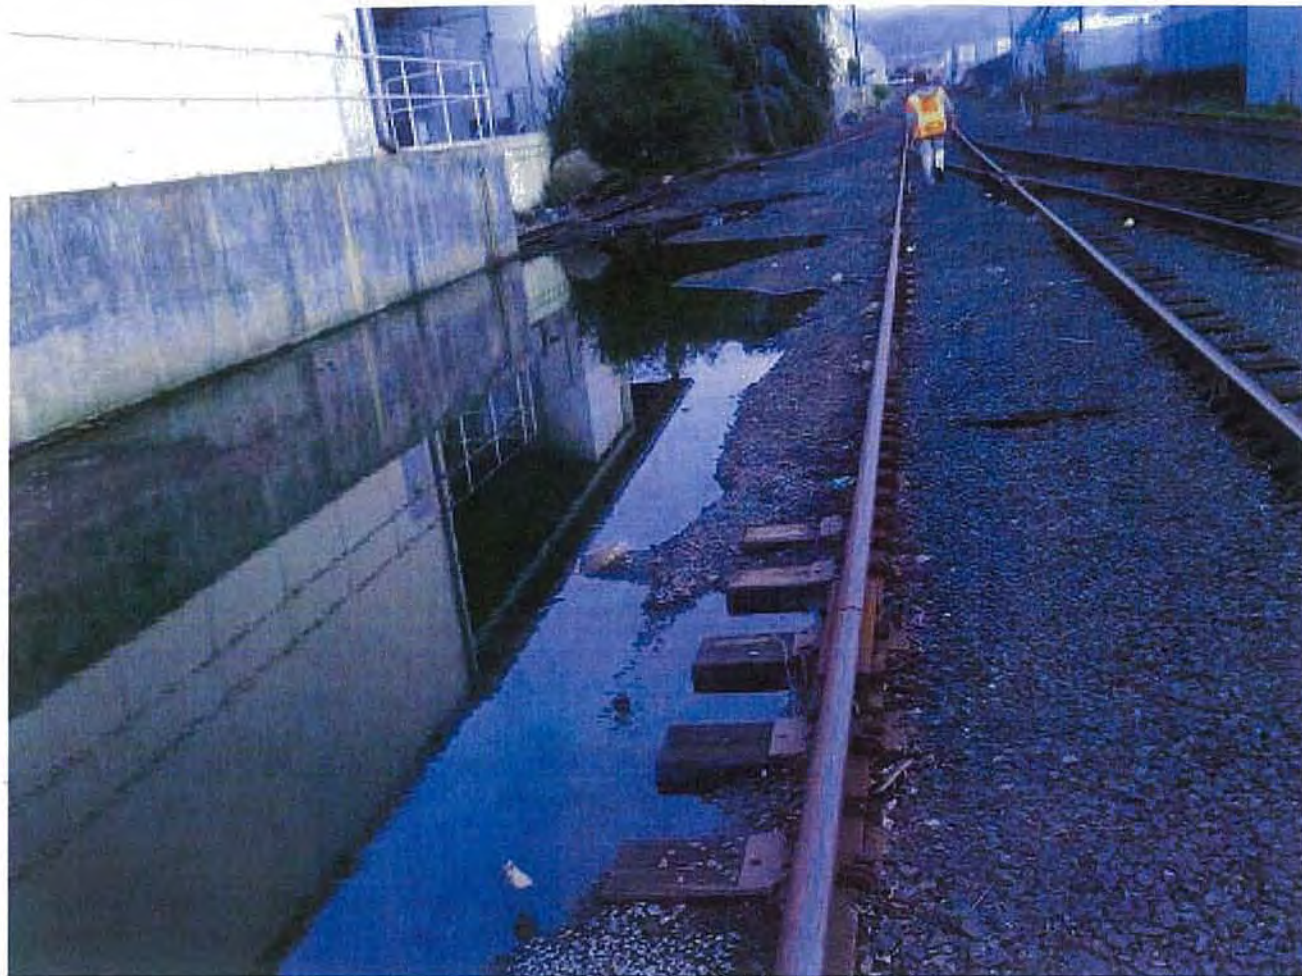
Storm water ponding rail spur 12-9-10

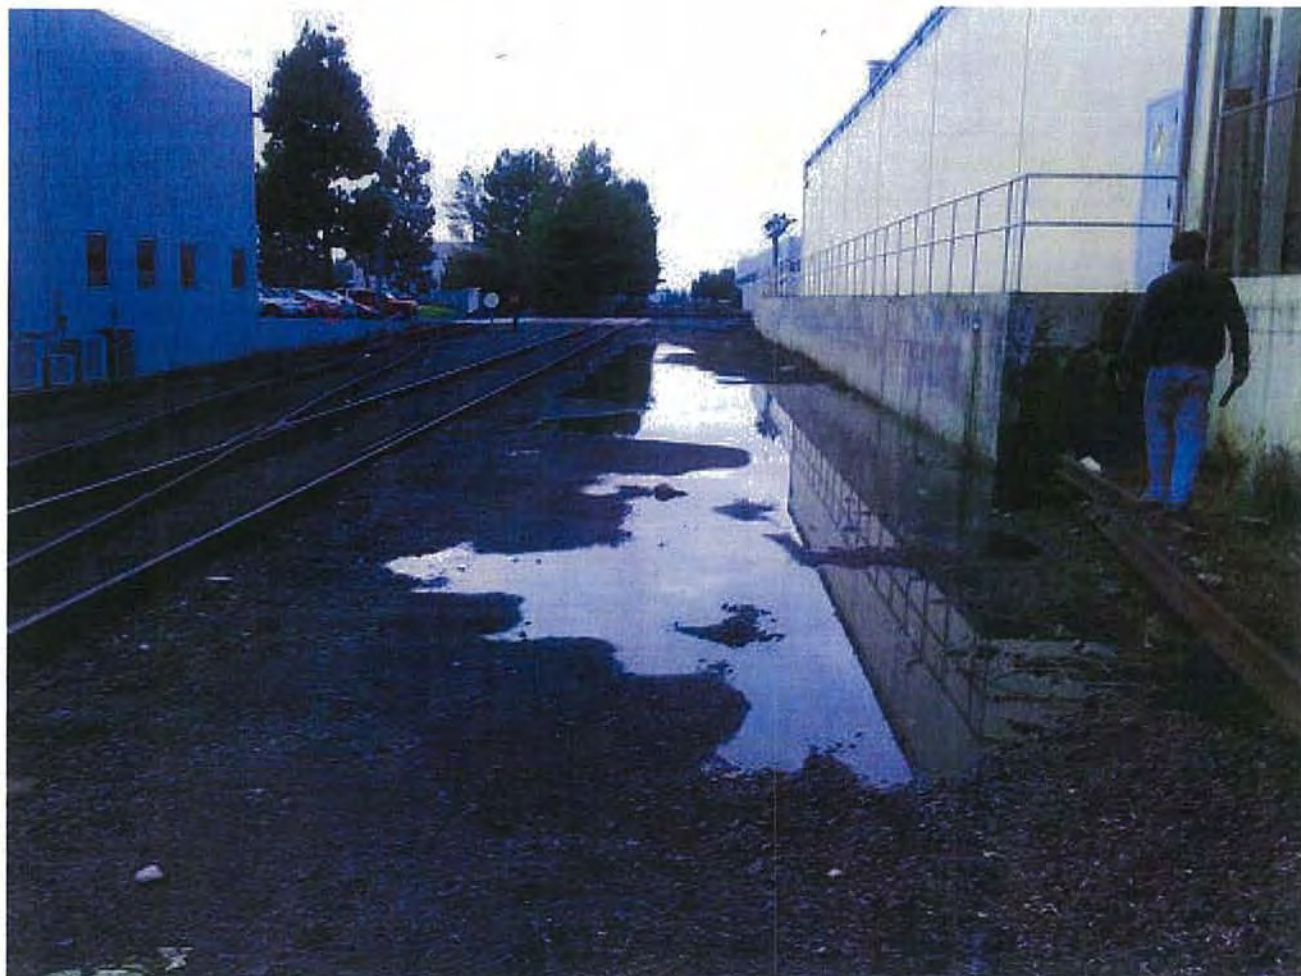
Storm water ponding due to drain cut at exit 12-9-10

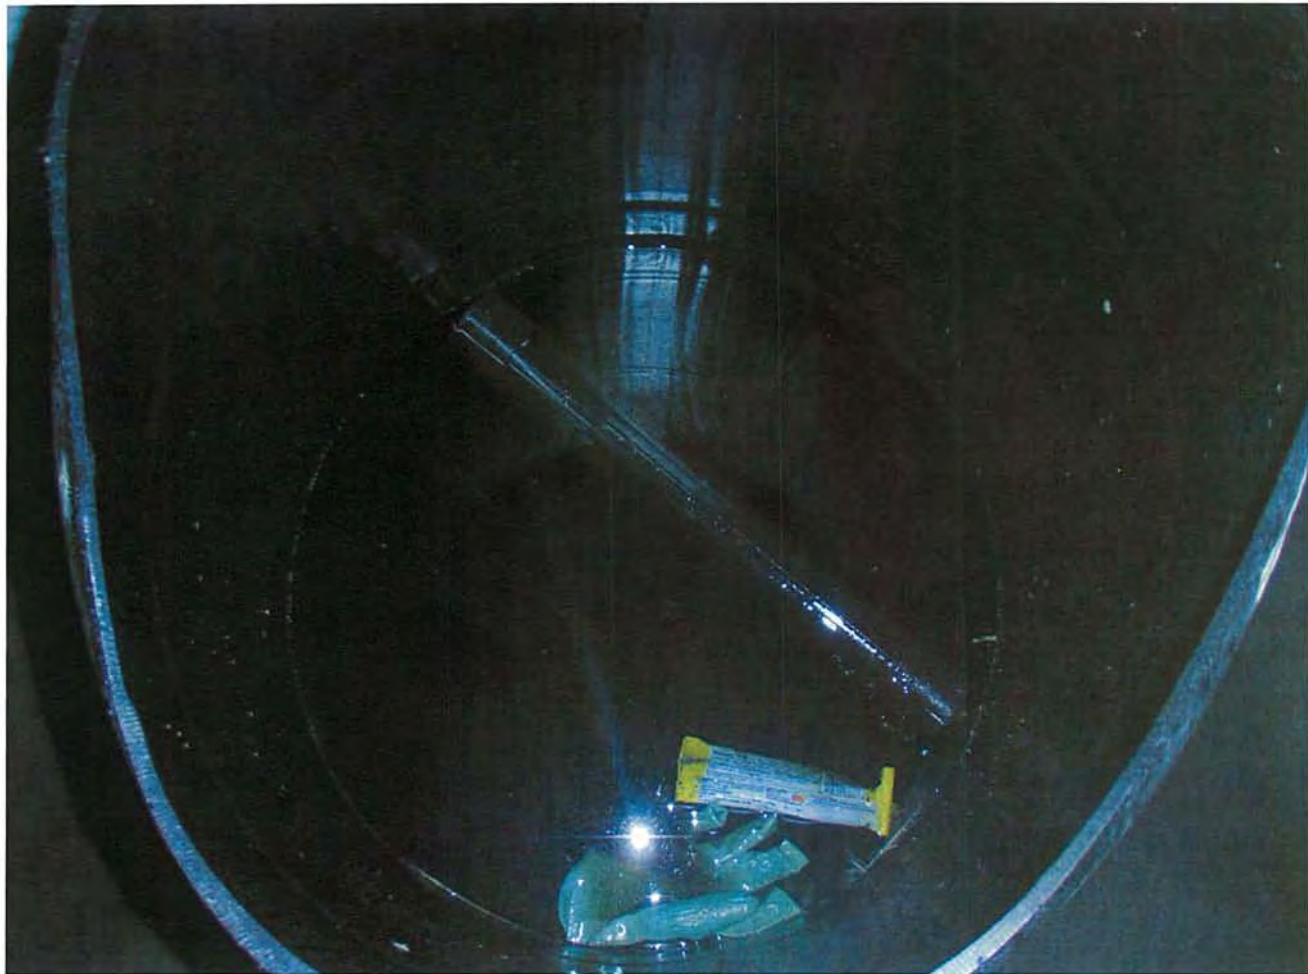
PC030023

022. Anodizing Area: An open 5-gallon container of unknown substance.
023. Anodizing Area: Open cut top 55-gallon container labeled "waste water." Facility representative stated it was placed in the location to collect rain water from a leak in the roof.

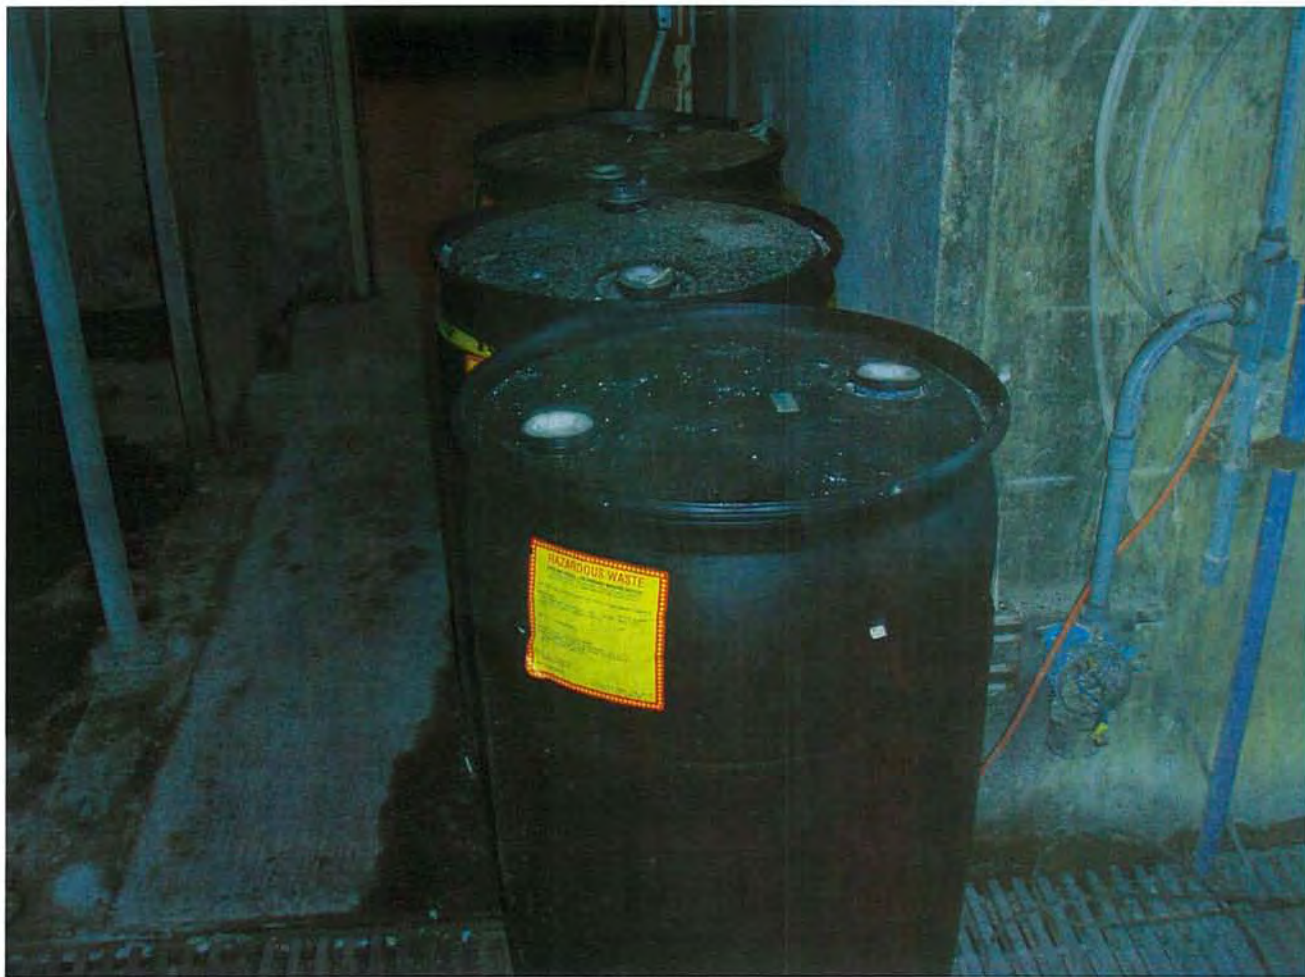
PC030027

027. Water Treatment and Equipment Area: Three 55-gallon containers of cyanide solution waste with hazardous waste labels.

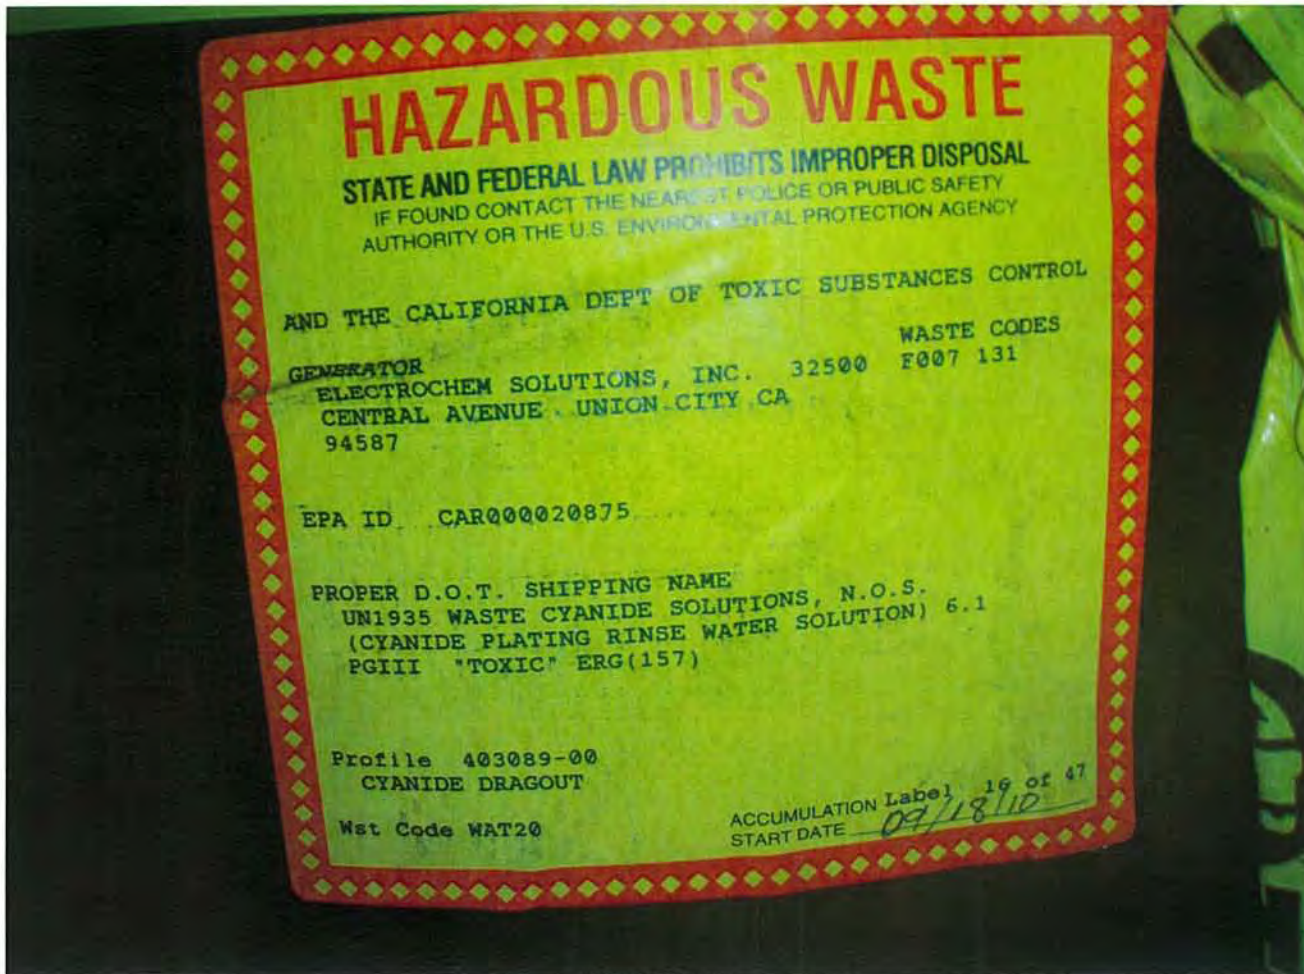
PC030028

028. Water Treatment and Equipment Area: Close up of the hazardous waste label on one of three 55-gallon containers of cyanide solution in previous photograph. Note: 9/18/10 was the earliest accumulation start date on these three containers.

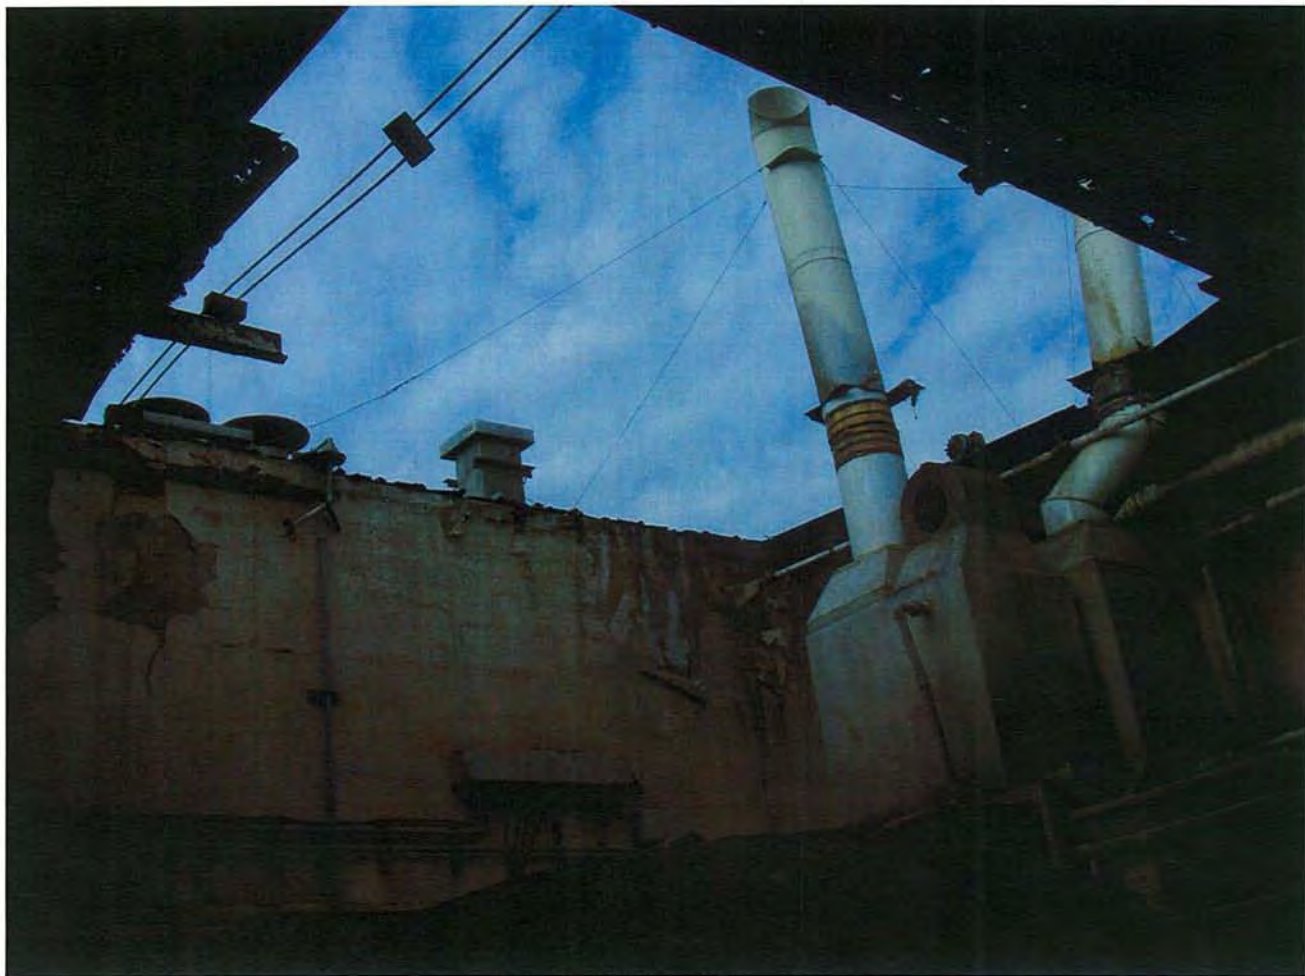
PC030035

035. Bulk Waste Processing Area: The roof corroded off this portion of the building.
036. Bulk Waste Processing Area: Six open top 55-gallon containers and one long rectangular container. One of the containers is labeled "sludge."

1. Submit an inventory of materials and provide adequate secondary containment for all the material located in the bulk waste treatment area;
2. Submit a schedule for repair or replacement of the roof over the bulk waste treatment area, or a plan to close this area permanently;
3. Submit a certification that the sump around the 90-day Hazardous Waste Treatment Area has been cleaned and functions as designed; and
4. Complete several additional tasks identified in the Order, within the time specified.

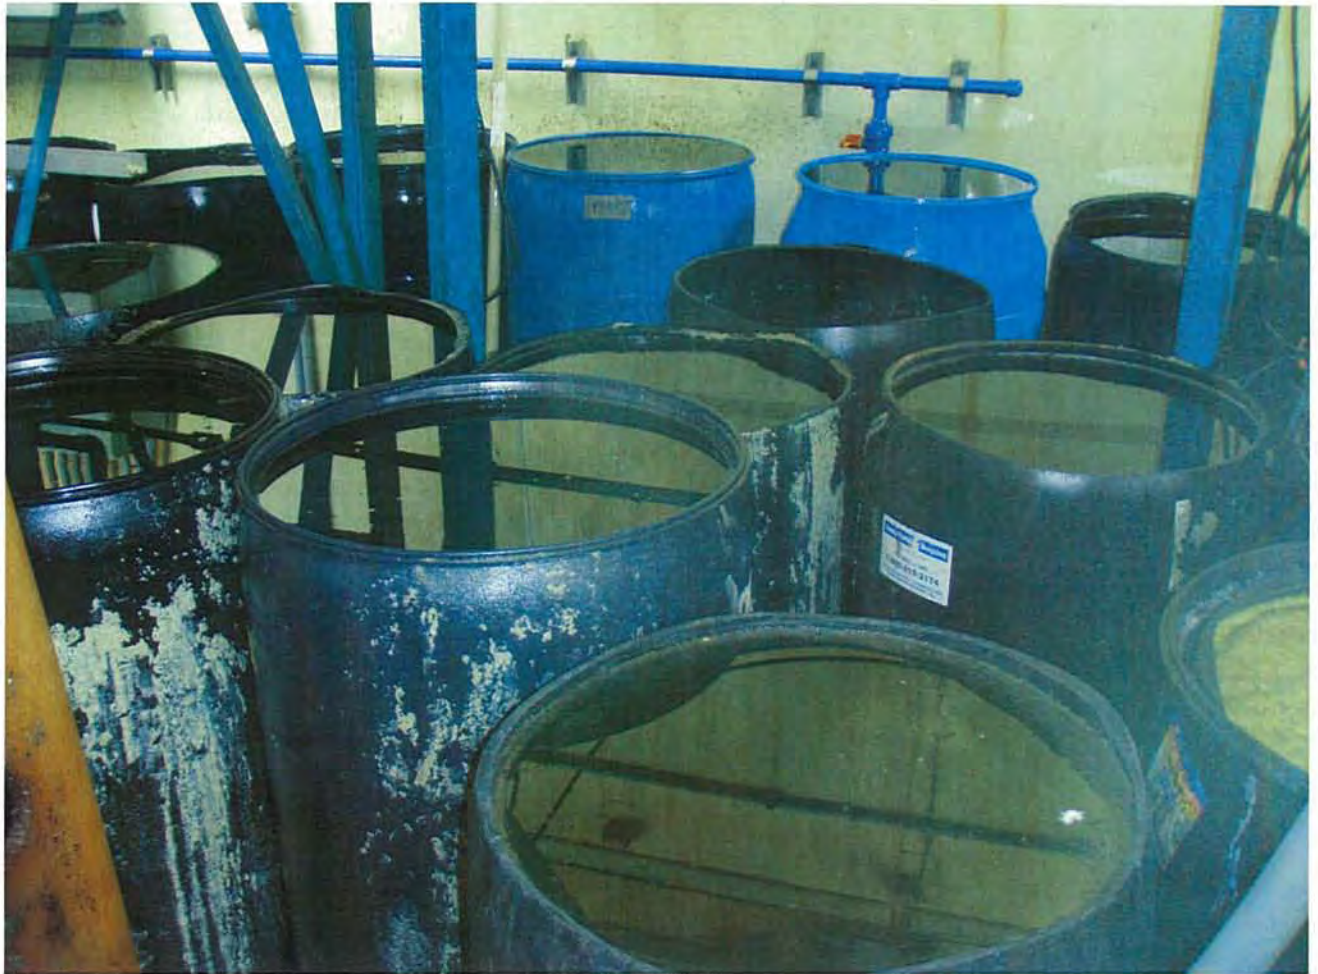
PC030041

041. Bulk Waste Processing Area: Approximately fourteen open top 55-gallon containers.
042. Bulk Waste Processing Area: Liquid observed on the floor in the area. The floor is lined, although torn in some locations.
