Re: September 28-29, 2010 Clean Water Act Inspections

NPDES DIAGNOSTIC EVALUATION INSPECTION

NPDES Permittee: American Samoa Power Authority

Dates of Inspection: 09/28/2010 Utulei Sewage Treatment Plant Inspection
09/28/2010 Sewer Collection System Inspection
09/29/2010 Fogagogo-Tafuna Sewage Treatment Plant Inspection

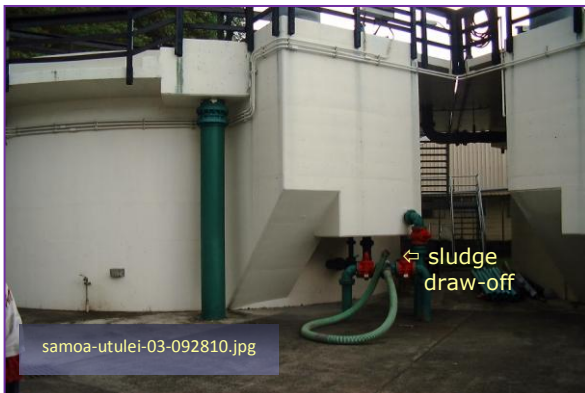
Photo #9: Utulei STP – Clarigester Sludge Draw-off
Taken By: Greg V. Arthur
Date: 09/28/10

Operations at Utulei have remained essentially unchanged since the previous NPDES permit issued in 2001. Clarigester No.1 and the chlorine contact chamber were observed to be inoperative. Everything else, including flow metering, was observed to be fully operational. See Table 4 on page 28 of this report for the statistical summaries of the influent and effluent sampling at Utulei.
