**Re: September 29, 2010 Clean Water Act Inspection  
And Termination of EPA Administrative Order CWA-309(a)**

**NPDES COMPLIANCE EVALUATION INSPECTION**

NPDES Permittee: MYD Samoa, Inc.

Facility: Satala Shipyard  
P.O. Box 7684, Pago Pago, Tutuila Island, American Samoa  
(NPDES Permit No. AS0020026)

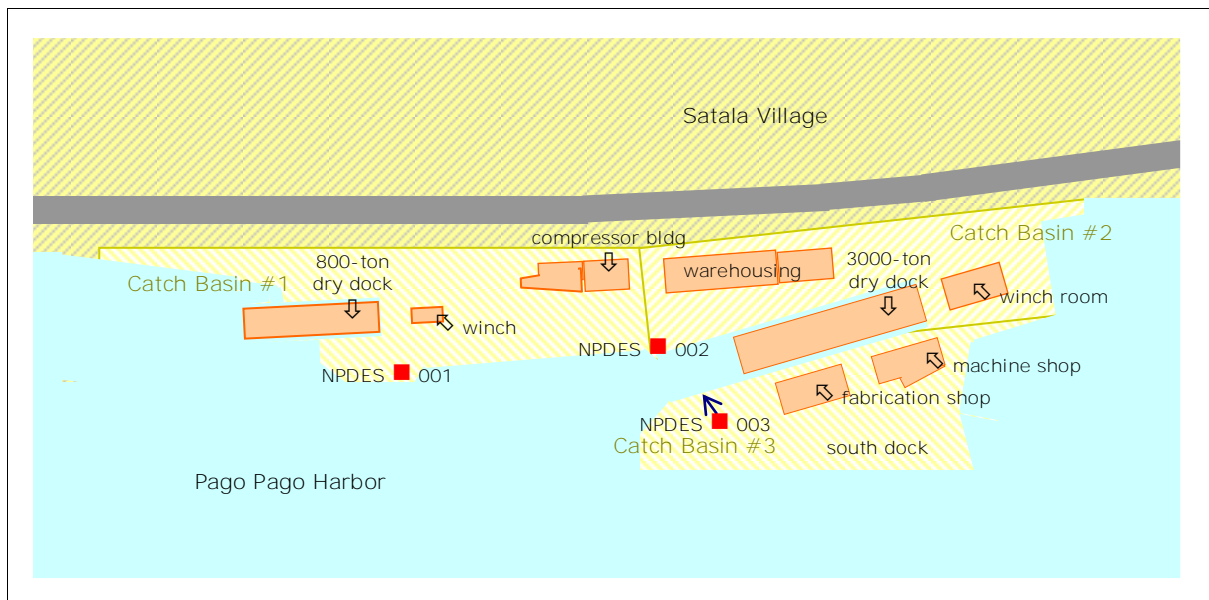
**Figure 1.3**  
MYD Samoa Satala Shipyard Layout

On the date of this inspection, the shipyard had significant unrepaired damage still evident from the tsunami that hit one year before. See Figure 1.3 on the next page the facility layout.

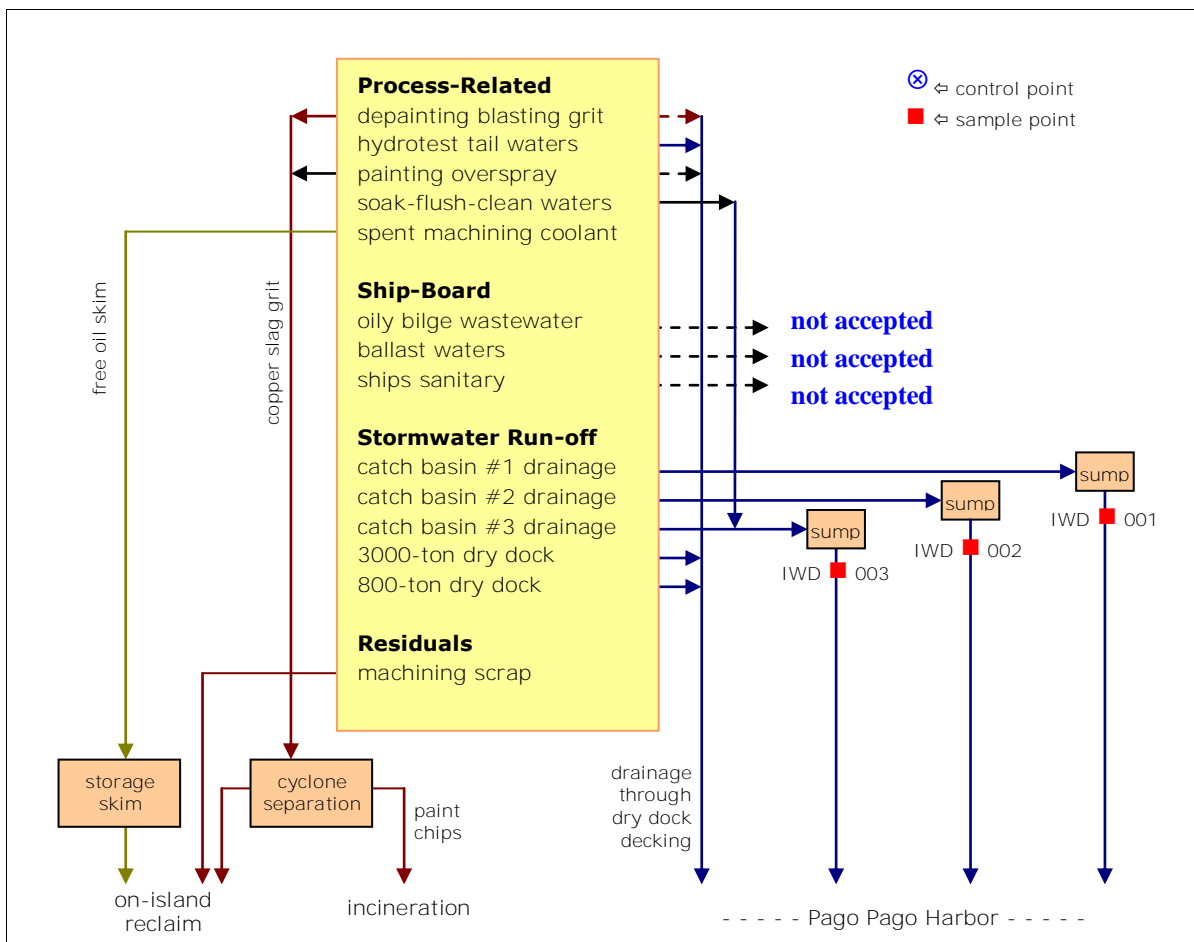
**Figure 1.4**  
 MYD Samoa Shipyard – Configuration of Wastewater Control

MYD Samoa generates process-related wastewaters and storm water run-off from shipyard and shipboard sources. Wastewater sources and controls at MYD Samoa were found during this inspection to be essentially the same as they were in 2009.

MYD Samoa accepts no shipboard sources of process-related wastewaters such as ballast, bilge, and ships sanitary wastes. Shipyard sources of process-related wastewaters include hydroblasting, painting, sand blasting, grinding, fabrication, machining, chemical cleaning and hose flushing, and hydrotesting. See Figure 1.4 on the previous page.

Storm water run-off would be expected from both dry docks, and the three drainage areas referred to as Catch Basins #1, #2 and #3. All of the shipyard sources and the drainage areas have the potential either to produce contaminated contact wastewaters or to discharge pollutants into the harbor. Drainage could contain free and emulsified oils, suspended solids, lead, or copper. There were no specific sources of arsenic, mercury, or PCBs identified during this inspection. MYD Samoa is not designed and does not have the capability to provide any wastewater treatment beyond make-shift oil interception. MYD Samoa also does not have non-domestic connections into the domestic ASPA sewers. As a result, the wastewater controls can only be through operational best management practices ("BMPs"). See Figure 1.4 on page 5 of this report.
