Environmental Technology Verification Report

VJ TECHNOLOGIES IXS HIGH FREQUENCY INTEGRATED X-RAY GENERATOR ALTERNATIVE TECHNOLOGY FOR SEALED SOURCE RADIOGRAPHY CAMERAS

Prepared by
Battelle

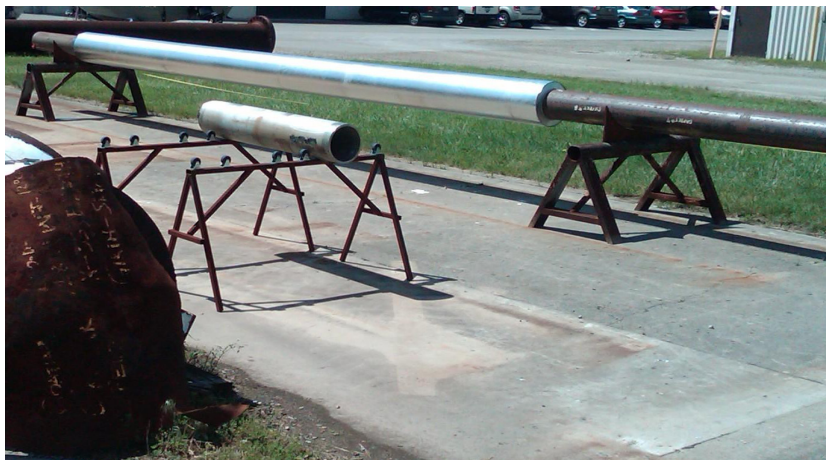
Figure 3-1. Pipe Sample 1 (top, right) with insulation and Pipe Sample 2 (bottom, left).

Pipe Sample 1 was a seam-welded carbon steel pipe measuring approximately 35 feet in length. The wall thickness was 0.188 inches. This sample consisted of three pipe sections welded together (two circumferential welds) and contained simulated corrosion defects set along two test lines 180 degrees apart. A five foot section in the middle of Pipe Sample 1 also contained natural corrosion from a pipe pulled from service. The pipe sections with the simulated

To simulate the refinery environment, a portion of Pipe Sample 1 was insulated with calcium silicate material, a common industrial insulating material. The insulation was jacketed with aluminum sheet metal. The jackets were held on by aluminum banding material (see Figure 3-1).

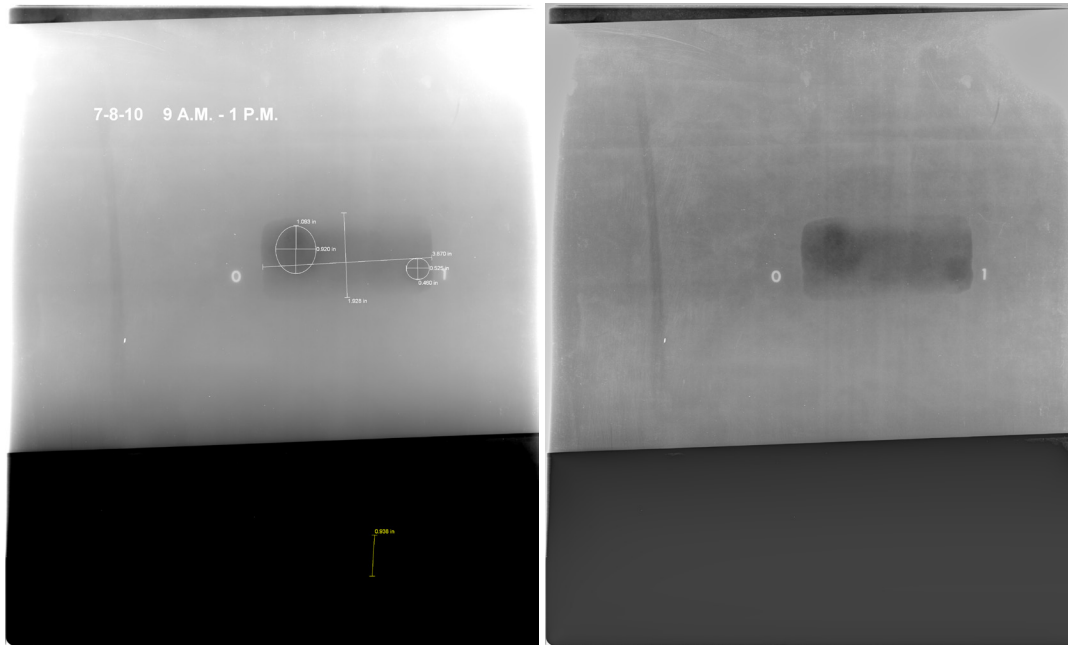
Both the radiography camera and the VJ Technologies IXS High Frequency Integrated X-Ray Generator were able to show the defect patches, natural corrosion, and weld under the insulation, as well as the defects on uninsulated pipe. Raw images were comparable in quality for non-contact images, as shown in Figure 6-1. After applying VJ Technologies ADE software to refine images, the x-ray technology images were clearer than those without adjustment. Figure 6-2 provides an example.

Figure 6-2. Example VJ Technologies IXS High Frequency Integrated X-Ray Generator results without adjustment (left) and with ADE adjustment (right).

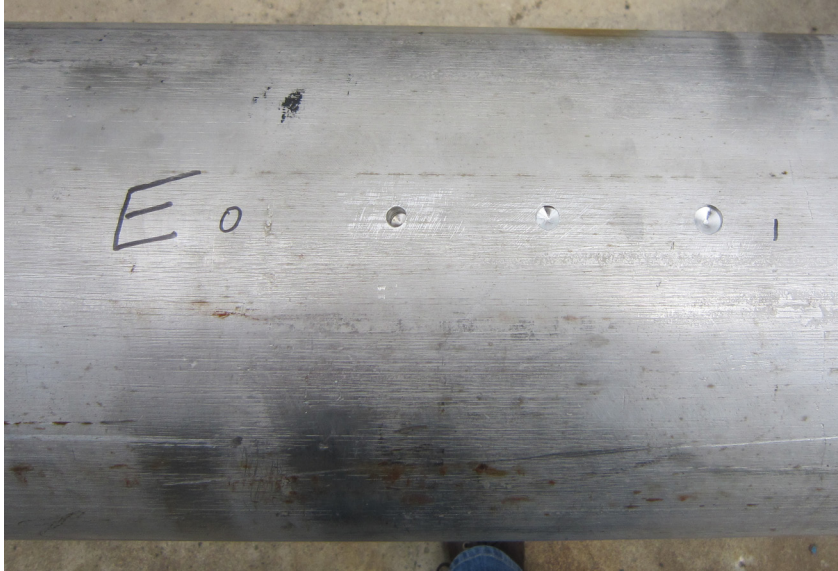
Technologies IXS High Frequency Integrated X-Ray Generator were measured using software to determine the length, width, and depth of each pit as well as the overall length and width of the defect patch. Appendix A provides pictures and details from a previous characterization study prior to this verification test for the defects on Pipe Sample 1. A picture of the Pipe Sample 2 simulated defects is provided in Figure 6-4. Results for the quantitative measurements are discussed in the following sections.

Figure 6-4. Uninsulated Pipe Sample 2 simulated defects.
