DRAFT
COMPLETION OF WORK REPORT

Second Unilateral Administrative Order for Removal Action
Centredale Manor Restoration Project Superfund Site
North Providence, Rhode Island

April 2005

LOUREIRO ENGINEERING ASSOCIATES, INC.
100 Northwest Drive
Plainville, Connecticut 06062

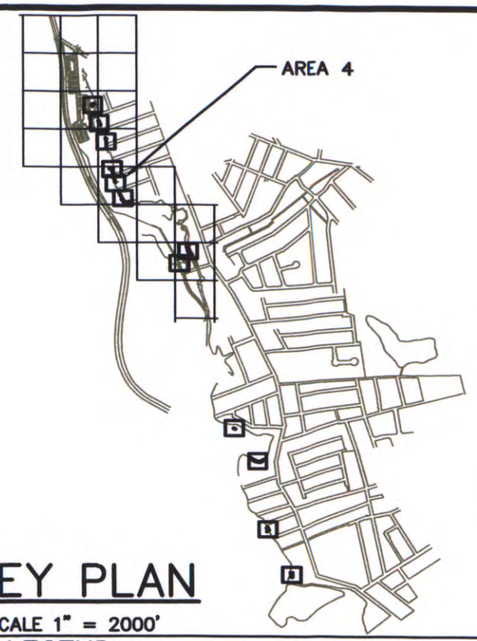
Comm.No.	FIGURE 5-14	LEA
15RP102

As shown in Figure 5-14, the limits of dioxin are not defined by the samples obtained. Samples obtained from location 03/04-DEL-101 and from location 03/04-DEL-103 were reported to contain concentrations of dioxin that exceed 1.0 ppb. Accordingly, the sampling grid was expanded as approved by EPA to obtain additional samples from sample locations 03/04-DEL-104 and 03/04-DEL-105. These additional samples were obtained and analyzed on September 10, 2002 in accordance with the above-referenced protocol. Also, as shown in Figure 5-20, the sample obtained from location 10-DEL-303 was reported to contain a concentration of dioxin that exceeds 1.0 ppb. Thus, on September 10, 2002 a sample from location 10-DEL-304 was obtained and analyzed in accordance with EPA approval and the above-referenced protocol. The laboratory analytical results for the samples obtained on September 10, 2002 were validated by EDS in accordance with the Region I Data Validation Functional Guidelines for Evaluating

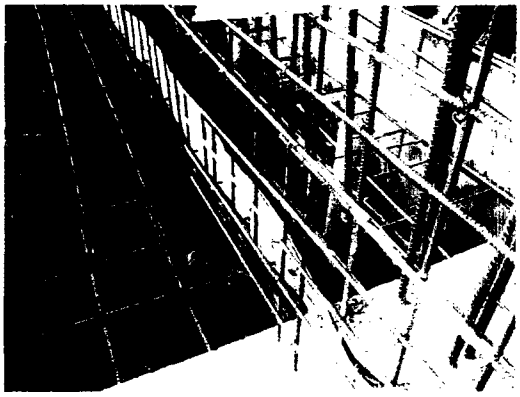
12.07.2001	Downstream of center section of dam structure	W	Concrete Formwork: Installed forms and reinforcing steel bars for dam footing

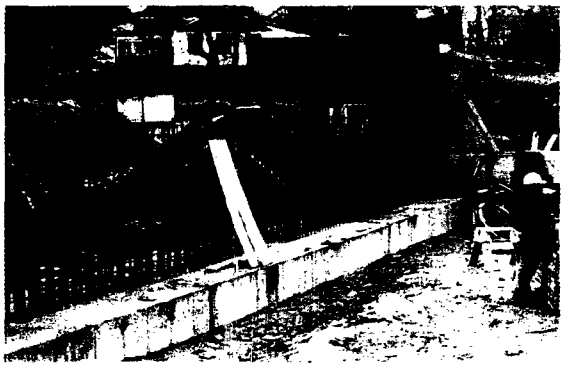
12.11.2001	Downstream cofferdam	NE	Placement of fabricated bar mats and reinforcing steel bars for dam wall construction
	12.13.2001	Downstream cofferdam	NE	Placement of fabricated bar mats and reinforcing steel bars for dam wall construction

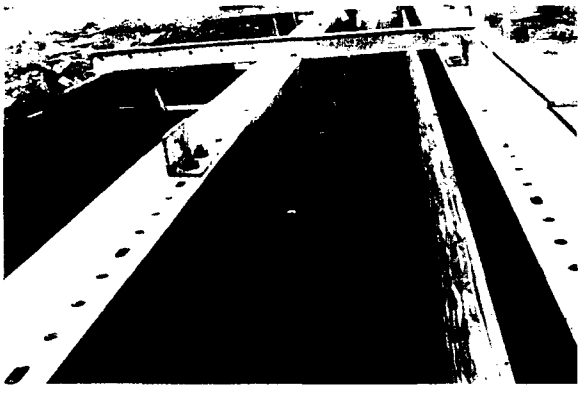
12.18.2001	West side of dam	E	Close-up view of forms for concrete dam wall
	12.18.2001	Downstream of dam along east side	NW	Placement of forms for concrete dam wall where it abuts existing granite stone wall

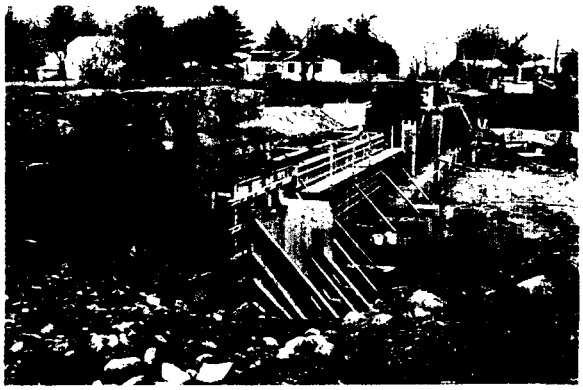
12.18.2001	Downstream cofferdam	NE	Placement of forms for concrete dam wall where it abuts existing granite stone wall
	12.19.2001	Standing on top of existing gate structure	W	Dam wall concrete pour

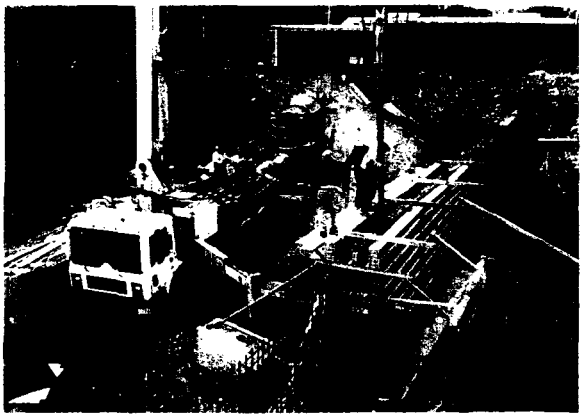
12.26.2001	Standing on top of existing gate structure	W	Dam wall concrete pour (2nd section of wall) Note: Placement of concrete curing mat
	12.20.2001	Downstream cofferdam	NE	Removal of first section of forms for concrete dam wall

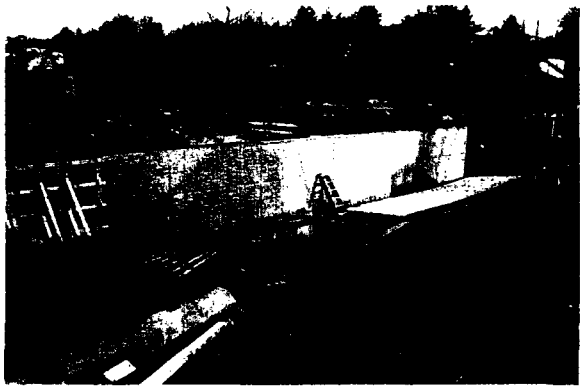
12.21.2001	Downstream cofferdam	NE	Removal of forms for concrete dam wall Note: Factory fabricated elastomeric textured concrete form liner
