Report on Emergency Incidents at Hazardous Waste Combustion Facilities and Other Treatment, Storage, and Disposal Facilities (TSDFs)

SUBJECT: Final Report on Emergency Incidents at Hazardous Waste Combustion Facilities and Other Treatment, Storage and Disposal Facilities (TSDFs)

**Report on Emergency Incidents at Hazardous Waste Combustion Facilities
and Other Treatment, Storage and Disposal Facilities (TSDFs)**

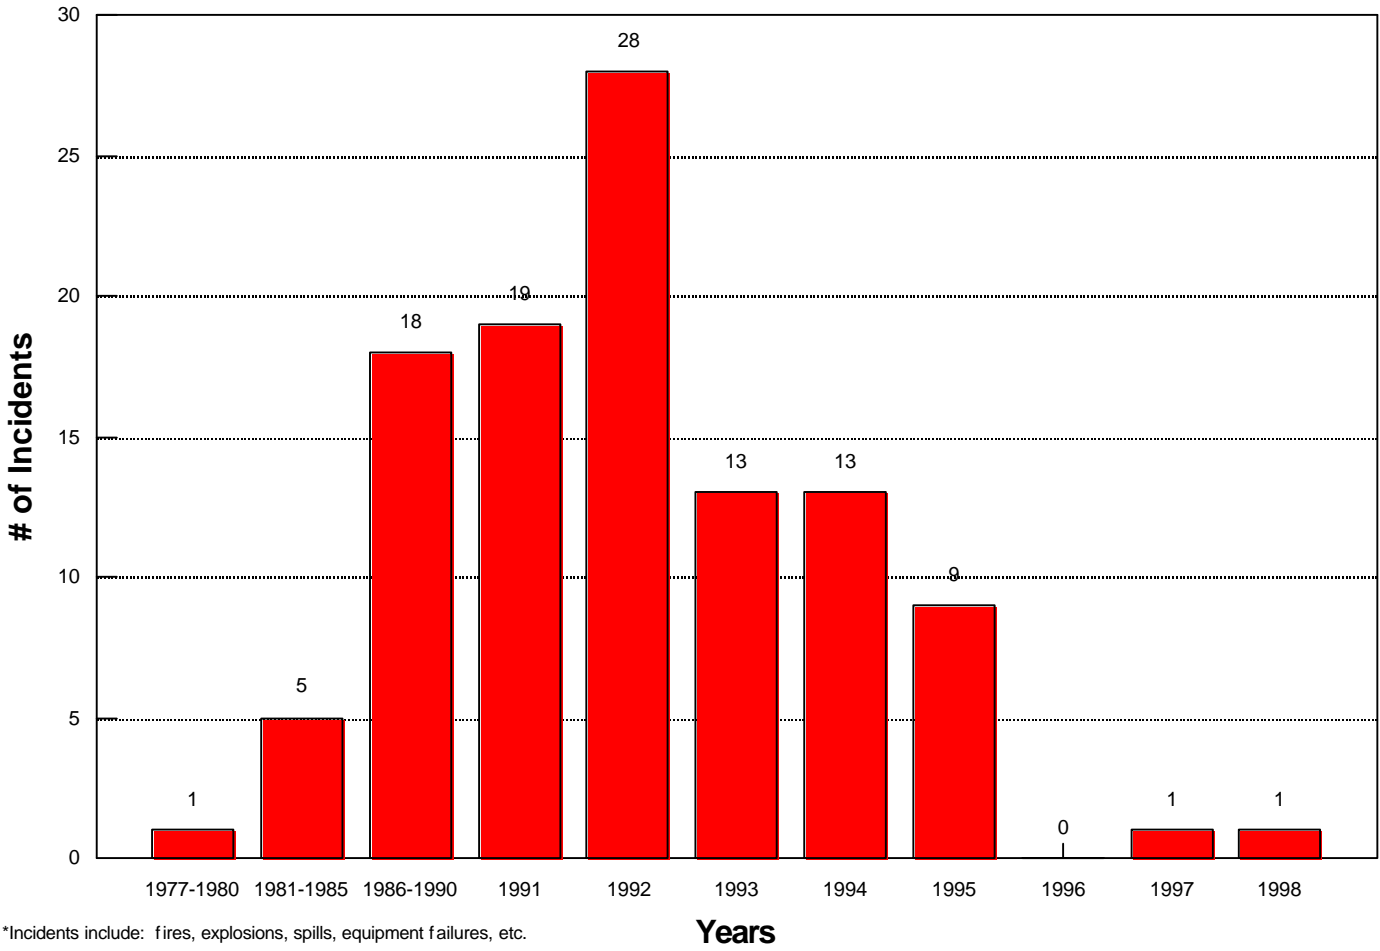
**CHART 1. Number of Incidents at Combustion Facilities and TSDFs
1977-1998**

The report begins with a summary table listing the number of reported incidents (per facility type) that have occurred in each of the EPA Regions, and the number of combustion facilities with incidents that resulted from the actual combustion of hazardous waste. On the next page is a chart showing the number of incidents that occurred at combustion facilities and TSDFs from 1977-1998. The chart is followed by a Regional summary of each individual incident and the EPA or State contacts who provided the information regarding the incident. The report ends with a complete listing (by Region) of each facility. Where available, detailed incident reports are included as attachments.
