# **COSTS OF REMEDIATION AT MINE SITES**

January 1997

U.S. Environmental Protection Agency  
Office of Solid Waste  
401 M Street, SW  
Washington, DC 20460

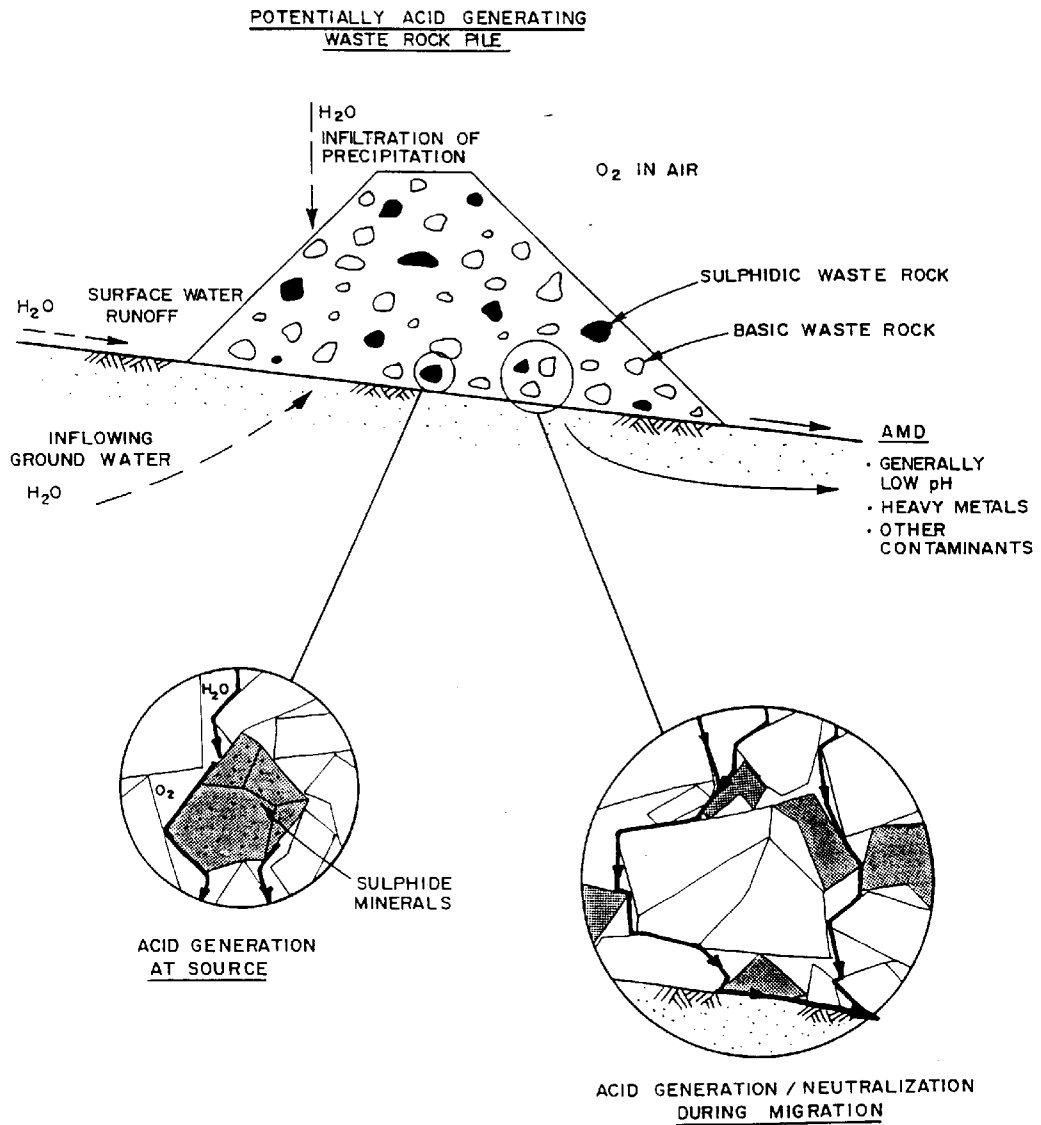
Figure 2-1. Schematic Showing Concept of Acid Generation and AMD Migration.

(Steffen, Robertson, and Kirsten, 1989) presents a conceptual schematic of acid generation and migration through a waste rock pile. The process involves the sulfide-containing and basic rock present in the pile, the potential sources of oxygen and water, and the acid generation/neutralization occurring where these elements are in contact. This figure illustrates water percolating through the dump, coming into contact with both acid-generating and -neutralizing materials, and emerging from the ore as ARD.

If ARD is not controlled, it can pose a threat to the environment due to the toxicity of heavy metals and other pollutants. Figure 2-1
