Dam Safety Assessment of CCW Impoundments

GenOn/NRG ELRAMA POWER STATION

GenOn/NRG Elrama Power Station

ROBERT R. BOWERS, P.E. – VICE PRESIDENT O'BRIEN & GERE ENGINEERS, INC.

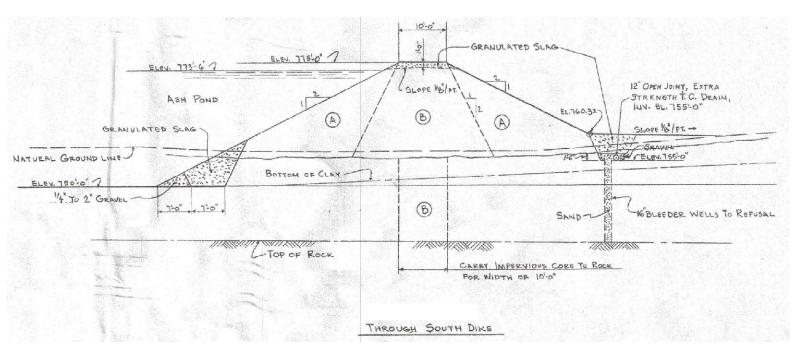
SECTION H-HSCALE: 1" = 20'-0"

BOTTOM ASH SETTLING POND SPD-1 (SOUTHERN EMBANKMENT)

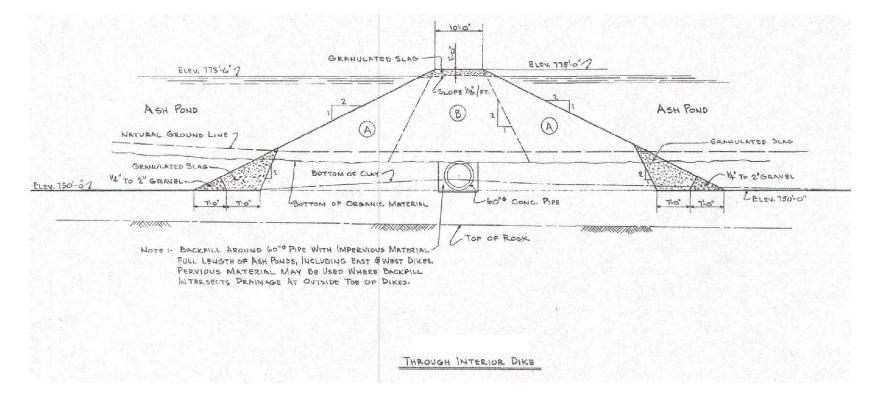
SECTION W-W SCALE: 1" = 20'-0"

BOTTOM ASH SETTLING PONDS SPD-1 & SPD-2 (DIVIDING DIKE)

REFERENCE: TAKEN FROM DRAWING NO. 3593-B74, TITLED "TYPICAL CROSS SECTIONS OF DIKE ASH POND AREA", DATED 9/20/51, BY DUQUESNE LIGHT COMPANY, PITTSBURGH, PA
