MEMORANDUM

SUBJECT: EPA Comments on "Assessment of Dam Safety of Coal Combustion Surface Impoundments: GenOn New Castle Power Plant, West Pittsburg, PA"

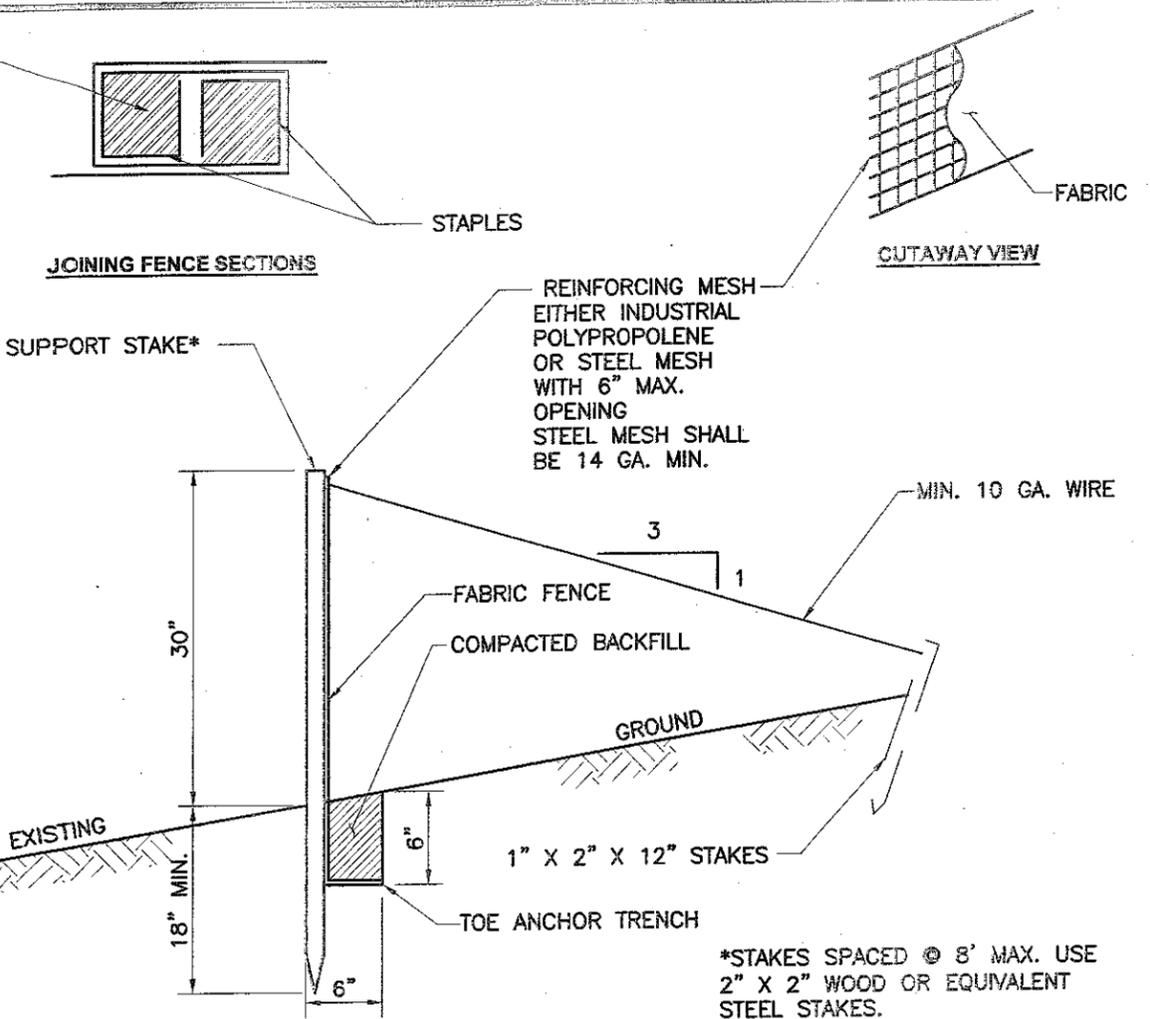
DETAIL 2
REINFORCED SILT FENCE (30" HIGH)
N.T.S.

FILTER FABRIC FENCE MUST BE INSTALLED AT EXISTING LEVEL GRADE. BOTH ENDS OF EACH FENCE SECTION MUST BE EXTENDED AT LEAST 8 FEET UPSLOPE AT 45 DEGREES TO THE MAIN FENCE ALIGNMENT.

SEDIMENT MUST BE REMOVED WHERE ACCUMULATIONS REACH 1/2 THE ABOVE GROUND HEIGHT OF THE FENCE.

ANY FENCE SECTION WHICH HAS BEEN UNDERMINED OR TOPPED MUST BE IMMEDIATELY REPLACED WITH A ROCK FILTER OUTLET.

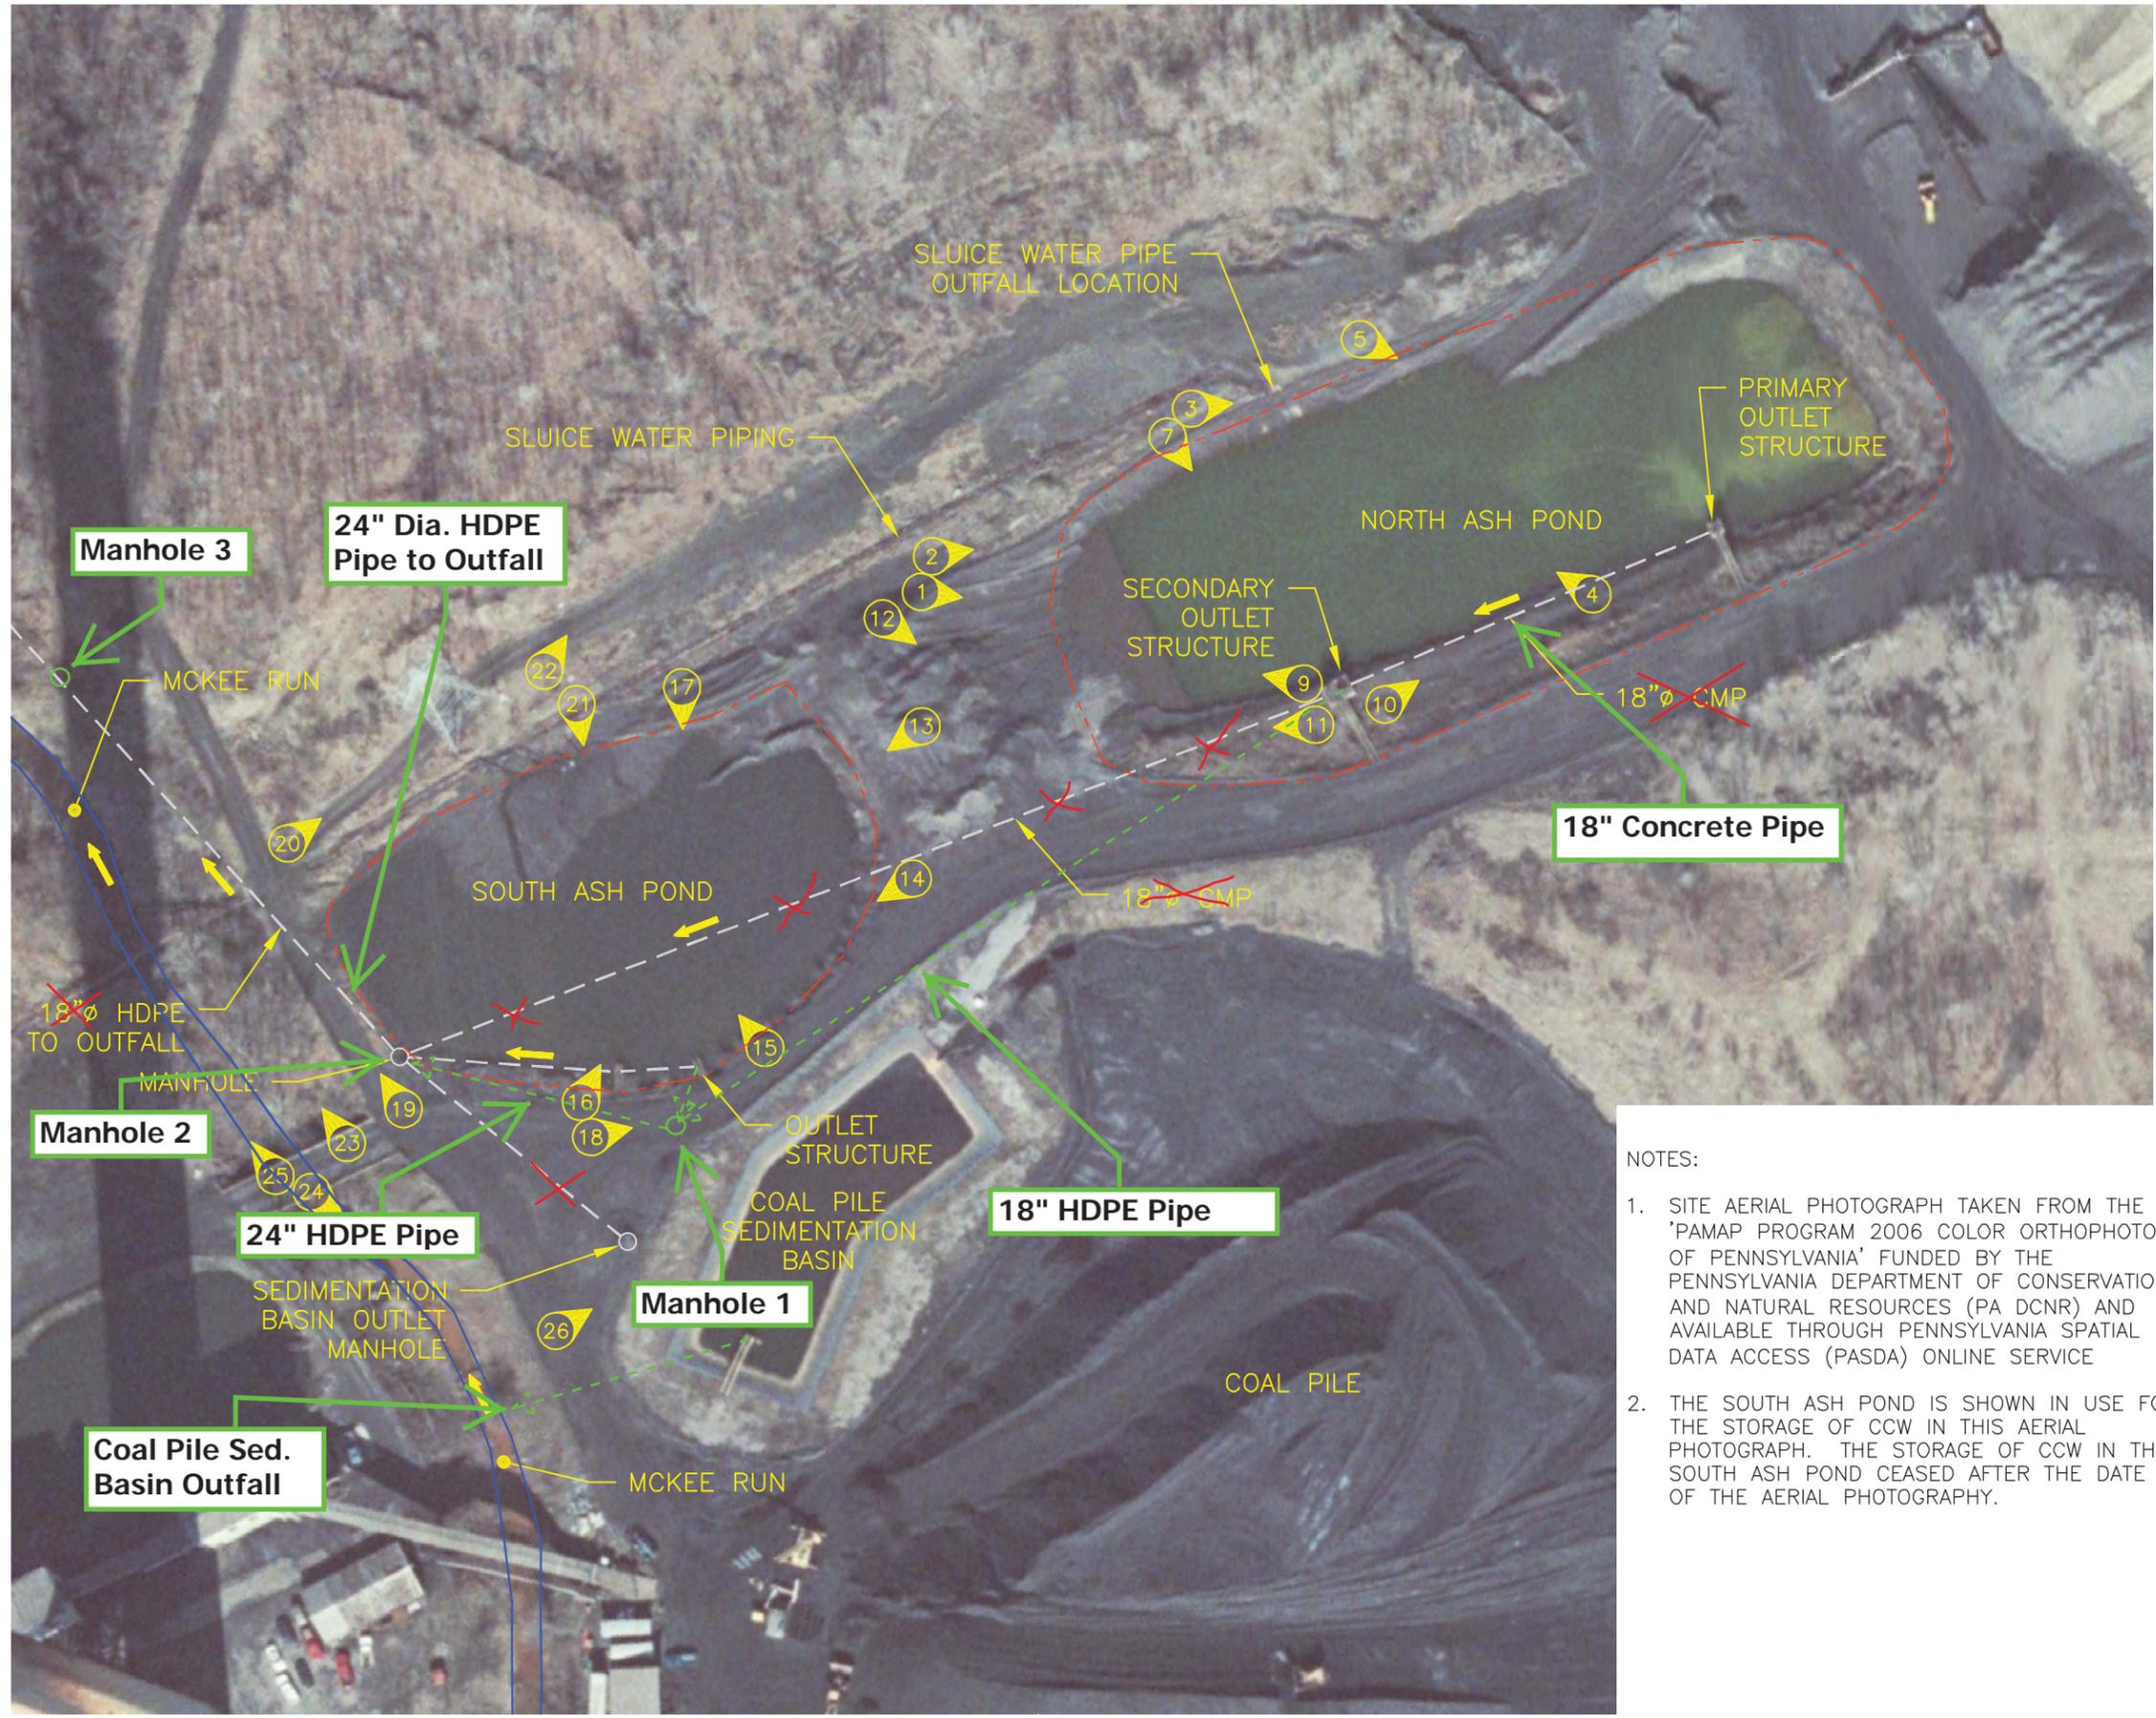
FIGURE 2

PHOTOGRAPH NUMBER AND ORIENTATION
-

APPROXIMATE CREST OF IMPOUNDMENT
-

APPROXIMATE LOCATION OF UNDERGROUND PIPING

1. SITE AERIAL PHOTOGRAPH TAKEN FROM THE 'PAMAP PROGRAM 2006 COLOR ORTHOPHOTOS OF PENNSYLVANIA' FUNDED BY THE PENNSYLVANIA DEPARTMENT OF CONSERVATION AND NATURAL RESOURCES (PA DCNR) AND AVAILABLE THROUGH PENNSYLVANIA SPATIAL DATA ACCESS (PASDA) ONLINE SERVICE
2. THE SOUTH ASH POND IS SHOWN IN USE FOR THE STORAGE OF CCW IN THIS AERIAL PHOTOGRAPH. THE STORAGE OF CCW IN THE SOUTH ASH POND CEASED AFTER THE DATE OF THE AERIAL PHOTOGRAPHY.

- The station owner and operator is NRG Power Midwest LP (NRG), a subsidiary of NRG Energy, Inc. and should replace "GenOn Energy" throughout the report.
- Page 2, note that while fly ash is dry handled, the ash is moistened to control dust prior to transport to the onsite landfill.
- Page 6, Section 2.3.3 Outlet Works. (See Revised Figure 2 and attached drawings)

The North Ash Pond has two outlet structures located along the eastern bank. The northern primary outlet structure consists of a concrete box with a rectangular weir equipped with stop logs to govern the water level in the pond. A steel slide gate serves as a baffle to exclude floating debris from the discharge. The top consists of an open steel grate. The effluent discharges into an 18" ~~corrugated metal pipe (CMP)~~ concrete pipe which extends below the bottom of the pond to the southern secondary outlet structure. ~~The concrete pipe was inspected in 2006 and found to be in good condition.~~ The secondary outlet structure consists of a concrete box with two separate rectangular weirs equipped with stop logs and slide gate baffles. The secondary outlet stop logs are set at a higher elevation than the primary outlet structure's stop logs and are used for overflow control. The effluent discharges into an 18" ~~CMP~~ HDPE pipe which extends ~~beneath the bottom of the Northern Ash Pond, through the embankment separating the North and South Ash Ponds, beneath the South Ash Pond along the access road~~ and discharges into ~~Manhole #1 a manhole~~ located ~~between the Coal Pile Sedimentation Basin and the South Ash Pond.~~ ~~on the southern crest of the South Ash Pond.~~ From ~~Manhole #1 this manhole~~ the effluent is conveyed by a 24" high-density polyethylene (HDPE) pipe, ~~transitioning to a 24" HDPE pipe for the last segment prior~~ to the outfall at the Beaver River. This outfall is permitted as Outfall 004 under NPDES Permit #PA0005061.
