**Coal Combustion Residue Impoundment
Round 11 - Dam Assessment Report**

Colbert Fossil Plant
Tennessee Valley Authority
Tuscumbia, Alabama

Dewberry & Davis, LLC
Fairfax, Virginia

EP-09W001727
June 2012

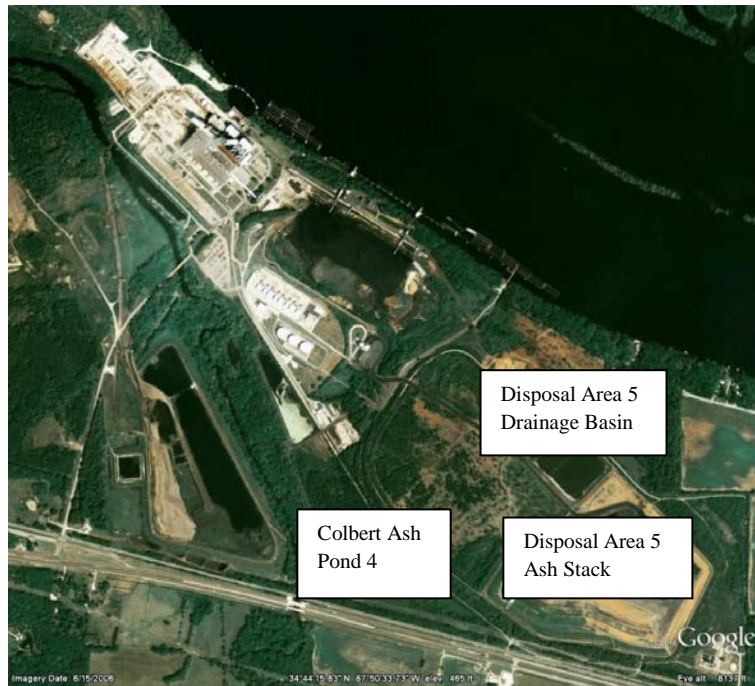
Figure 2.1-2 also shows the location of Disposal Area 5 on the site.

Figure 2.1-2 Ash Pond 4 and Disposal Area 5 Locations

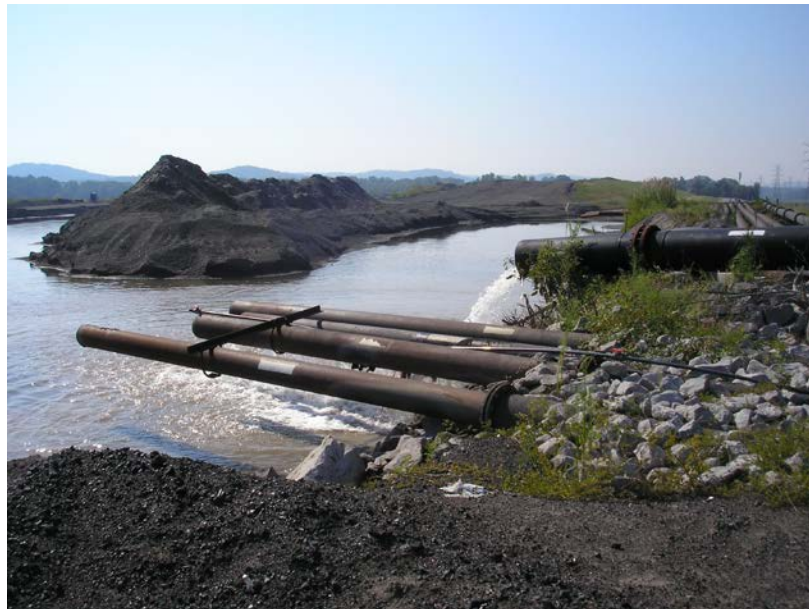
Sluiced ash from the plant is discharged to the northwest corner of Ash Pond 4 and routed southward through interior ditches in the bottom ash. At the south end of the impoundment the sluiced ash is deposited into the main settling pond. Decant water is released from Ash Pond 4 through a siphon and an overflow spillway located in the northeast portion of the impoundment. Periodically bottom ash is dredged from the east side of Ash Pond 4 and stacked in the west side. Photograph 4.2.2-1 shows sluiced ash entering Ash Pond 4 and the ditches through the stacked ash.

Figure 4.2.2-1: Sluiced Ash Discharge to Ash Pond 4. South Flowing Ditches through Stacked Ash in Background

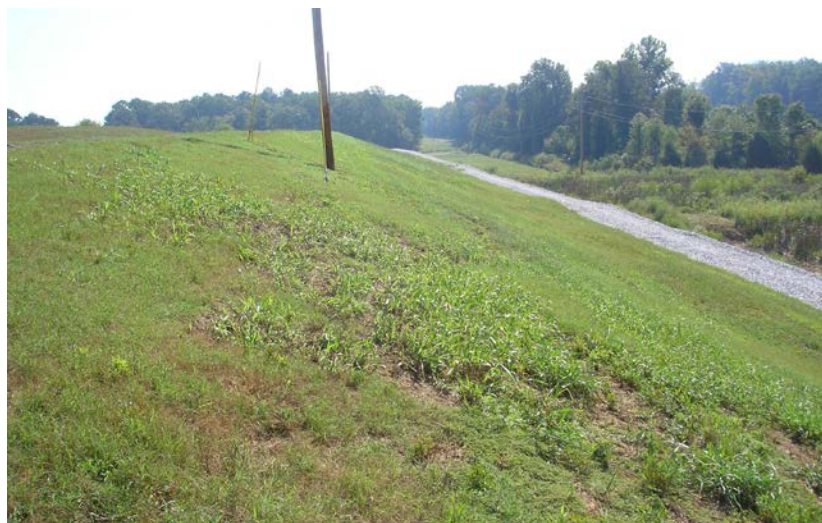
The crest of the embankment impounding Ash Pond 4 is a 25-foot wide gravel roadway. There were no signs of significant depressions, tension cracks, settlement or shear failure along the crest. Photograph 5.2.1-1 shows the crest of the west embankment.

Photograph 5.2.1-2: West Dike Crest (Bottom Ash Stack on left)

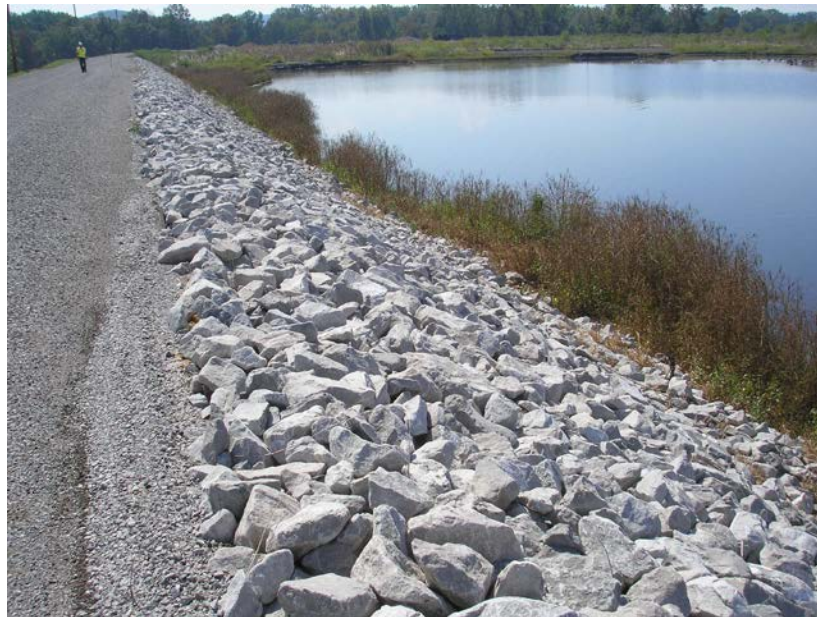
The inside slopes of the north and east embankments of Ash Pond 4 are armored with medium rip rap to protect against wind driven wave erosion. The inside slope of the south embankment is vegetated with grass and weed. There were no signs of slumps or slides in the visible portions of the slopes and no significant erosion was noted. Photograph 5.2.2-1 shows the inside slope of the east embankment near the south end and the east end of the south embankment.

Photograph 5.2.2-1: Inside Slope of East Embankment with South Embankment in the Background.

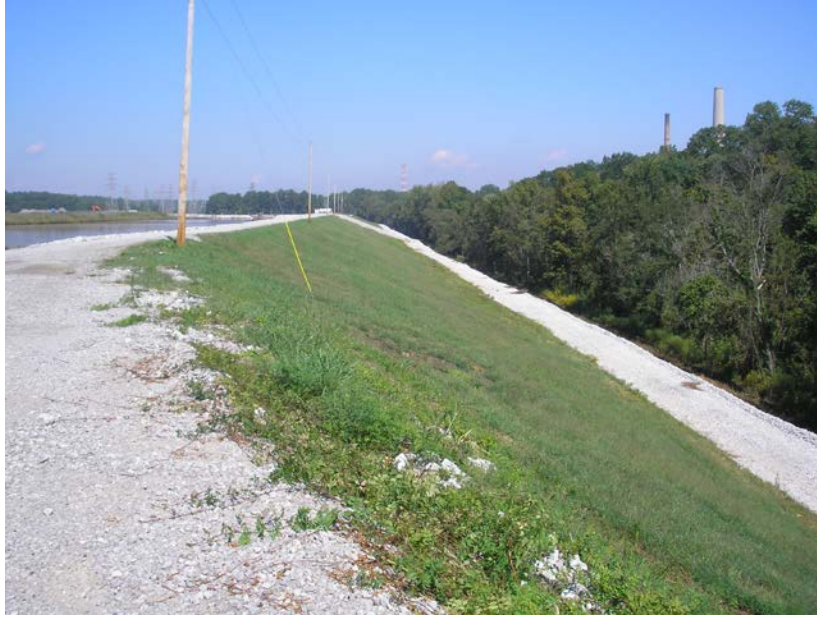
The outside slopes of the Ash Pond 4 impoundment are generally grassed. No signs of scarps, sloughing or other indication of distress were observed. Seepage areas have been identified and treated with inverted filter drains. A riprap filter drain/buttress has been placed along the toe of the east dike and portions of the south and west embankments. Photograph 5.2.3-1 shows representative outside slope filter drain/buttress conditions. Photograph 5.2.3-2 shows a seepage patch at the toe of the west embankment.

Photograph 5.2.3-1: Outside Slope of East Embankment with Inverted Filter Drain and Riprap Buttress

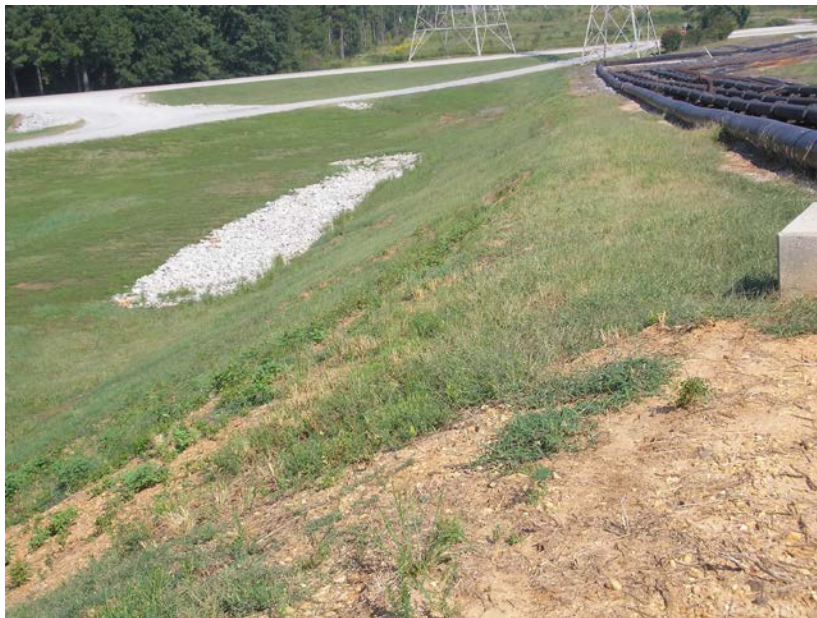
Photograph 5.2.3-2: Seepage Blanket at Toe of West Embankment North End

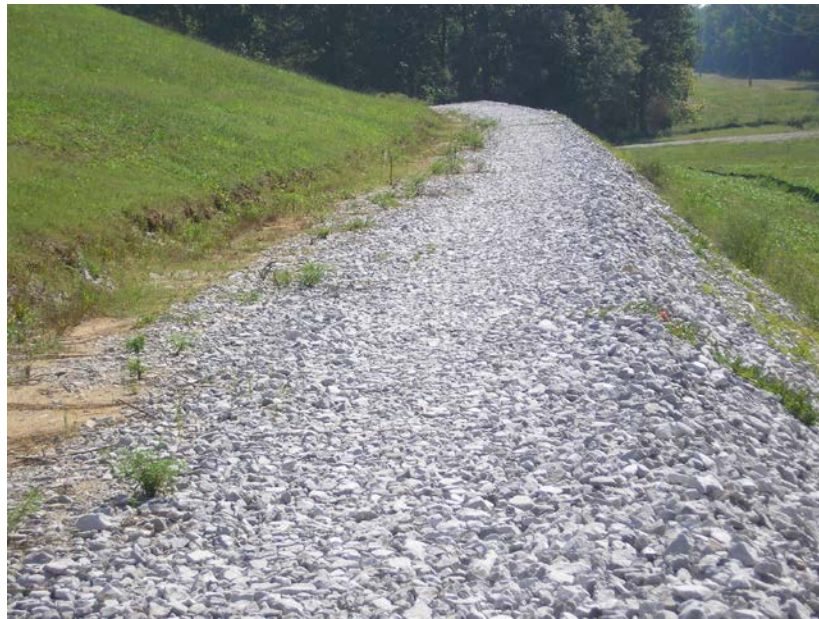
Exterior groins are vegetated. Southeast and northeast exterior groins have inverted filter toe drains and buttresses. Photograph 5.2.4- 1 shows representative conditions observed at the groins.

Photograph 5.2.4-1: Southeast Outside Groin with Inverted Filter Drain and Buttress

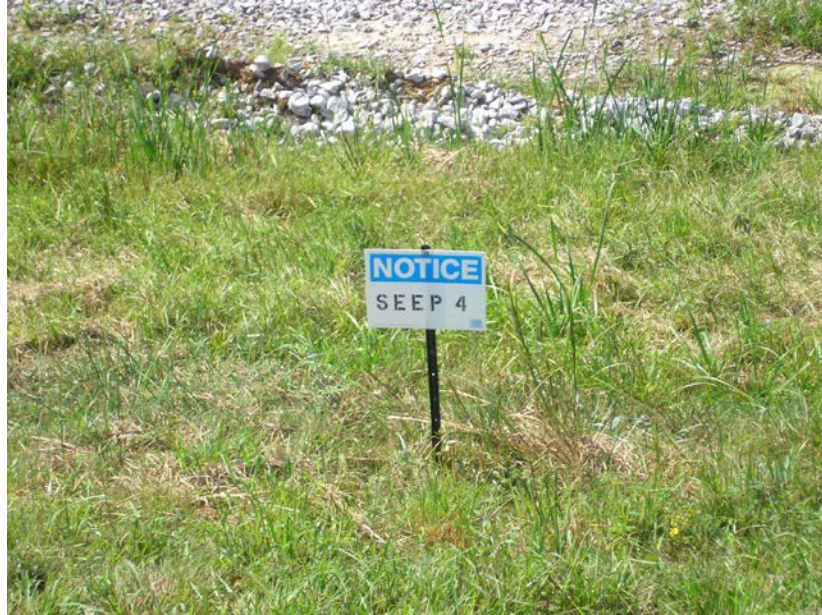
Significant seepage was noted in the southeast exterior groin area. The area was marked and remediation is planned for the area. Photograph 5.2.4-2 shows the observed seepage area at the southeast groin.

Photograph 5.2.4-2: Seepage Area Being Monitored near Southeast Groin

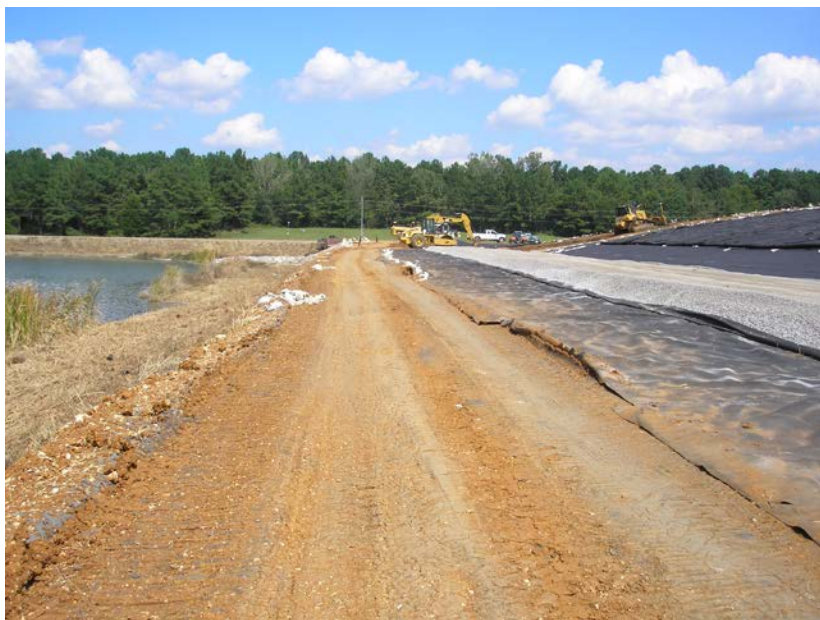
The crest of Disposal Area 5 consists of a compacted clay roadway. The crest shows no signs of significant depressions, tension cracks, or other indications of settlement or shear failure. Photograph 5.3.1-1 shows the crest of the embankment between the ash stack and drainage basin portions of Disposal Area 5. The photograph was taken at the crest of the west embankment.

Photograph 5.3.1-1: Disposal Area 5 Crest between Ash Stack and Drainage Basin

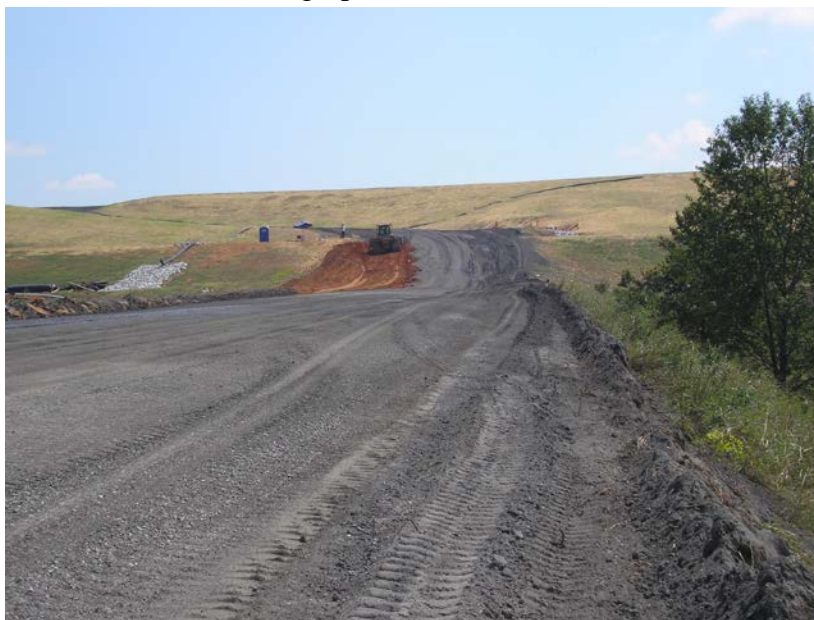
The crest of the Drainage Basin embankment consists of compacted clay, except that the south embankment crest has a compacted ash roadway surface shown in Photograph 5.3.2-2.

Photograph 5.3.2-2: Crest of Drainage Basin South Embankment with Compacted Ash Road Surface

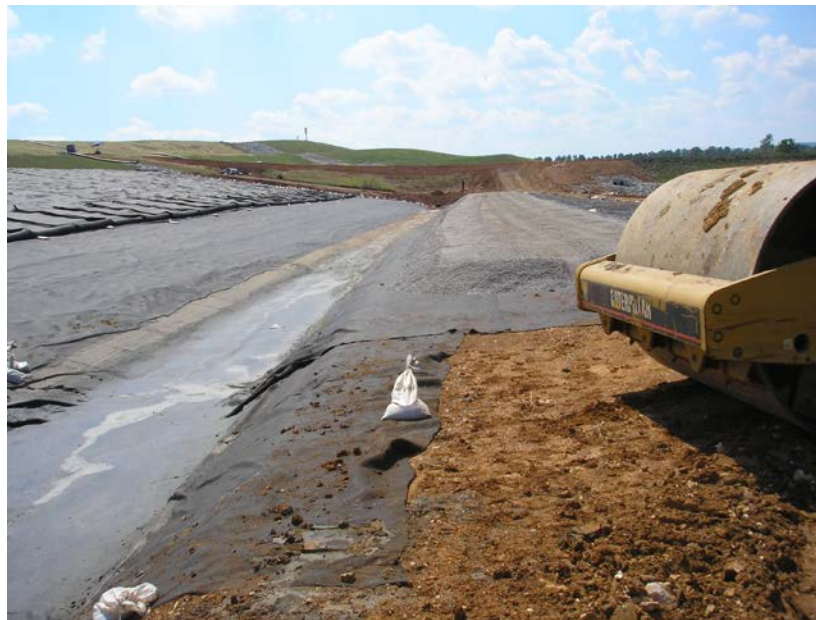
The Disposal Area 5 ash stack area has been filled with sluiced ash to approximate elevation 480 and stacked with dry ash to a height of approximately 80 – 100 feet above the original pond embankment level. The dry stacking has been accomplished using tiered construction with benches every 20 feet of height. The inside slopes of the ash stack portion of Disposal Area 5 are no longer visible. Figure 5.3.2-1 shows the inside of the ash stack impoundment at the embankment crest elevation. Construction of a segment of the stack interior drainage system and perimeter ditch is in progress.

Photograph 5.3.2-1: Disposal Area 5 Ash Stack Perimeter Ditch Construction Along Inside of Impoundment Embankment Crest.

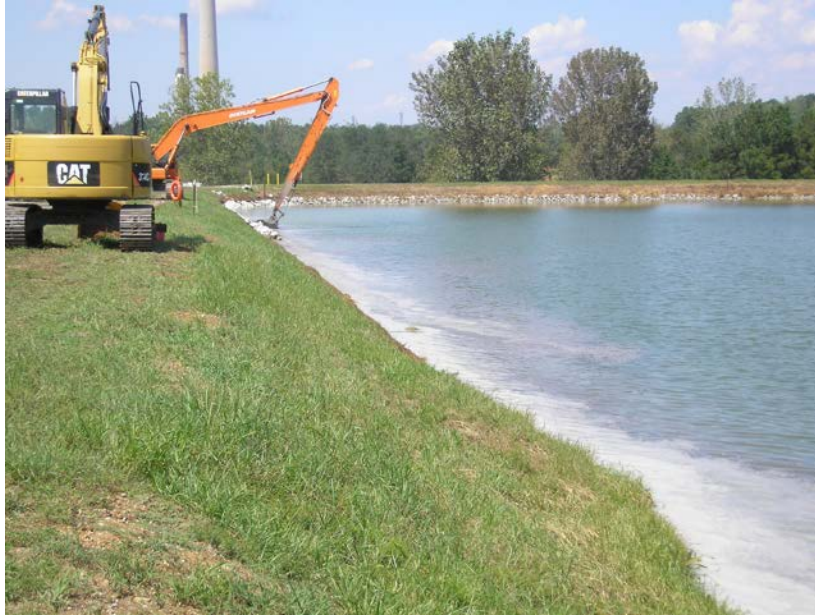
The inside slope of Disposal Area 5 Drainage Basin embankments is vegetated with various species of grass and weeds. Sections of the slope are armored with riprap at the water level to provide protection against wind driven wave erosion. As shown in Photograph 5.3.2-2 construction to complete slope armoring was underway during Dewberry's site visit.

Photograph 5.3.2-2: Disposal Area 5 Drainage Basin South Embankment Inside Slope; Track Hoe Installing Riprap for Wave Erosion Protection.

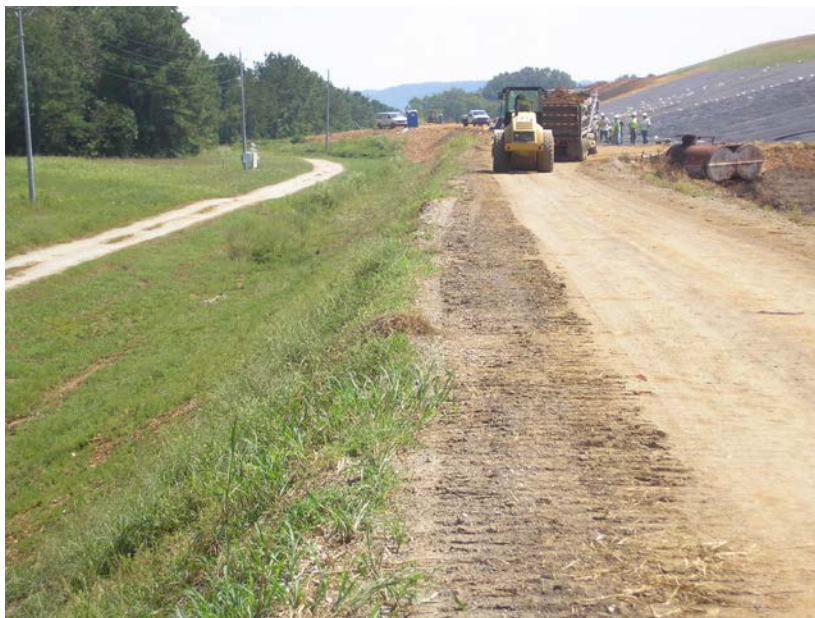
The outside slope of embankments impounding the ash stack is generally grassed. Areas under construction on the outside slope have a cover of fugitive grading soils along the outside slope near the crest. Photograph 5.3.3-1 shows a section of outside slope with soil spilled onto the embankment.

Photograph 5.3.3-1: Ash Pond 5 North Embankment Outside Slope with Fugitive Soil Adjacent to Construction along Ash Stack

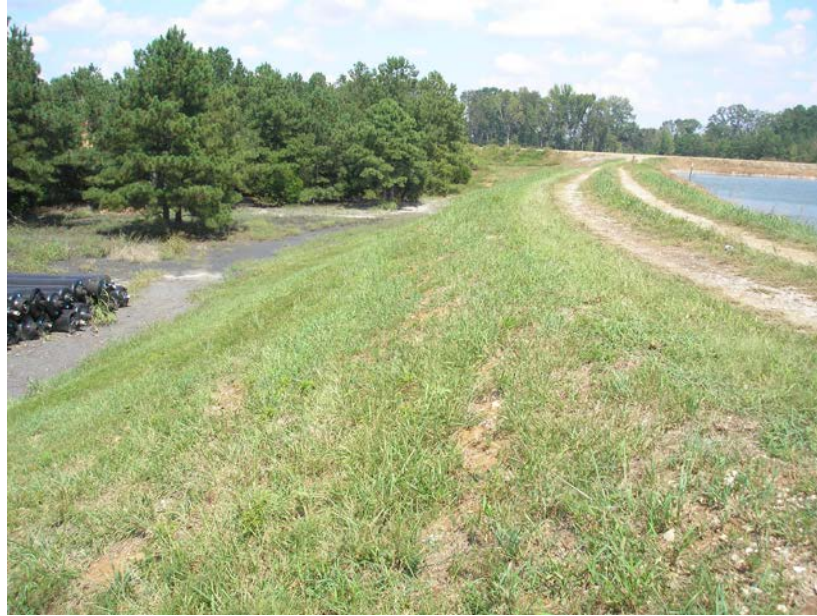
The outside slopes of the north, south, and west dikes of the Drainage Basin are vegetated with various species of grass and weeds. Photograph 5.3.3-2 shows representative conditions observed during Dewberry's site visit. Some small trees were growing on the lower half of the south embankment. Photograph 5.3.3-3 shows the small trees observed along the south embankment. The east embankment separates the Drainage Basin and the ash stack unit of Disposal Area 5.

Photograph 5.3.3-2: Drainage Basin West Embankment Outside Slope

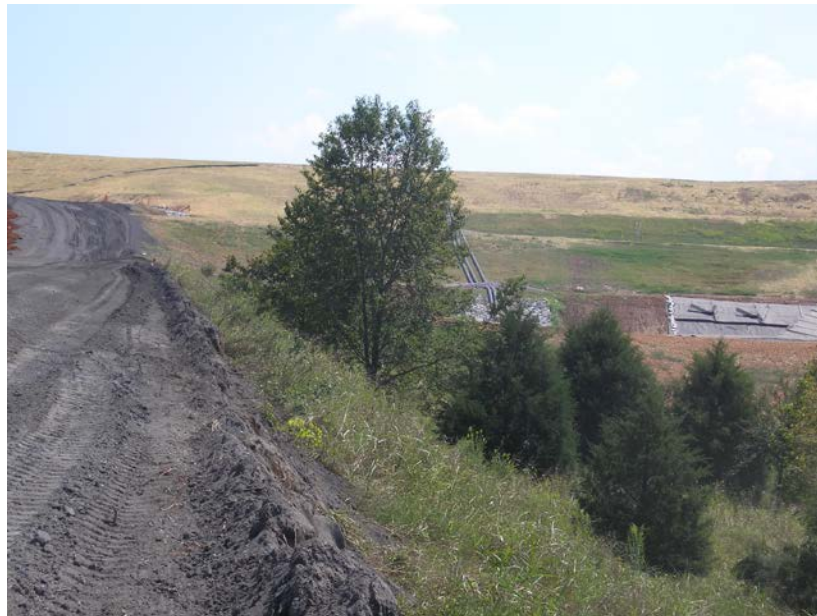
Photograph 5.3.3-3: Drainage Basin South Embankment Trees on Outside Slope

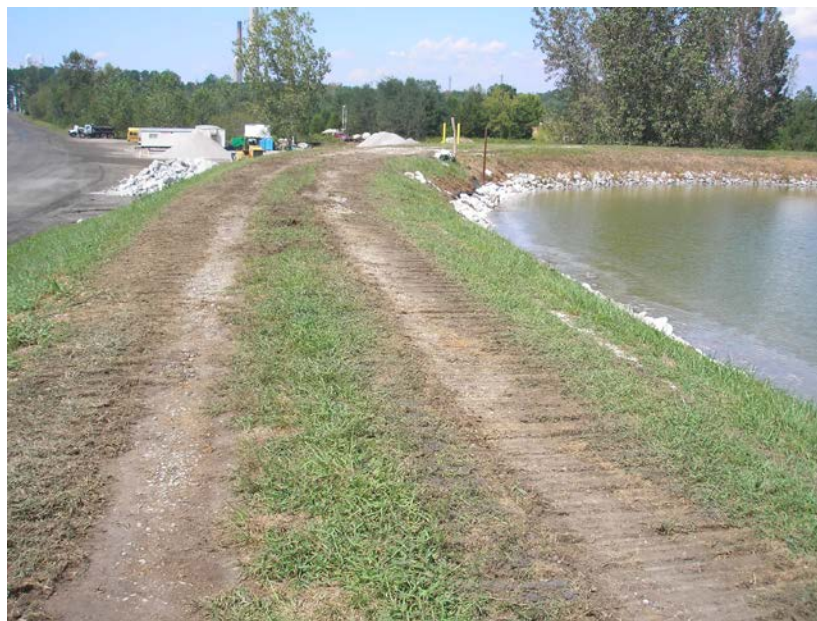
Ash stacking operations have covered the inside groins of the Disposal Area 5 ash stack. The internal groins for the Drainage Basin are covered with medium riprap at the water level and a light cover of grass above the rip rap. Photograph 5.3.4-1 shows the groin on the interior of the Drainage Basin.

Photograph 5.3.4-1: Disposal Area 5 Drainage Basin Inside Groin at Southwest Corner

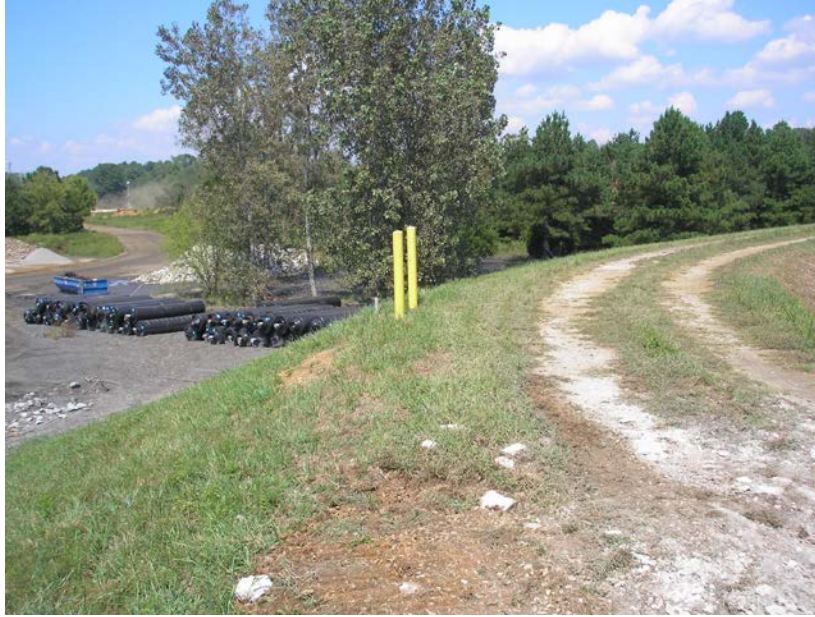
Outside groins are vegetated with various species of grass and weeds similar to the outside slopes. Photograph 5.3.4-2 shows representative conditions observed during Dewberry's site visit.

Photograph 5.3.4-2: Disposal Area 5 Drainage Basin Outside Groin at Southwest Corner

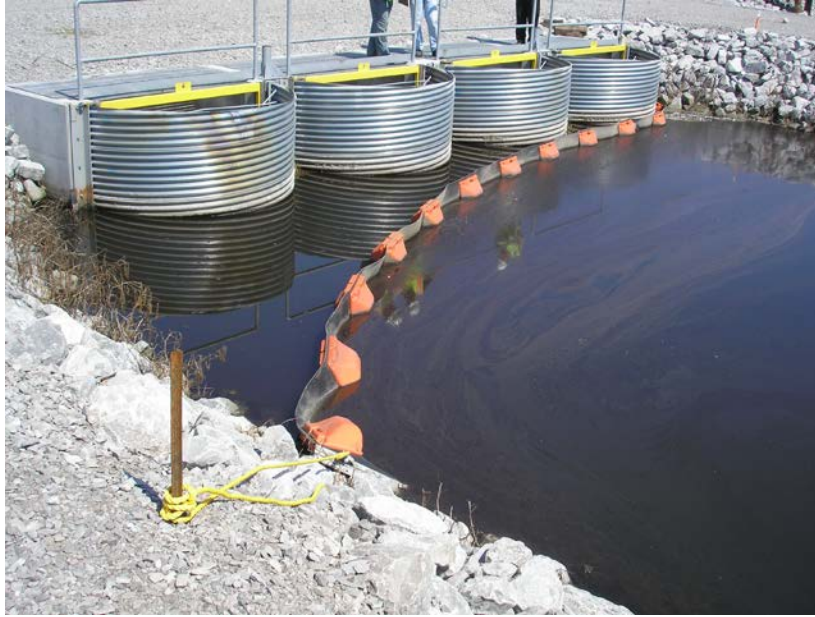
The overflow spillway is a concrete structure with four cells about 8-feet by 4-feet in plan dimension. A 96-inch diameter corrugated metal half-pipe skimmer is attached to each spillway inlet. Photograph 5.4.1-1 shows the front of the spillway.

Photograph 5.4.1-1 Ash Pond 4 Spillway Structure.

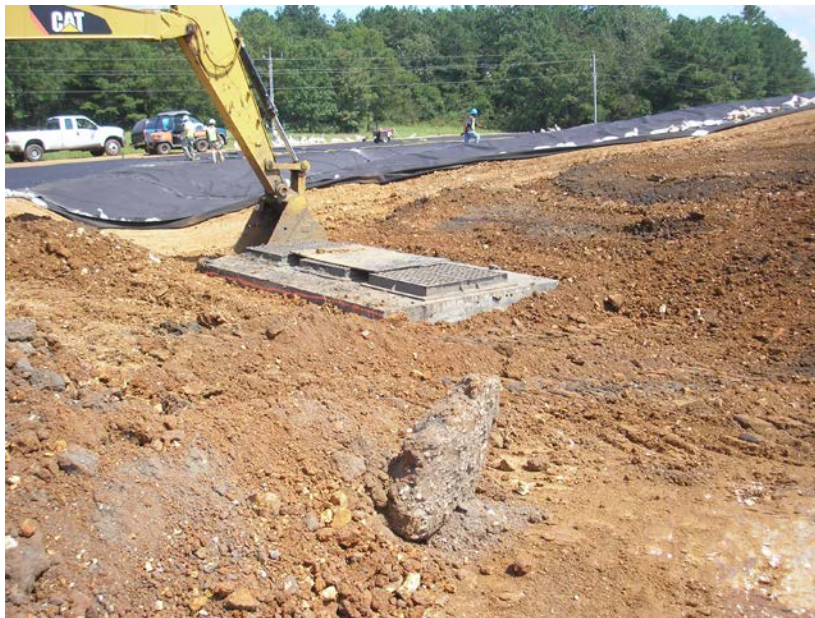
Surface runoff from the Disposal Area 5 ash stack is captured by a perimeter ditch located inside the impounding embankment crest. The ditch conveys water to a drop inlet that discharges through pipes in the northeast groin area into the Drainage Basin. Internal drainage is also directed to the perimeter drain. Photograph 5.4.1-2 shows the ditch and inlet structure under construction.

Photograph 5.4.1-2: Ash Stack Drainage System Outlet to Disposal Area 5 Drainage Basin

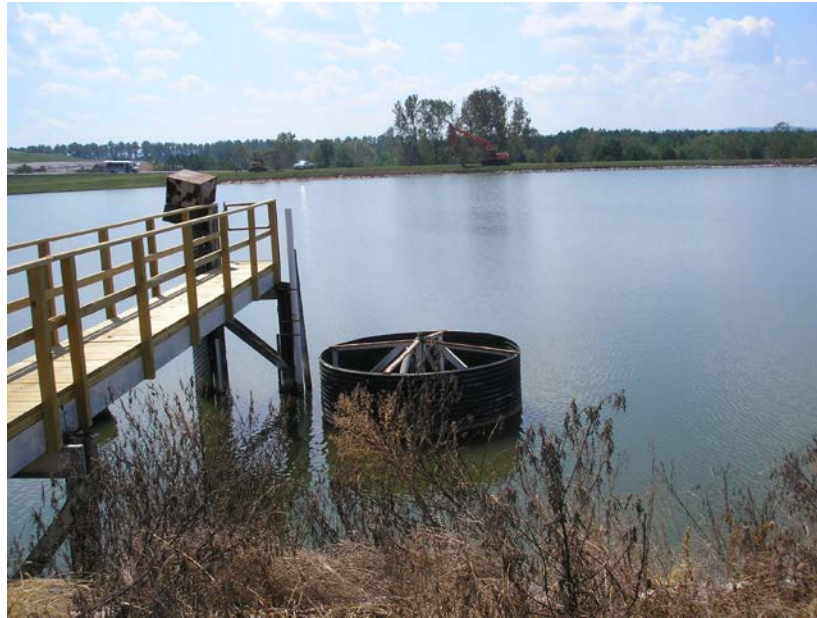
The overflow structure in the Drainage Basin consists of a 48-inch diameter reinforced concrete riser with a corrugated metal skimmer and trash rack. Photograph 5.4.1-3 shows the riser structure.

Figure 5.4.1-3: Ash Pond 5 Drainage Basin Rise Spillway

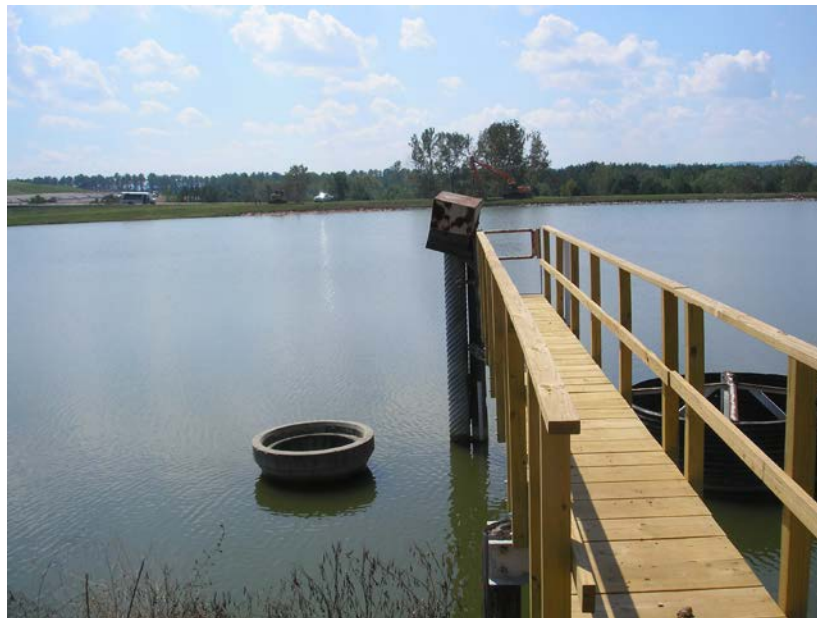
There is a second (inactive) reinforced concrete riser pipe in the Disposal Area 5 Drainage Basin. The elevation of the pipe is above the primary spillway. Photograph 5.4.1-4 shows the second riser pipe.

Photograph 5.4.1-4: Ash Pond 5 Drainage Basin Inactive Riser

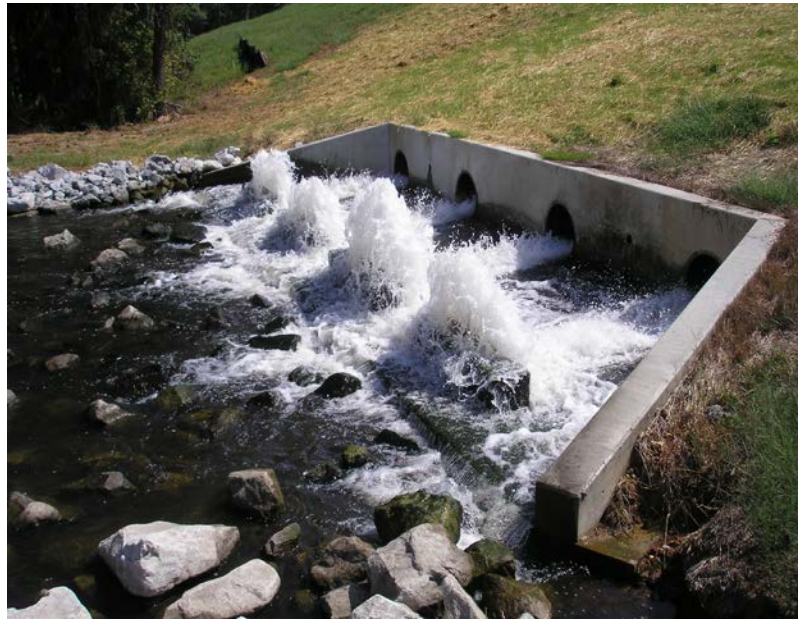
The Ash Pond 4 spillway outlet is four 27-inch diameter HDPE pipes through the west embankment to a reinforced concrete headwall structure. The headwall structure is shown in Photograph 5.4.2-1.

Photograph 5.4.2-1: Ash Pond 4 Spillway Conduits and Outlet Structure

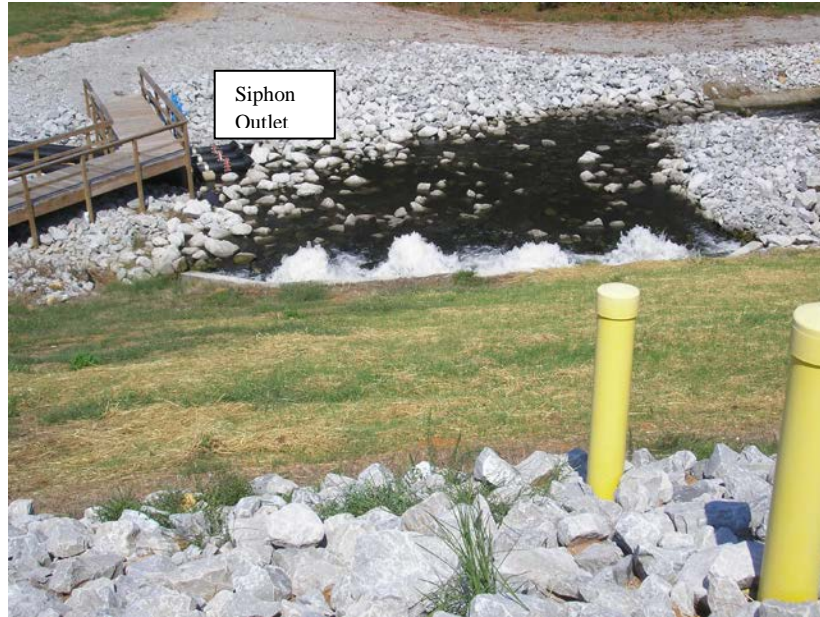
The siphon system discharges into the same drainage channel a short distance downstream from the spillway headwall structure. Photograph 5.3.2-1 shows the drainage channel and the siphon pipe outlet conduits.

Photograph 5.4.2-2: Spillway Discharge Channel. Outlet End of Siphon Pipes to Right of Walkway in top Left Portion of Photograph.

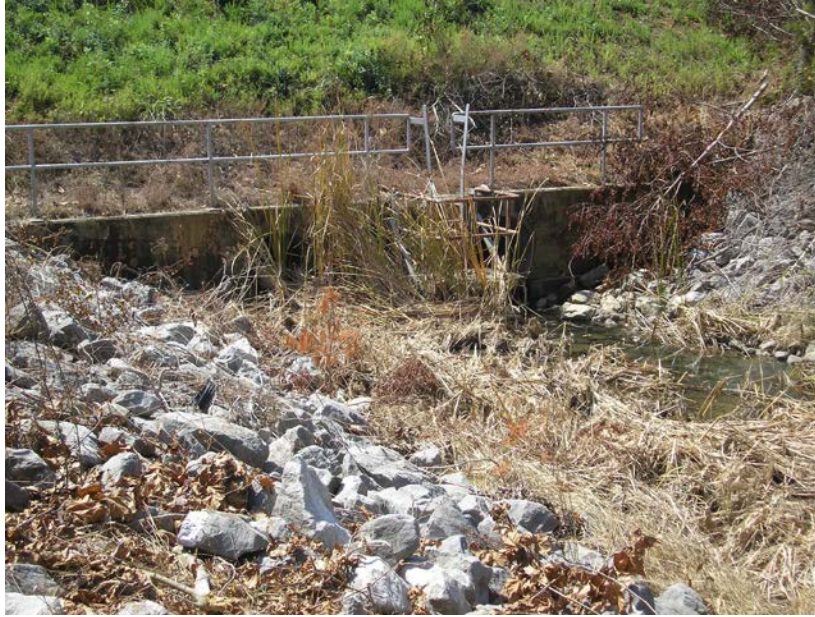
At the time of Dewberry's site visit the Drainage Basin pool level was below the riser and no water was entering the spillway. No water was observed exiting the outlet pipe. The area around the outlet headwall was overgrown with weeds that obscured observation of the outlet and may reduce outlet flow capacity. Photograph 5.4.2-3 shows the Disposal Area 5 Drainage Basin outlet structure.

Photograph 5.4.2-3: Disposal Area 5 Drainage Basin Spillway Structure

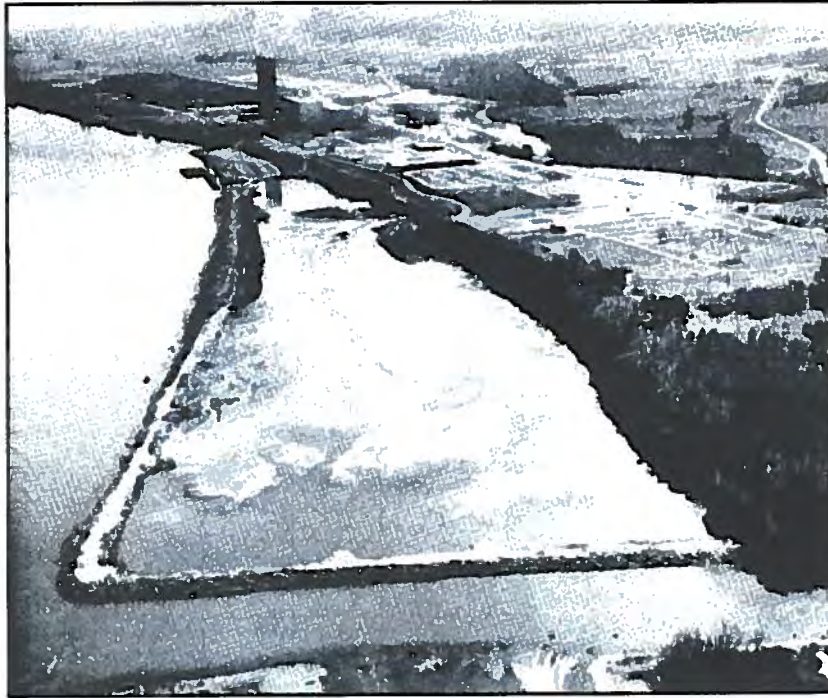
Bottom ash was initially sluiced to an on-site pond to the west of the main plant. The pond is now abandoned (see **Figure 2**).

Figure 2 – Ash Disposal Area 1 at the Colbert Plant

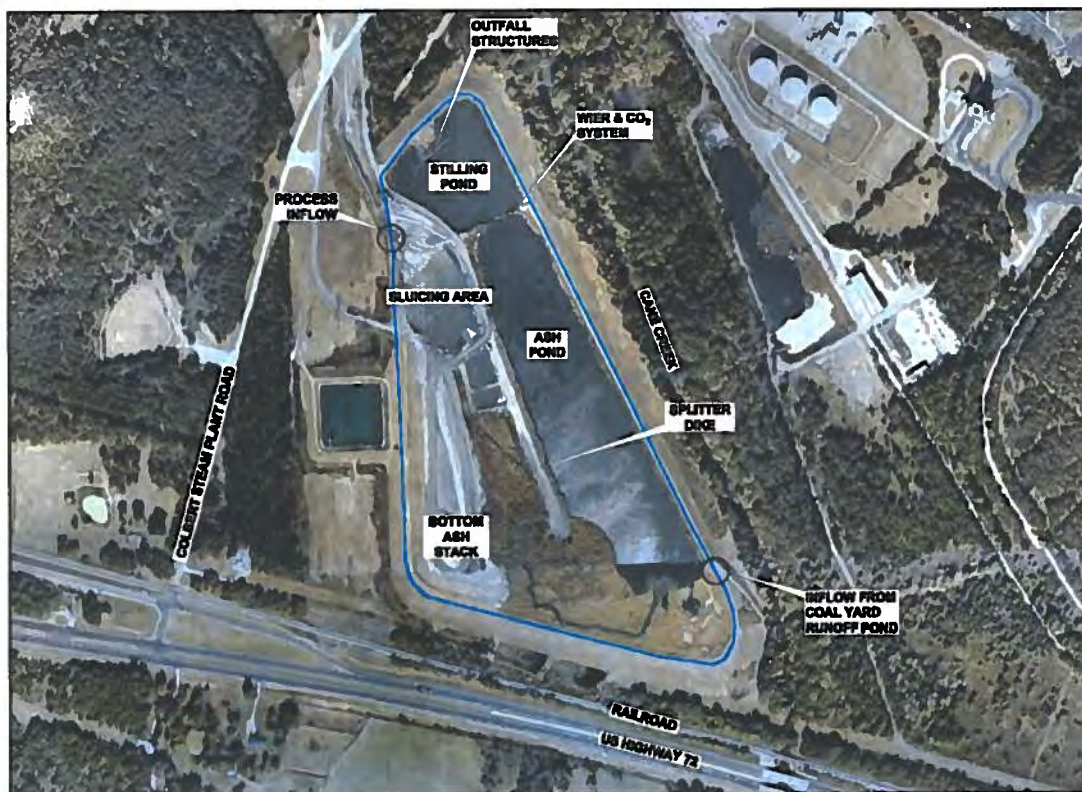
Figure 3 – Wet Operations Aerial Image (North direction to top)

According to the current Long Term Disposal Plan (see **Section 1402**) currently, approximately 27,000 dry tons/year of bottom ash is wet-slucied to Bottom Ash Pond 4, which receives an average of 5.4 million gallons per day (MGD, annualized flow) of ash sluice water.⁽²⁾ Solids settle out as the sluice water moves northward, and the clarified supernatant water is decanted into Stilling Pond 4.

Bottom Ash Pond 4 occupies approximately 52 acres of land south of the power plant site as shown in **Figure 3**. In 1972, the first phase of Bottom Ash Pond 4 was constructed and put into service. Initially it was constructed of nearly 6,700 feet total length, and 20-foot tall clay dikes. In 1984 the dikes were raised 20 feet by upstream construction, wherein clay embankments were raised over previously sluiced ash. From 1982 to 1990, both fly ash and bottom ash were sluiced into Pond 4. After 1990, the pond received only sluiced bottom ash. Dewatered bottom ash is removed and stacked on its west side. This ash stacking operation began in 1999 and remains active.

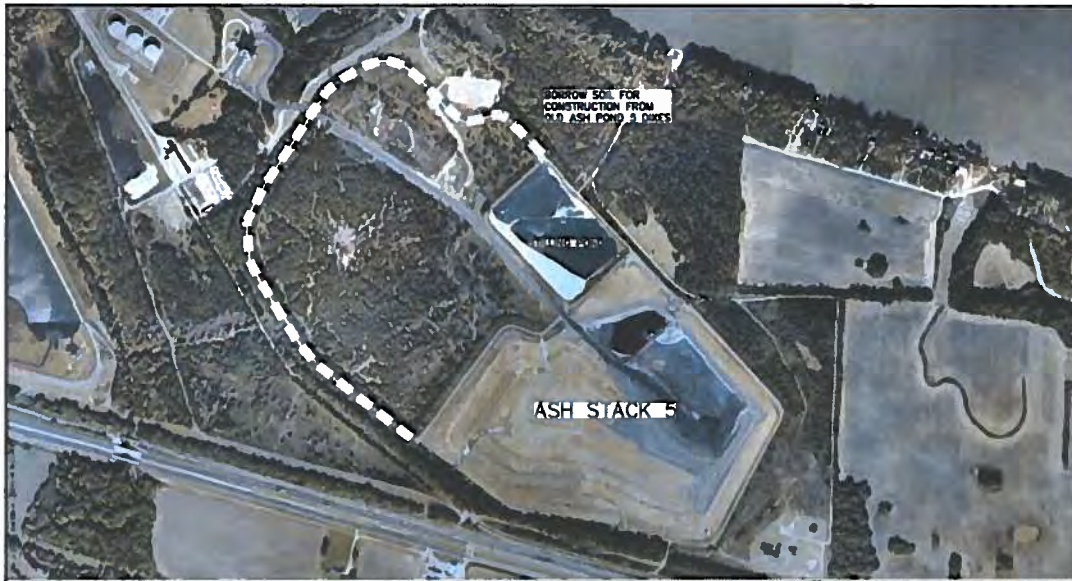
Figure 4 – Ash Disposal Area (Stack) 5 Aerial Image

The interior area was originally used as a dredge cell, receiving dredged ash from Bottom Ash Pond 4 from 1983 to 1990. Sinkholes opened up in 1984, soon after the pond operation began, prompting repairs and eventual cessation of usage.⁽³⁾ In 1990 dredging was stopped and disposal methods were converted to a dry stacking operation. The stack appears fully built out in the south and west portions and currently disposal activity is on the northeast side.

COF generates approximately 251,800 tons/year of dry fly ash that is collected in silos and transferred to an on-site dry ash stack for disposal [Ash Disposal Area (Stack) 5 (see **Figure 4**)]. The active Ash Disposal Area 5 is approximately 75 acres in area and is enclosed by a perimeter dike system that is approximately 7,500 feet in total length and ranges from 10 feet to 30 feet high with side slopes ranging from 1.5H:1V to 2H:1V. Slopes of the dry stack are approximately 3.5H:1V to 4H:1V, with benches located on 20-foot height intervals.

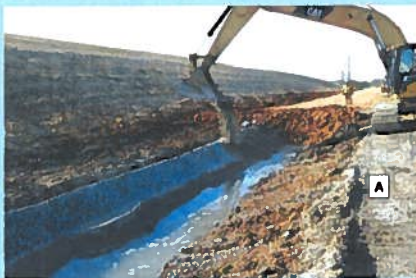
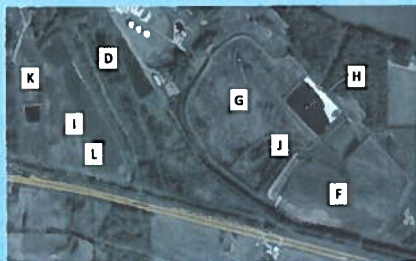
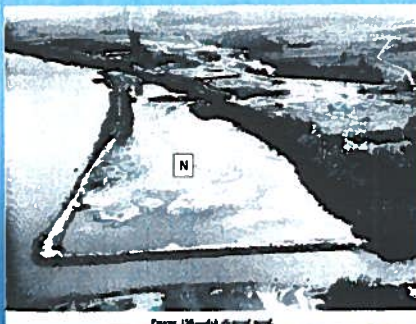
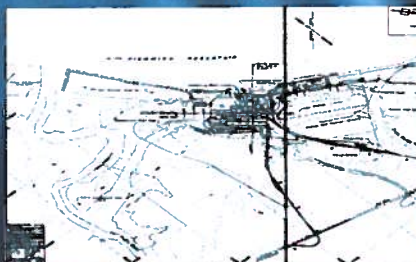
History of Colbert Fossil Plant Coal Combustion Products Disposal Facilities

2010 Existing Conditions

2010 Ash Disposal Area 5 Perimeter Construction

1999 Aerial Photograph

1950's Aerial Photograph

- 2011
2010
2009
- A** In 2010 TVA began Seepage and Drainage Remediation construction, circumnavigating Ash Stack 5 with drainage improvements and buttressing, to mitigate high seepage gradients and increase slope stability safety factors.

- B** Stantec's February 2010 draft geotechnical report for Ash Stack 5 identified excessive seepage gradients in the perimeter ditches and recommended improvements to increase the slope stability safety factors.

- C** During 2010 and 2011 Pond 4 spillways were lowered to drop the normal pool in Pond 4 and the stilling basin from +456 to +453, and the perimeter dike tops were lowered from +460 to +458 to eliminate the "high hazard" categorization.

- D** Stantec's 2010 Ash Pond 4 geotechnical report recommended pond modifications to increase seepage and slope stability safety factors.
 - E** In 2009 TVA classified Ash Pond 4 as a "high hazard" impoundment.

- 1984
1983
- G** Leaks in Pond 5 were noted in July and again in October 1984. 31-acres at the East end of Pond 5, and a 17-acre stilling basin were clay-lined, and dredging to this lined area resumed in 1986 and continued until cells 1 and 2 were filled.

The historical timeline included in **Section 501** provides an overview of the history of the CCP facilities at COF. The timeline provides historical aerial photographs and a description of the major construction events. It also notes any major failures that may have occurred.

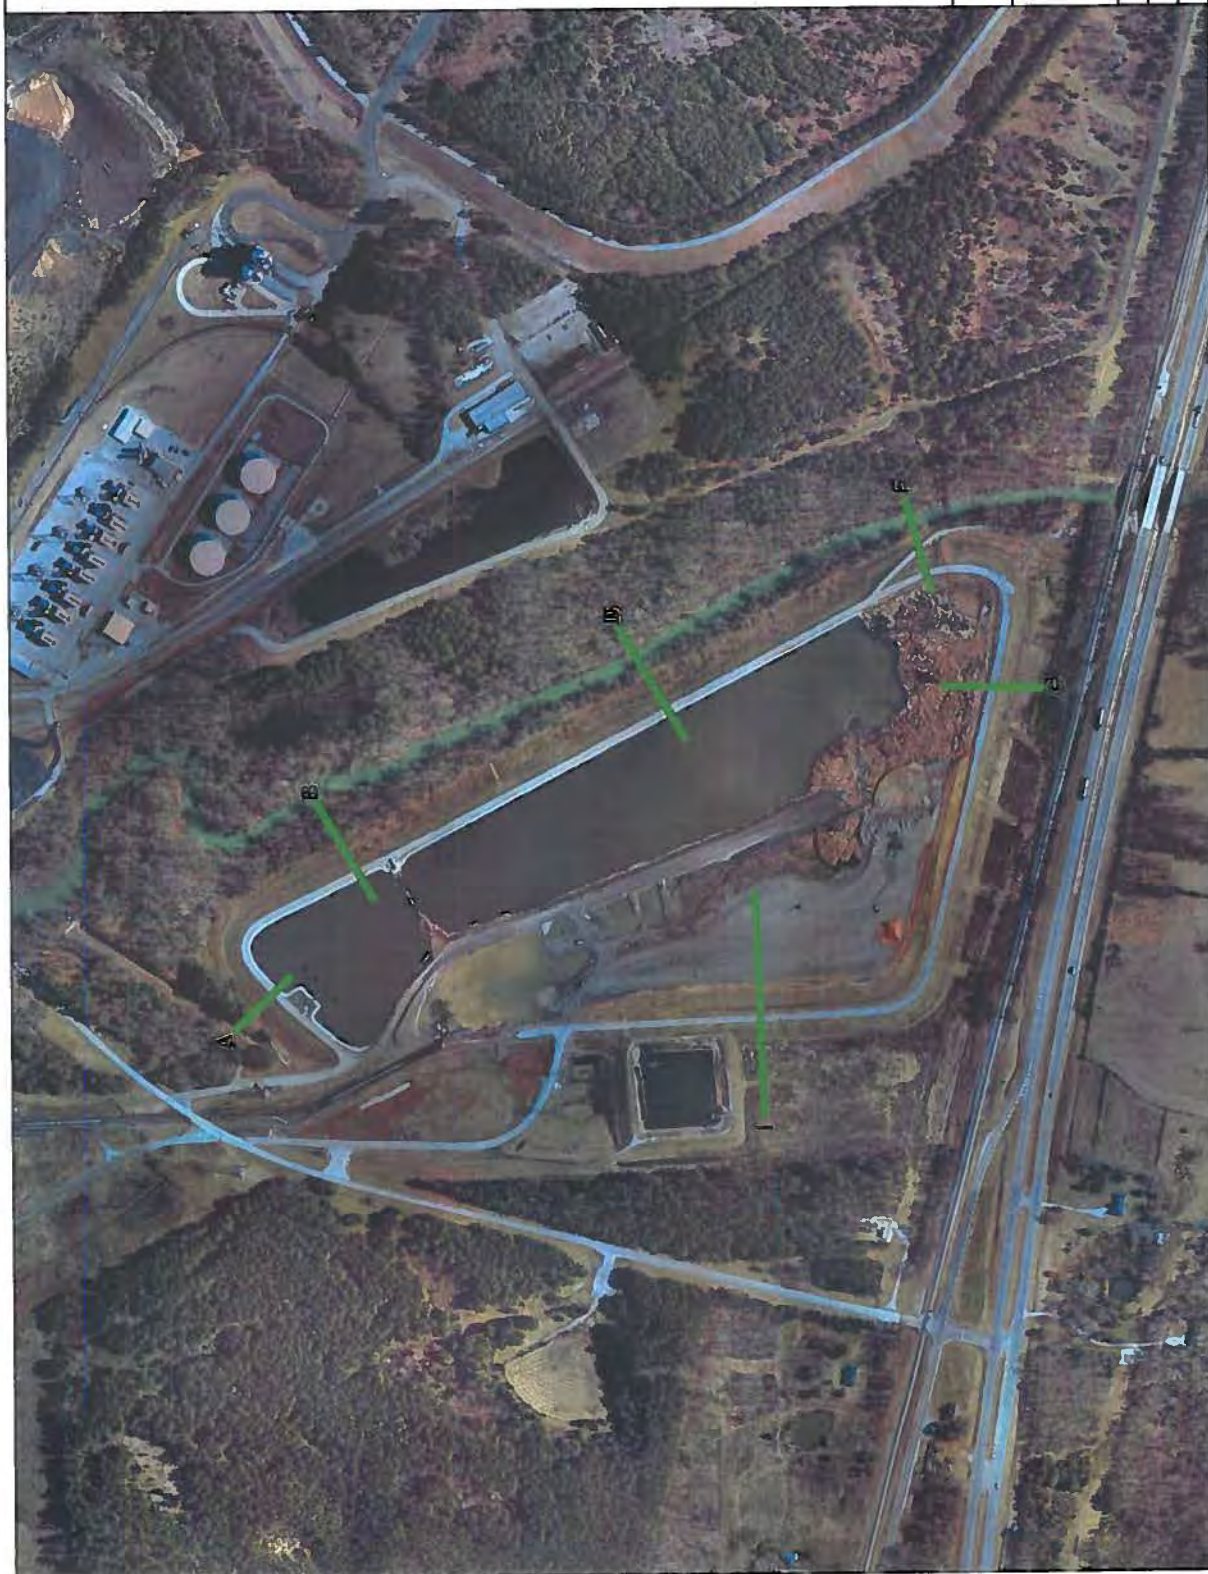
SUMMARY OF STABILITY RESULTS FROM STANTEC GEOTECH REPORT YARD ASH POND 4

A — **Static Factor of Safety (F.S.)
for Slope Stability
F.S. ≥ 1.5**

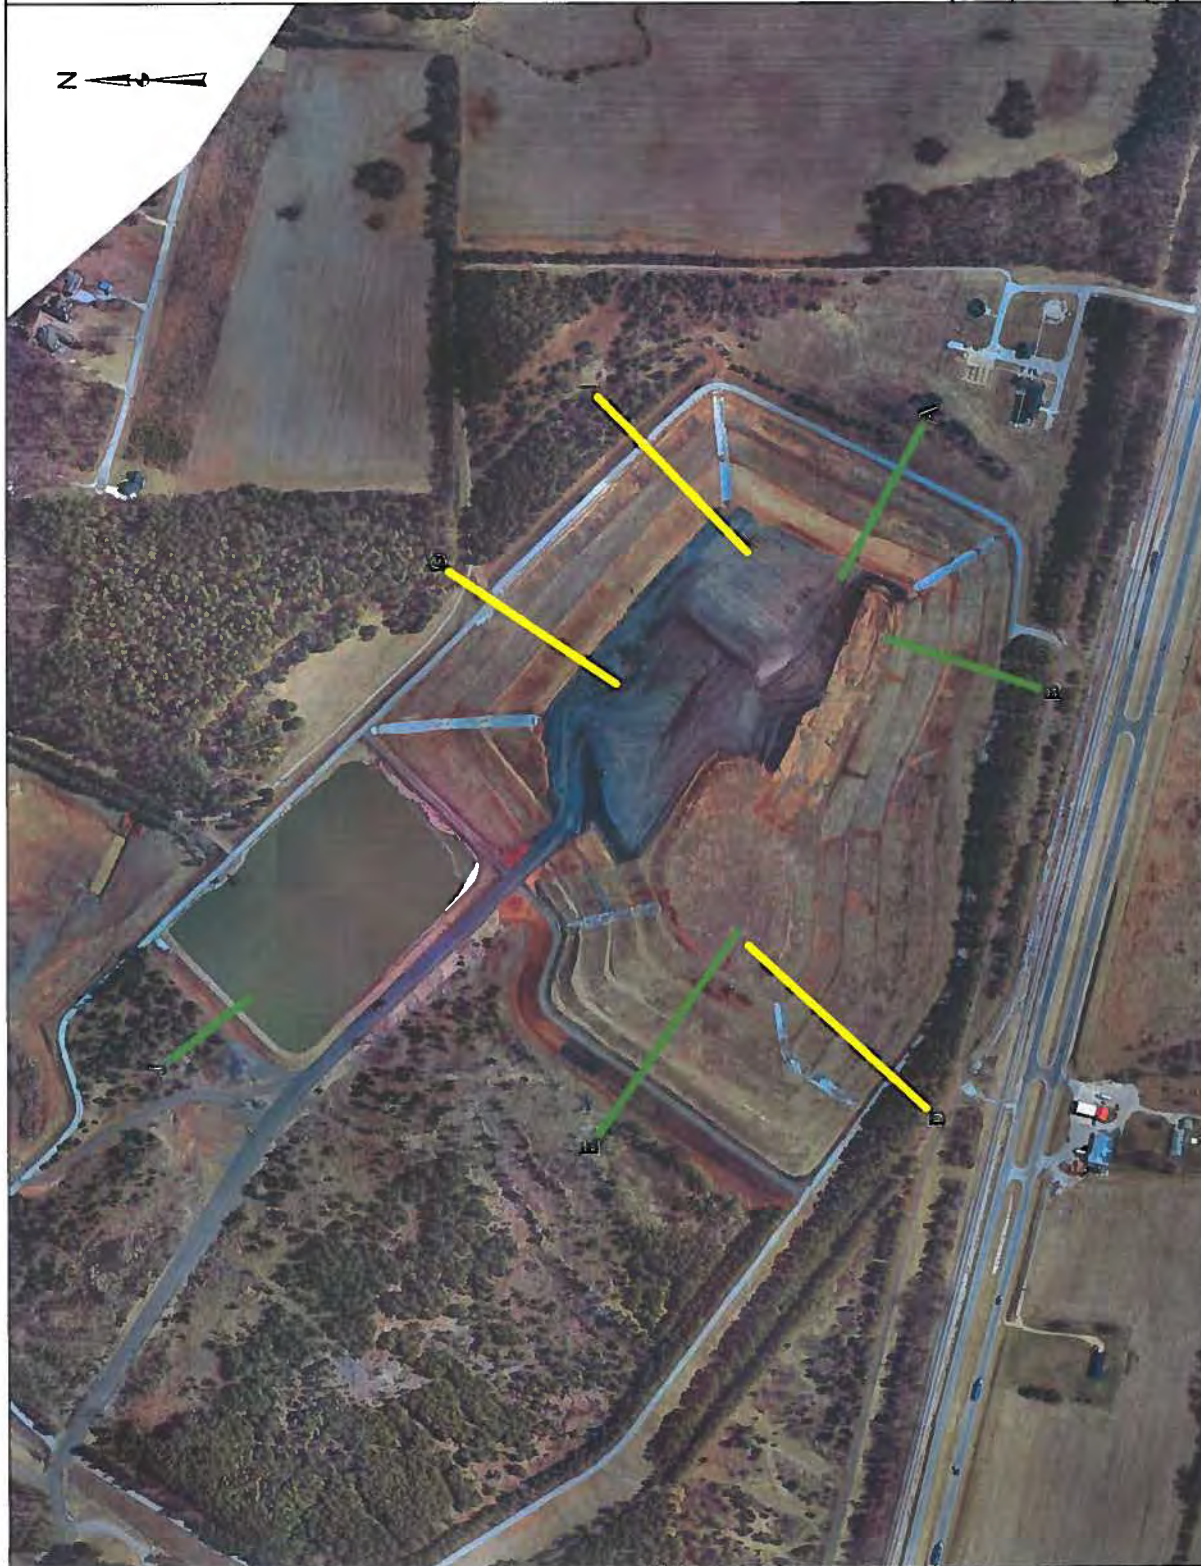
SUMMARY OF STABILITY RESULTS FROM STANTEC GEOTECH REPORT YARD DISPOSAL AREA NO. 5

- A** Static Factor of Safety (F.S.) for Slope Stability (global) $F.S. \geq 1.5$
- A** Static Factor of Safety (F.S.) for Slope Stability (global) $1.3 \leq F.S. < 1.5$
- A** Static Factor of Safety (F.S.) for Slope Stability (global) $F.S. < 1.3$

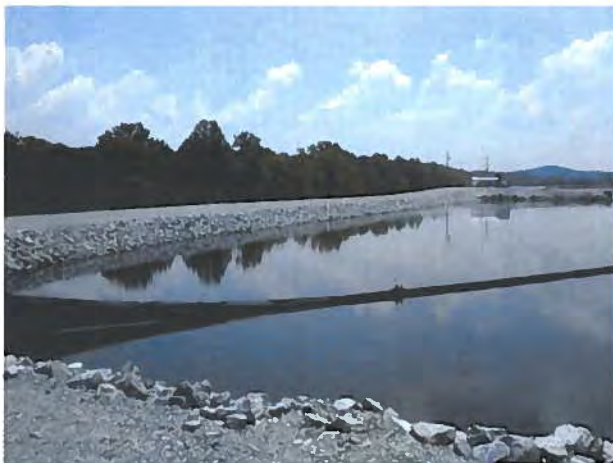
Photo 1

View of interior wave wash protection from northern corner.

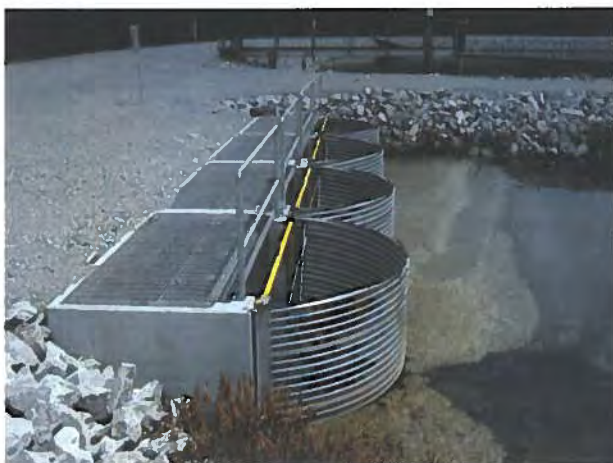
Photo 2

New spillways.
