**Coal Combustion Residue Impoundment
Round 11 - Dam Assessment Report**

Colbert Fossil Plant
Tennessee Valley Authority
Tuscumbia, Alabama

Dewberry & Davis, LLC
Fairfax, Virginia

EP-09W001727
June 2012

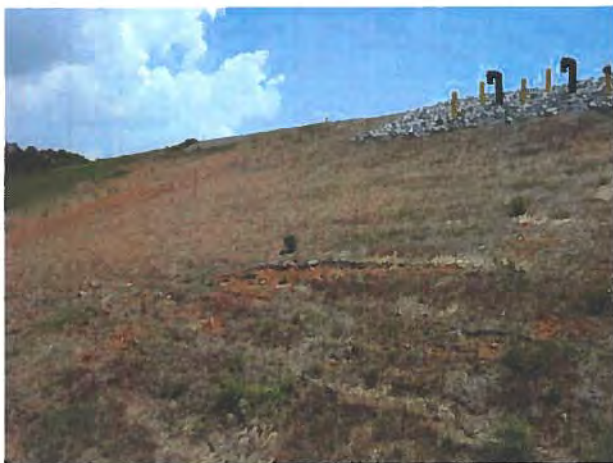
Photo 3

Refilled and regraded dike face over new spillway pipes. Vegetation not yet fully established.

Vegetation:	Grasses, generally good coverage. Vegetation was yet to take root sufficiently where regrading was completed over the new spillways (Photo 3). At the toe of the slope and extending to the bank of Cane Creek, vegetation was thick and overgrown (Photo 9). Vegetation was not yet established at the site of a recent test trench on the south side of the pond (Photo 14). Recent regrading efforts in relation to the chemical pond closure also showed sparse vegetation extending onto the west slope (Photo 21).
Trees:	Two tree stumps were observed near the crest of the exterior slope on the west side of the pond (Photo 22).
Erosion:	Rutting was observed from mowing equipment in and around seepage areas on the east and southeast sides (Photos 6, 8, 13, 17) but no significant erosion gullies and/or rills were observed that appeared to be associated with seepage on the dike slopes. Minor erosion of gravel on the segment of access road that crosses the slope face near the southeast corner (Photo 11) was observed. Some eroded material was deposited on the rock working platform at Seep 4 (Photo 16). One significant erosion gully was noted adjacent to the chemical pond closure on the west side of the dike (Photo 21).

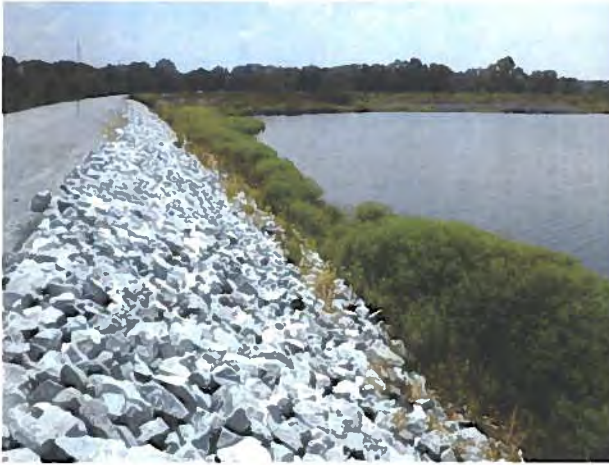
Photo 4

View of vegetation on silted material below wave wash protection approaching the southeast corner.

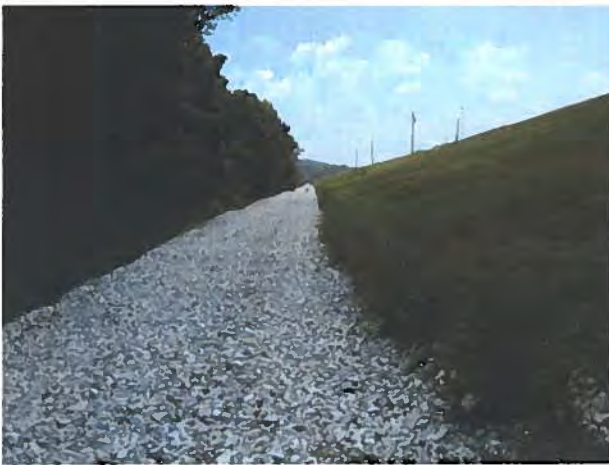
Photo 5

Typical view of good vegetation coverage and rock working platform along east side perimeter dike.

Instabilities:	None observed.
Uniform Appearance:	Yes.
Seepage:	Seepage has been ongoing reportedly since 1984 on the east and south dike slopes and was observed during this inspection as well. Seeps have been labeled 1 through 4 by TVA and are monitored regularly. Flow appears to remain minimal with clear water. Seepage was observed on the slopes (Photos 6, 8, 10, 11, 12, and 16) and at the toe of the perimeter dike (Photos 7, 13, and 17). Previously noted seepage along the bank of Cane Creek was not observed/located on this inspection due to overgrown vegetation.
Benches:	A crushed stone working platform is in place around the east and south sides in preparation for seepage collection construction (Photos 5 and 15).

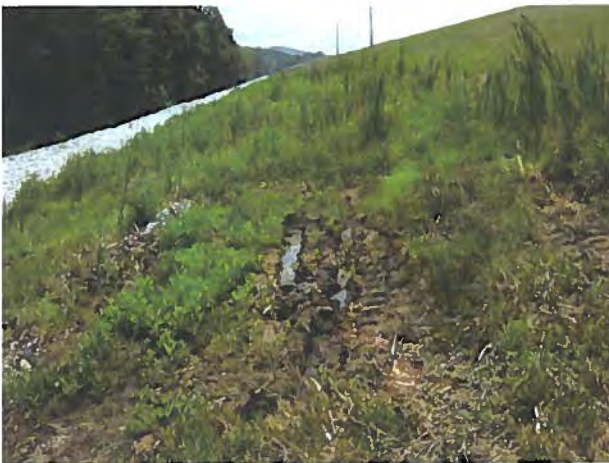
Photo 6

Rutting and standing water at Seep 2.

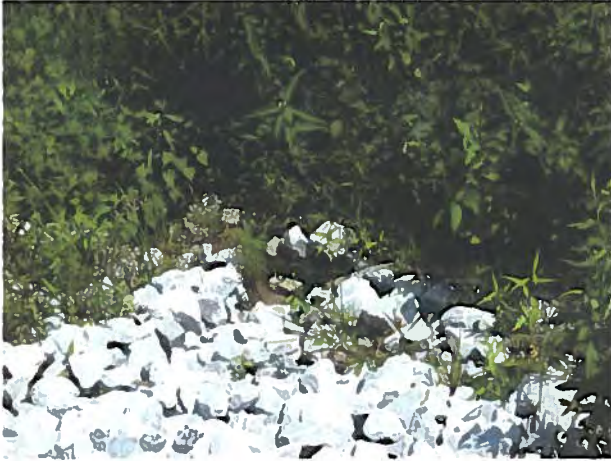
Photo 7

Standing water below the rock platform
downslope of Seep 2.

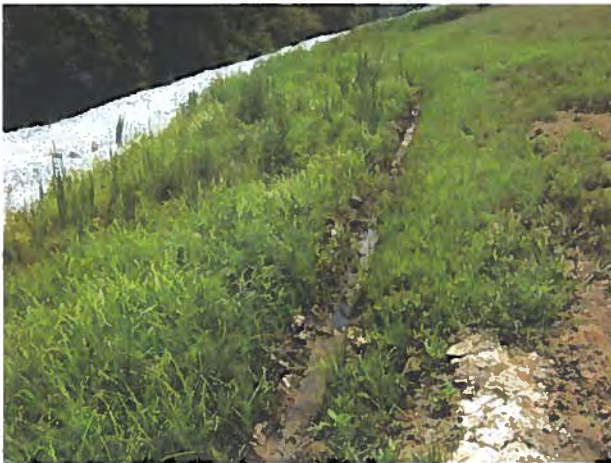
Photo 8

Continued standing water in rutting of Seep
2.

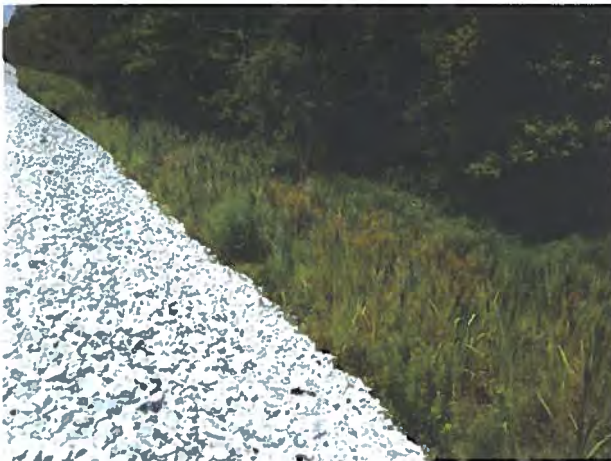
Photo 9

Typical view of overgrown vegetation at toe
of perimeter dike and rock platform along
east side of ash pond.

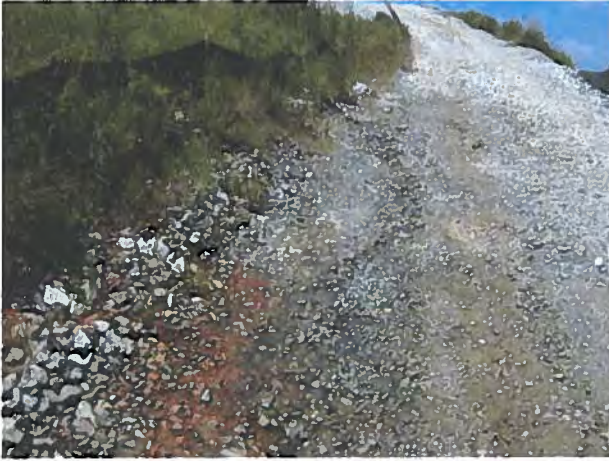
Photo 10

Water from Seep 3 flowing onto access road ditch.

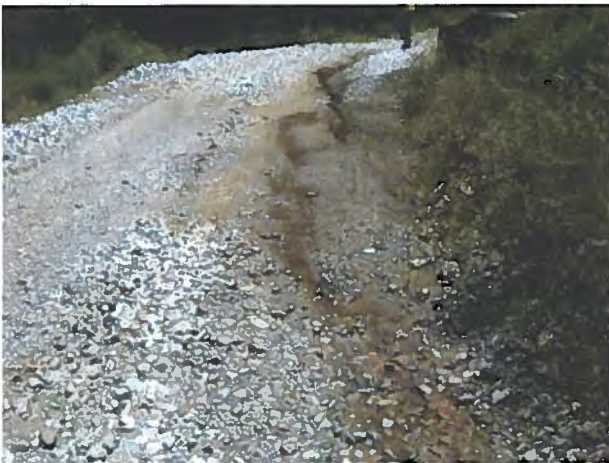
Photo 11

Seepage from Seep 3.

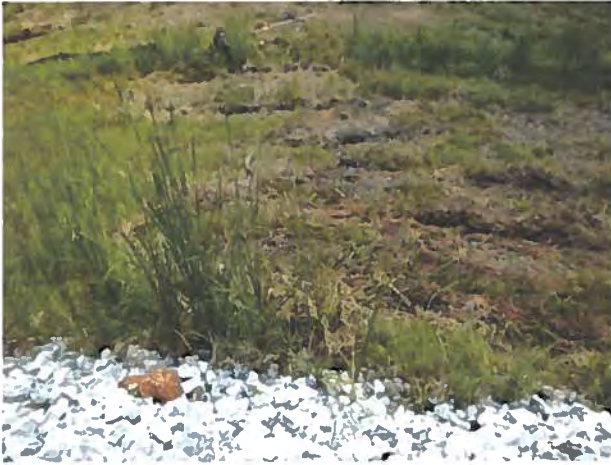
Photo 12

Seepage onto rock platform at southeast corner of dike. TVA survey point #3034.

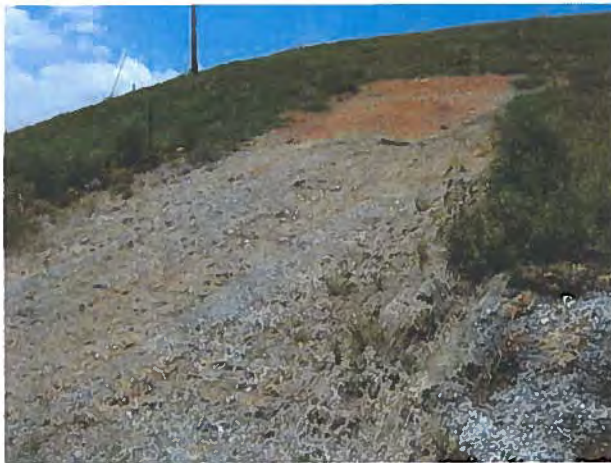
Photo 13

Soft, wet, and rutted ground downslope of seep observed in Photo 12.

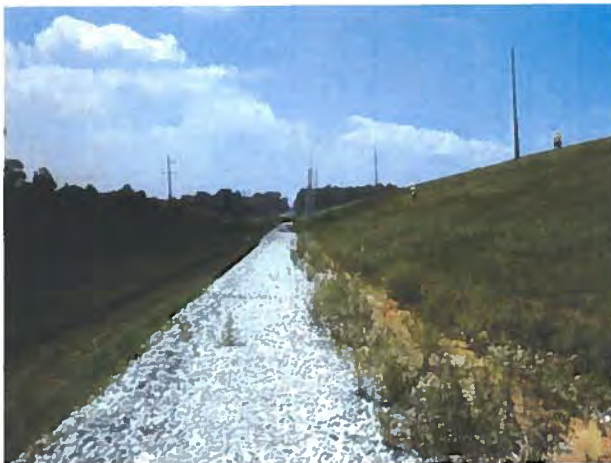
Photo 14

Refilled and regraded site of test dig on southeast corner alongside seep observed in Photo 12. Vegetation not yet established.

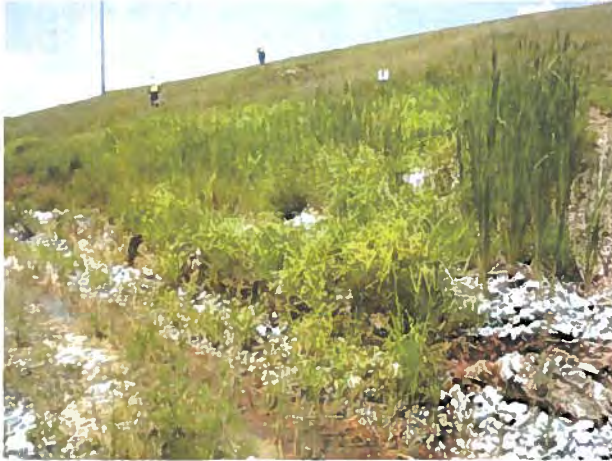
Photo 15

Typical view of rock working platform along south side of ash pond.

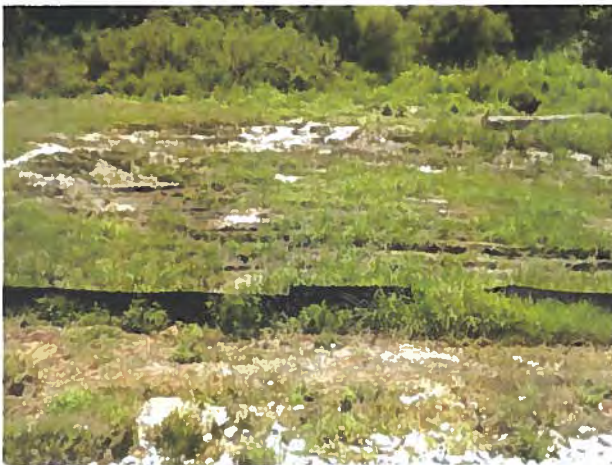
Photo 16
Seep 4.

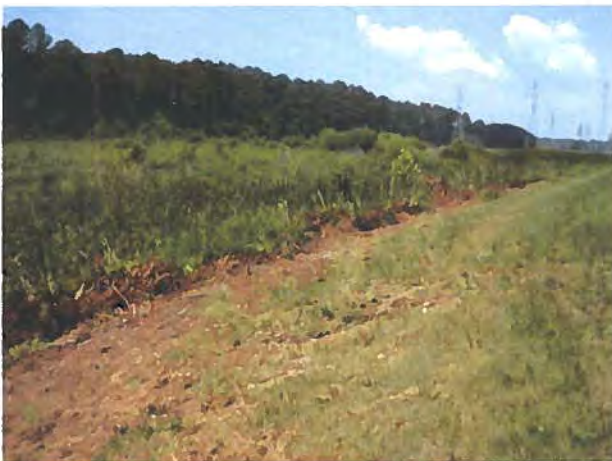
Photo 17
Soft, wet, and rutted ground downslope of
Seep 4 observed in Photo 16.

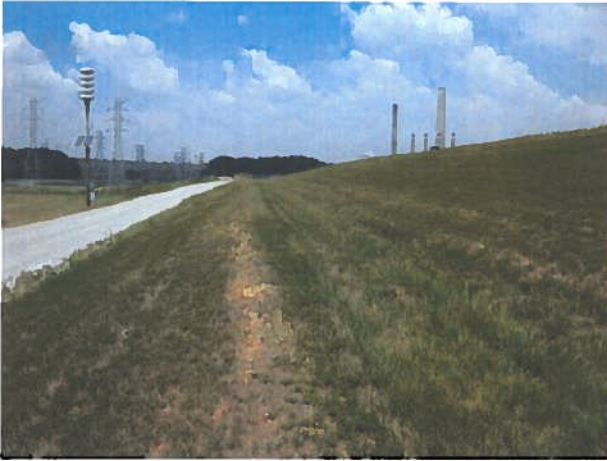
Photo 18
Recently trimmed vegetation along toe at
southwestern edge of perimeter dike.

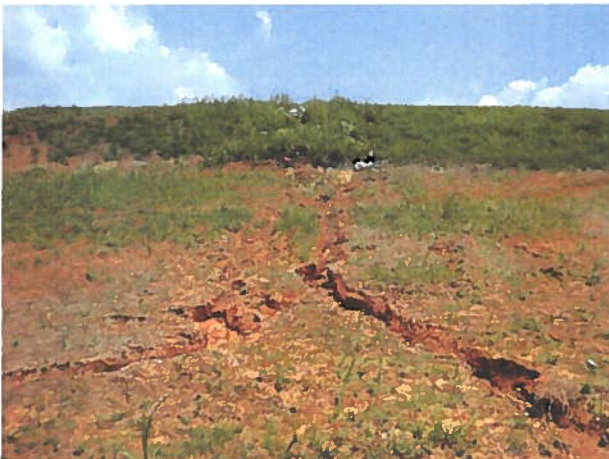
Photo 20

Closed chemical pond.

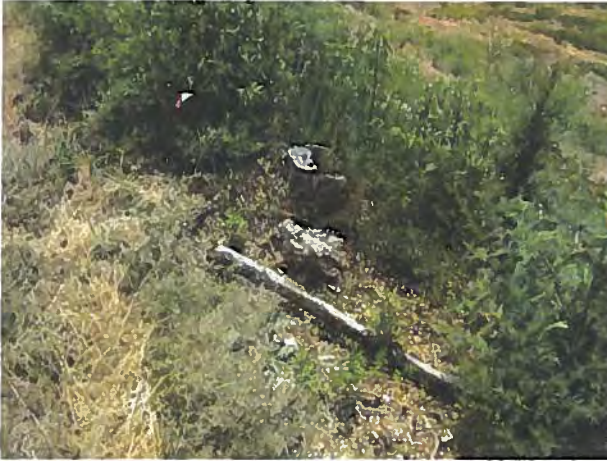
Photo 21

Sparse vegetative coverage and erosion into chemical pond closure from drainage pipe in ash pond dike. TVA survey point #3035.

- It is recommended that a layer of ALDOT Class 2 riprap be placed directly below the outlet end of the drain pipe located along the west dike adjacent to the chemical pond closure area (Photo 21). This pipe crosses beneath the perimeter dike crest and drains surface water onto unprotected soil. Repair of the erosion gullies beyond this pipe should be in accordance with the "General Guidelines for Rill and Gully Erosion Repair at TVA Fossil Plants" document included in Enclosure G. In addition, continued efforts should be made to enhance vegetation coverage at the closed chemical pond area by seeding as needed. (Item 20 and 21 in Enclosure L, Priority 4)

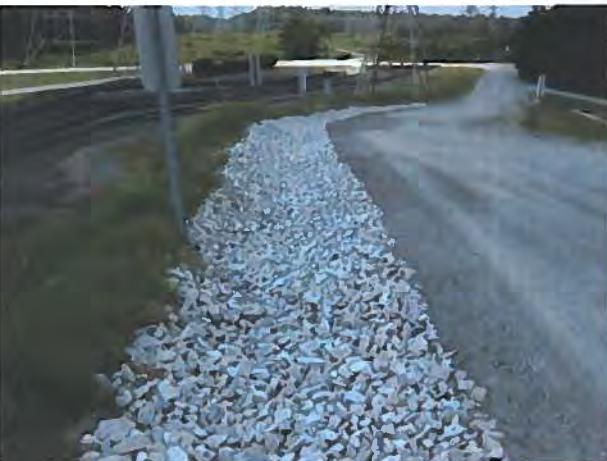
Photo 23

View of dredge pipes being used as
emergency spillway system. Pipes outlet
into spillway drainage channel to the right of
the photo, south and upstream of the main
spillways.

- The dike crests and pool elevation were lowered within the stilling pond to remove the previous high hazard designation.
- A new siphon system was constructed using three 12-inch diameter dredge pipes (torpedo strainer inlets) with float balls tethered to the existing dike within the pond to the south of the new main spillway inlet. The pipes outlet into the stormwater drainage channel just upstream of the main spillway outlets (Photo 23).

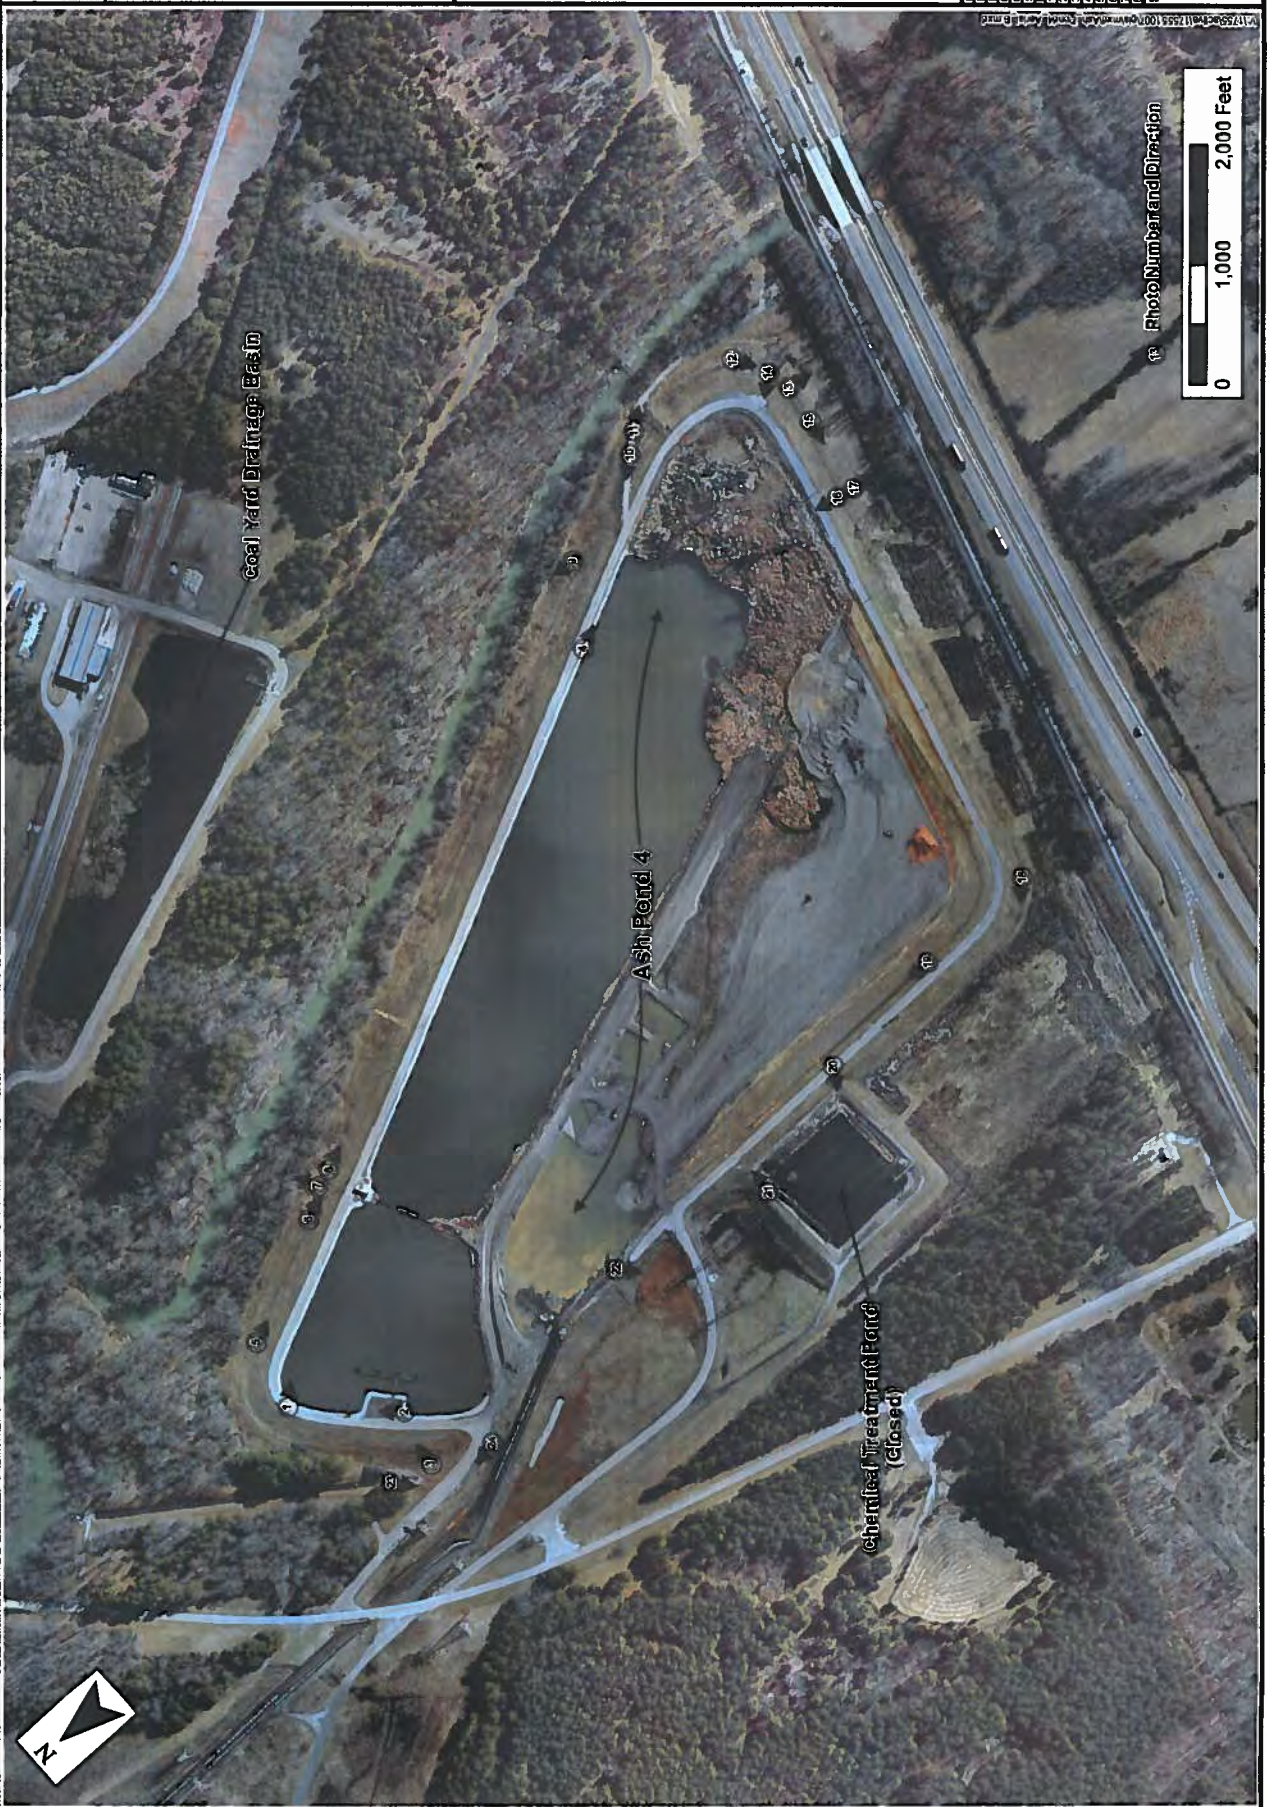
Photo 24

New riprap lined stormwater drainage
channel alongside the access roadway.

- Improvements were made to storm water drainage at the northwest side of the pond by lining the drainage channel alongside the access road with riprap (Photo 24).

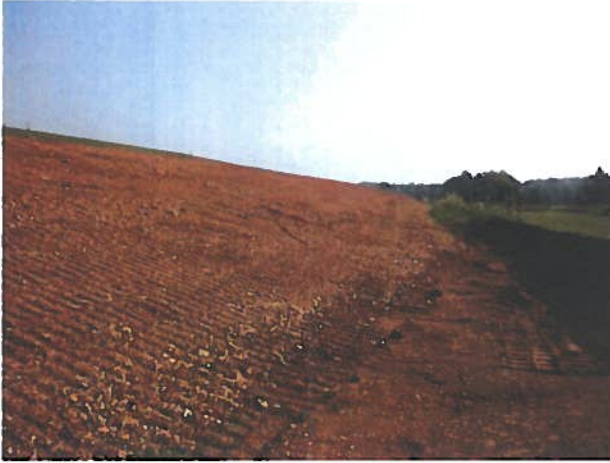
Photo 1

Typical view of southeast slope of perimeter dike, looking northeast (construction ongoing).

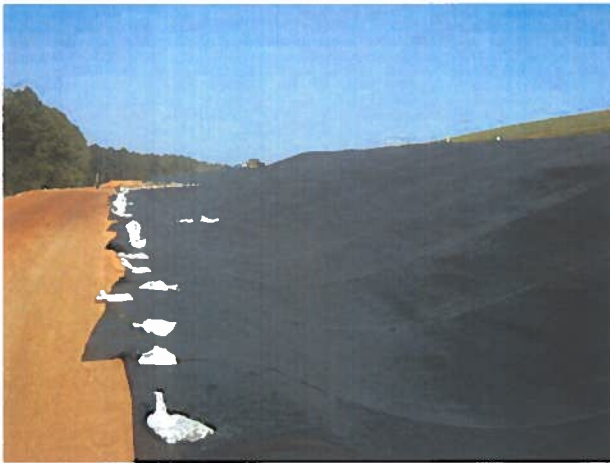
Photo 2

Perimeter ditch improvements construction along south side, looking west.

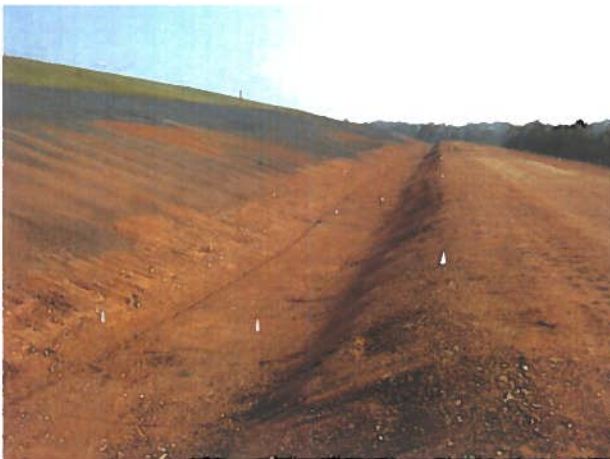
Photo 3

Perimeter ditch regrading along southeast side of stack, looking northeast.

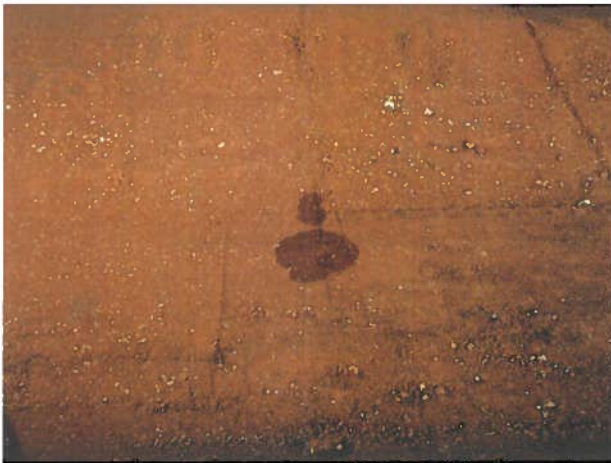
Photo 5

Seepage beginning to appear along perimeter ditch regrading near south/southeast corner. TVA survey point #3016.

Vegetation:	Sparse to no vegetation in down-drains. No vegetation in perimeter ditches under construction.
Rip-Rap Channel Lining:	Riprap protection coverage was generally good in the down-drains.
Erosion:	Down-drain erosion noted at two locations within the east down-drain between the perimeter dike and first bench (Photo 7) and between the second and third benches (Photo 31). Eroded/silted material had covered crushed stone present at the first bench of the north down-drain (Photo 29).
Sedimentation in Ditches:	No sedimentation observed - perimeter ditch improvements under construction at time of this inspection. See Photos 2 and 3 for typical views of ongoing construction.
Standing Water in Ditches or on Benches:	Standing water was observed at a few locations along the northeast and southeast spans of the perimeter ditch (Photos 5, 6, 8, and 9). This appeared to be a result of seepage occurring as construction was ongoing.

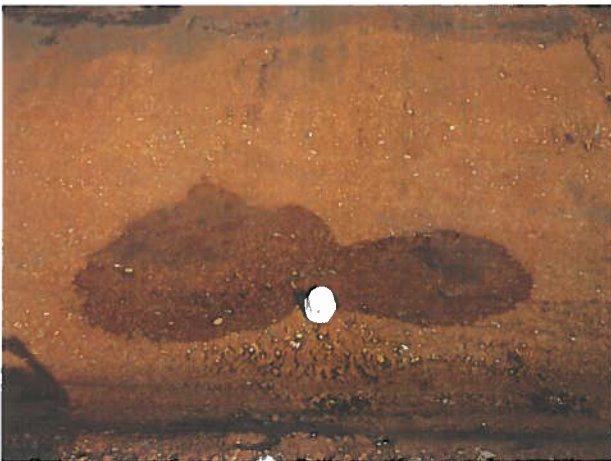
Photo 6

Seepage beginning to appear along perimeter ditch near south/southeast corner.

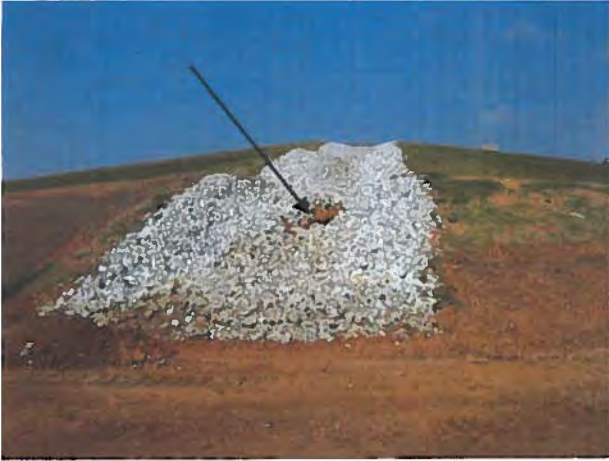
Photo 7

Slough and erosion in down drain at northeastern corner between perimeter dike and first bench. TVA survey point #3019.

- Erosion gullies and/or eroded material were noted in the riprap down-drains at the northeast corner (Photos 7, 29, and 31). It is recommended that the erosion be repaired by cleaning sedimentation and placing new ALDOT Class 2 riprap to re-establish coverage. (Items 31, 55, and 57 of Enclosure L, Priority 4)

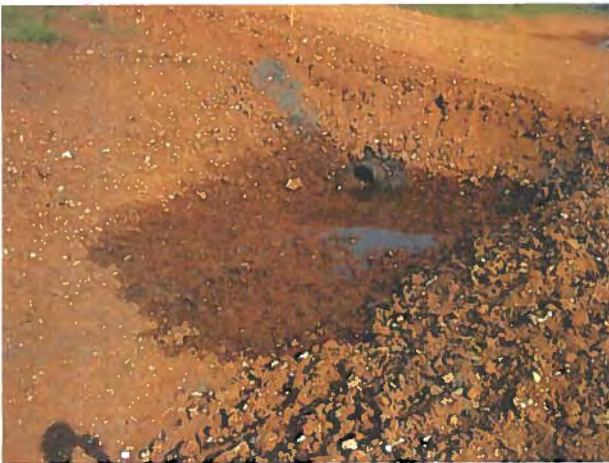
Photo 8

Seepage collection along perimeter ditch underneath construction road near northeast corner.

Silted/Impeded Drainage Pipes:	None observed, although reportedly some areas of the perimeter ditch regrading had been overfilled by the contractor which impeded drainage (Photo 8).
Other:	Seepage boils which had been noted in the perimeter ditch in past inspections were not observed during this inspection. Construction to mitigate this issue was ongoing at the time of inspection. Some seepage was observed within the perimeter ditch along the northeast and southeast areas, as described above.

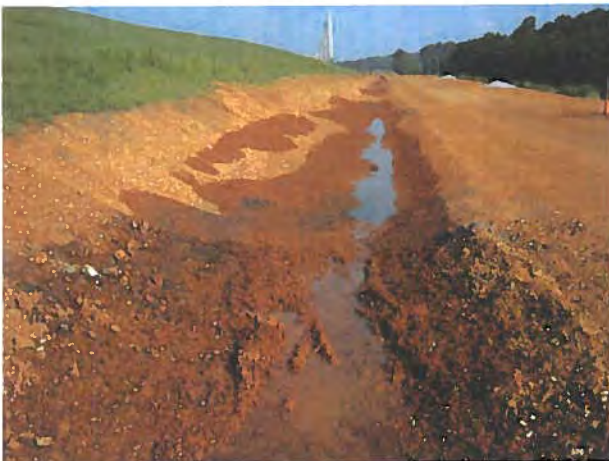
Photo 9

Seeps continuing within perimeter ditch along northeast side of stack. TVA survey point #3018.

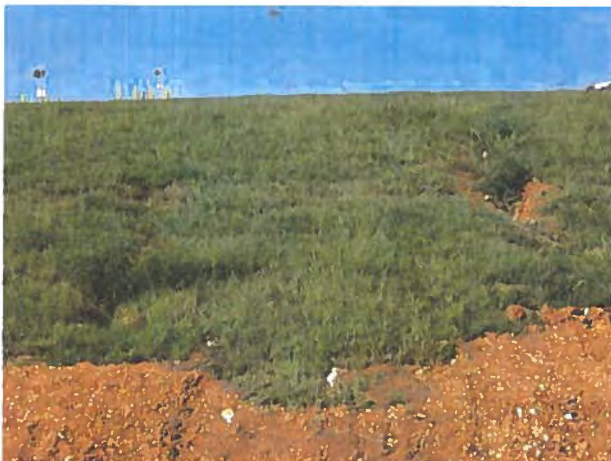
Photo 10

Erosion rills below first bench along northeast side of stack. TVA survey point #3017

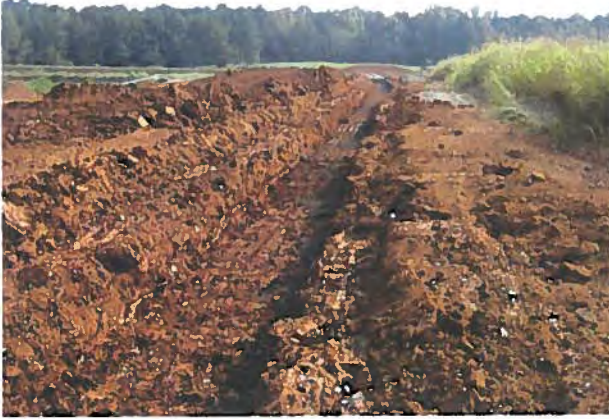
Photo 13

Perimeter ditch regrading/excavation underway on northwest side of stack alongside drainage basin.

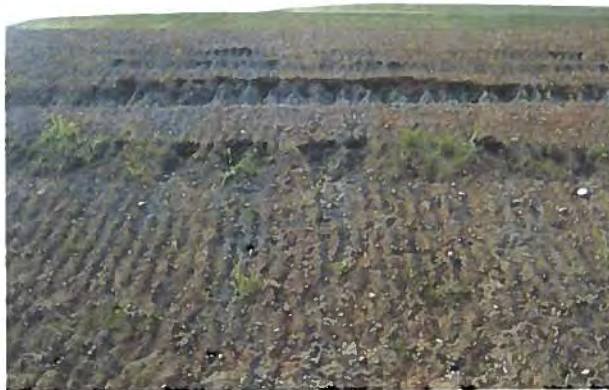
Photo 15

More extensive erosion gullies on northwest side of stack above perimeter ditch (construction ongoing). TVA survey point #3023.

Trees:	None observed.
Erosion:	Numerous areas of erosion were observed. Erosion rills and gullies were especially prevalent in the "bend" area extending from the perimeter dike up to the first bench south of the main haul road (Photos 14 through 19). Other instances of erosion were noted on the northern corner of the first bench (Photos 28 and 29) and on the second bench near the southeast down-drain (Photo 32).
Instabilities:	None observed.
Uniform Appearance	Yes.
Benches:	Yes, on approximate 20-foot foot height intervals, approximately 25 feet wide and sloped toward the stack.
Slope:	Approximately 2H:1V for perimeter dike; approximately 3H:1V to 4H:1V for dry stack slopes (as measured in 2009 TVA survey used for Stantec geotechnical evaluation).
Height:	Approximately 120 ft. (from top to toe of perimeter dike).
Other:	During this inspection, seepage areas were observed near the toe of the perimeter dike along the west side of the stack approaching the southwest corner (Photos 19, 20, and 21). TVA personnel reported that this area has exhibited seepage and wet ground conditions for some time. The area exhibited wet ground conditions and no discernable flow was detected.

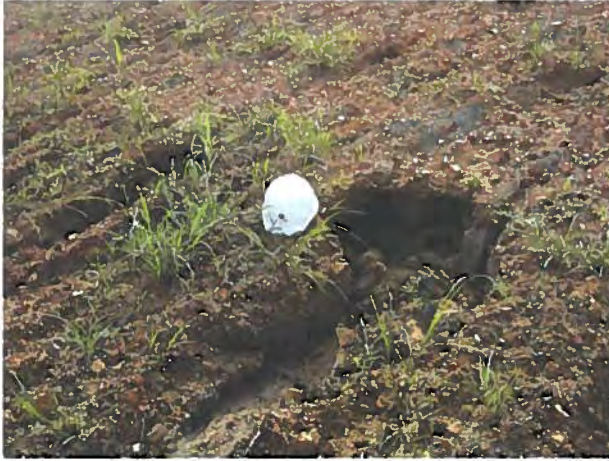
Photo 16

Close-up of erosion gullies from Photo 15.

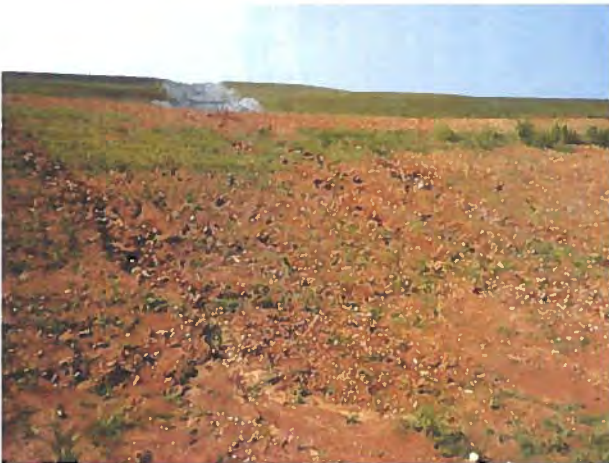
Photo 17

Typical sparse vegetation and erosion gullies along slopes of perimeter dike, northwest side of stack. TVA survey point #3022.

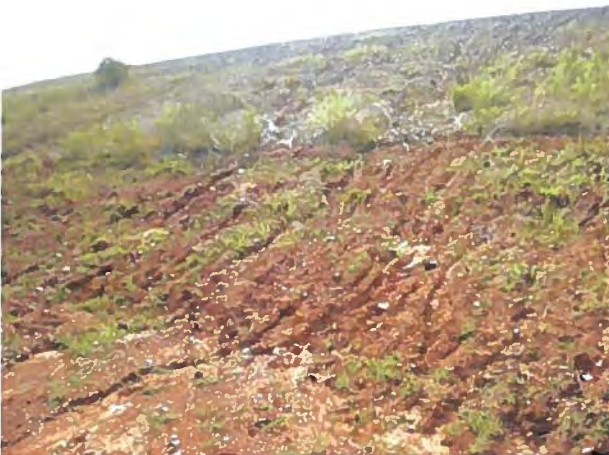
Photo 18

Additional erosion rills and sparse vegetation on perimeter dike along northwest side of stack.

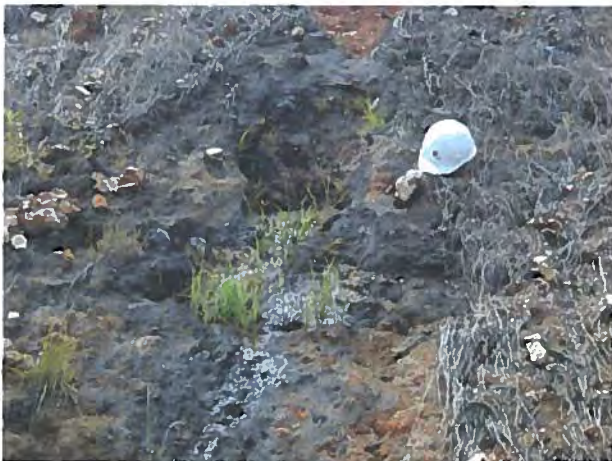
Photo 19

Seepage and erosion of perimeter dike near southwest corner. TVA survey point #3027.

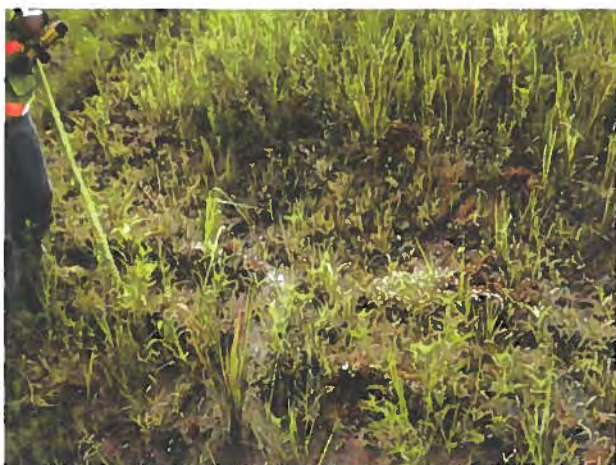
Photo 20

"Start point" of seepage observed at toe of perimeter dike on northwest side. Minimal flow with clear water noted. TVA survey point #3024.

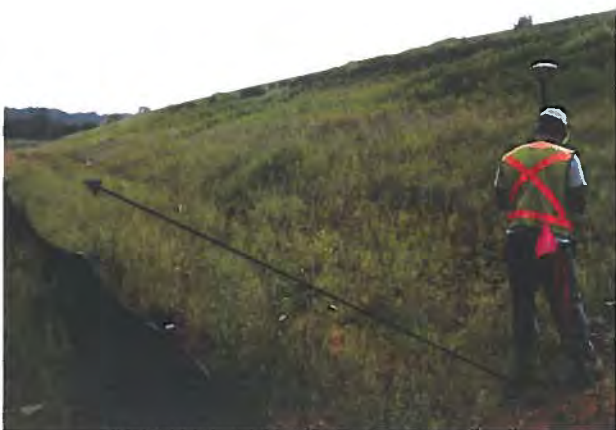
Photo 21

"End point" of seep beginning in Photo 20, approximately 91 feet southwest. TVA survey point #3025.

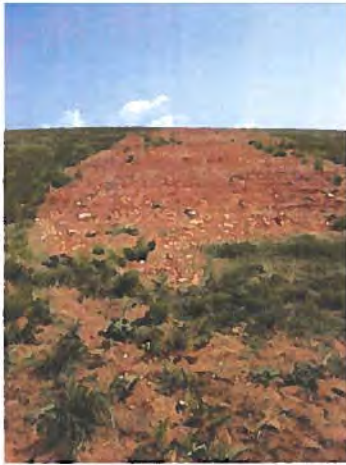
Photo 25

Previous erosion repair area, vegetation not yet established. TVA survey point #3029.

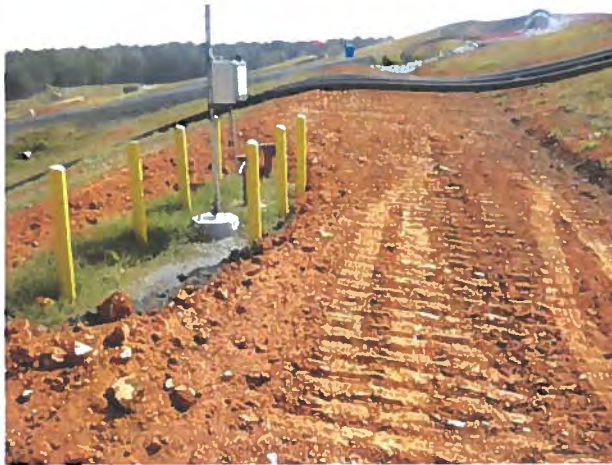
Photo 26

Regrading and fill material observed around boring STN-117A on second bench (construction ongoing).

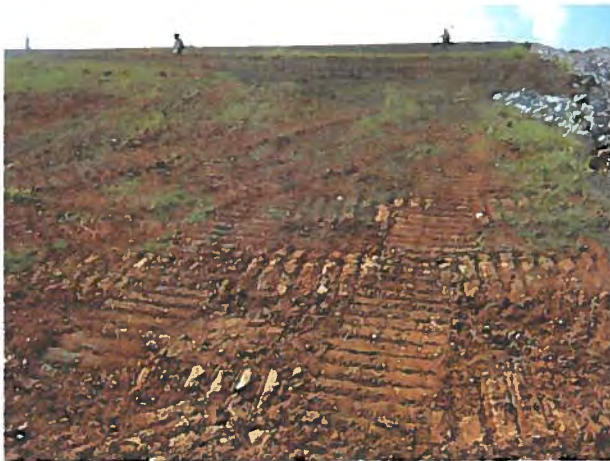
Photo 27

Sparse to no vegetation alongside down drain on northwest side of stack between first and second benches (construction ongoing). TVA survey point #3030.

Vegetation:	Thick grasses/brush in areas that have not yet been subject to regrading during current construction, including the northeast perimeter dike (Photo 4) and south perimeter dike (Photo 22). Other areas of the perimeter dike lacked vegetation coverage at the time of this inspection due to ongoing construction, including the southeast area (Photo 1). The west side of the perimeter dike generally exhibited poor coverage (Photos 17 and 18), particularly in the bend just south of the main haul road. This area of poor coverage extended up the stack (Photos 14 and 15). Grass coverage was generally fair extending farther south along the west perimeter dike (Photo 21). Above the perimeter dike, grass coverage was generally good in most areas (Photos 11 and 24). Areas of sparse to poor coverage were noted sporadically across the stack slopes and benches in other areas (Photos 12, 23, 25, 27, and 30 for typical examples).

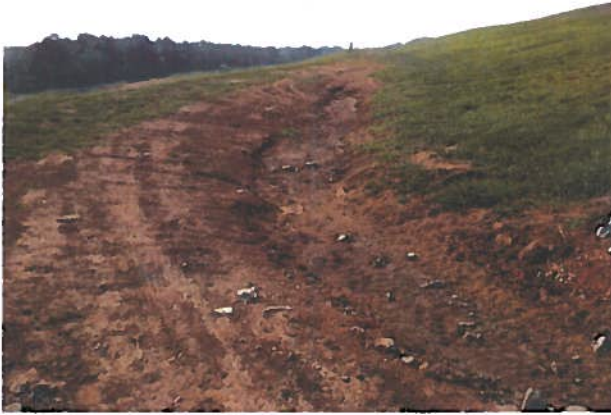
Photo 28

Bare soil and erosion on first bench approaching northern downdrain. TVA survey point #3020.

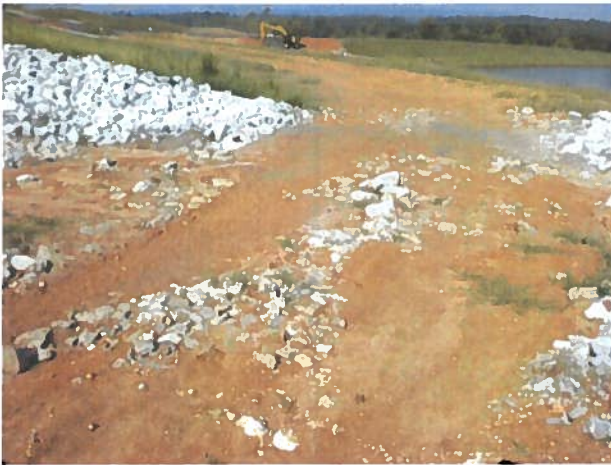
Photo 29

Eroded material from Photo 28 in downdrain and lack of rock coverage on first bench. Adjacent to TVA point #3020.

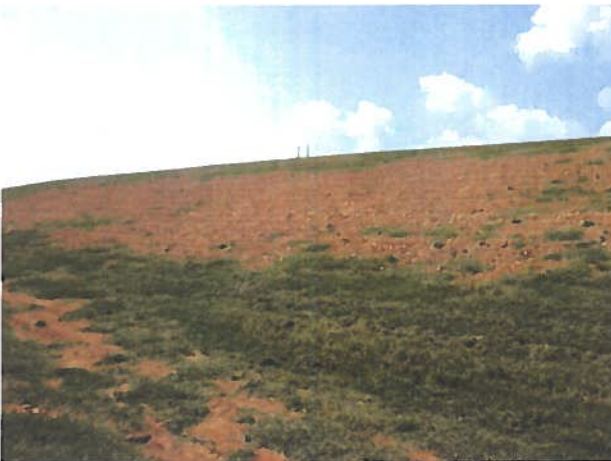
Photo 30

Large area of previous erosion repair between second and third benches on northeast side of stack; vegetation not yet established. TVA survey point #3032.

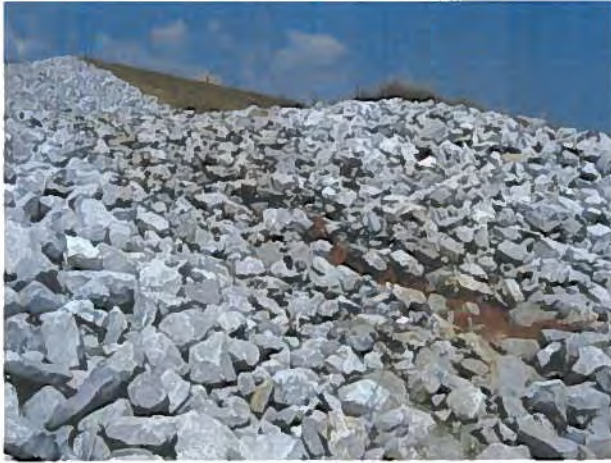
Photo 31

Localized erosion in downdrain on northeast corner between first and second benches. TVA survey point #3033.

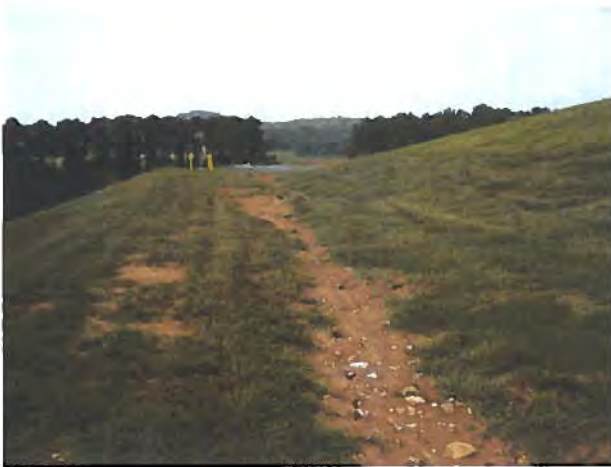
Photo 32

Erosion on second bench near southeast downdrain. TVA survey point #3034.

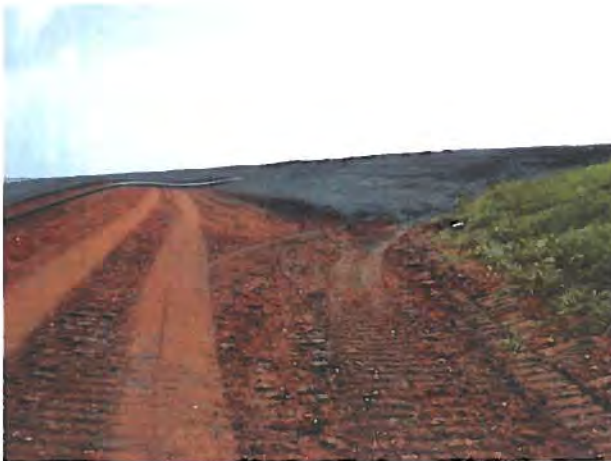
Photo 33

Recent ash placement at top of stack. View from fourth bench on northwestern side. Note pipes from new stormwater drainage system in background.

- A stormwater drainage system has been constructed in addition to regrading efforts at the top of the stack in the active staking area prior to the 2010 inspections. This system consists of three pipes held in place atop the stack with riprap which discharge into the perimeter ditch just south of the main haul road (Photos 34 and 35).
- Previous areas of erosion observed during the 2010 inspections have been mitigated, but vegetation coverage is still lacking (Photos 25 and 30).
- A new inlet structure to the Area 5 Drainage Basin has been constructed and improvements are underway to the drainage ditch leading to the inlet box.

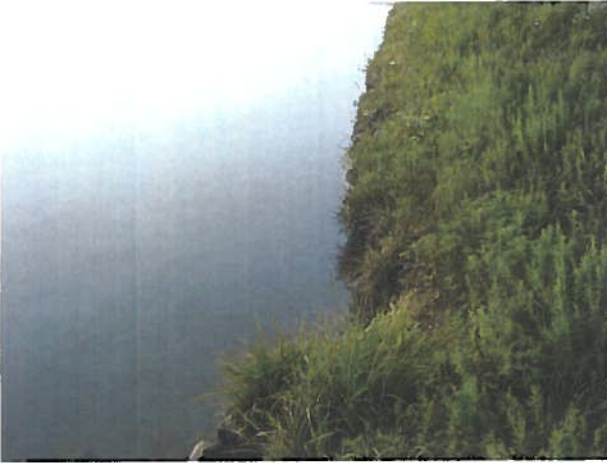
Photo 1

Minor erosion/sloughing on interior dike slope. TVA survey point #3007.

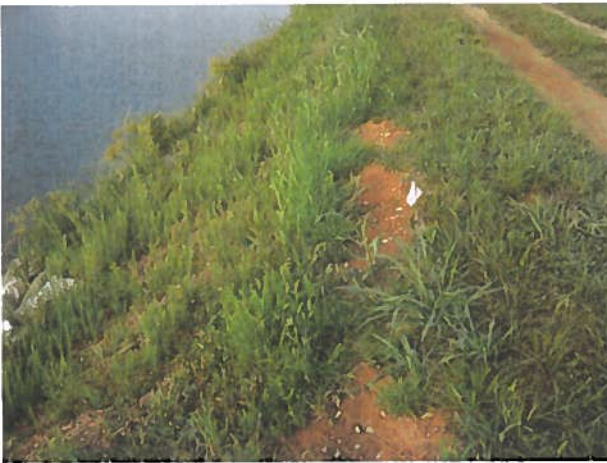
Photo 2

Sparse vegetation coverage, typical along portions of northwest dike interior slope and edge of crest. TVA survey point #3009.

Vegetation:	Grass to overgrown brush. Grass coverage generally adequate with occasional areas of sparse coverage (Photos 2 and 7). Construction was ongoing at the time of this inspection with regraded material not yet vegetated on the southeast dike near the new inlet (Photo 13). Overgrown brush was present on the interior slopes and silted material along the southeast dike to the south of the new inlet construction (Photo 16).
Trees:	A tree stump on the interior side of the crest had not been properly removed (Photo 10).
Wave Wash Protection:	Riprap protection was observed along northwest dike (Photos 3 and 7).
Erosion:	Minor wave wash erosion was generally present at the waterline along much the southwest dike. A small sough was also observed along the southwest dike as well (Photo 1). Occasional sparse vegetation with minor erosion rills was observed (Photo 2, typical).
Instabilities:	None observed.

Crest Cover and Slope:	Access road along the northwest and southwest dike generally exhibited grass coverage outside of wheel paths (upper corners of Photos 2 and 7). Crushed stone coverage on northeast side was generally good. Cover on the southeast dike crest was generally bare from ongoing construction.
Erosion:	Minor erosion noted alongside access road near northern corner (Photo 2).
Alignment:	No issues observed.

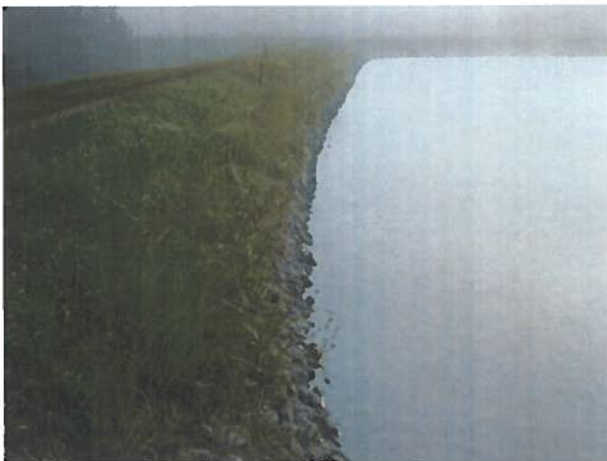
Photo 3

Wave wash protection present on interior of northwest dike.

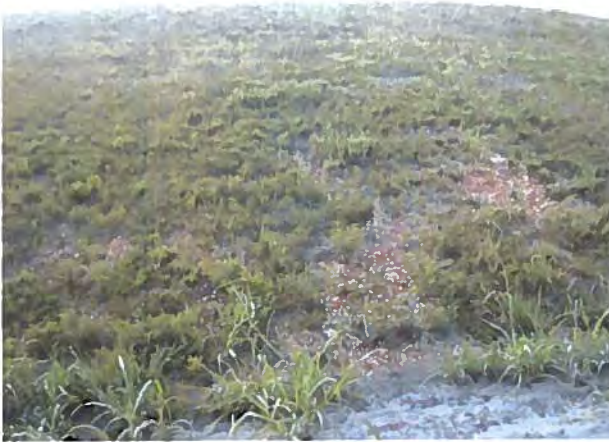
Photo 4

Typical vegetation on northwest exterior slope. TVA survey point #3008.

Vegetation:	Grass, generally fair to adequate coverage across the majority of the southwest and northwest dike (Photos 4 and 5) with occasional areas of sparse coverage (Photo 6). Coverage along the northeast dike was generally sparse and exhibited track marks from dozer activity (Photos 8 and 11). Vegetation was overgrown along the southernmost 100 feet of the northeast dike (Photo 12).
Trees:	An apparent tree removal cavity on the face of the northeast dike over the spillway area was observed (Photo 9).
Erosion:	Minor erosion observed sporadically in areas of poor coverage as noted above (Photos 4, 5, and 6). No large erosion rills or gullies were observed.
Instabilities:	None observed.
Uniform Appearance:	Yes.
Seepage:	None observed.
Benches:	None observed.
Foundation Drains and Seepage Collection Systems:	None exist.
Instrumentation:	Two piezometers were installed by Stantec in 2009 as part of the geotechnical exploration.

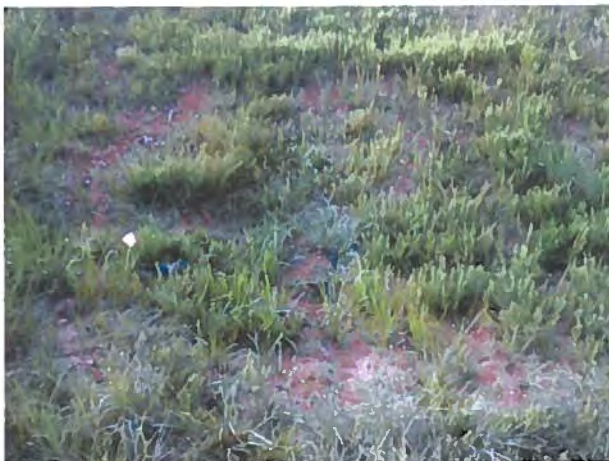
Photo 6

Minor erosion and sparse vegetation from previous regrading efforts. Exterior slope of northwest dike near north corner. TVA survey point #3011.

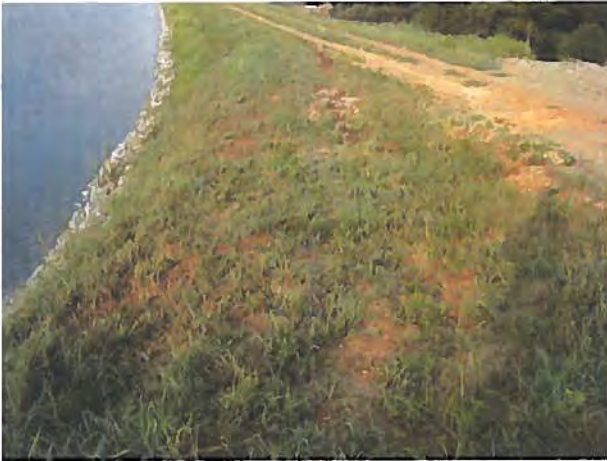
Photo 7

Area of sparse vegetation near northern corner. TVA survey point #3012.

Settlement/Cracking:	None observed.
Bare Spots/Rutting:	Occasional sparse vegetation as observed in Photo 7. Areas of the southeast dike were part of ongoing construction at the time of this inspection and were bare of vegetation. No rutting was observed.
Width:	16 to 19 ft. in most areas, 32 ft. at outlet area.

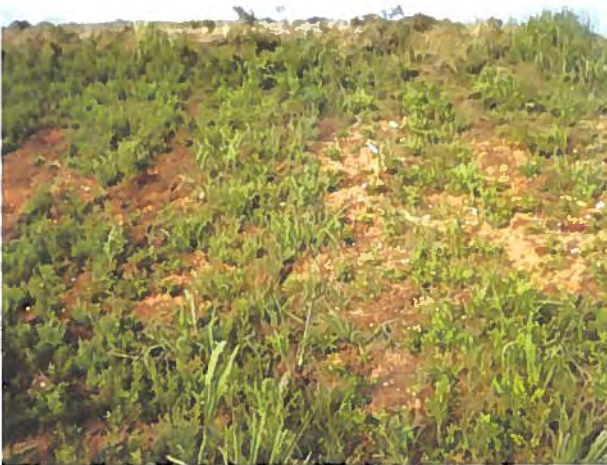
Photo 8

Typical sparse vegetation conditions along exterior side of northeast dike from tree removal and regrading efforts.

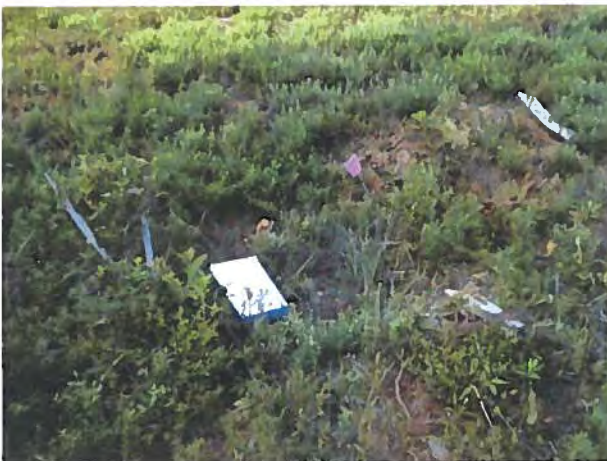
Photo 9

Apparent tree removal cavity. TVA survey point #3013.

- A tree removal cavity and old tree stump were observed along the northeast dike (Items 70 and 71 of Enclosure L). The cavity should be filled and the tree stump removed in accordance with the "General Guidelines for Removal of Trees on Slopes at TVA Fossil Plants" document in Enclosure I. (Priority 4).

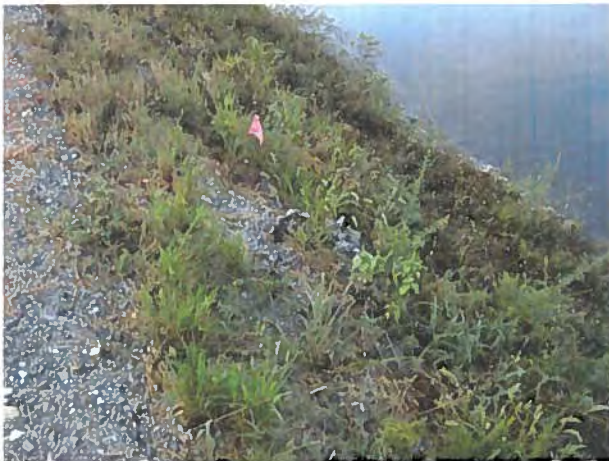
Photo 10

Tree stump not removed. Interior side of northeast dike. TVA survey point #3014.

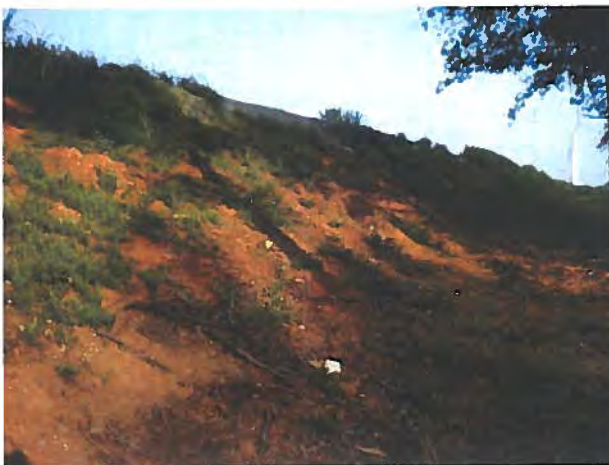
Photo 11

Typical conditions of sparse vegetation along majority of exterior side of northeast dike after tree removal.

dike south of the spillway were observed to be steeper than 2H:1V after initial regrading from apparent tree removal efforts (Photo 11).

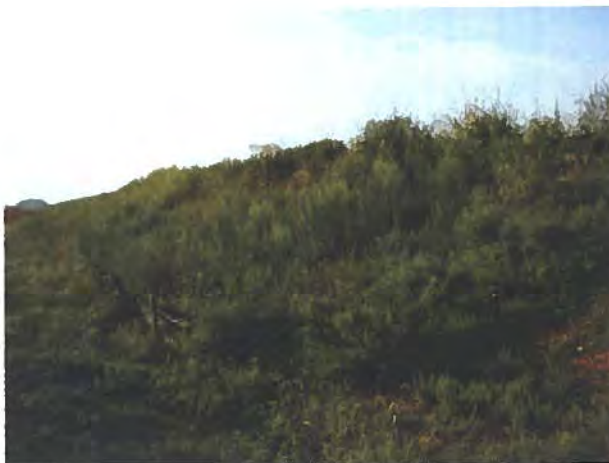
Photo 12

Typical overgrown conditions along easternmost 100 feet (approx.) of northeast dike exterior slope. Overgrown area continued southeast towards Dry Stack 5 area.
