**Coal Combustion Residue Impoundment
Round 11 - Dam Assessment Report**

Colbert Fossil Plant
Tennessee Valley Authority
Tuscumbia, Alabama

Dewberry & Davis, LLC
Fairfax, Virginia

EP-09W001727
June 2012

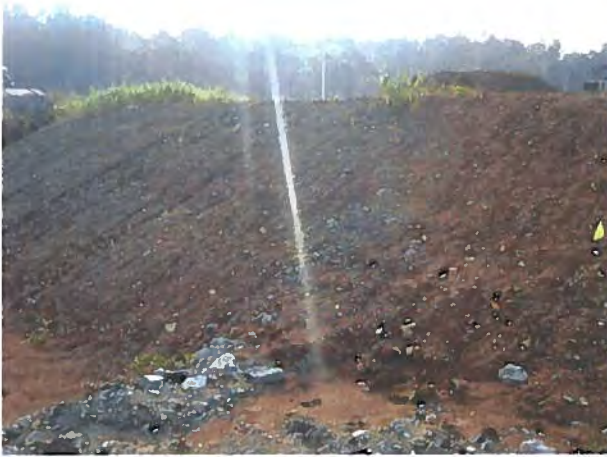
Photo 13

Bare ground immediately left/northeast of new inlet along interior slope of southwest dike (construction ongoing). TVA survey point #3015.

Vegetation:	Grass to overgrown brush. Grass coverage generally adequate with occasional areas of sparse coverage (Photos 2 and 7). Construction was ongoing at the time of this inspection with regraded material not yet vegetated on the southeast dike near the new inlet (Photo 13). Overgrown brush was present on the interior slopes and silted material along the southeast dike to the south of the new inlet construction (Photo 16).
Trees:	A tree stump on the interior side of the crest had not been properly removed (Photo 10).
Wave Wash Protection:	Riprap protection was observed along northwest dike (Photos 3 and 7).
Erosion:	Minor wave wash erosion was generally present at the waterline along much the southwest dike. A small sough was also observed along the southwest dike as well (Photo 1). Occasional sparse vegetation with minor erosion rills was observed (Photo 2, typical).
Instabilities:	None observed.

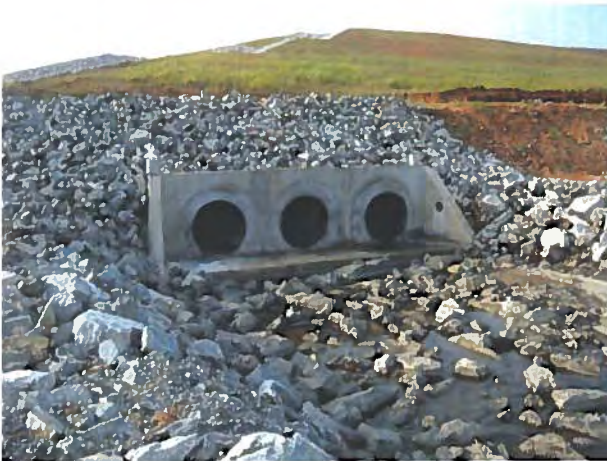
Photo 14

New inlet from Dry Stack 5. Three 36-inch pipes with riprap protection around headwall.

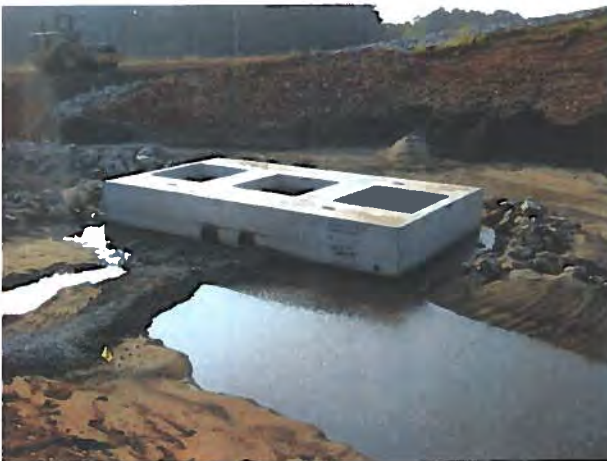
Photo 15

New inlet box (construction ongoing).

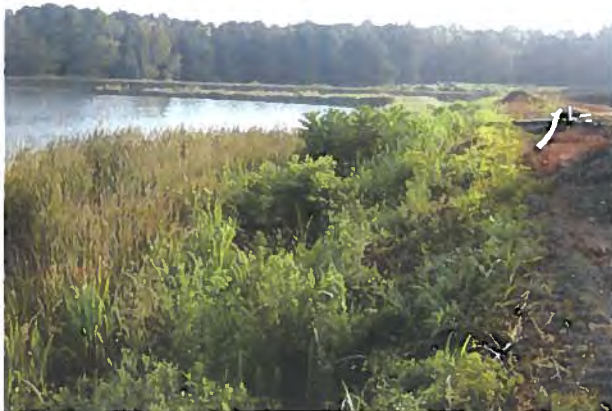
Photo 16

Overgrown area along interior of southeast dike.

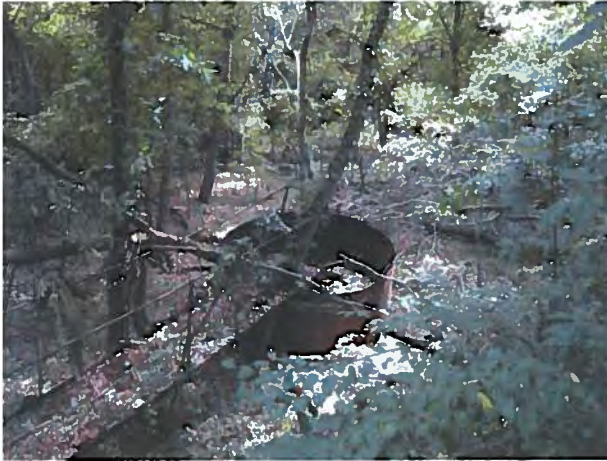
Photo 1

Former northwest spillway inlet.

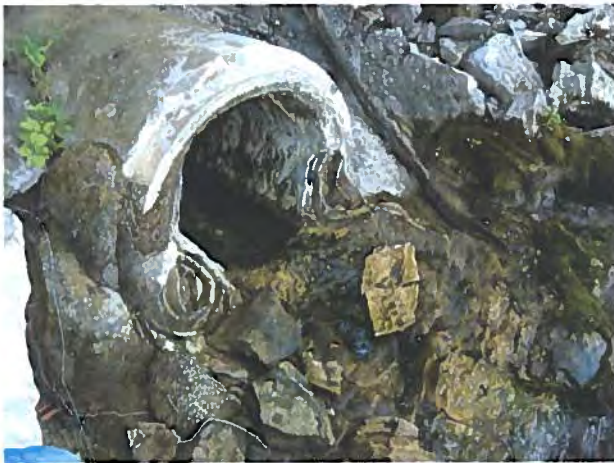
Photo 2

Former northwest spillway outlet pipe.

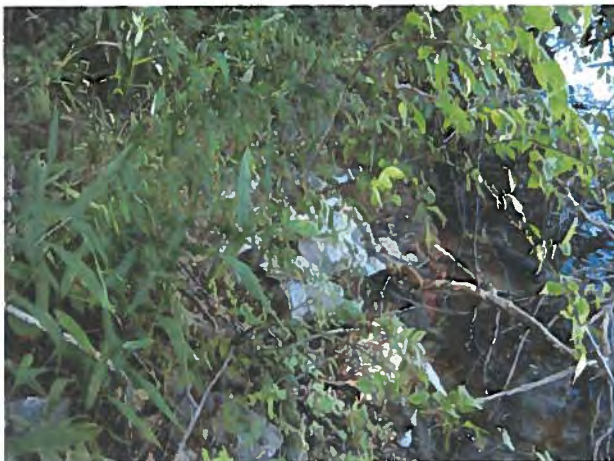
Photo 3

Typical condition at toe of bank with minor erosion.

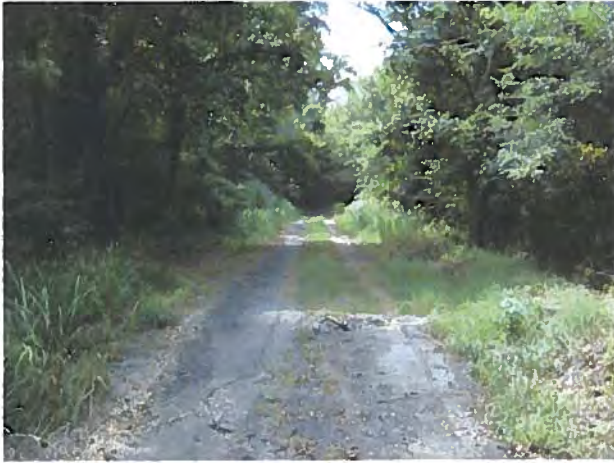
Photo 4

Typical view of access roadway along crest of closed area.

Crest Cover and Slope:	The access roadway crest contains a mixture of fly ash in some areas and bottom ash in others with sparse grass cover (Photo 4).
Erosion:	Minor erosion was noted along the access road in the southwestern area of the crest (Photo 5).
Alignment:	No issues observed.
Settlement/Cracking:	None observed.
Bare Spots/Rutting:	None observed.
Width:	25 ft.

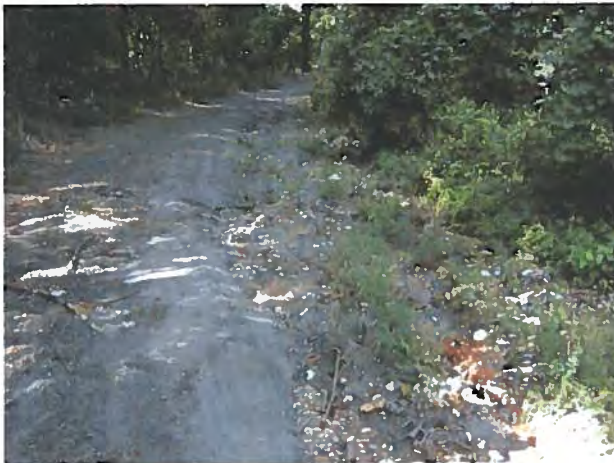
Photo 5

Minor erosion on access road in southwestern stretch of closed area.

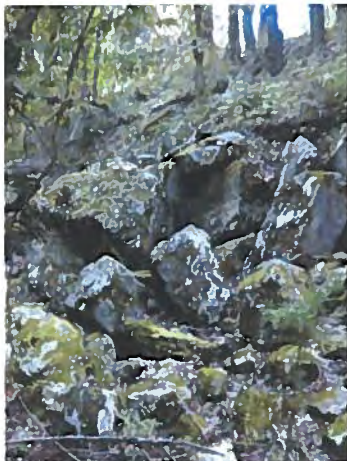
Photo 6

Typical view of boulders on exterior slopes.

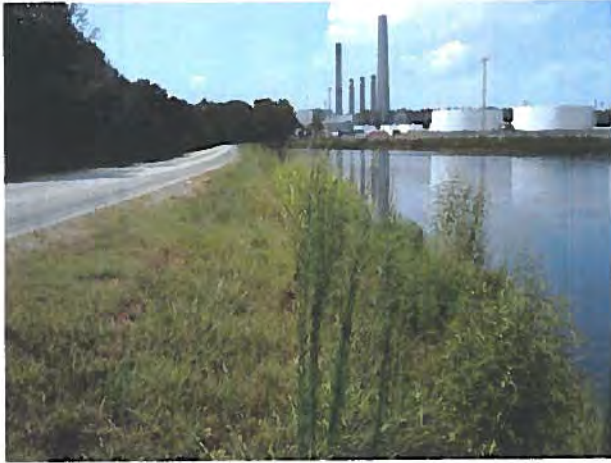
Photo 1

Typical view of crest and interior slope looking northwest.

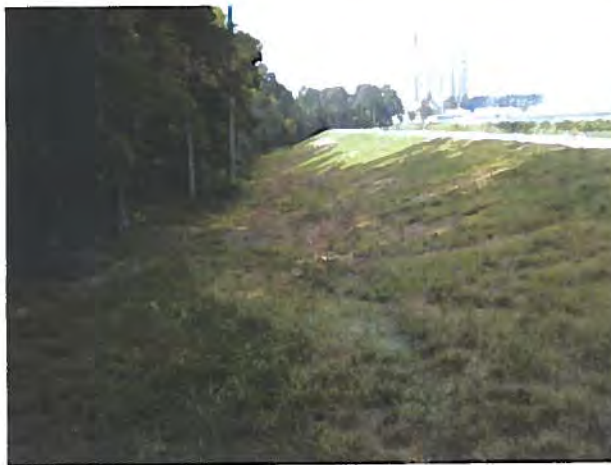
Photo 2

Typical view of exterior slope looking northwest.

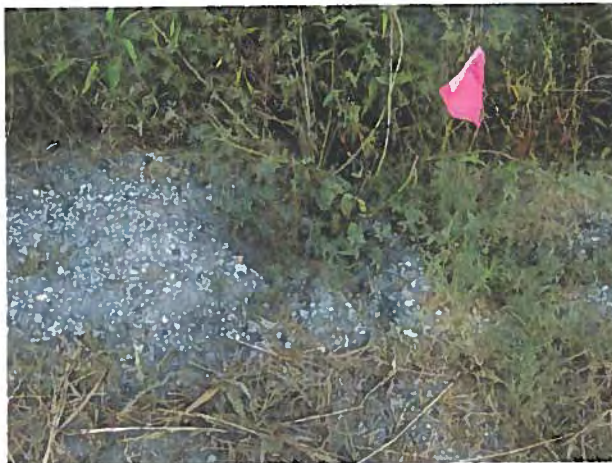
Photo 3

Typical minor erosion along interior slope. Erosion evident along majority of interior northwest slope. TVA survey point #3000.

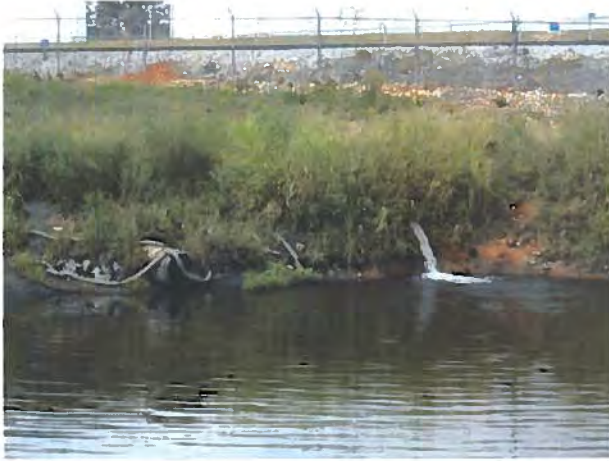
Photo 4
View of influent pipes.

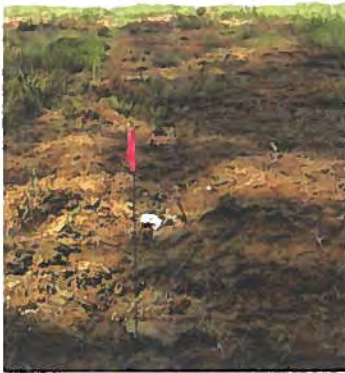
Photo 5
Minor erosion rill on exterior slope. TVA
survey point #3004.

Vegetation:	Grass with some areas of sparse to no coverage along the west dike (Photos 7 and 9).
Trees:	None observed.
Erosion:	Instances of minor erosion and/or rutting were observed (Photos 5, 6, 8, and 11). Erosion rills were generally shallow and minor on the west dike. Some eroded material has accumulated at the toe of the slope (Photo

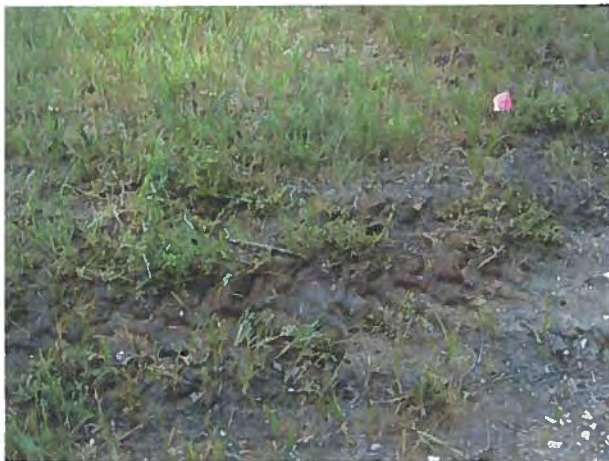
Photo 6
Rutting in soft, relatively damp area. TVA
survey point #3006.

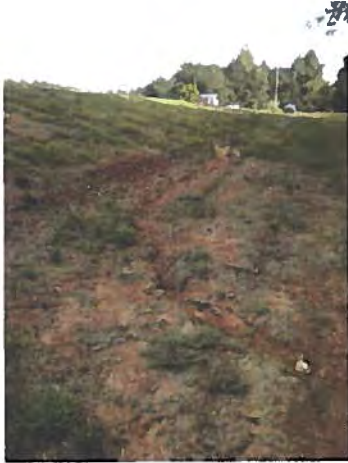
Photo 7

Minor erosion and rutting in poorly vegetated area along exterior slope. TVA survey point #3001.

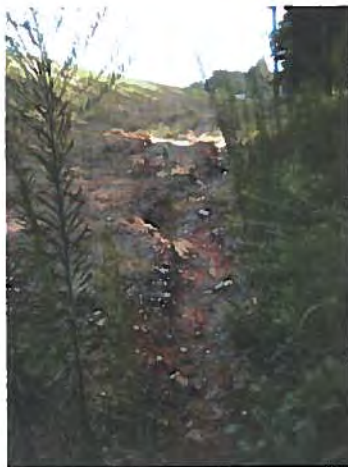
Photo 8

Continuation of erosion downslope and to the north/northwest of Photo 7. TVA survey point #3002.

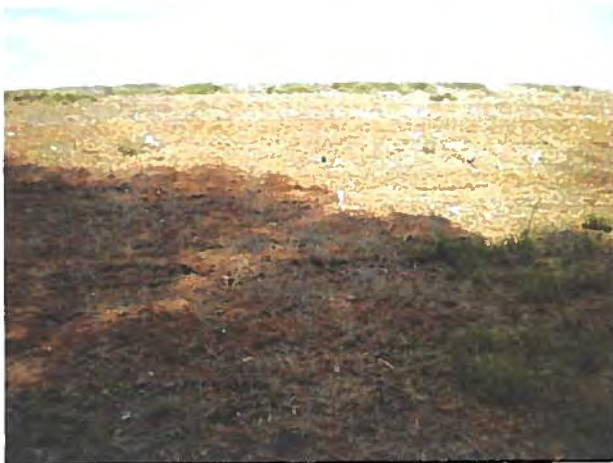
Photo 9

Large area on exterior slope lacking vegetation. TVA survey point #3003.

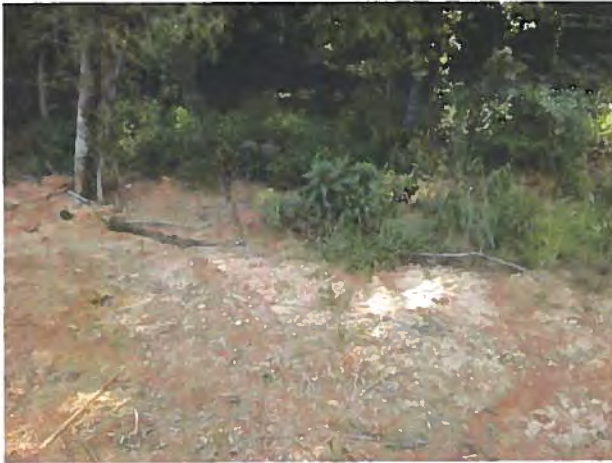
Photo 10

Accumulated eroded material immediately downslope at toe of bare area in Photo 9.

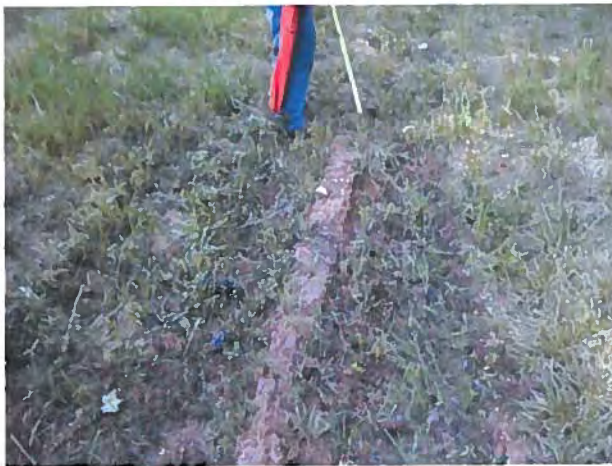
Photo 11

Typical rutting along toe of exterior slope.
TVA survey point #3005.

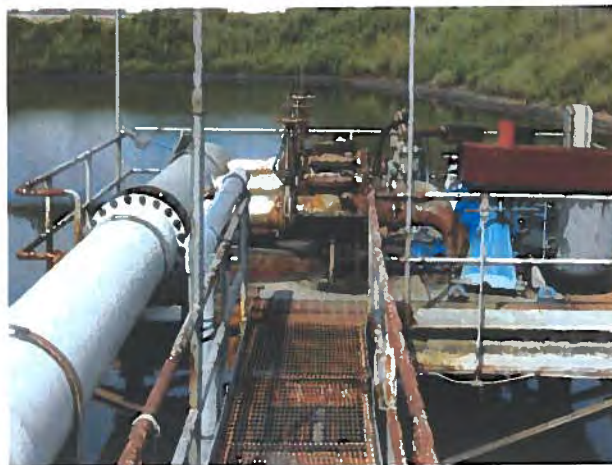
Photo 12

Pump structure in basin.

Number:	This basin does not have spillway weirs. The outlet system is via 3 pumps which operate on an automatic float switch basis. Operation can also be switched to manual. The pumps are mounted on an elevated platform at the southwest corner (Photo 12).
Size, Type and Material:	N/A
Height of Riser Inlets:	N/A
Access:	N/A
Joints:	N/A
Mis-Alignment:	N/A
Closed/Abandoned Conduits:	None reported or observed.

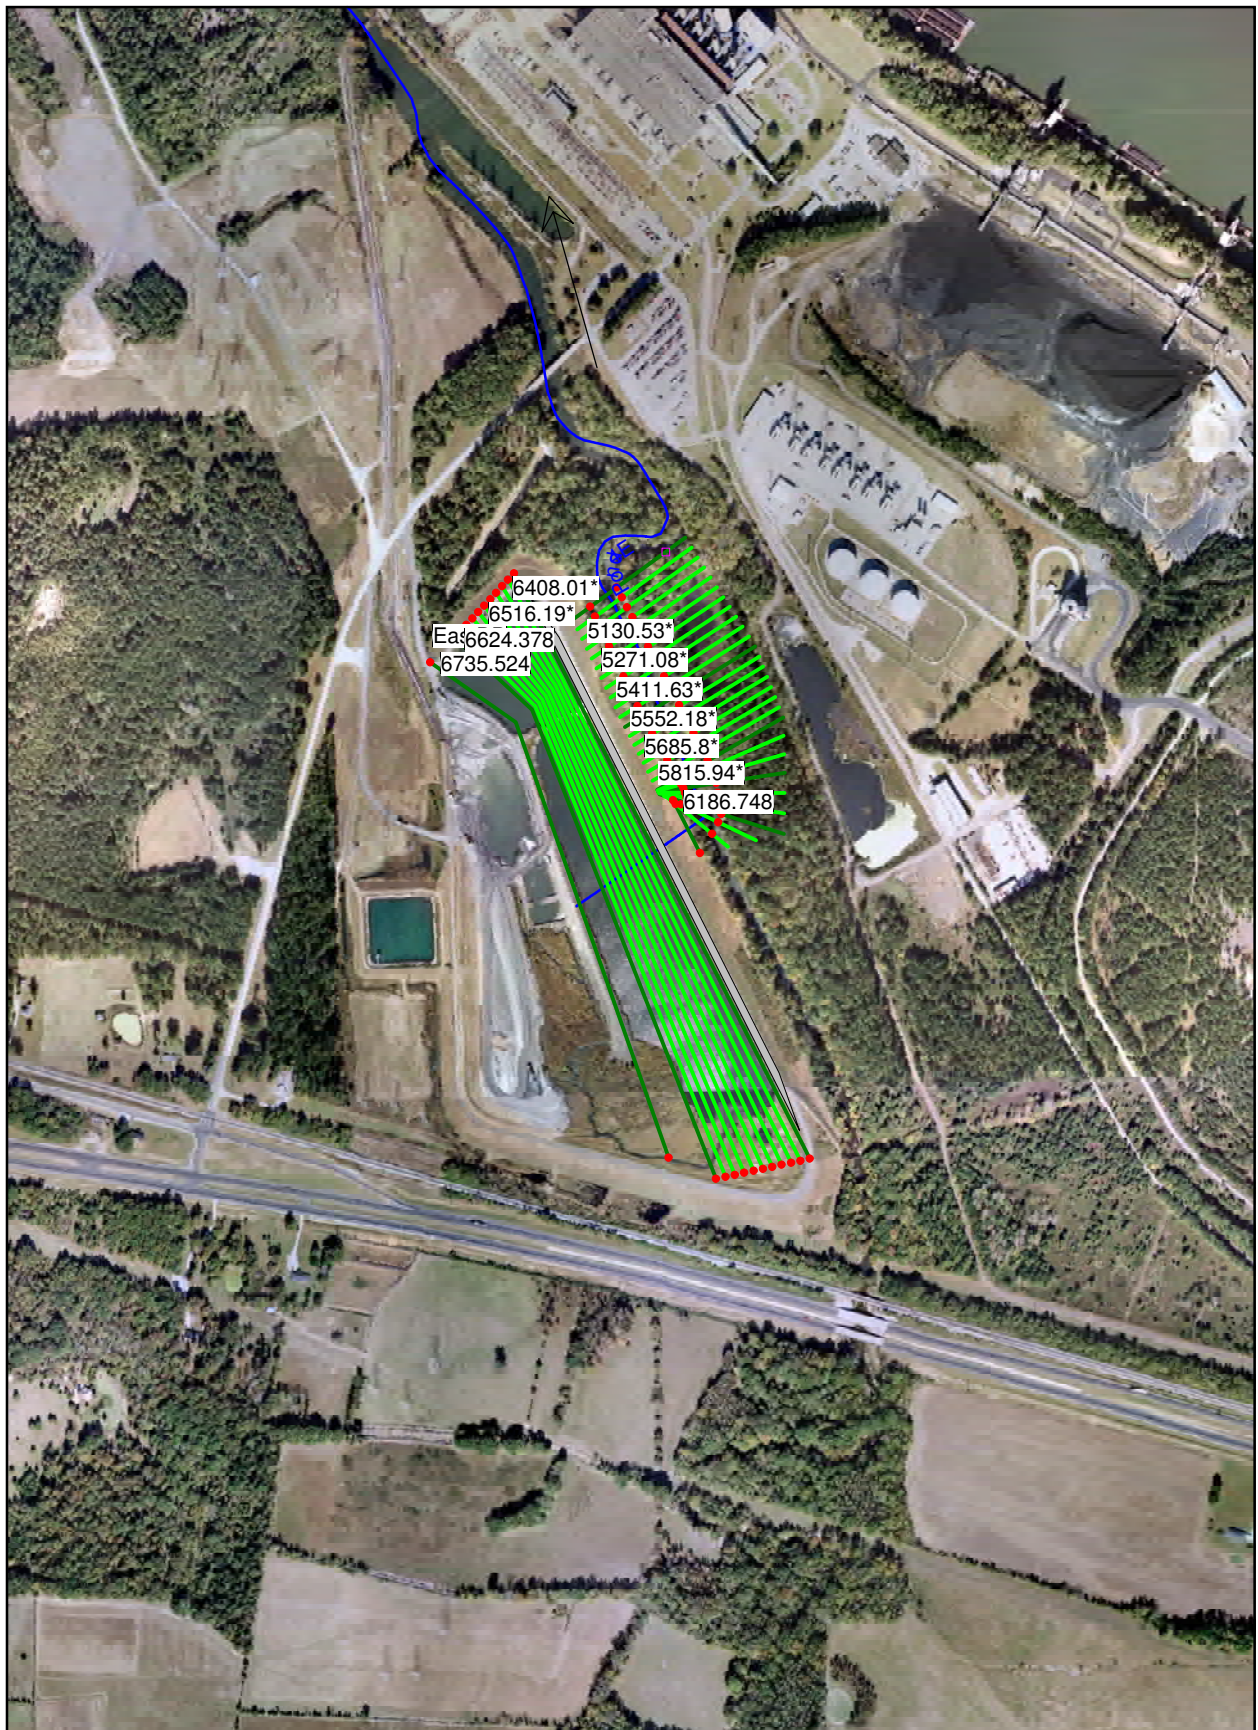
Pond 4 East Dam Break HEC-RAS Model
Dike Elevation 460.0

COF Pond 4 Existing Conditions East Dam Break Analysis Dike Elevation 460.0

1 in Horiz. = 800 ft 1 in Vert. = 400 ft

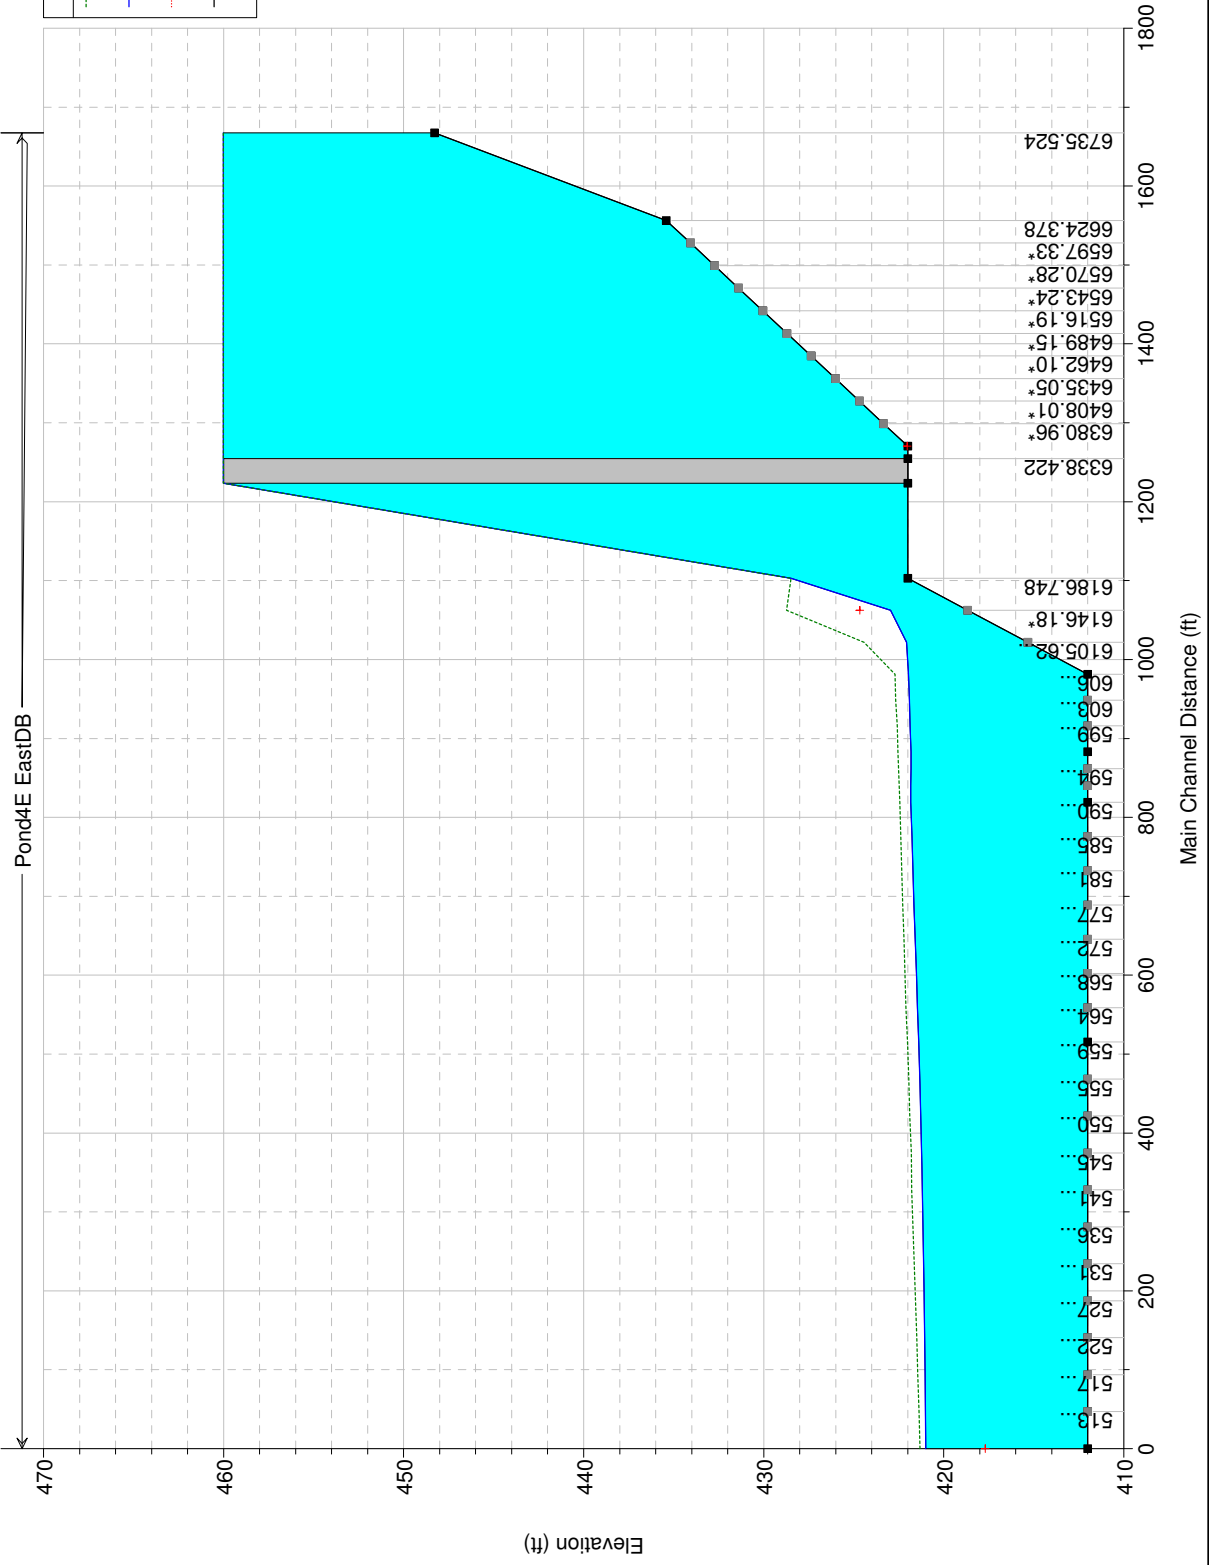
RS = 6624.378 Pond 4 Cross Section - 6624

Colbert Pond 4 East DB Final Analysis Plan: Pond4ExEastBreakEI460FlyAsh 3/31/2010

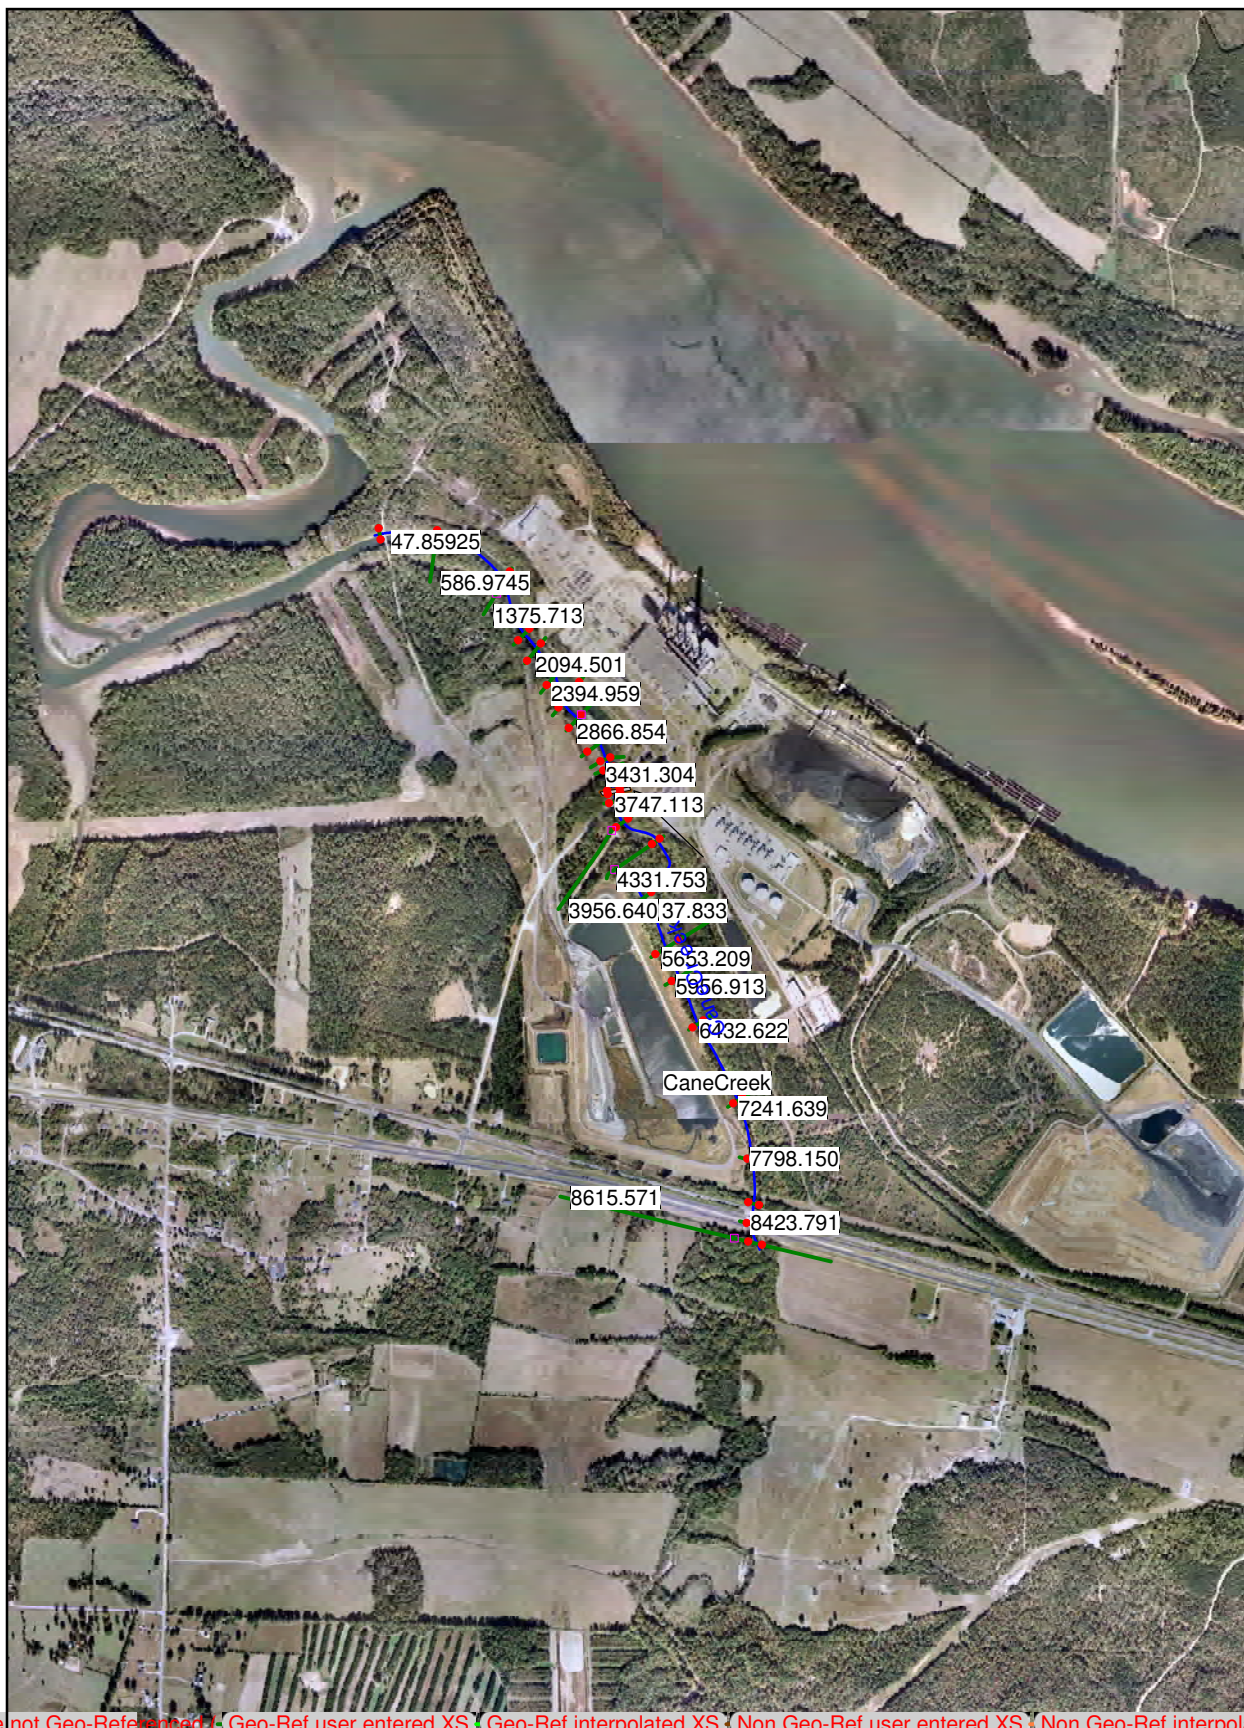
Cane Creek East Dam Break HEC-RAS Model
Dike Elevation 460.0

2 of the 25 XS's are not Geo-Referenced. (Geo-Ref user entered XS, Geo-Ref interpolated XS, Non Geo-Ref user entered XS, Non Geo-Ref interpolated XS)
 1 in Horiz. = 1800 ft 1 in Vert. = 800 ft

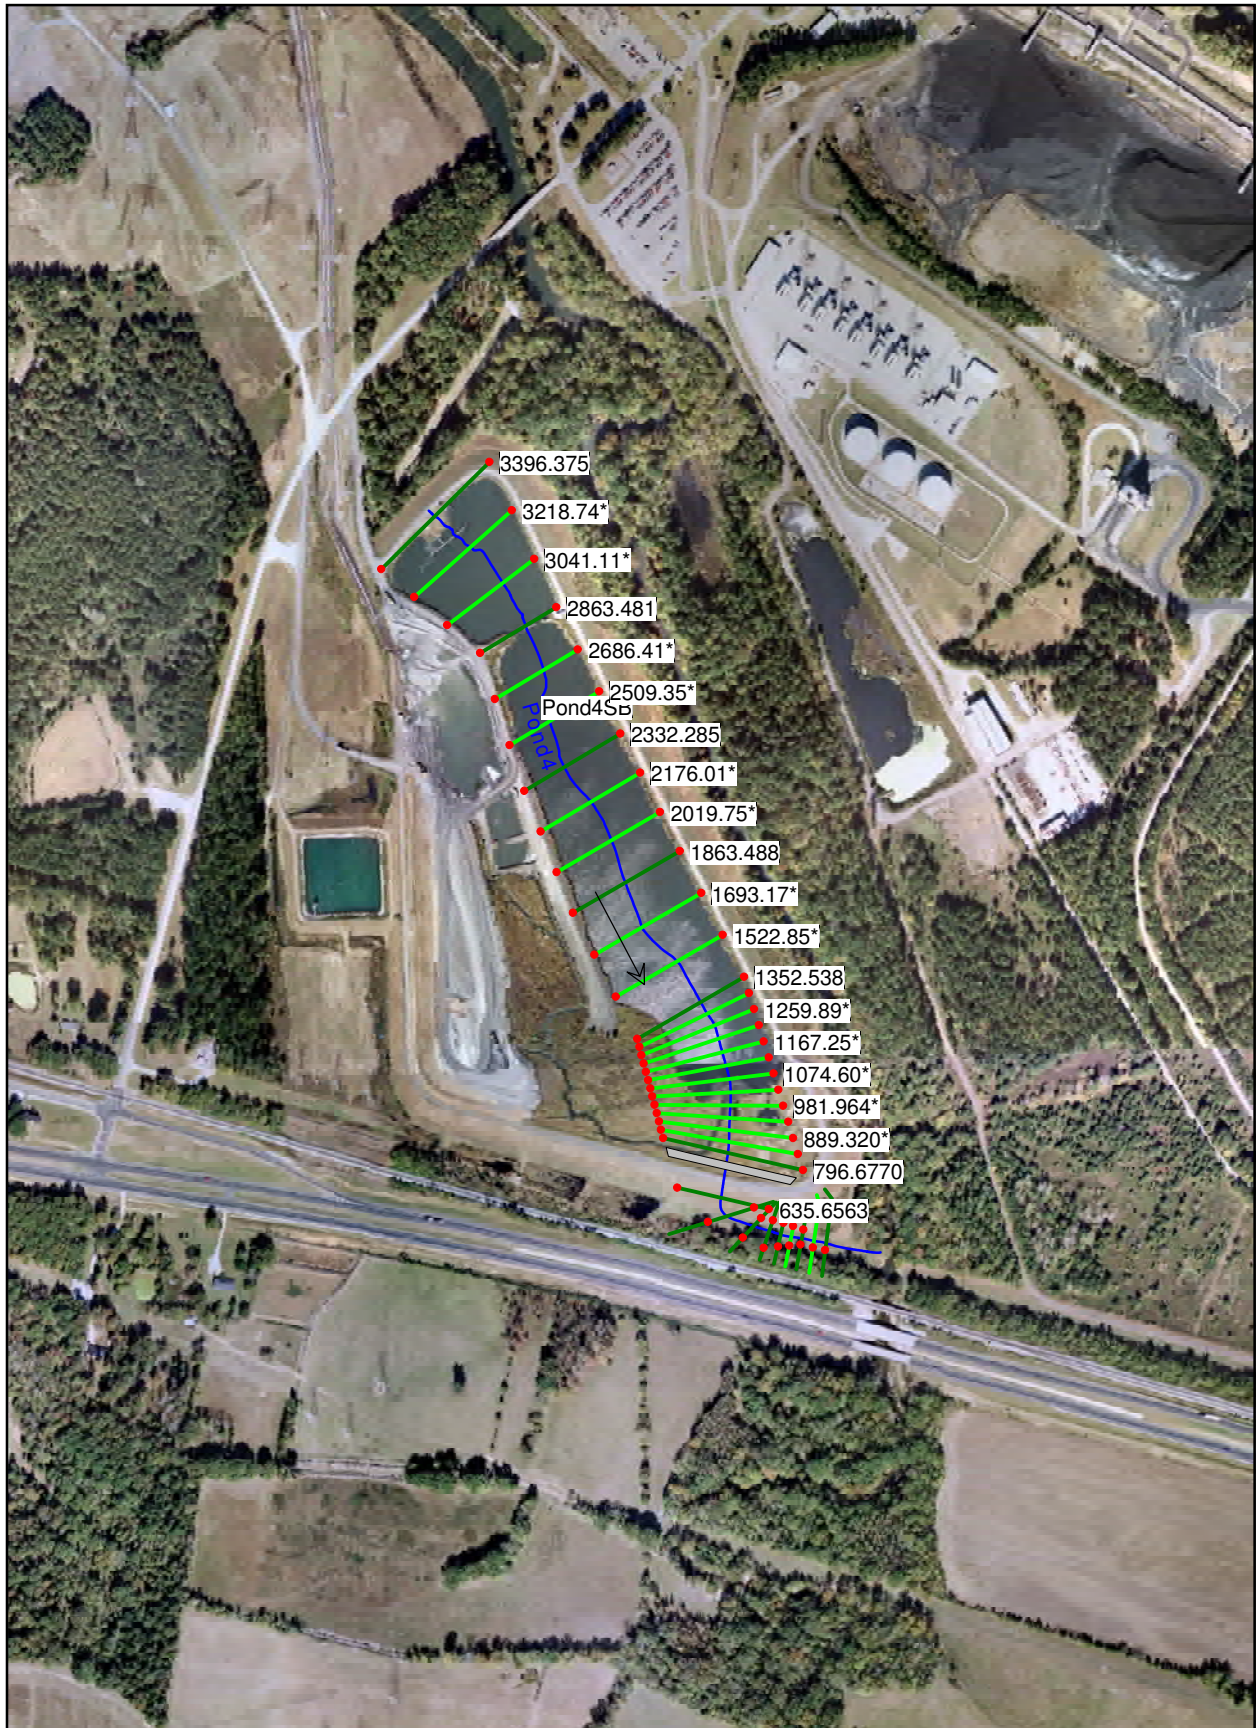
Pond 4 South Dam Break HEC-RAS Model
Dike Elevation 460.0

Modeling efforts for existing conditions started at maximum water surface elevations in relation to dike elevations. The analysis began with a dike elevation set at 460.0, and persisted through elevation 457.0, in increments of one foot. Dam breach models were built and analyzed for corresponding dike elevations. Embankment failures were modeled using an unsteady state analysis of the flood wave out of the pond.

- Dam breach simulations at the south dike involving soil/ash/water mixtures do not endanger the railroad, highway or residence. This result indicates that saturated ash in the southern part of the pond, whether in its existing condition or under a future cap/closure, is not expected to endanger human life at the railroad, highway or residence in the event of failure at the south dike.

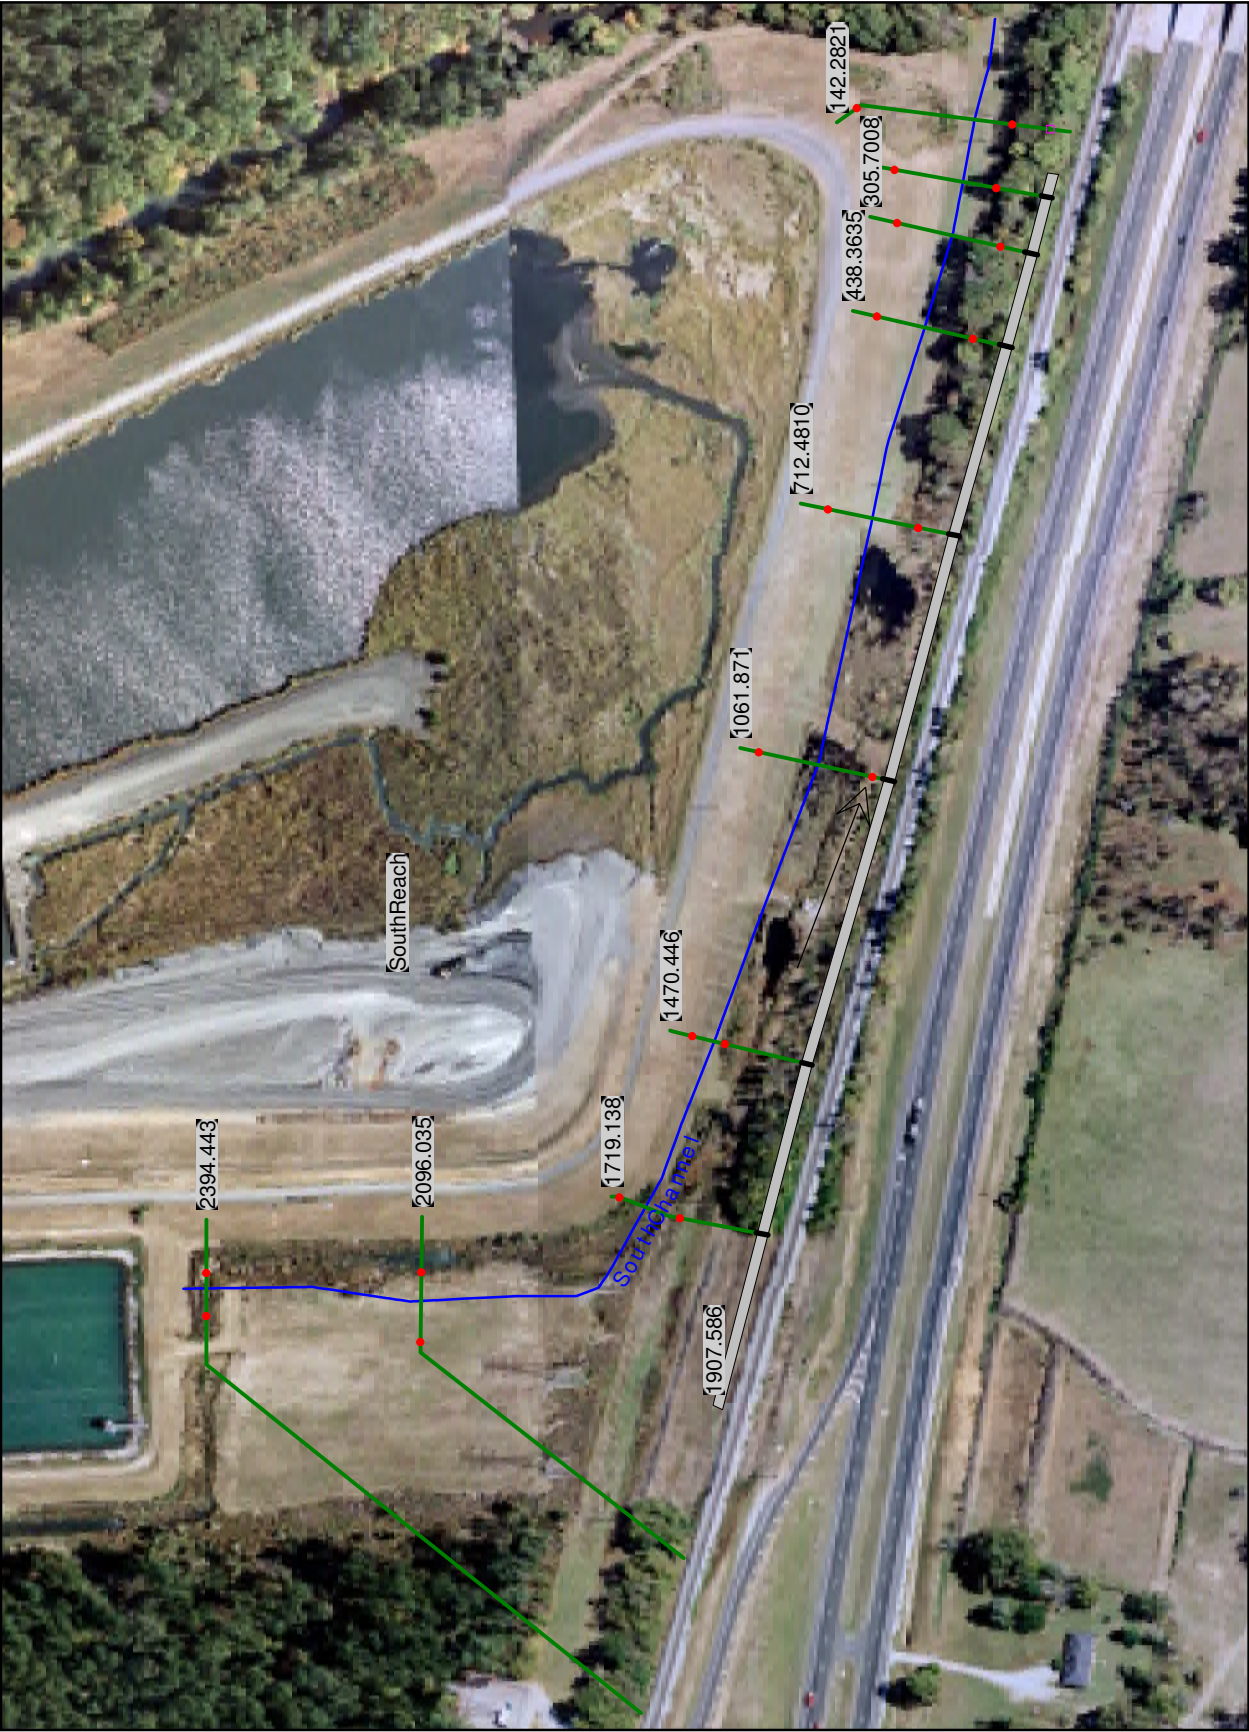
**Pond 4 South Dam Break
South Channel HEC-RAS Model
Dike Elevation 460.0**

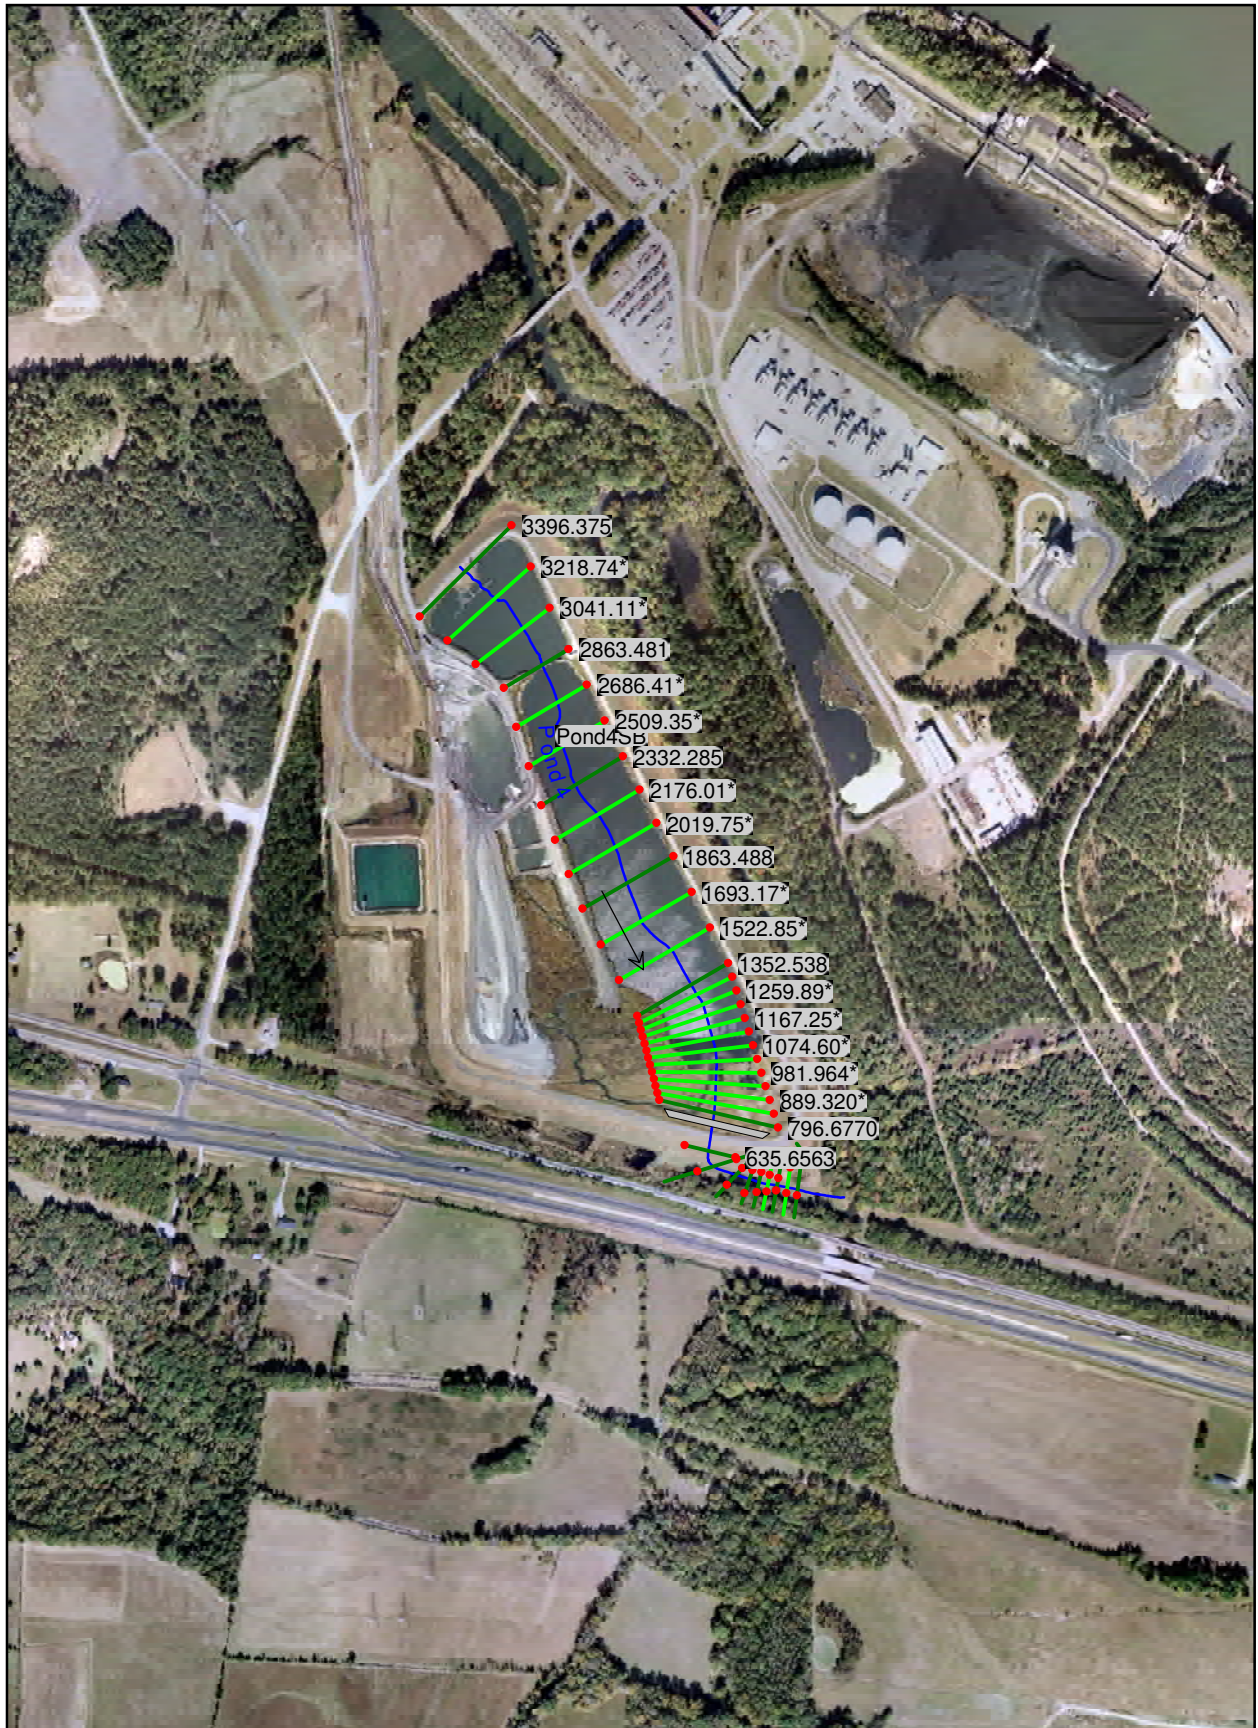
Pond 4 South Dam Break HEC-RAS Model
Dike Elevation 458.0

1 in Horiz. = 800 ft 1 in Vert. = 400 ft

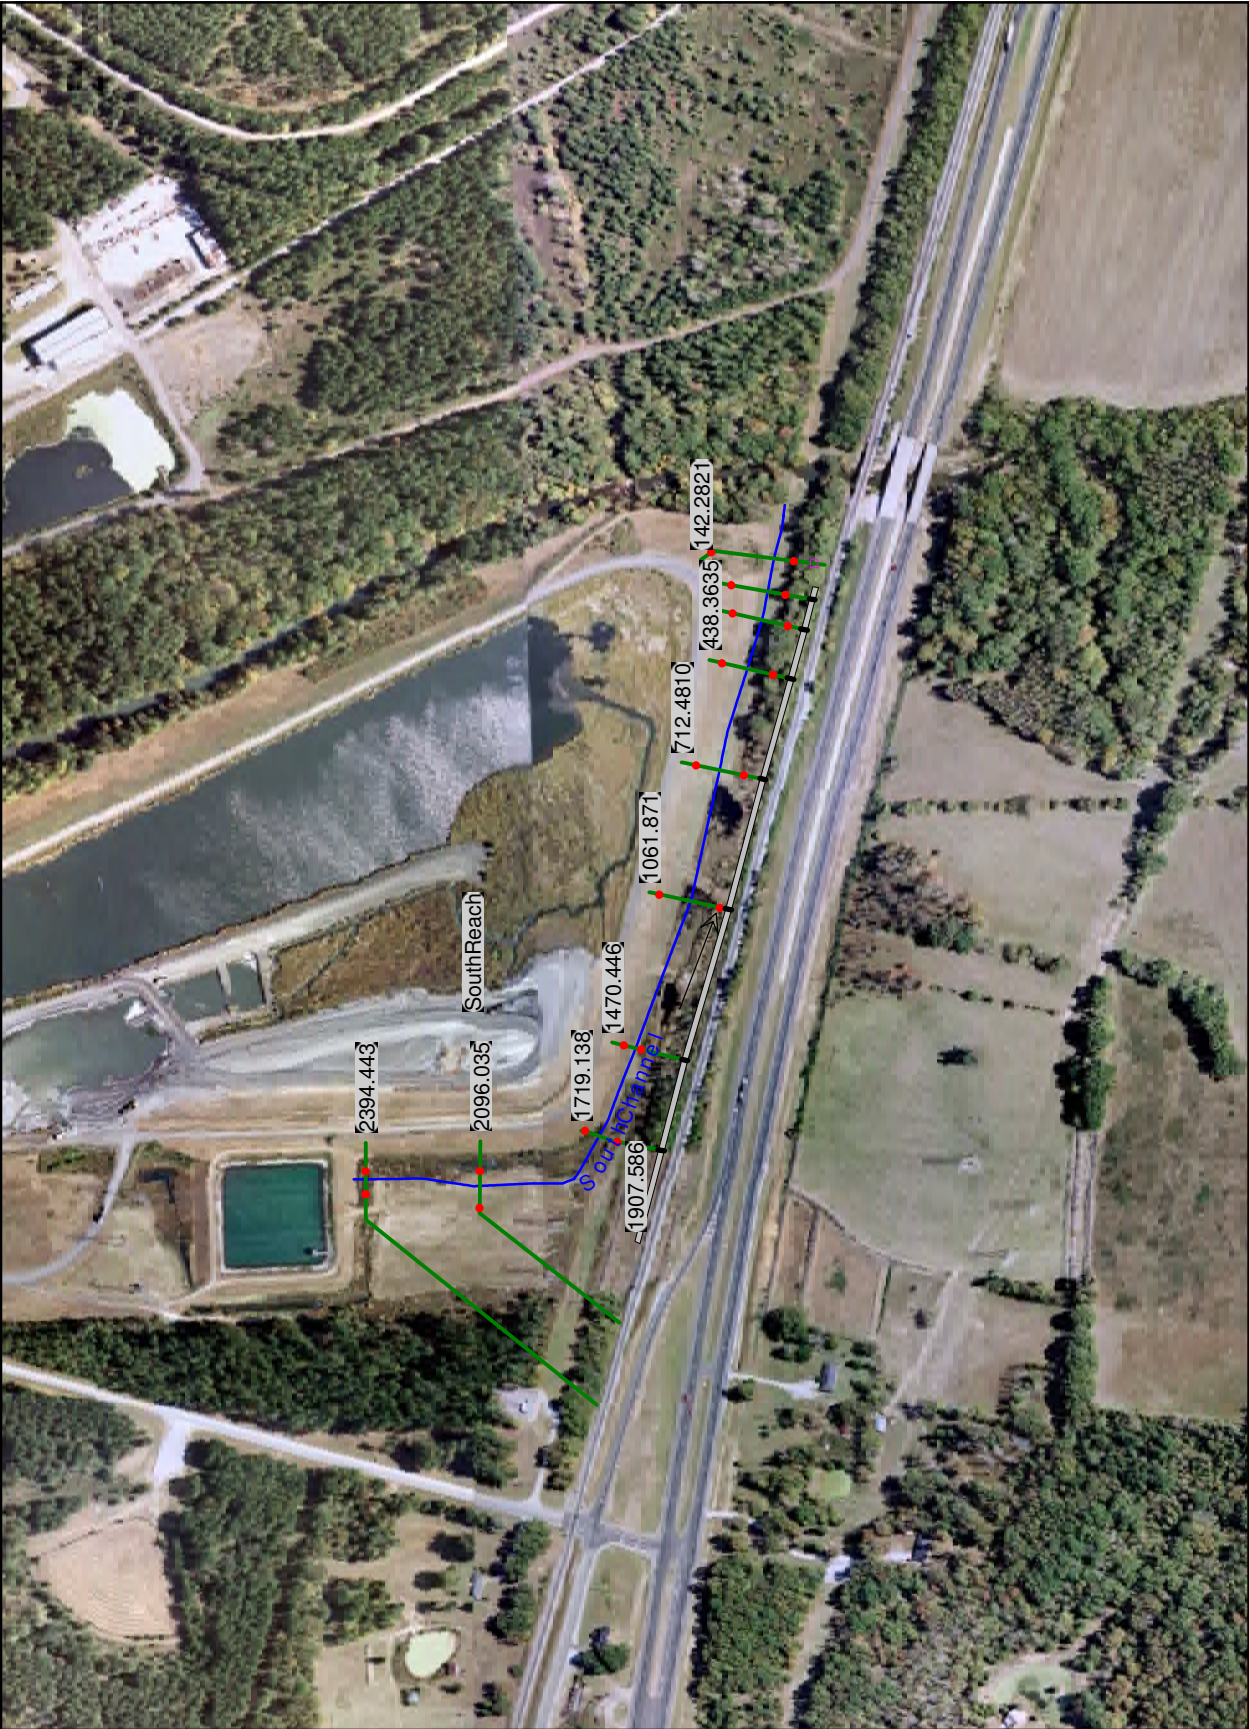
**Pond 4 South Dam Break
South Channel HEC-RAS Model
Dike Elevation 458.0**

1 in Horiz. = 500 ft 1 in Vert. = 500 ft
