**Coal Combustion Residue Impoundment
Round 11 - Dam Assessment Report**

Colbert Fossil Plant
Tennessee Valley Authority
Tuscumbia, Alabama

Dewberry & Davis, LLC
Fairfax, Virginia

EP-09W001727
June 2012

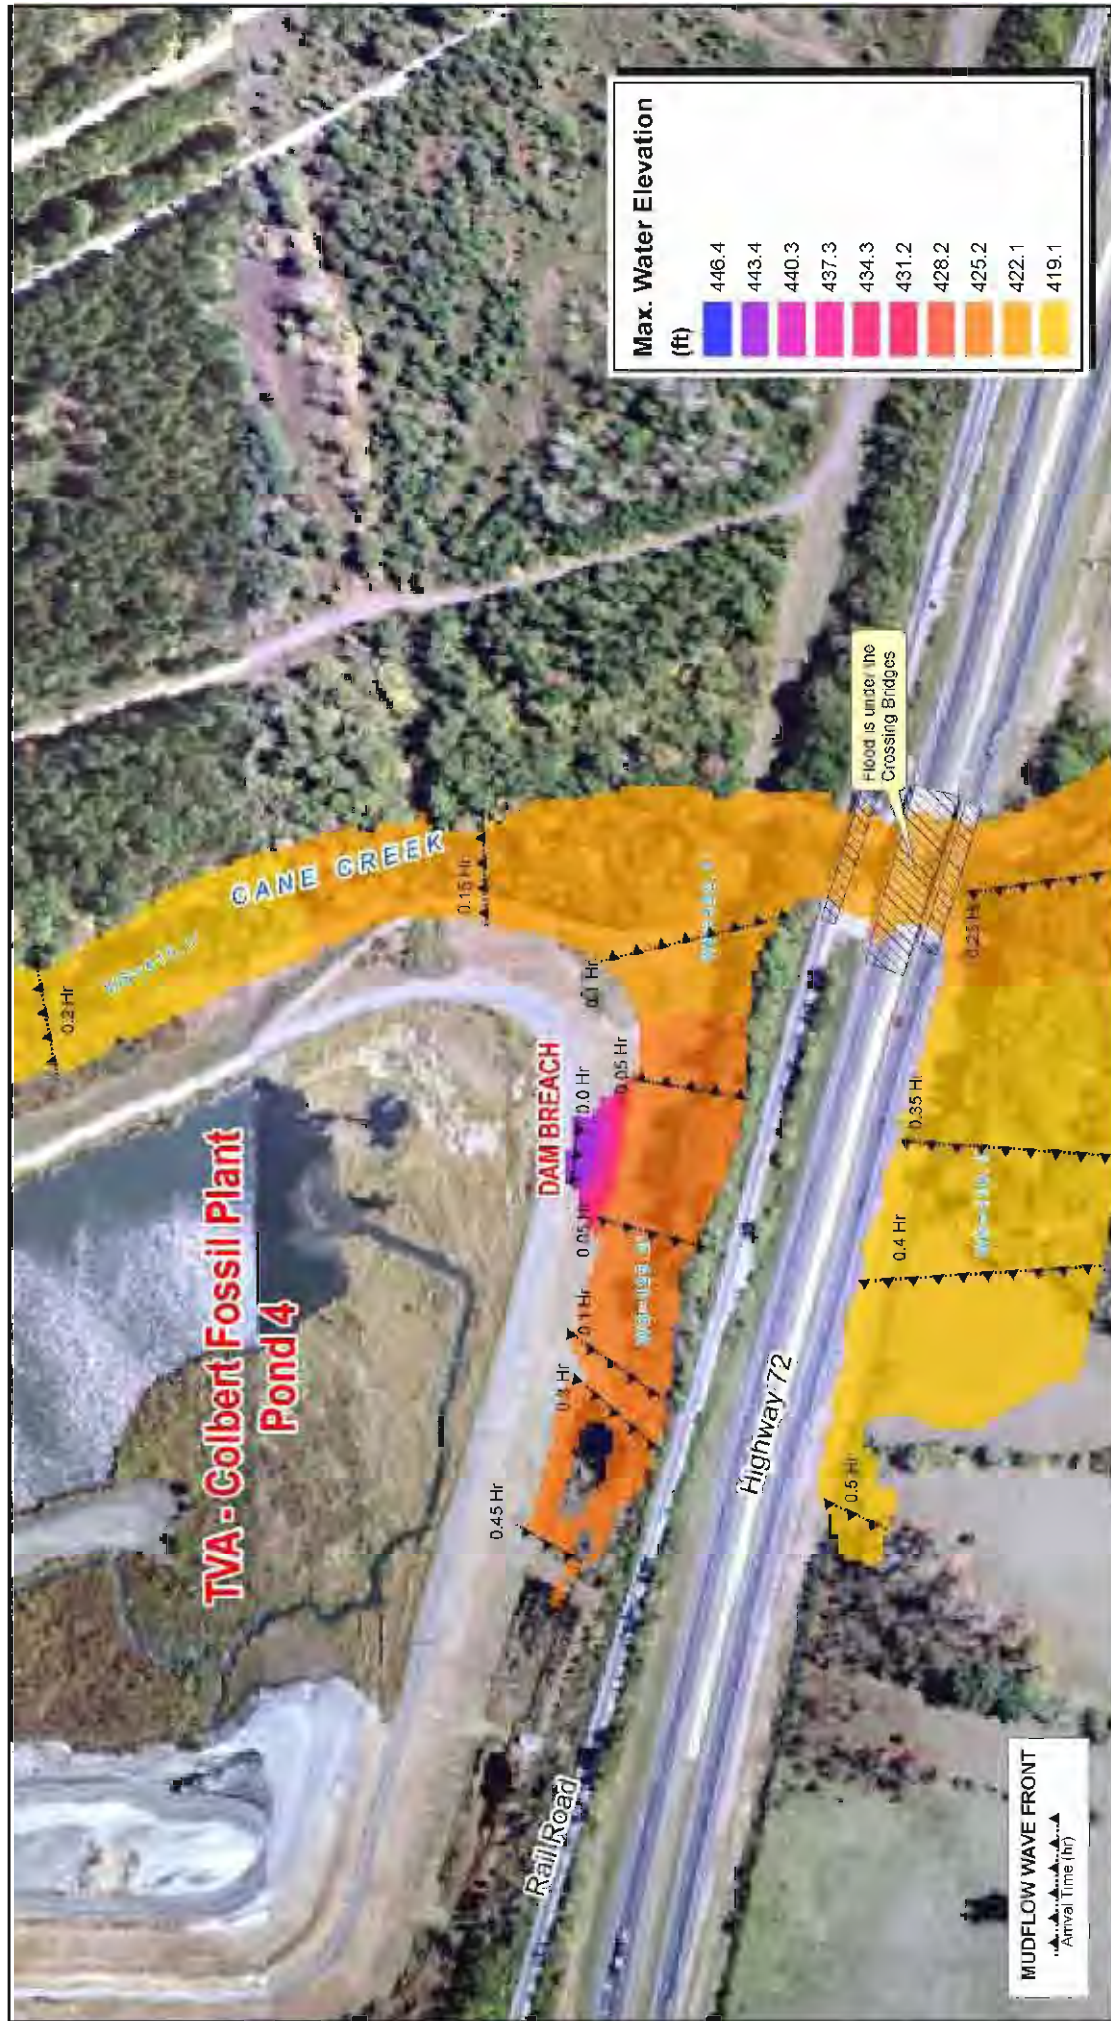
Date: 3/30/2010 Map I

Scenario I - Failure to Top of Bottom Ash with an initial W.S. at 480'
Final Breach Bottom=438.5 ft
Peak Breach Flow= 9,520 cfs

Dam Failure Flood Inundation Map

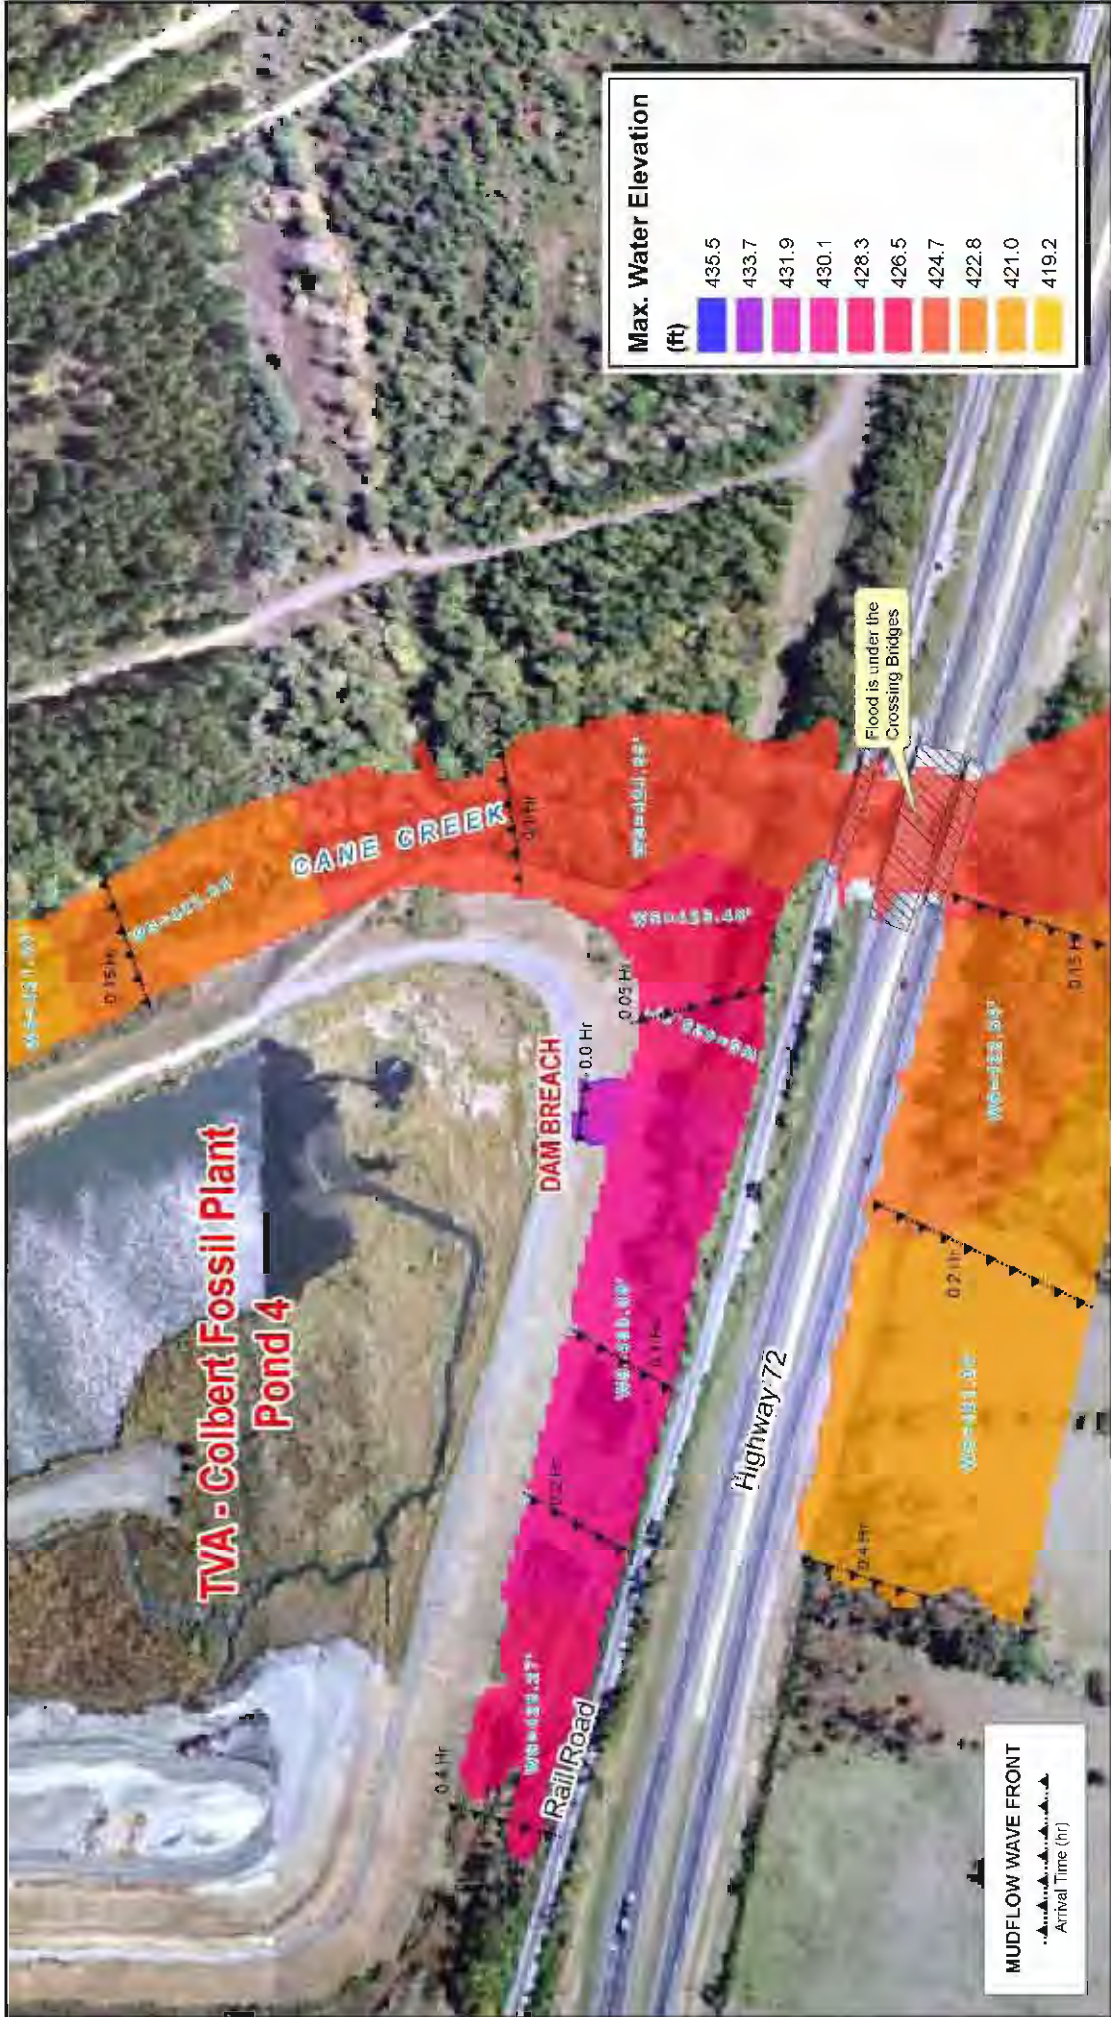
Date: 3/30/2010 Map II

Scenario II - Failure to Bottom of Fly Ash with an Initial W.S. at 460 ft
 Final Breach Bottom=422 ft
 Peak Breach Flow= 24,120 cfs

Dam Failure Flood Inundation Map
Scenario II

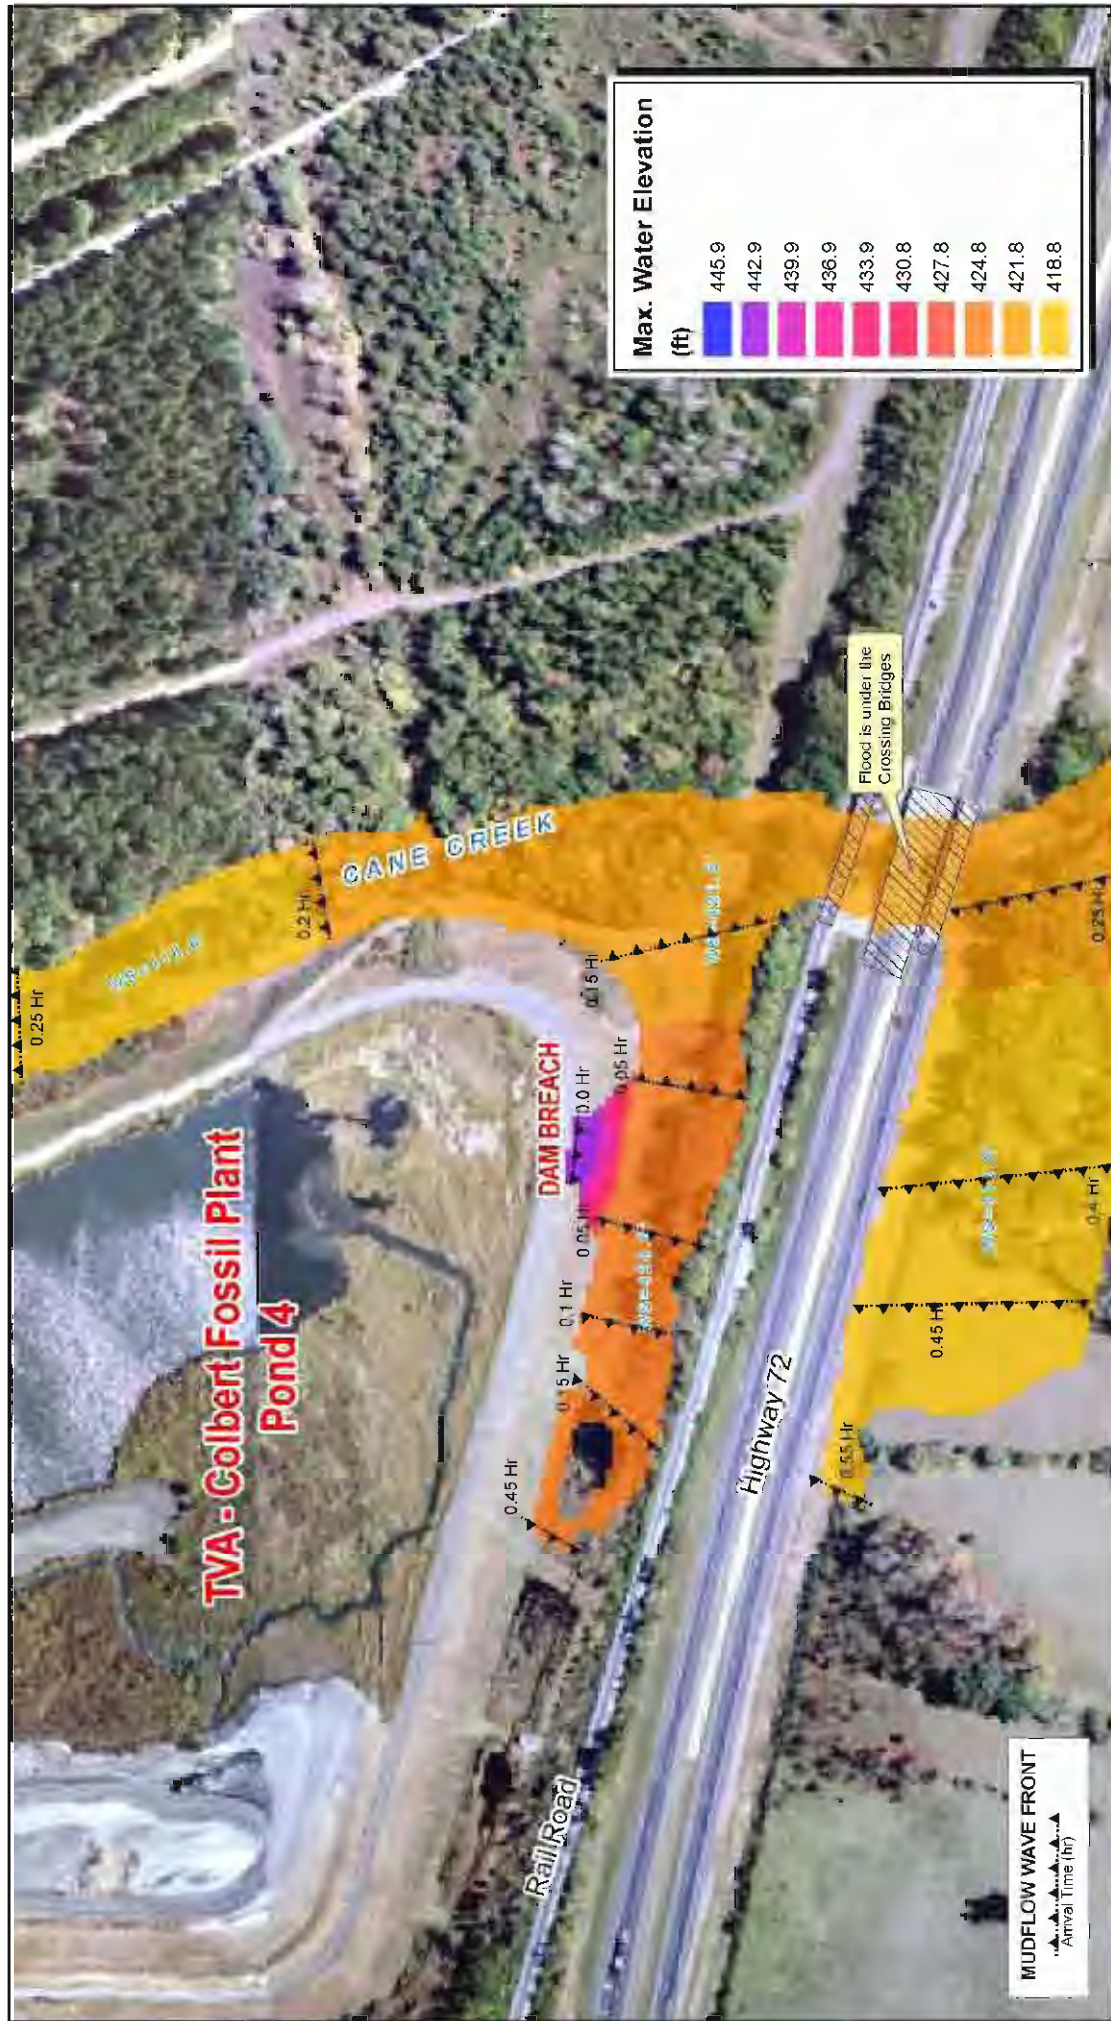
Scenario III- Failure to Top of Bottom Ash with an Initial W.S. at 458 ft
Final Breach Bottom=438.5 ft
Peak Breach Flow= 8,150 cfs

Dam Failure Flood Inundation Map

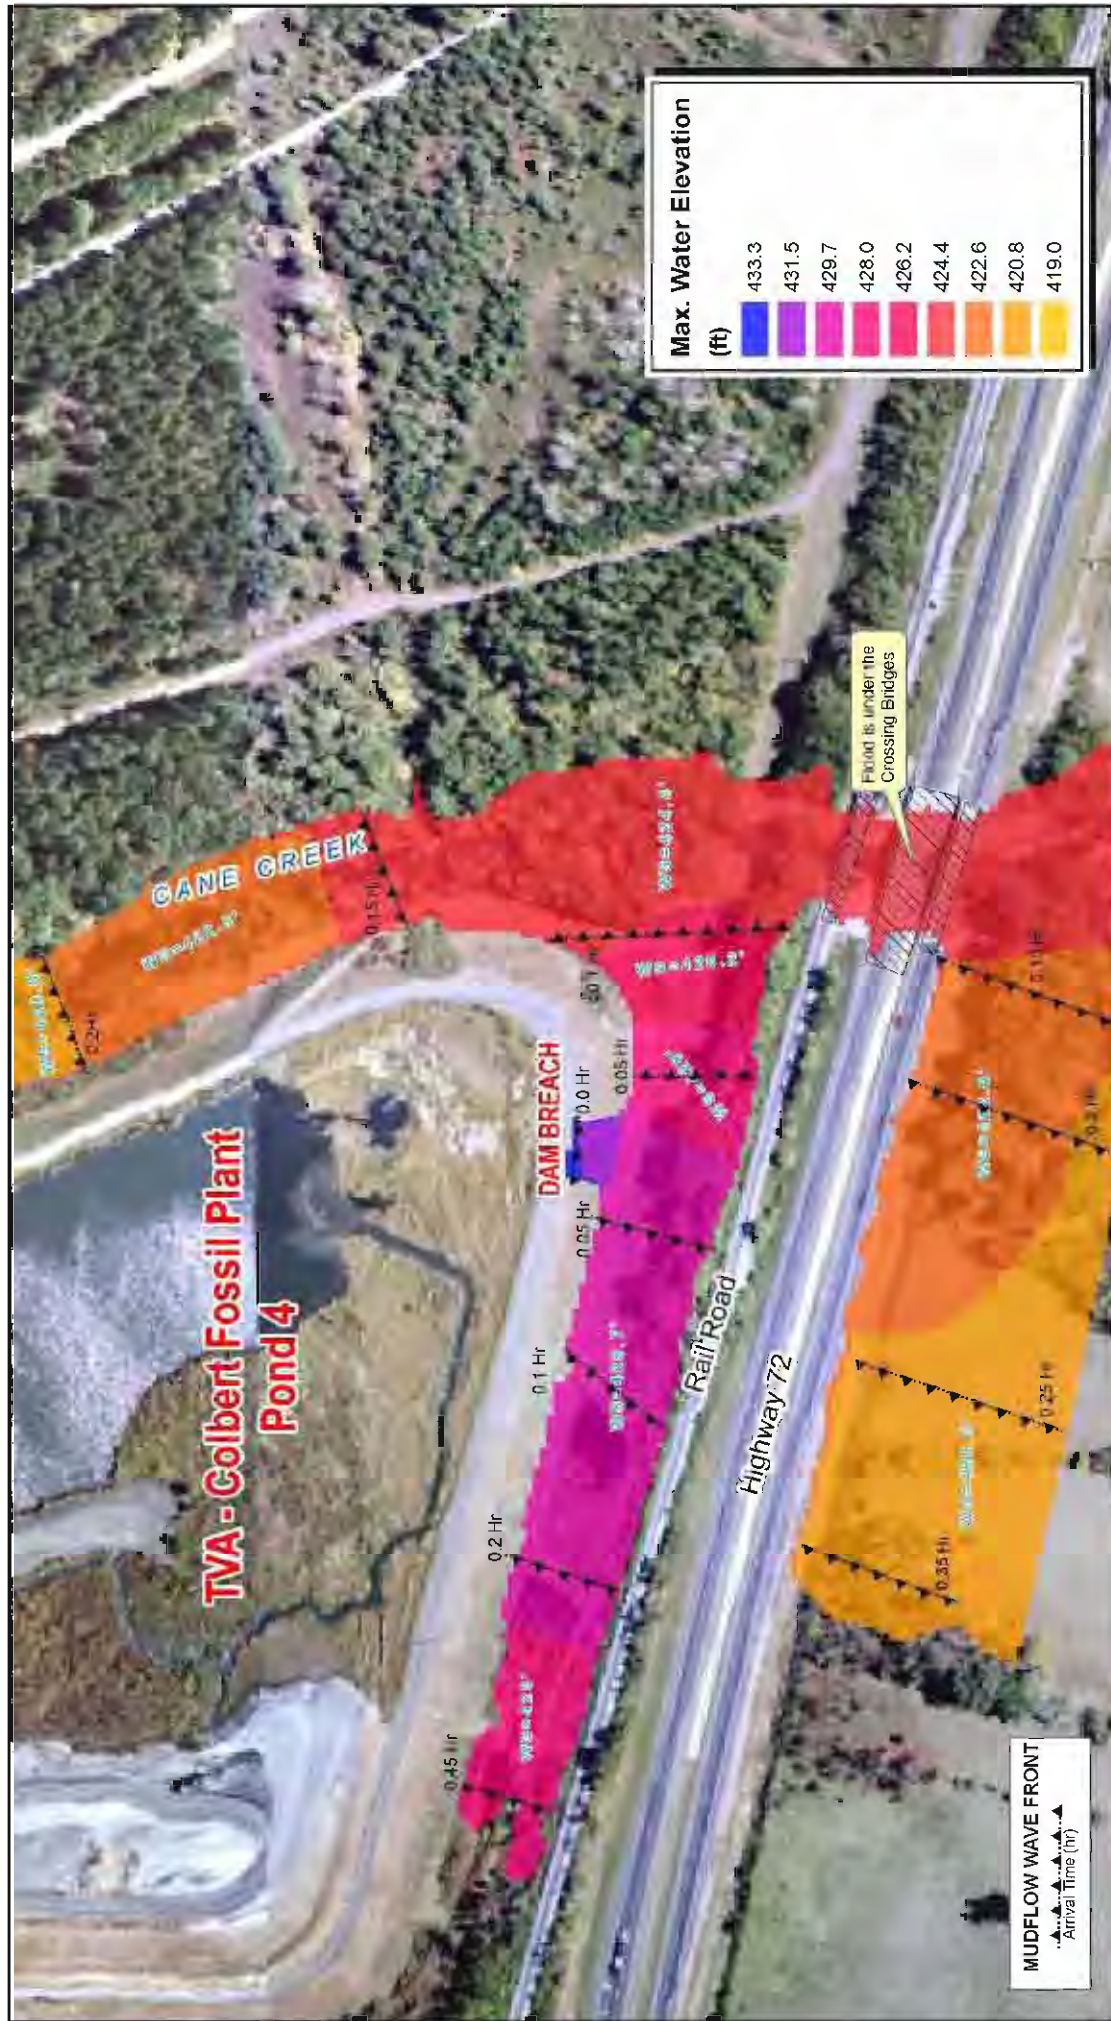
Scenario IV: Failure to Bottom of Fly Ash with an Initial W.S. at 458 ft
Final Breach Bottom=422 ft
Peak Breach Flow= 22,870 cfs

Dam Failure Flood Inundation Map

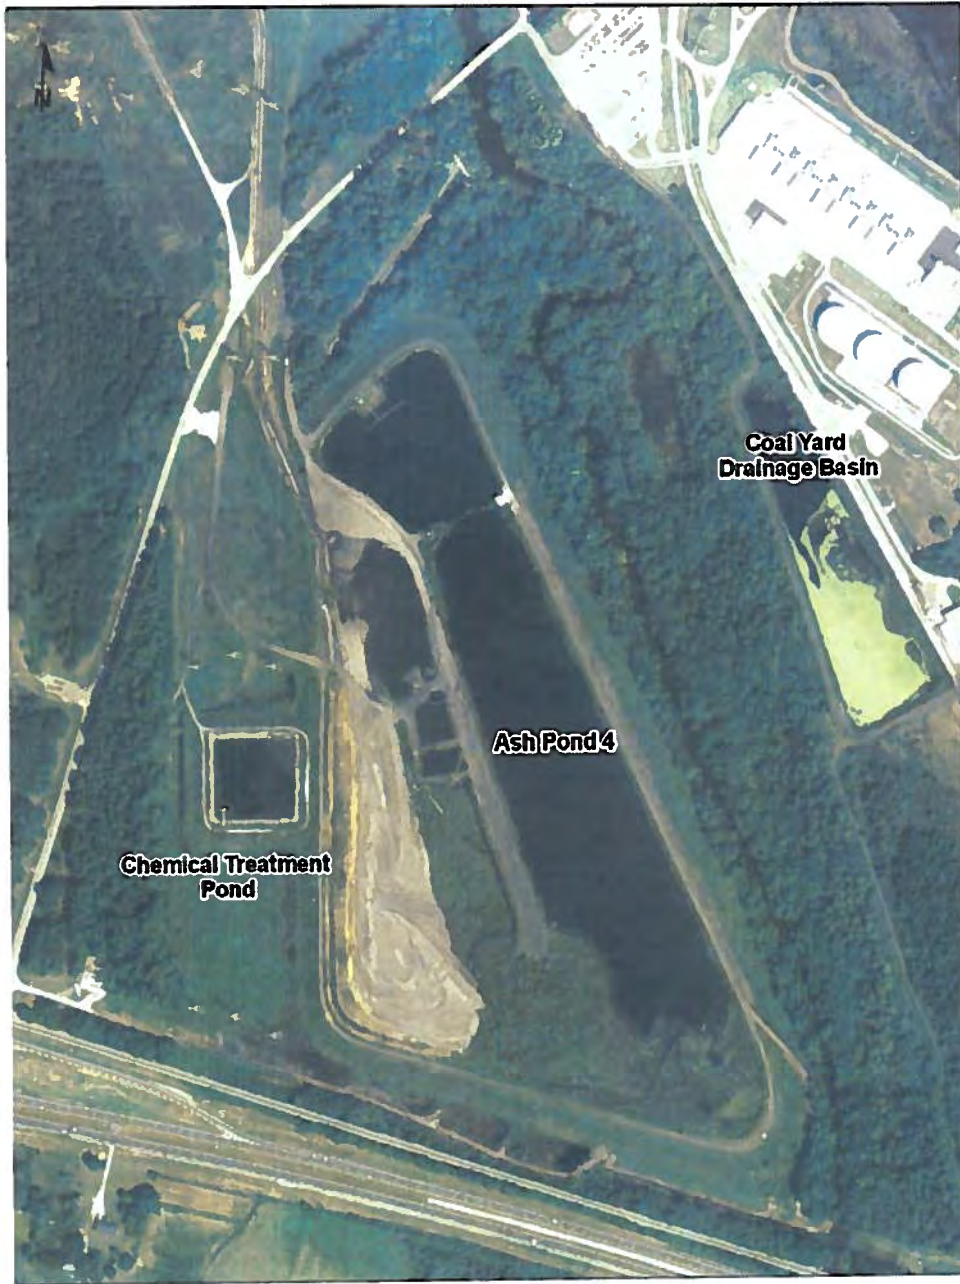
Figure 2.1. Colbert Ash Pond 4 Overview

**Colbert Fossil Plant, Ash Pond 4
Tuscumbia, Alabama**

The Colbert Fossil Plant is located in Tuscumbia, Colbert County, Alabama on the south bank of Pickwick Reservoir along the Tennessee River, approximately 50 miles west of Decatur in northwest Alabama. Ash Pond 4 is situated approximately 3,000 feet south of the plant's powerhouse. This disposal area is bordered by the plant access road to the west, US Highway 72 to the south, and Cane Creek to the north and east. Figure 2.1 on the following page provides a plan view of the Colbert Ash Pond 4 area.

Ash Pond 4 is approximately 52 acres in area, and is enclosed by a perimeter dike system that is approximately 6,700 feet in total length. The dike crest supports a gravel access road and is currently at an approximate elevation of 460 to 461 feet. The overall constructed height of the perimeter dike system varies from approximately 20 to 30 feet on the west side to about 40 feet on the east side, adjacent to Cane Creek.

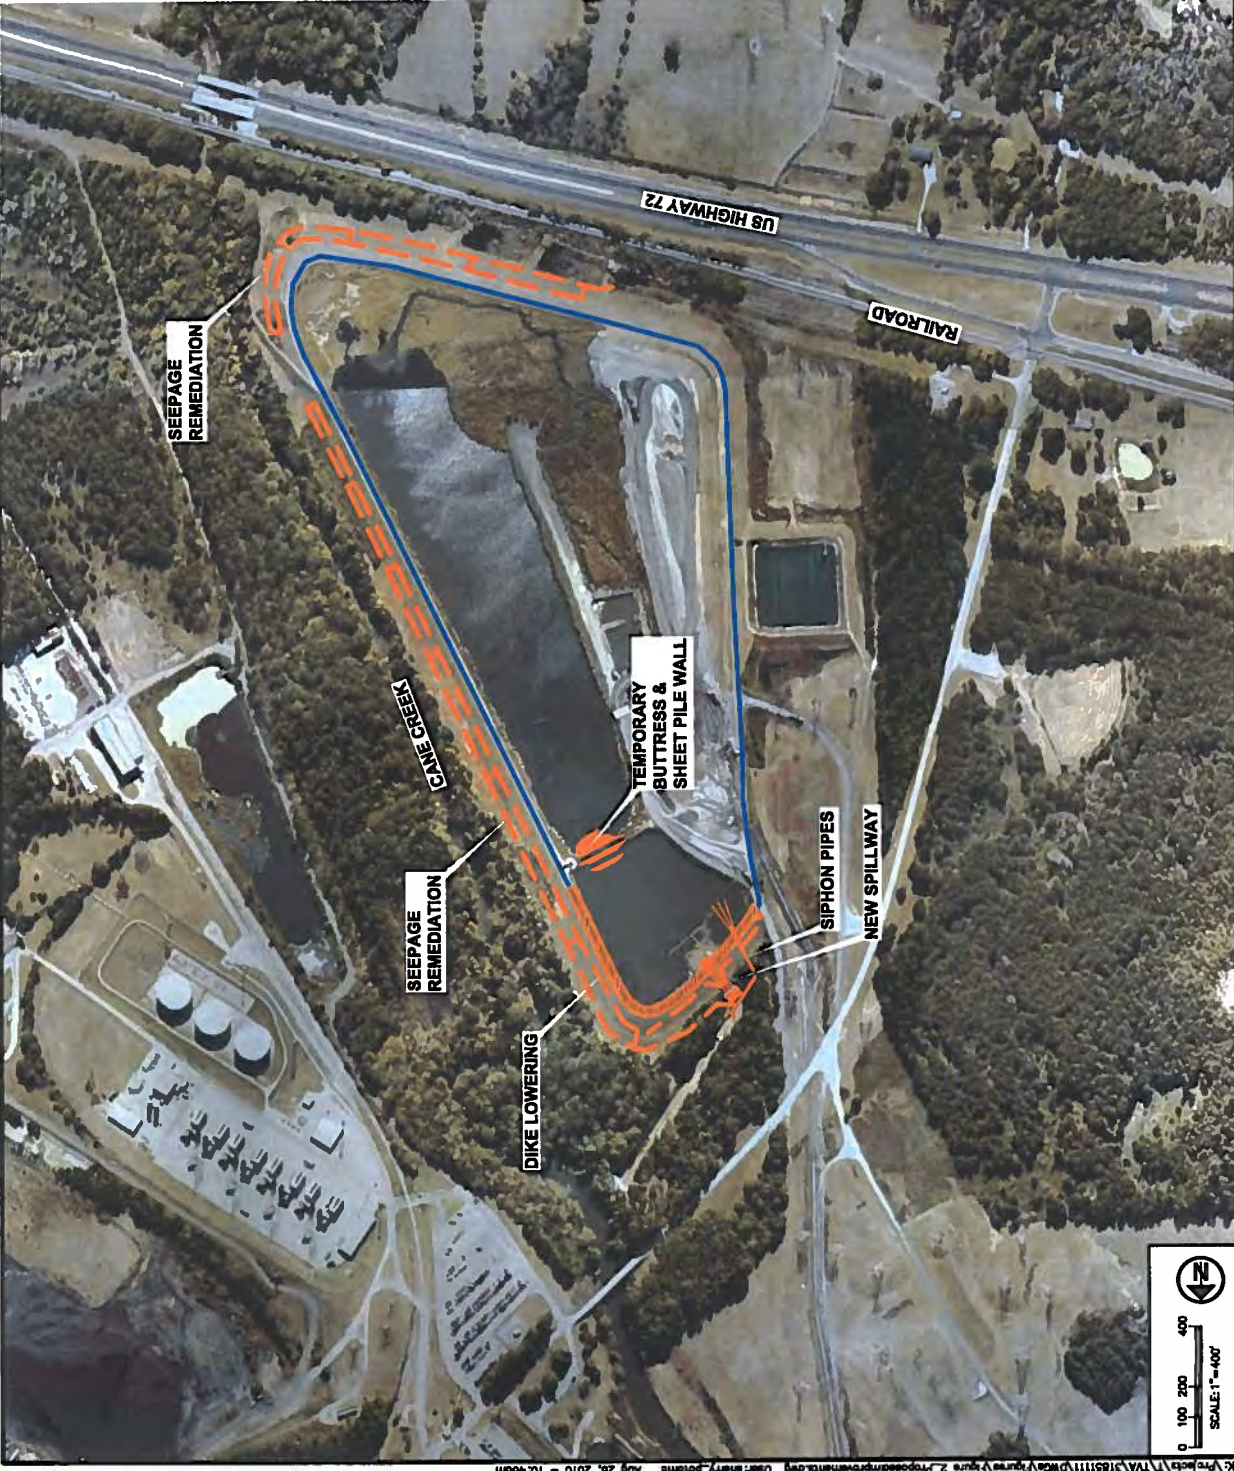
PROPOSED IMPROVEMENTS

- SEEP REPAIR LOCATION
- AREA OF DIKE LOWERING

Proposed improvements to Pond 4 include the removal of the high hazard designation, replacement of the existing spillway system, including installation of siphons, and remediation of the observed seepage on the outboard dikes. Additionally, both the high hazard removal and spillway improvements will be facilitated by the initial construction of a temporary rock buttress and sheet pile wall across the boundary between the stilling pond and the main pond. The proposed Pond 4 improvements are shown in Figure 2.

A temporary rock buttress and sheet pile wall will be constructed across the pond in the area near the finger dikes. Figure 2 shows the location of the temporary buttress and sheet pile wall. The purpose of the temporary buttress and sheet pile wall is to divide the stilling pond (north) from the main pond (south), so that the stilling pond may be temporarily lowered to facilitate construction of the new spillway system while keeping the free water volume of the main pond roughly equal with pre-construction conditions. Construction of the temporary buttress and sheet pile wall allows for temporary lowering of the water in the stilling pond to El. 447 for construction of the new Pond 4 spillway, while operating the rest of the pond at normal pool elevation (El.456.6). A sheet pile wall will be driven down the center of the buttress after fill placement is completed, and will provide hydraulic separation to allow for dewatering of the north pond. A lowered center opening section will be provided through the crest of the buttress. Inflows coming into the pond during construction will pass over this lowered section, across the buttress and into the stilling pond, ultimately being discharged to Cane Creek via the siphons.

The high hazard classification will be removed by lowering a portion of the dikes to El. 458 and lowering the long-term operating pool in Pond 4 to El. 453. Figure 2 shows the location of the dike lowering.

The new spillway was designed to replace the existing morning glory spillways. Construction of a new spillway will allow TVA to grout full and abandon the old spillways, thereby eliminating the potential for negative environmental impacts and potential property damage and loss of life should one or more of the old morning glory spillways fail. Siphons will be installed to draw down the water level to El.447 in the stilling pond for construction of the new spillway, while the water level in the main pond will be maintained near El. 456 by the temporary buttress and sheet pile. The siphons will remain in-place for emergency usage. Figure 2 shows the location of the proposed spillway and siphons.

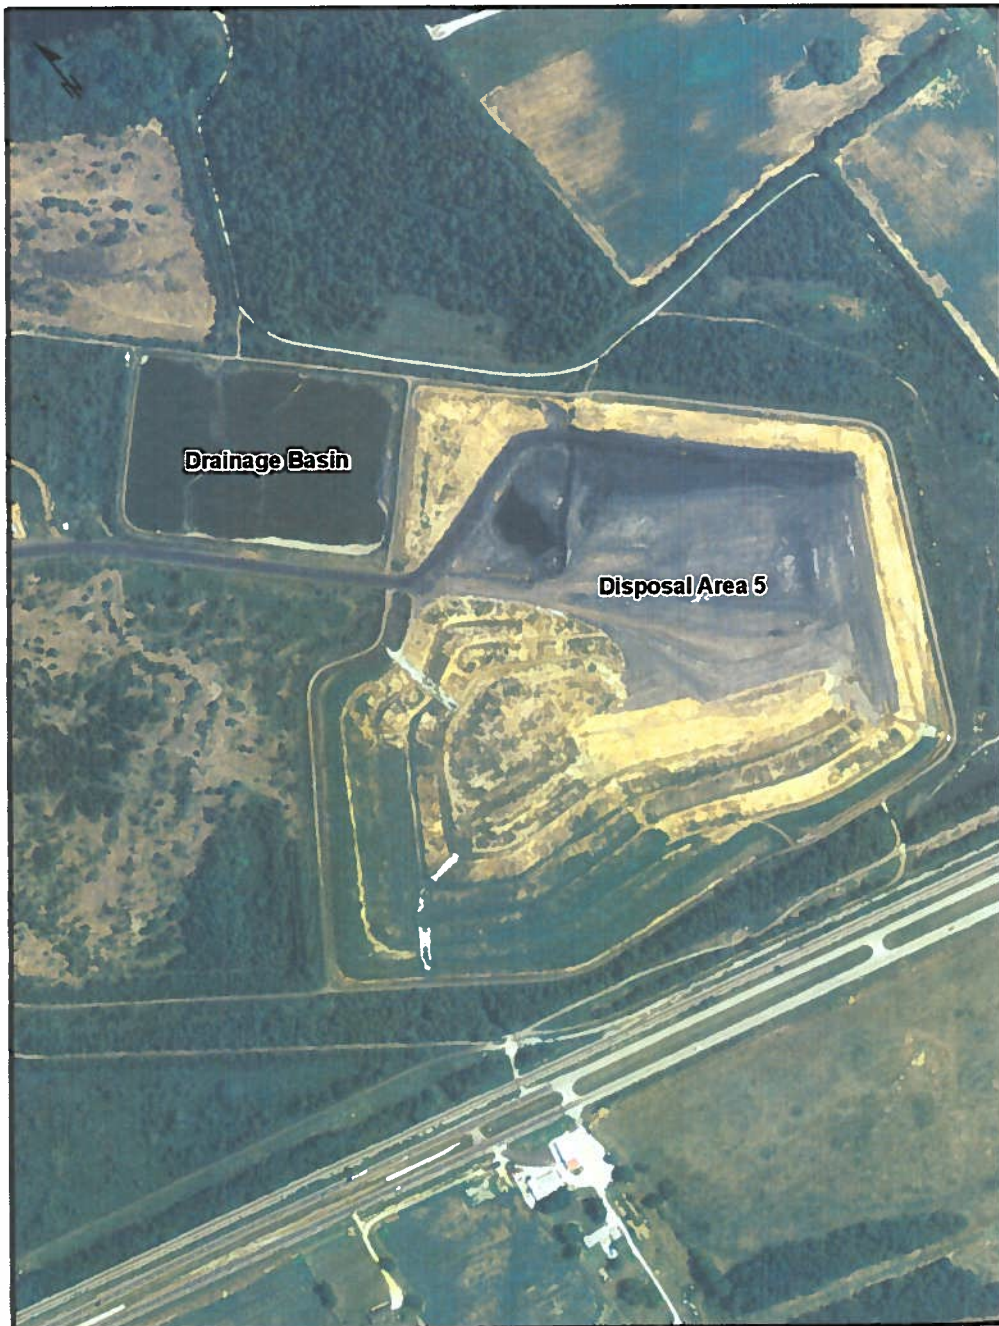
**Colbert Fossil Plant, Disposal Area 5
Tuscumbia, Alabama**

The Disposal Area 5 Dry Stack is approximately 75 acres in area, and is enclosed by a perimeter dike system that is approximately 7,500 feet in total length. The dike crest supports a gravel access road and is currently at an approximate elevation of 480 to 490 feet. The overall constructed height of the perimeter dike system varies from approximately 10 feet on the southwest side to about 30 feet at other locations. Dike slopes range from

The Colbert Fossil Plant is located in Tuscumbia, Colbert County, Alabama on the south bank of Pickwick Reservoir along the Tennessee River, approximately 50 miles west of Decatur in northwest Alabama. Disposal Area 5 is situated approximately 5,000 feet southeast of the plant's powerhouse. This disposal area is bordered by US Highway 72 to the south, the Tennessee River to the north, and a water treatment facility to the southeast. Figure 2.1 on the following page provides a plan view of Colbert's Disposal Area 5.

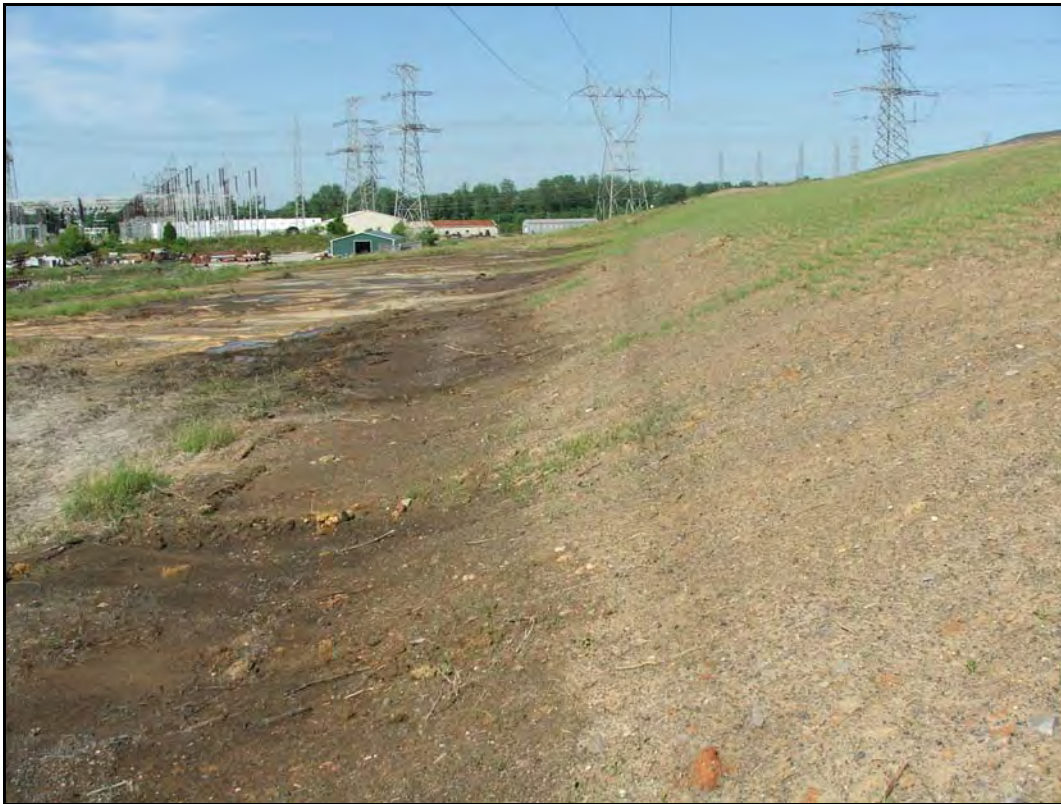
Figure 2. Example of Action Level 1 – Non-Flowing – Wet Area

Seepage occurs in all earthen dams and dikes. The key is to properly collect and control seepage in a manner that does not cause damage to the embankment. Seepage that is not flowing but is evident by damp areas or ponded water does not generally represent an imminent threat to the embankment in terms of erosion (see Figure 2). However, if left unattended this seepage can lead to slope instabilities. Therefore, this should be noted so that it can be observed for changing conditions both at the downstream observation point and immediately upstream along the interior slopes.

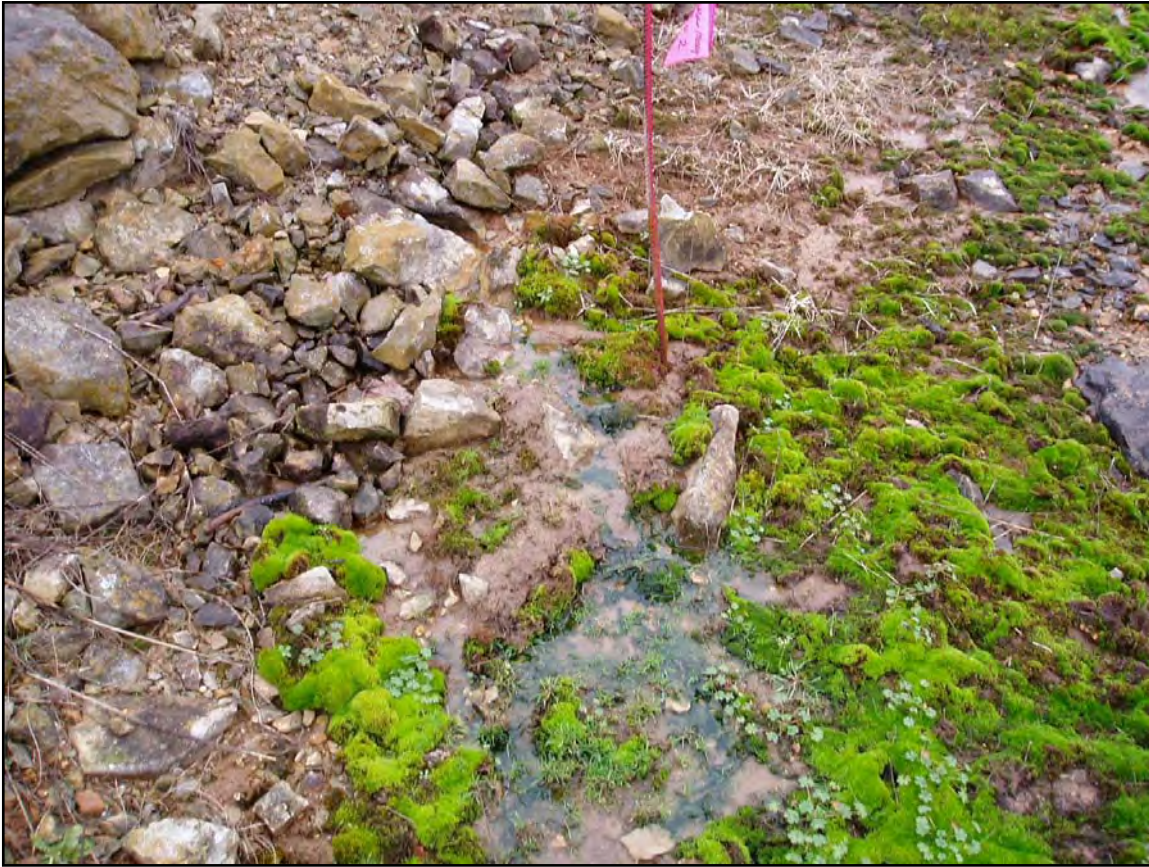
Figure 3. Example of Action Level 2 – Clear Flowing – Seepage Boil

of flowing seepage water showing no evidence of erosion is depicted in Figure 3. Note that a seep does not need to be continuously turbid for a piping situation to be forming.

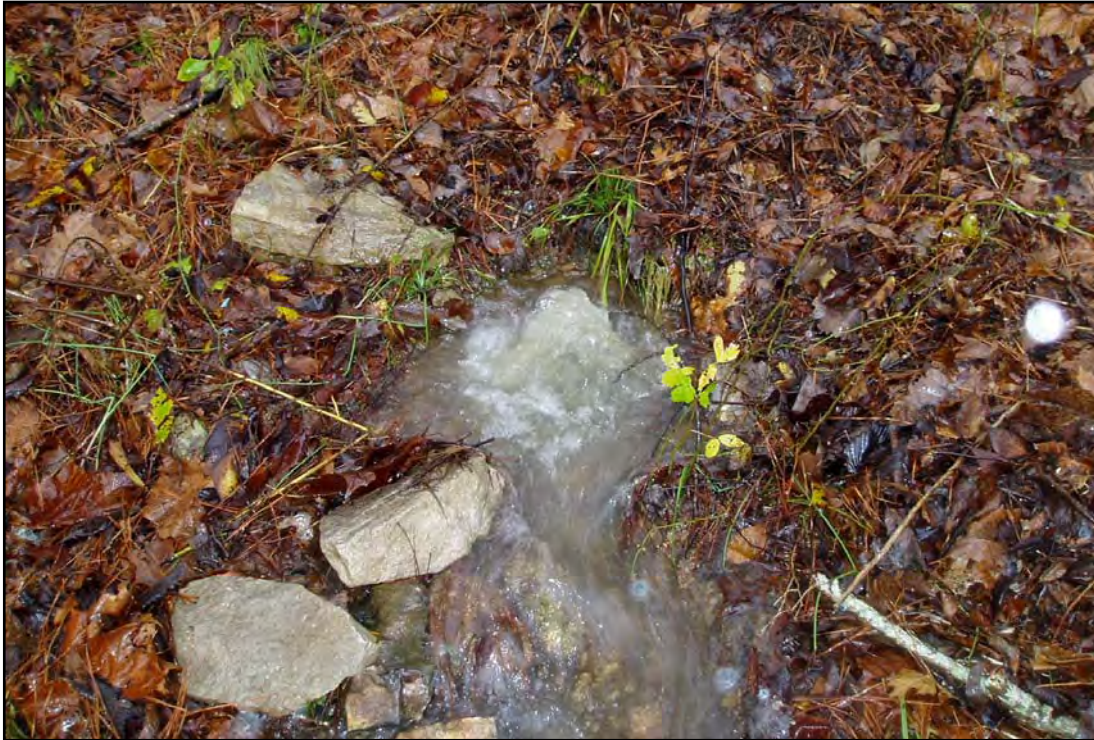
Figure 4. Example of Action Level 3 – Turbid Flowing – Seepage Boil

Left unmitigated seepage demonstrating active erosion can lead to progressive failure of the embankment and catastrophic loss of the impoundment. Evidence of erosion can be in the form of turbid flow, sediment deposition, boil, obvious hole or soil “pipe”. Evidence of erosion can be subtle and as a result, any flowing seepage should be carefully reviewed and monitored frequently. Careful attention should be given to seepage below water such as a stilling pond, creek or river (see Figure 6). This type of seepage is difficult to observe and determine if soil erosion is occurring. In moving water, evidence of seepage boils conveying embankment soil/ash materials will likely be (partially) washed away. Examples of active erosion are shown in Figures 4 thru 5.

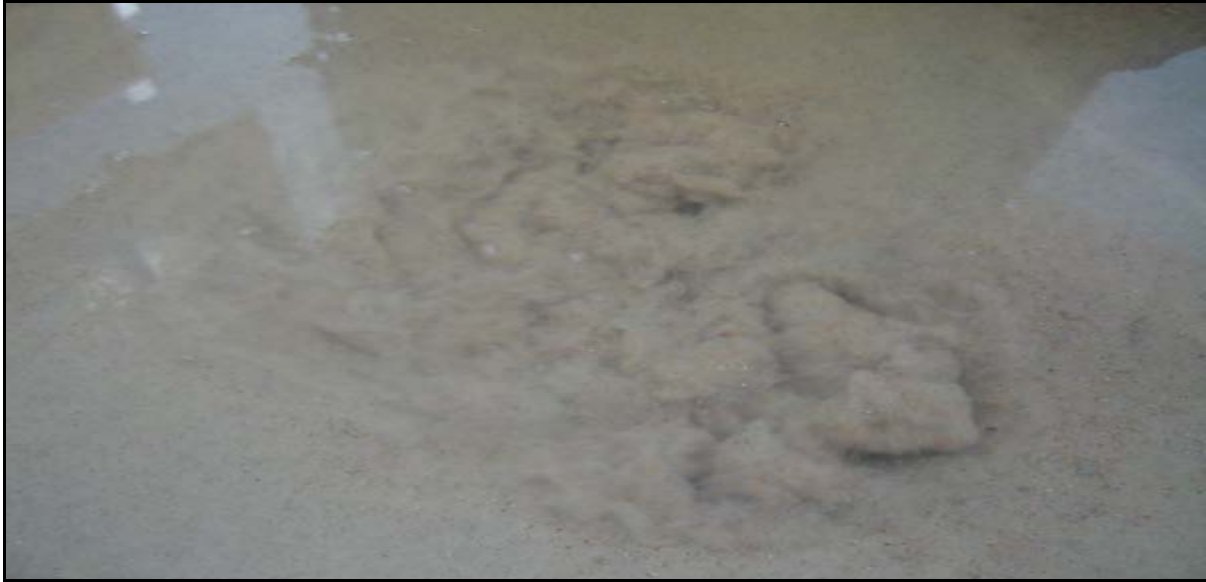
Figure 6. Example of Action Level 3 – Underwater Turbid Flowing – Seepage Boil

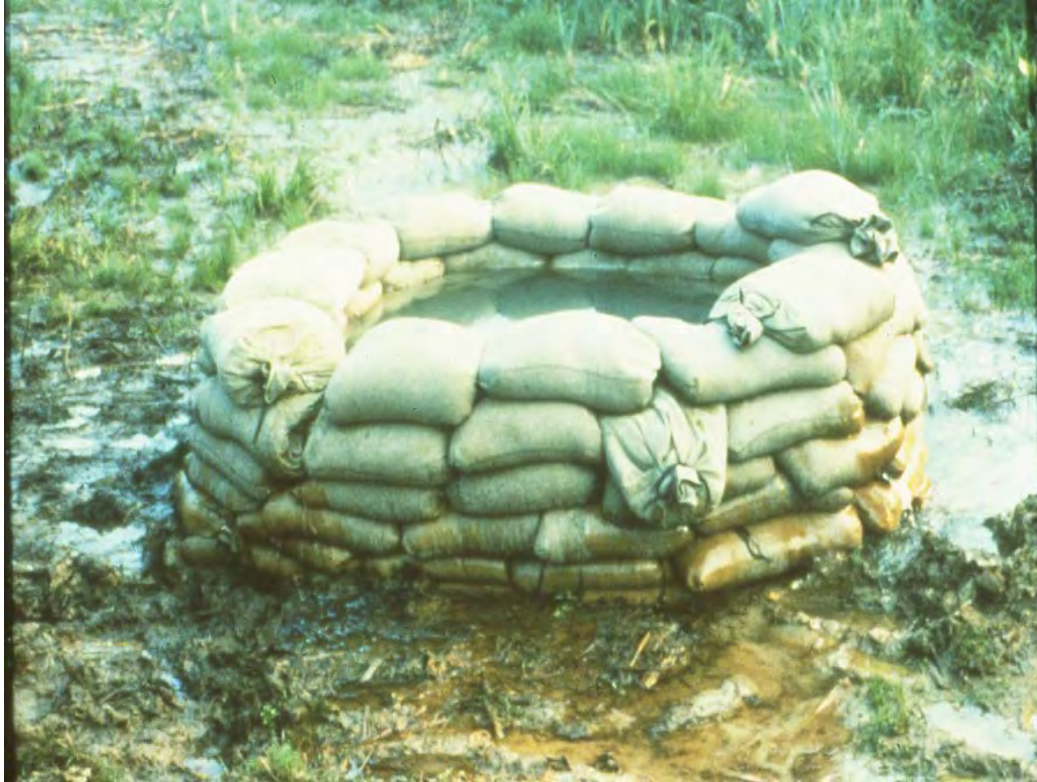
Figure 7. Sand Bag Treatment (Temporary)

- Silt Fence as required by guidance provided in the Best Management Practices for Erosion Prevention and Sediment Control
- An example of sandbagging is provided in Figure 7.
