**Coal Combustion Residue Impoundment
Round 11 - Dam Assessment Report**

Colbert Fossil Plant
Tennessee Valley Authority
Tuscumbia, Alabama

Dewberry & Davis, LLC
Fairfax, Virginia

EP-09W001727
June 2012

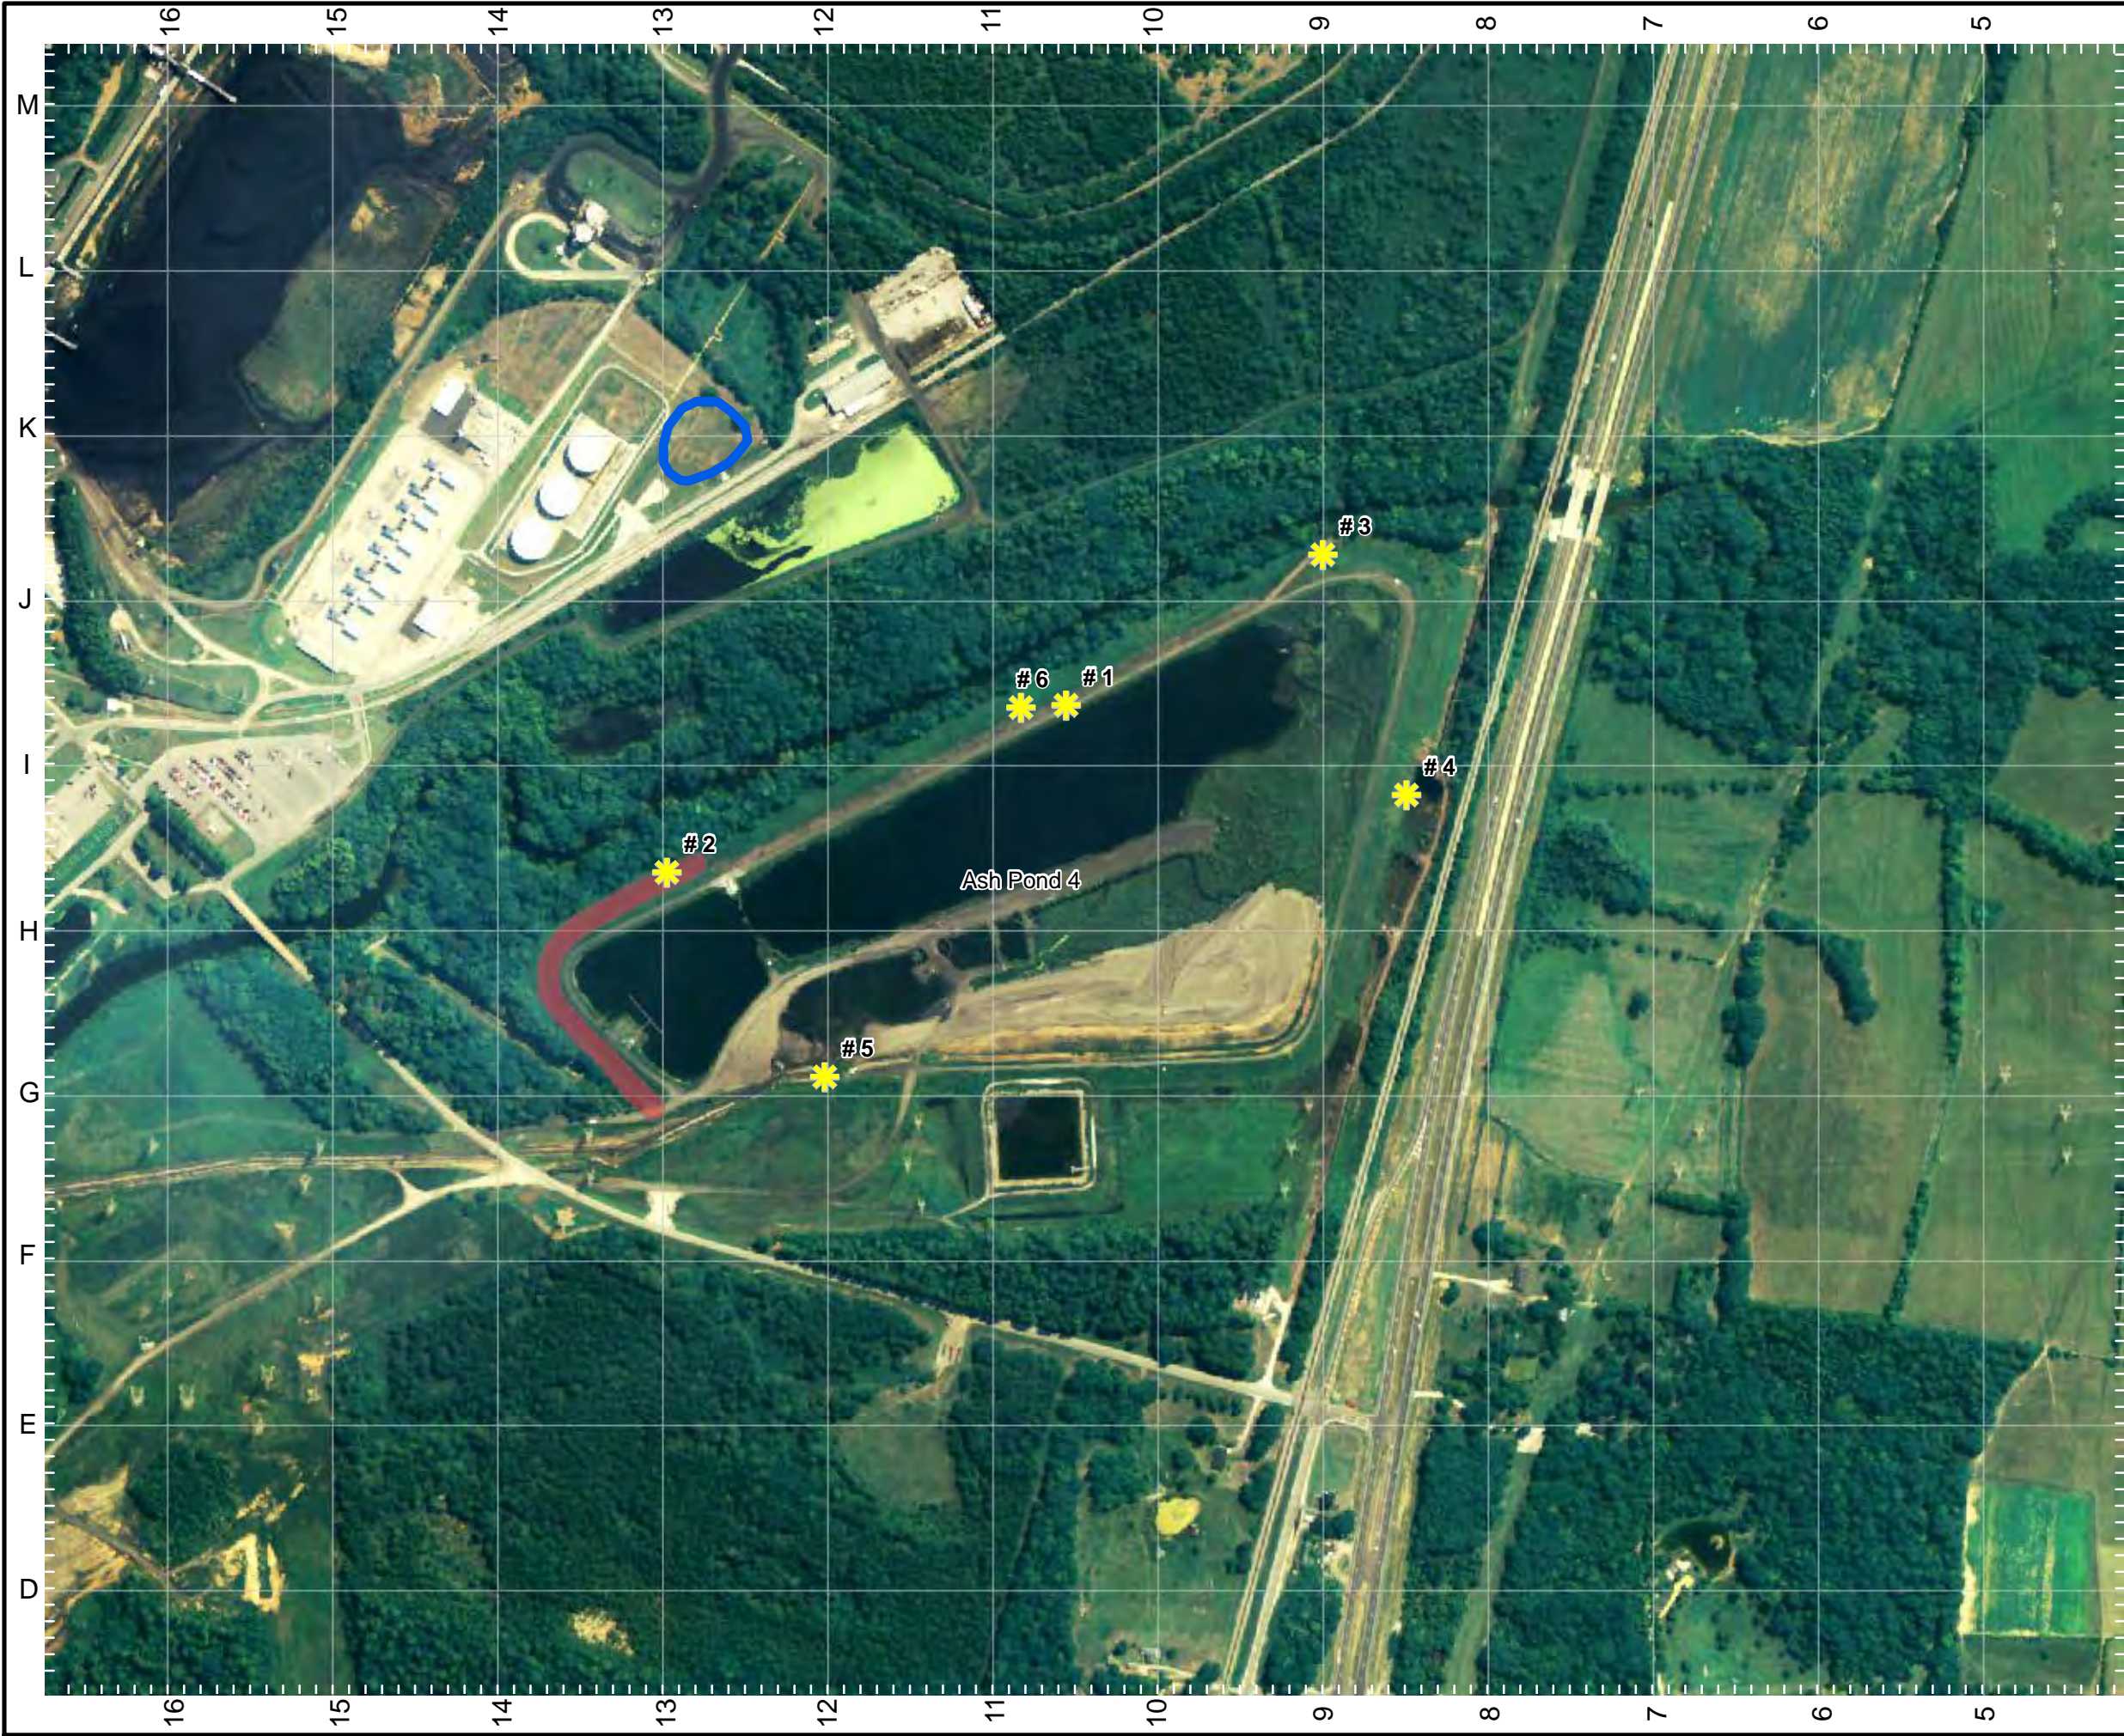
Ash Pond 4 Site Plan

Notes:
1. The areas identified on this drawing should not be considered as the only areas where seepage might occur. Therefore, a complete inspection of the dike should be performed annually as outlined in Stantec's Dam Safety Training Presentation dated August, 2009.
2. Grid spacing is 500 feet.

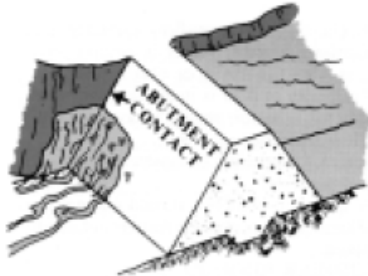
Seepage Problem	Recommendations
<p data-bbox="256 373 682 430">Seepage Water Exiting at Abutment Contact</p>

<p data-bbox="755 436 1404 646">Study leakage area to determine quantity of flow and extent of saturation. Stake out the saturated area and monitor for growth or shrinkage. Inspect frequently for slides. Water level in the impoundment may be lowered to increase embankment safety. A QUALIFIED ENGINEER should inspect the conditions and recommend further actions to be taken.</p>
<p data-bbox="240 806 695 863">Seepage Water Exiting as a Boil in the Foundation</p>

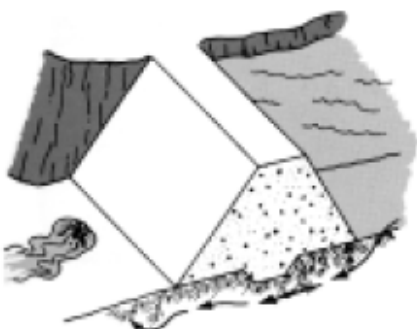
<p data-bbox="755 867 1404 1140">Examine boil for transportation of foundation materials, evidenced by discoloration. If soil particles are moving downstream, create a sand bag or earth dike around the boil. This is a temporary control measure. The pressure created by the water level within the dike may control flow velocities and prevent further erosion. If erosion continues, lower the reservoir level. A QUALIFIED ENGINEER should inspect the condition and recommend further actions to be taken.</p>

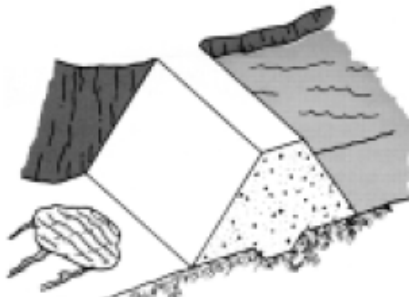
<p data-bbox="272 1299 662 1327">Spongy Condition at Toe of Dam</p>

<p data-bbox="755 1379 1404 1495">Carefully inspect the area for outflow quantity and any transported material. A QUALIFIED ENGINEER should inspect the condition and recommend further actions to be taken.</p>

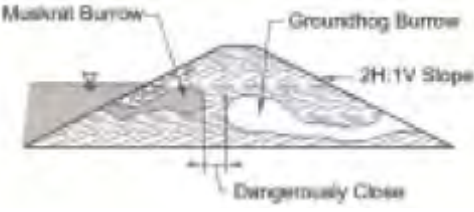
Seepage Problem	Recommendations
<p style="text-align: center;">Rodent Activity</p>

<p>Control rodents to prevent more damage. Determine exact location of digging and extent of tunneling. Remove rodents and backfill existing holes.</p>
<p style="text-align: center;">Seepage Water Exiting from a Point Adjacent to the Outlet</p>

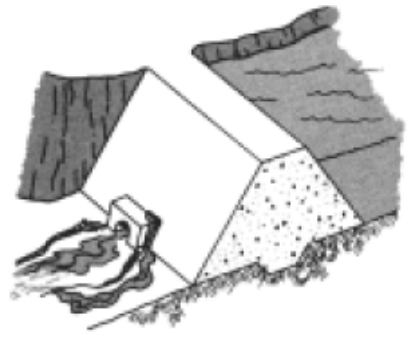
<p>Investigate the area by probing and/or carefully shoveling to see if the cause can be determined. Determine if leakage water is carrying soil particles evidenced by discoloration. Determine quantity of flow. If flow increases, or is carrying embankment materials, reservoir level should be lowered until leakage stops. A QUALIFIED ENGINEER should inspect the condition and recommend further actions to be taken.</p>
<p style="text-align: center;">Sinkhole</p>

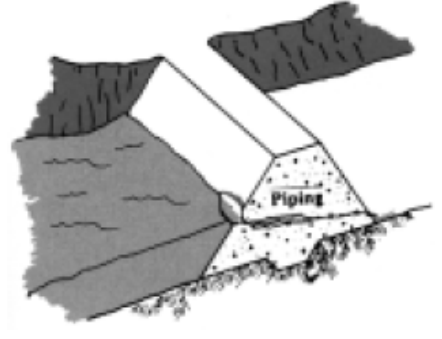
<p>Inspect other parts of the dam for seepage or more sinkholes. Identify exact cause of sinkholes. Check seepage and leakage outflows for dirty water. A QUALIFIED ENGINEER should inspect the conditions and recommend further actions to be taken.</p>

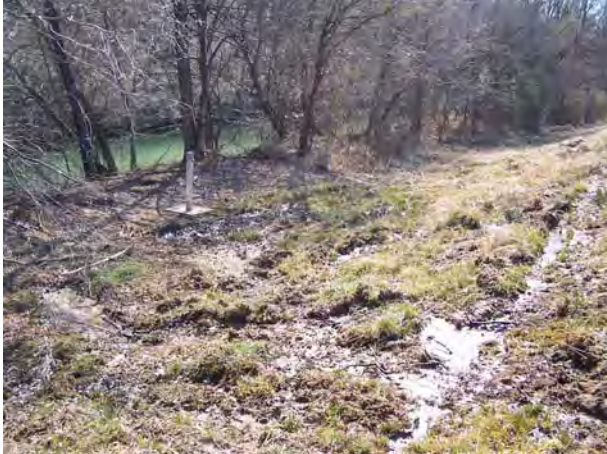
Area of Concern 1

3/9/2010 –East Dike

Typical seep area exhibiting wet/saturated ground conditions along Ash Pond 4. Photo is representative of east dike. SAP Level 2 for east side.

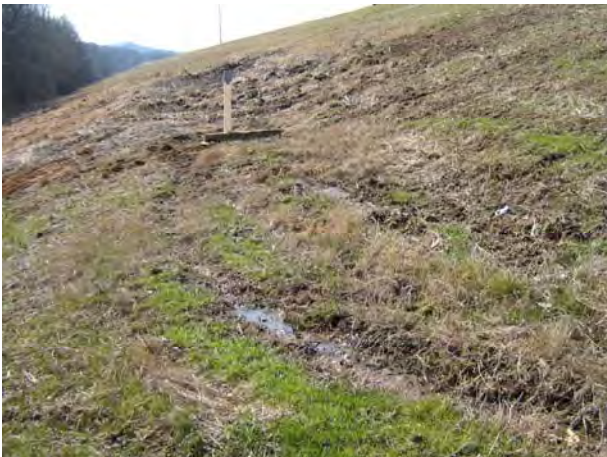
Area of Concern 2

3/9/2010 – East Dike

Typical seep area exhibiting wet/saturated ground conditions along Ash Pond 4. Photo is representative of east dike. SAP Level 2 for east side.

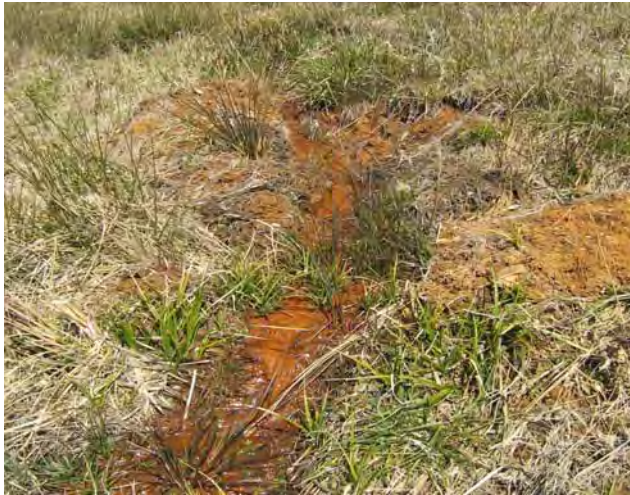
Area of Concern 4

3/9/2010 - Southeast Corner

Typical seep area exhibiting wet/saturated ground conditions along Ash Pond 4. Photo is representative of southeast area. SAP Level 2 for southeast side.

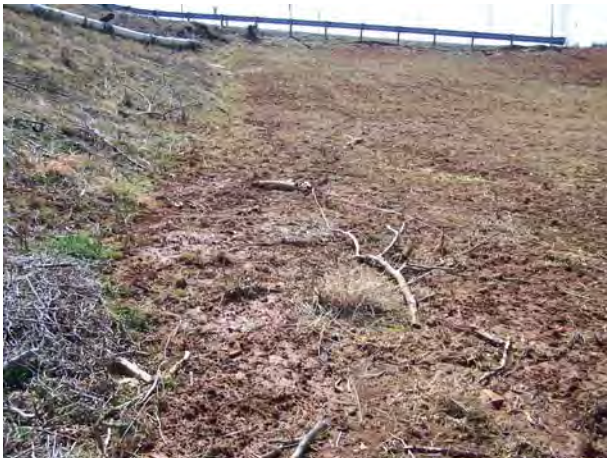
Area of Concern 5

3/9/2010 – West Dike

Typical seep area, exhibits less pronounced and widespread seepage along Ash Pond 4. Photo is representative of west dike. SAP Level 1 for west side.
