5. Lead Pigtail Removal Program

Figure 5-1, Portland Water Bureau's Progress in Removing Lead Pigtails

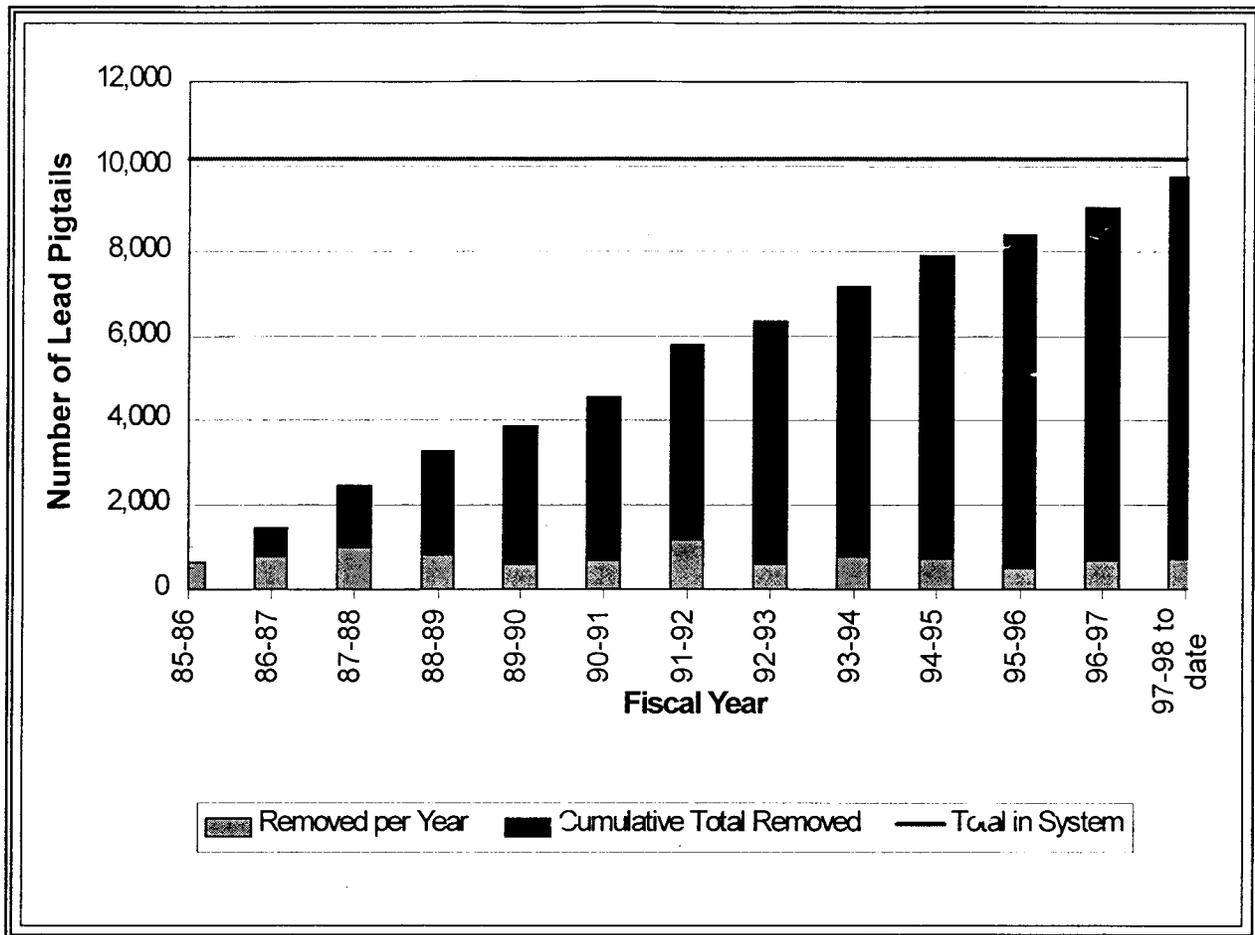
**Figure 5-1
Portland Water Bureau's Progress in Removing Lead Pigtails**

Figure 5-1 shows the Water Bureau’s progress in removing lead pigtails. Currently, there are 410 lead pigtails remaining in the system. All remaining pigtails are scheduled to be removed by no later than June 30, 1998.
