**GEOLOGIC FEATURES AND THEIR
POTENTIAL EFFECTS ON CONTAMINANT
MIGRATION, SANTA SUSANA FIELD
LABORATORY**

Howard G. Wilshire, Ph.D.

October 5, 2006

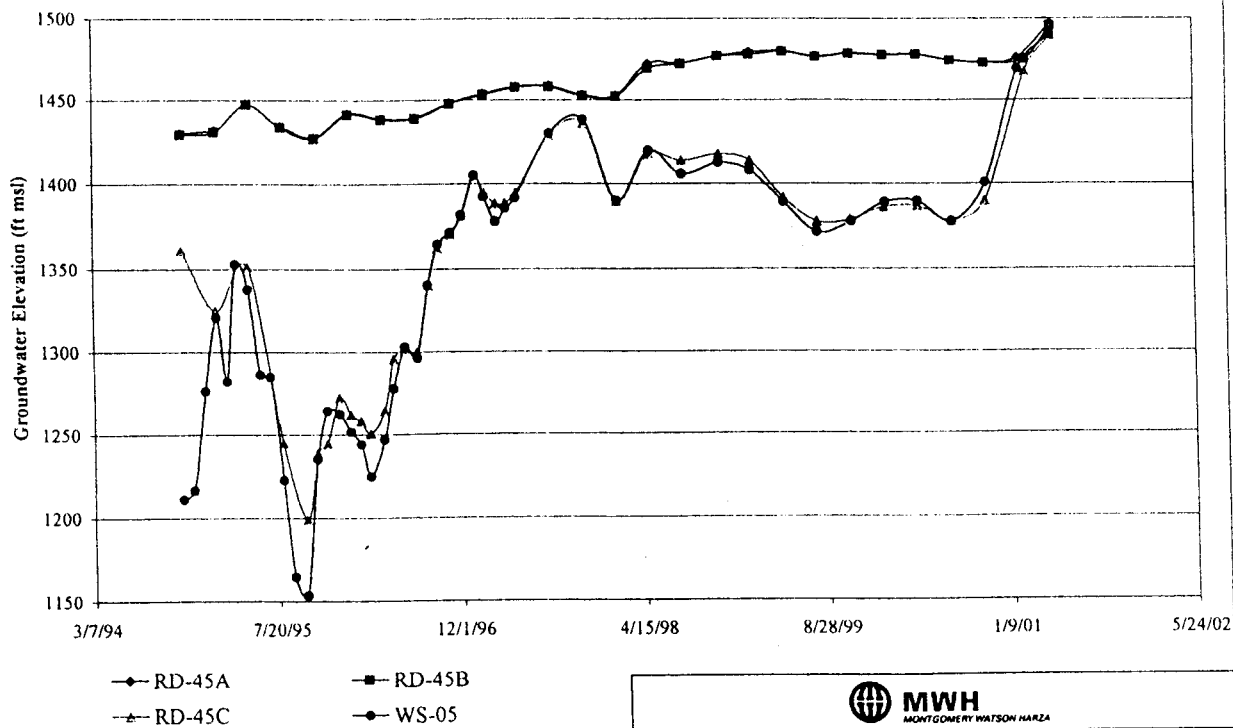
ROCKETDYNE PROPULSION AND POWER
 SANTA SUSANA FIELD LABORATORY
 VENTURA COUNTY, CALIFORNIA
LONG-TERM HYDROGRAPH OF THE RD-45 CLUSTER AND WS-5
 FIGURE 15

Exhibit 2. Hydrographs, 1994-2001, for wells WS-5, RD-45A, RD-45B, and RD-45C. From MWH, Technical Memorandum, Geologic Characterization of the Eastern Portion of the Santa Susana Field Laboratory (February 2002), Figure 15. Note faults differ from current representations.

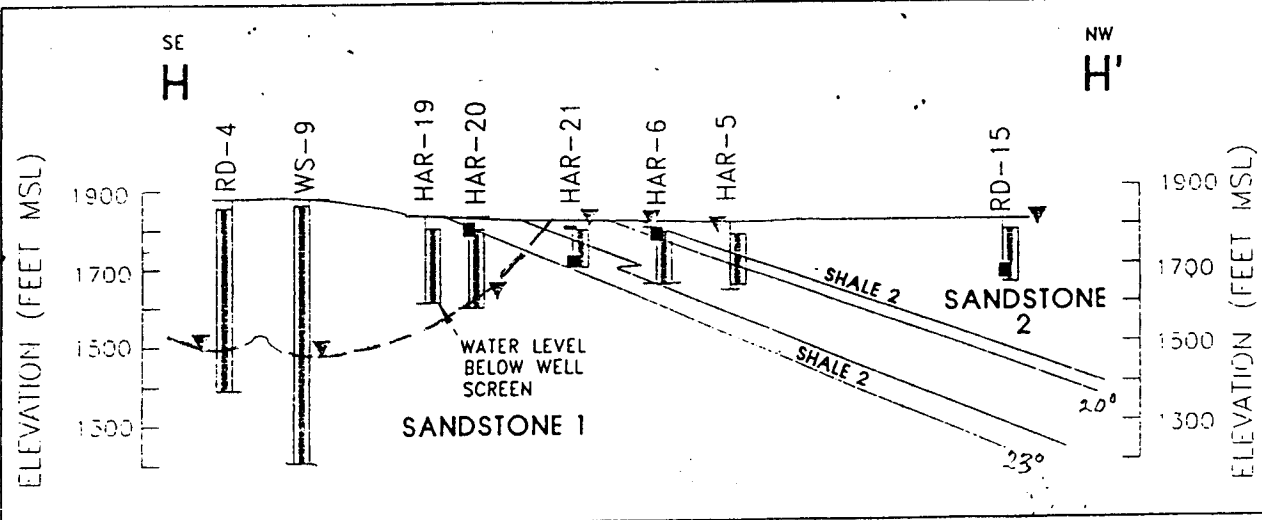
Exhibit 6. Section illustrating 200-300 feet difference in water elevations in wells screened on opposite sides of Shale 2 (from MWH, Technical Memorandum, Geologic Characterization of the Eastern Portion of the Santa Susana Field Laboratory (February 2002), p. 5-1). Note section line is viewed toward the south, contrary to normal practice.

Exhibit 6 illustrates the case that Shale-2 acts as an aquitard between Sandstones-1 and -2 (old designations), as seen in water levels in wells RD-4, WS-9, HAR-19, and HAR-20 screened in Sandstone-1, and HAR-21, HAR-6, HAR-5, and RD-15 screened in Sandstone-2. Wells RD-4 and WS-9 are pumped wells with water levels governed by long-term extraction. Wells screened in Sandstone-2 are about 200 to 300 feet higher than those screened in Sandstone-1. It should be noted that the section in Exhibit 6 is viewed toward the south, contrary to normal practice.⁹⁵ The section does not position HAR-20 and HAR-21 consistently with the rather complex representation of Shale-2 in Fig. 2-9 of the Near-Surface Groundwater study. In addition, the well distribution is a shotgun pattern, but no information is given on how the wells were projected to the section line. It also is not clear why other wells in the area were not used to assess the water level differences—wells not used that might represent Sandstone-1 conditions include RD-49A, RD-49B, RD-49C, and C-5, and those that might represent Sandstone-2 conditions, but which were not used, include HAR-22, HAR-23, and RD-16.

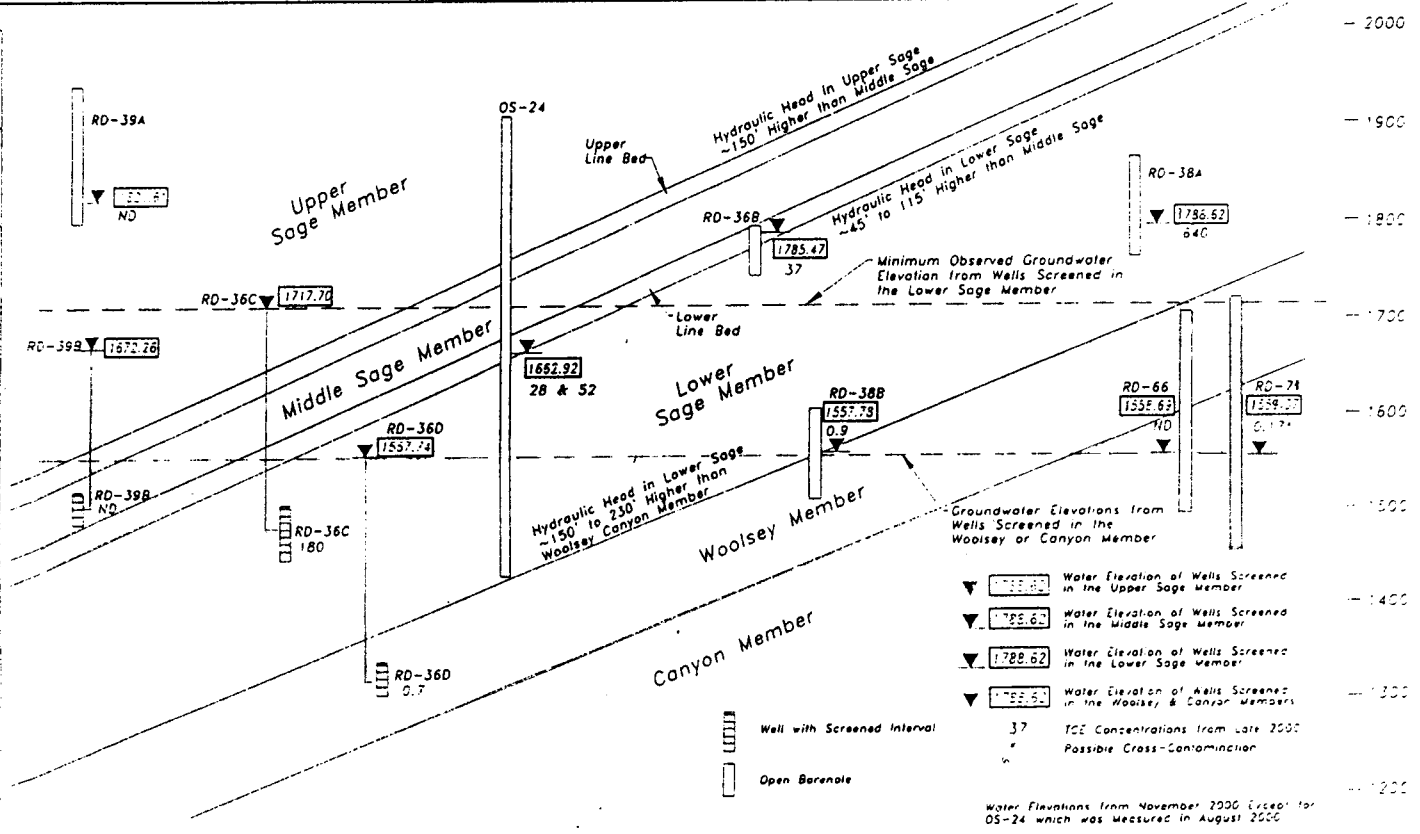
Exhibit 7. Diagrammatic representation of the stratigraphic positions of open intervals for wells RD-39A, RD-39B, RD-36C, RD-36D, OS-24, RD-36B, RD-38B, RD-38A, RD-66, and RD-71 (from MWH, Technical Memorandum, Geologic Characterization of the Eastern Portion of the Santa Susana Field Laboratory (February 2002), p. 5-6).
