NPDES Industrial Storm Water Investigation and Case Development Worksheet

National Database Information		General	
Inspection Type	Industrial Stormwater	Inspector Name	Rick Sakow, US EPA, R9
WDID Number	GUR05A267	Telephone	(415) 972-3495
Inspection Date	July 18-19, 2013	Entry Time	9:47 AM, July 18, 2013
Inspector Type	Clean Water Act and RCRA Hazardous Waste	Exit Time	11:55 AM, July 19, 2013
Facility Type/SIC	SIC 3731, Shipbuilding and Repair	Signature	<i>Rick Sakow</i> 11/2/2013

Facility Location Information				
Name/Location/ Mailing Address	Guam Shipyard Building 20 Sumay Drive Sumay Cove Santa Rita, GU 96915			
GPS Coordinates (as measured in Google Earth Pro)	Latitude	133°26'20.21" N	Longitude	144 39' 49.08" E
Receiving Water(s)	Apra Harbor			
	Name	Telephone		
Owner	U.S. Navy owns the property and subleases it to the Guam Economic Development and Commerce Authority, which subleases the land to Guam Shipyard.			
Operator	Mathew Pothen, President and CEO		(671) 339-1637/58

Guam Shipyard (facility) is located at Point Orote across the entrance into Apra Inner Harbor from Polaris Point in the Territory of Guam. Storm water runoff discharges into Inner and Outer Apra Harbor thro

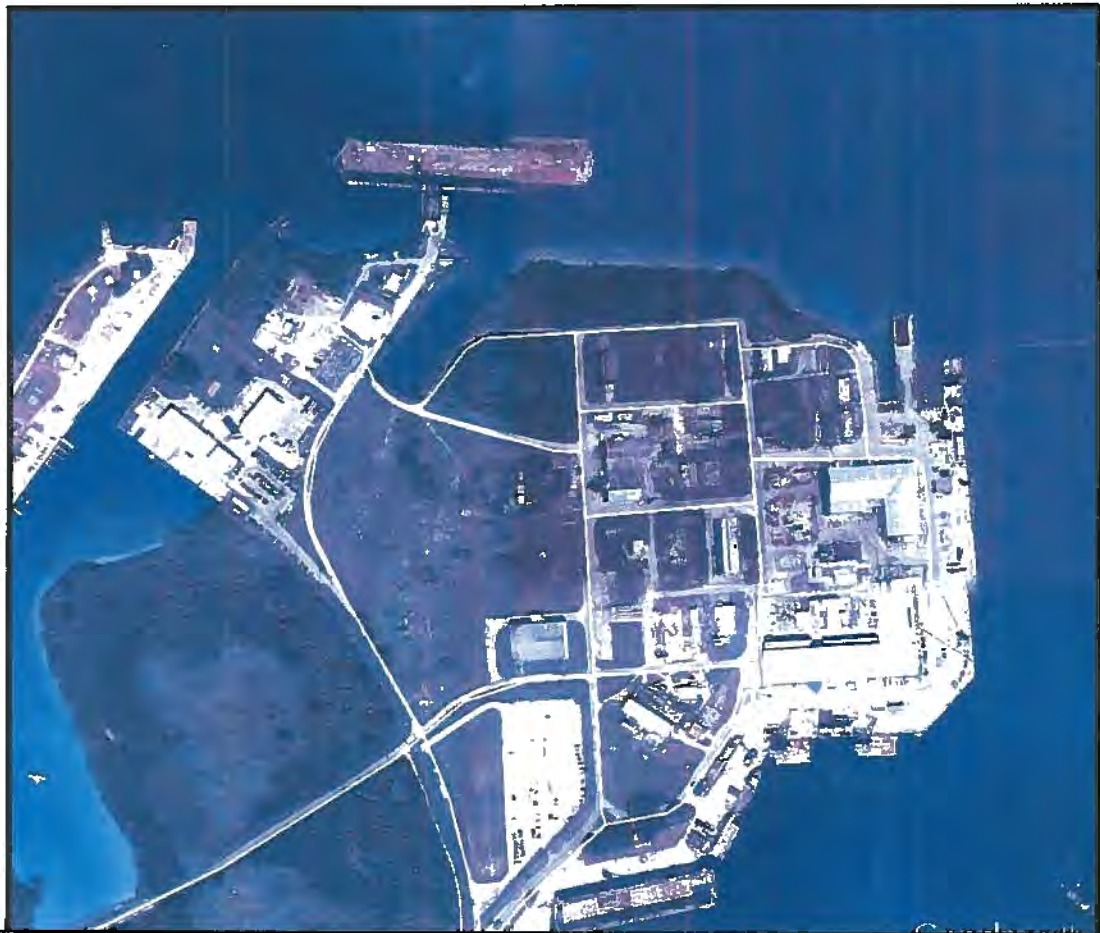
Below is a Google Earth Pro aerial photograph of the Guam Shipyard. This aerial was taken March 27, 2013. A site map of the facility has been included in Attachment 4.
