**ENFORCEMENT CONFIDENTIAL  
NEIC WORK PRODUCT NO. VP0989E01**

**INSPECTION AND SANITARY SURVEY REPORT  
FOR THE  
GUAM WATERWORKS AUTHORITY  
PUBLIC WATER SYSTEM  
Guam, United States Territory  
April 23 – May 4, 2012**

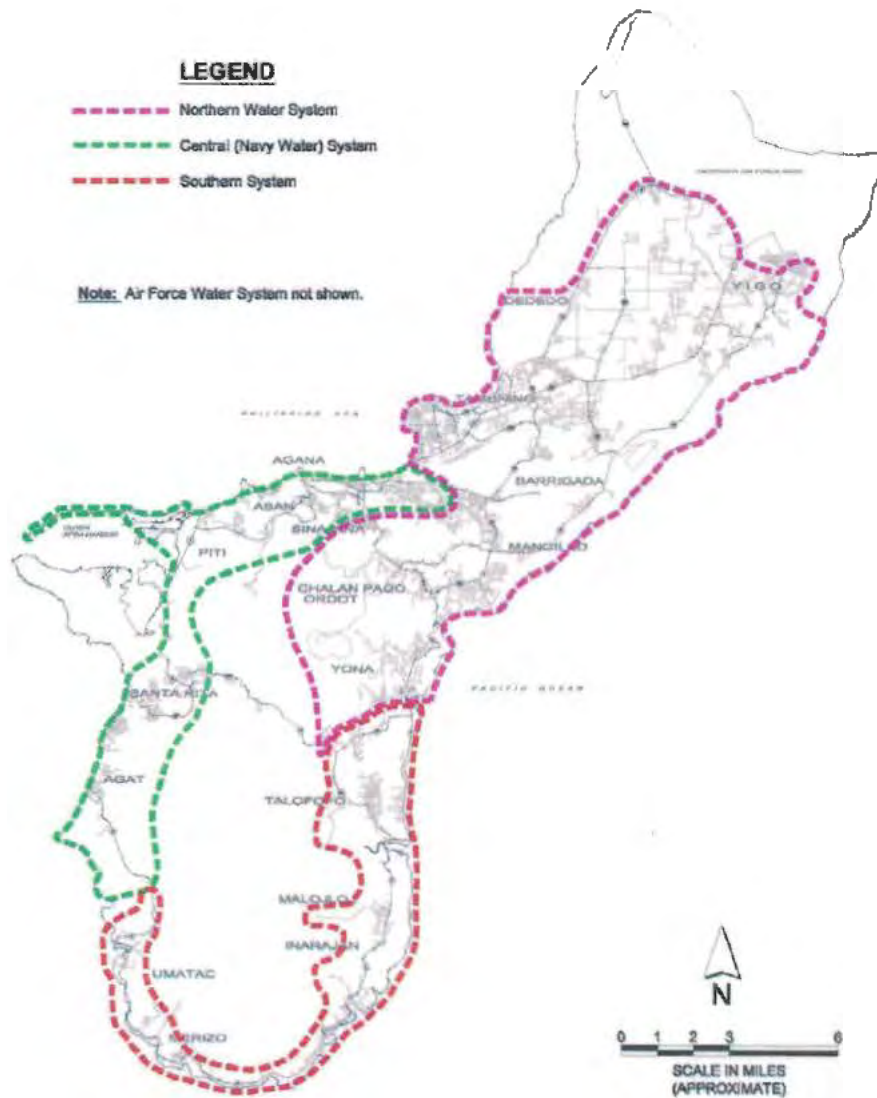
Figure 2 illustrates the boundaries among the GWA Northern, Central and Southern PWS. Note that the boundaries illustrated in Figure 2 are inexact insofar as the three GWA PWS have potential overlaps of service areas that result from the utilization of different sources over time. More information concerning service overlaps can be found in the GWA Master Plan.

**Figure 2. GWA PWS Boundaries**  
Project Name  
Location  
Source: GWA Master Plan
