CHALLENGES OF MEDIUM CRUDE OIL SPILLS IN SPRING RUNOFF CONDITIONS

April 29, 2009

SWAT Consulting Inc.

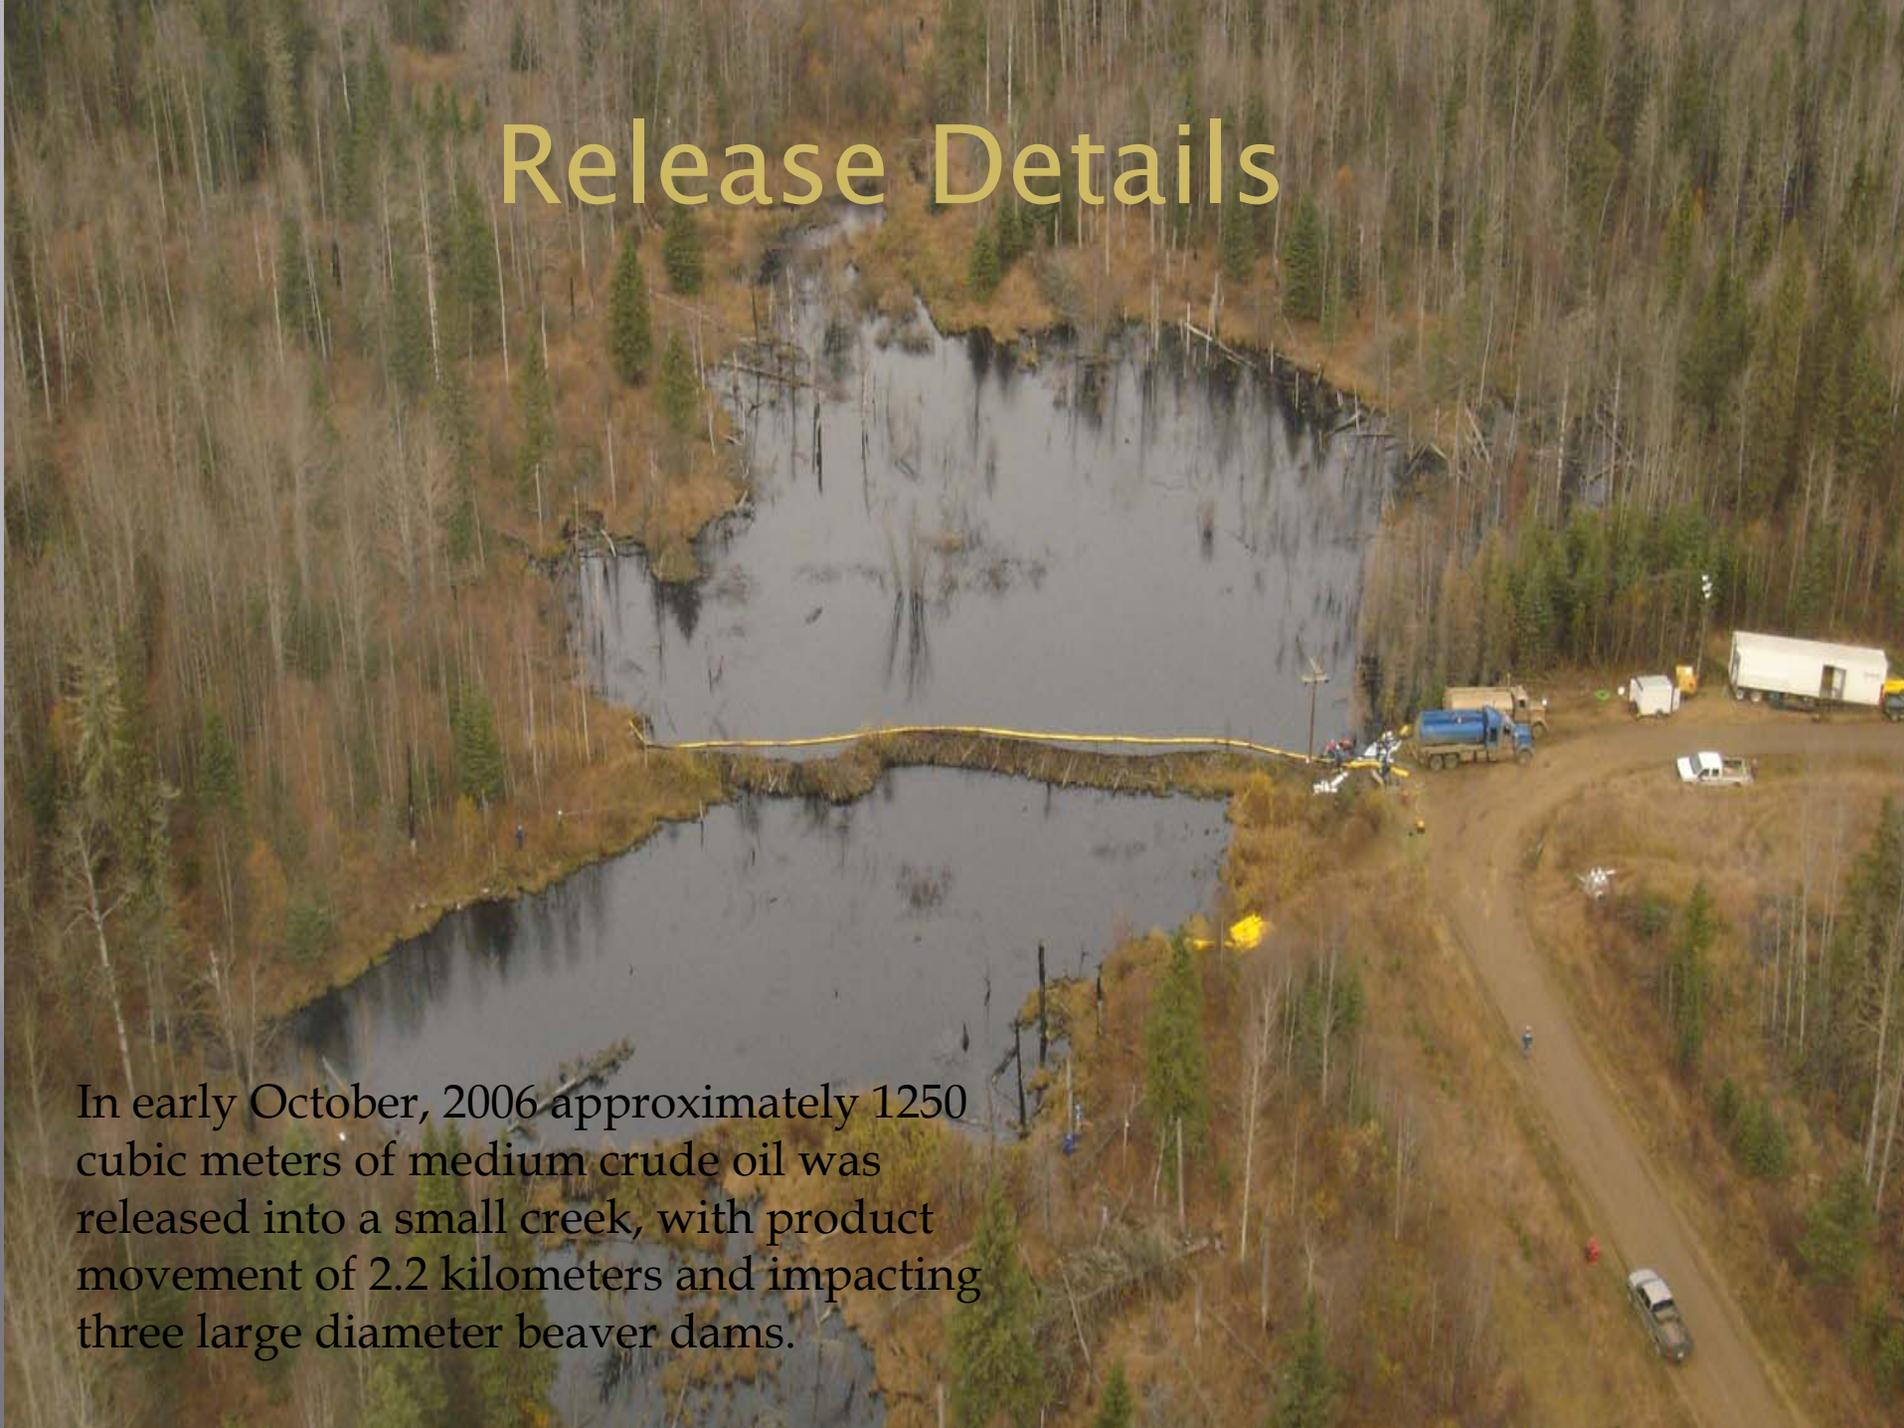
Release Details

An aerial photograph showing a large body of water, likely a creek or small lake, surrounded by a dense forest. A yellow containment boom is stretched across the water, separating a section of the water from the rest. On the right side of the image, there is a dirt area with several vehicles, including a blue tanker truck, a white trailer, and a white car. The water appears dark and still, reflecting the surrounding trees. The overall scene suggests an environmental remediation or containment operation in a wooded area.

In early October, 2006 approximately 1250 cubic meters of medium crude oil was released into a small creek, with product movement of 2.2 kilometers and impacting three large diameter beaver dams.

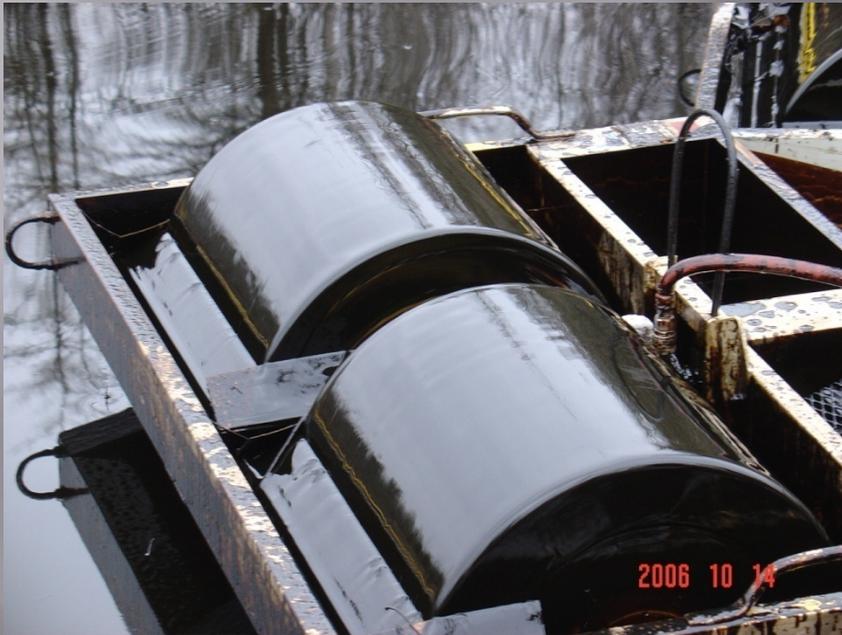
Initial Containment and Recovery

- During the fall of 2006 approximately 1215 cubic meters of crude oil was recovered and accounted for using conventional recovery techniques, such as pumps, skimmers, vacuum units and absorbents, or remained at the break site.

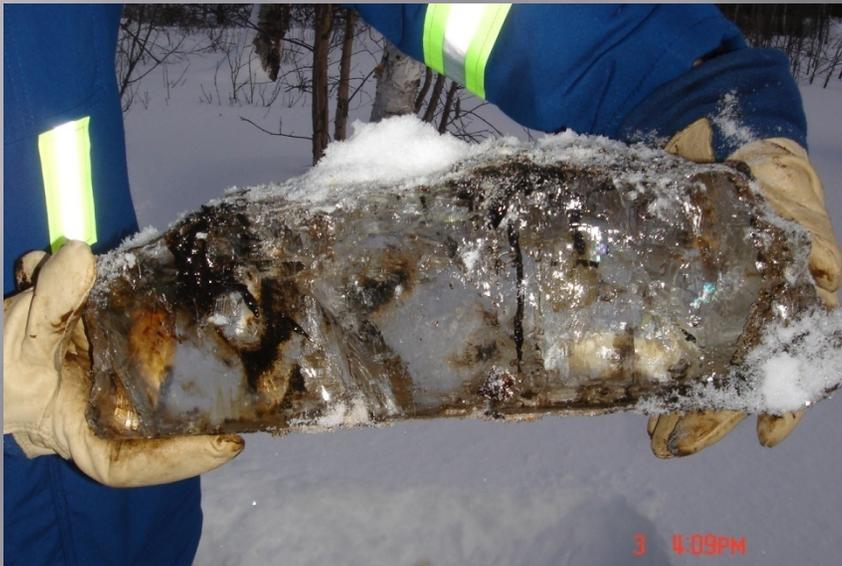
Winter Preparation

- ▣ A small volume (35m³) of free product remained under the ice as the water froze. The site was secured for the winter utilizing six soil constructed inverted weirs within the creek system. Portions of the beaver dams were removed to confine the flow of the creek to a central channel.

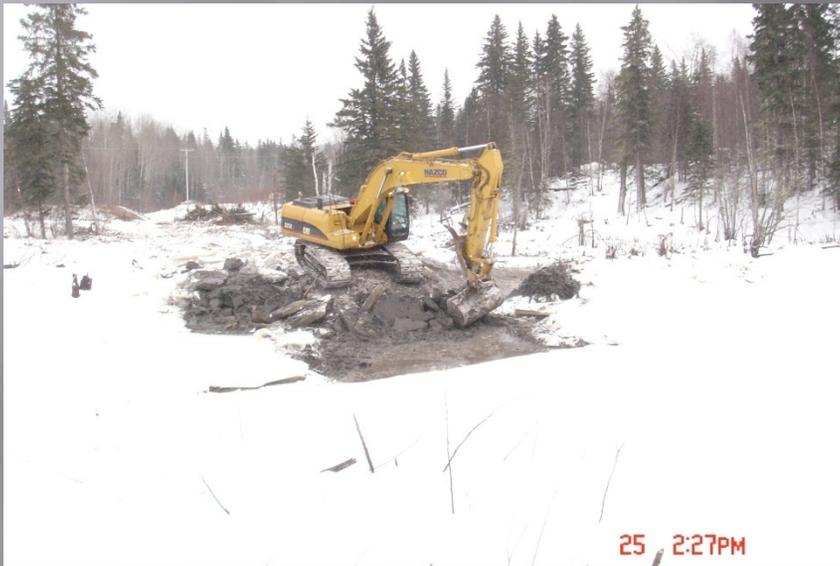
Beaver Dam Removal

- ▣ Selected breaching of the beaver dam allowed us to direct the flow of the creek to a central channel. This also gave us the capacity regulate downstream water levels by plugging the breach points as required.

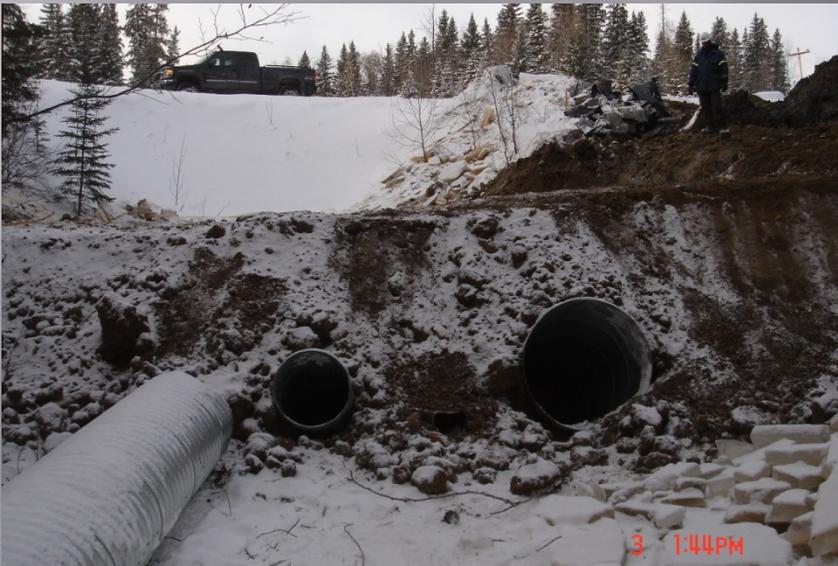
Challenges

- ▣ To ensure sufficient flow rates, all of the weir discharges were built larger than the culverts within the engineered roads on the same creek.

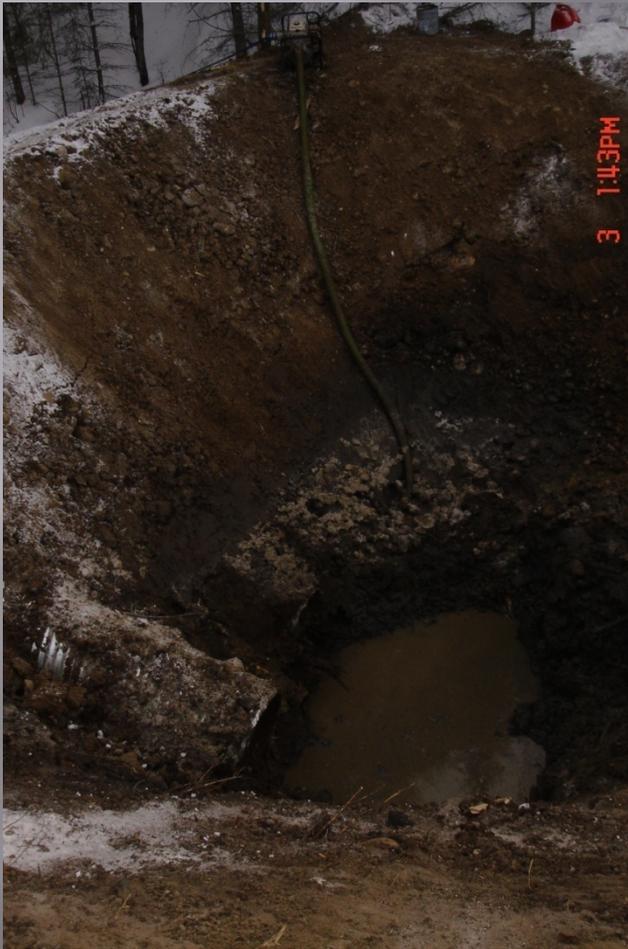
Challenges

- ❑ As the native soils were too porous, so soil was brought in to insure the integrity of the weirs.
- ❑ Large retention ponds were built upstream to allow dissolved hydrocarbons time to settle out of the water column.

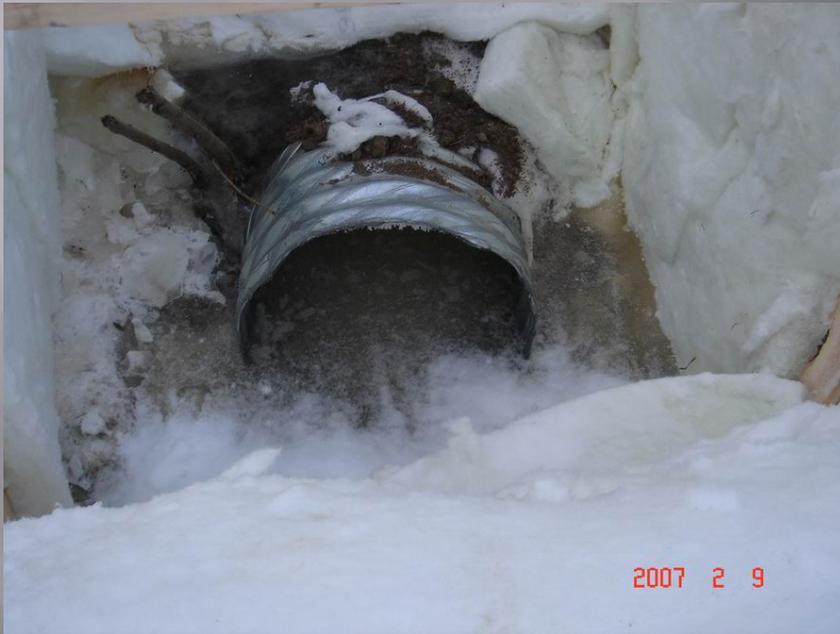
Challenges

- ❑ Cold temperatures caused the weirs to freeze off. This allowed water levels to rise upstream of the weirs compromising the weirs capacity and integrity.

- Insulated weir houses with catalytic heaters were constructed. This allowed us to regulate the temperature at the weir discharge.

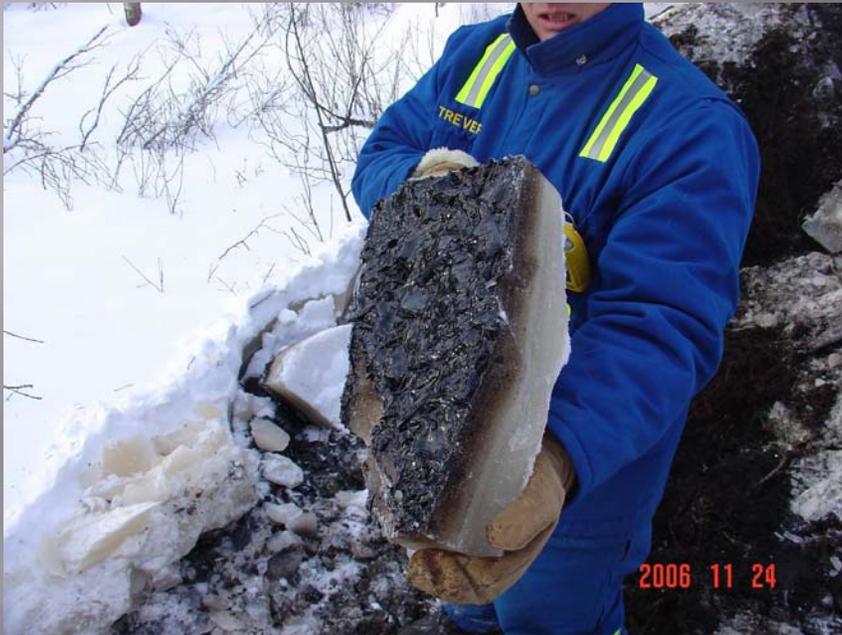
Challenges

- ▣ With the creek confined to the central channel some free product was left stranded under the ice. Come spring, the thawing ground would allow product to impact soils.

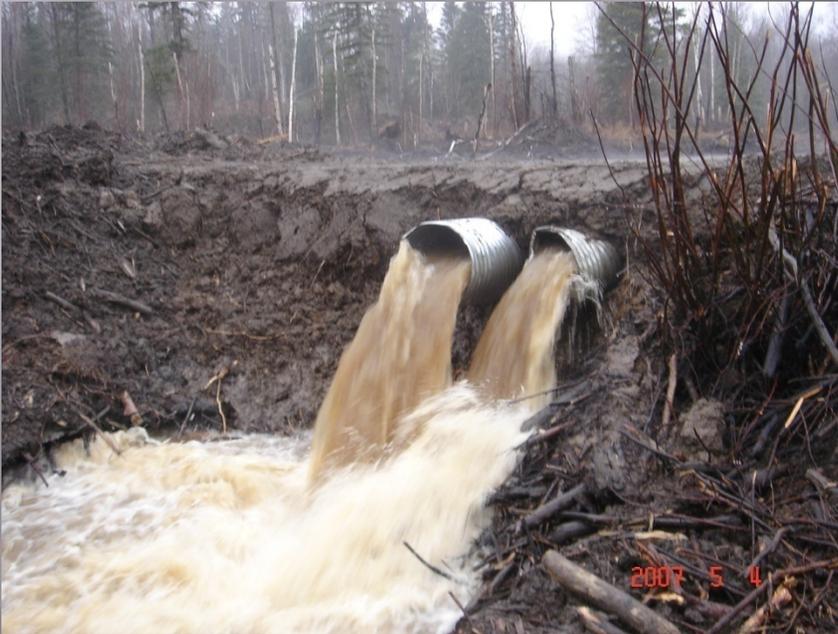
Spring Run Off

- Spring run off and heavy precipitation resulted in a one in ten year flood. During the flood the challenges of containing the residual hydrocarbons consisted of site safety, maintaining water levels, ensuring the structural integrity of the weirs and access roads, maintaining surface containment and managing woody debris.

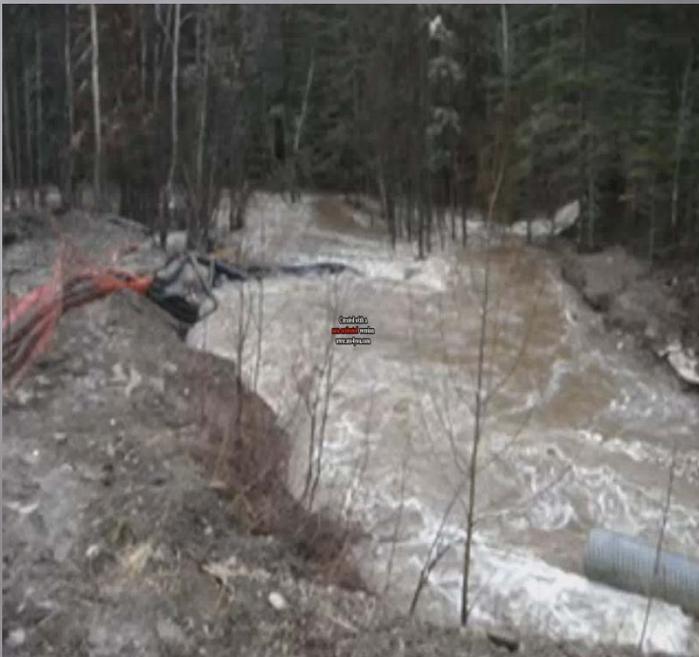
Challenges

- ▣ Spring runoff and heavy rains caused water levels to rise on average 30 cm per hour.

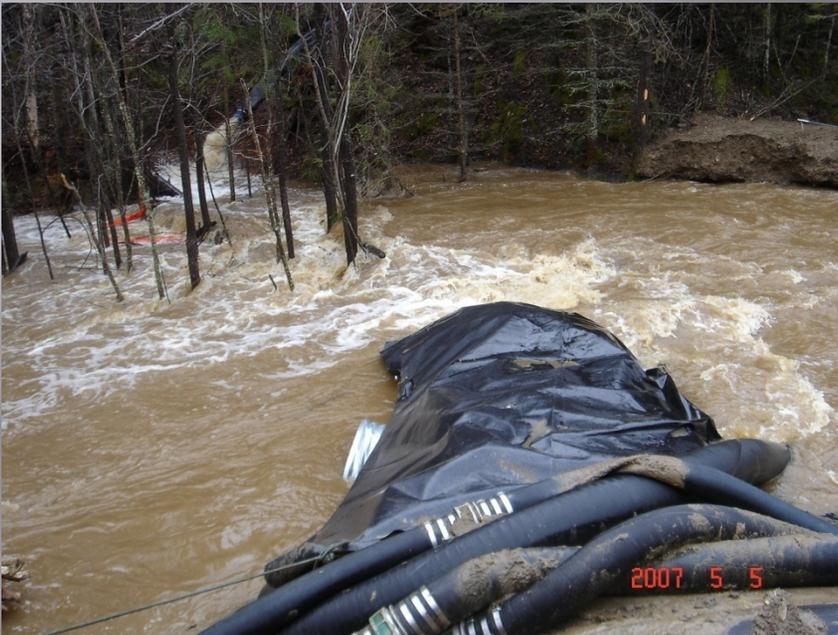
Challenges

- ▣ Severe fluctuations in water level made weir containment unreliable.

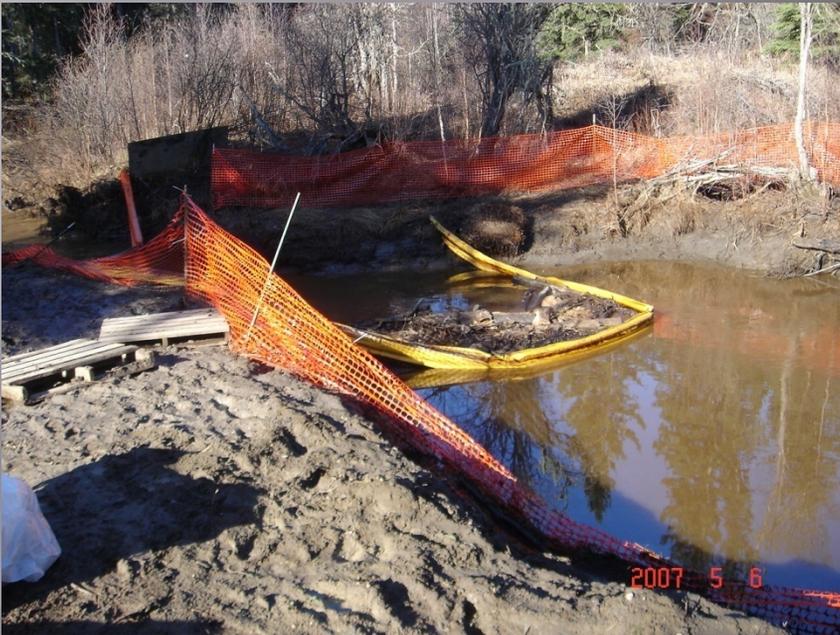
Challenges

- ▣ Flood conditions brought large quantities of woody debris down stream threatening surface containment.

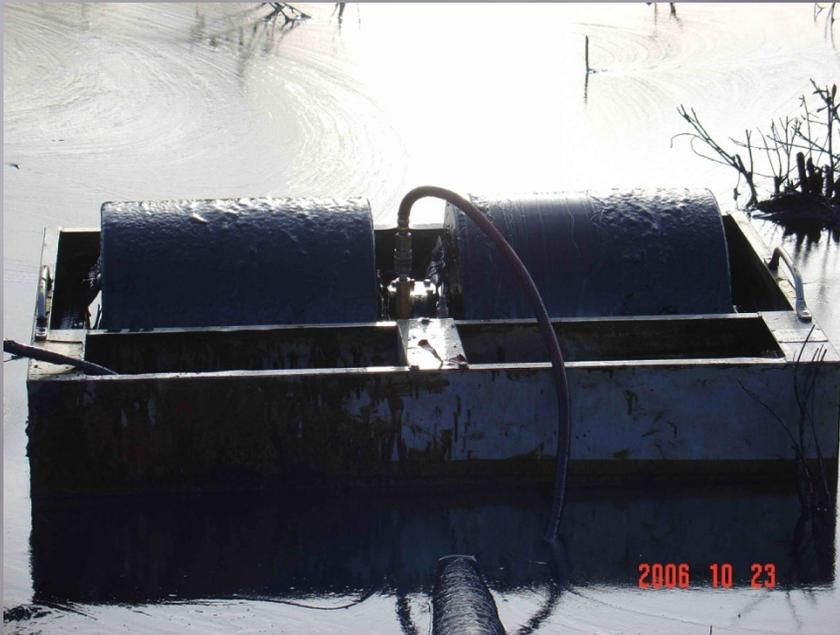
Challenges

- ▣ Remote location and poor access made sending impacted equipment out to be decontaminated extremely difficult.

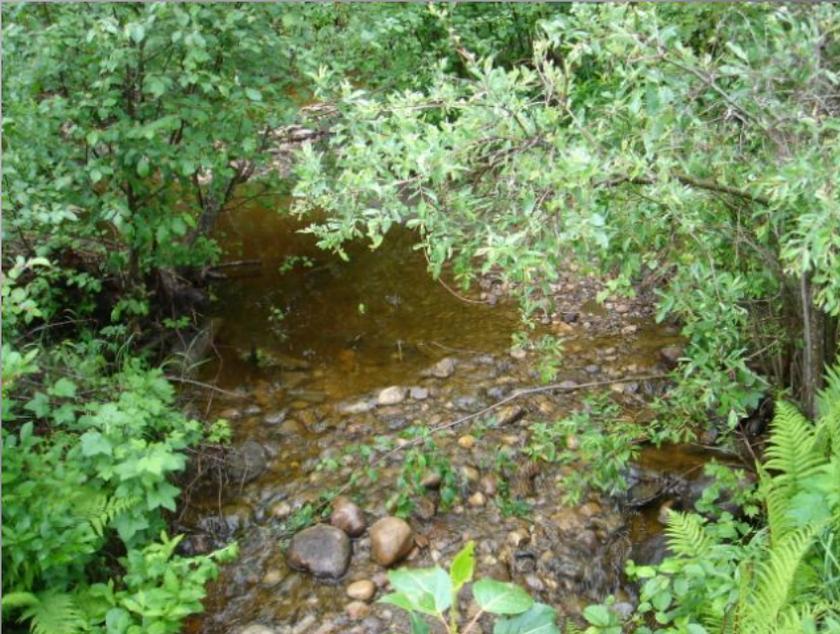
Final Phase

- ▣ Post flood operations consisted of the treatment of shoreline impact, impacted soil removal and reclamation.

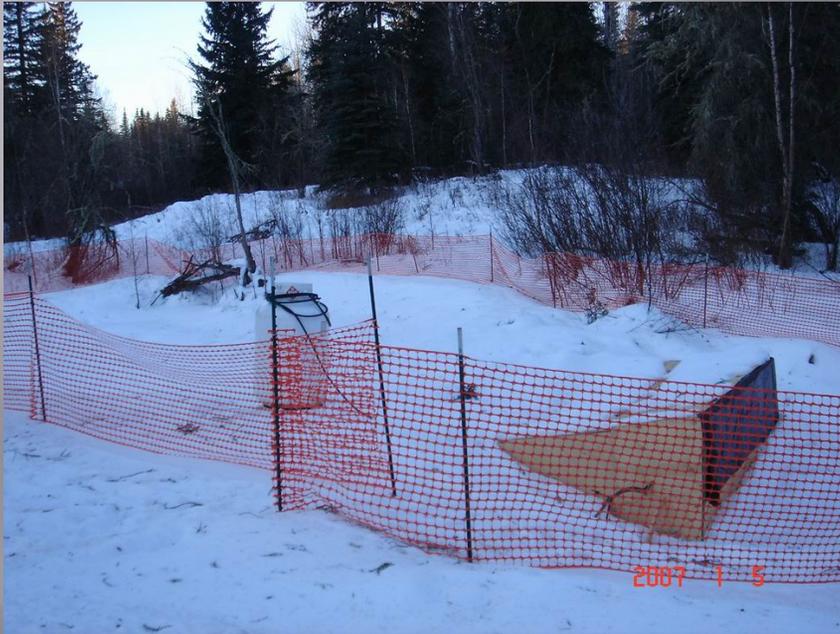
Learnings

- Due to the narrow out flow on earthen weirs cold weather will cause them to freeze off.
 - Utilization of an insulated weir house prevents freeze up the weir

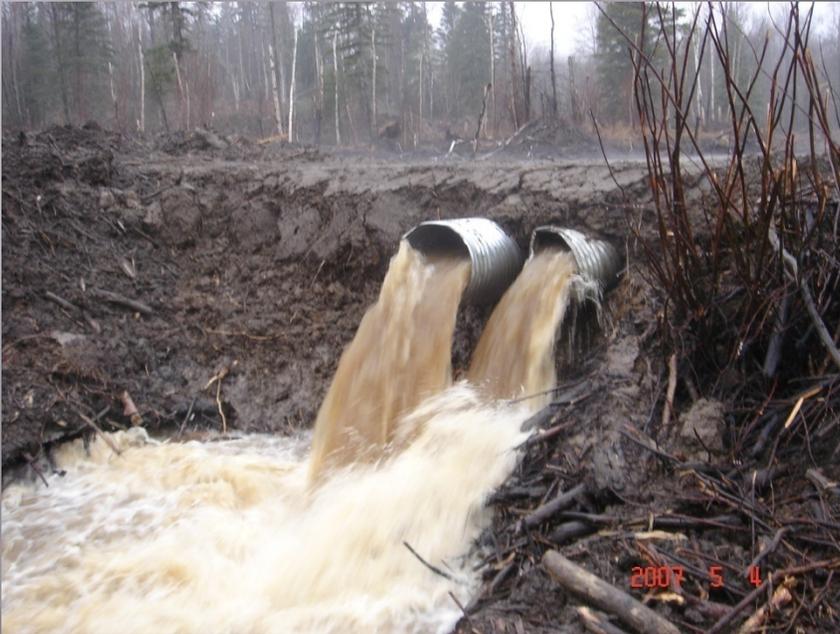
Learnings

- Due to trucking costs earthen weirs can be cost prohibitive.
- Earthen weirs are easily under cut in high flow situations
- Earthen weirs must be keyed into the banks causing significant impact to the creek.

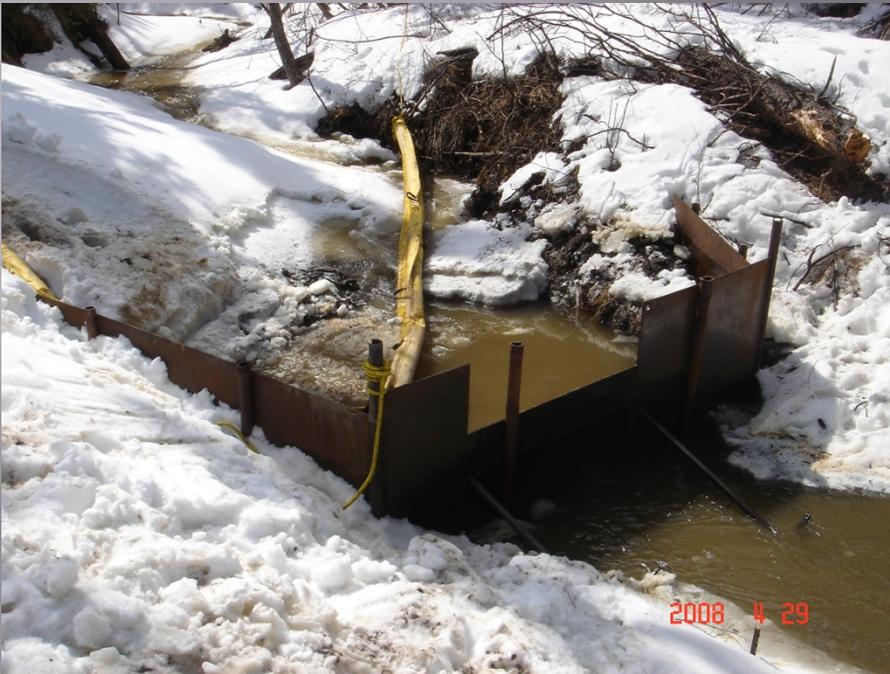
Learnings

- ▣ SWAT has developed low impact prefabricated weirs to offset the difficulties associated with earthen weirs.

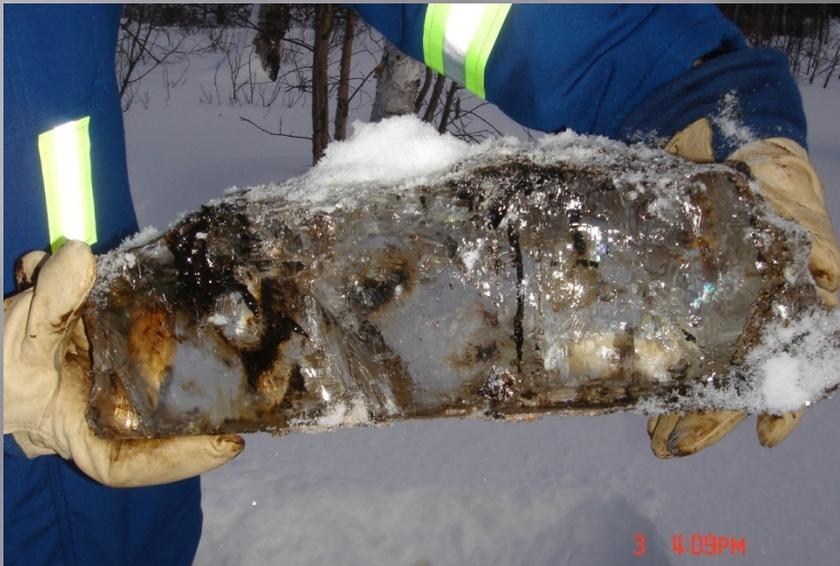
Learnings

- ❑ Removal of product frozen into the ice is cost prohibitive. Frozen product should be left in-situ until spring unless it will cause additional impact to soils or vegetation.

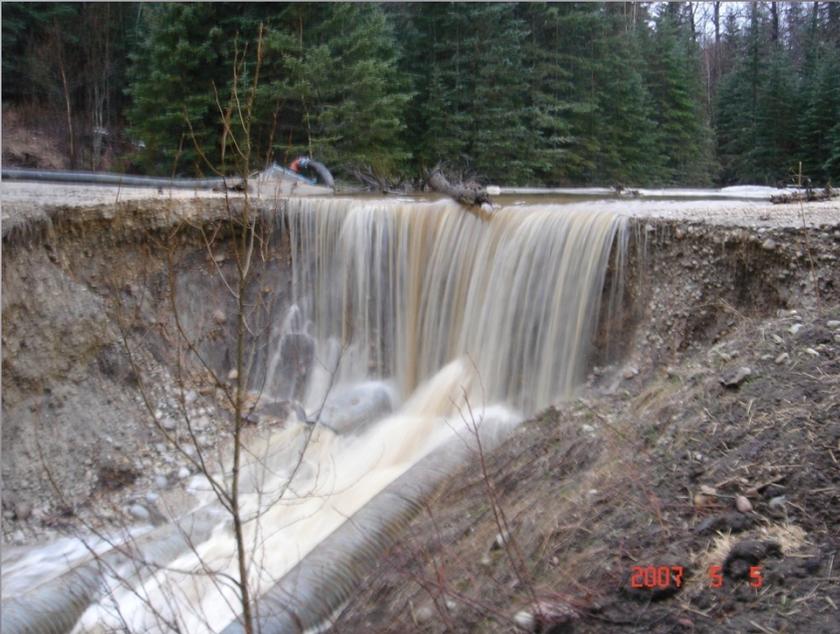
Learnings

- ▣ Water volumes in freshet can not be accurately predicted.
 - Pumping equipment and heavy machinery should be kept readily available to ensure quick response to rapidly rising water levels.

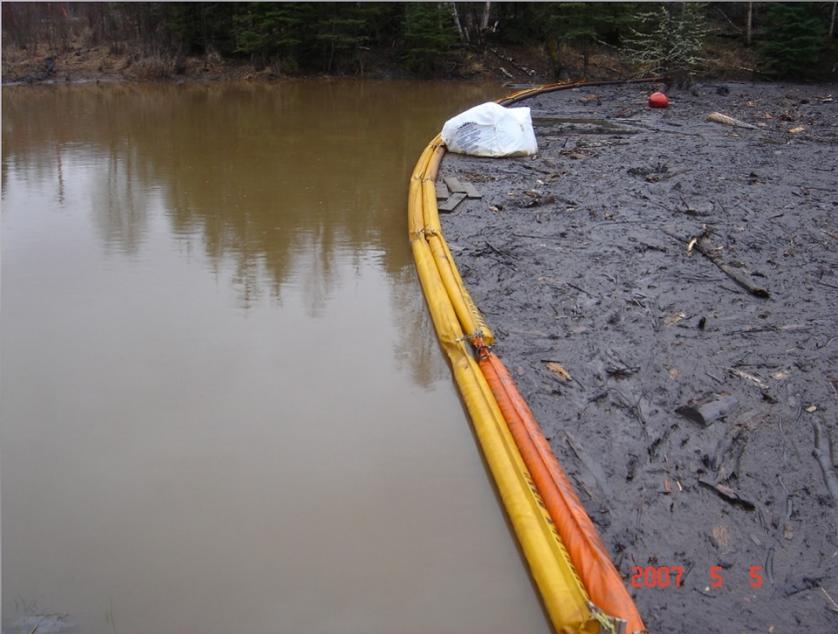
Learnings

- ❑ Fluctuating water levels decreases the effectiveness of earthen weirs.
 - Make sure surface containment is in place before freshet begins.

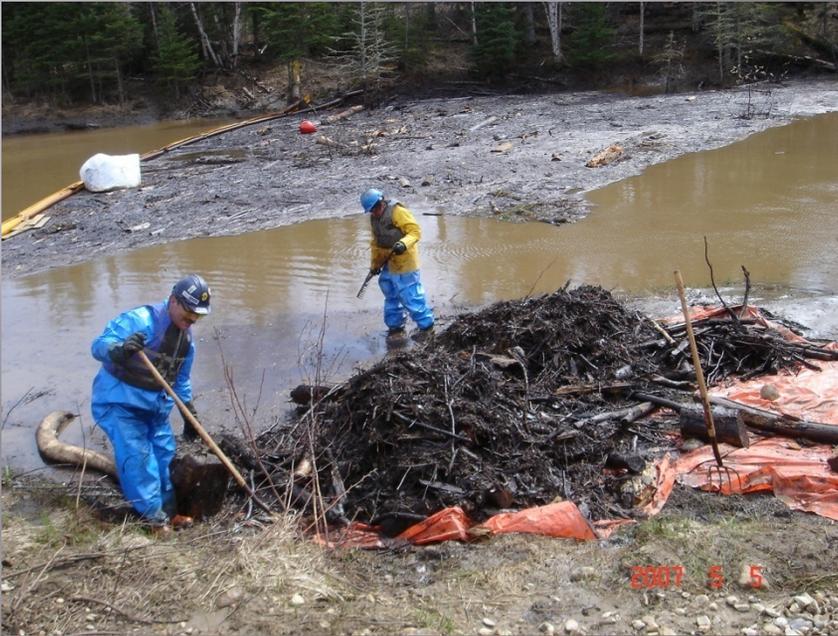
Learnings

- ❑ Increased amounts of woody debris due to flooding can negatively impact surface containment.
 - Prompt removal of woody debris is vital.
- ❑ Disposal costs for woody debris can be very high.
 - Utilize in-situ burning when ever permitted.

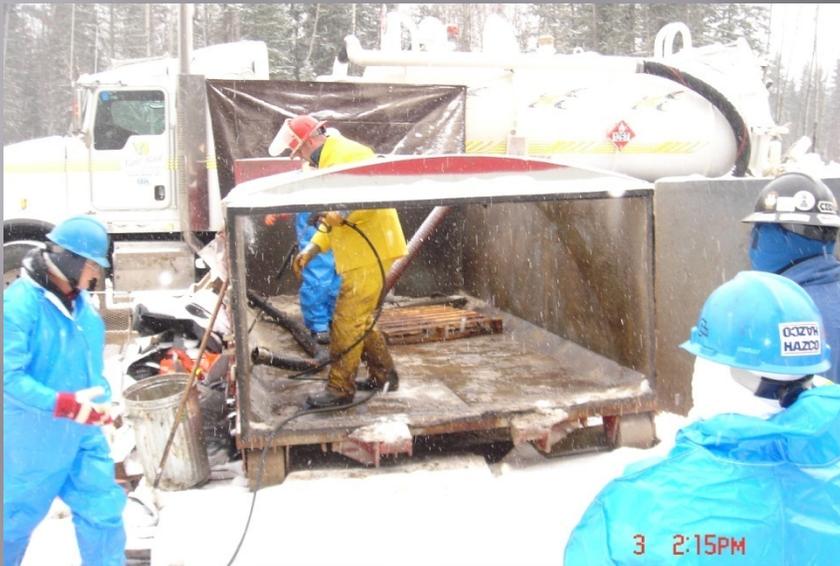
Learning

- Off site decontamination of equipment can be very expensive if not readily available.
- Impacted equipment sent off site can increase a spill's footprint.
 - When ever possible set up a decontamination area on site.
