# ***APPLYING FASTER WATER BOOMING TECHNIQUES to COASTAL ENVIRONMENTS***

## ***“BOOMING of BOLINAS LAGOON PRESERVE”***

***CARL J. OSKINS,***

*DOWCAR Environmental Management, Inc.*

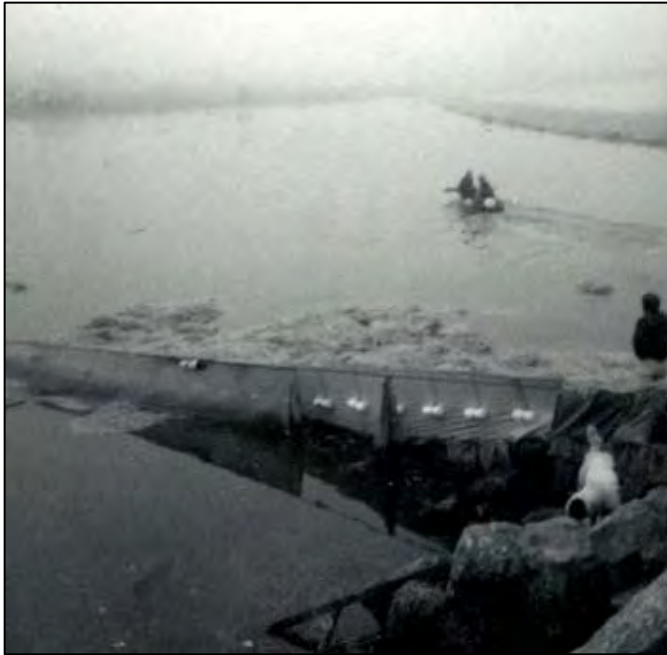
***Barrier of  
Boom and Hay***

**OIL CONTAINED USING BOOM,  
LOGS, HAY AND CABLE  
to CREATE a BARRIER  
ACROSS the LAGOON MOUTH**

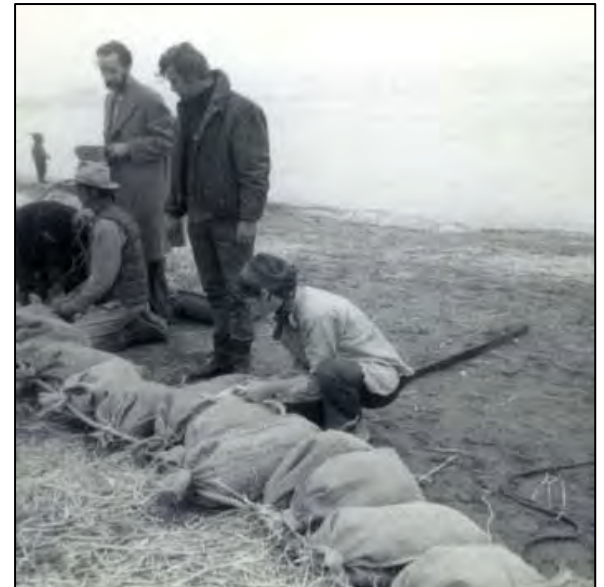
***Bagged Hay  
on Rope  
Ready to  
Be Deployed***

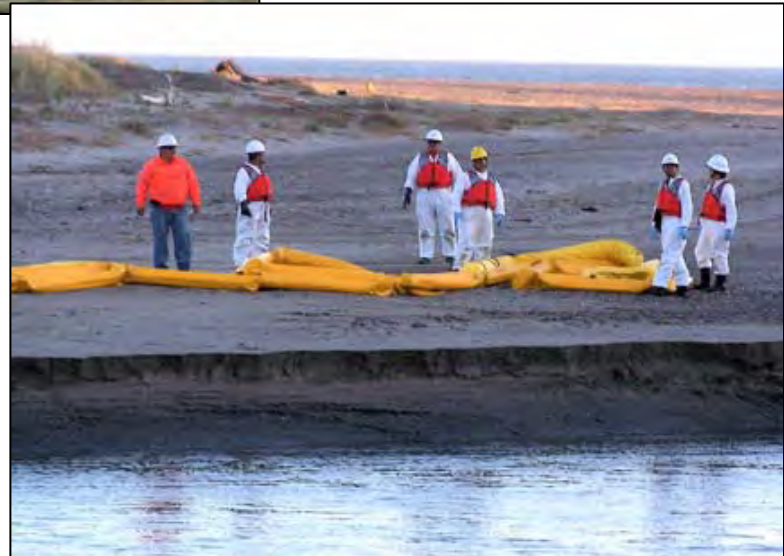
*On Day 4, a Contractor  
Attempts to  
Boom Bolinas Lagoon.*

*They Gave Up after the  
Fifth Boom broke.*

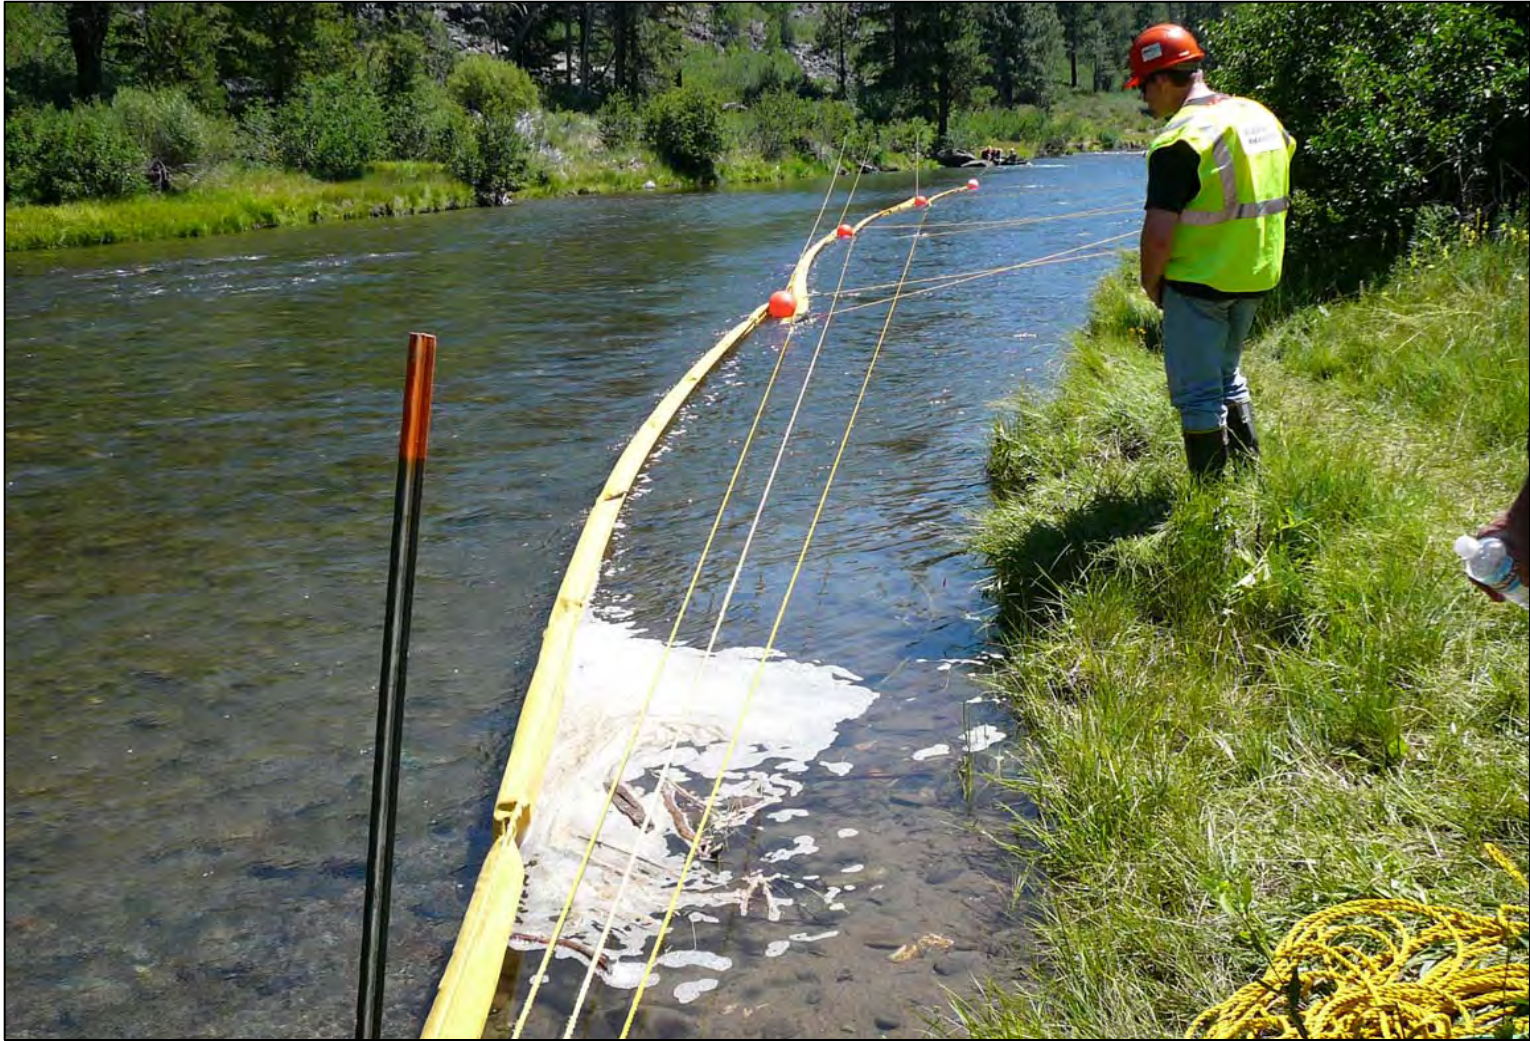
***Cascade Diversionary Boom Deployment  
Truckee River - Truckee, CA***

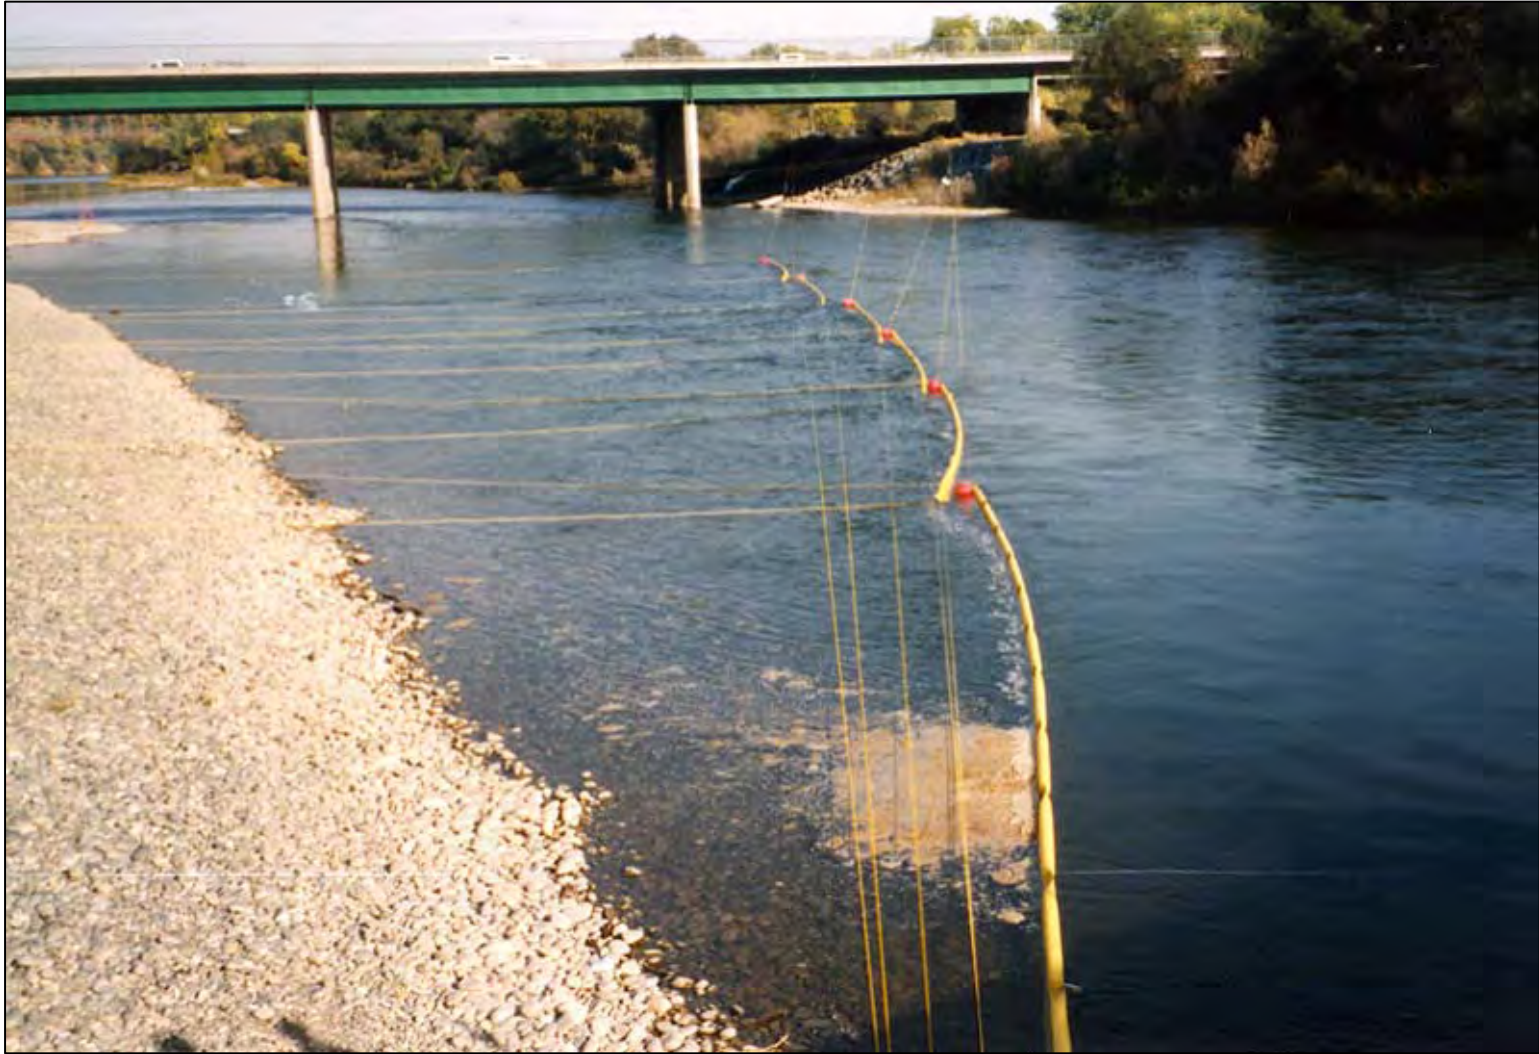
***Cascade Diversionary Boom Deployment  
American River - Sacramento, CA***

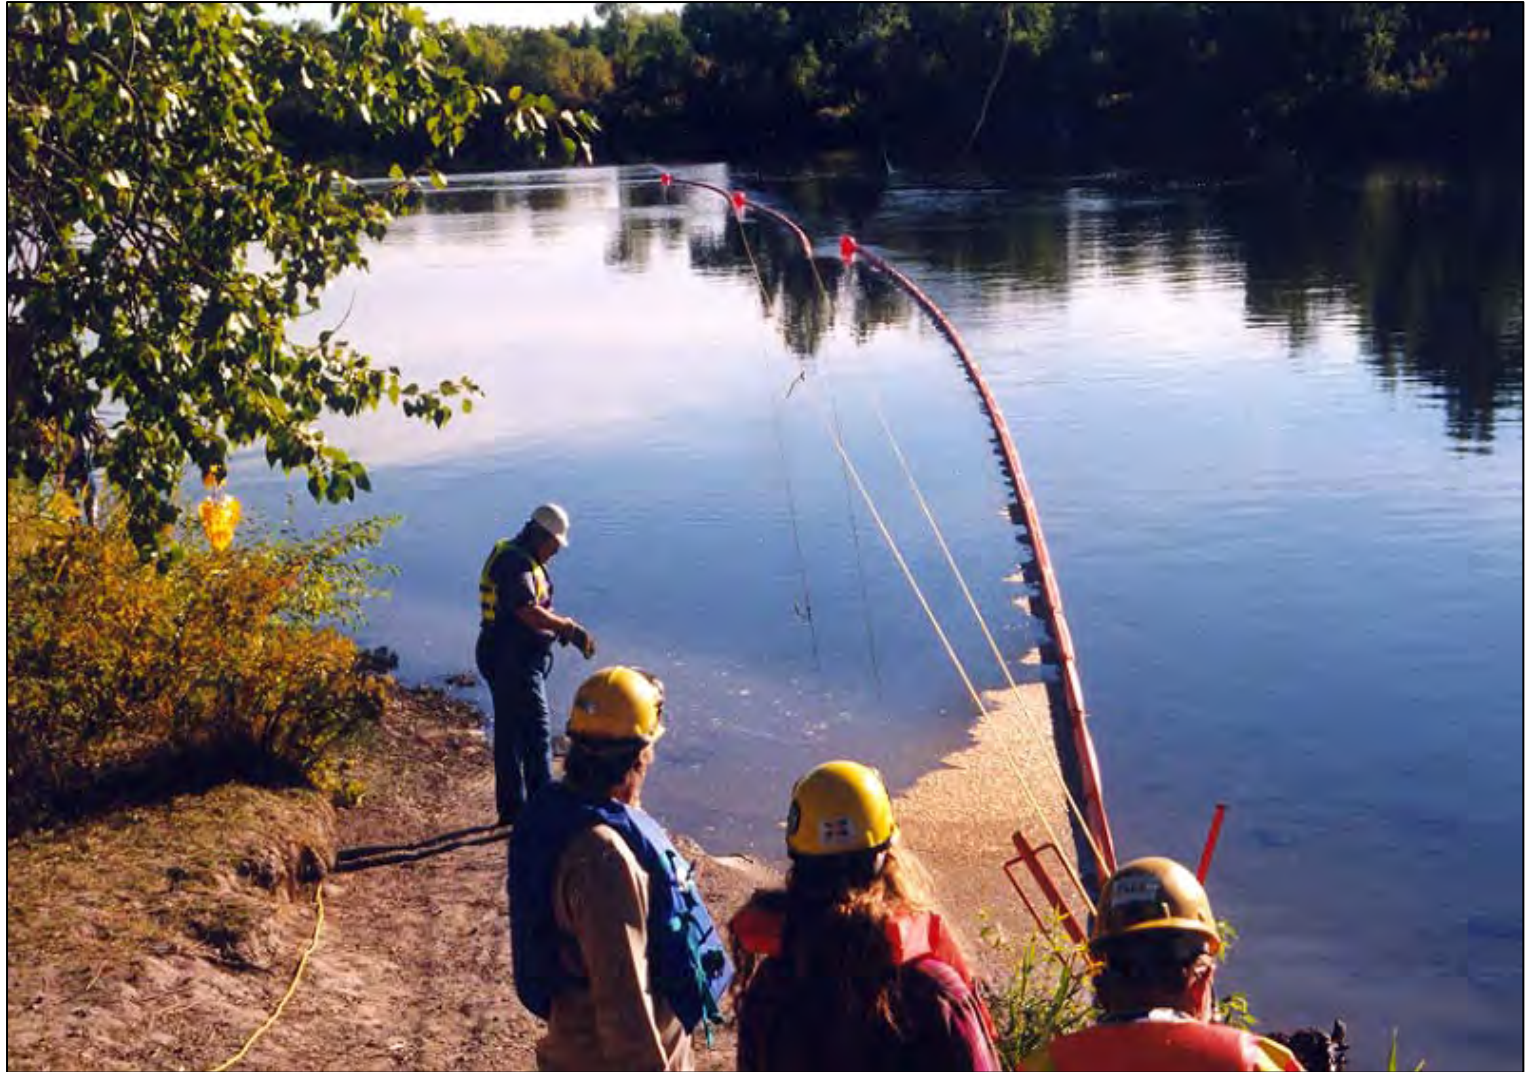
***Cascade Diversionary Boom Deployment  
Missouri River - Great Falls, Montana***

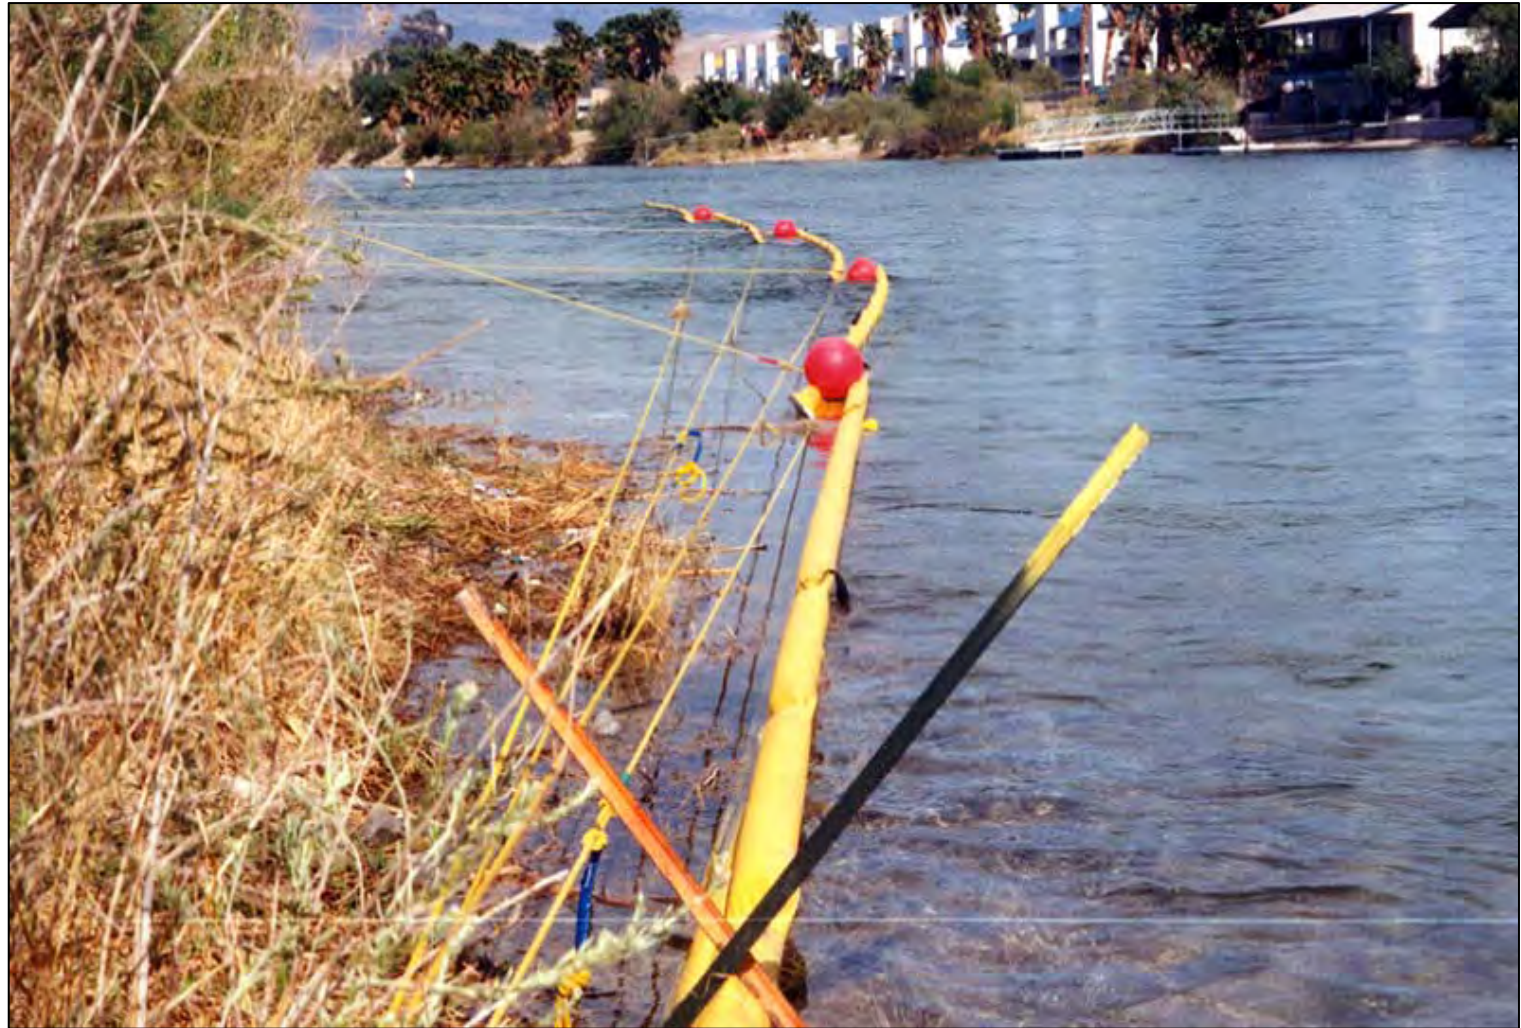
*Cascade Diversionary Boom Deployment  
Colorado River - Laughlin, Nevada*

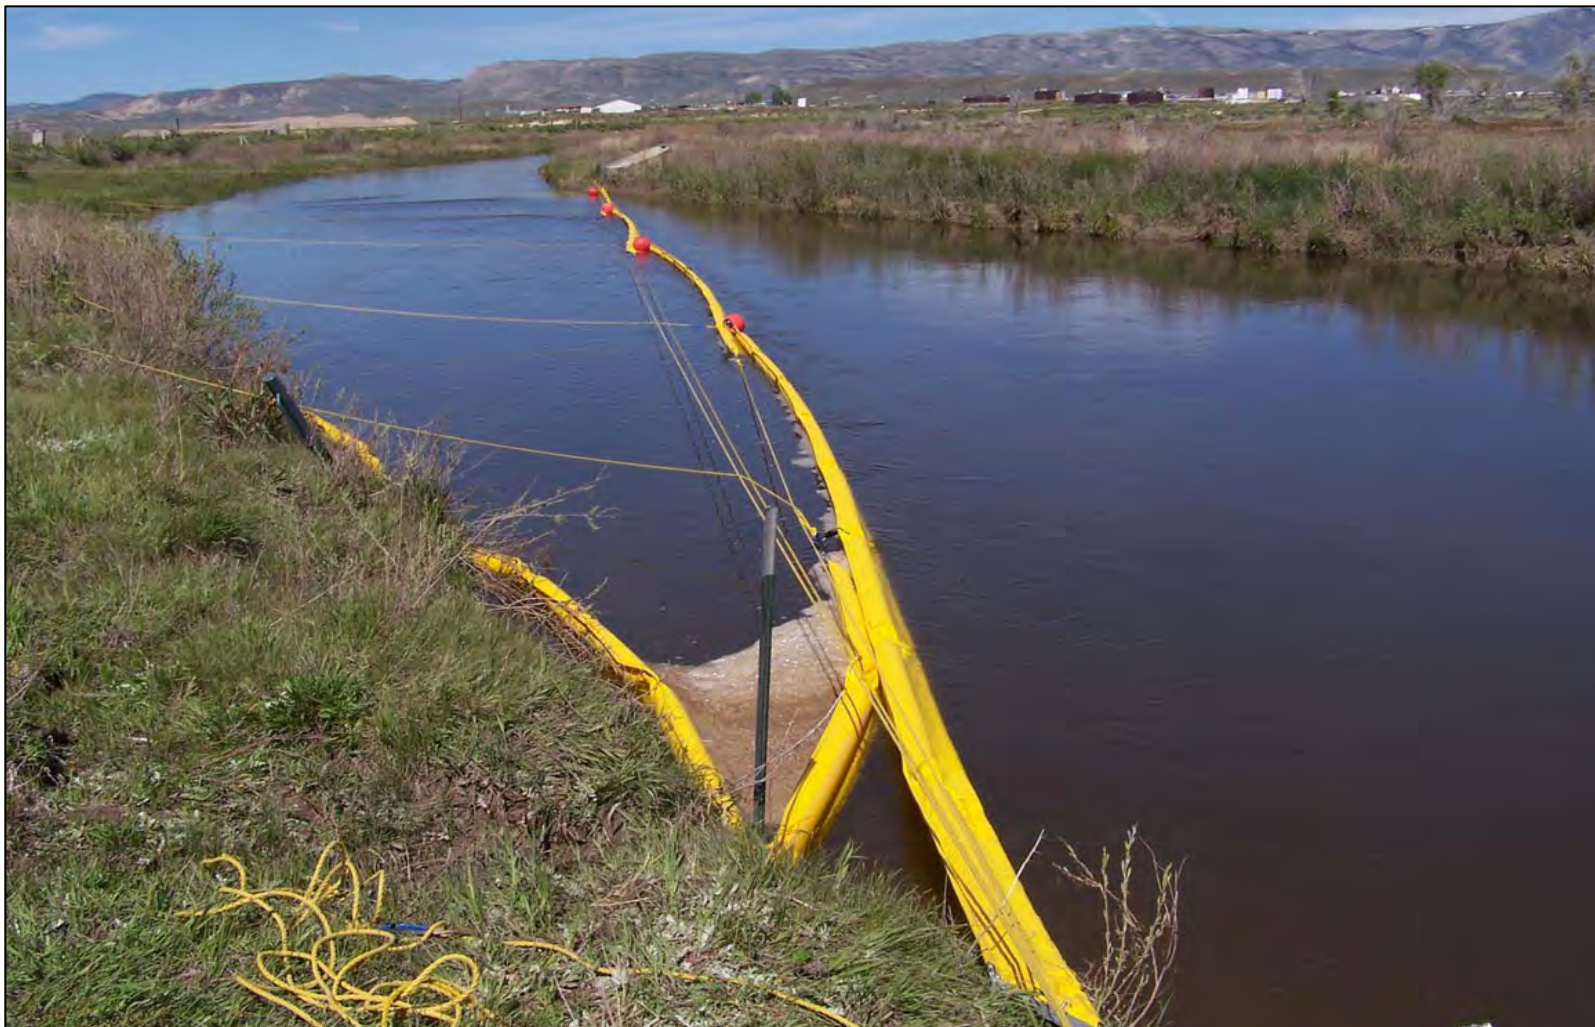
***Cascade Diversionary Boom Deployment with Shoreline Protection  
Green River - La Barge, WY***

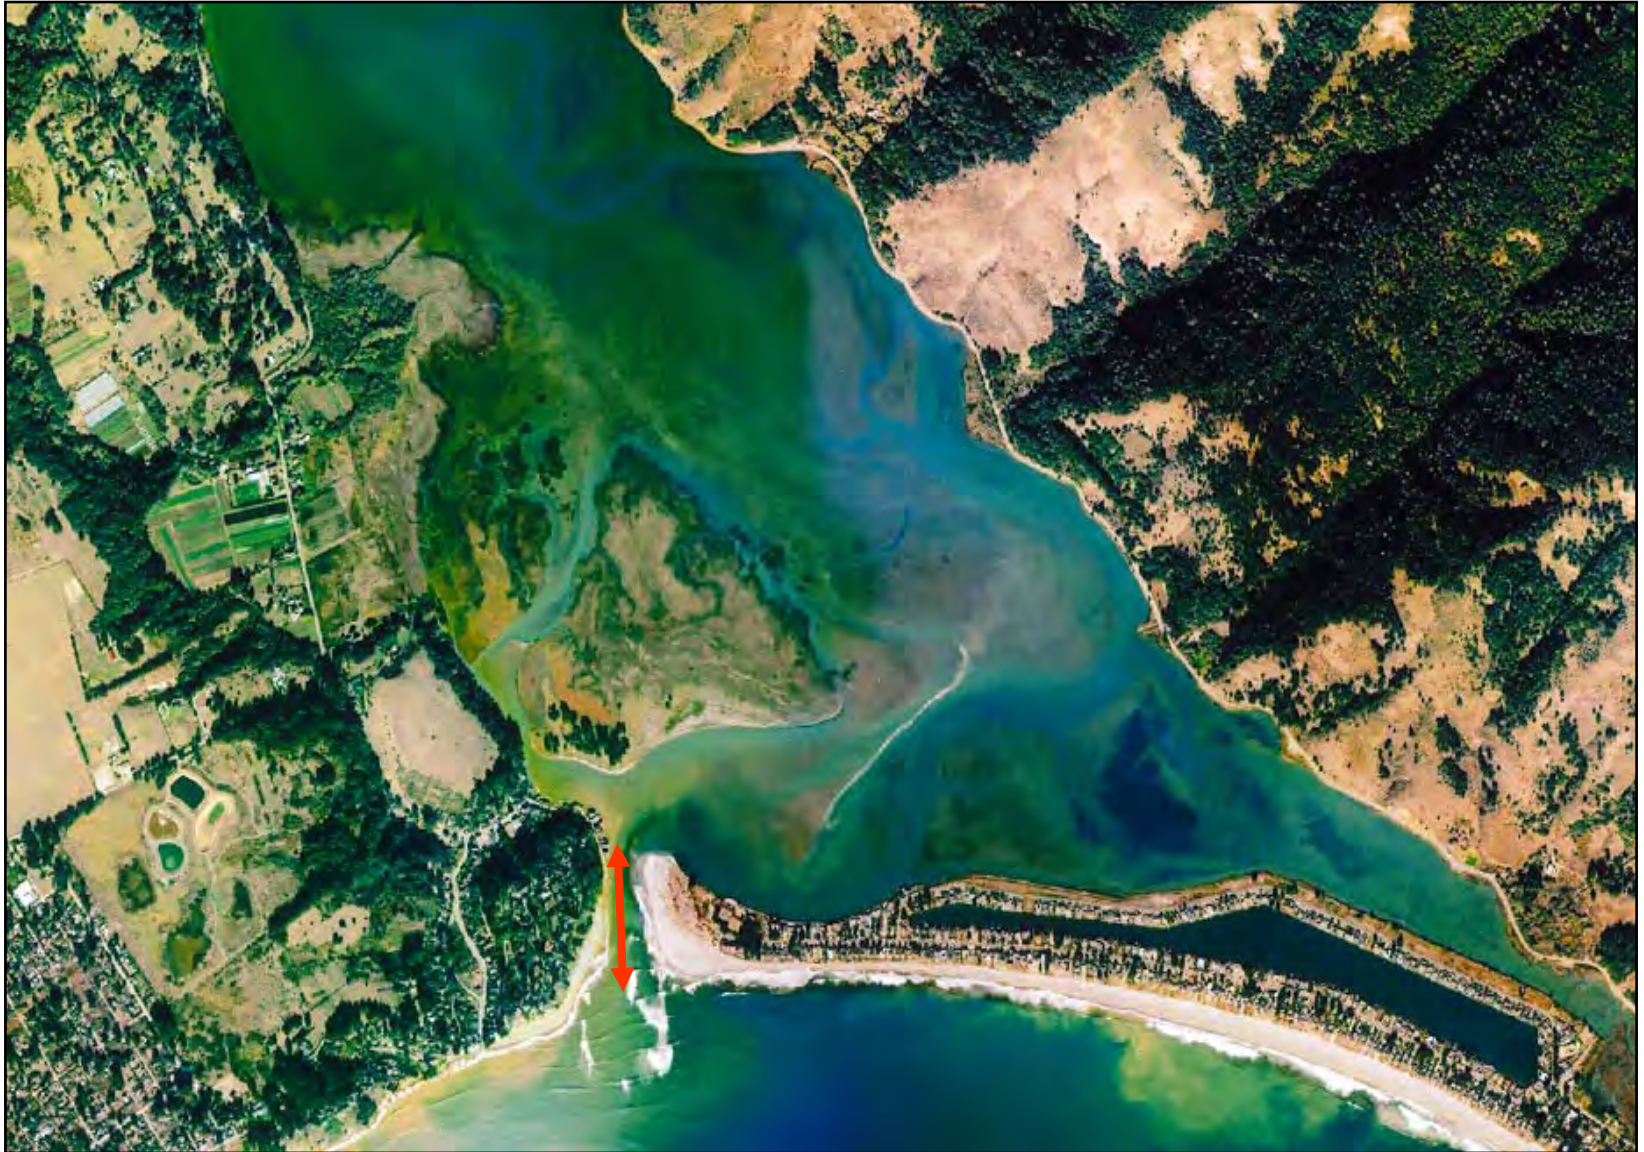
## *NARROW ENTRANCE to BOLINAS LAGOON is SIMILAR to FAST RIVERS*

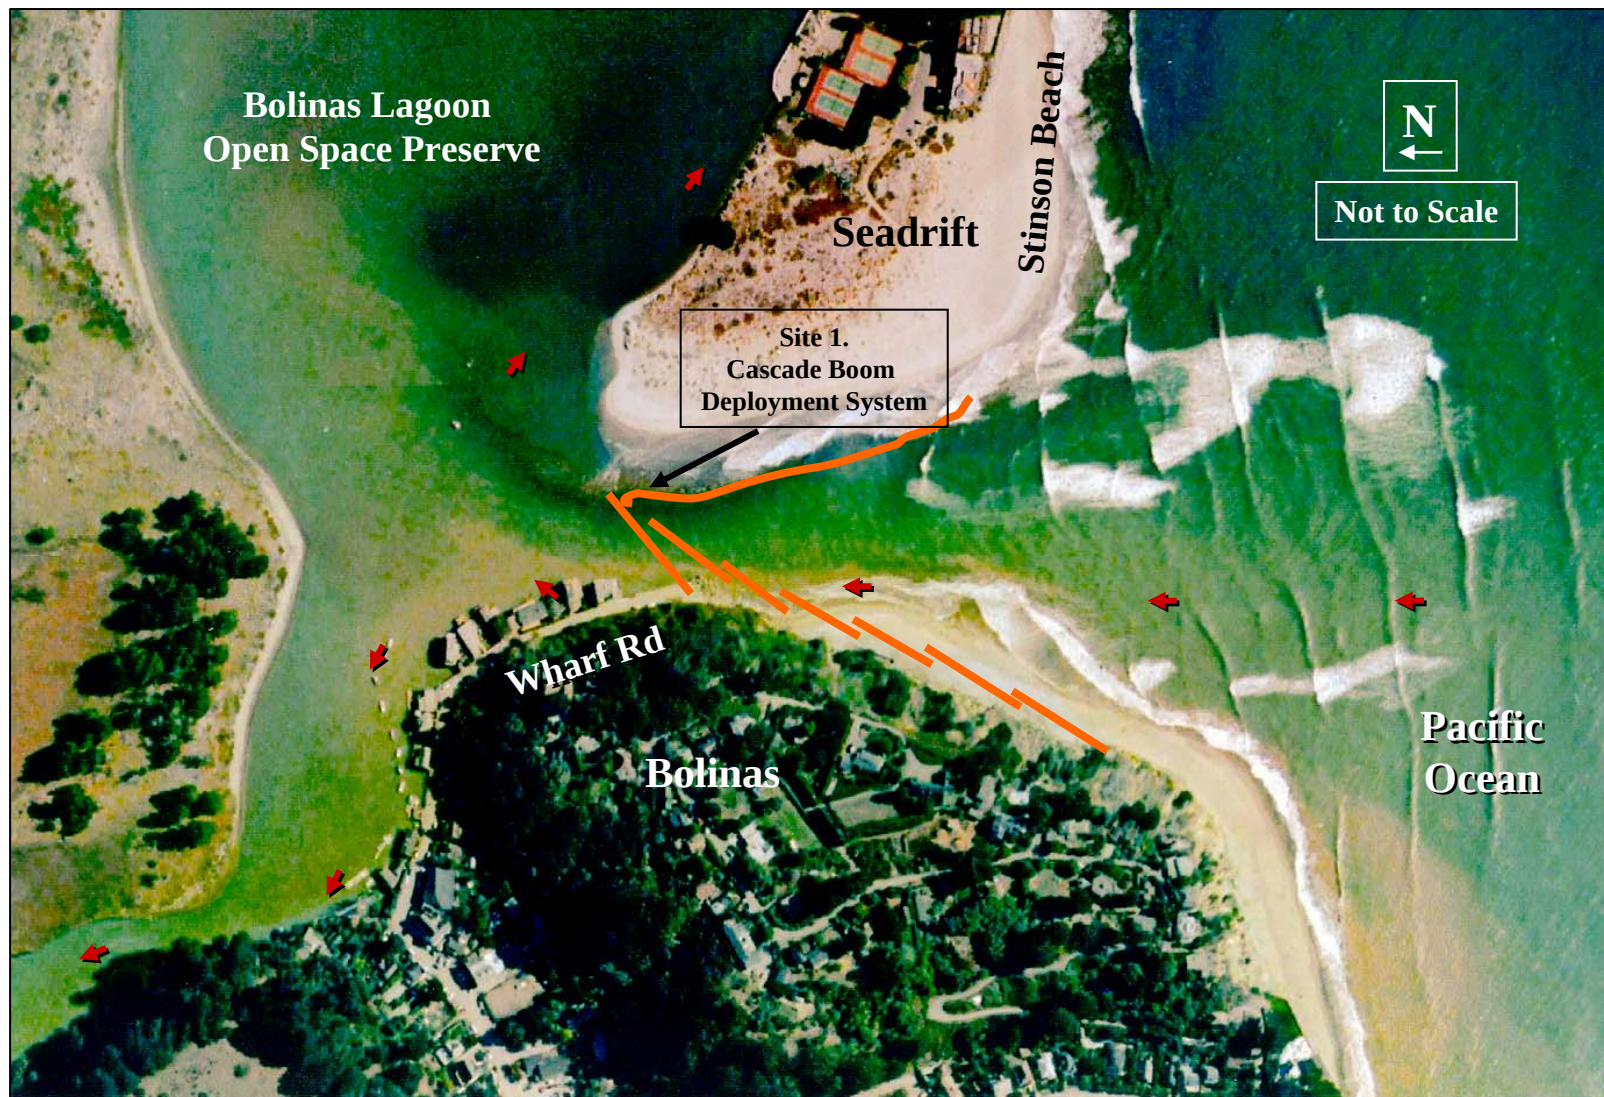
## STRATEGY for BOOMING ENTRY to BOLINAS LAGOON

*Cascade Boom Deployment, Containment & Recovery Strategies - Bolinas Lagoon  
High Tide Aerial Photos with Boom Deployment Overlay*

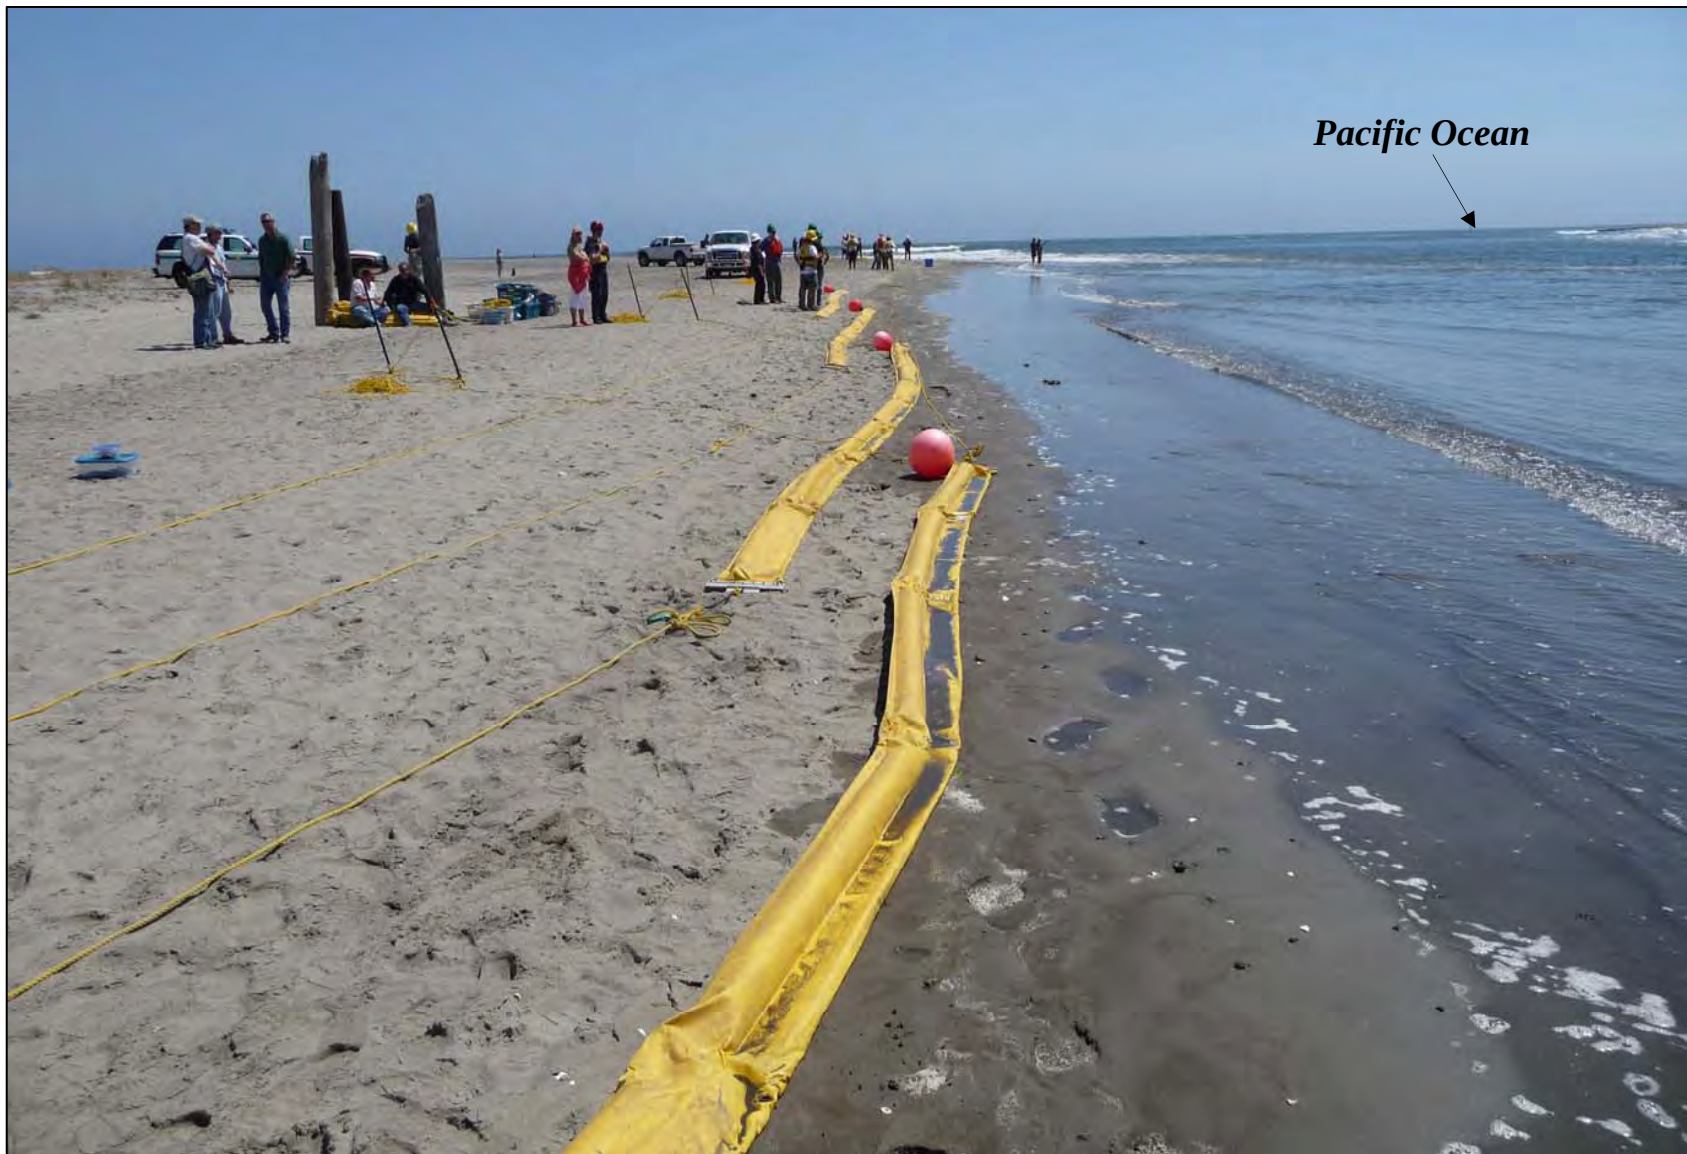
***Boom Laid Out Along the Shore  
Preparing to Deploy Cascade System - 1<sup>st</sup> Exercise***

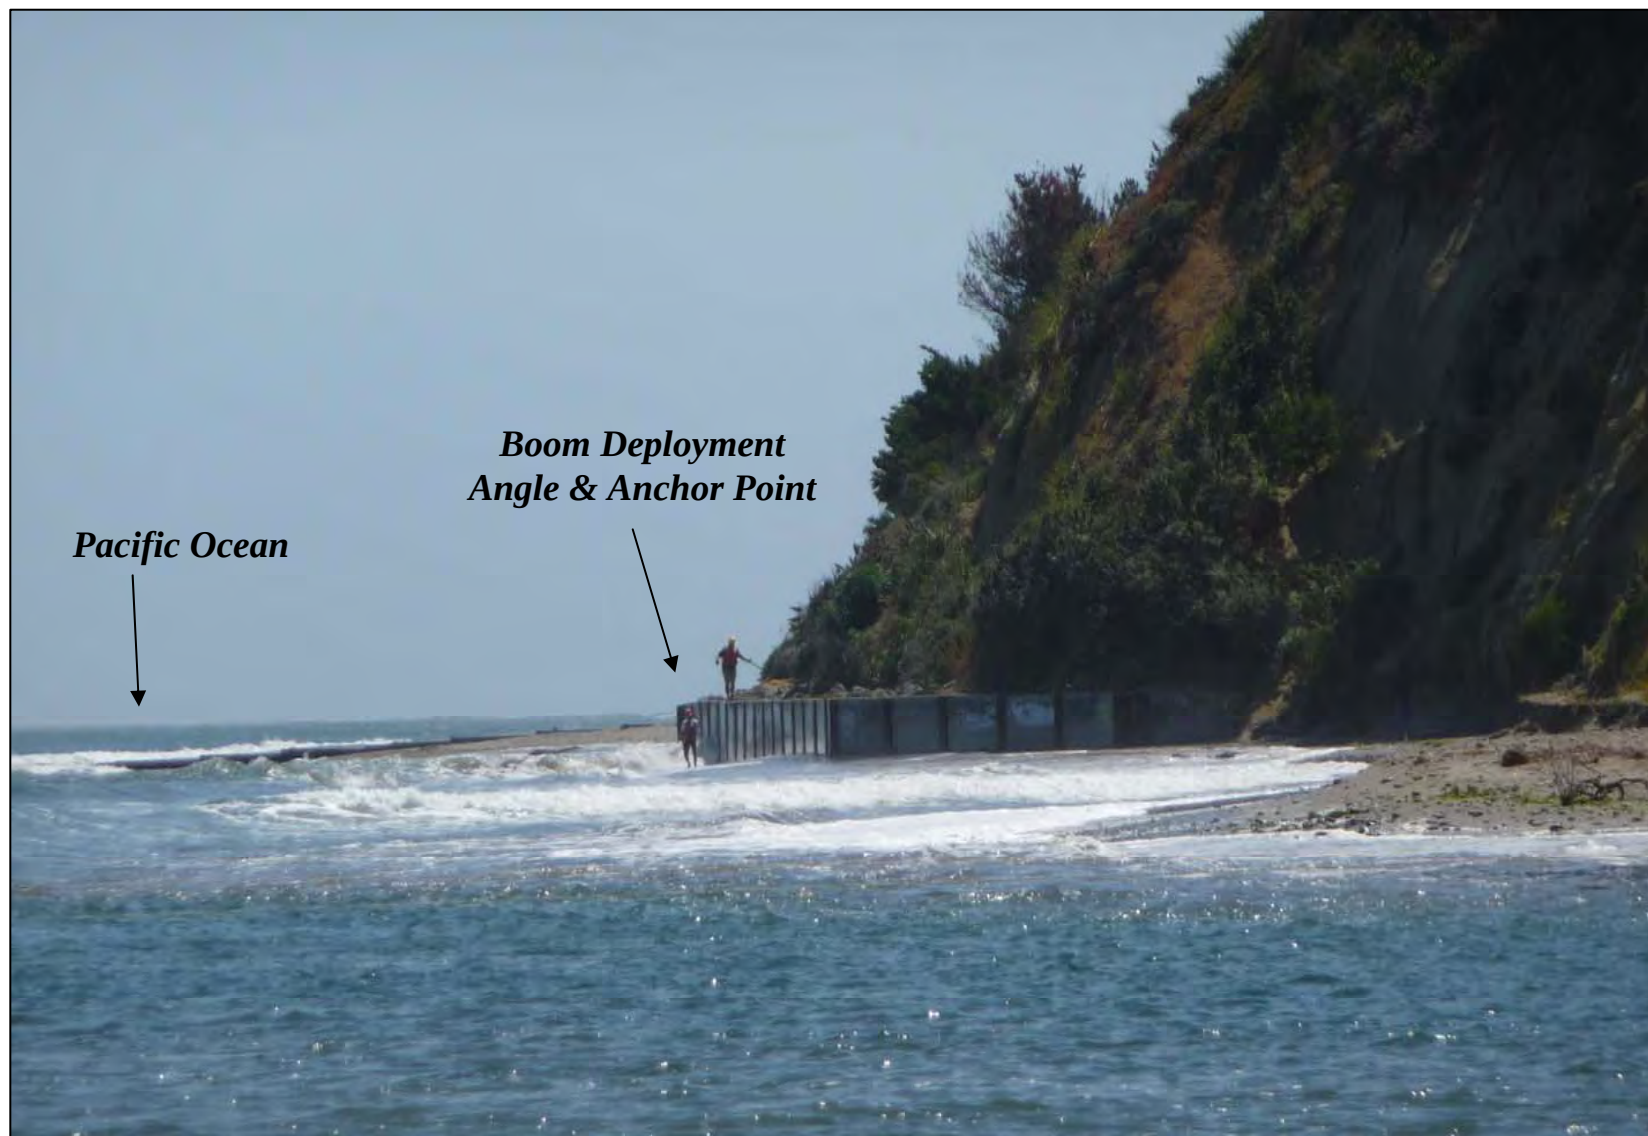
***Team “C” on Far Shore Locates Anchor Points  
Pacific Ocean is Behind Them – 1<sup>st</sup> Exercise***

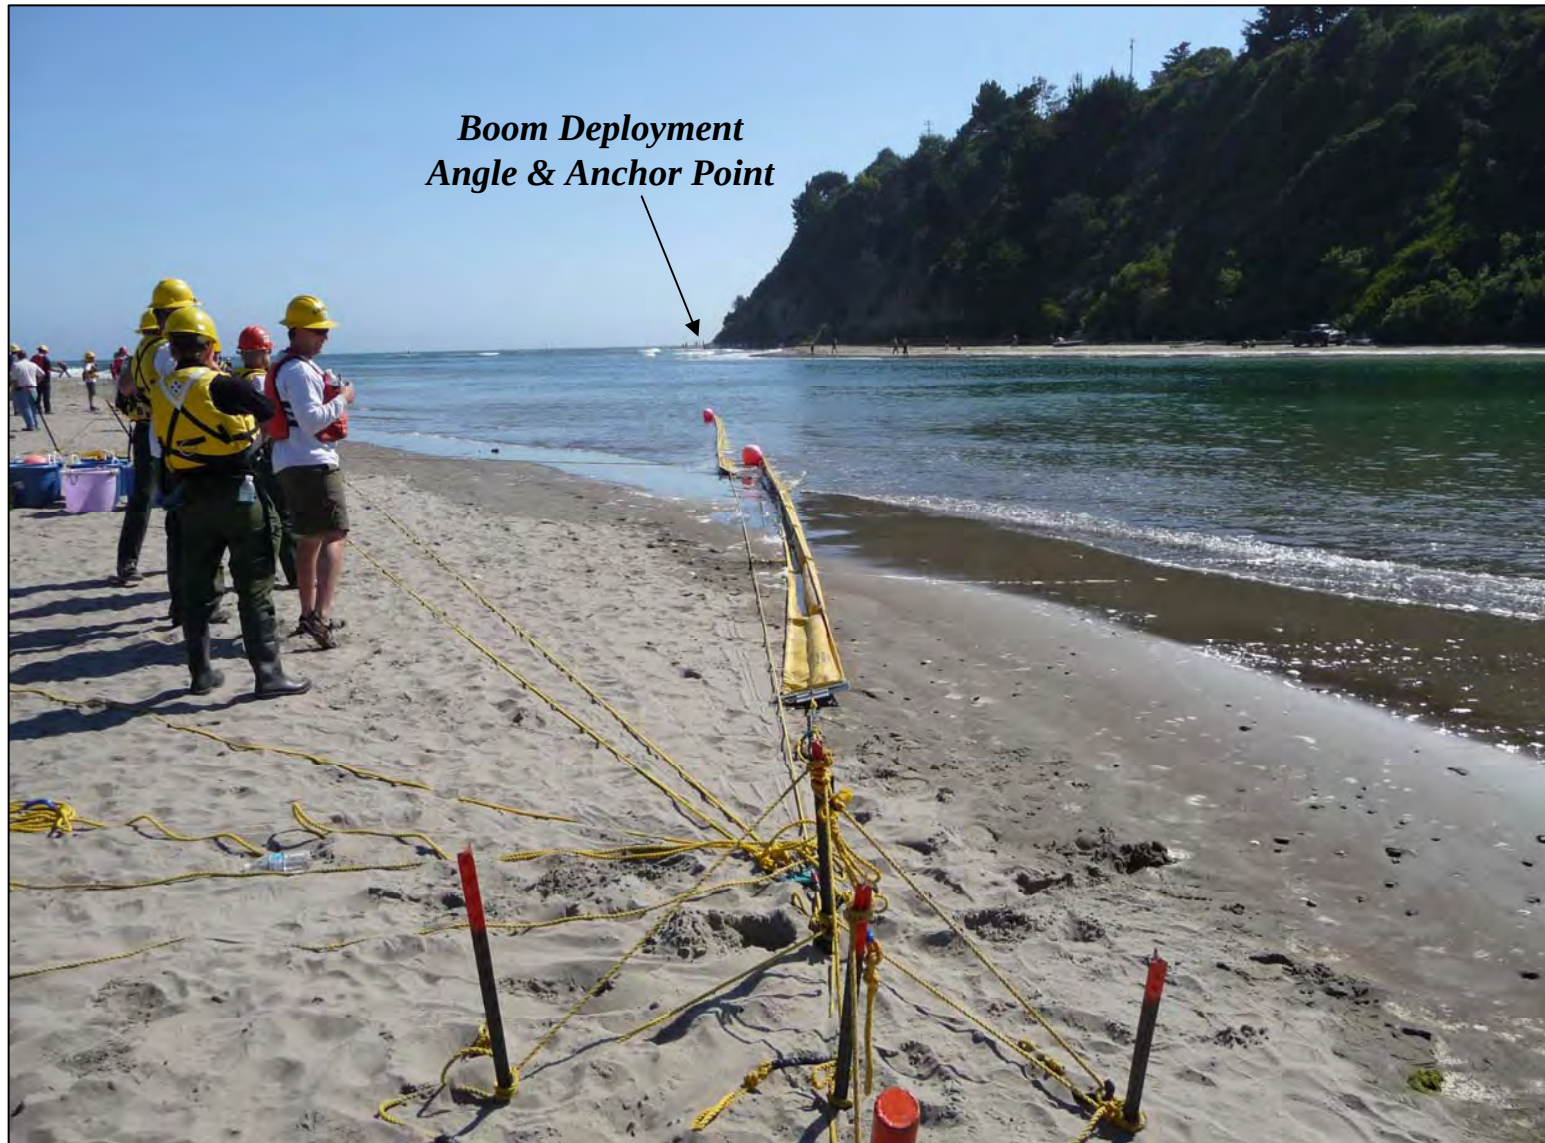
***Two (2) Booms Deployed 1<sup>st</sup> Exercise***

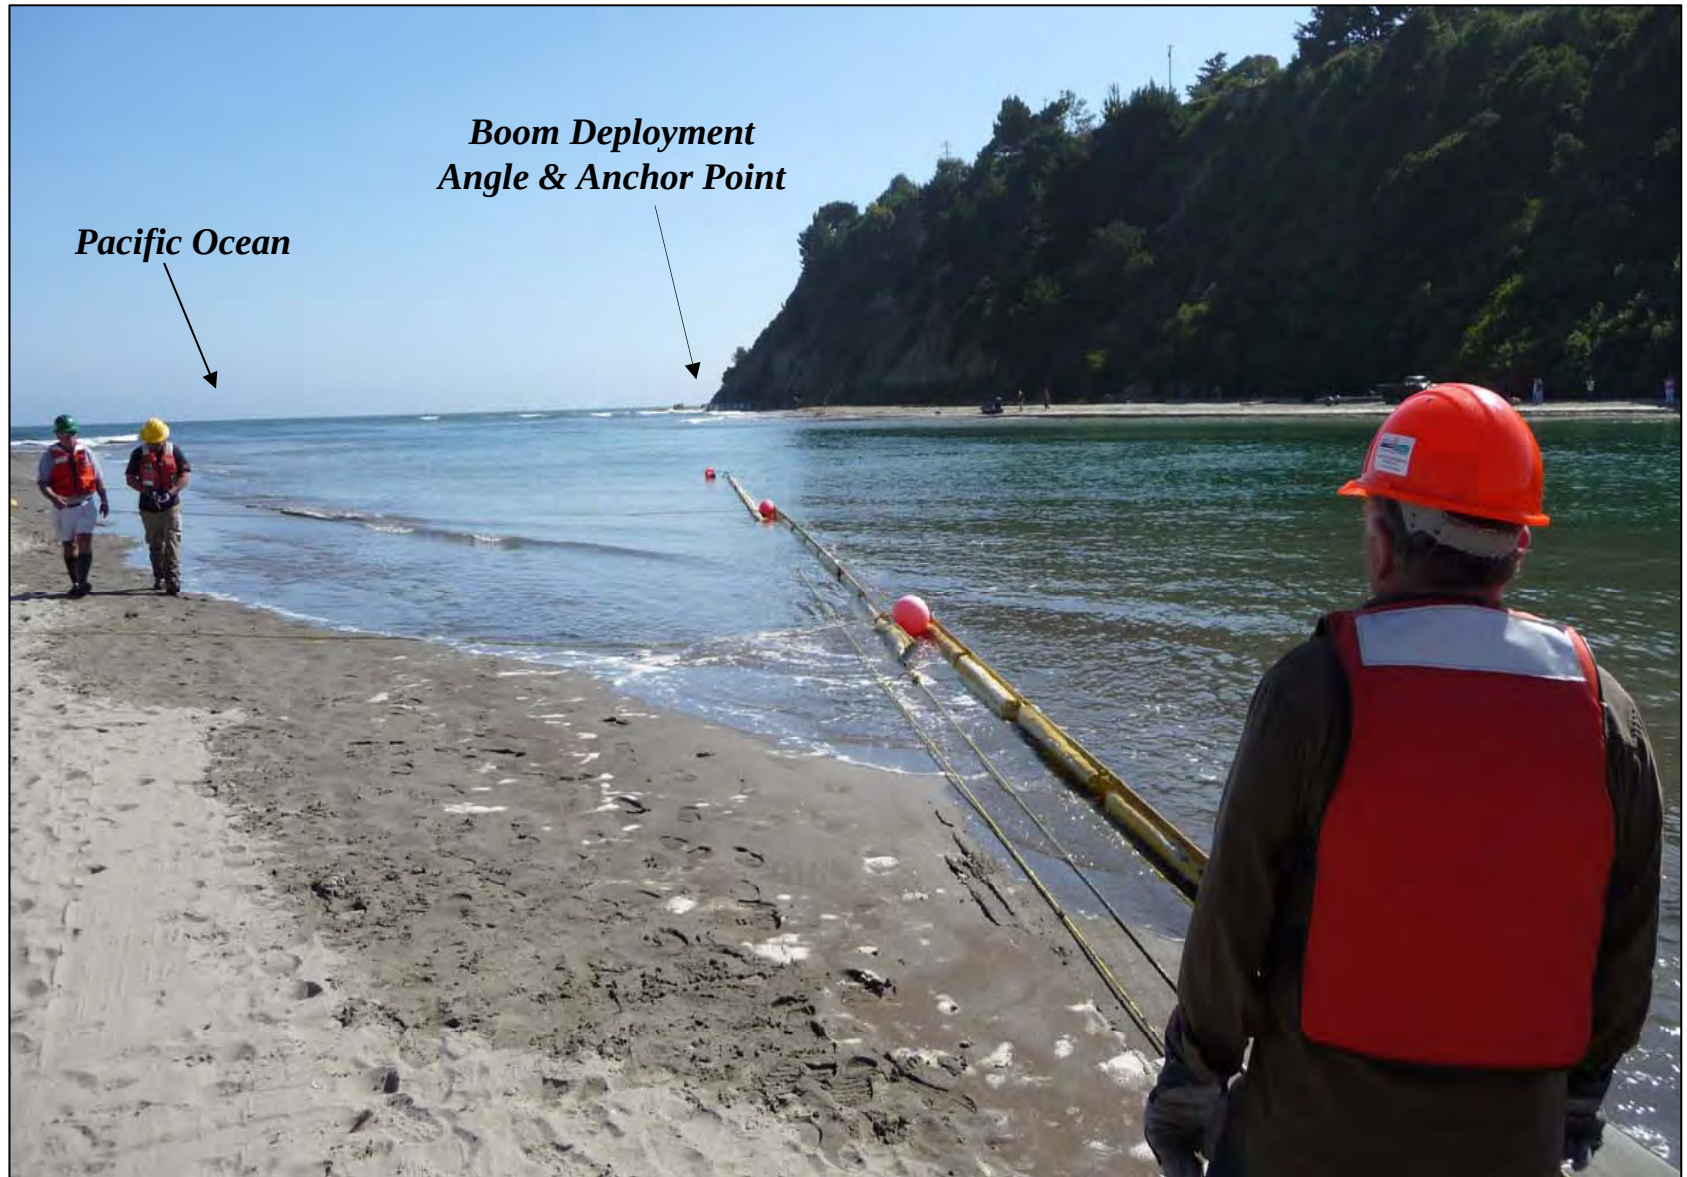
***Four (4) Booms Deployed - 1<sup>st</sup> Exercise***

## ***INCREASED BOOM DEPLOYMENT ANGLE for 2<sup>nd</sup> EXERCISE BECAUSE***

- ***NOT EXPECTING INCREASED CURRENT SPEED  
BECAUSE of TIDAL CURRENT***
- ***PROBLEMS in ANCHORING on/or NEAR SEAWALL  
DURING 1<sup>st</sup> EXERCISE***
- ***SAFETY CONCERNS of MOVING PERSONNEL with ANCHORING  
LINES and ANCILLARY EQUIPMENT  
THRU HIGH and FAST TIDAL WATERS ENROUTE to ANCHOR SITES***
- ***SUCCESS of DEPLOYING OIL SPILL CONTAINMENT BOOMS  
in FAST WATER CASCADE SYSTEM  
DURING 1<sup>st</sup> EXERCISE***

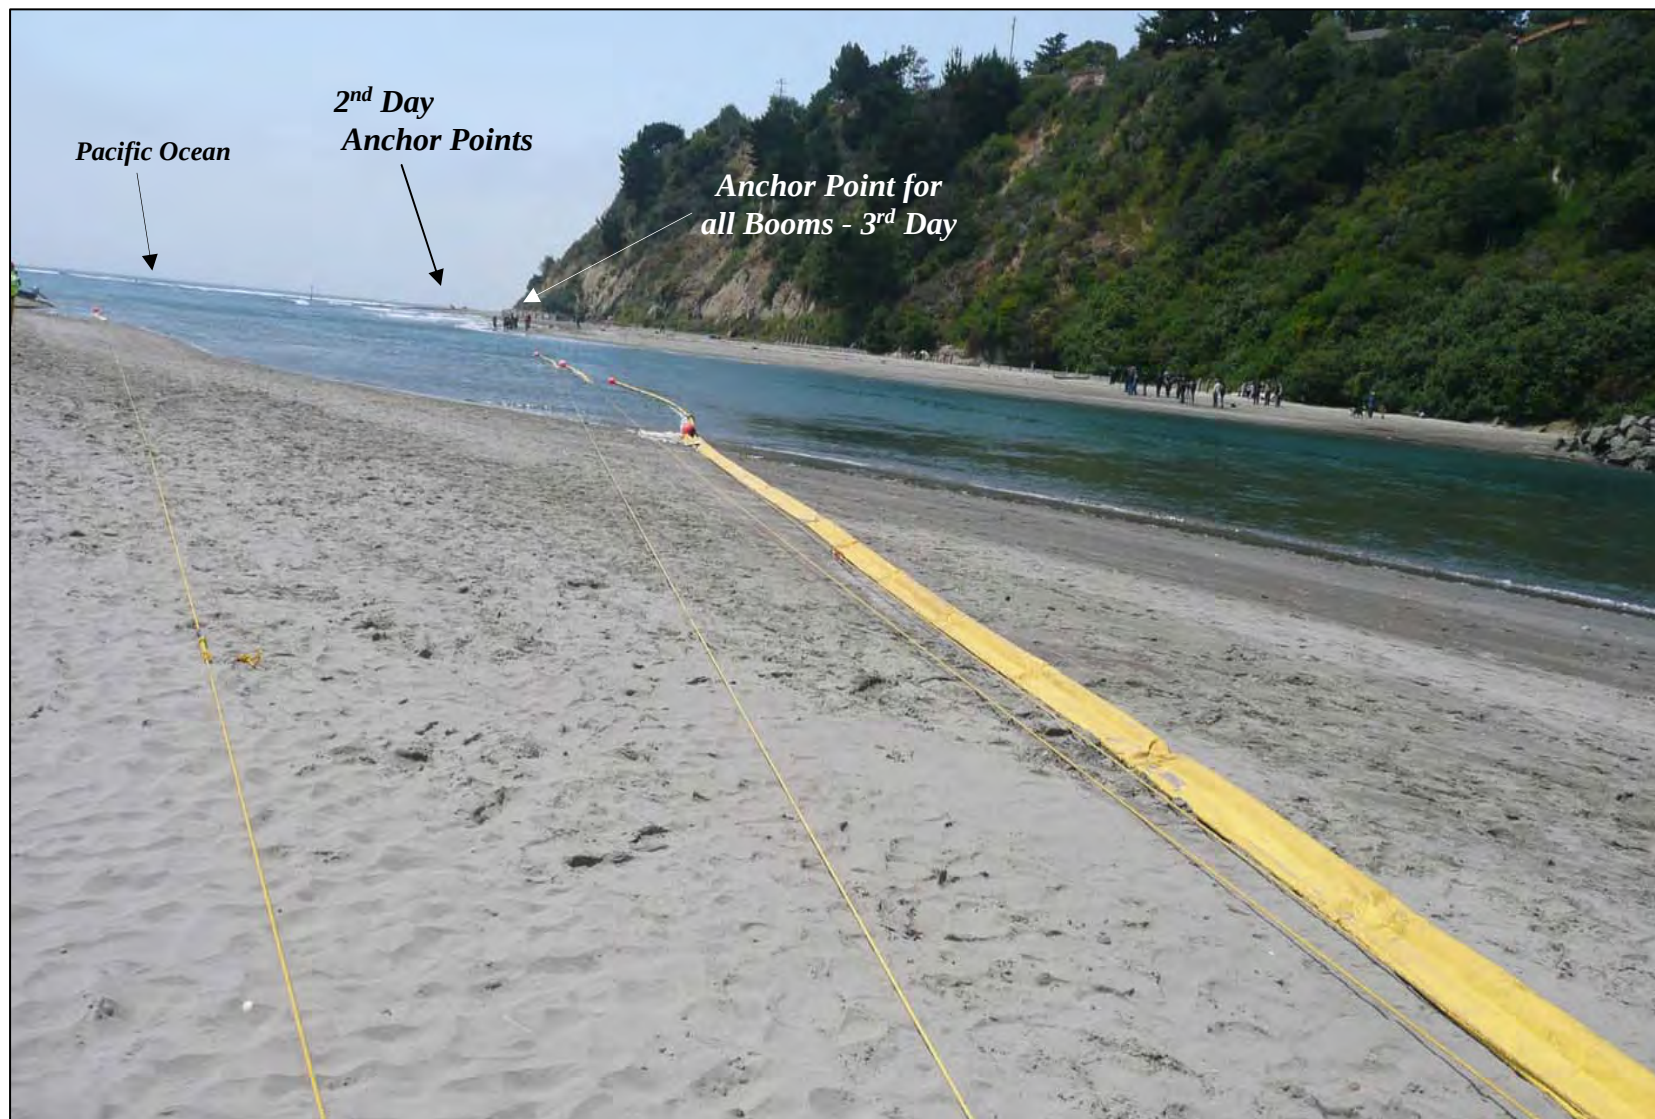
***Four Booms Deployed  
Boom 1 Onshore due to Low Tide in Anticipation of Incoming High Tide***
