# ***APPLYING FASTER WATER BOOMING TECHNIQUES to COASTAL ENVIRONMENTS***

## ***“BOOMING of BOLINAS LAGOON PRESERVE”***

***CARL J. OSKINS,***

*DOWCAR Environmental Management, Inc.*

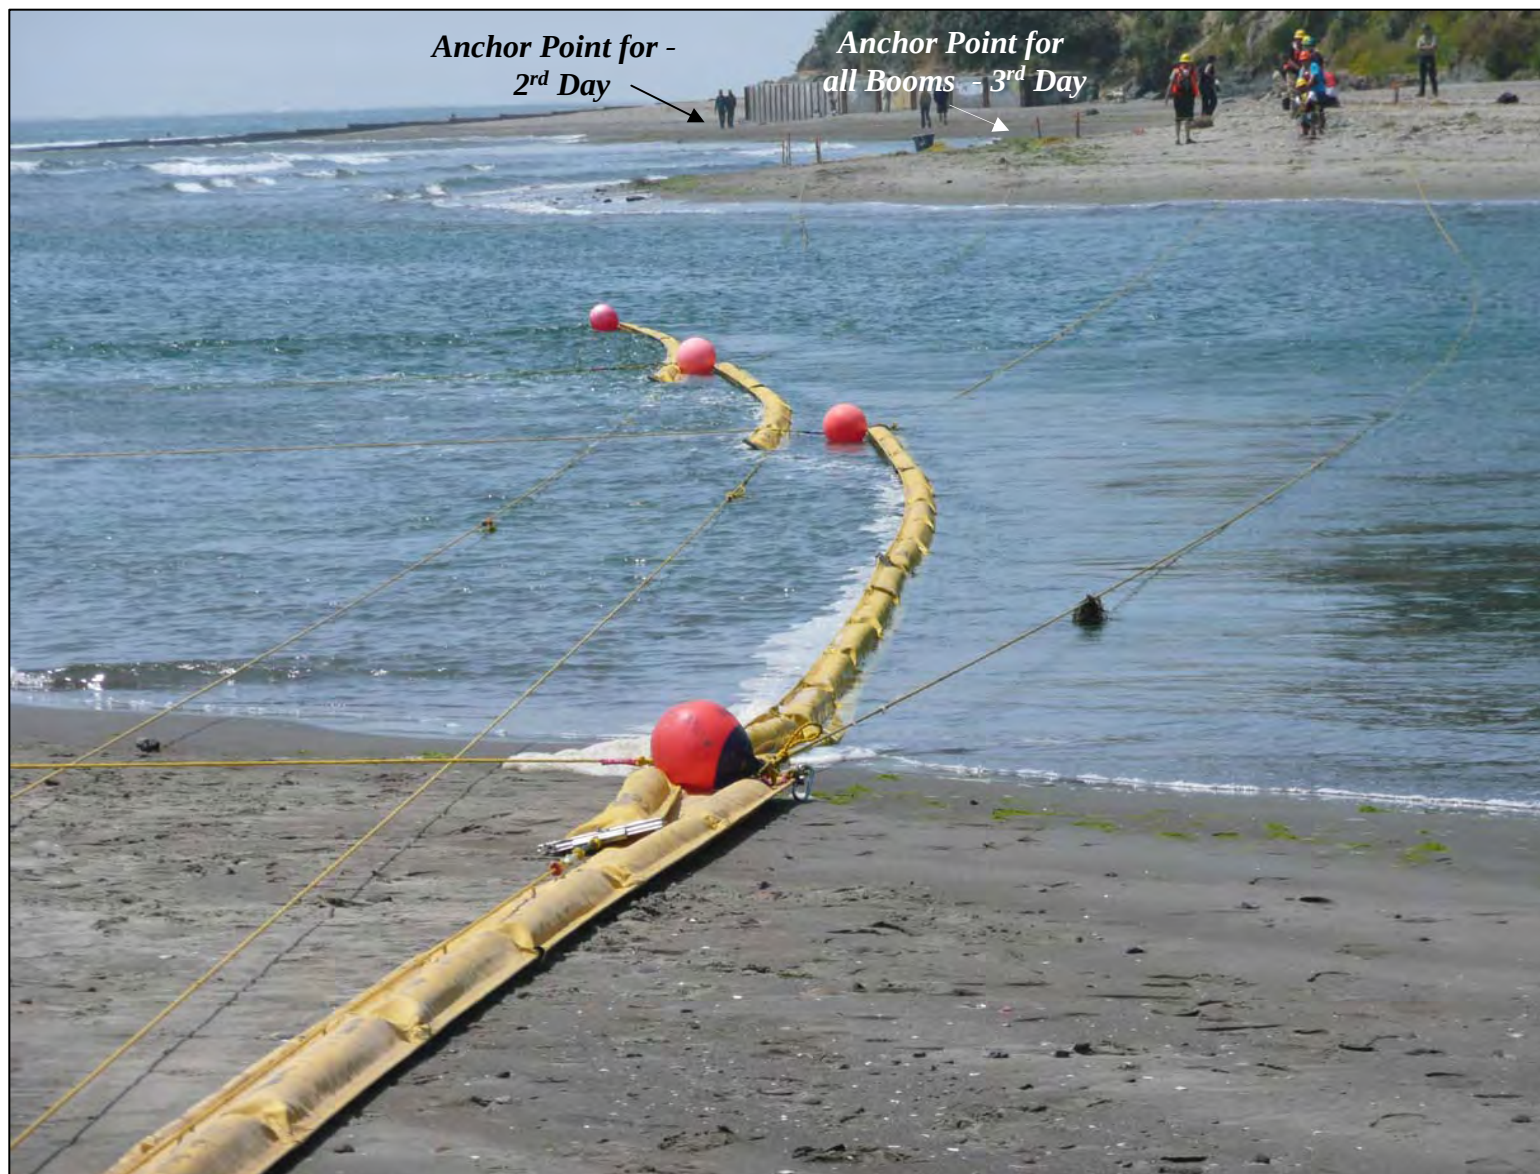
***Four Booms Deployed - Containment of Rice Hulls Beginning***

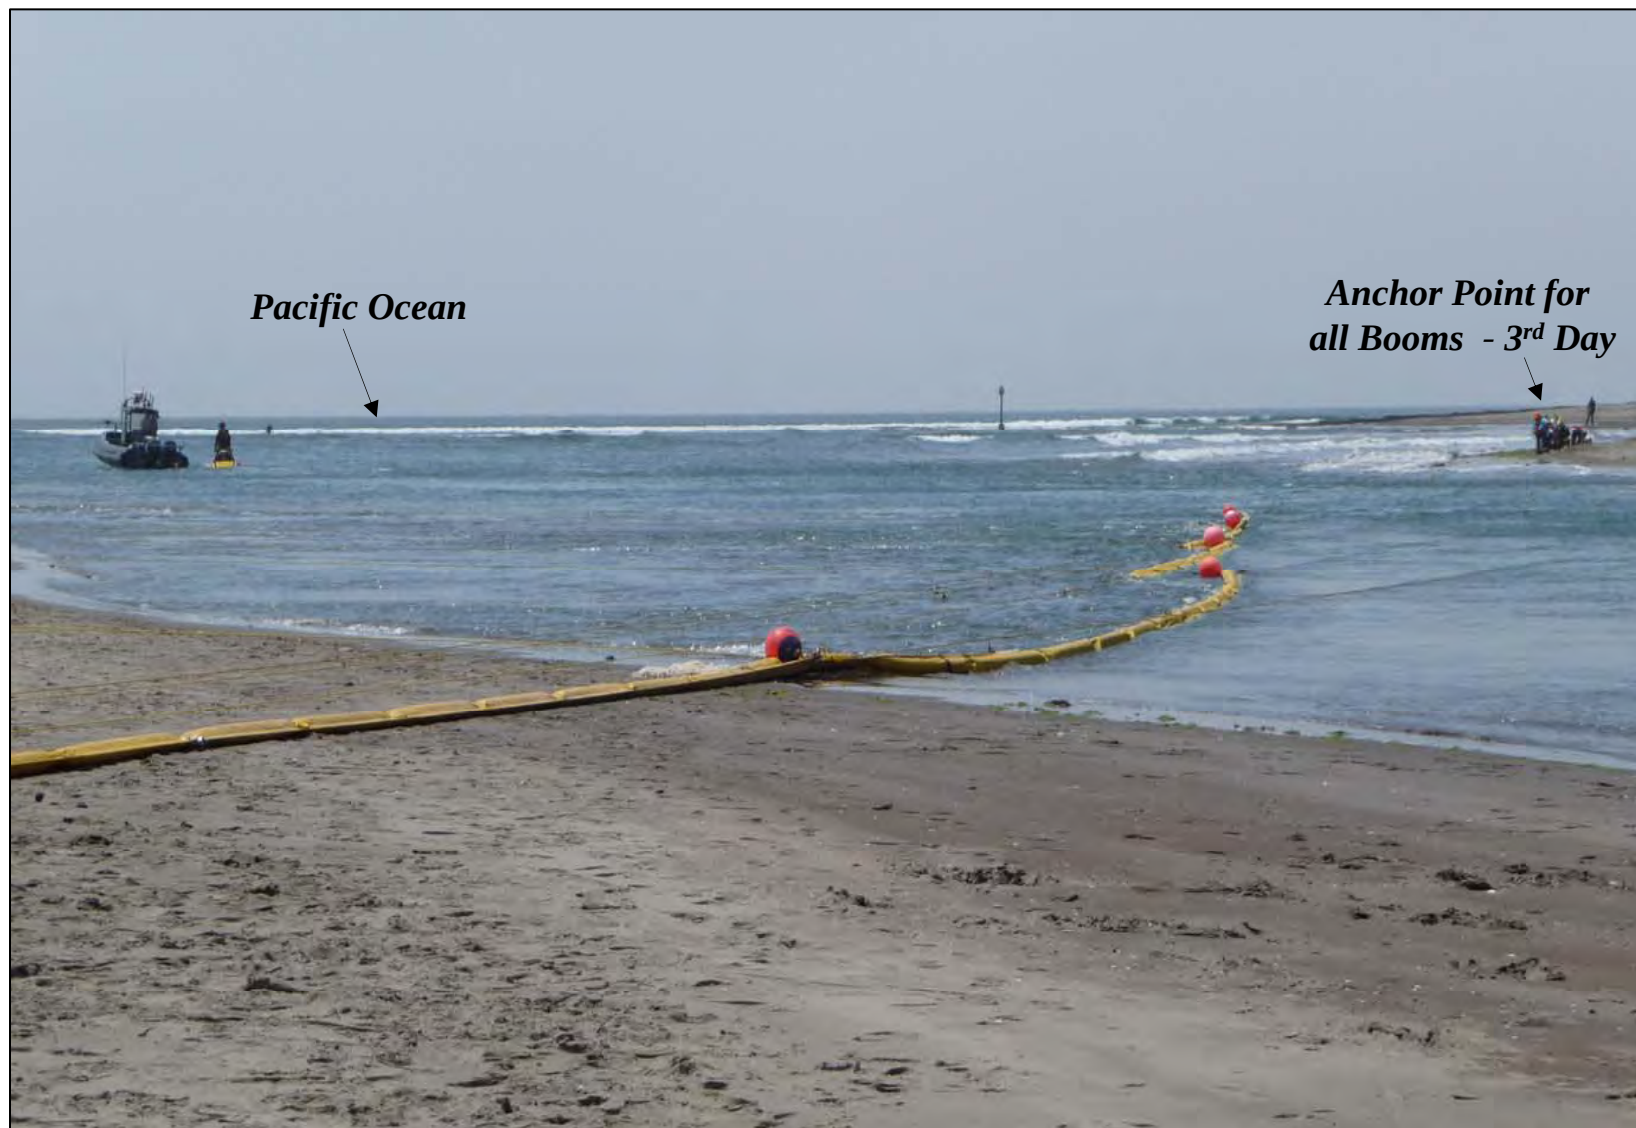
***Cascade System for Fast Water Environments  
is Effective in a Coastal Water Environment***

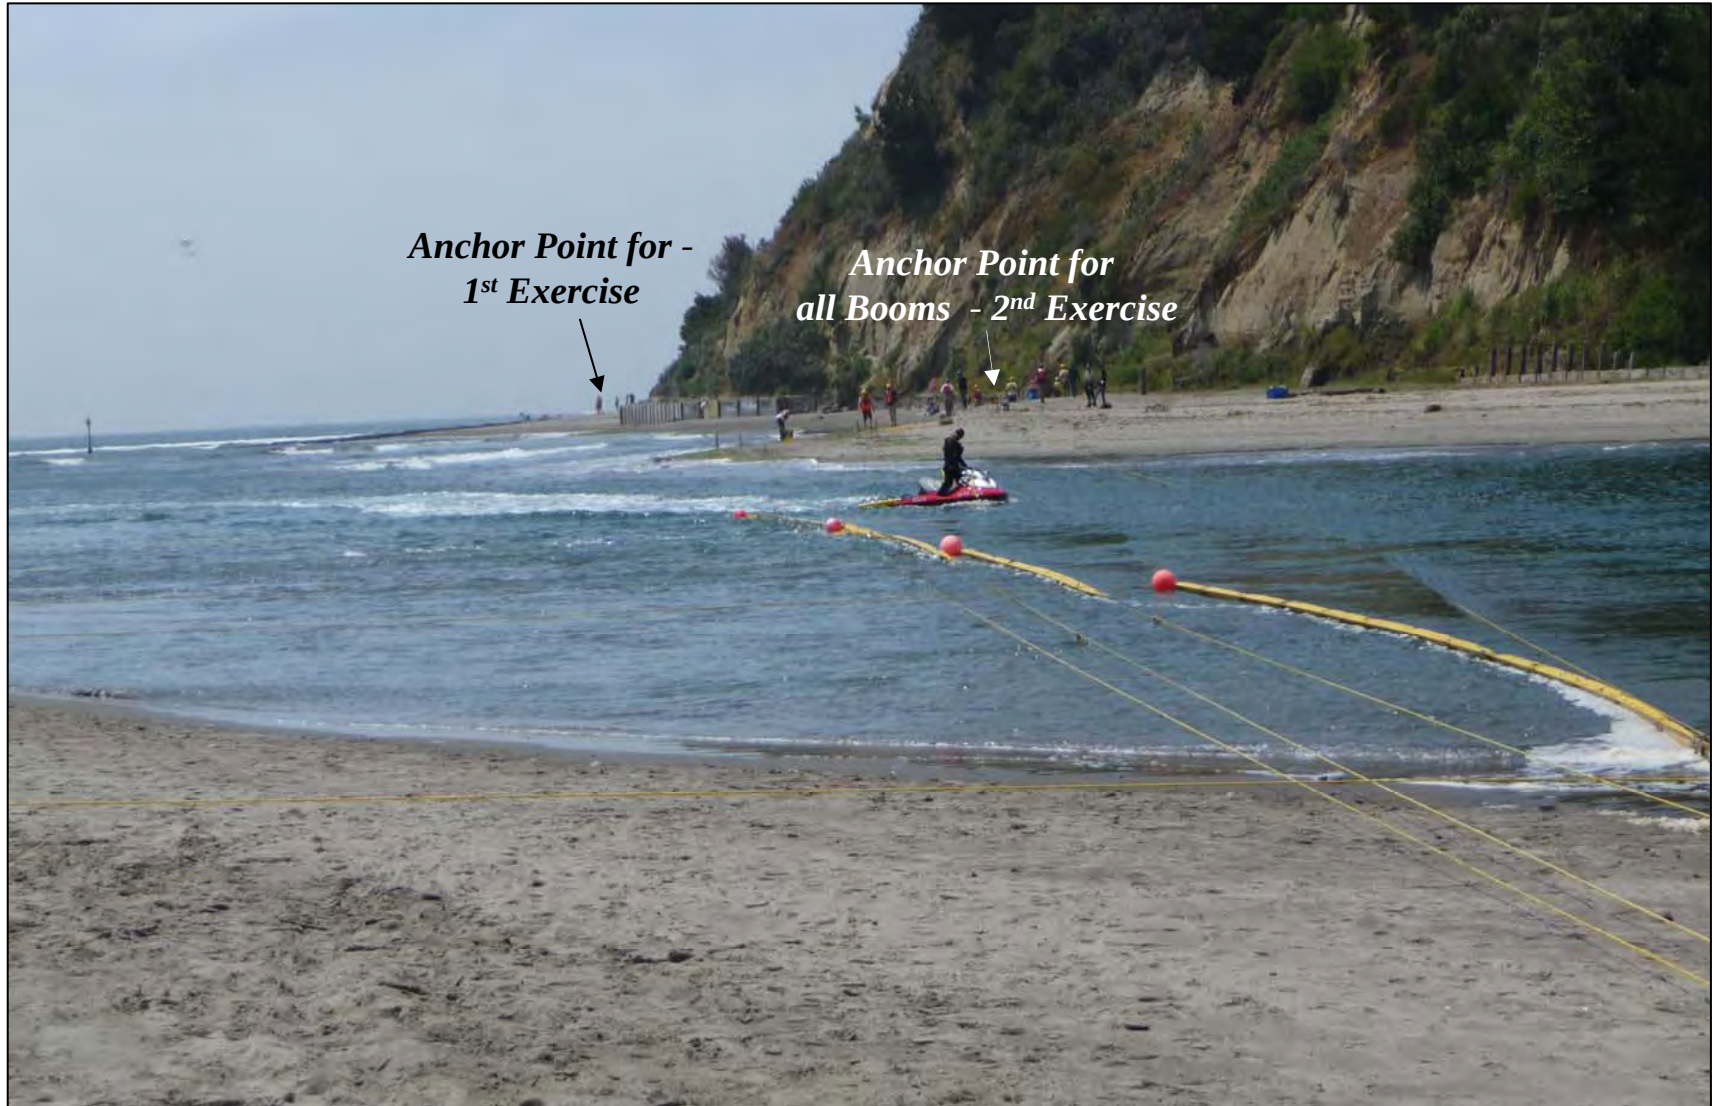
***Five Booms Deployed***

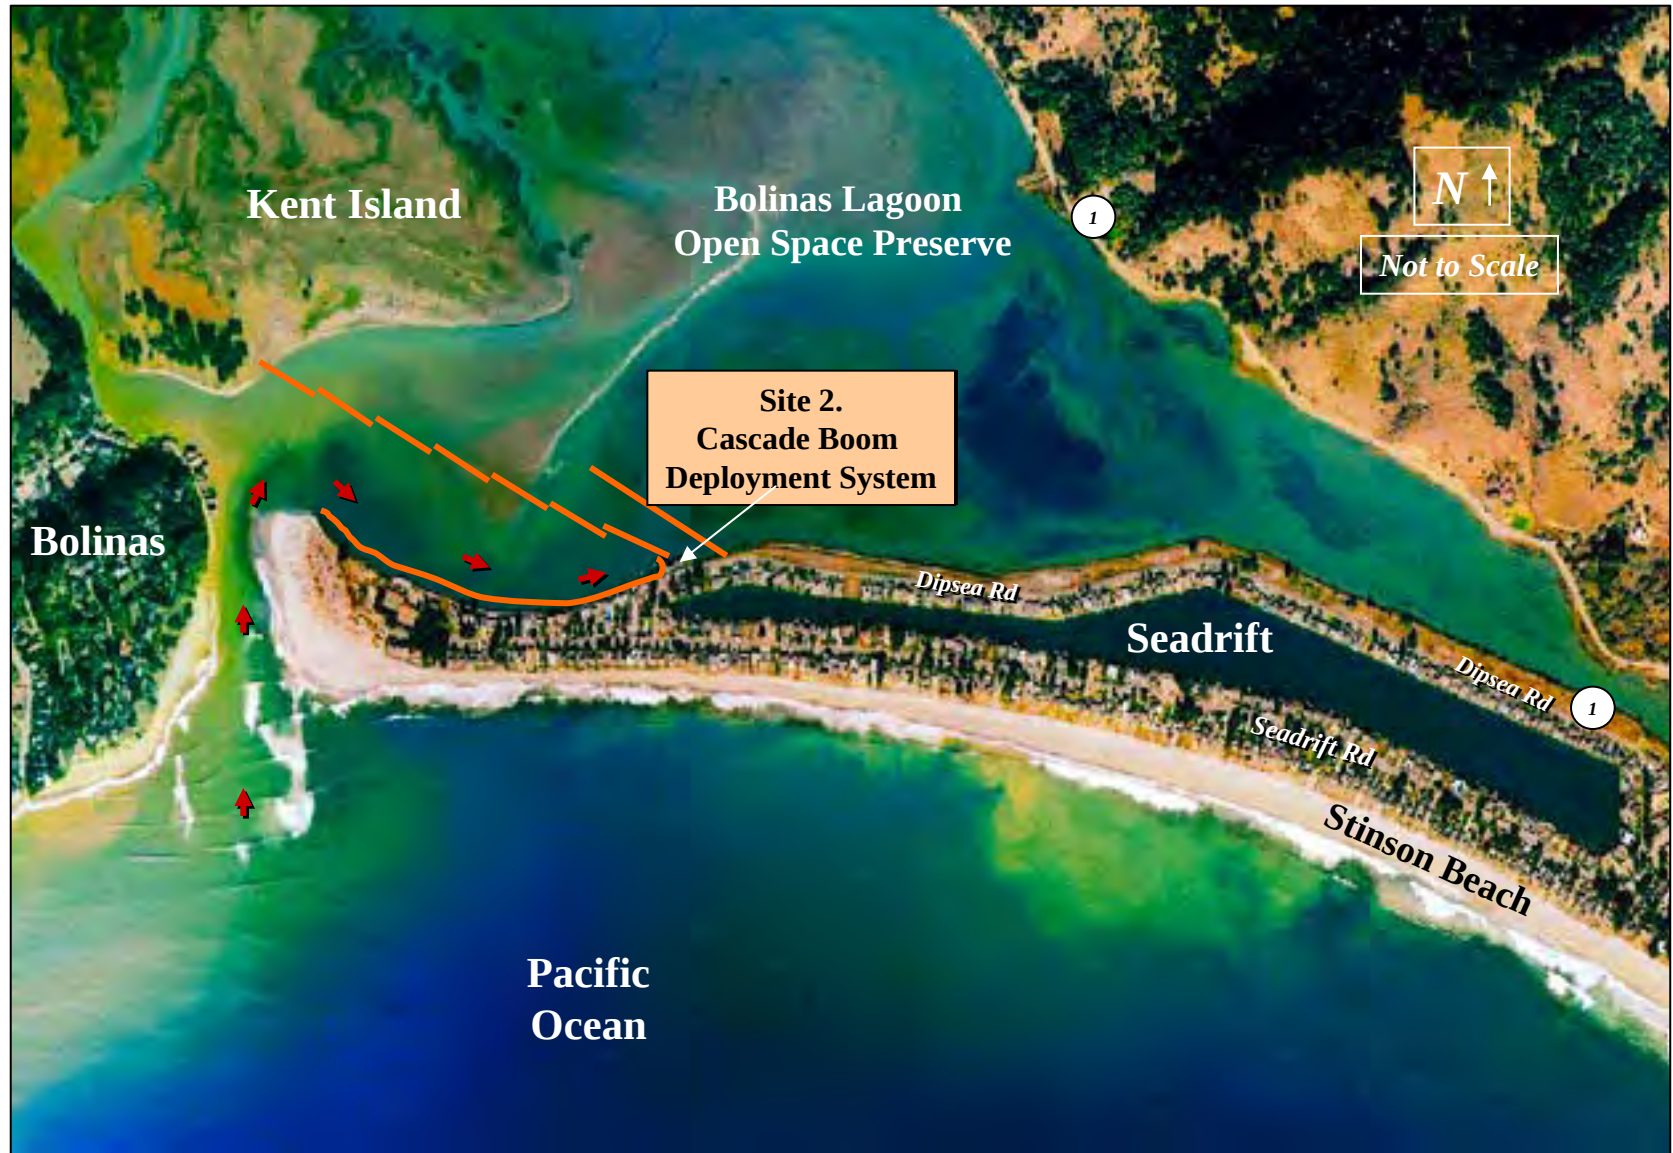
***Boom Deployment, Containment & Recovery Strategies  
Bolinas Lagoon Open Space Preserve - High Tide***

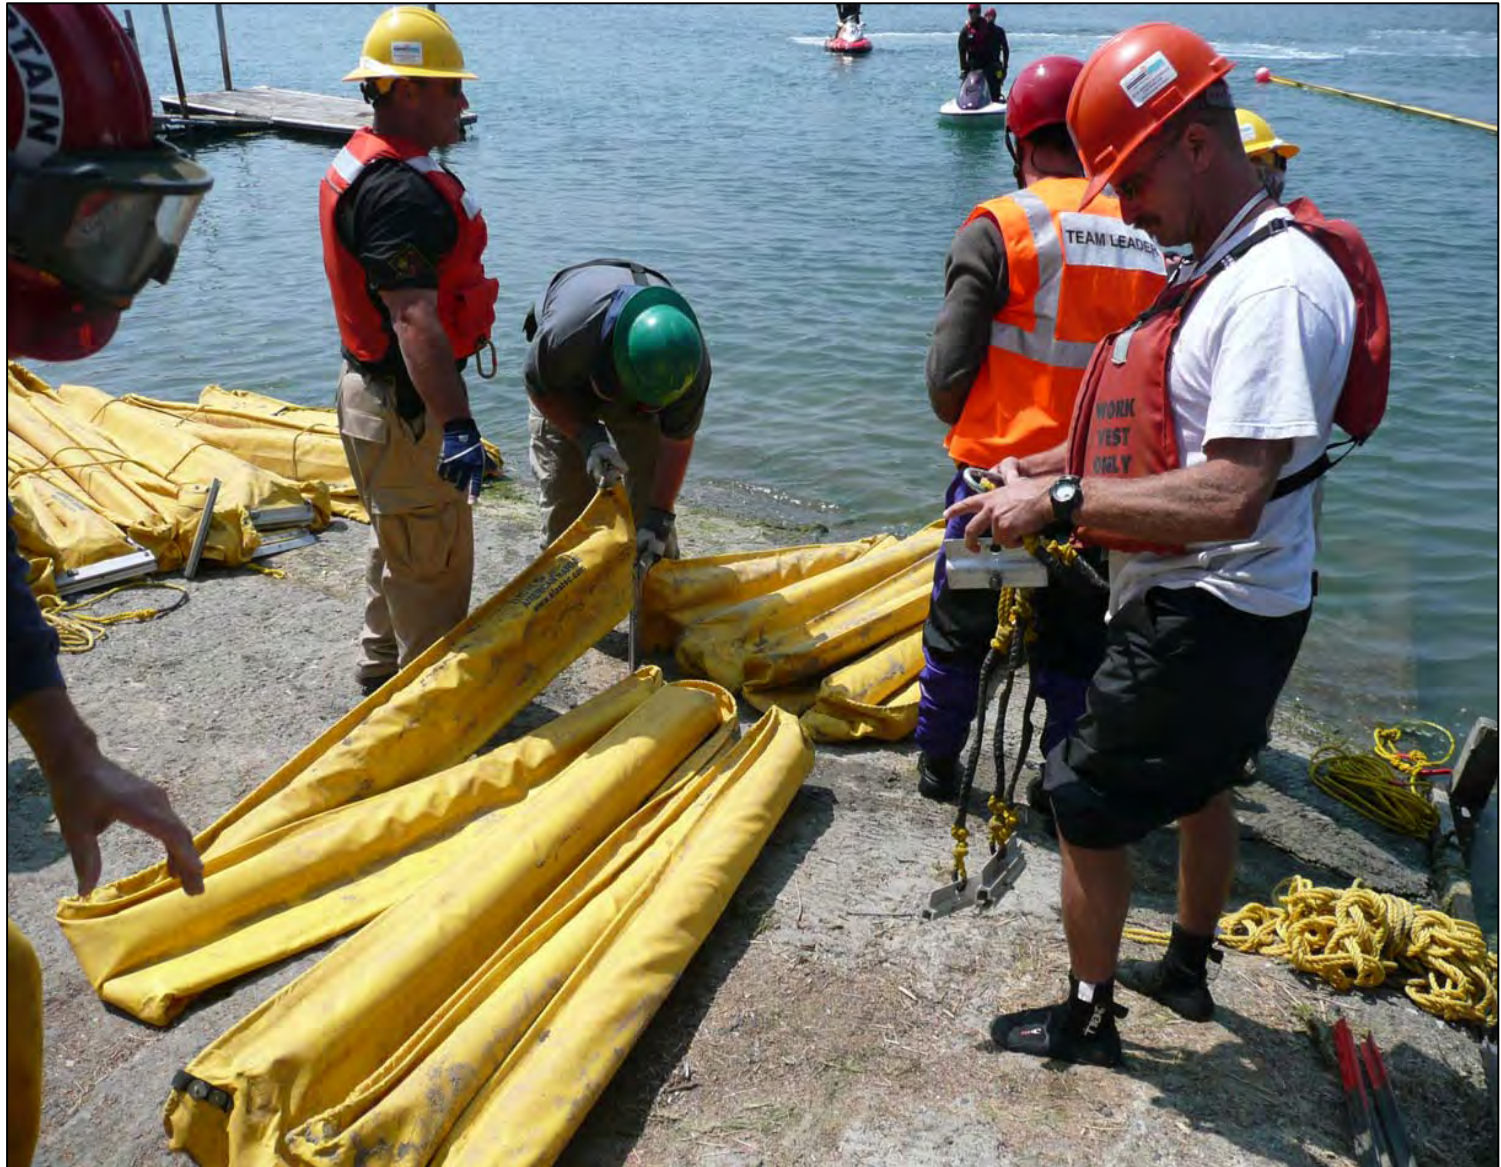
***Boom in 100' Lengths is Zig-Zagged on the Boat Ramp in Seadrift***

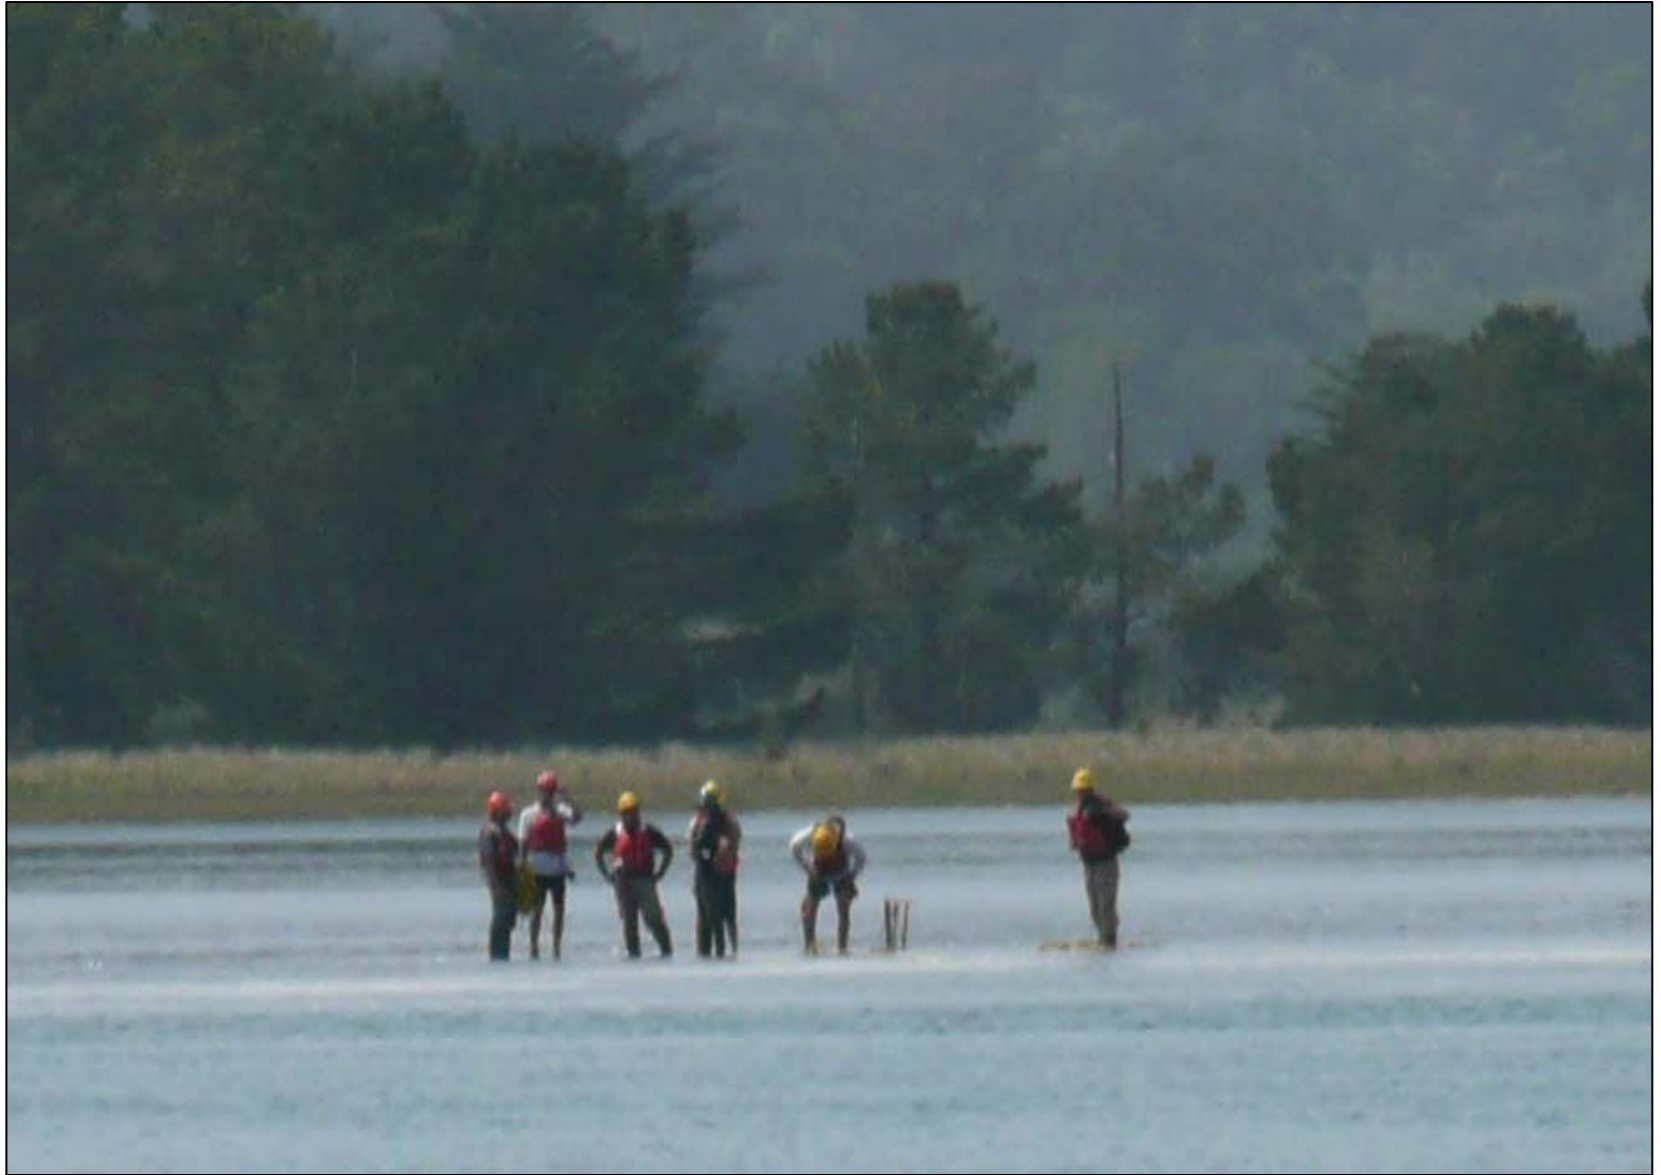
***Team Setting Up Anchor to Receive Boom***

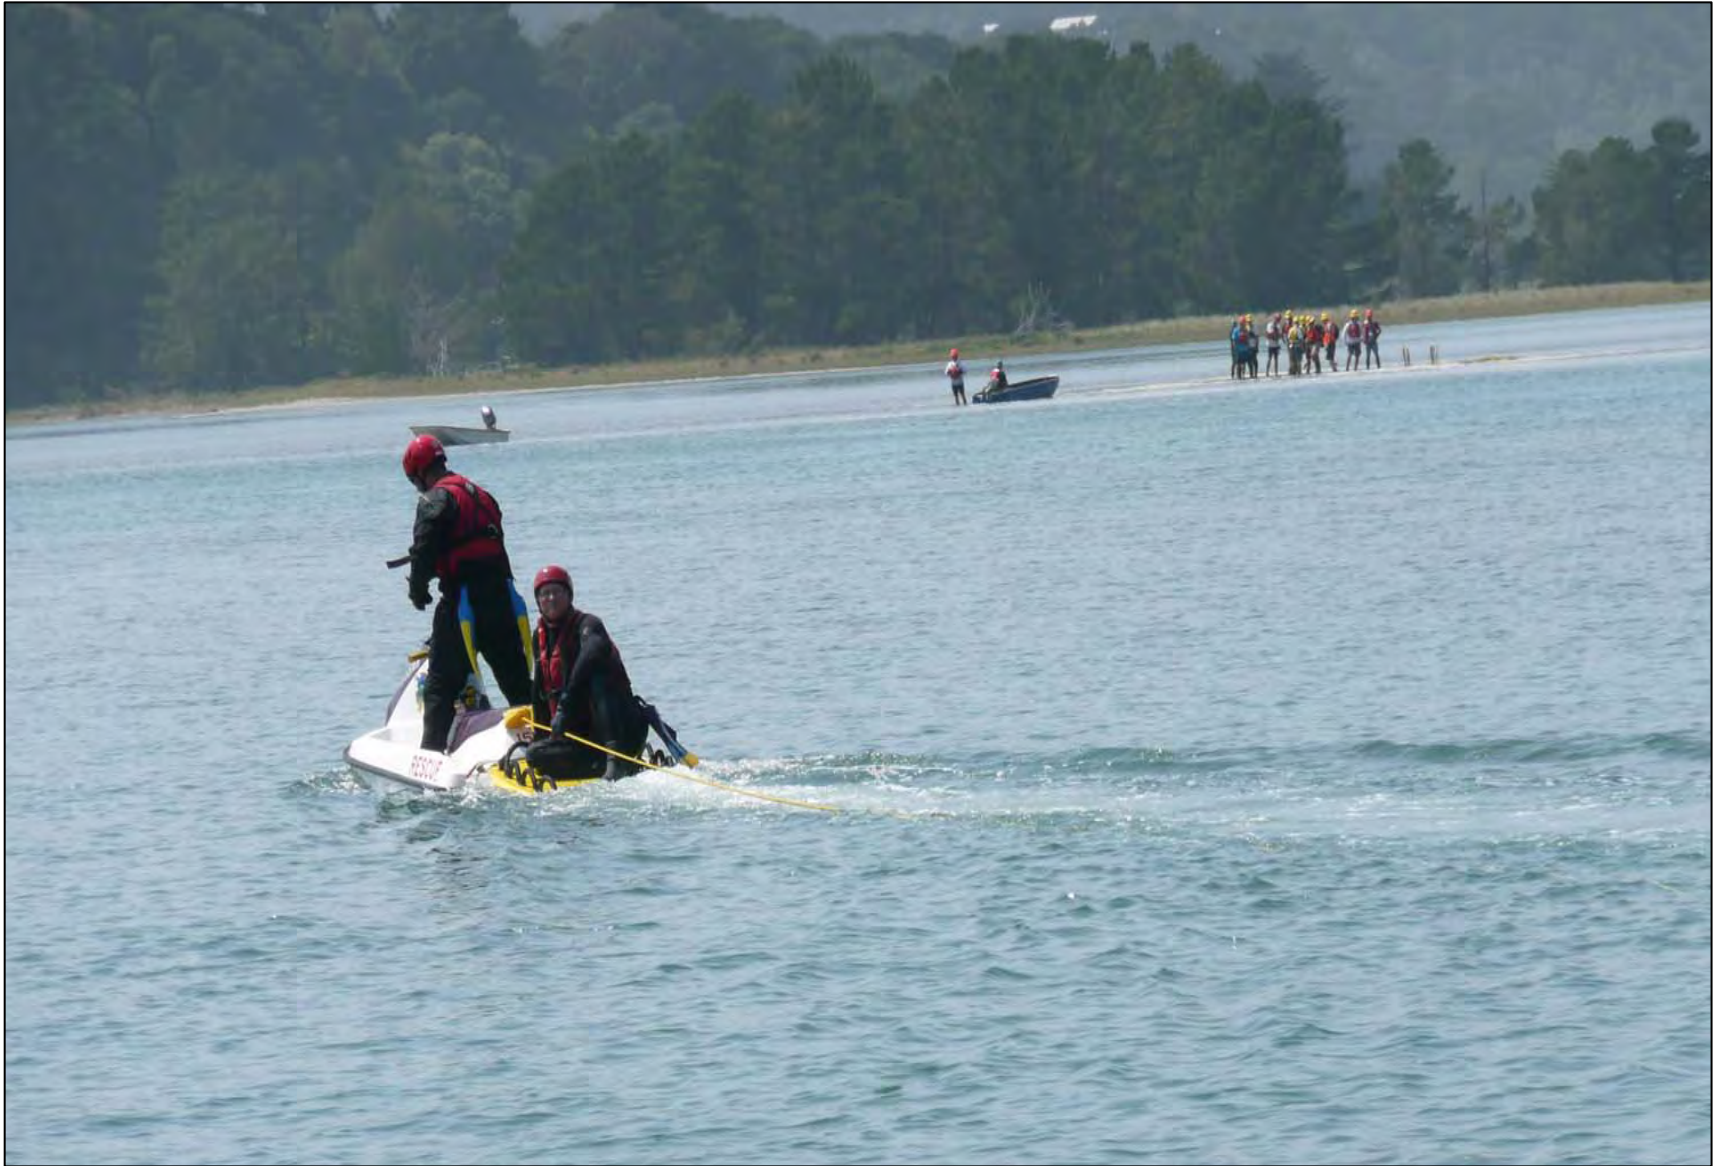
***Jet Ski Ferries Line Attached to Boom to Anchor Team on Sand Bar Small Island***

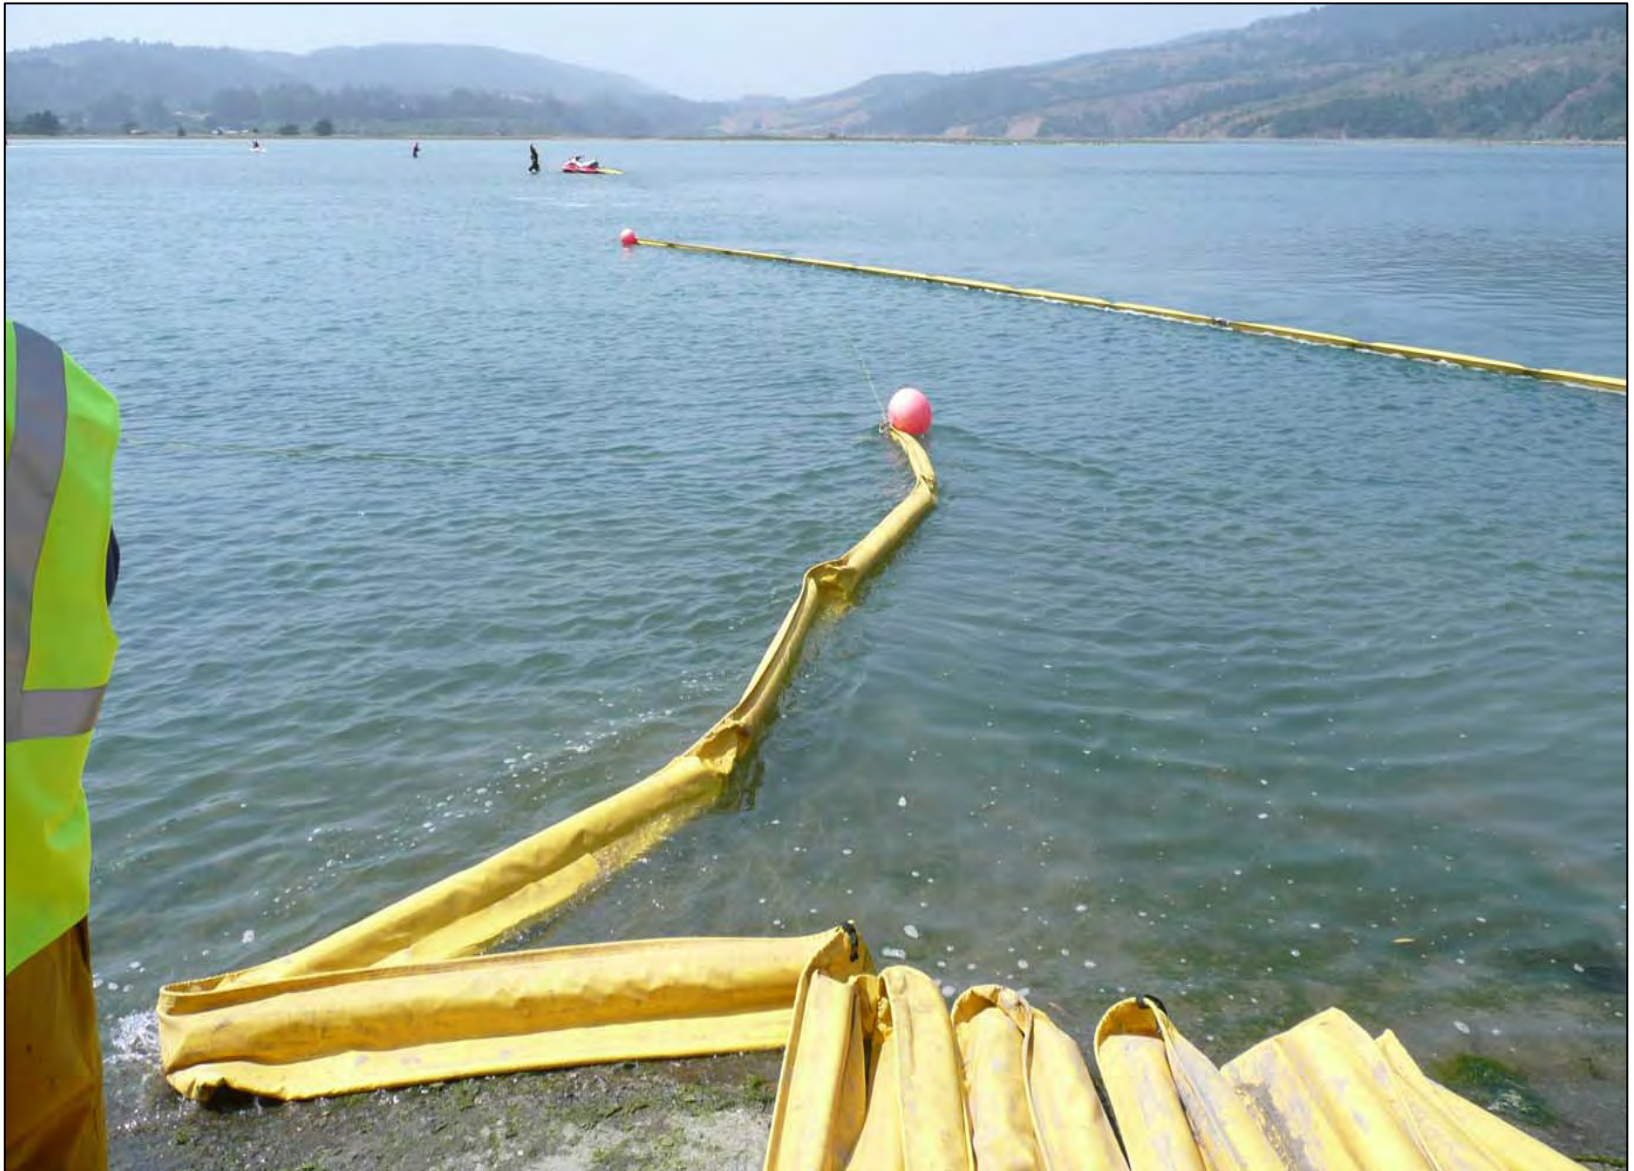
***Team on Sandbar Island Pulls Line and Boom is Being Deployed***

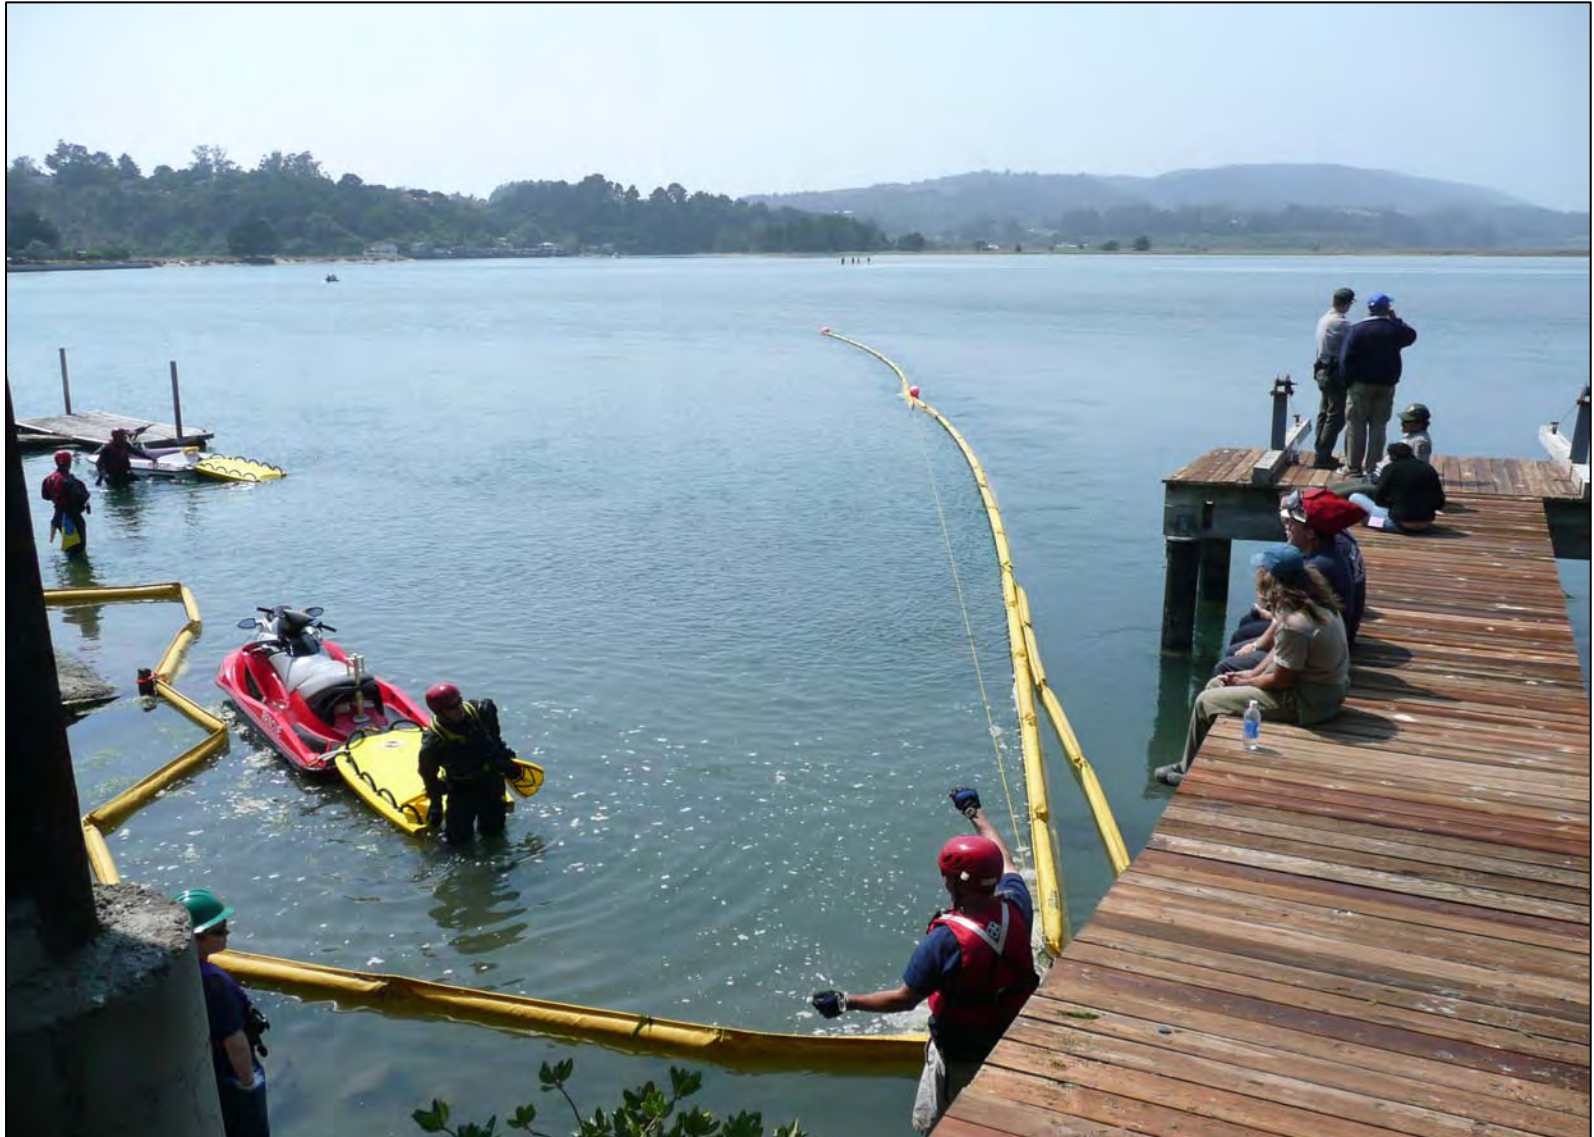
***Shoreline Containment & Protection Boom Being Deployed***

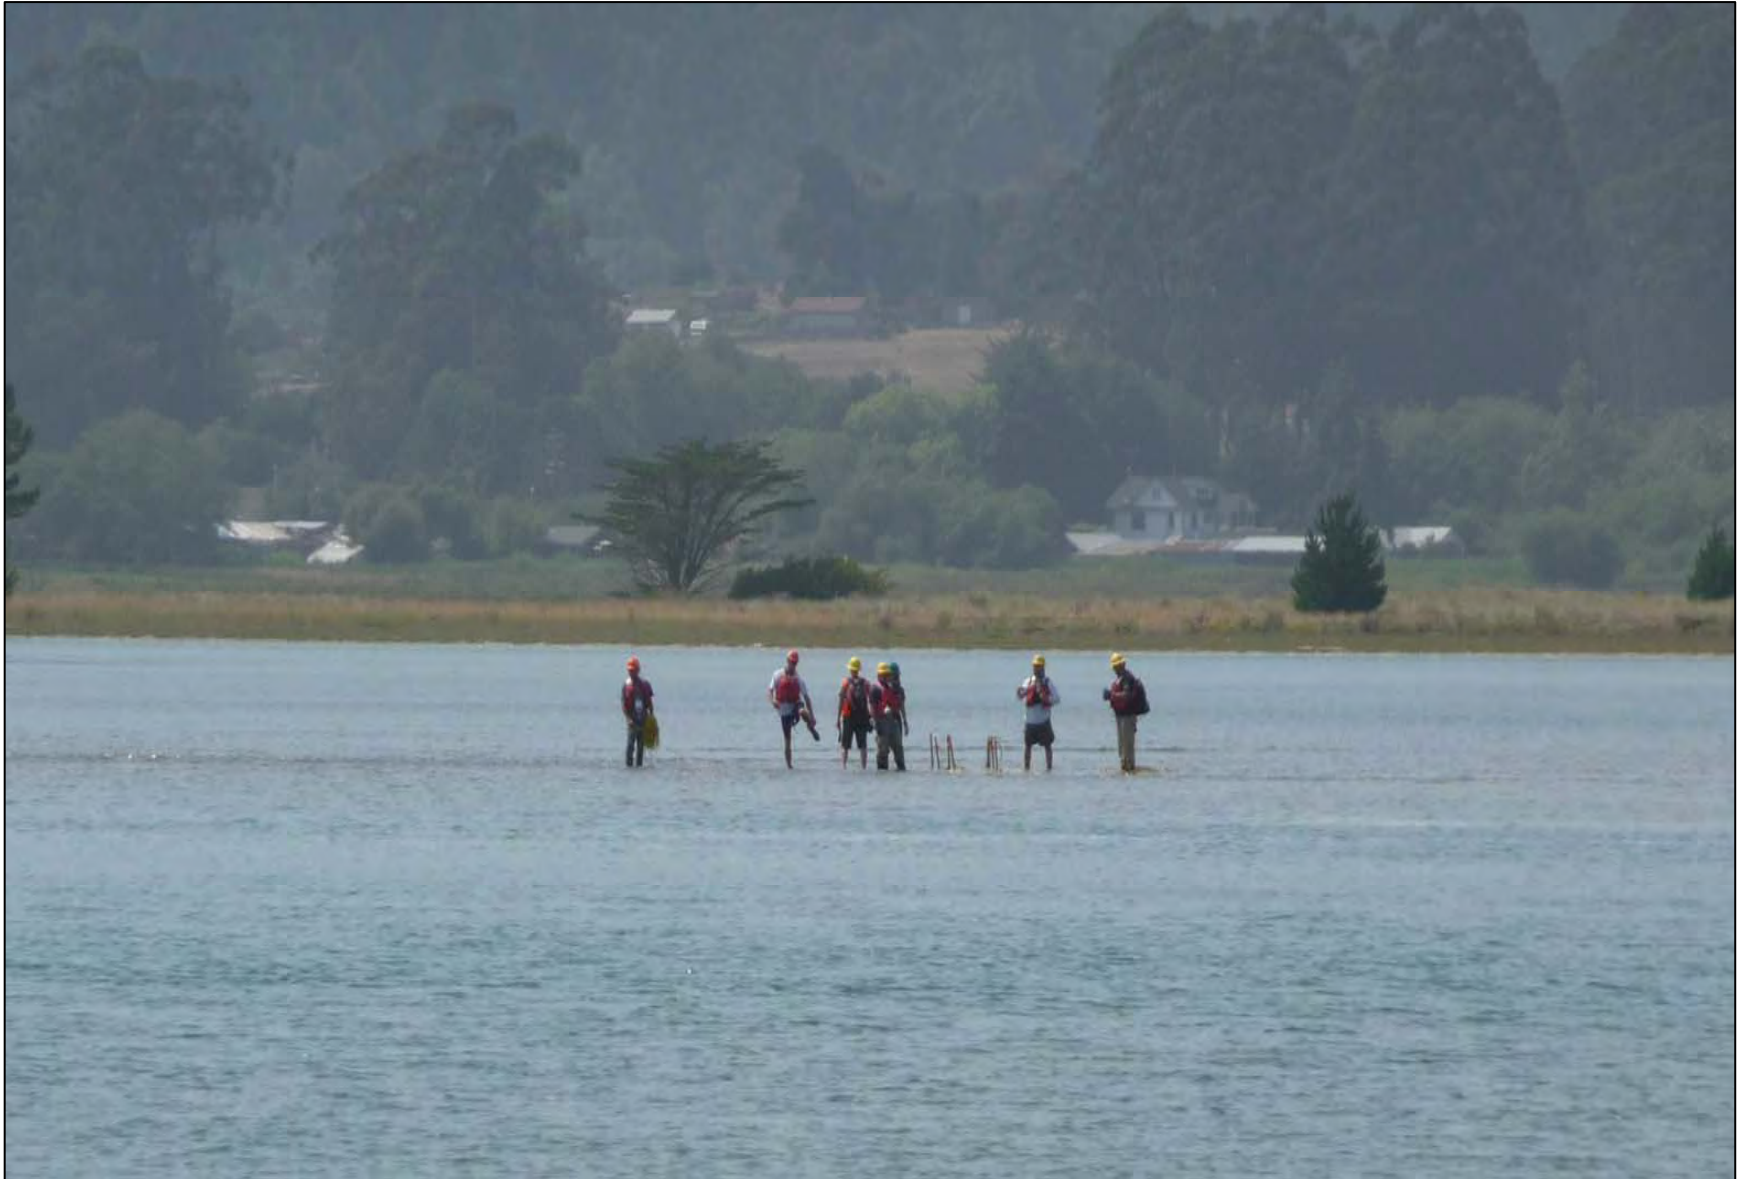
***Team Waits to be Ferried back to Nearside Seadrift Boat Ramp as the Tide Comes in***

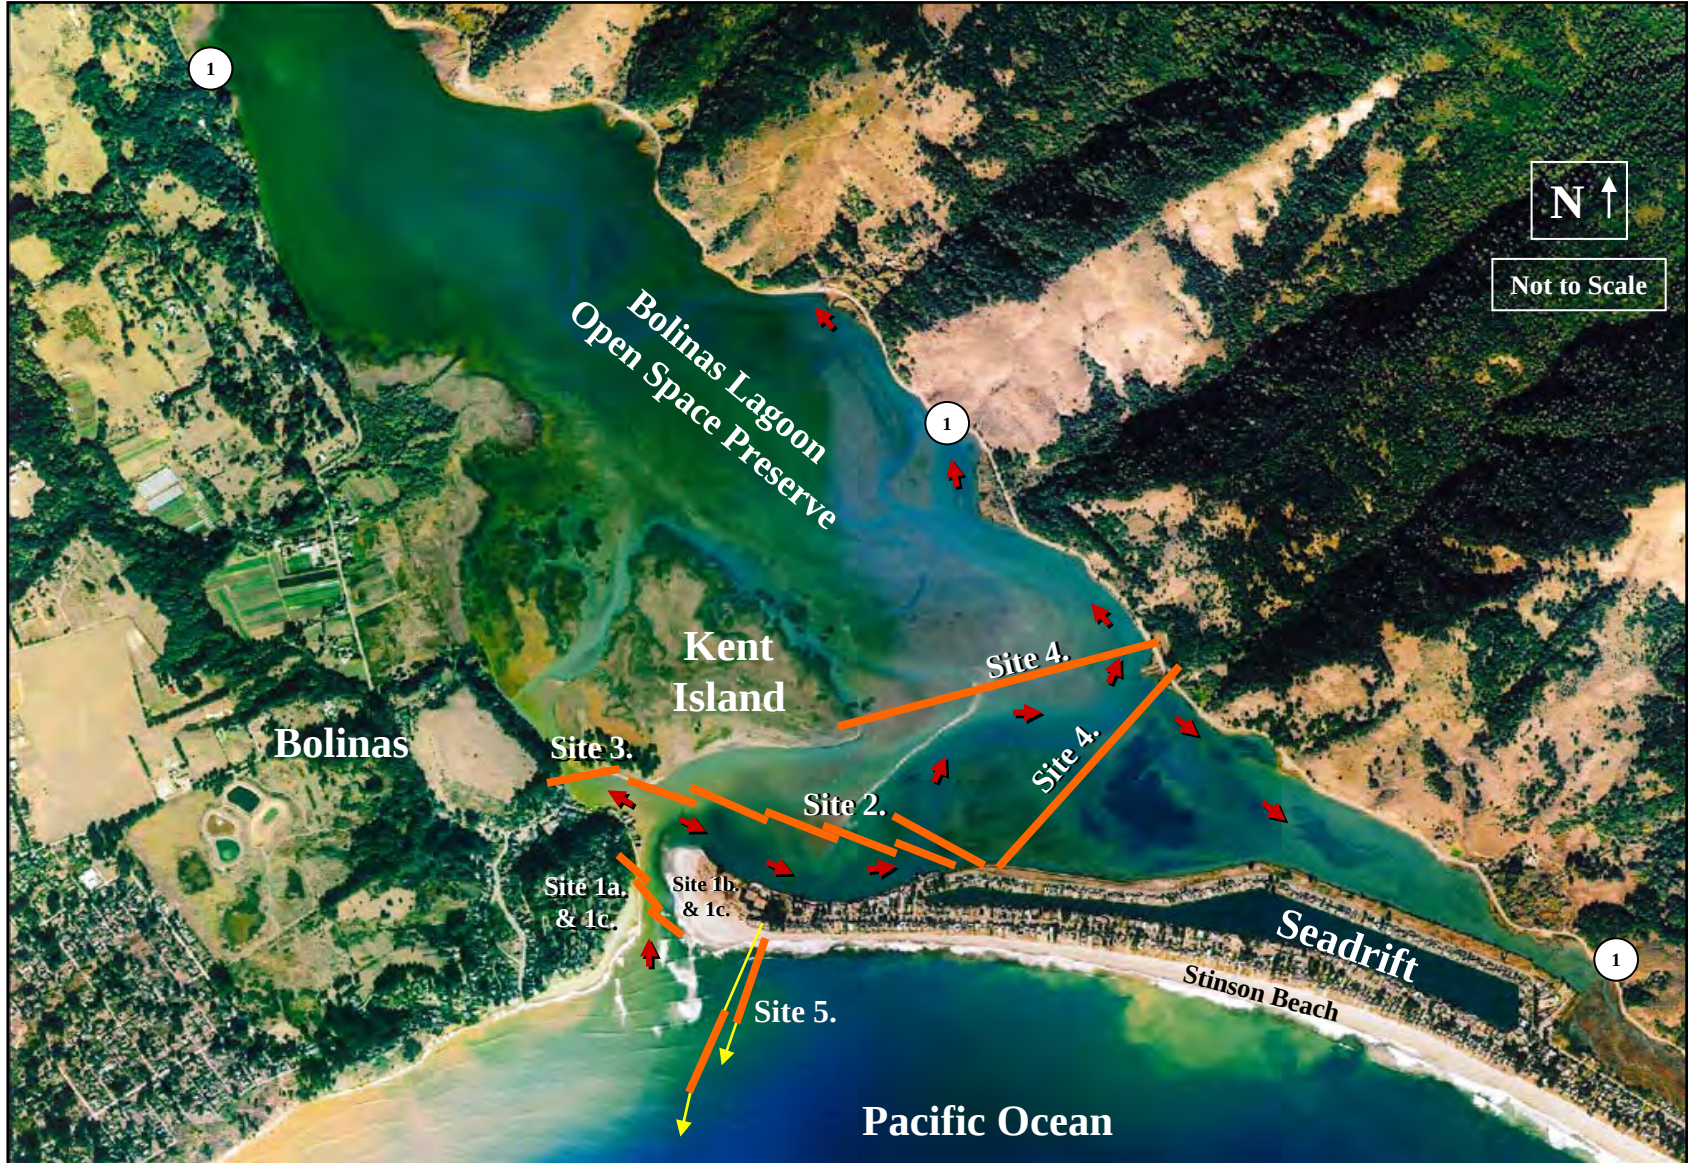
***Boom Deployment, Containment & Recovery Strategies  
Bolinas Lagoon Open Space Preserve - High Tide Aerial Photo***
