**Coal Combustion Residue Impoundment
Round 9 - Dam Assessment Report**

Flint Creek Power Plant

Bottom Ash Dike

SWEPCO

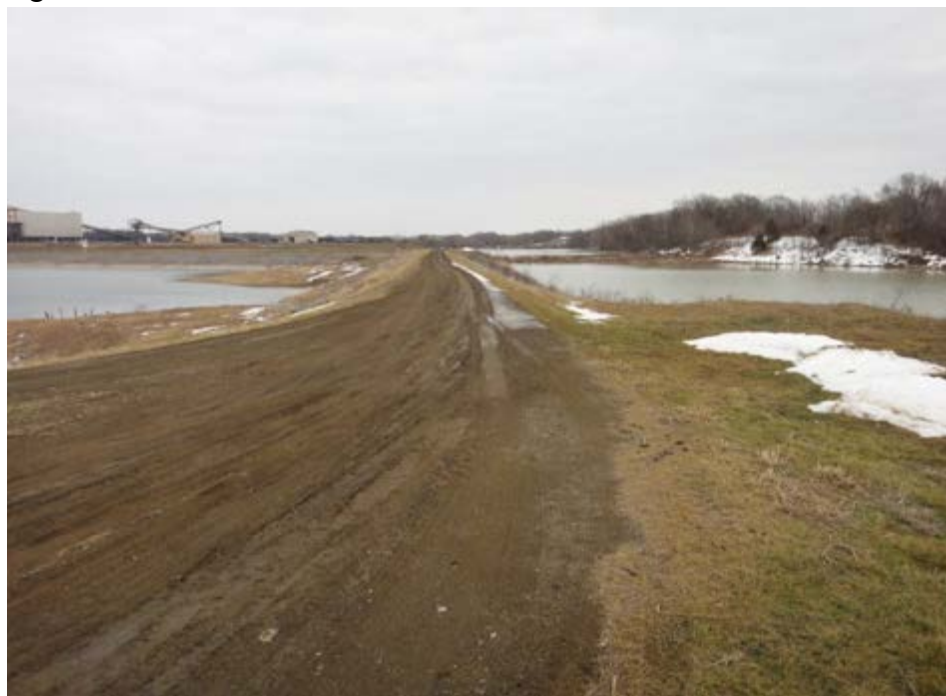
Figure 5.2.1-1: Photo Showing Crest, West Dike

The west dike is shared by both the primary and secondary pond. The crest had no signs of depressions, tension cracks, or other indications of settlement or shear failure, and appeared to be in satisfactory condition. Figure 5.2.1-1 shows conditions of the crest on the west dike.

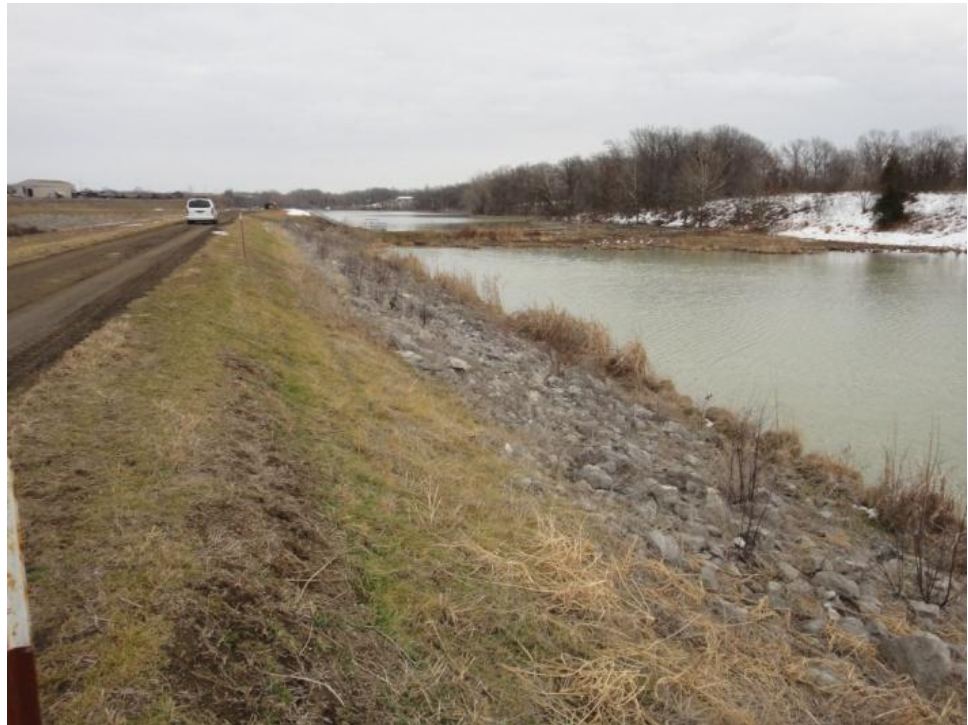
Figure 5.2.2-1: General condition of the inside slope, west dike

There were no observed scarps, sloughs, bulging, cracks, or depressions or other indications of slope instability or signs of erosion. The lower portion of the inside slope was protected with rip rap. Figure 5.2.2-1 shows the general condition of the inside slope, west dike.

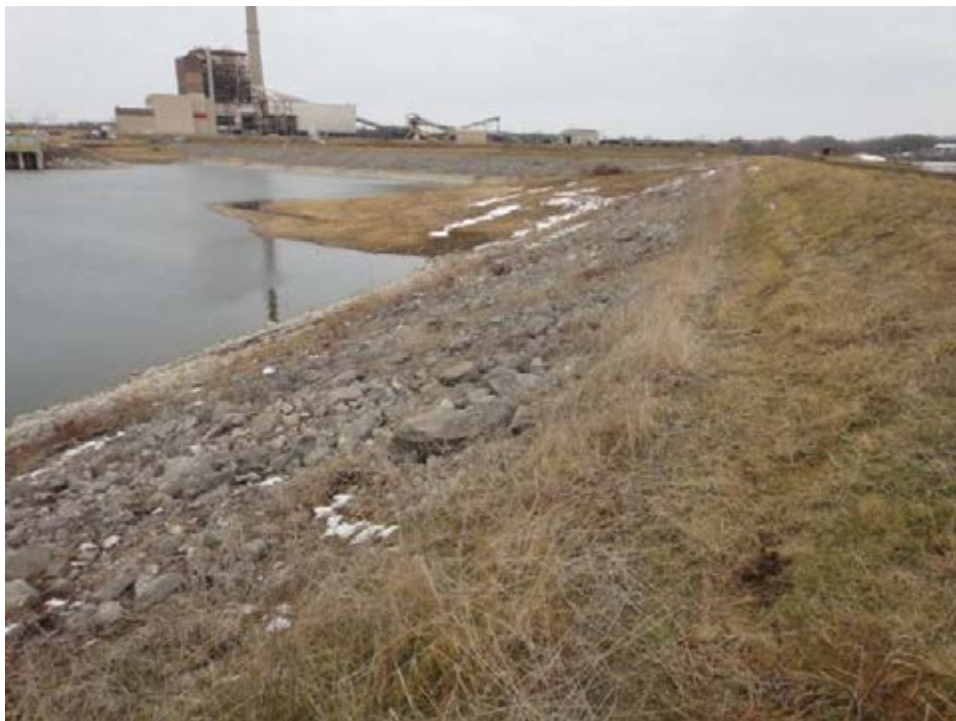
Figure 5.2.3-1: General condition of the west dike outside slope and groin

There were no observed scarps, sloughs, bulging, cracks, or depressions or other indications of slope instability or signs of erosion. The lower portion of the outside slope was protected with rip rap. Figure 5.2.3-1 shows the general condition of the outside slope of the Primary Bottom Ash Pond; the cooling pond is on the left side of the picture.

There were no observed scarps, sloughs, bulging, cracks, or depressions or other indications of slope instability or signs of erosion. Figure 5.2.3-1 also shows the general condition of the groin.

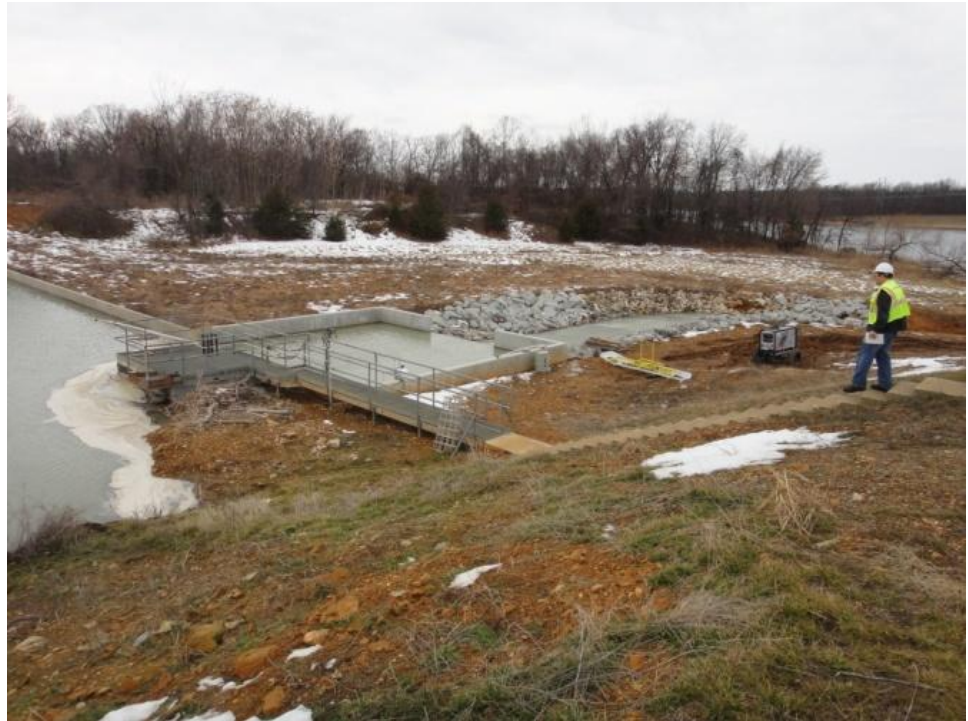
Figure 5.4.1-1. Main outlet structure

The primary overflow structure was observed to be working properly, discharging flow from the bottom ash ponds. The outlet structure visually appeared to be in satisfactory condition. There were no signs of clogging of the spillway and the water exiting the outlet was flowing clear. Figure 5.4.1-1 shows the main outlet structure.

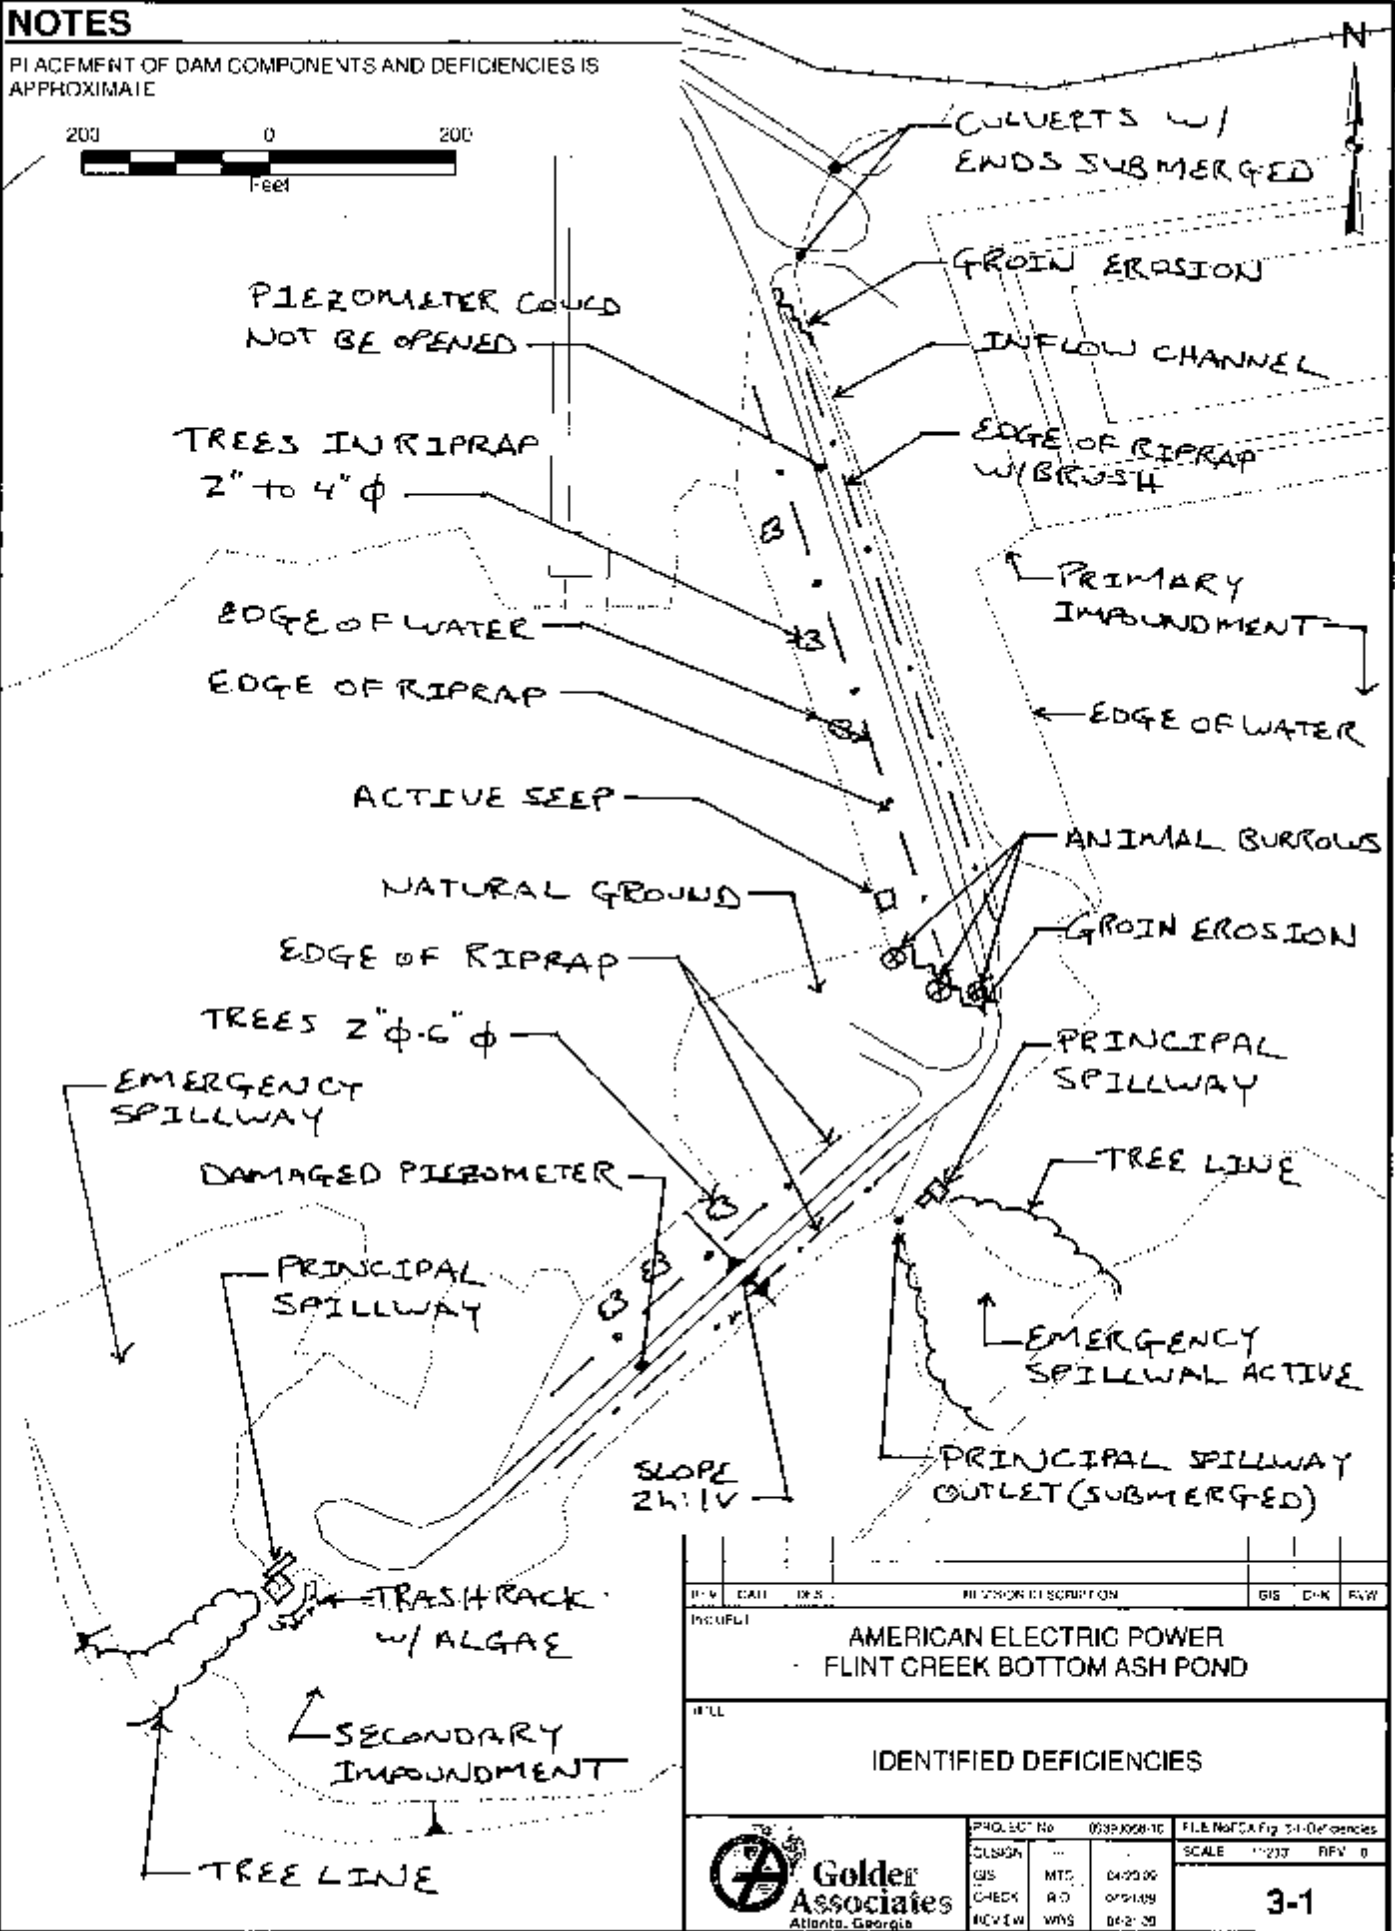
REV	DATE	BY	DESCRIPTION	GIS	D-K	REV
1			AMERICAN ELECTRIC POWER FLINT CREEK BOTTOM ASH POND			
IDENTIFIED DEFICIENCIES						
PROJECT No		0539-0028-10		FILE No/CA Fig 3-1 of series		
DESIGN	MTS	04-20-06	SCALE 1"=20'			
GIS	AD	05-14-09	REV 0			
CHECK	WNS	06-2-09	3-1			
REVIEW

See Figure 3-1 for the location of structures and deficiencies itemized below.

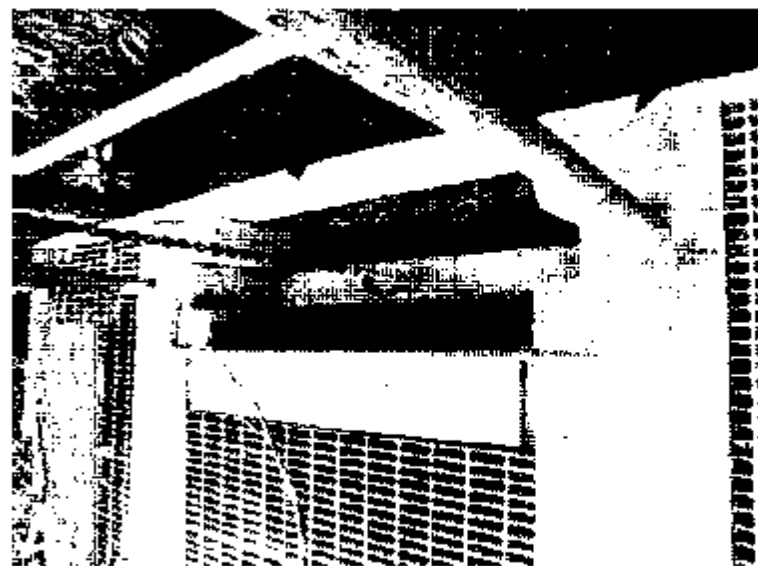
4.) Emergency Spillway Control Section – Primary Impoundment:
 Poor condition due to significant riprap displacement.

The emergency spillway was activating at the time of inspection
 The riprap control section has significant displacement.

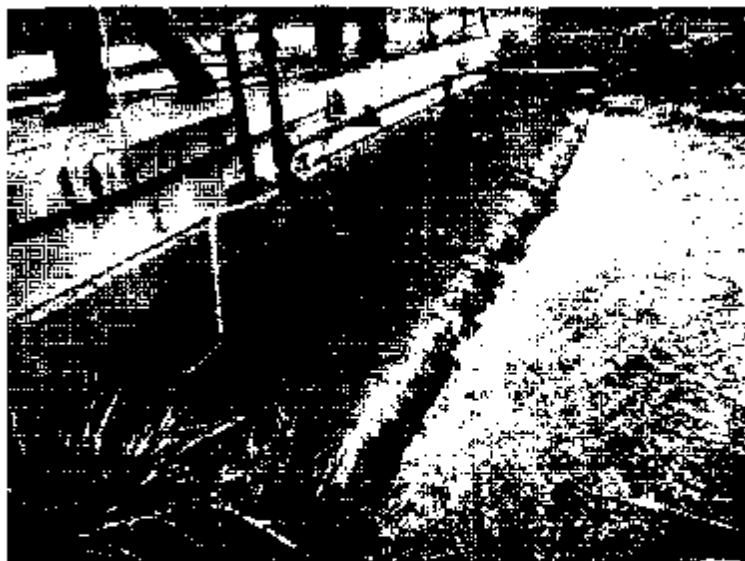
8.) Principal Spillway Discharge
Channel Secondary Impoundment;
Fair condition.

Channel appears stable.

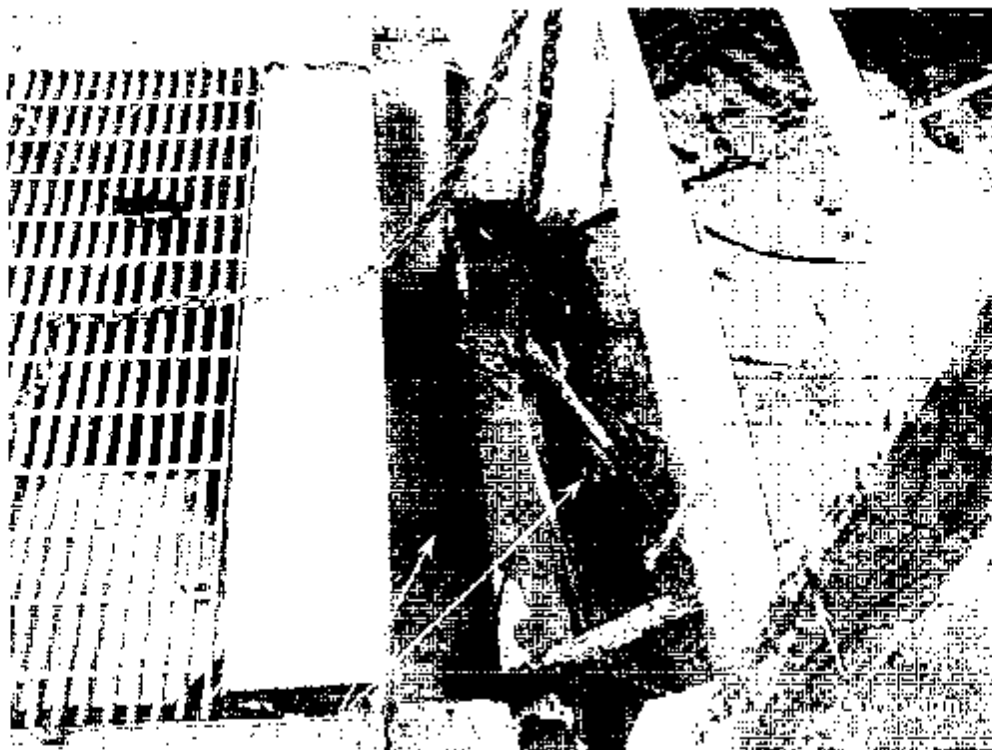
Photo 1. Primary ash pond principal spillway with significant blockage at inlet and minor corrosion of steel and chipping of concrete components.

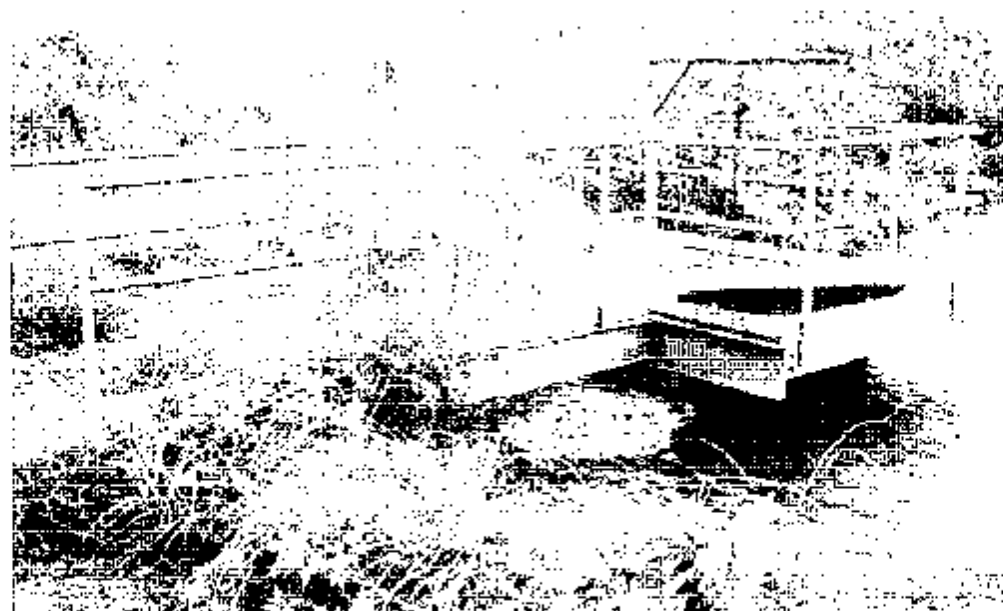
Photo 2. Primary ash pond principal spillway with significantly high and woody vegetation growing adjacent to it.

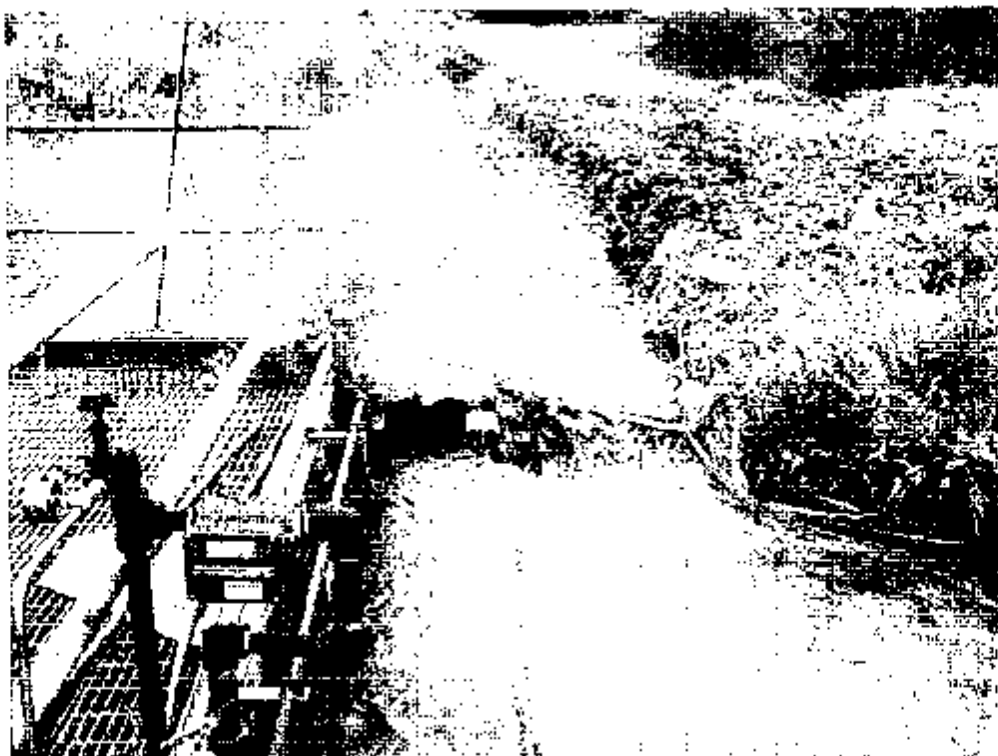
Photo 5. Secondary ash pond principal spillway weir with minor growth of woody vegetation and active emergency spillway prepared for reconstruction.

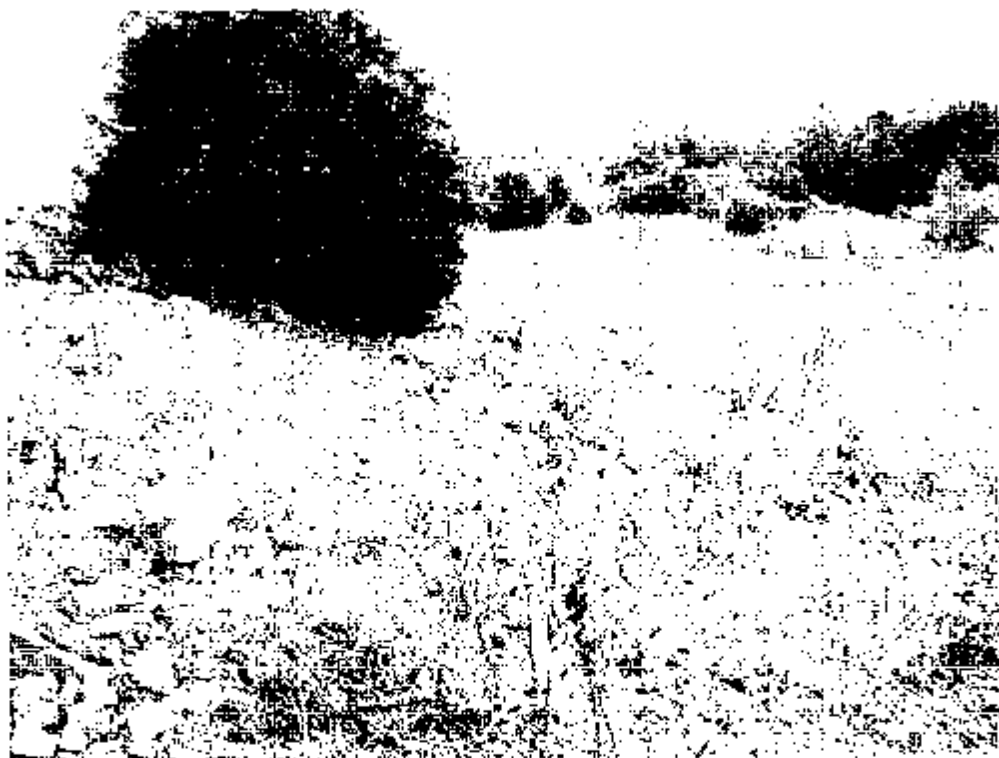
Photo 24. Downstream slope of secondary dam, looking left, with one large tree remaining and significantly high vegetation growing through the riprap.

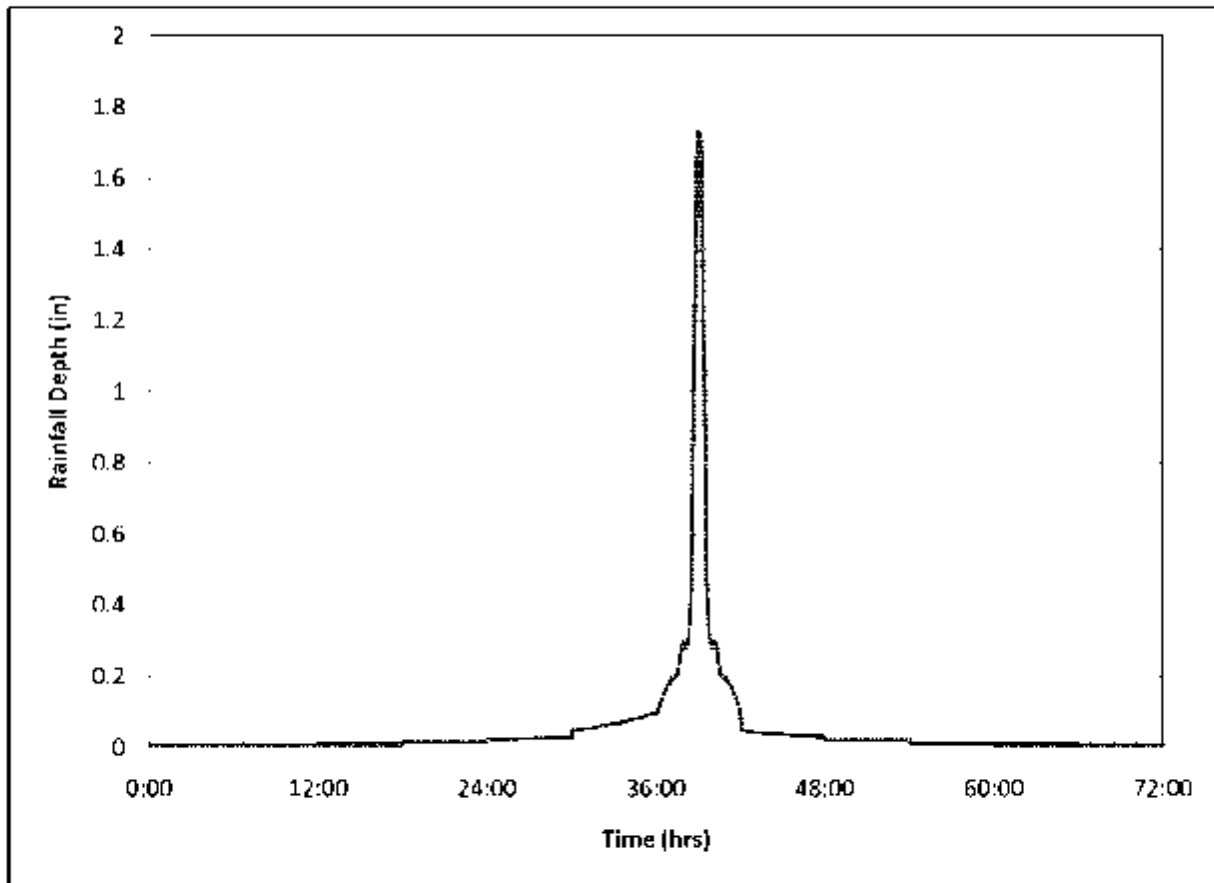
Figure 7 – PMP Rainfall Hyetograph

Storm Duration (hr)	Depth (in)
1	15.89
2	19.98
3	23.22
6	29.14
12	34.10
24	38.61
48	42.92
72	45.40
