**Coal Combustion Waste Impoundment
Round 7 - Dam Assessment Report**

Riverside Generating Station

Ash Ponds

MidAmerican Energy Company
Bettendorf, Iowa

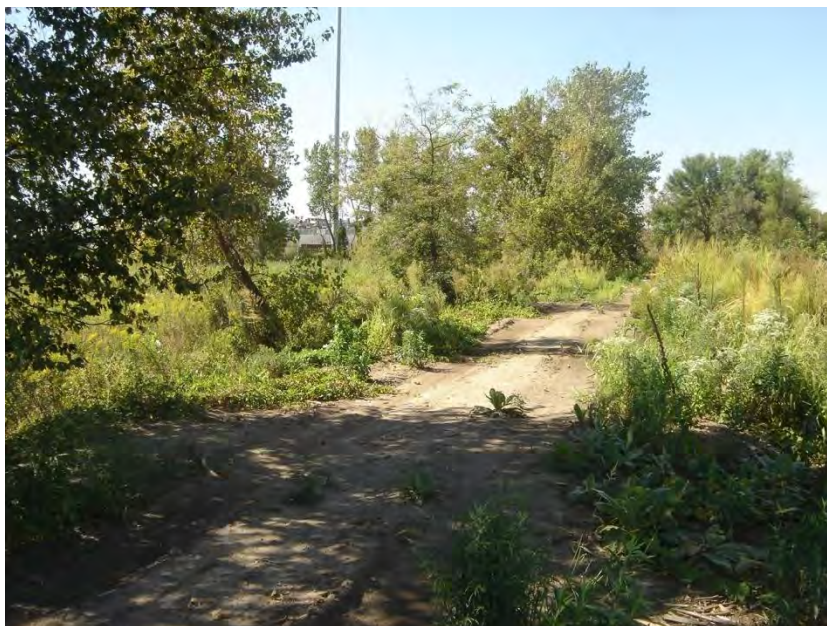
Figure 5.2.1: Crest and Slope of North Ash Pond dike.

The crest had no signs of rutting, depressions, tension cracks or other indications of settlement or shear failure, and appeared to be in satisfactory condition. See Figure 5.2.1.

Maintenance should be performed on the North Ash Pond embankments consisting of the removal of thick woody-stemmed vegetation, dense brush and trees covering the upstream and downstream slope and establishing a grassed condition. Photo documentation has been provided by MidAmerican (see Appendix A, Doc 13), subsequent to the site visit, that indicate that this maintenance has been performed.

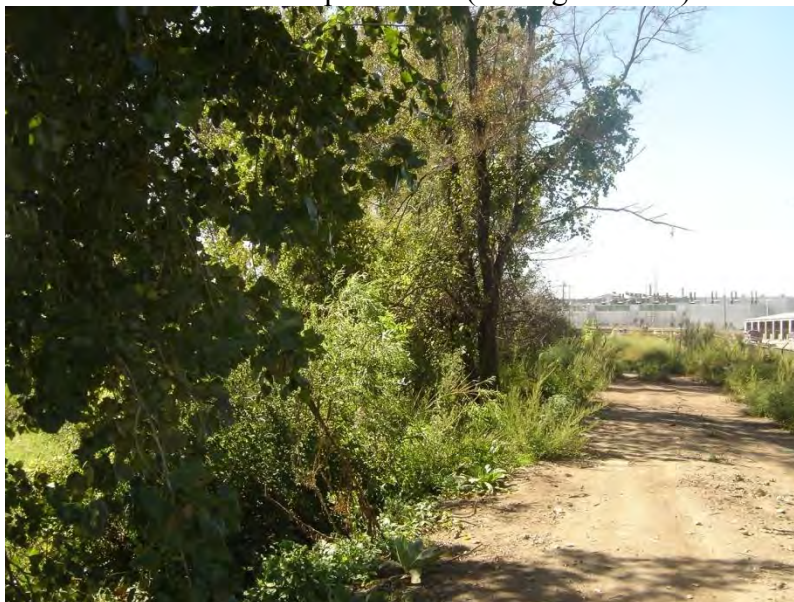
Figure 5.2.2: Crest and Upstream/Inside Slope of North Ash Pond dike.

The upstream/inside slope of the North Ash Pond was covered by thick woody-stemmed vegetation, dense brush and trees; a thorough visual observation could not be performed (see Figure 5.2.2).

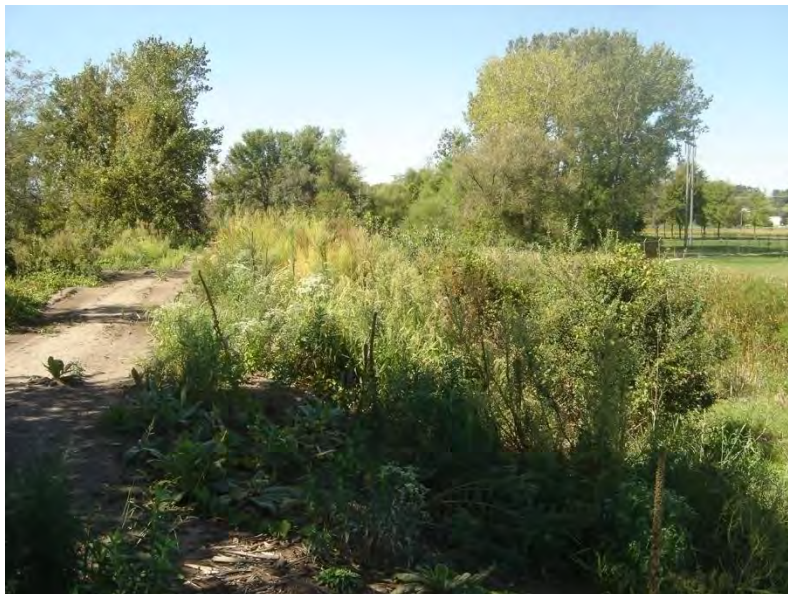
Figure 5.2.3a: Crest and Downstream/Outside Slope of North Ash Pond dike.

The downstream/outside slope and toe of the North Ash Pond was covered by thick woody-stemmed vegetation, dense brush and trees; a thorough visual observation was unattainable. Areas of rill and sheet erosion were visible (see Figure 5.2.3b).

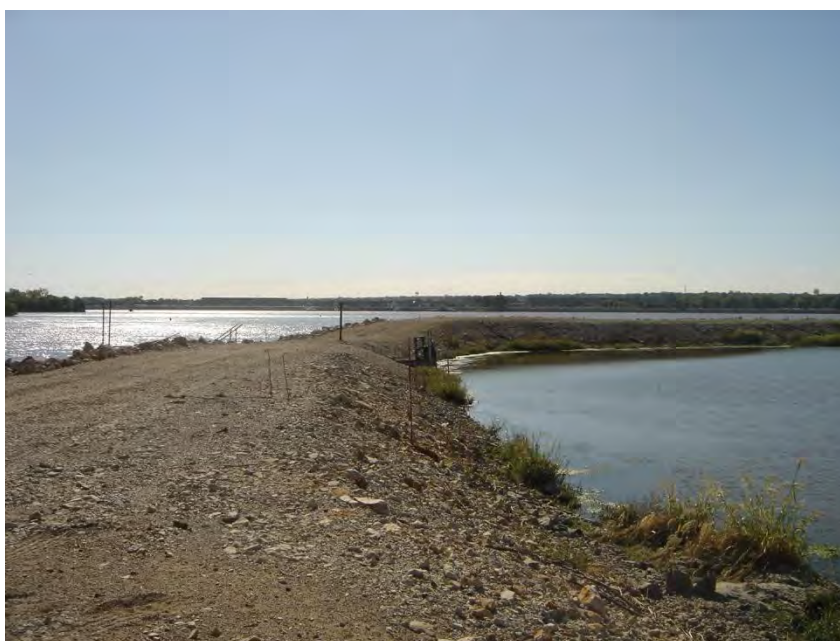
Figure 5.3.1: Crest and Upstream/Inside Slope of South Ash Pond dike.

The crest is covered by graded aggregate base material and had no signs of any rutting, depressions, tension cracks or other indications of settlement or shear failure, and appeared to be in satisfactory condition (Figure 5.3.1).

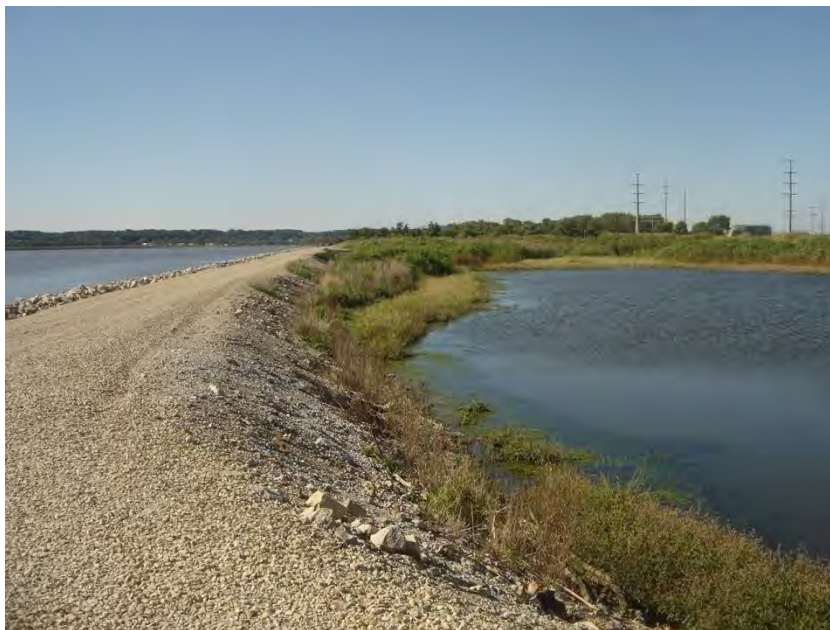
Figure 5.3.2: Upstream/Inside Slope of South Ash Pond dike.

The upstream slope of the separation dike is mostly lined with rip rap and stone (Figure 5.3.2). Scarps, sloughs, depressions, bulging or other indications of slope instability or signs of erosion were not observed.

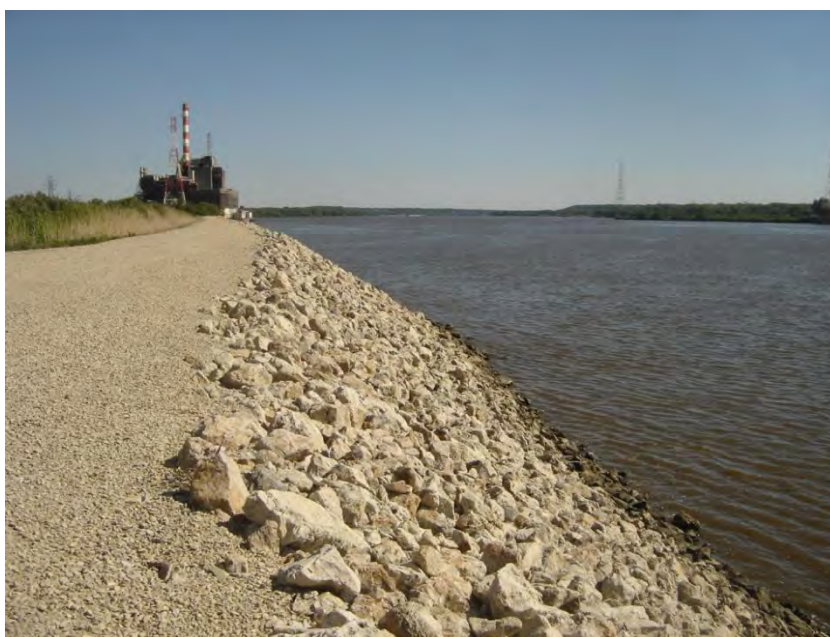
Figure 5.3.3: Downstream/Outside Slope of South Ash Pond dike.

The downstream slope is mostly lined with rip rap and stone (Figure 5.3.3). Scarps, sloughs, depressions, bulging or other indications of slope instability or signs of erosion were not observed. The toe of this slope is below the normal water surface elevation of the Mississippi River; therefore, visual assessment of seepage could not be performed.

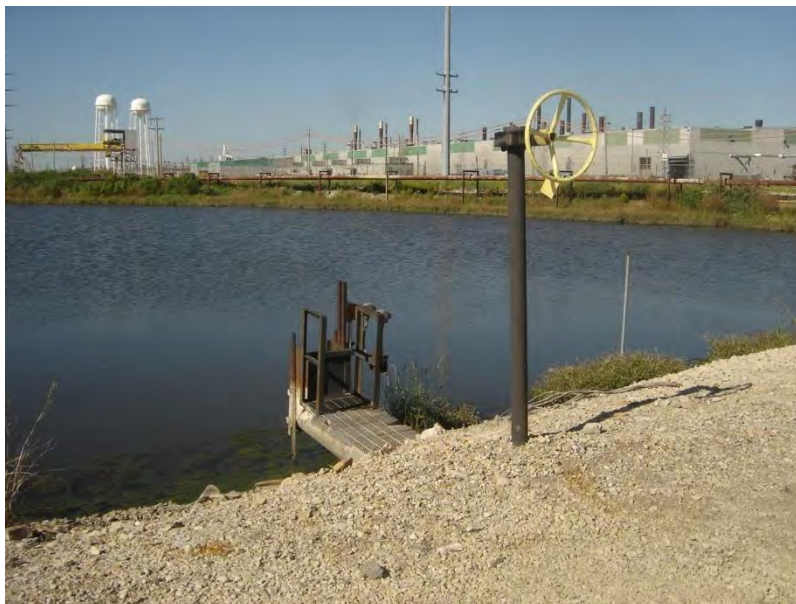
Figure 5.4.1: Overflow Structure of South Ash Pond (note control valve for decant pipe system in foreground).

The North Ash Pond does not contain an overflow structure (no normal pool is maintained). The South Ash Pond is equipped with a 15-inch diameter welded steel overflow pipe system that was above the normal operating pool at the time of the site visit (Figure 5.4.1). The visible portion of the overflow conduit had no apparent deterioration.

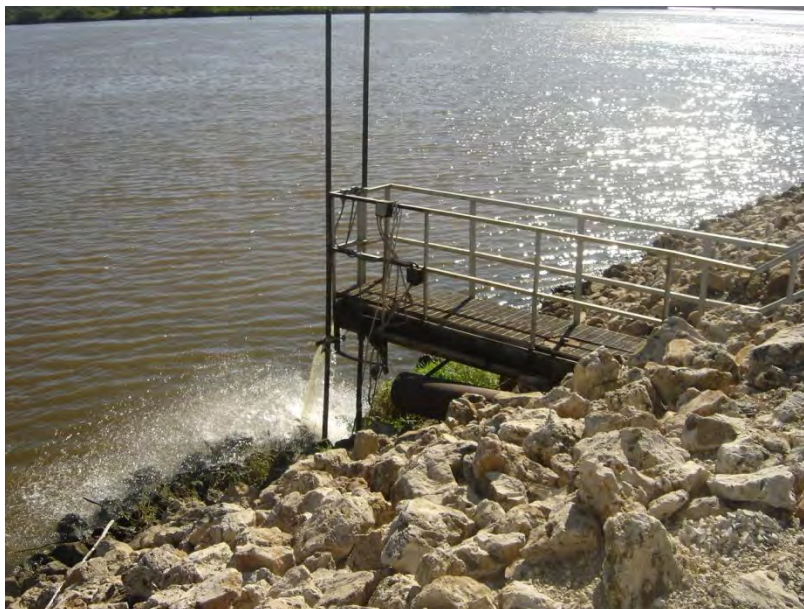
Figure 5.4.2: Outlet Conduit for South Ash Pond (note presence of overflow pipe outlet).

The North Ash Pond does not contain an outlet structure (no normal pool is maintained). The South Ash Pond is equipped with a regulated 15-inch diameter welded steel decant pipe that was flowing at the time of the site visit (Figure 5.4.2). The visible portion of the outlet conduit had no apparent deterioration.

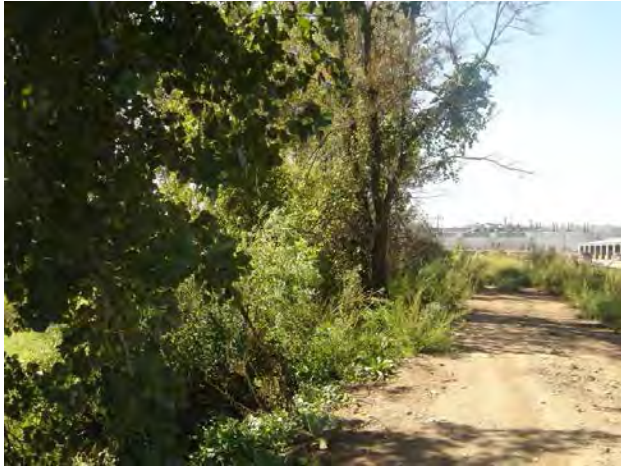
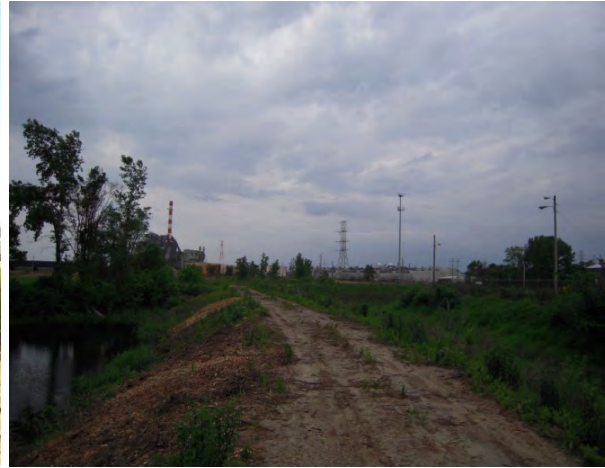
2.0 DESCRIPTION OF THE COAL COMBUSTION WASTE MANAGEMENT UNIT(S)

The final draft report provides an assessment of “**Fair**” for the North Surface Impoundment. It was recommended that MidAmerican perform maintenance on the North Surface Impoundment embankments to remove any thick, woody-stemmed vegetation, dense brush and trees covering the upstream and downstream slope. Since the on-site inspection was conducted in September 2010, MidAmerican has implemented those recommendations. MidAmerican also plans on establishing a grassed condition on the embankments over the spring and summer of this year. As a result, MidAmerican respectfully requests that the ranking for the North Surface Impoundment be changed to “**Satisfactory**” in the final report. The photographs supporting this request are provided below.
