**Coal Combustion Waste Impoundment  
Round 5 - Dam Assessment Report**

*Wateree Station (Site #01)*

*Ash Pond 1*

*Ash Pond 2*

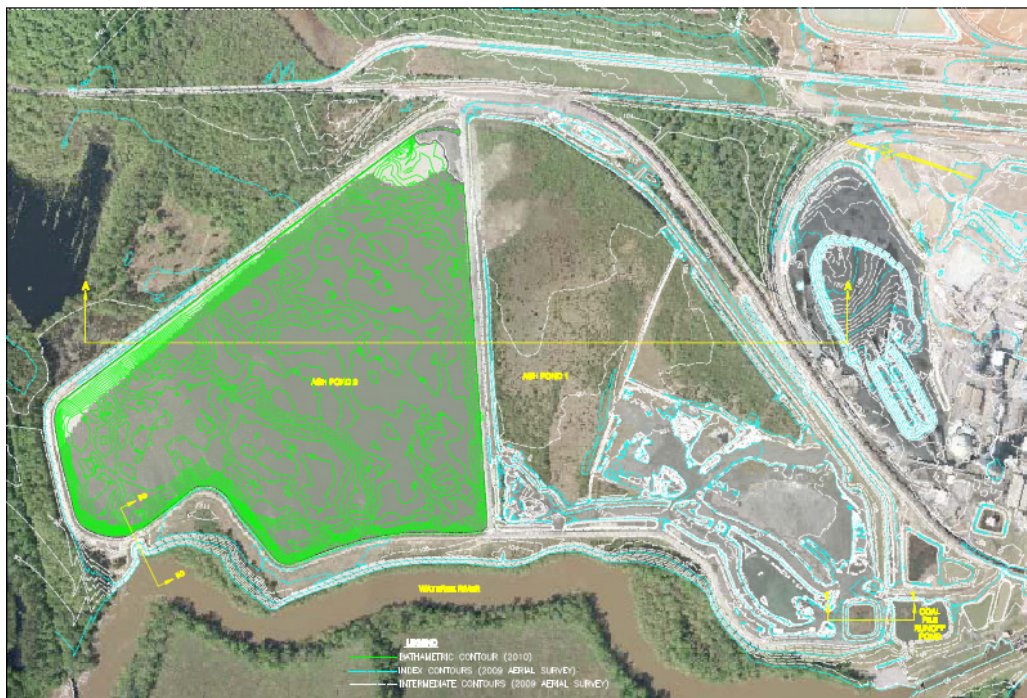
Figure 2.2: Ash Pond 1 & 2 Plan View

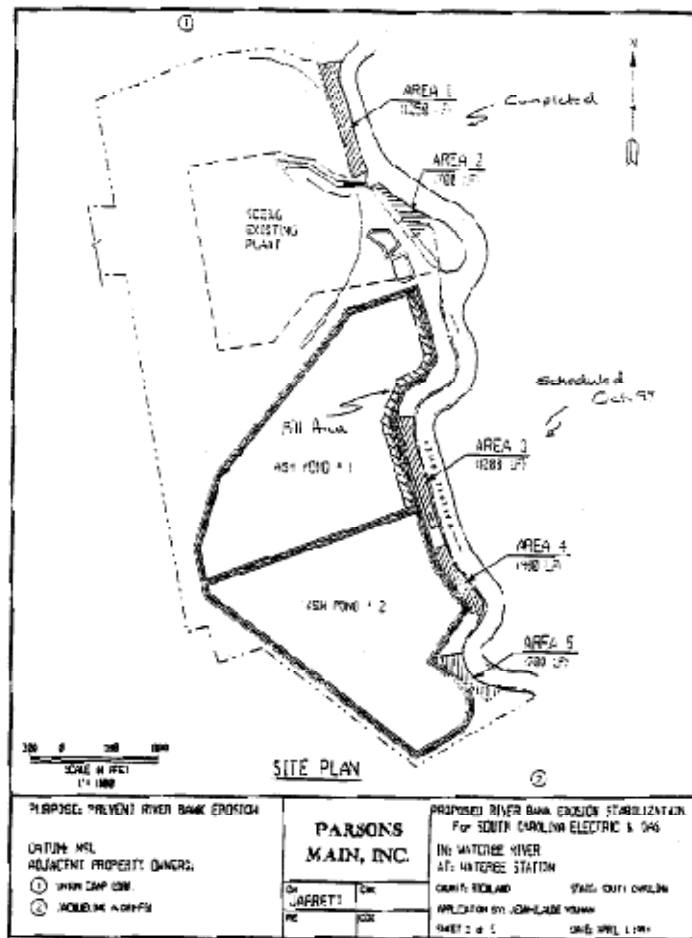
A riverbank stabilization occurred onsite to protect the ash pond facility (which includes Ash Ponds 1 & 2). Approximately 2,000 LF of riverbank was stabilized which also included adding fill along the embankment at Ash Pond 1. See Figure 4.1.3 below and Appendix A, Doc 06: Riverbank Stabilization Project.pdf for the complete documents.

**Figure 4.1.3: Riverbank Stabilization**

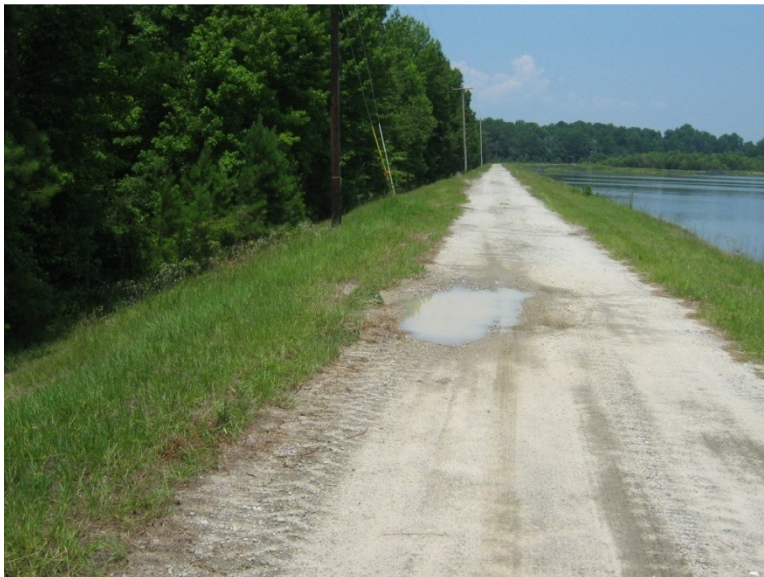
Ash Pond 2 - The crest was covered by a graded aggregate base material. The crest had no significant signs of any rutting, depressions, tension cracks or other indications of settlement or shear failure, and appeared to be in satisfactory condition. There were pot-holes holding water which required routine maintenance, but was not a current safety hazard.

Figure 5.2.1: Ash Pond 2 Crest – Water Ponding

Ash Pond 2 - Vegetation should be cut or mowed on an as-needed basis to prevent the establishment of large woody-stemmed vegetation. Pot-holes in crest need to be repaired and corrected to prevent water from ponding.

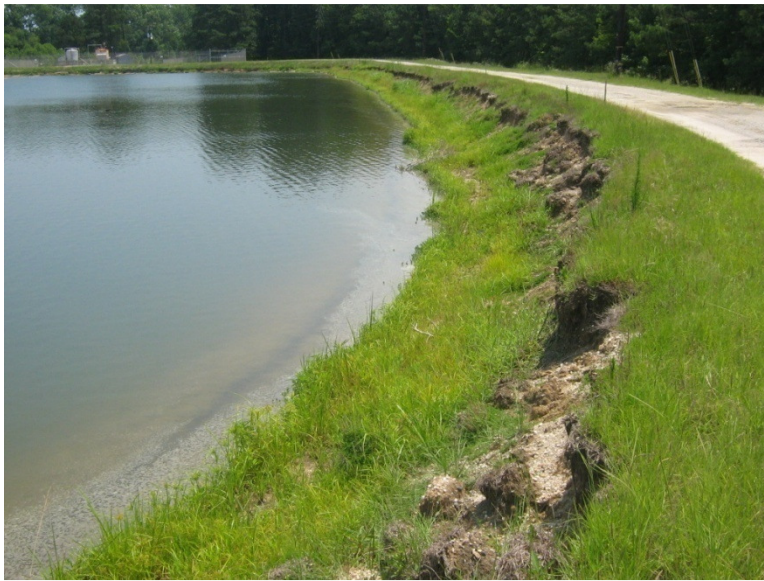
Ash Pond 2 – The upstream slopes are mostly vegetated with tall grasses and other wetland vegetation. No scarps, sloughs, depressions, bulging or other indications of slope instability were observed. Erosion was observed along the upstream slope at the southern embankment which requires maintenance.

**Figure 5.2.2: Ash Pond 2 Upstream Slope Erosion**

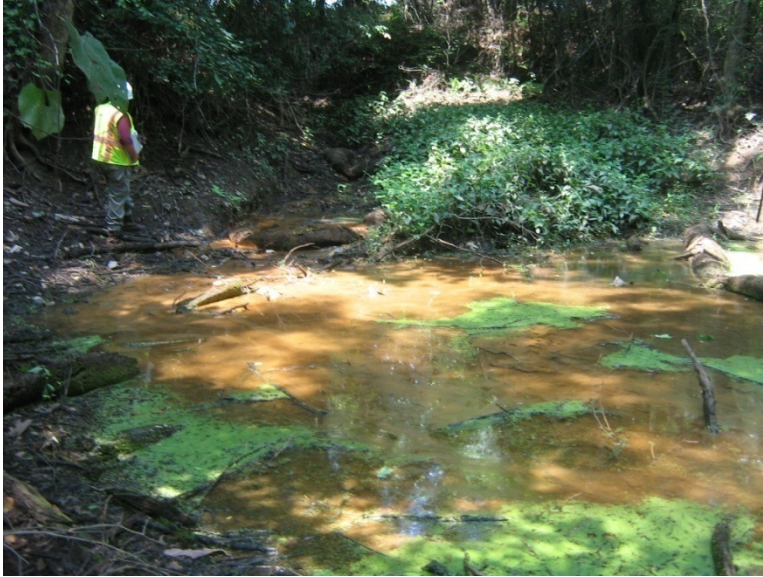
Ash Pond 1 – The downstream slopes are mostly vegetated with tall grasses and other wetland vegetation. No scarps, sloughs, depressions, bulging or other indications of slope instability were observed. Seepage was observed at two areas downstream of Ash Pond 1. From visual observance, flow appeared to clear and consistent, but this needs to be monitored.

**Figure 5.2.3a: Ash Pond 1 Downstream Seepage**

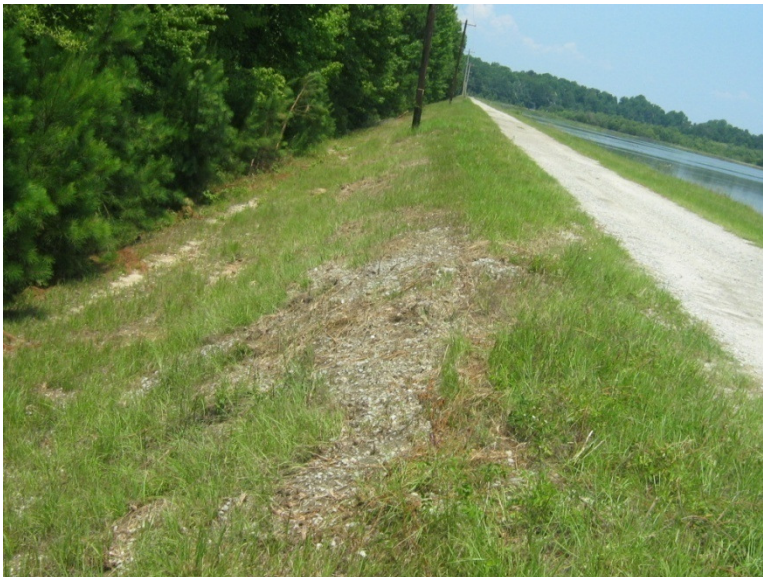
Ash Pond 2 - The downstream slopes are mostly vegetated with tall grasses and other wetland vegetation. No scarps, sloughs, depressions, bulging or other indications of slope instability were observed. Pine trees (less than 2" in diameter) were observed along the downstream slope and toe. This is not a safety hazard, but vegetation needs to be routinely mowed. Reseeding needs to occur in areas where vegetation is bare (see Figure 5.2.3b).

**Figure 5.2.3b: Ash Pond 2 Downstream Slope**

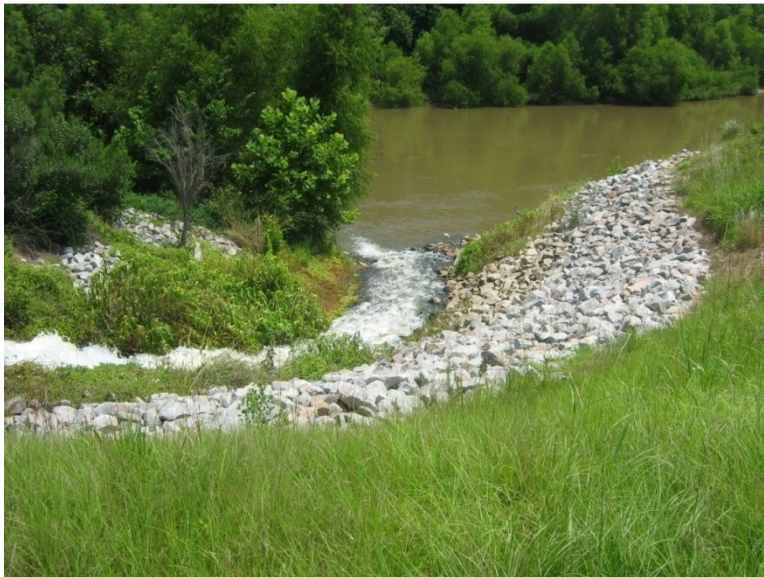
Ash Pond 2 - The visual portion of the outlet conduit was functioning properly with no apparent deterioration.

**Figure 5.3.2: Ash Pond 2 Discharge into Wateree River**

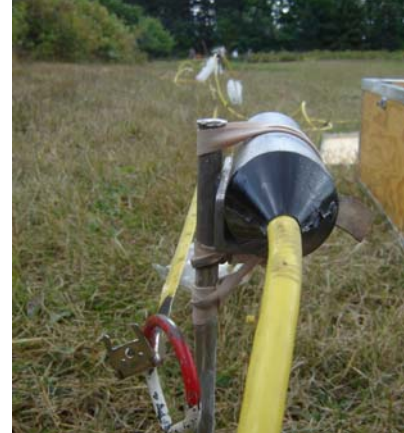
F&ME utilizes the SuperSting Earth Resistivity System manufactured by Advanced Geosciences, Inc. (AGI). The system consists of the SuperSting eight-channel resistivity meter and a multi-electrode cable with 42 electrodes at nine feet spacing and an automatic switching unit. The eight channels allow eight resistivity measurements to be taken simultaneously. The electrodes are “grounded” at the desired design electrode spacing utilizing steel spring clips and stakes pushed into the ground subgrade.

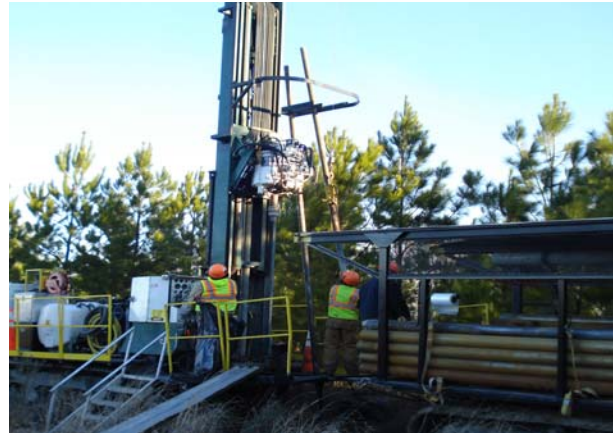
F&ME determined that rotosonic drilling would provide the best subsurface method of exploration of the containment system. The rotosonic drilling was accomplished with an ATV-mounted Prosonic SR-116 rig. The adjoining photo shows the rig in operation at Wateree Station. The primary benefit of rotosonic drilling is that it provides continuous sampling of the subsurface materials. Additional benefits of this technology are very rapid drilling rates and reduced volumes of drilling waste. A sonic rig uses an oscillator or head with eccentric weights driven by hydraulic motors to generate high sinusoidal force in a rotating pipe drill. The frequency of vibration (generally between 50 and 120 cycles per second) of the drill bit or core barrel can be varied to allow optimum penetration of subsurface materials. A dual string assembly allows advancement of casing with the pipe drill used to collect samples. Four inch diameter continuous sampling of the subsurface soils was accomplished.

A total of 700 feet of rotosonic drilling was performed at 15 individual boring locations. The boring locations are noted as B-1 to B-15 on Figure 4 in Appendix C. We have also included a fence diagram, which graphically depicts each individual boring stratification, stationing, and elevation. The borings were located along the containment structure perimeter

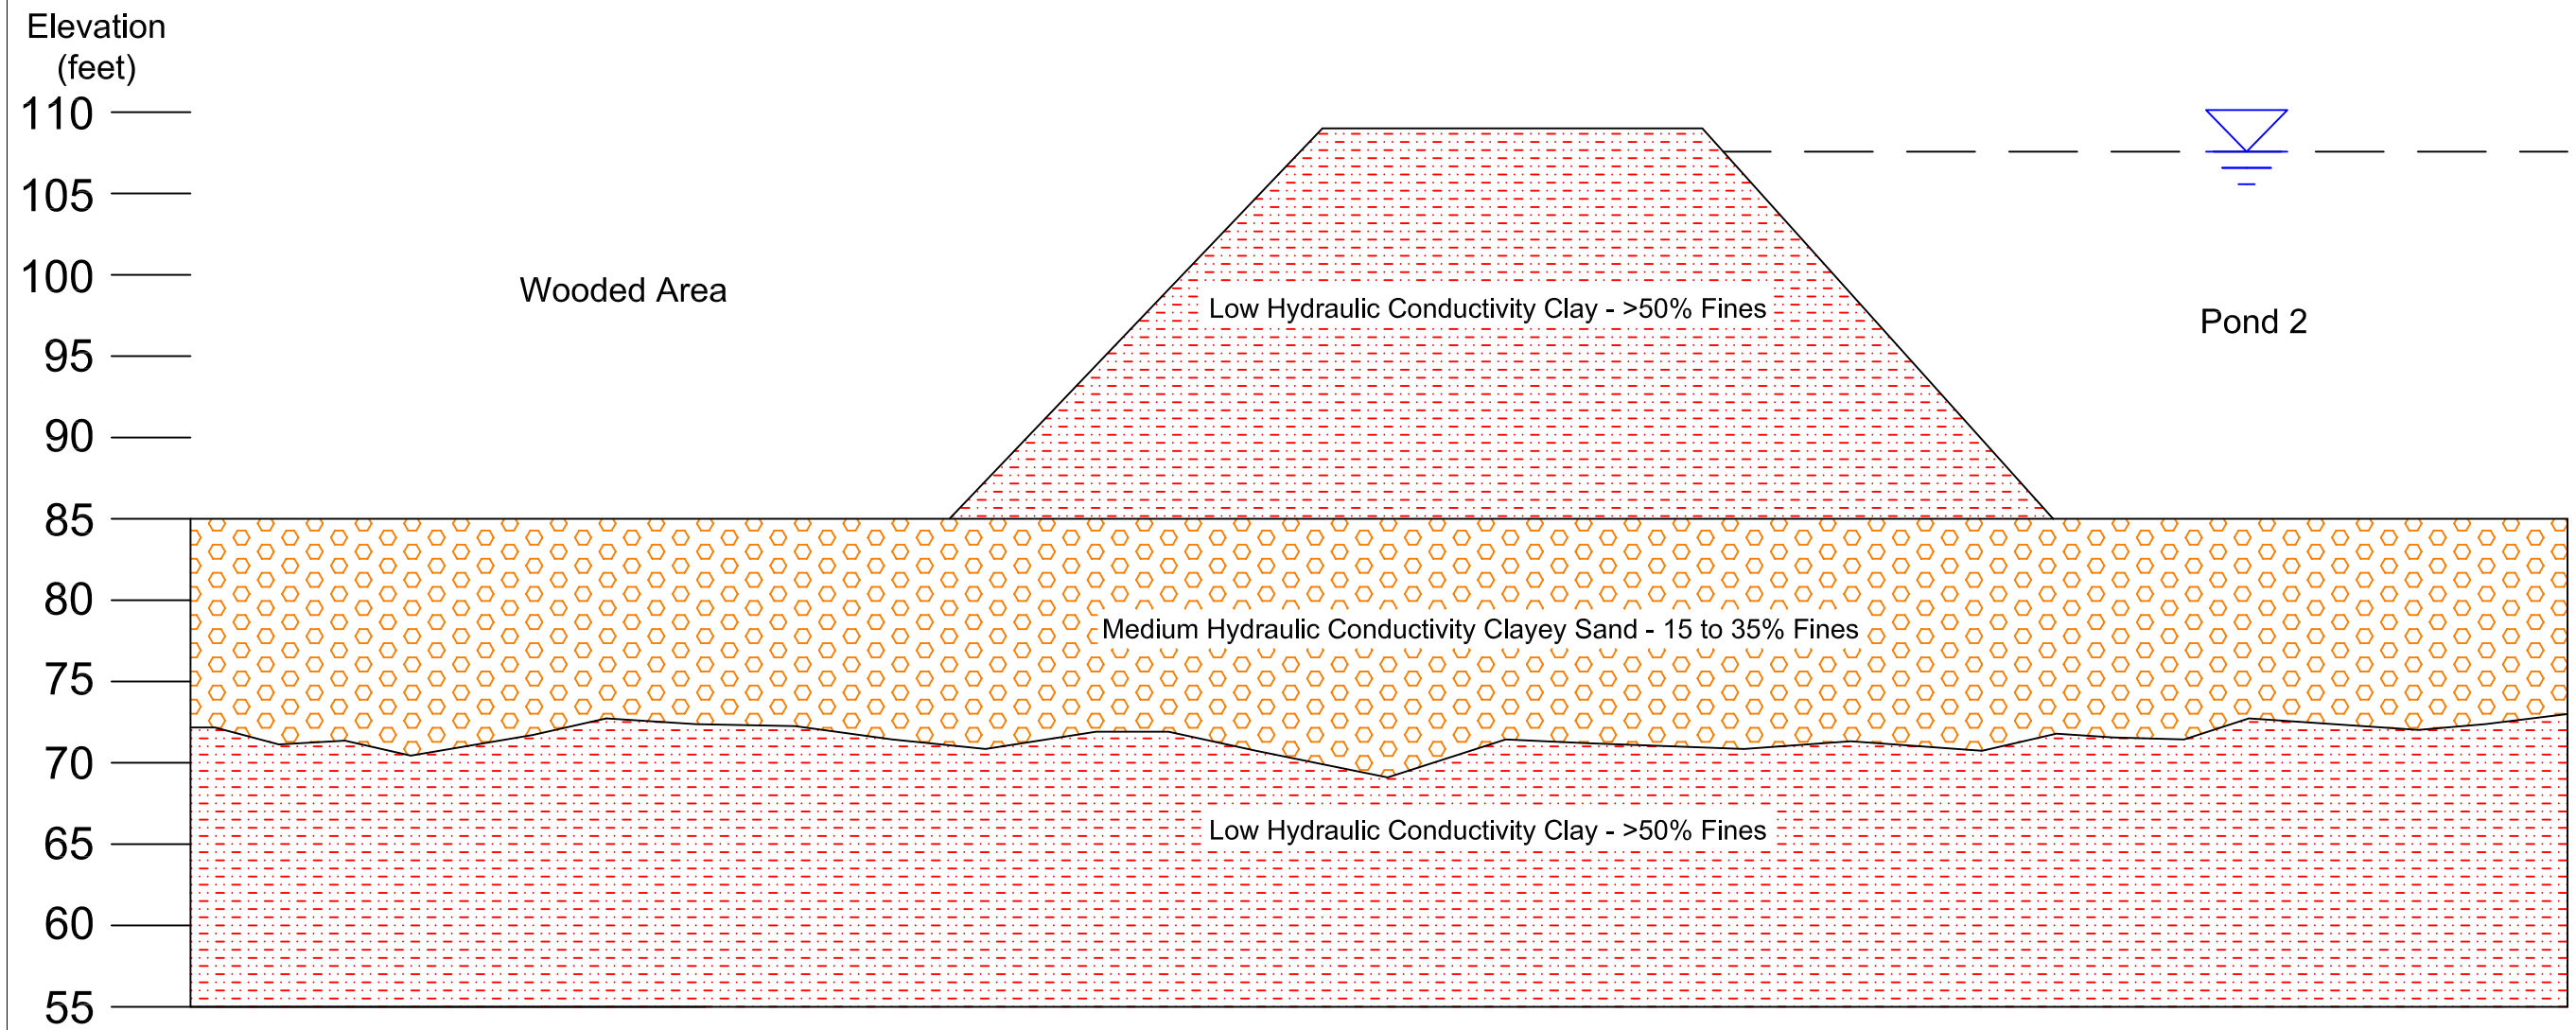
# Containment Structure Segment 2 - Constructed Embankment Schematic Cross Section

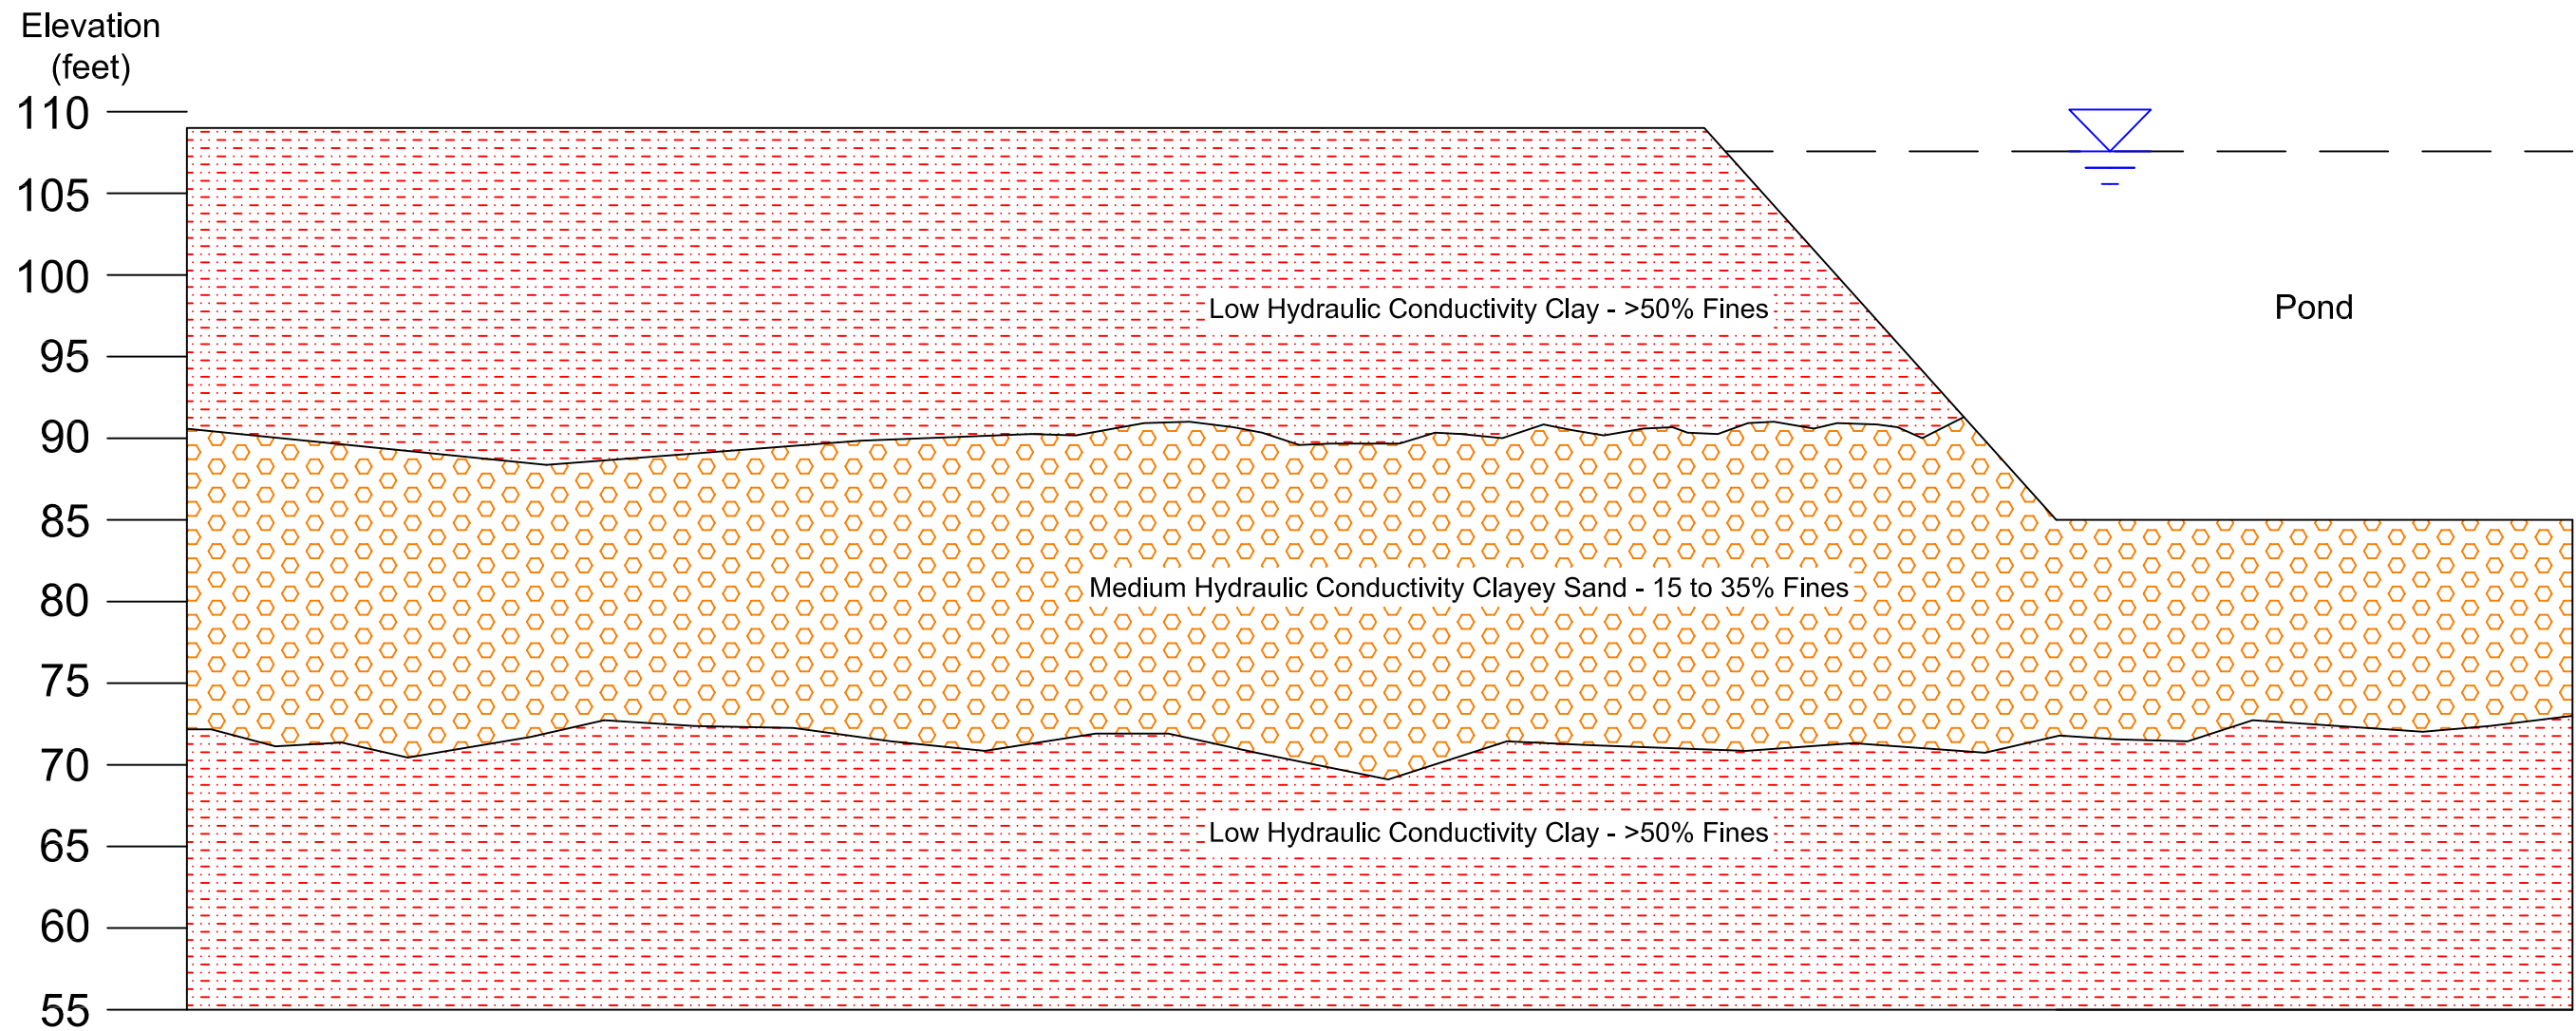
Figure SCS-3

**Containment Structure Segment 3 - Natural Ground (Incised) Schematic  
Cross Section**

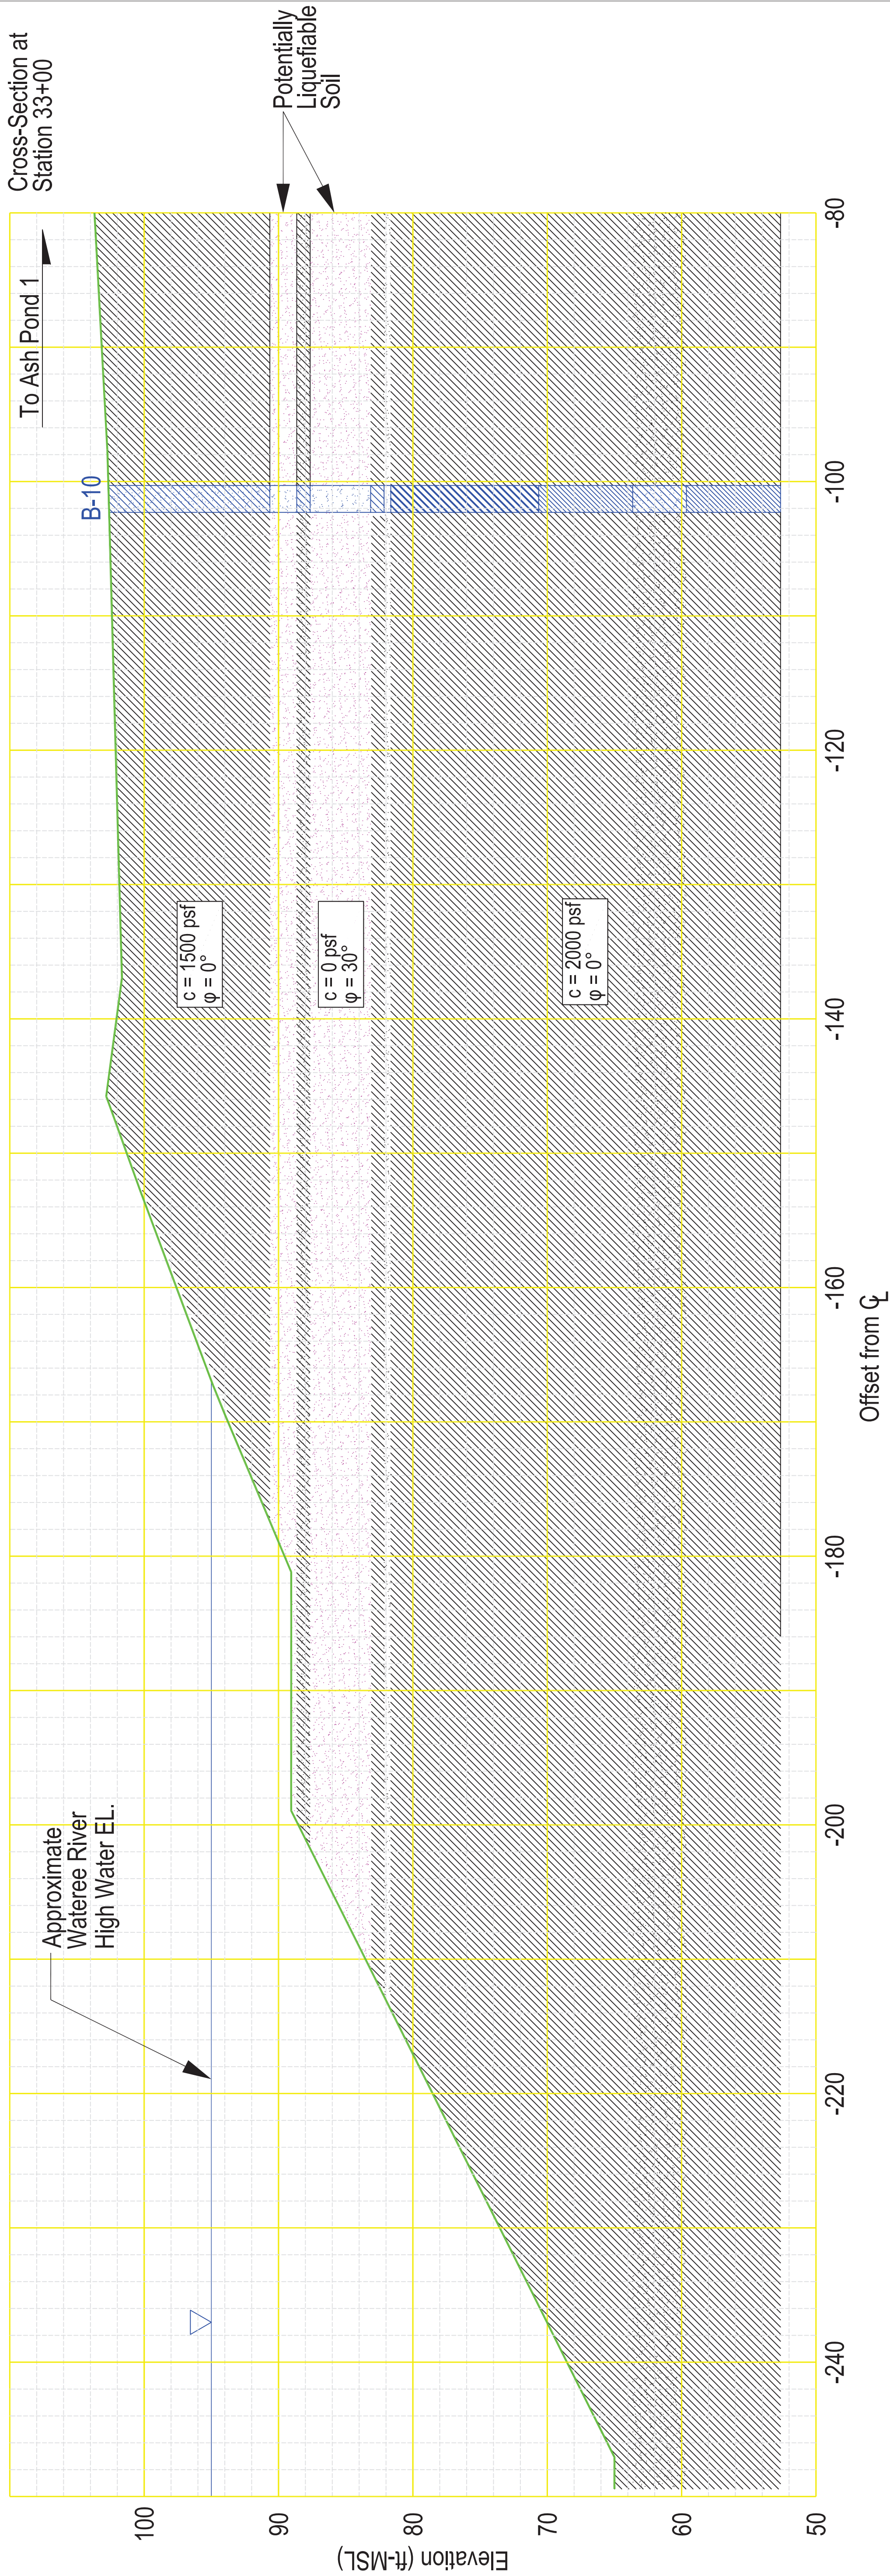
FIGURE 5

SCE&G Wateree Station - Sta. 33+00 - Earthquake - Steady Seepage
