Comments on Draft Report for Hugo

Re: Western Farmers Electrical Cooperative  
Hugo Power Plant  
Comments on Assessment of Dam Safety of  
Coal Combustion Surface Impoundments

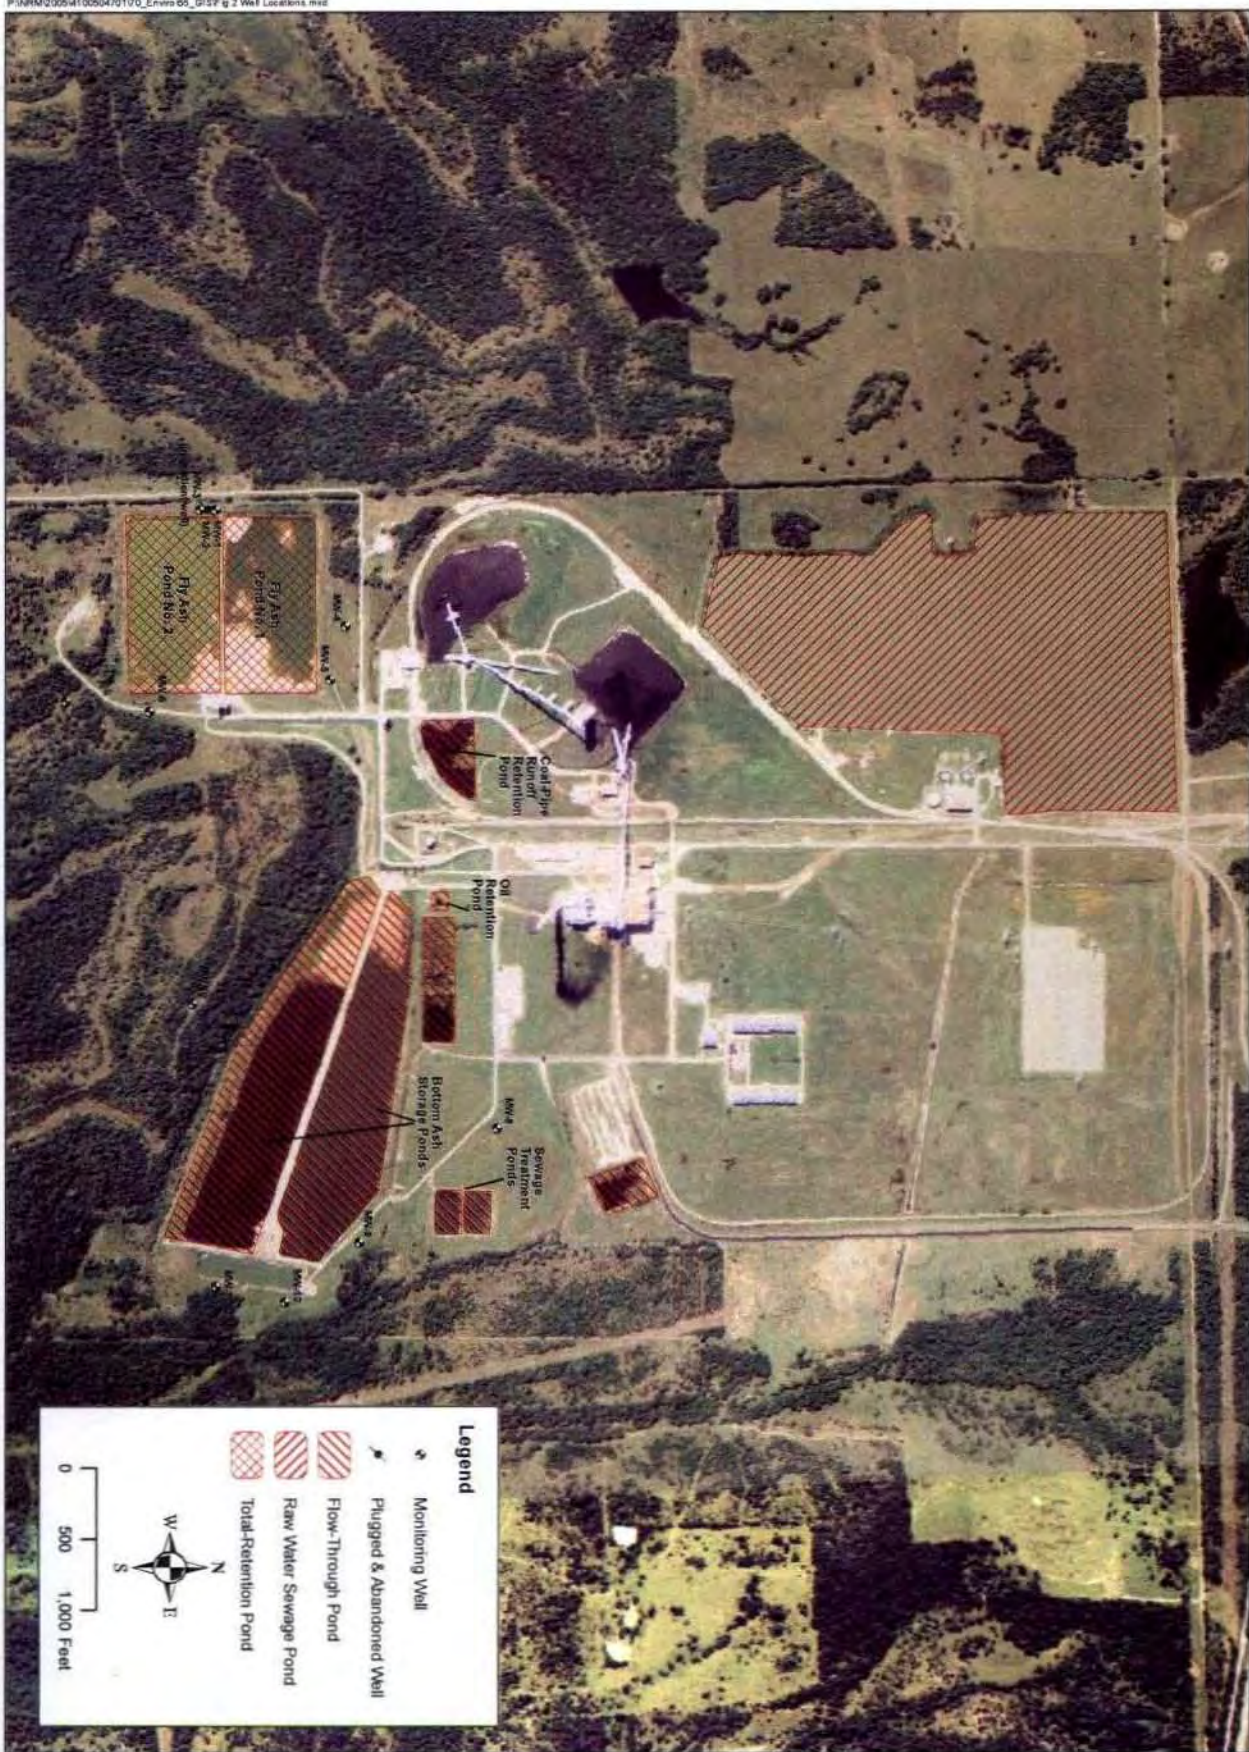
| Figure Number | 2 |

The section states there are two monitoring wells at the site. Actually there are 11 monitoring wells at the site. There are two (2) up-gradient wells and nine (9) down-gradient wells. Of the nine (9) down-gradient wells, five (5) are down-gradient of the fly ash impoundment and four (4) are down-gradient of the bottom ash impoundment. A drawing is attached showing the approximate location of the monitoring wells.

| Figure Title | Site Layout and Well Locations |
