Work Plan for Installation of a Non-Combustible Cover over Radiologically-Impacted Material At or Near the Ground Surface in Radiological Areas 1 and 2

West Lake Landfill Operable Unit-1

January 4, 2016 Revised February 12, 2016 Final March 16, 2016

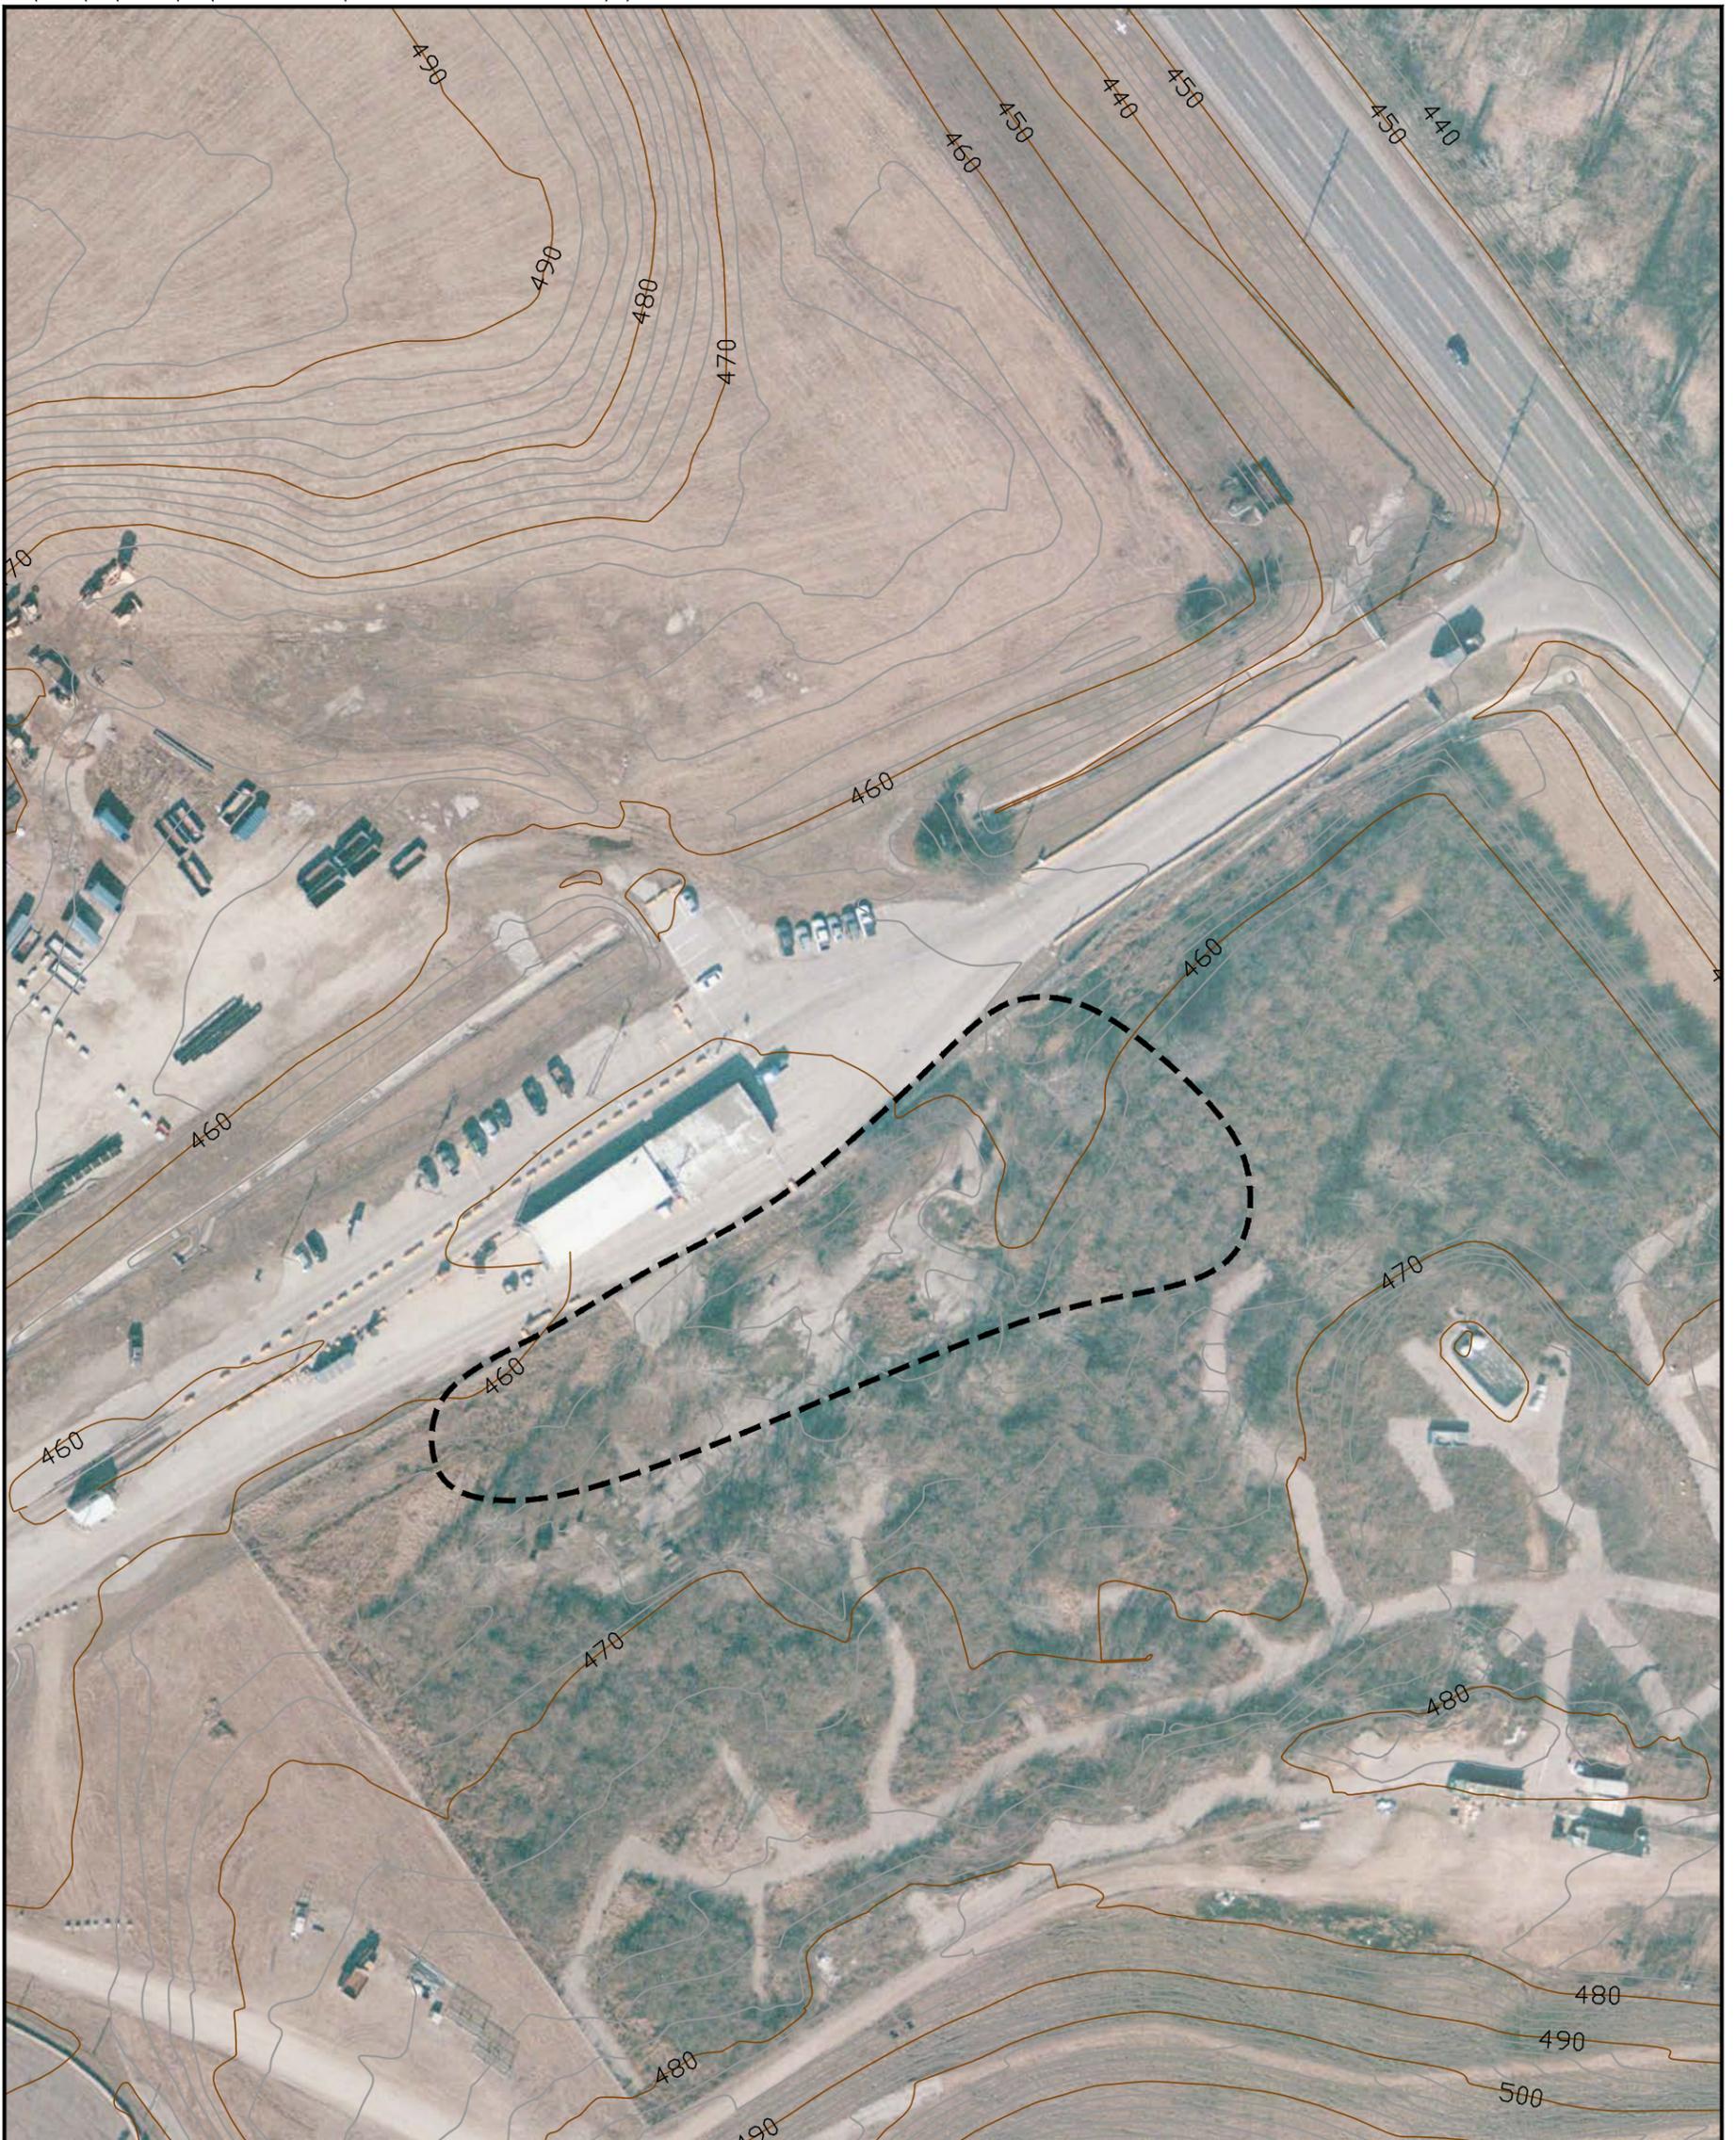
Figure 1
 Extent of Surface RIM as Defined in the RI
 Area 1

The approximate extent of surface RIM was previously identified on Figures 6-1 and 6-3 of the OU-1 Remedial Investigation report (EMSI, 2000). These figures were used as the initial basis for defining the extent of surface RIM (Figures 1 and 2). The results of the 1995 overland gamma survey (McLaren/Hart, 1996) were also reviewed to identify other areas where surface RIM may potentially be present in Areas 1 and 2. The results of these evaluations are summarized on Figures 3 and 4.

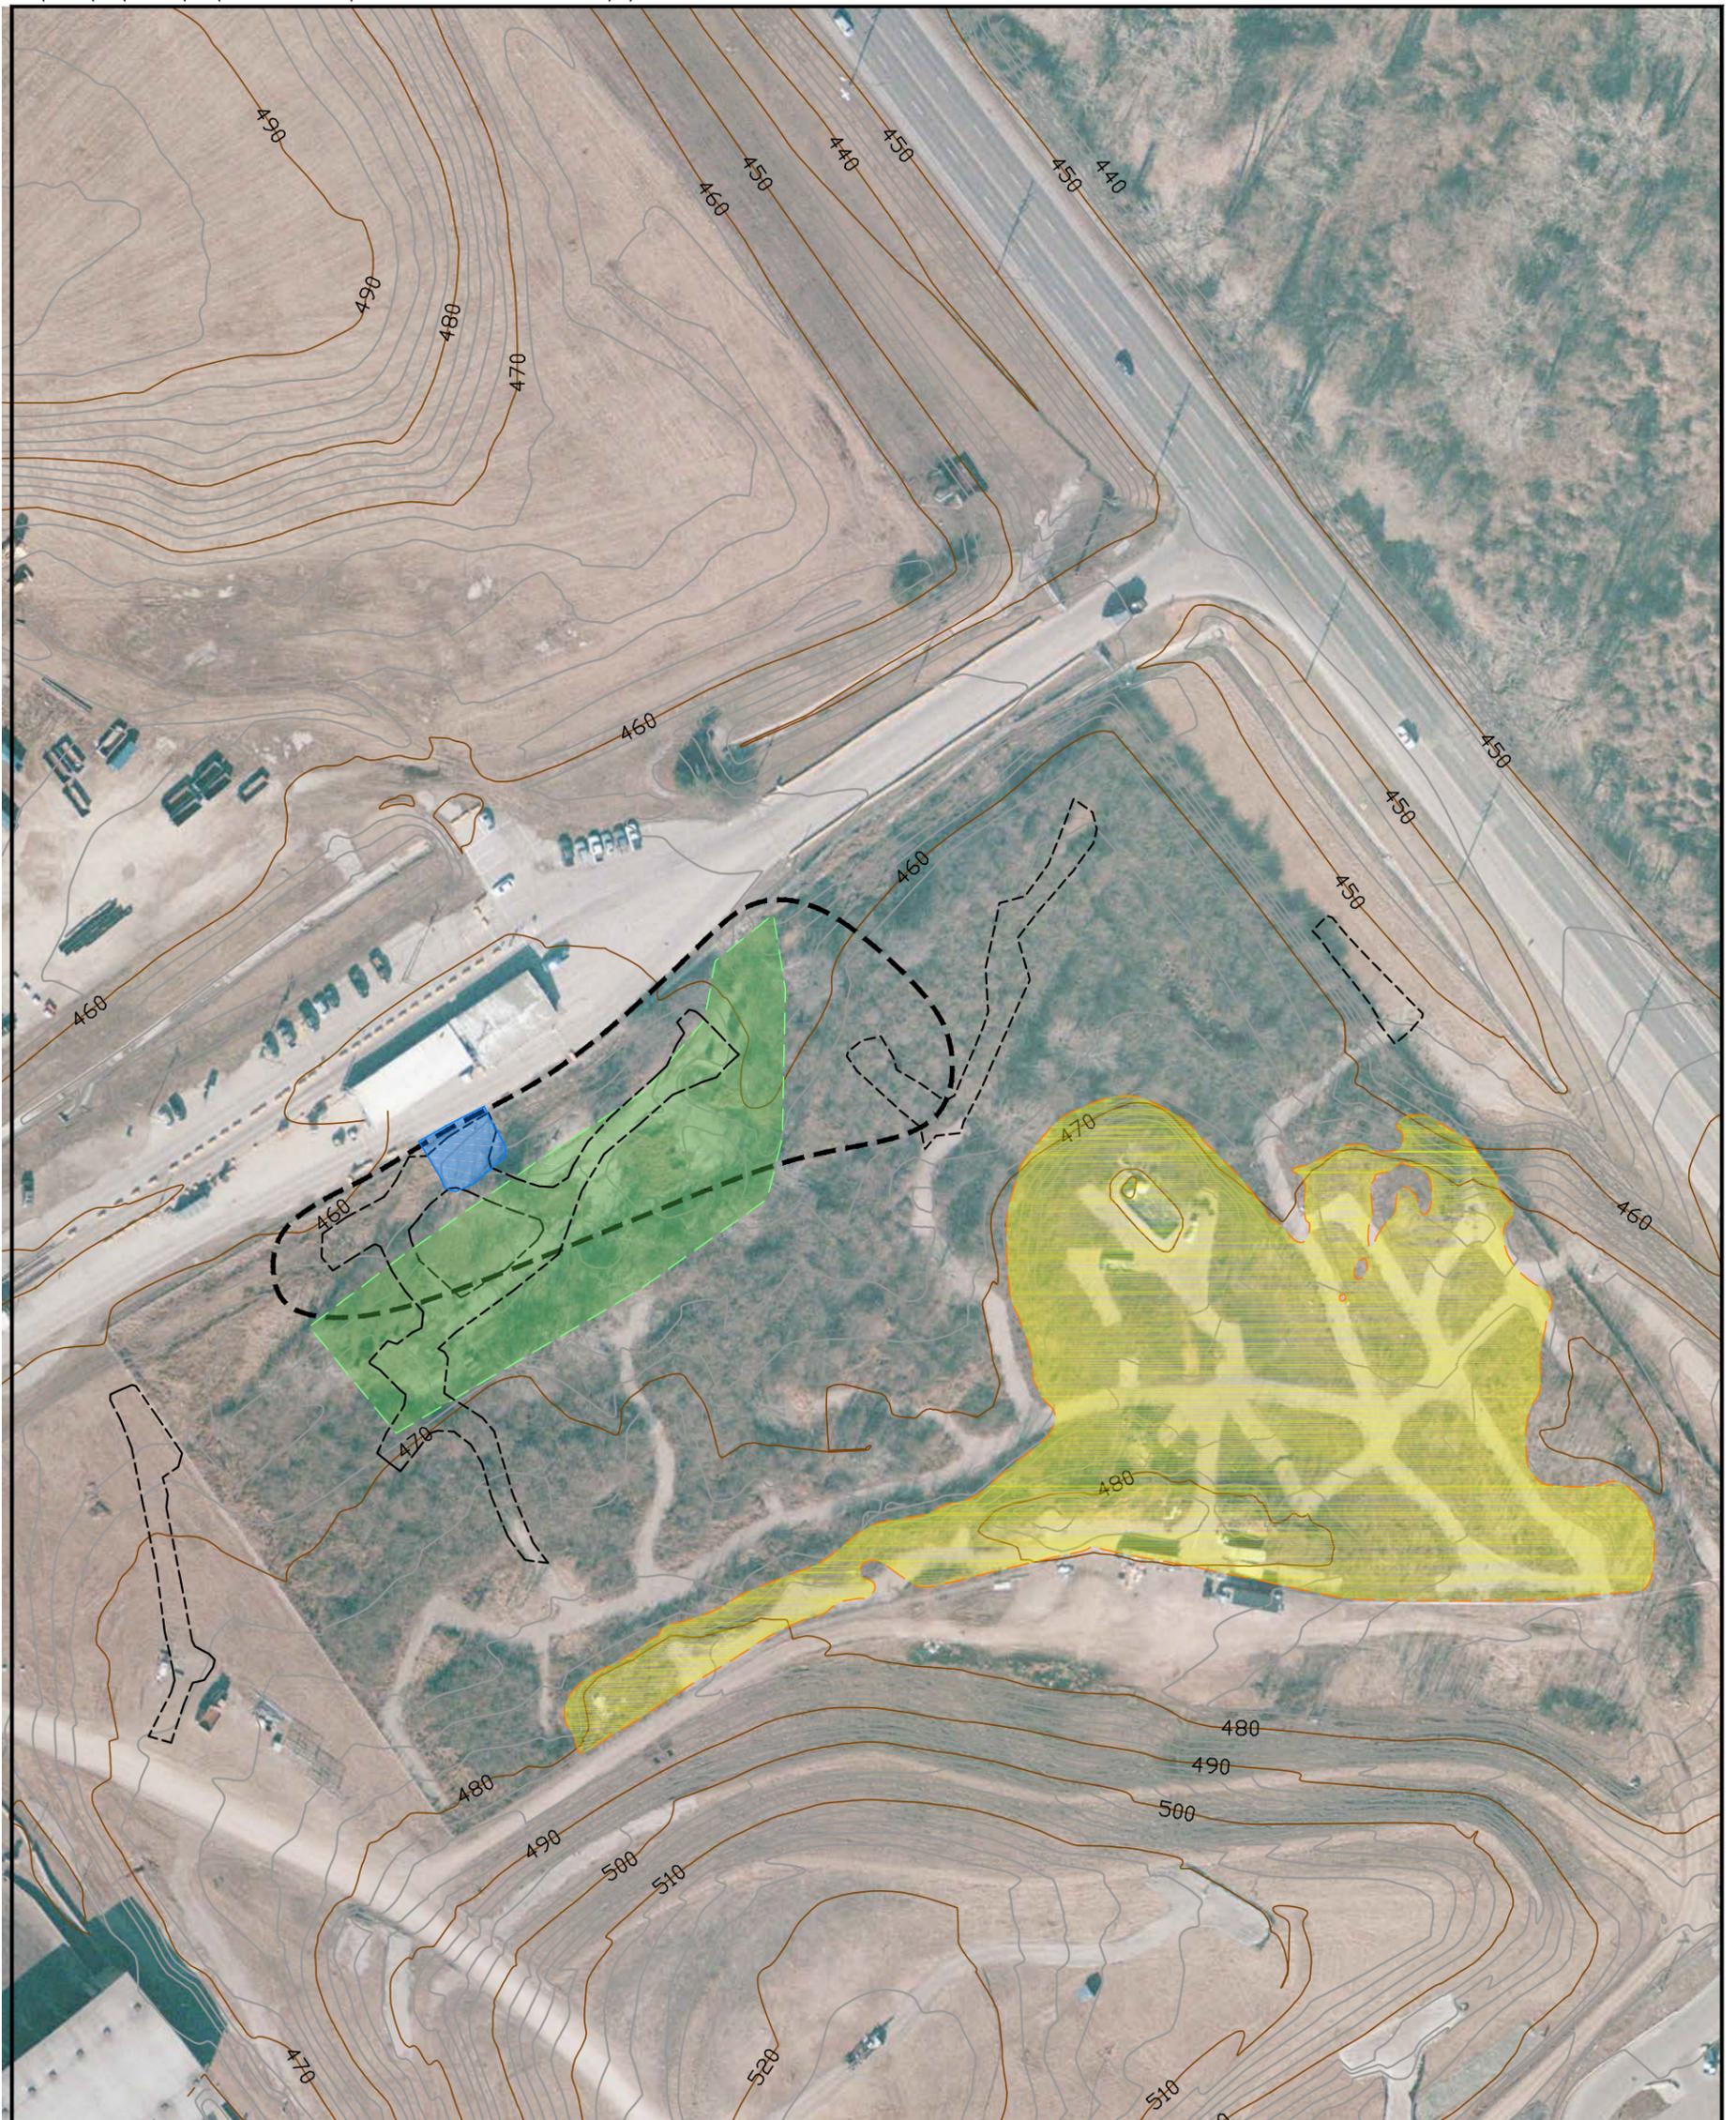
Figure 5
Extent of Surface RIM and Areas of Existing Cover
Area 1

A feasibility study (FS) of potential remedial alternatives was completed in 2006 for OU-1. The FS identified regrading of the surface of Areas 1 and 2 to promote drainage in conjunction with installation of a new engineered landfill cover as likely components of remedial action for OU-1. In anticipation of the regrading and landfill cover construction activities, Bridgeton Landfill prepared a Materials Management Plan (MMP) (EMSI, 2006), which was subsequently approved by the Missouri Department of Natural Resources (MDNR). The purpose of the MMP was to allow Bridgeton Landfill to accept for disposal inert fill material that could be placed on the surfaces of Areas 1 and 2 to assist with the anticipated regrading and cover construction activities. Pursuant to the MMP, over the period from approximately 2006 through 2008, Bridgeton Landfill accepted concrete rubble, brick and other inert fill material which was placed in a topographic low (surface depression) in Area 1 and on the ground surface in Area 2. The extent of inert fill material on the surface of Areas 1 and 2 is shown on Figures 5 and 6.

In addition to the inert fill material, portions of the surface of Area 1 were historically covered with asphalt pavement. The extent of the asphalt pavement in Area 1 is shown on Figure 5. Cracks and other discontinuities exist in the asphalt pavement such that grasses, weeds and small trees have rooted in the area of the asphalt pavement.

Lastly, as part of recently performed additional investigations in Areas 1 and 2, vegetation was cleared and geotextile overlain by a nominal 8-inch thick layer of road base was placed along the roads and drill pads used to access Areas 1 and 2 to perform additional soil borings. The locations of the various roads in Areas 1 and 2 are shown on Figures 5 and 6.

Based on the extent of RIM described in Section 2.1 and shown on Figures 3 and 4, and also taking into account the extent of inert fill material and road base that currently exists in Areas 1 and 2 (Figures 5 and 6), the anticipated extent of the NCC has been identified as shown on Figures 7 and 8. Please note that the extent of asphalt pavement in Area 1 is not included as part of the extent of existing cover material because as noted above, vegetation has grown up through cracks and other discontinuities in the asphalt pavement and asphalt is not considered to be a non-combustible material. By comparison, the inert fill material and road base that currently exist in Areas 1 and 2 were included as part of the estimation of existing cover material. The areas of inert fill that are in close proximity to the proposed extent of new non-combustible cover will need to be visually inspected to determine if any additional rock cover needs to be placed on or adjacent to the existing inert fill material.

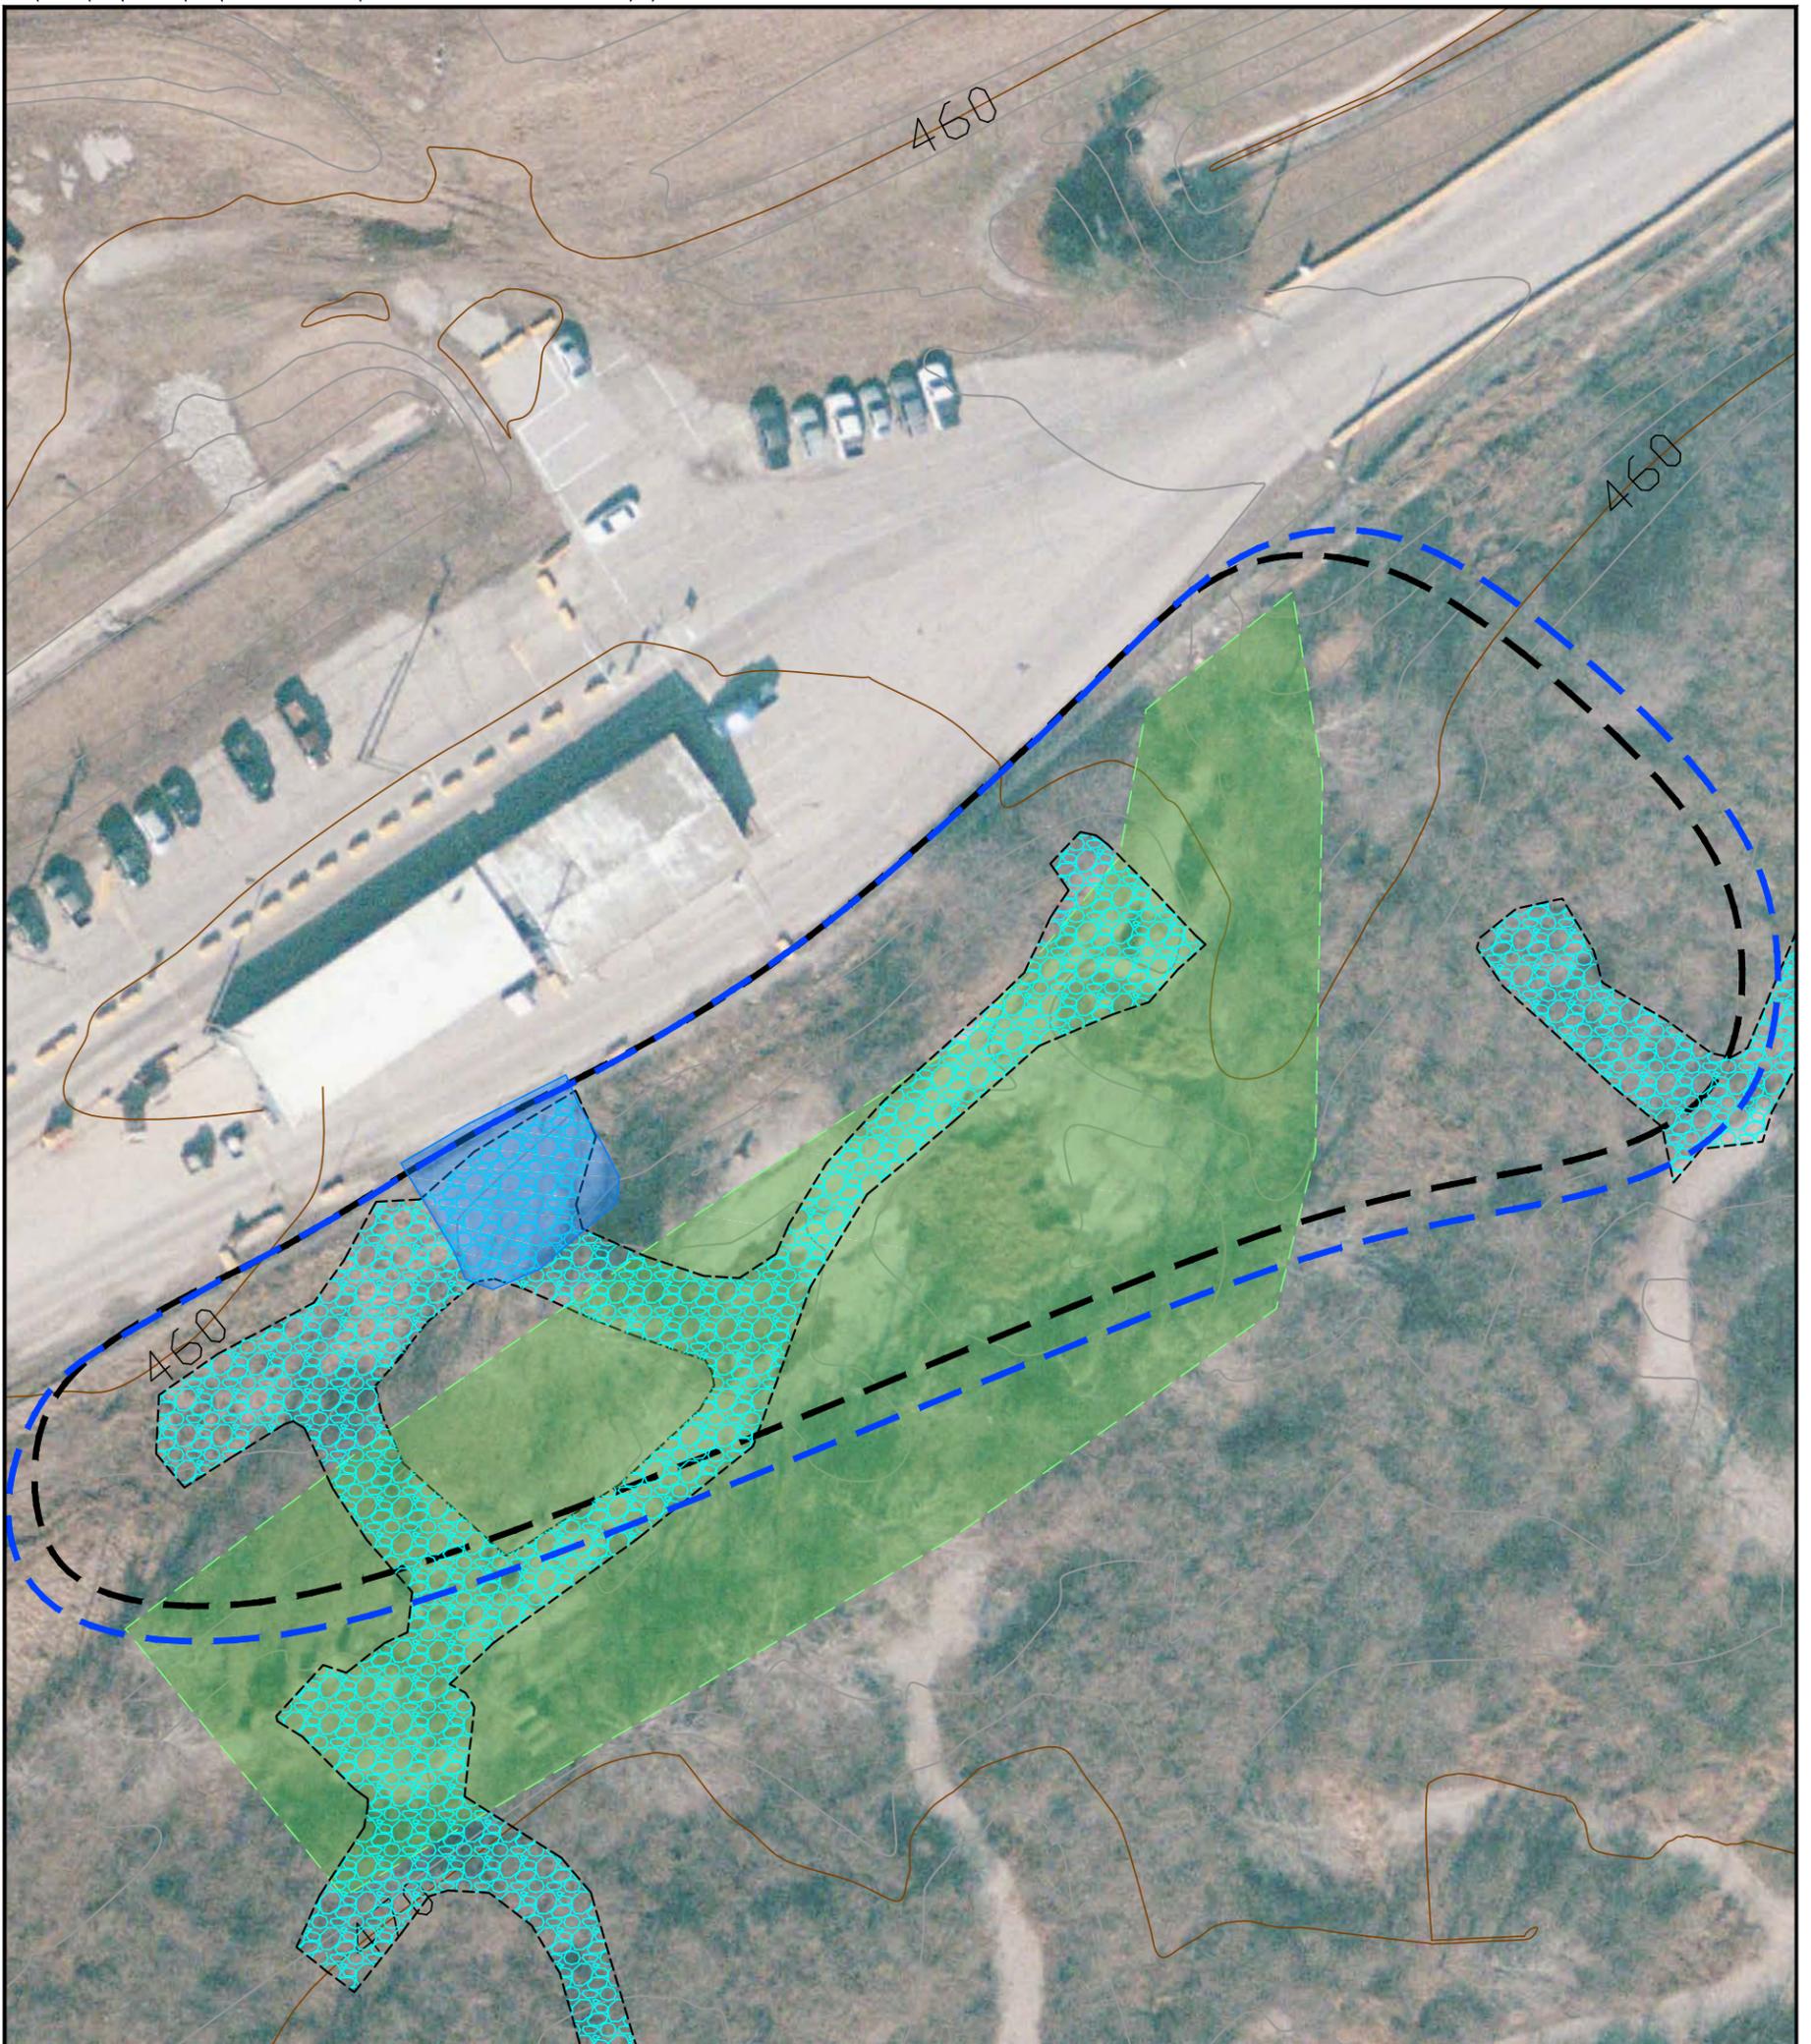
Figure 7
Preliminary Extent of Non-Combustible Cover - Area 1
 West Lake Landfill Superfund Site

Given that the extent of surface RIM in Areas 1 and 2 is approximately 1.4 acres in Area 1 and 8.74 acres in Area 2 and the extent of existing inert fill and road base cover is approximately 0.4 acres in Area 1 and 0.79 acres in Area 2, the total area for NCC construction in Areas 1 and 2 is estimated to be 1.0 and 7.95 acres, respectively. In order to ensure that the extent of surface RIM in these areas is completely covered, the bid specifications for the NCC will require the contractor to extend the cover placement nominally 10 ft beyond the edge of all areas where surface RIM is identified as being present within Areas 1 and 2; however, the cover will not extend beyond the limits of the Area 1 or 2 waste disposal units. Therefore, the total extent of the NCC cover is anticipated to be approximately 1.2 acres in Area 1 and 8.75 acres in Area 2 for a total area of approximately 10 acres in these two areas.

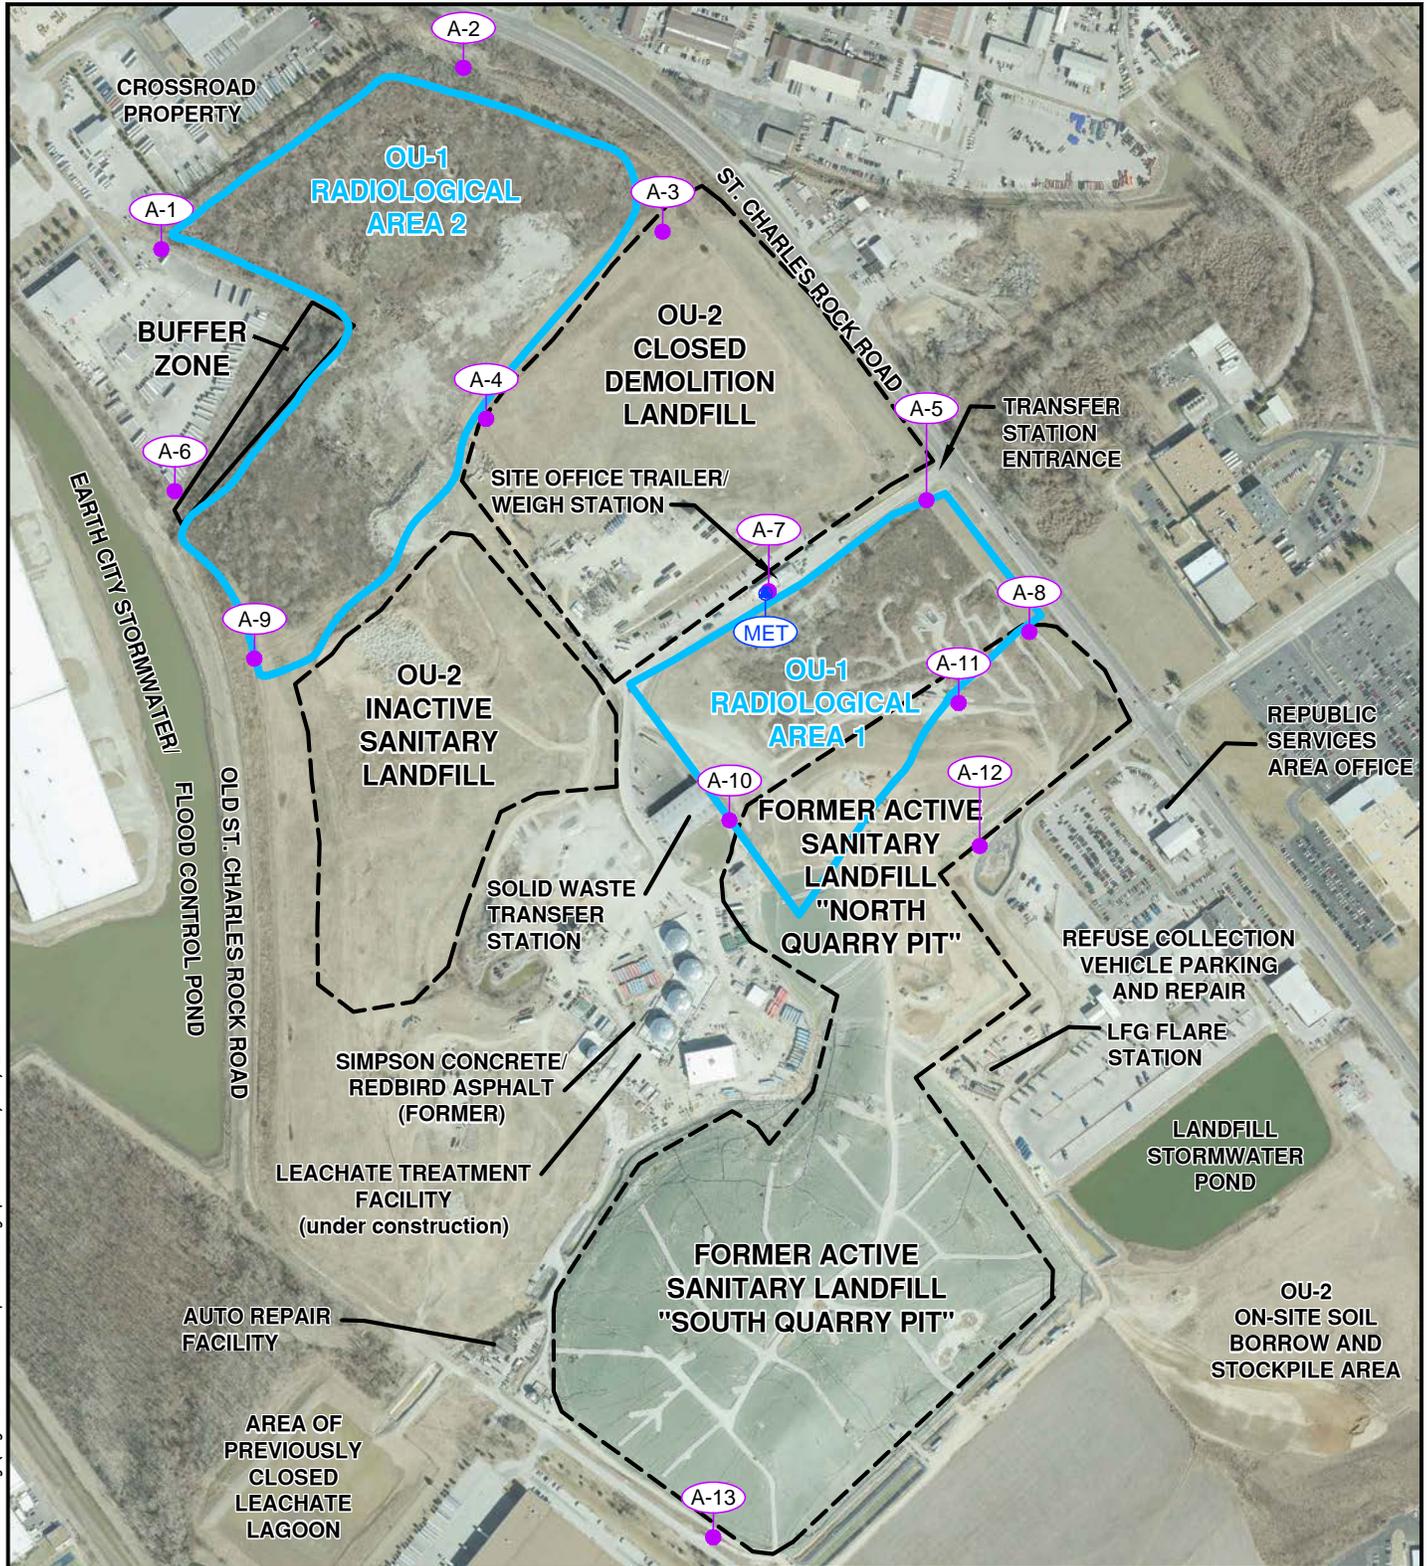
Figure 9

- 1) For on-site workers – portable air sampler on job site
 - 2) For community – use present air monitoring program consisting of 13 air monitoring stations around perimeter of Areas 1 & 2

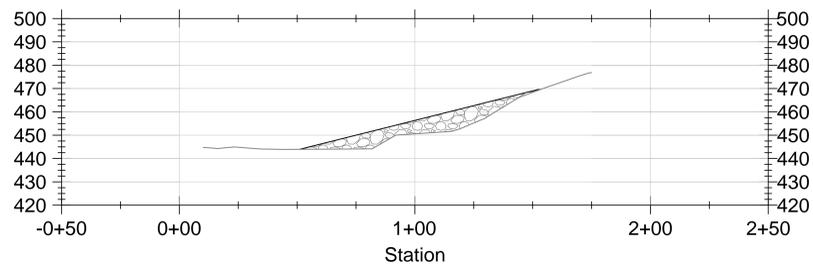
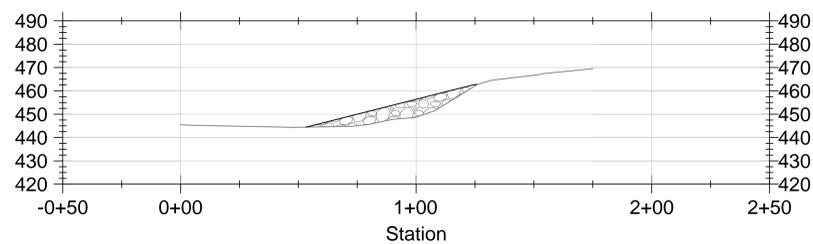
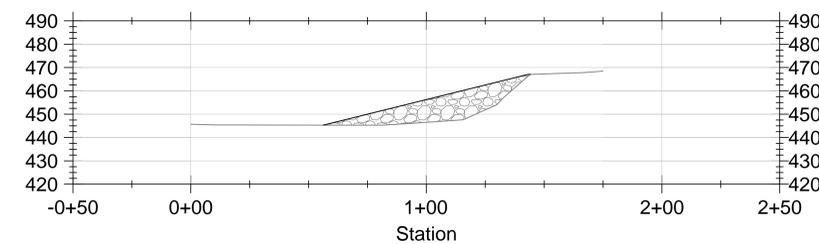
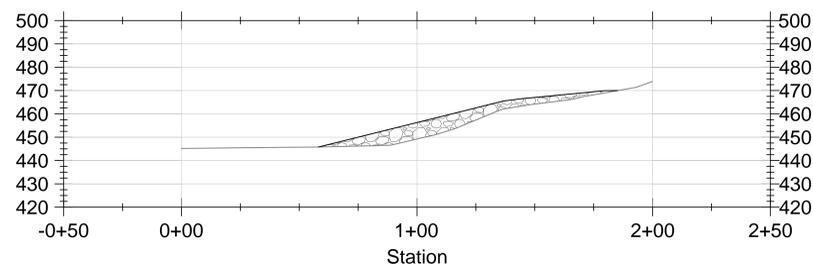
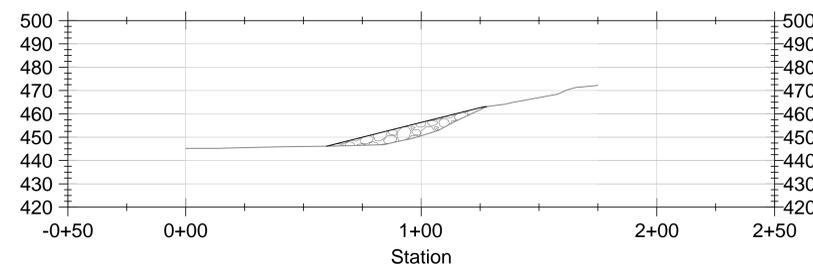
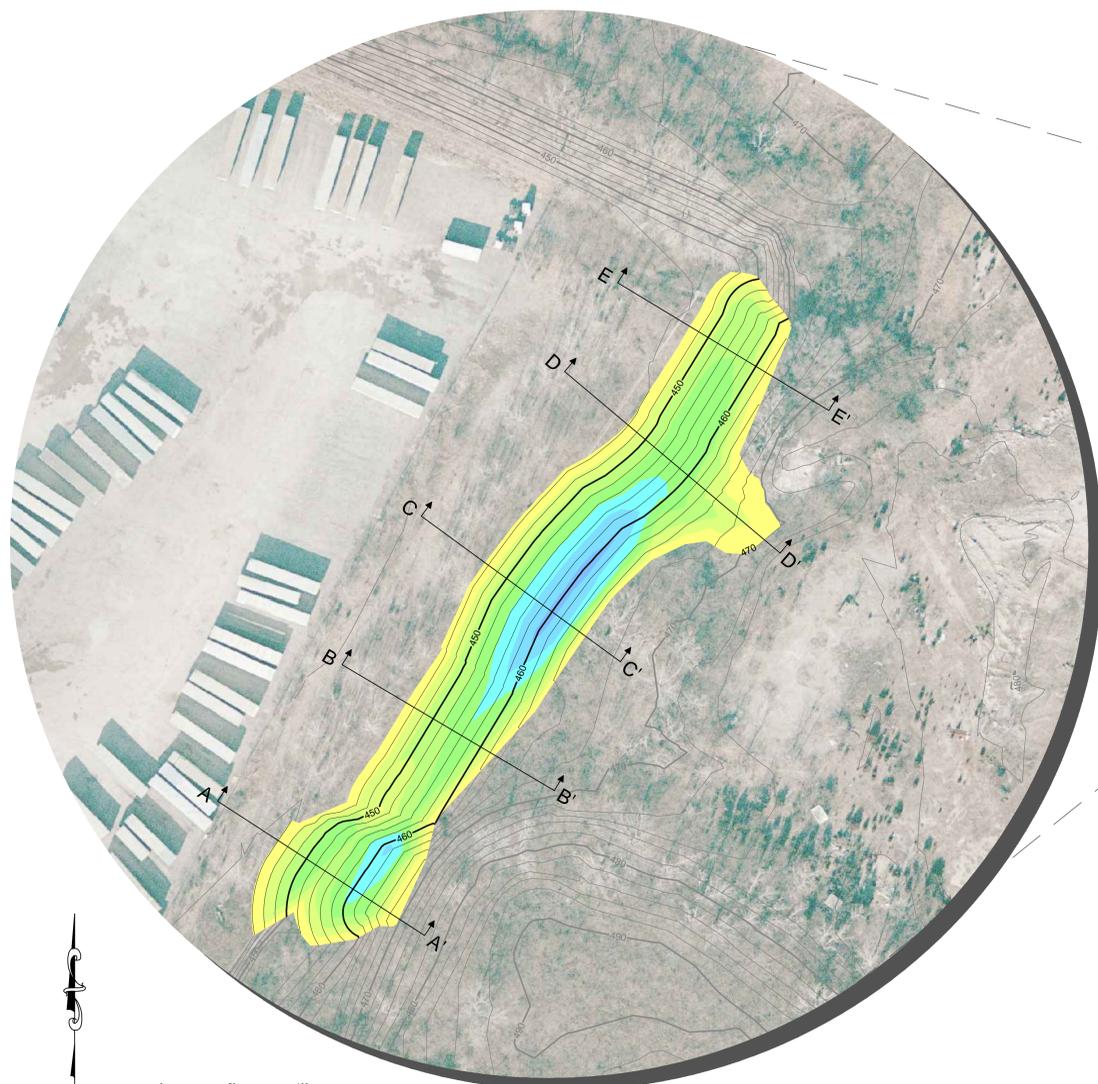
Area 2 Sloped Rock Fill – Plan and Profile View

Thickness Map			
Range	Minimum Depth	Maximum Depth	Color
1	0	2	Yellow
2	2	4	Light Green
3	4	6	Green
4	6	8	Dark Green
5	8	10	Cyan
6	10	12	Blue
7	12	14	Dark Blue

FILL VOLUME: 8,639 CY

- 5) Install rock buttress in Area 2 in that portion of the berm located above the southeast corner of the adjacent Buffer Zone (Figure 4)
- 6) Perform radiological soil sampling around the perimeter on the non-combustible covers in Areas 1 & 2 (including the Buffer Zone) to confirm all RIM at or near the surface has been covered.
