U.S. Environmental Protection Agency
Region IX

**Van Duzen River and Yager Creek
Total Maximum Daily Load
for Sediment**

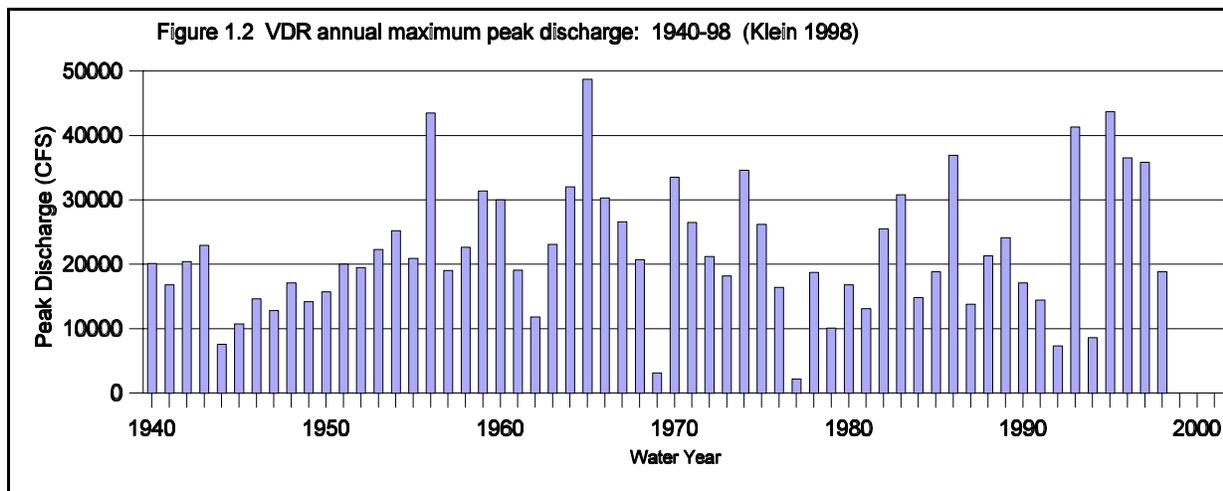
The quantity and duration of rainfall during storm events is a major factor influencing geomorphic processes in the VDR. The VDR basin receives 50-100 inches of precipitation annually, which occurs almost entirely from October through April, including a small fraction of snowfall. Between two and six intense rainstorms typically occur each winter. Summer fog provides cooler temperatures in the lower basin while the middle and upper basins are drier and warmer during the summer months. High magnitude, infrequent storms cause widespread flooding and modification of channel characteristics in the VDR. Multiple layers of roots on old redwood trees growing in floodplains are evidence of silt deposition due to prehistoric flooding (Stone and Vasey 1968). Floods in 1861, 1955 and 1964 are considered the largest floods of record in the Van Duzen (Kelsey 1977). Figure 1.2 illustrates the wide variability in the annual maximum peak discharge in water years from 1940 through 1998.

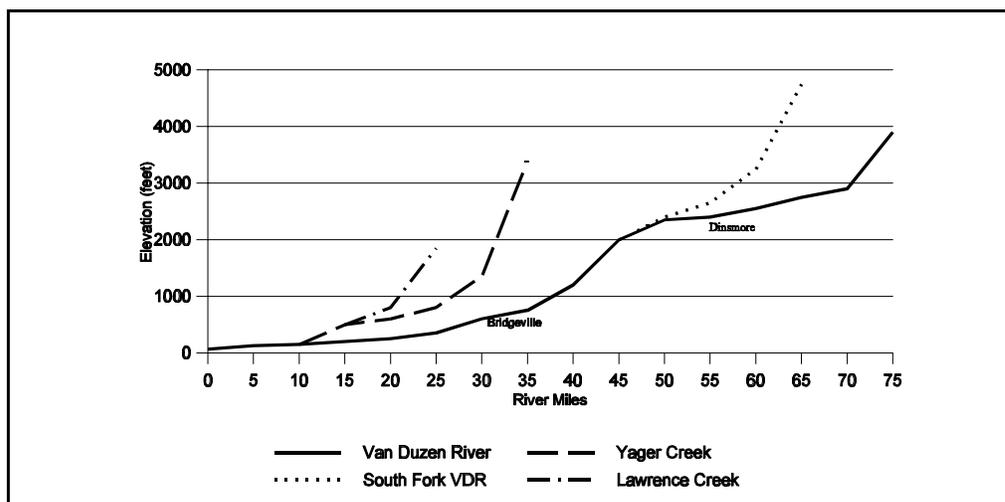
Figure 1.3 Longitudinal profile of VDR (adapted from Kelsey and Allwardt 1975).

The VDR’s sediment transport mechanisms encompass a range of channel types including: 1) depositional reaches (strongly alluvial, low gradient, low confinement, able to meander relatively freely); 2) transport reaches (weakly or non-alluvial, steeper gradient, more confined, coarse textured sediments); and 3) source reaches (steep headwater swales). A longitudinal profile of the VDR adapted from Kelsey and Allwardt (1975) illustrates the changes in gradient from the lower floodplains to upper Yager Creek and VDR (Figure 1.3).

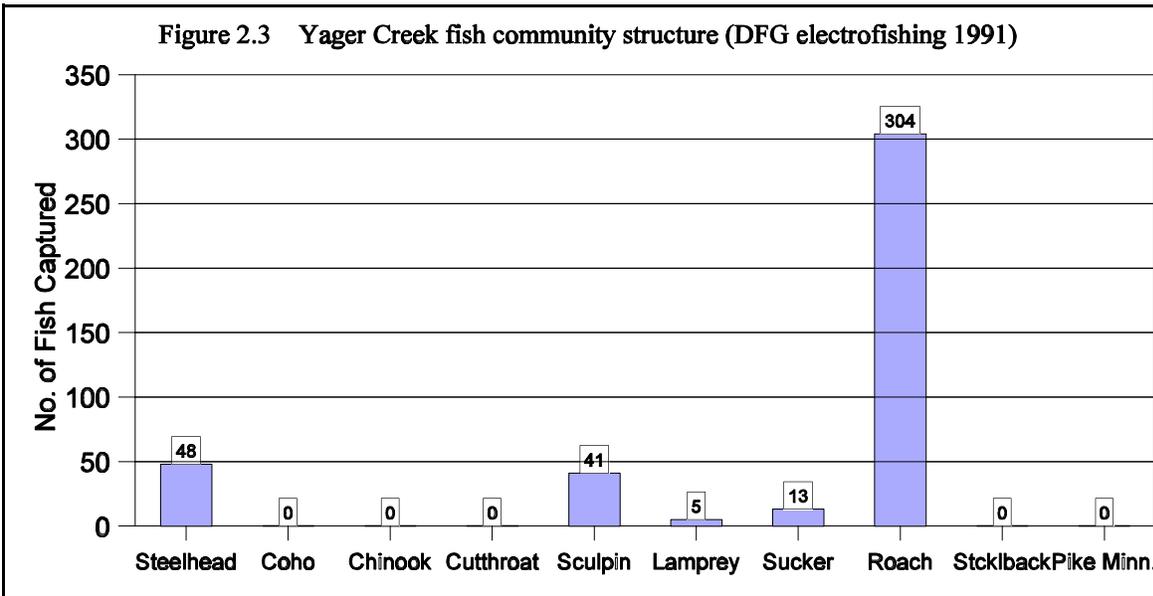
The fish community structure in Yager Creek in 1991, as measured by DFG, was much different than the 1951 account. As illustrated in Figure 2.3, Yager Creek contained a higher ratio of roach compared to steelhead. The presence of western roach and Sacramento pike minnow, both introduced species in much of the lower mainstem VDR and to some extent lower gradient tributaries, may be causing mortality to juvenile salmonids and forcing them to use less suitable habitat. Both species appear to thrive in aggraded channel conditions (described below) and warmer stream temperatures that have persisted since the 1964 flood. DFG (1991) found higher numbers of steelhead in tributaries to Lawrence Creek in 1991 but very few coho or chinook salmon.

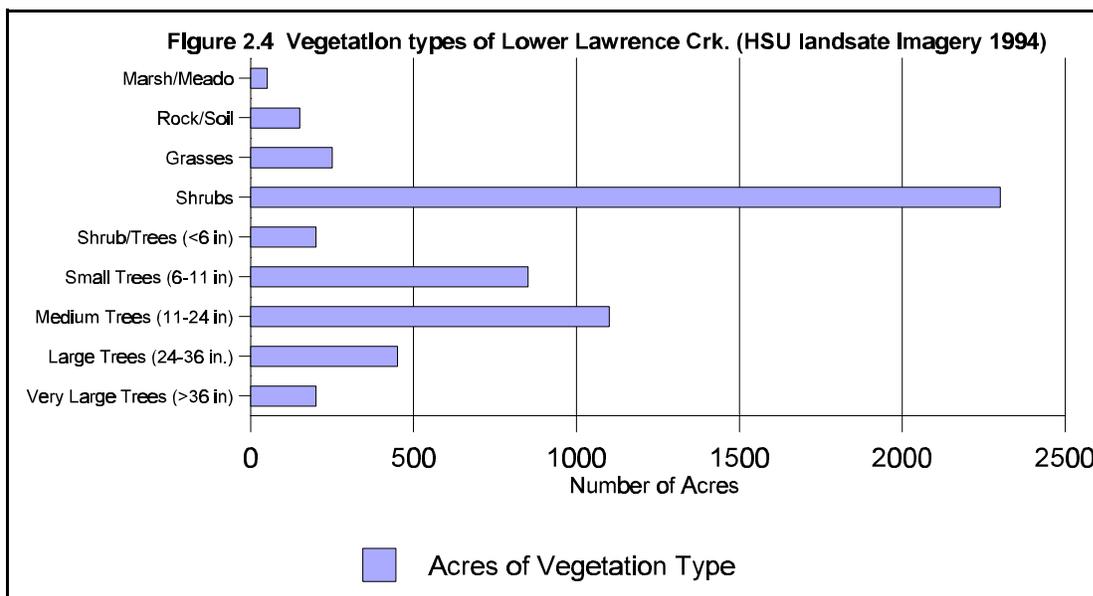
Portions of the lower basin have been heavily harvested within the last decade, thereby increasing sediment delivery risks to watercourses particularly in critical spawning and rearing subwatersheds, such as Lawrence Creek and associated tributaries. For example, 44% of the Yager Creek area under industrial timber management is dominated by a “young” forest type, indicating a high percentage of relatively recent (within last decade) harvesting and associated soil disturbance (PL 1998). Figure 2.4 displays the timber and vegetation types created from a 1994 Landsat image by the Humboldt State University spatial Analysis Laboratory.

The relatively large acreages of shrub and small tree classes in figure 2.4 are indicative of clear cut or heavy selection logging conducted prior to 1994. Intensive timber harvesting can affect several physical and biological watershed processes including: hydrology (water yield, evapotranspiration, peak flows, timing of runoff, etc.), sediment transport, canopy cover and stream temperatures, large woody debris recruitment rates, etc. as described by Spence et al. (1996). Intensive management on steep streamside slopes, unstable areas and riparian zones can especially affect sediment delivery rates. PWA determined that 20% of the total historic sediment delivery in the lower basin was associated with timber harvest activities, as discussed more thoroughly in Chapter 4.

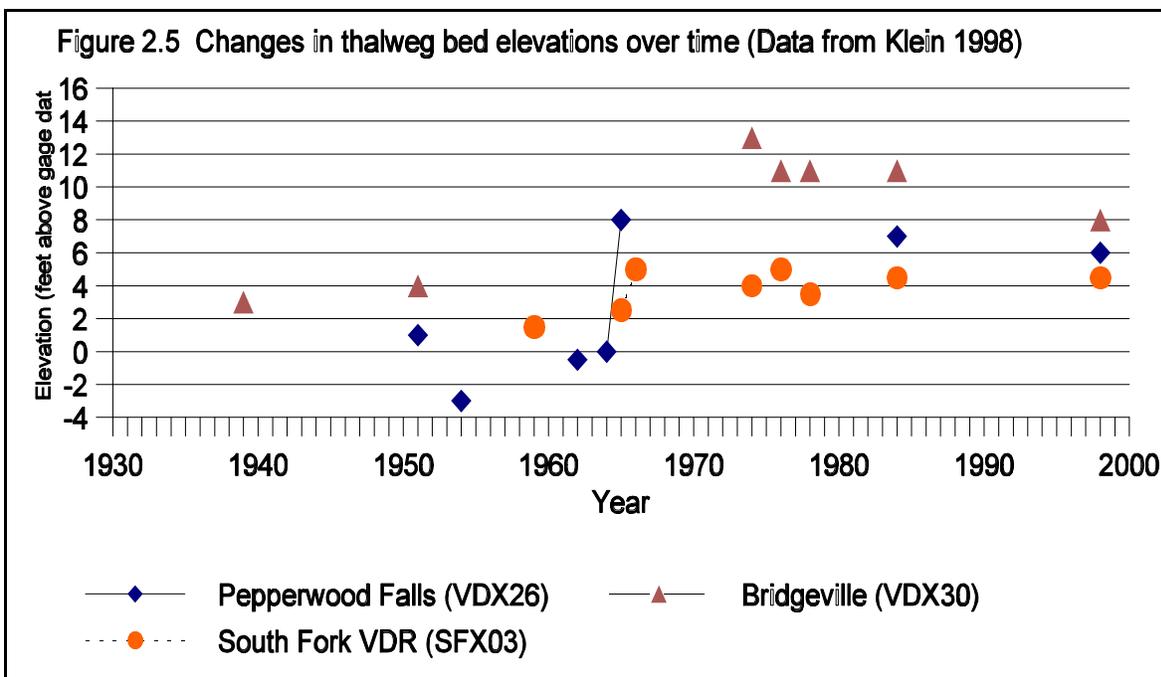
The low gradient reach between Bridgeville and Little Larabee Creek in the middle basin was dramatically altered by aggradation due to the 1964 event (Kelsey 1977). This reach of the middle mainstem VDR appears to be recovering toward pre-1964 levels, based on more recent channel cross-sections survey data (Klein 1998). Figure 2.5 illustrates the change in thalweg elevation (deepest point) of cross section measured at three points on the VDR including: the former US Geologic Survey (USGS) gaging station at Pepperwood Falls, the old Highway 36 bridge at Bridgeville, and the former USGS gaging station on the South Fork VDR. Channel downcutting and pool development in the middle mainstem reach between Bridgeville and Baker Creek is particularly beneficial for spawning and rearing of chinook and steelhead.

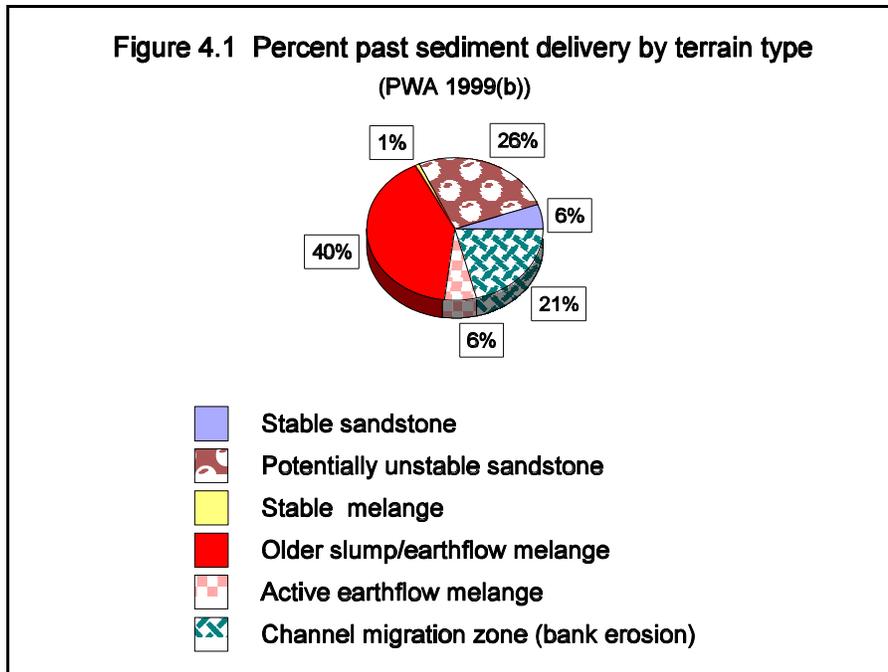
Estimated sediment yield determined by PWA (1999(b)) conforms fairly well to the expected relative importance of sediment yield (derived from Kelsey 1977). PWA (1999(b)) provides a full discussion of the comparison between PWA's erosion estimates and Kelsey's original projections.

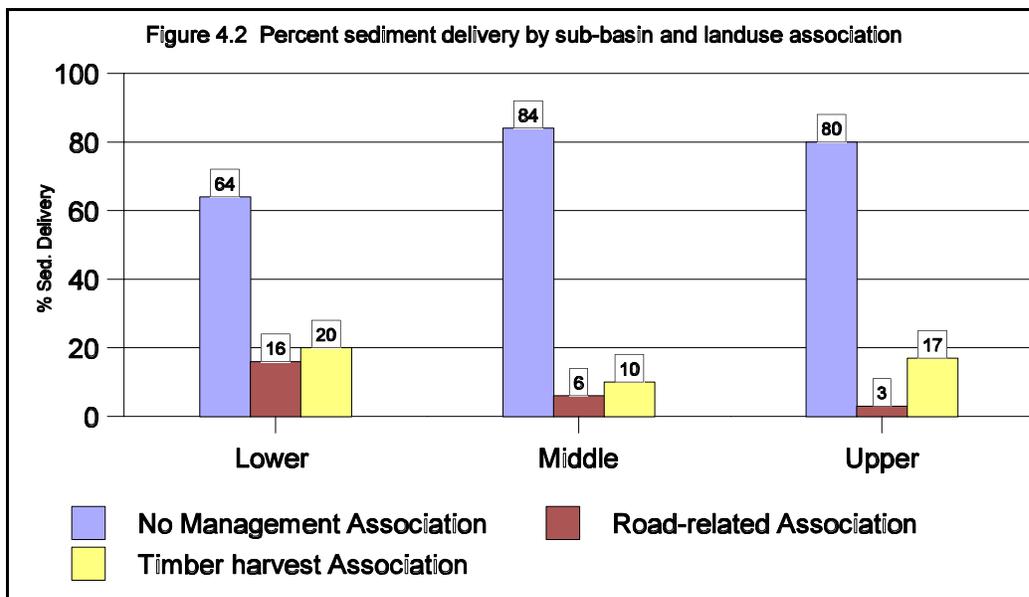
Within the middle basin, management-associated sediment yield associated with tractor harvested areas reflect a low percentage of cable harvesting over the previous three decades. While natural volumes (and rates) of sediment yield are highest in the middle watershed, management-associated sources account for 293 yds³/mi²/year.

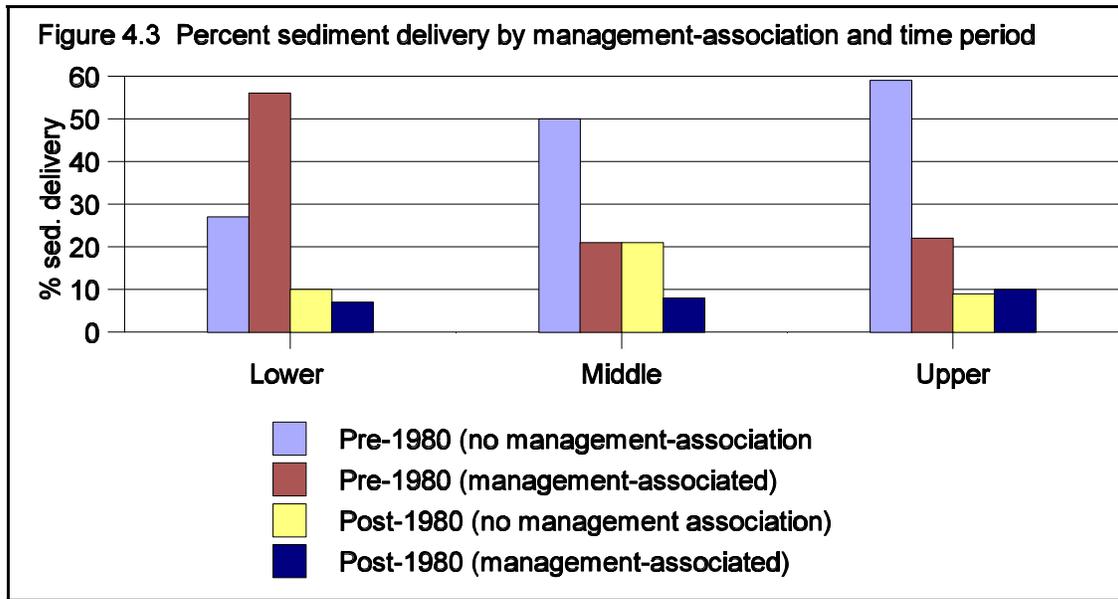
The data suggests considerably less natural and management related sediment is being produced in the VDR basin in the post-1980 period. This may reflect differences in the frequency and magnitude of storms which trigger widespread watershed response, but also could be partially attributed to improvements in land management practices brought on by the FPR or voluntarily by individual landowners.
