## OPERATIONAL AND REGULATORY HISTORY AND WASTE CHARACTERISTICS

WOONASQUATUCKET RIVER (NORTH)  
CENTREDALE MANOR SITE  
2074 SMITH STREET  
NORTH PROVIDENCE, RHODE ISLAND

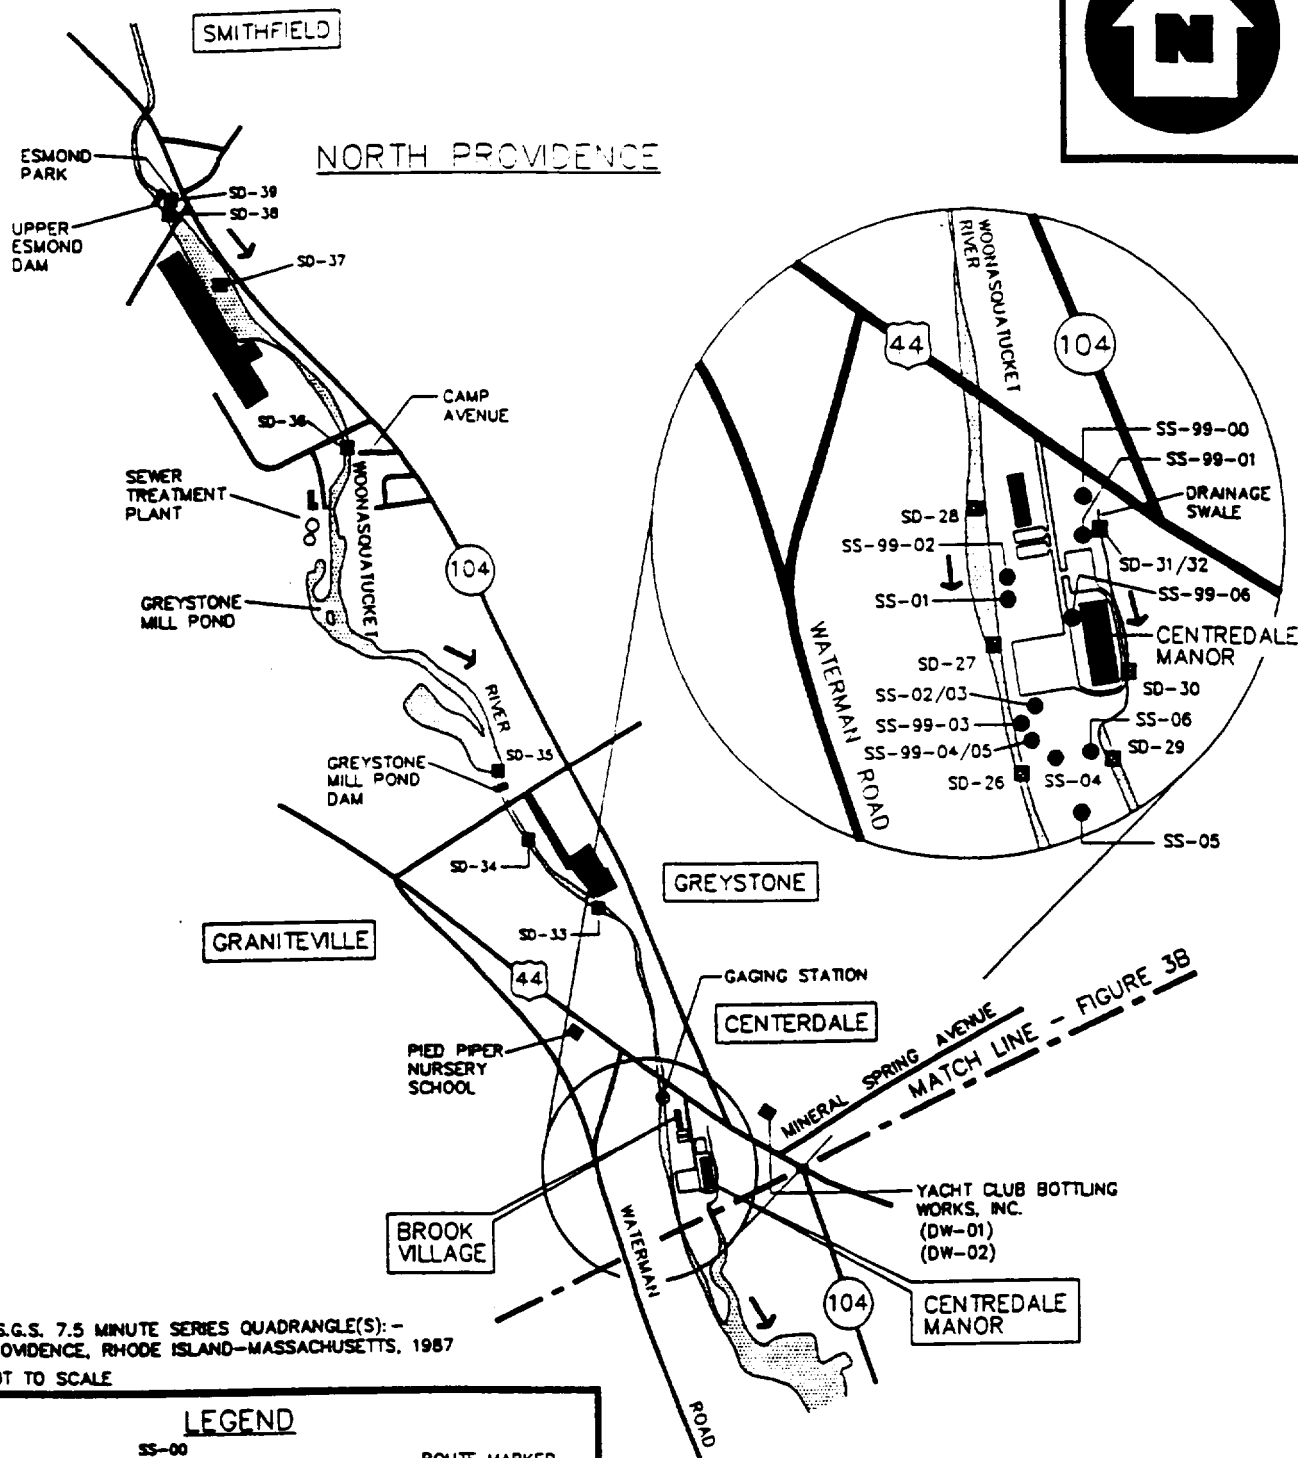
| FILE NAME:<br>S:\98060017\FIG1CX | FIGURE 3A |

## SAMPLE LOCATION MAP

On 9 September 1998, START personnel collected five soil samples from the Centredale Manor property, one soil sample from the Brook Village property, 35 sediment samples from the Woonasquatucket River, and four sediment samples from the drainage channel. All sampling activities were conducted in accordance with the EPA approved Task Work Plan, dated 31 August 1998. The soil and sediment samples were submitted to the EPA Region VII laboratory for dioxin and HCX analyses, to an EPA CLP laboratory for SVOC and pesticide/PCB analyses, and to a Delivery of Analytical Services (DAS) laboratory for TOC analysis. Sample locations are depicted on Figures 3A, 3B, and 3C and described in Table 1.

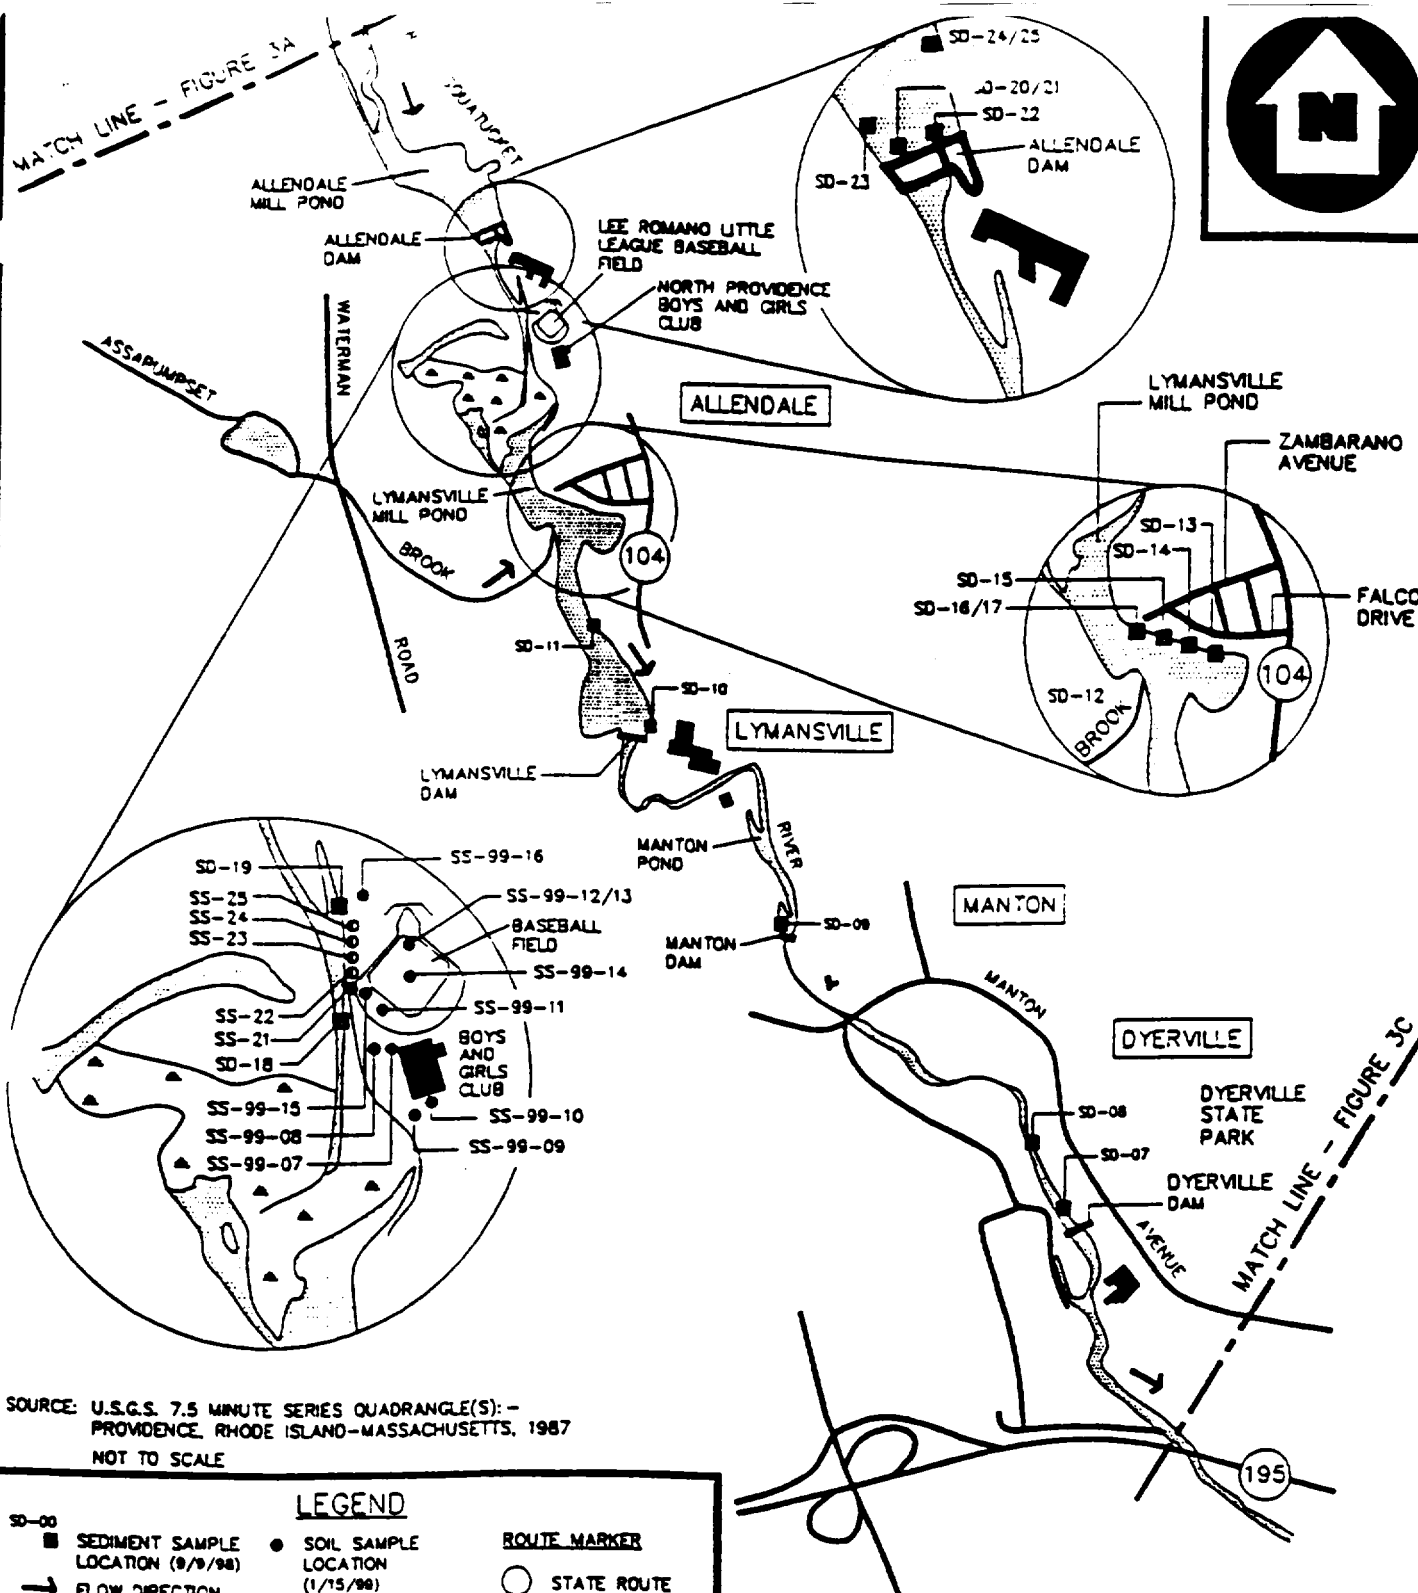
| FILE NAME: | FIGURE 3B | |

## SAMPLE LOCATION MAP

WOONASQUATUCKET RIVER (CENTRAL)  
CENTREDALE MANOR SITE  
2074 SMITH STREET  
NORTH PROVIDENCE, RHODE ISLAND

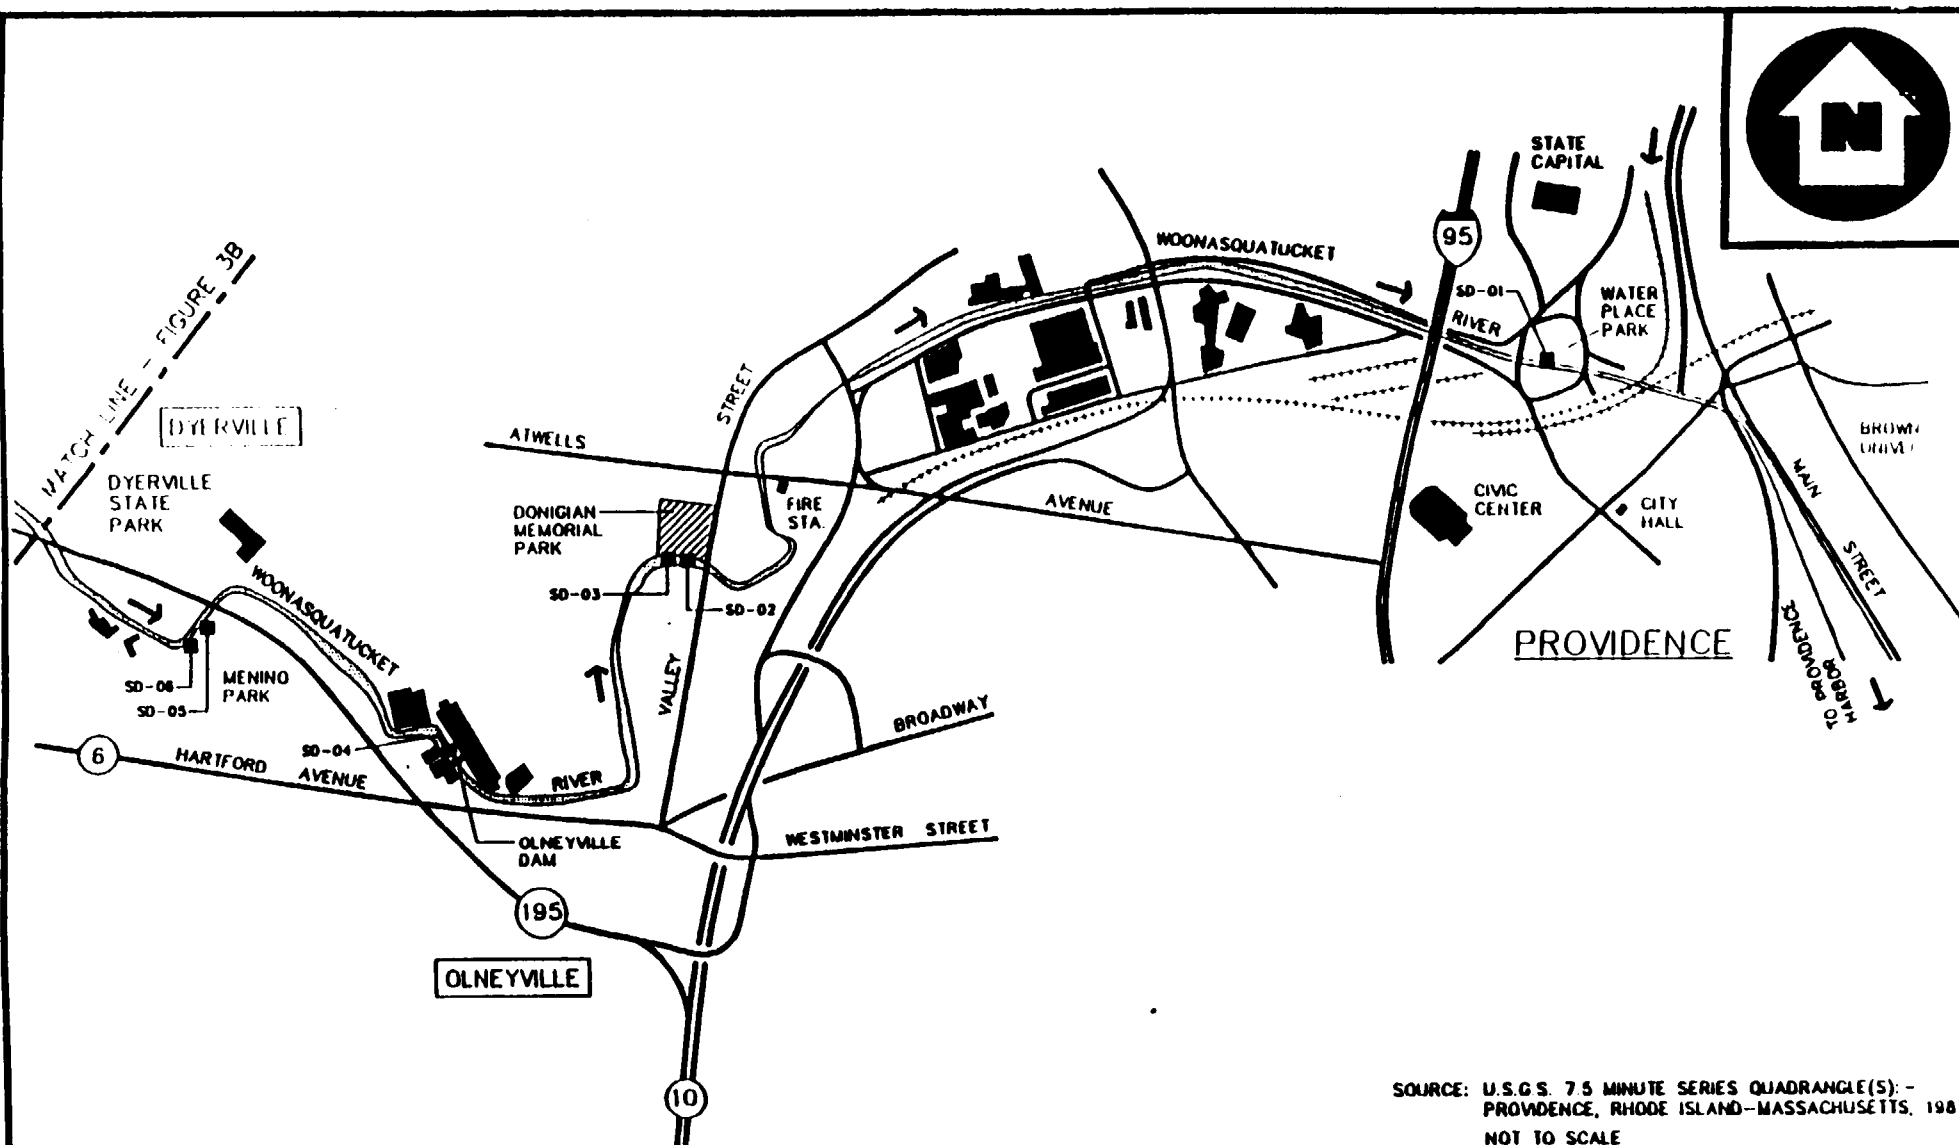
FIGURE 3C

### SAMPLE LOCATION MAP

WOONASQUATTUCK RIVER (SOUTH)  
CENTREDALE MANOR SITE  
2074 SMITH STREET  
NORTH PROVIDENCE, RHODE ISLAND
