**DRAFT  
TECHNICAL MEMORANDUM**

**MANTON AND DYERVILLE REACHES**

**SEDIMENT SAMPLING**

**CENTREDALE MANOR RESTORATION PROJECT  
NORTH PROVIDENCE, RHODE ISLAND**

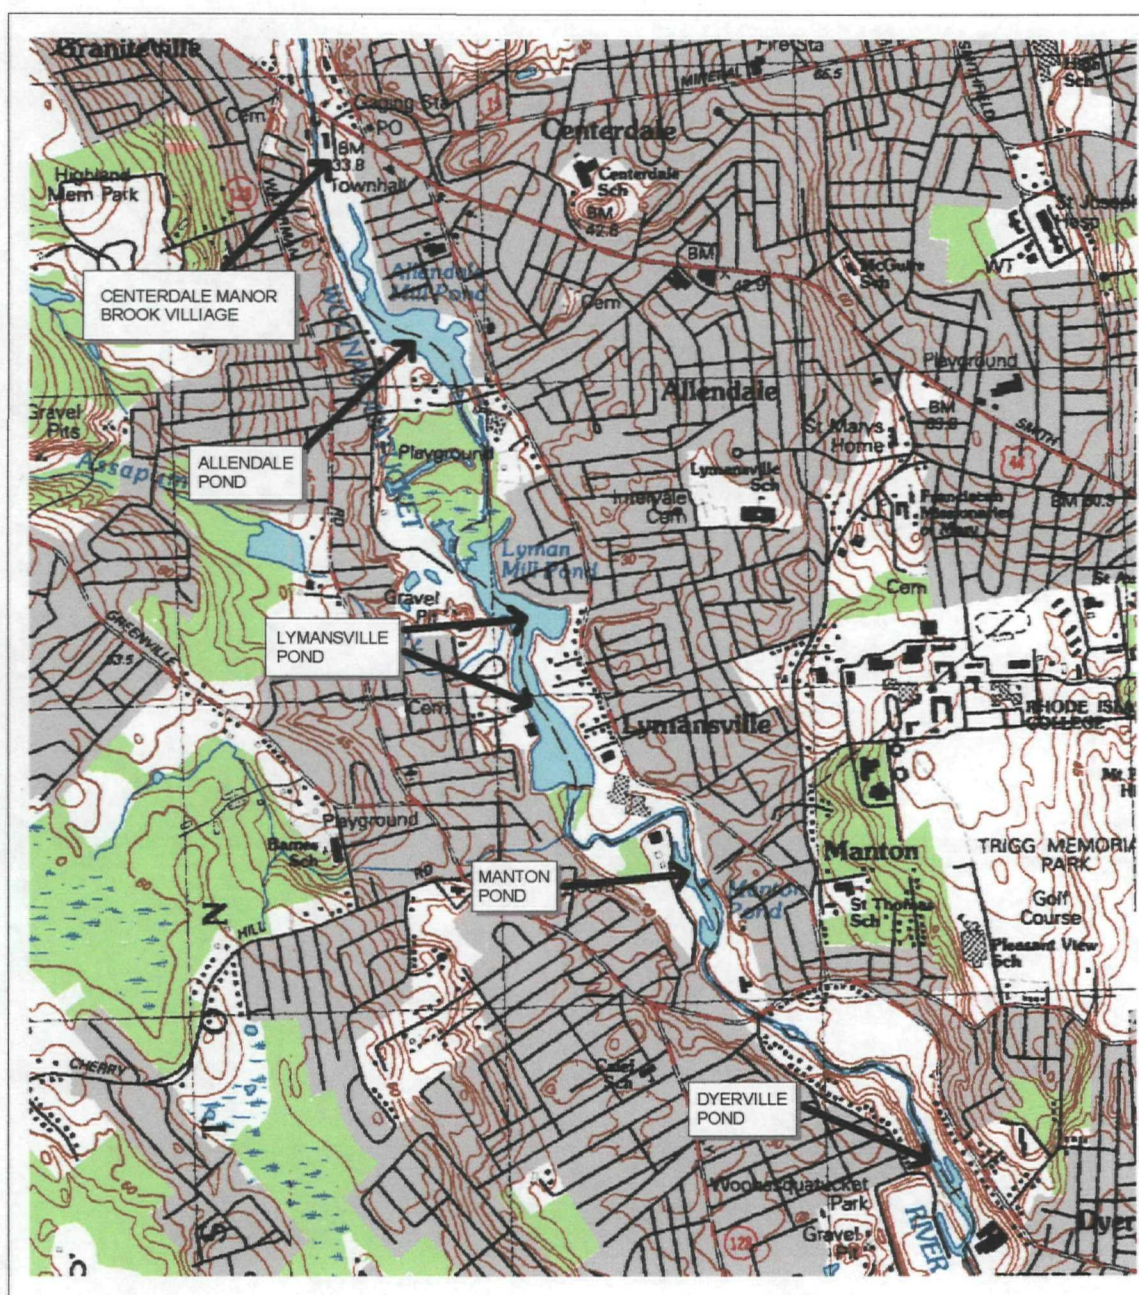
### FIGURE 1-1

### SITE LOCUS FIGURE

#### CENTREDALE MANOR RESTORATION PROJECT SITE NORTH PROVIDENCE, RHODE ISLAND

The samples were collected downstream of the Centredale Manor Restoration Project Site where dioxins, polychlorinated biphenyls (PCBs), metals, and other contaminants have previously been detected. The Woonasquatucket River study area defined for this investigation is depicted on Figure 1-1.

Figure 1-1 depicts the location of the site. Figure 2-1 provides some detail of the site features. The Centredale Manor Apartment Building and the adjacent apartment building known as "Brook Village", are located on the site of the former Metro-Atlantic Chemical Corporation, which operated from the 1940s to the 1970s in a former mill complex on the site. Parking lots, roadways, lawn areas, and two high-rise residential buildings currently cover this "source area". The Woonasquatucket River follows the west boundary of the Centredale Manor and Brook Village Properties. The remains of a raceway for the former mill complex are present on the eastern boundary of the site.

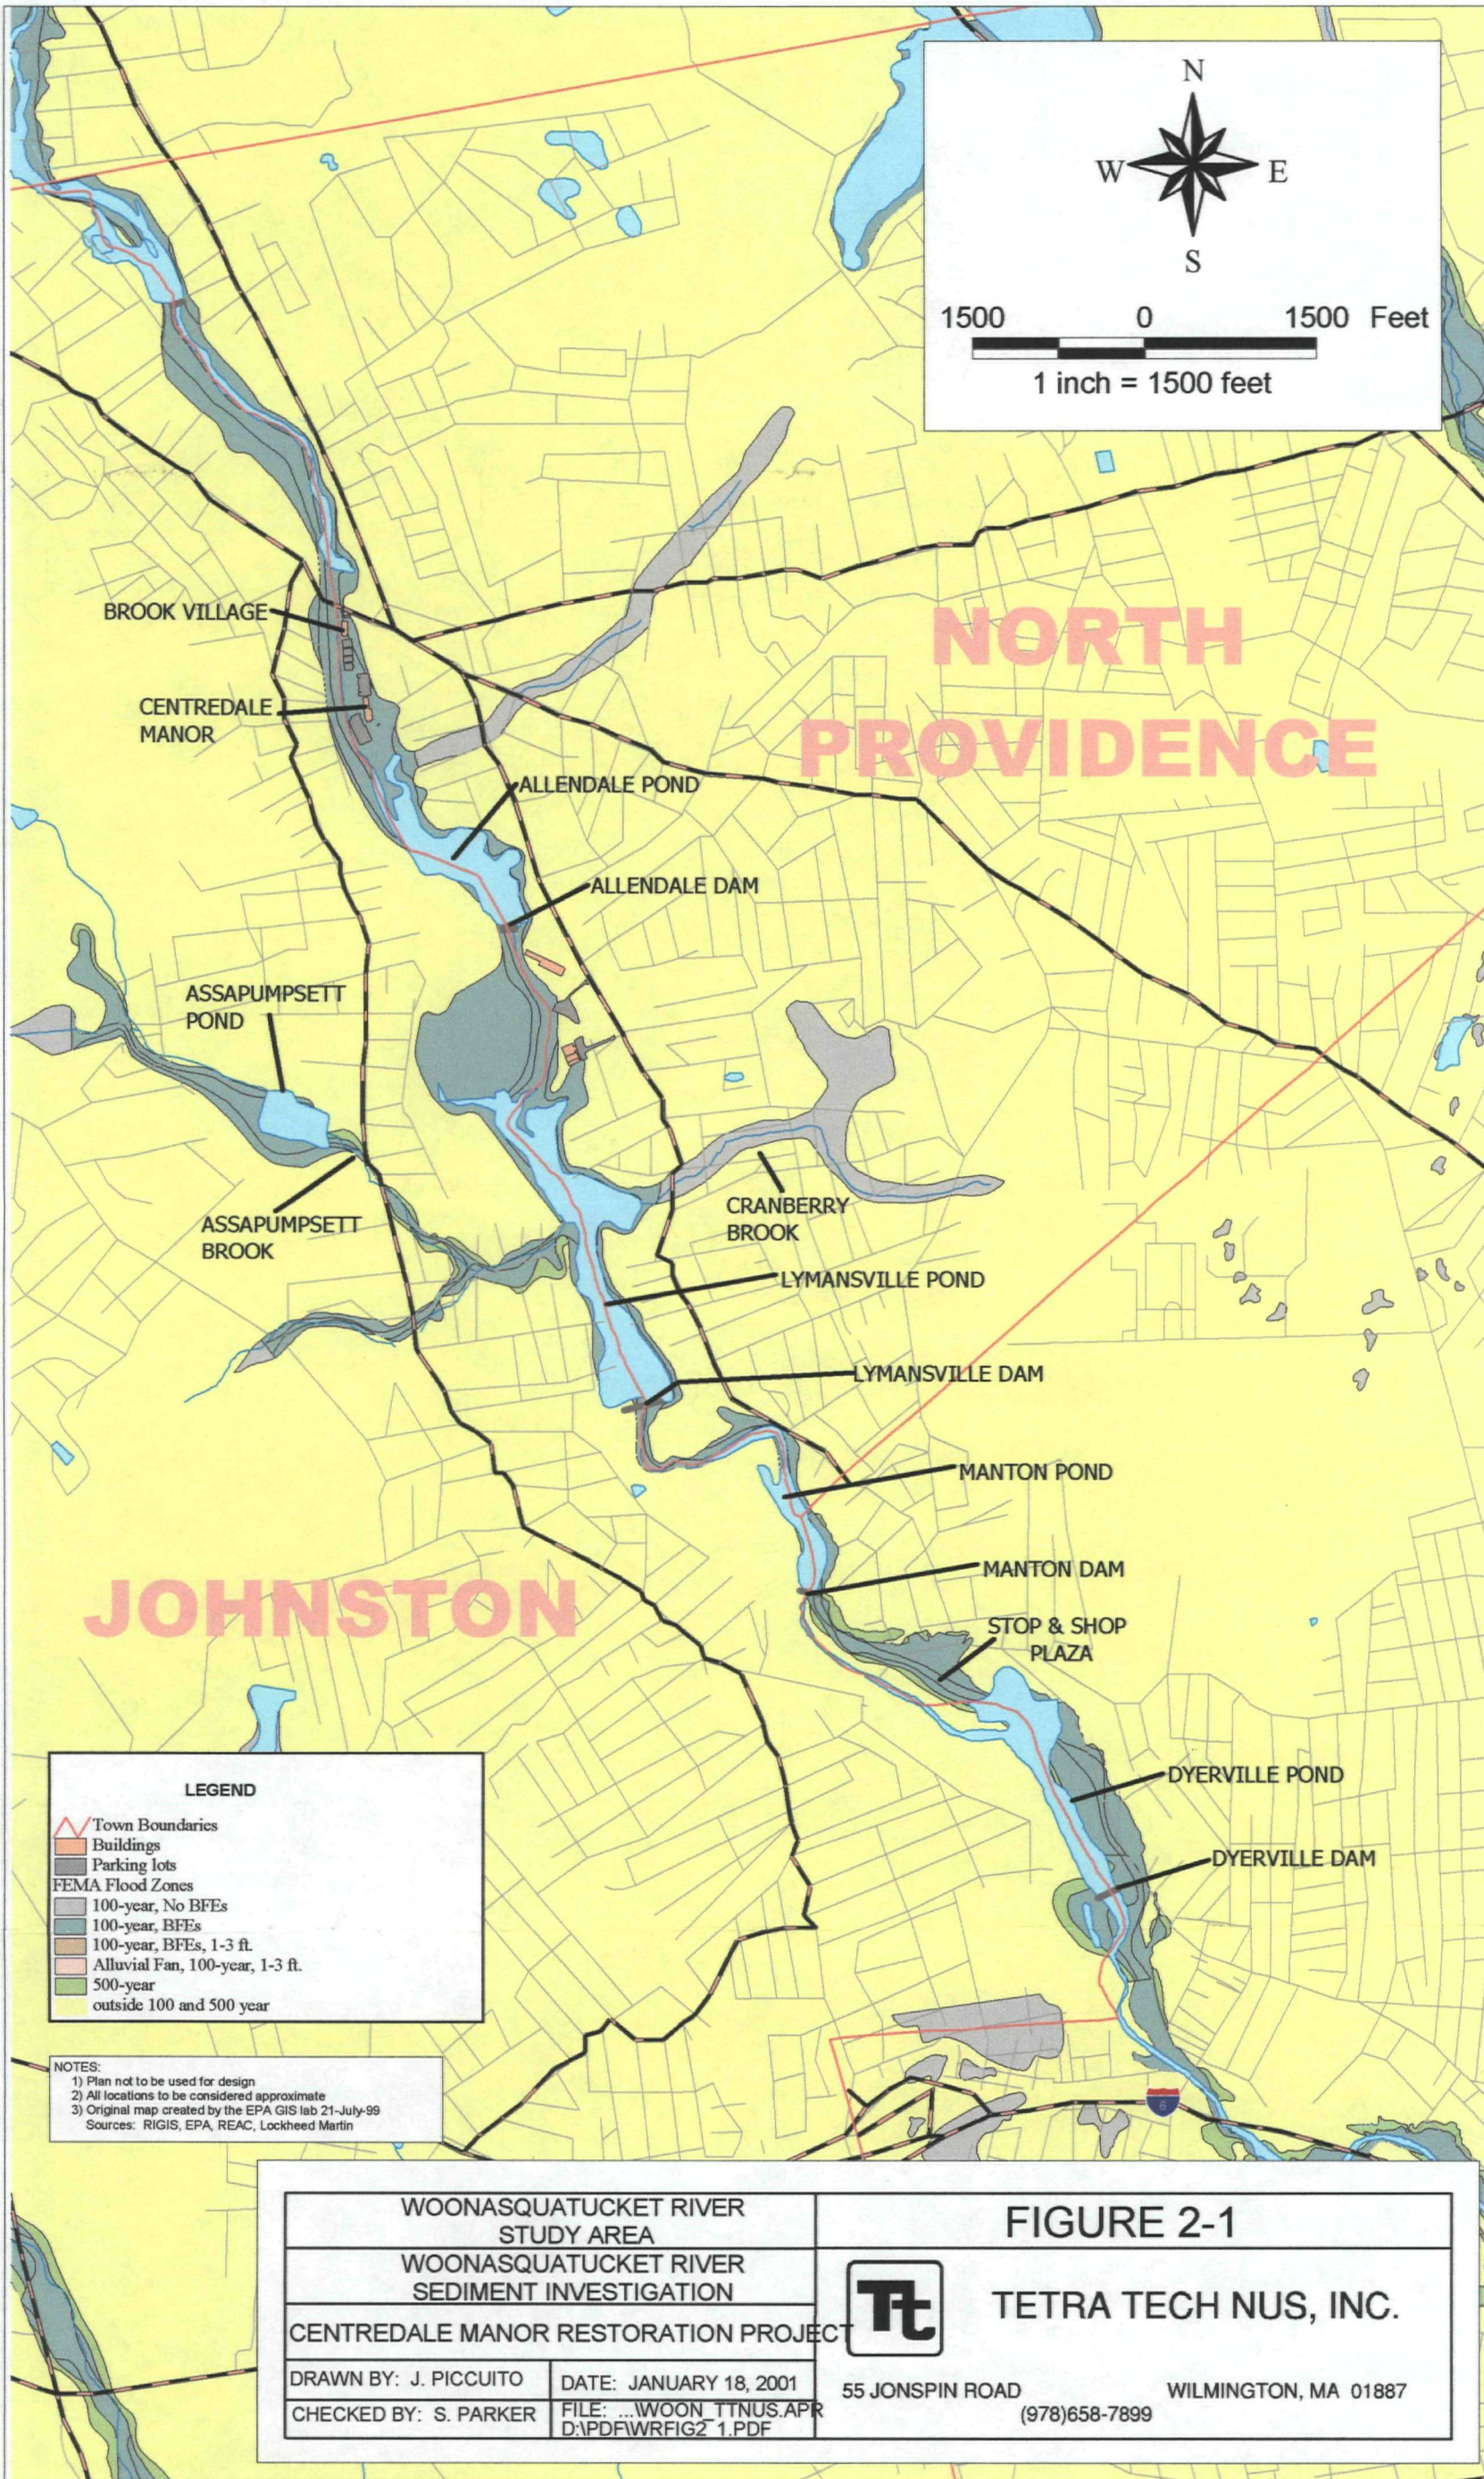
| WOONASQUACKET RIVER STUDY AREA | | FIGURE 2-1 | |

| WOONASQUACKET RIVER SEDIMENT INVESTIGATION | | TETRA TECH NUS, INC. | |

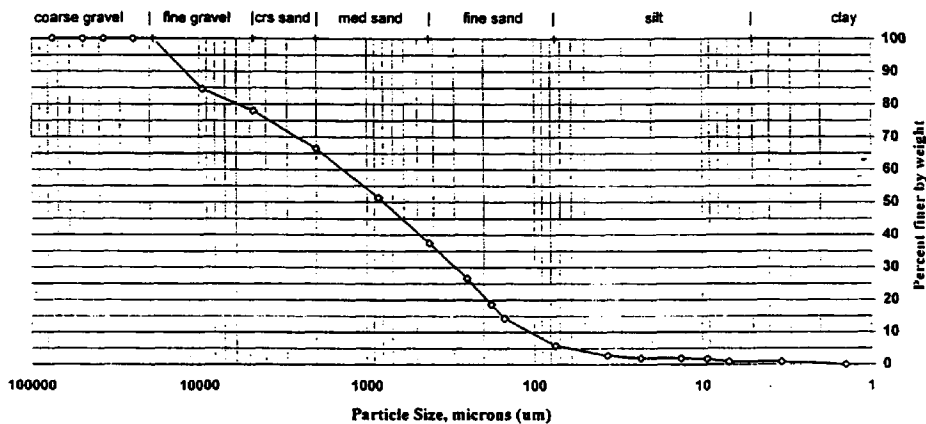
Lab ID: 430728 Sample ID: D02183

Percent Solids: 81.7% Maximum Particle Size: 19 mm  
 Specific Gravity: 2.65 Shape (> #10): Subrounded  
 Hardness (> #10): Hard

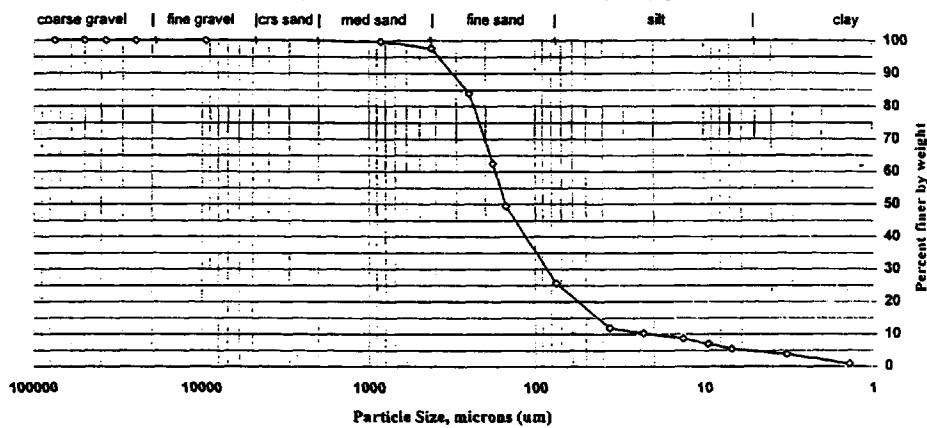
Sample ID: D02186

Percent Solids: 54.2%Maximum Particle Size: Med sandSpecific Gravity: 2.65Shape (> #10): N/AHardness (> #10): N/A

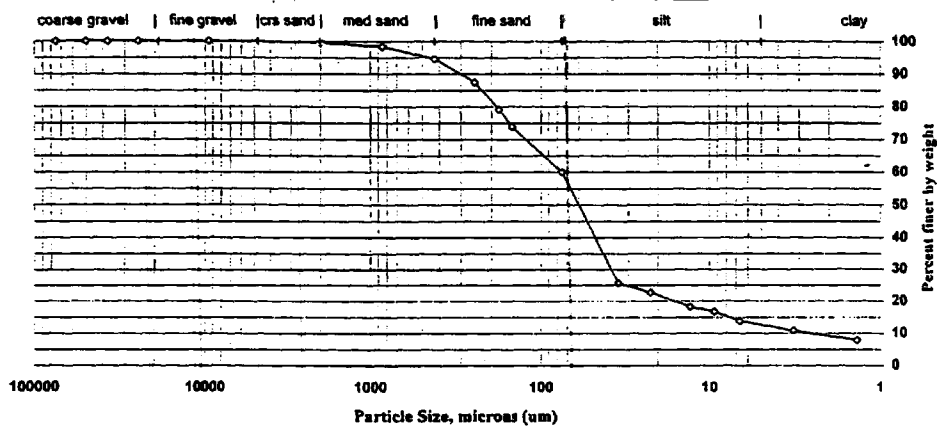
Percent Solids: 68.6%  
 Specific Gravity: 2.65

Maximum Particle Size: Crs sand  
 Shape (> #10): Subrounded  
 Hardness (> #10): Hard

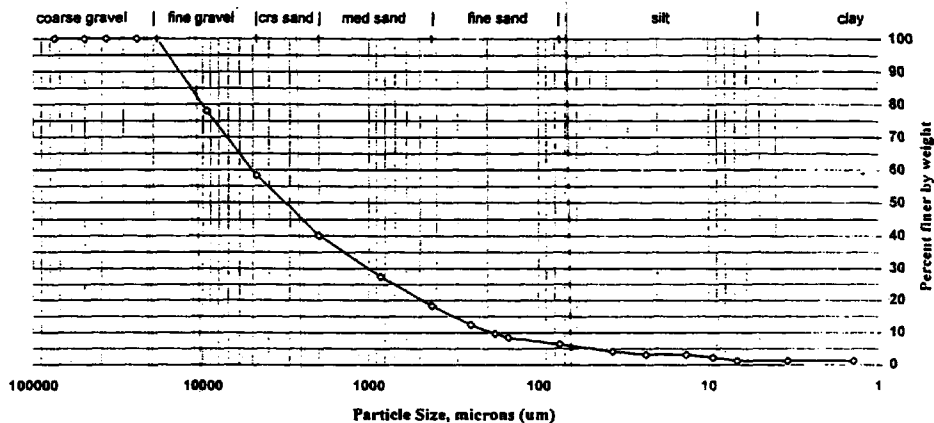
Percent Solids: 71.7%  
 Specific Gravity: 2.65

Maximum Particle Size: 19 mm  
 Shape (> #10): Subangular  
 Hardness (> #10): Hard

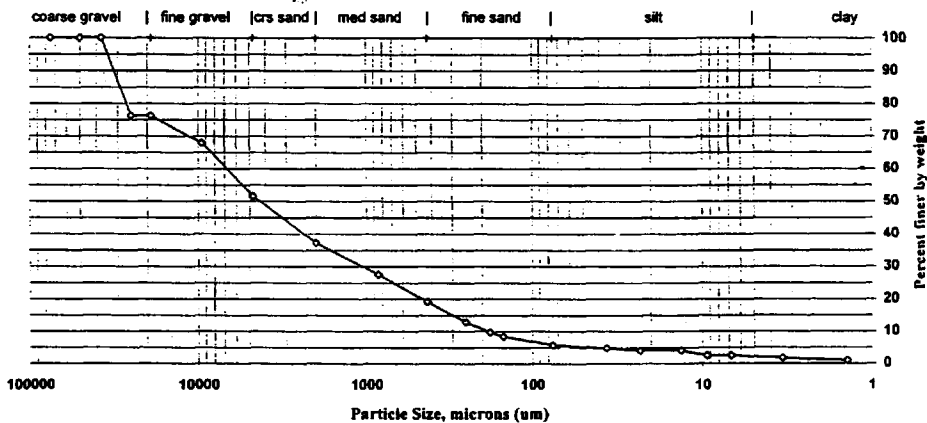
Percent Solids: 69.9%  
 Specific Gravity: 2.65

Maximum Particle Size: 37.5 mm  
 Shape (> #10): Subangular  
 Hardness (> #10): Hard

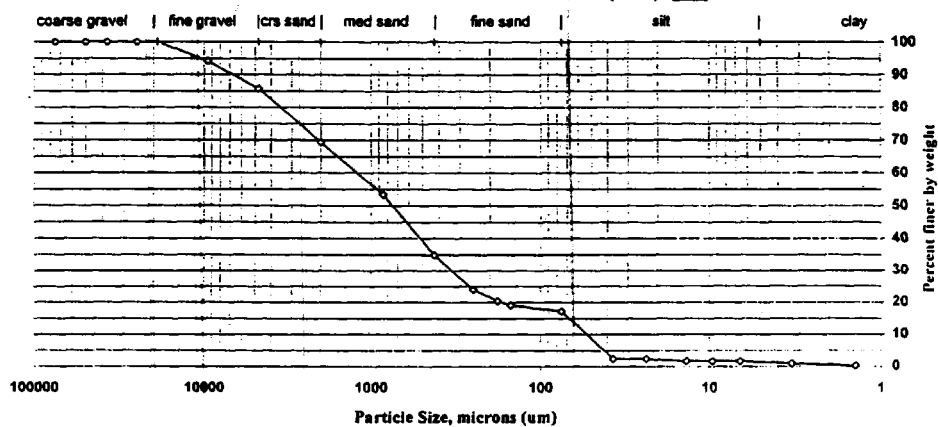
Percent Solids: 84.3%  
Specific Gravity: 2.65

Maximum Particle Size: 19 mm  
Shape (> #10): Subrounded  
Hardness (> #10): Hard

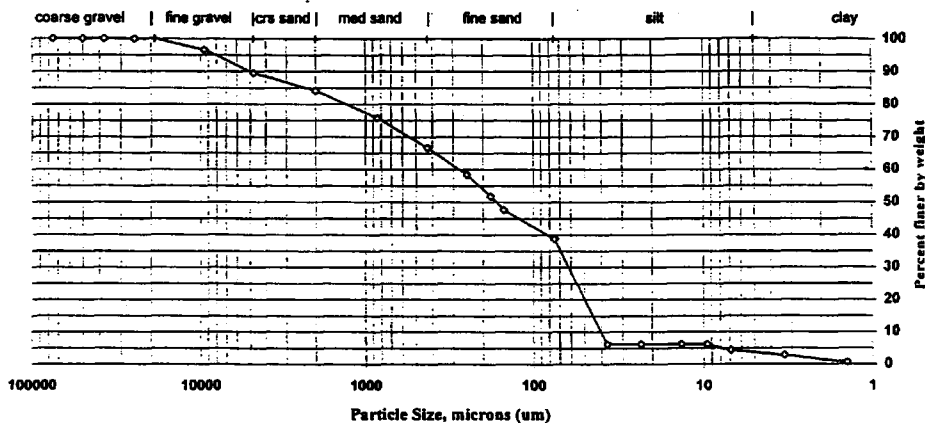
Percent Solids: 44.1%  
 Specific Gravity: 2.65

Maximum Particle Size: 19 mm  
 Shape (> #10): Subrounded  
 Hardness (> #10): Hard

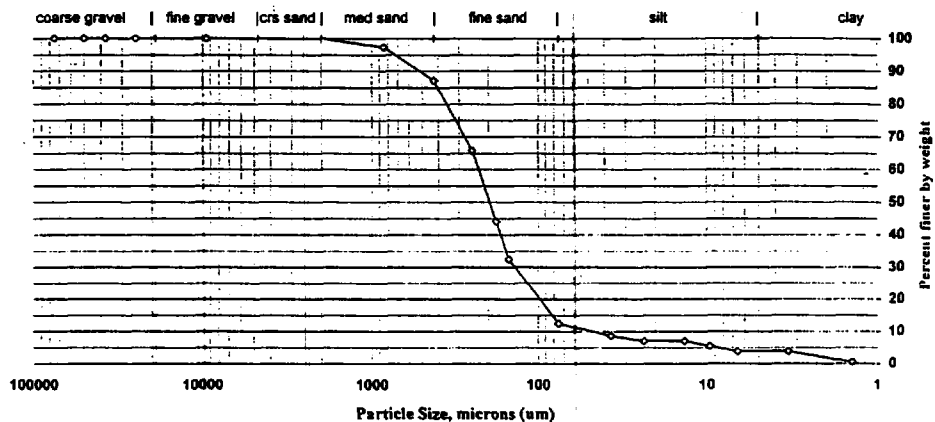
Percent Solids: 59.9%  
 Specific Gravity: 2.65

Maximum Particle Size: Crs sand  
 Shape (> #10): Subangular  
 Hardness (> #10): Brittle
