Appendix A.2

**SUPPLEMENTAL
DATA COMPENDIUM
FOR
WELLS G&H SUPERFUND SITE
ABERJONA RIVER STUDY
(OPERABLE UNIT 3)**

Woburn, Massachusetts

MAY 1998

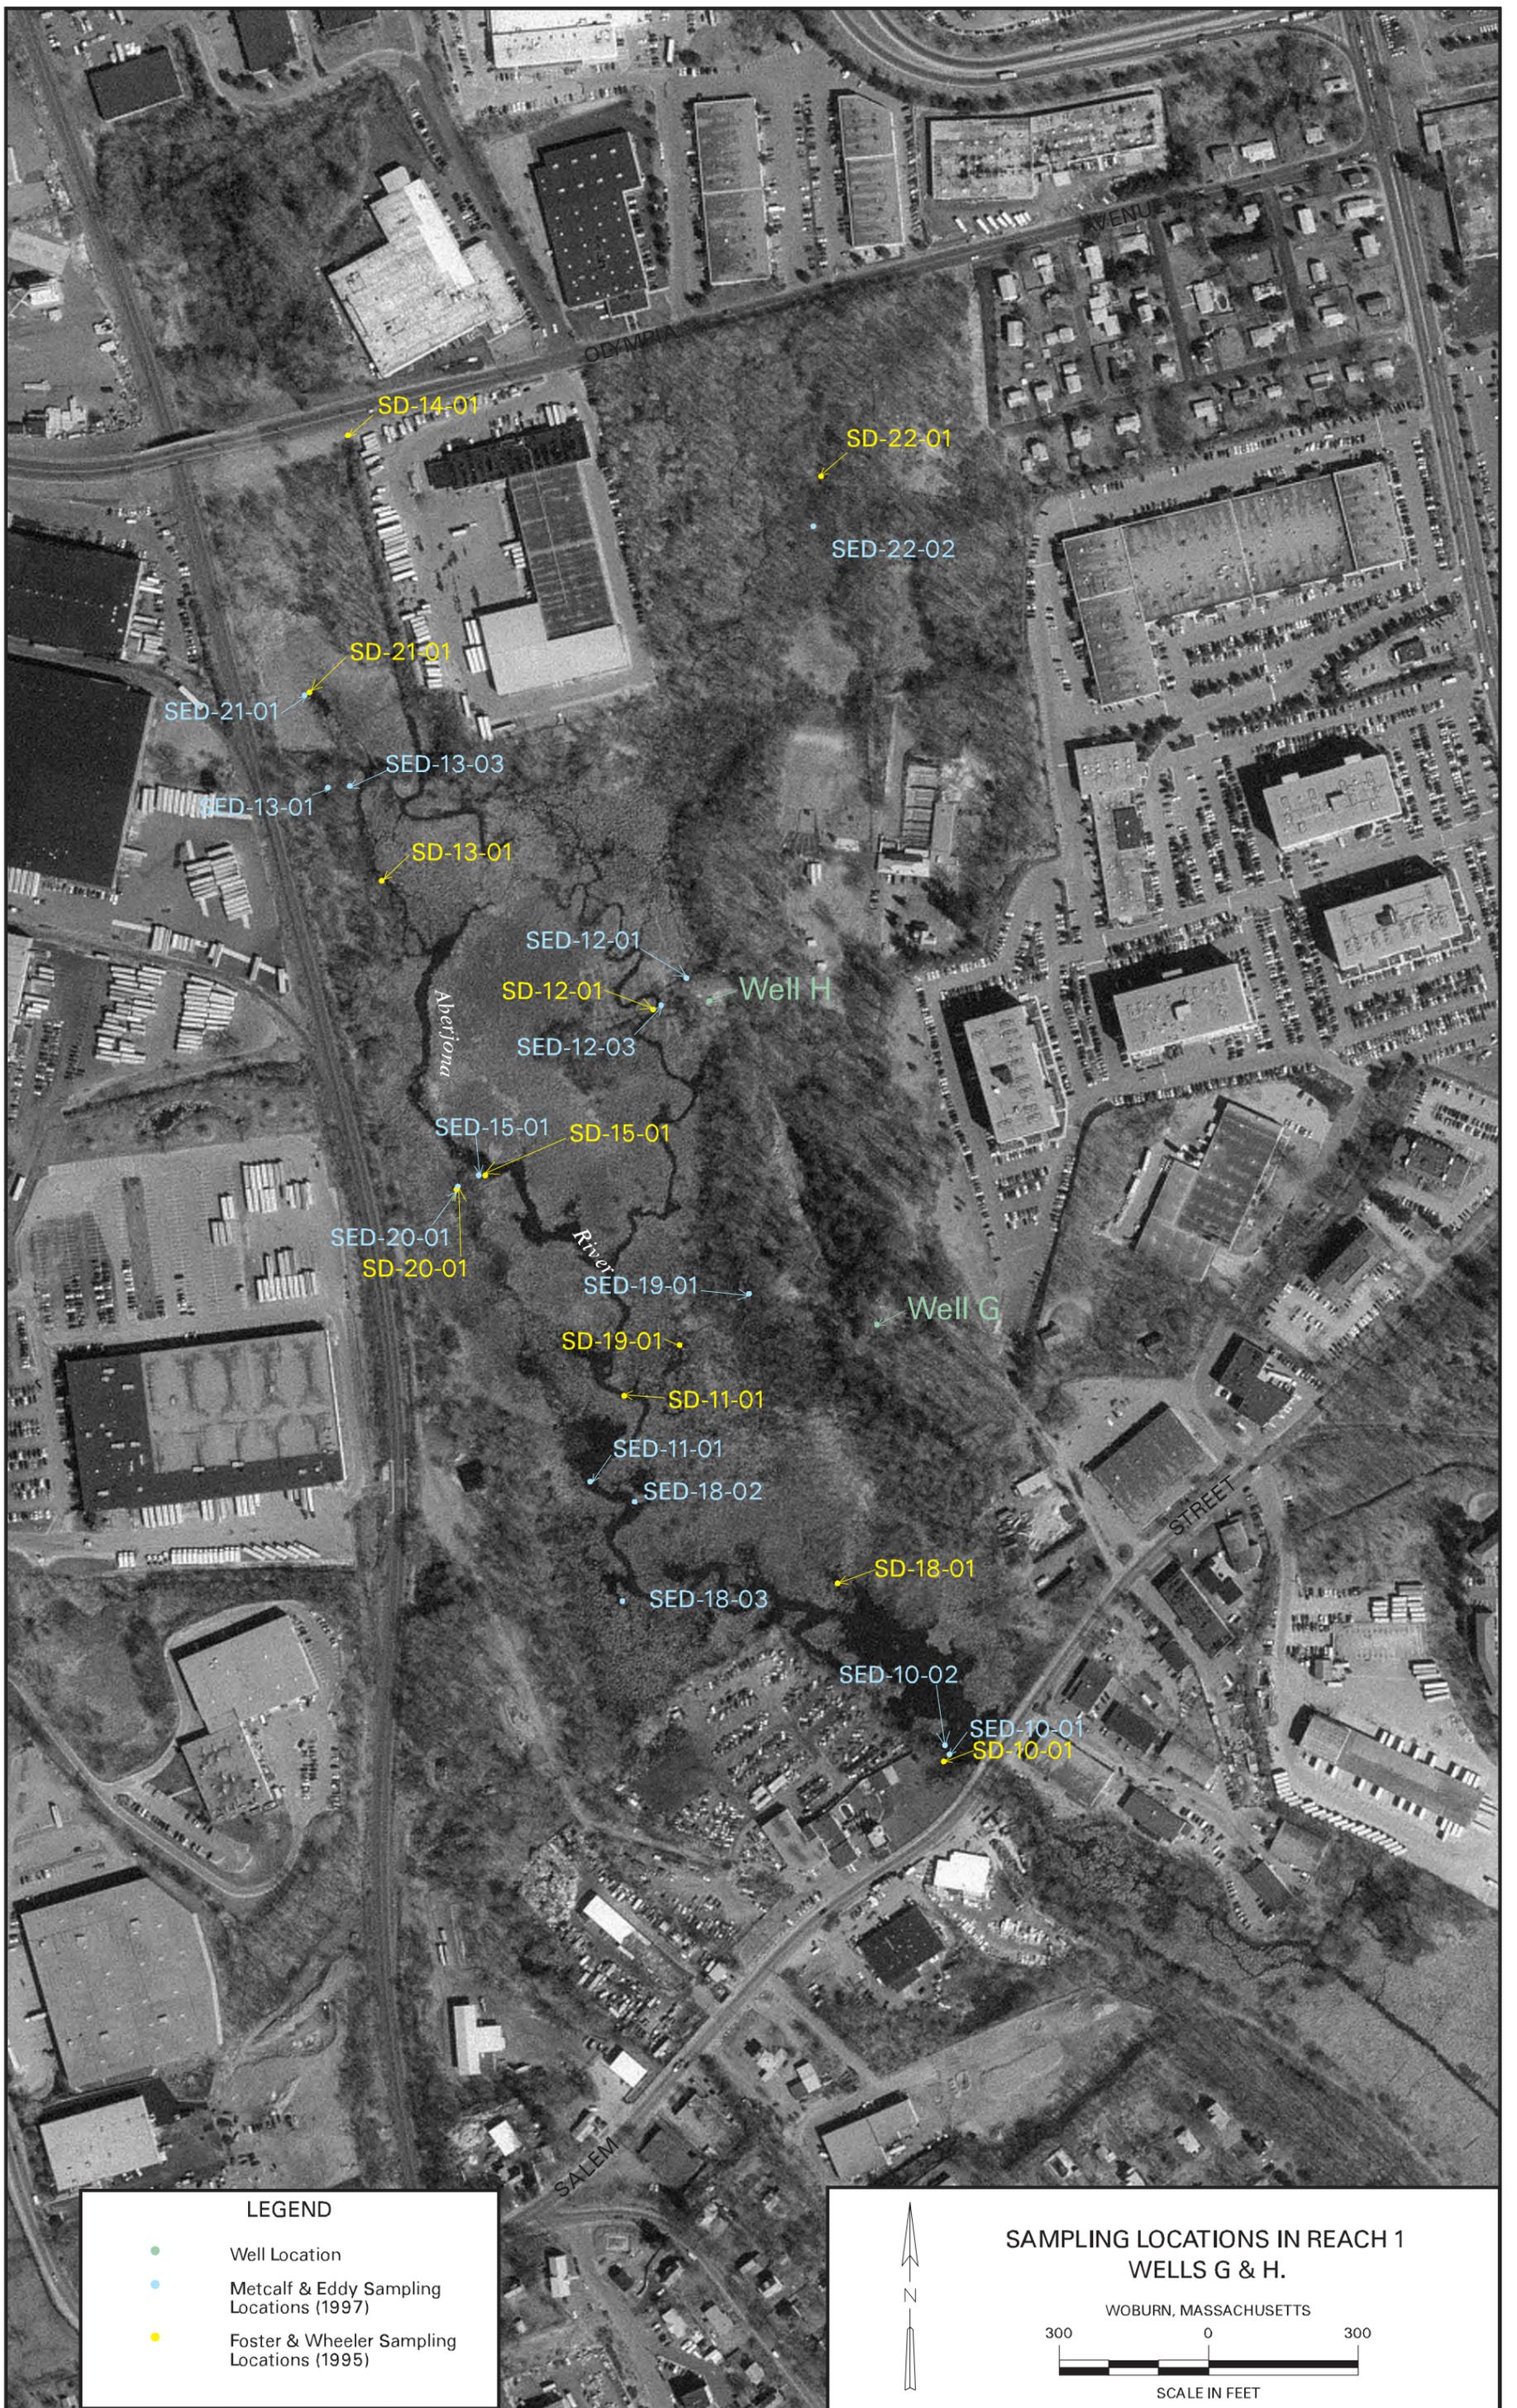
**SAMPLING LOCATIONS IN REACH 1
WELLS G & H.**

Sediment samples from 28 sampling locations (Figures 2-1 through 2-5, Table 2-1) within the Aberjona River, surrounding wetlands, and several background locations were collected and analyzed for volatile organic compounds (VOCs), polynuclear aromatic compounds (PAHs), pesticides and polychlorinated biphenyls (PCBs), low concentration metals, acid volatile sulfides/simultaneously extracted metals (AVS/SEM), and total combustible organics (TCO), grain size, moisture content, and pH. As per the QAPP, TCO analyses were conducted rather than Total Organic Carbon (TOC) due to the measurement of TCO being greater than one percent. The sampling was conducted between November 12, 1997 and November 20, 1997.

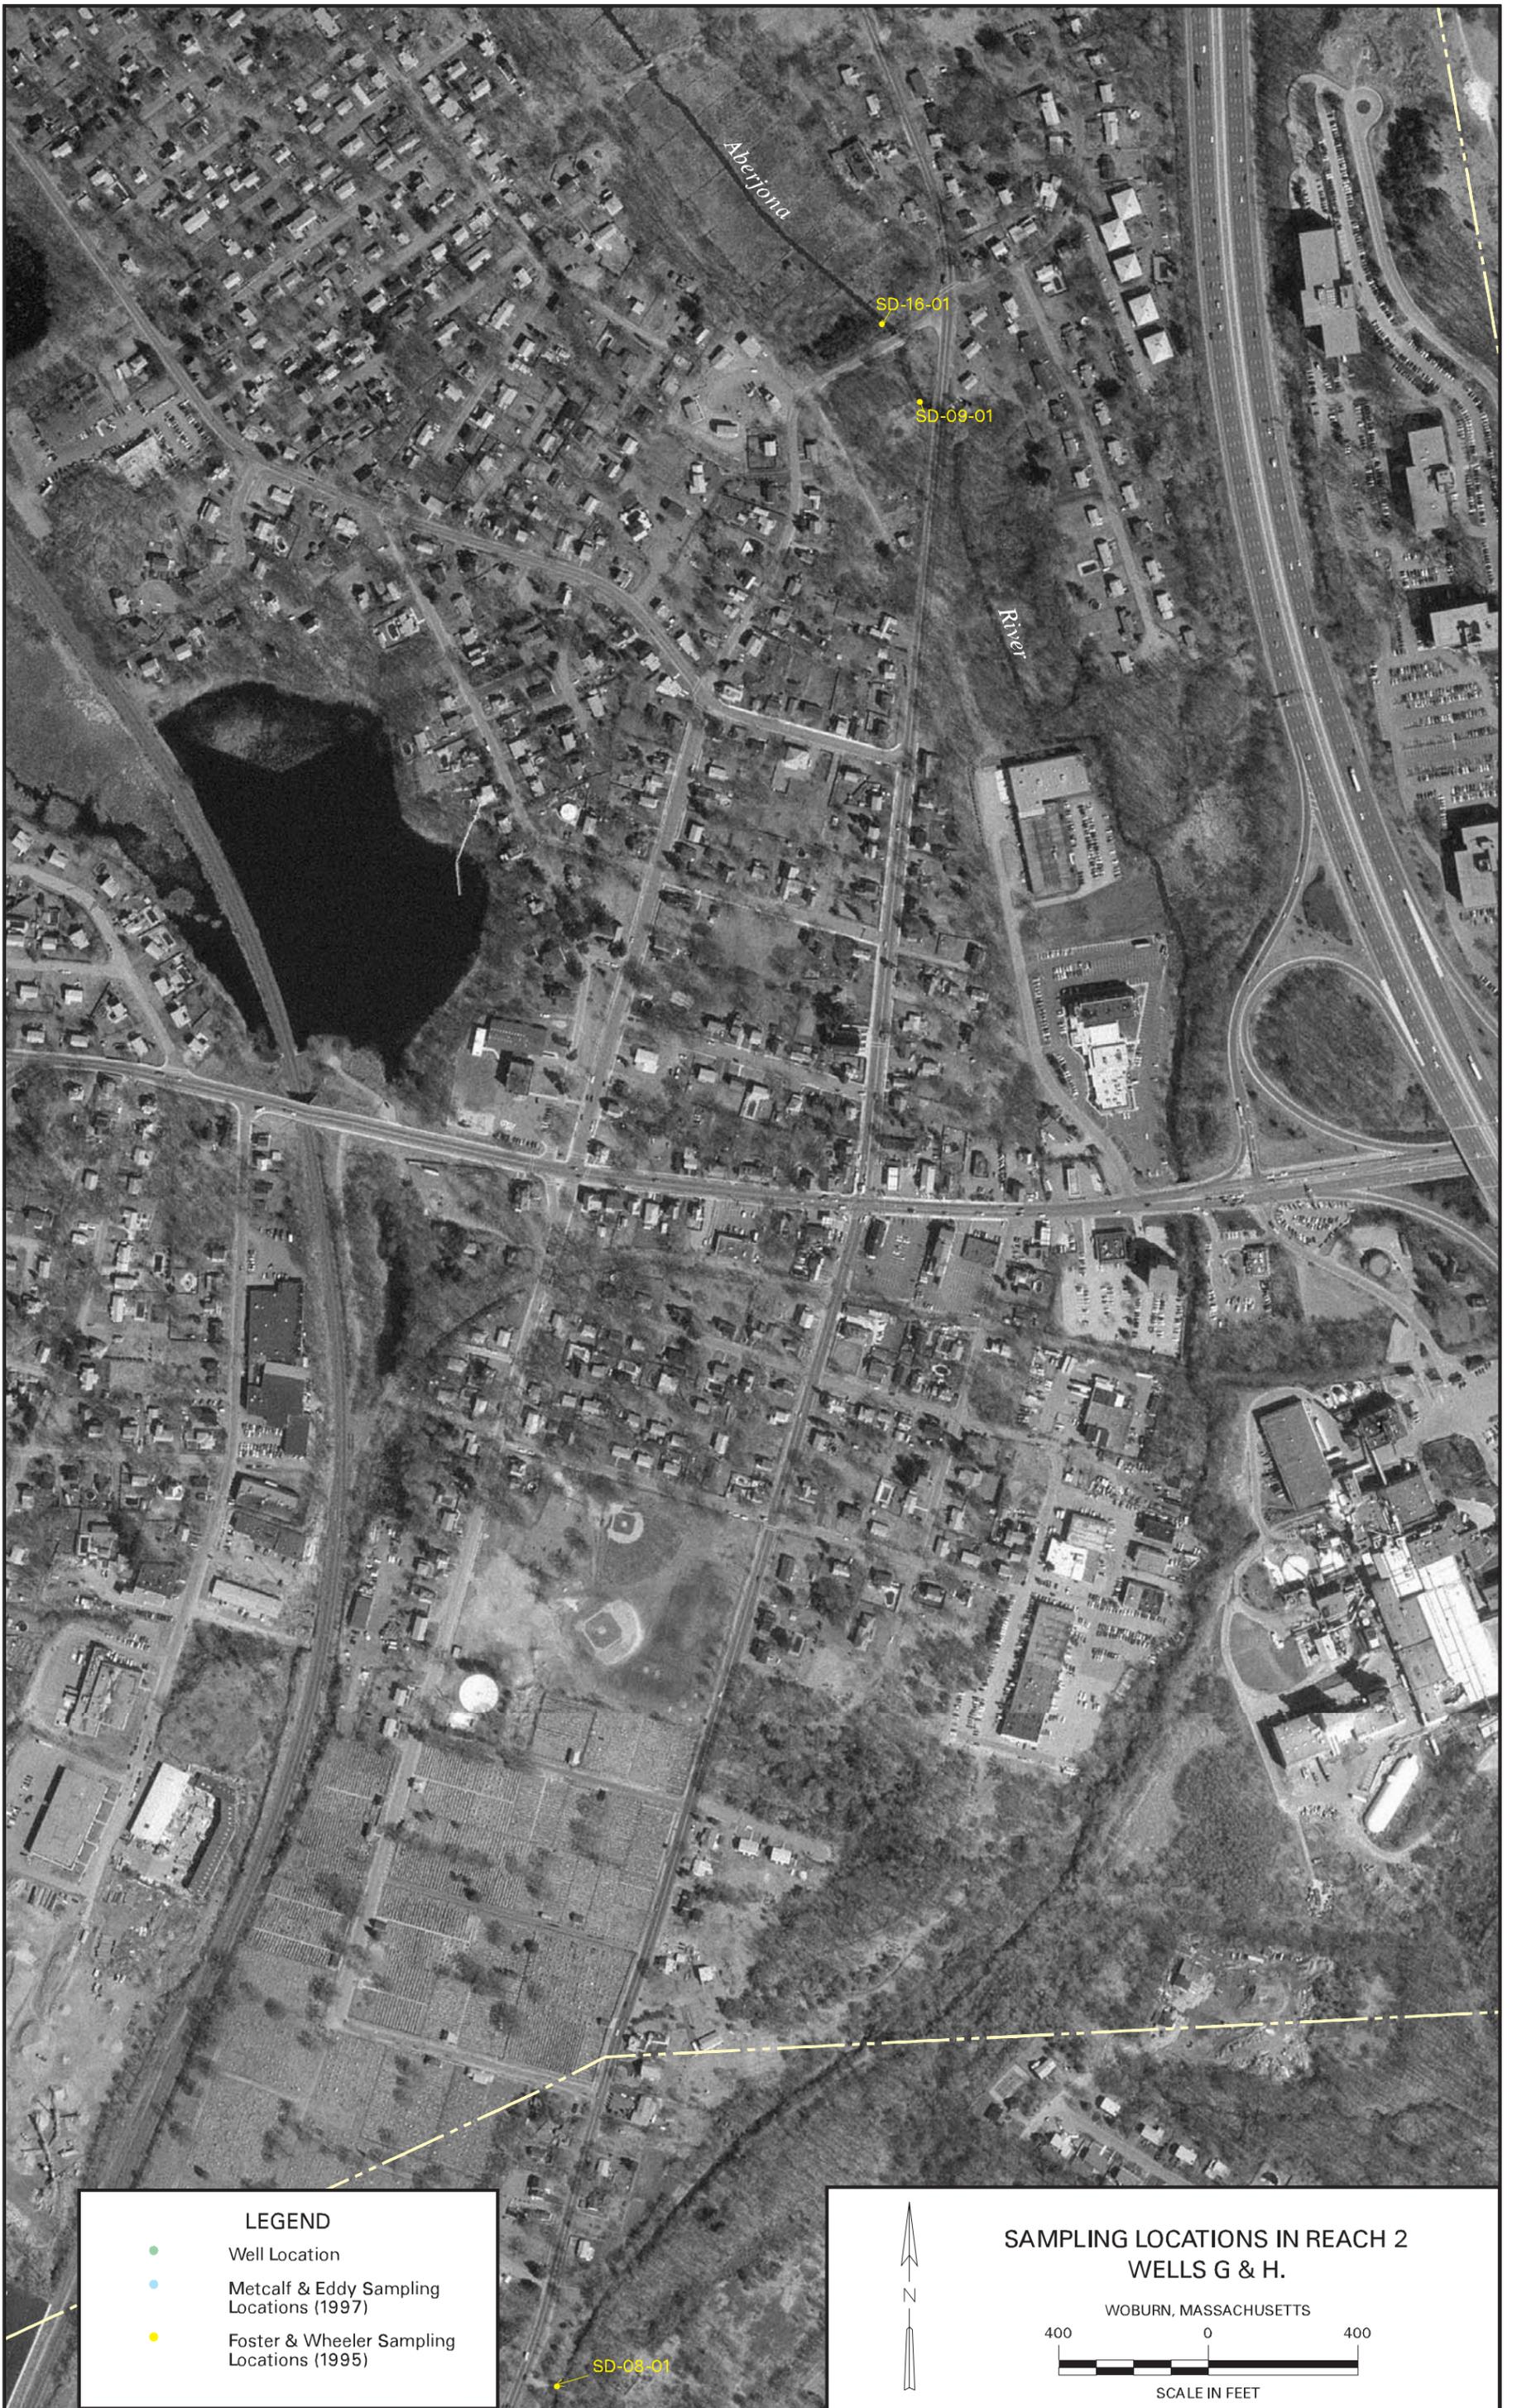
**SAMPLING LOCATIONS IN REACH 2
WELLS G & H.**

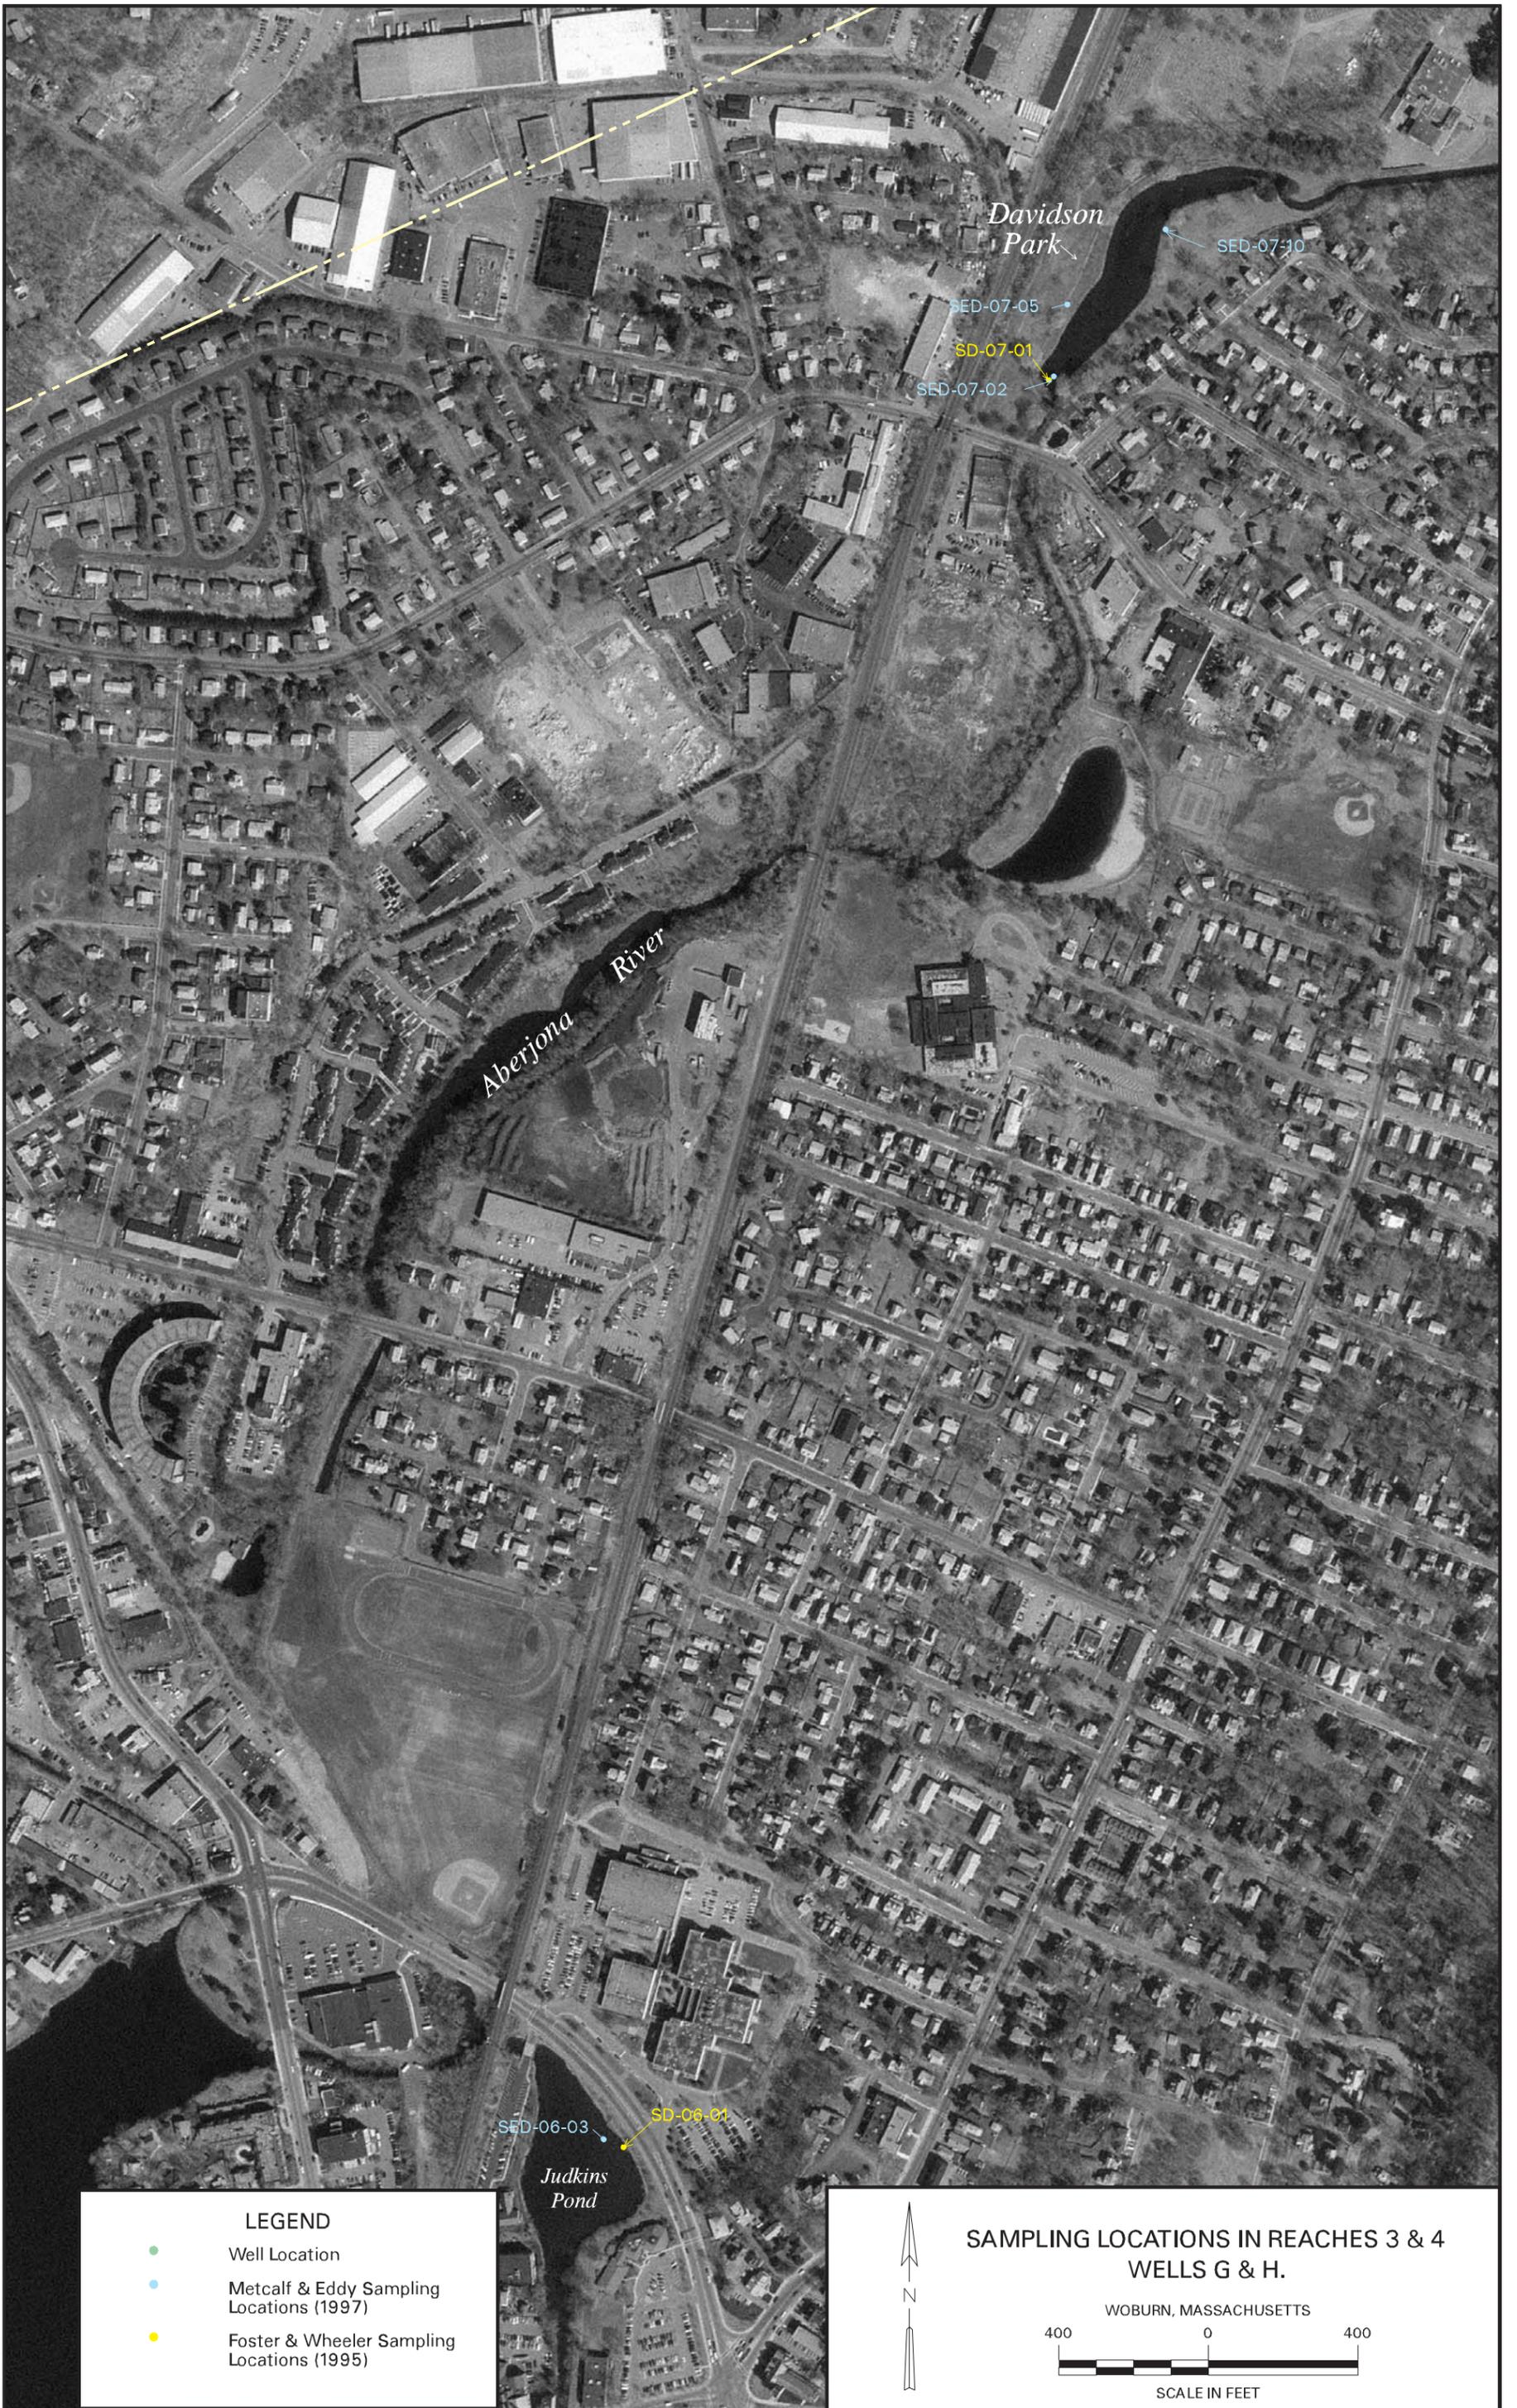
**SAMPLING LOCATIONS IN REACHES 3 & 4
WELLS G & H.**

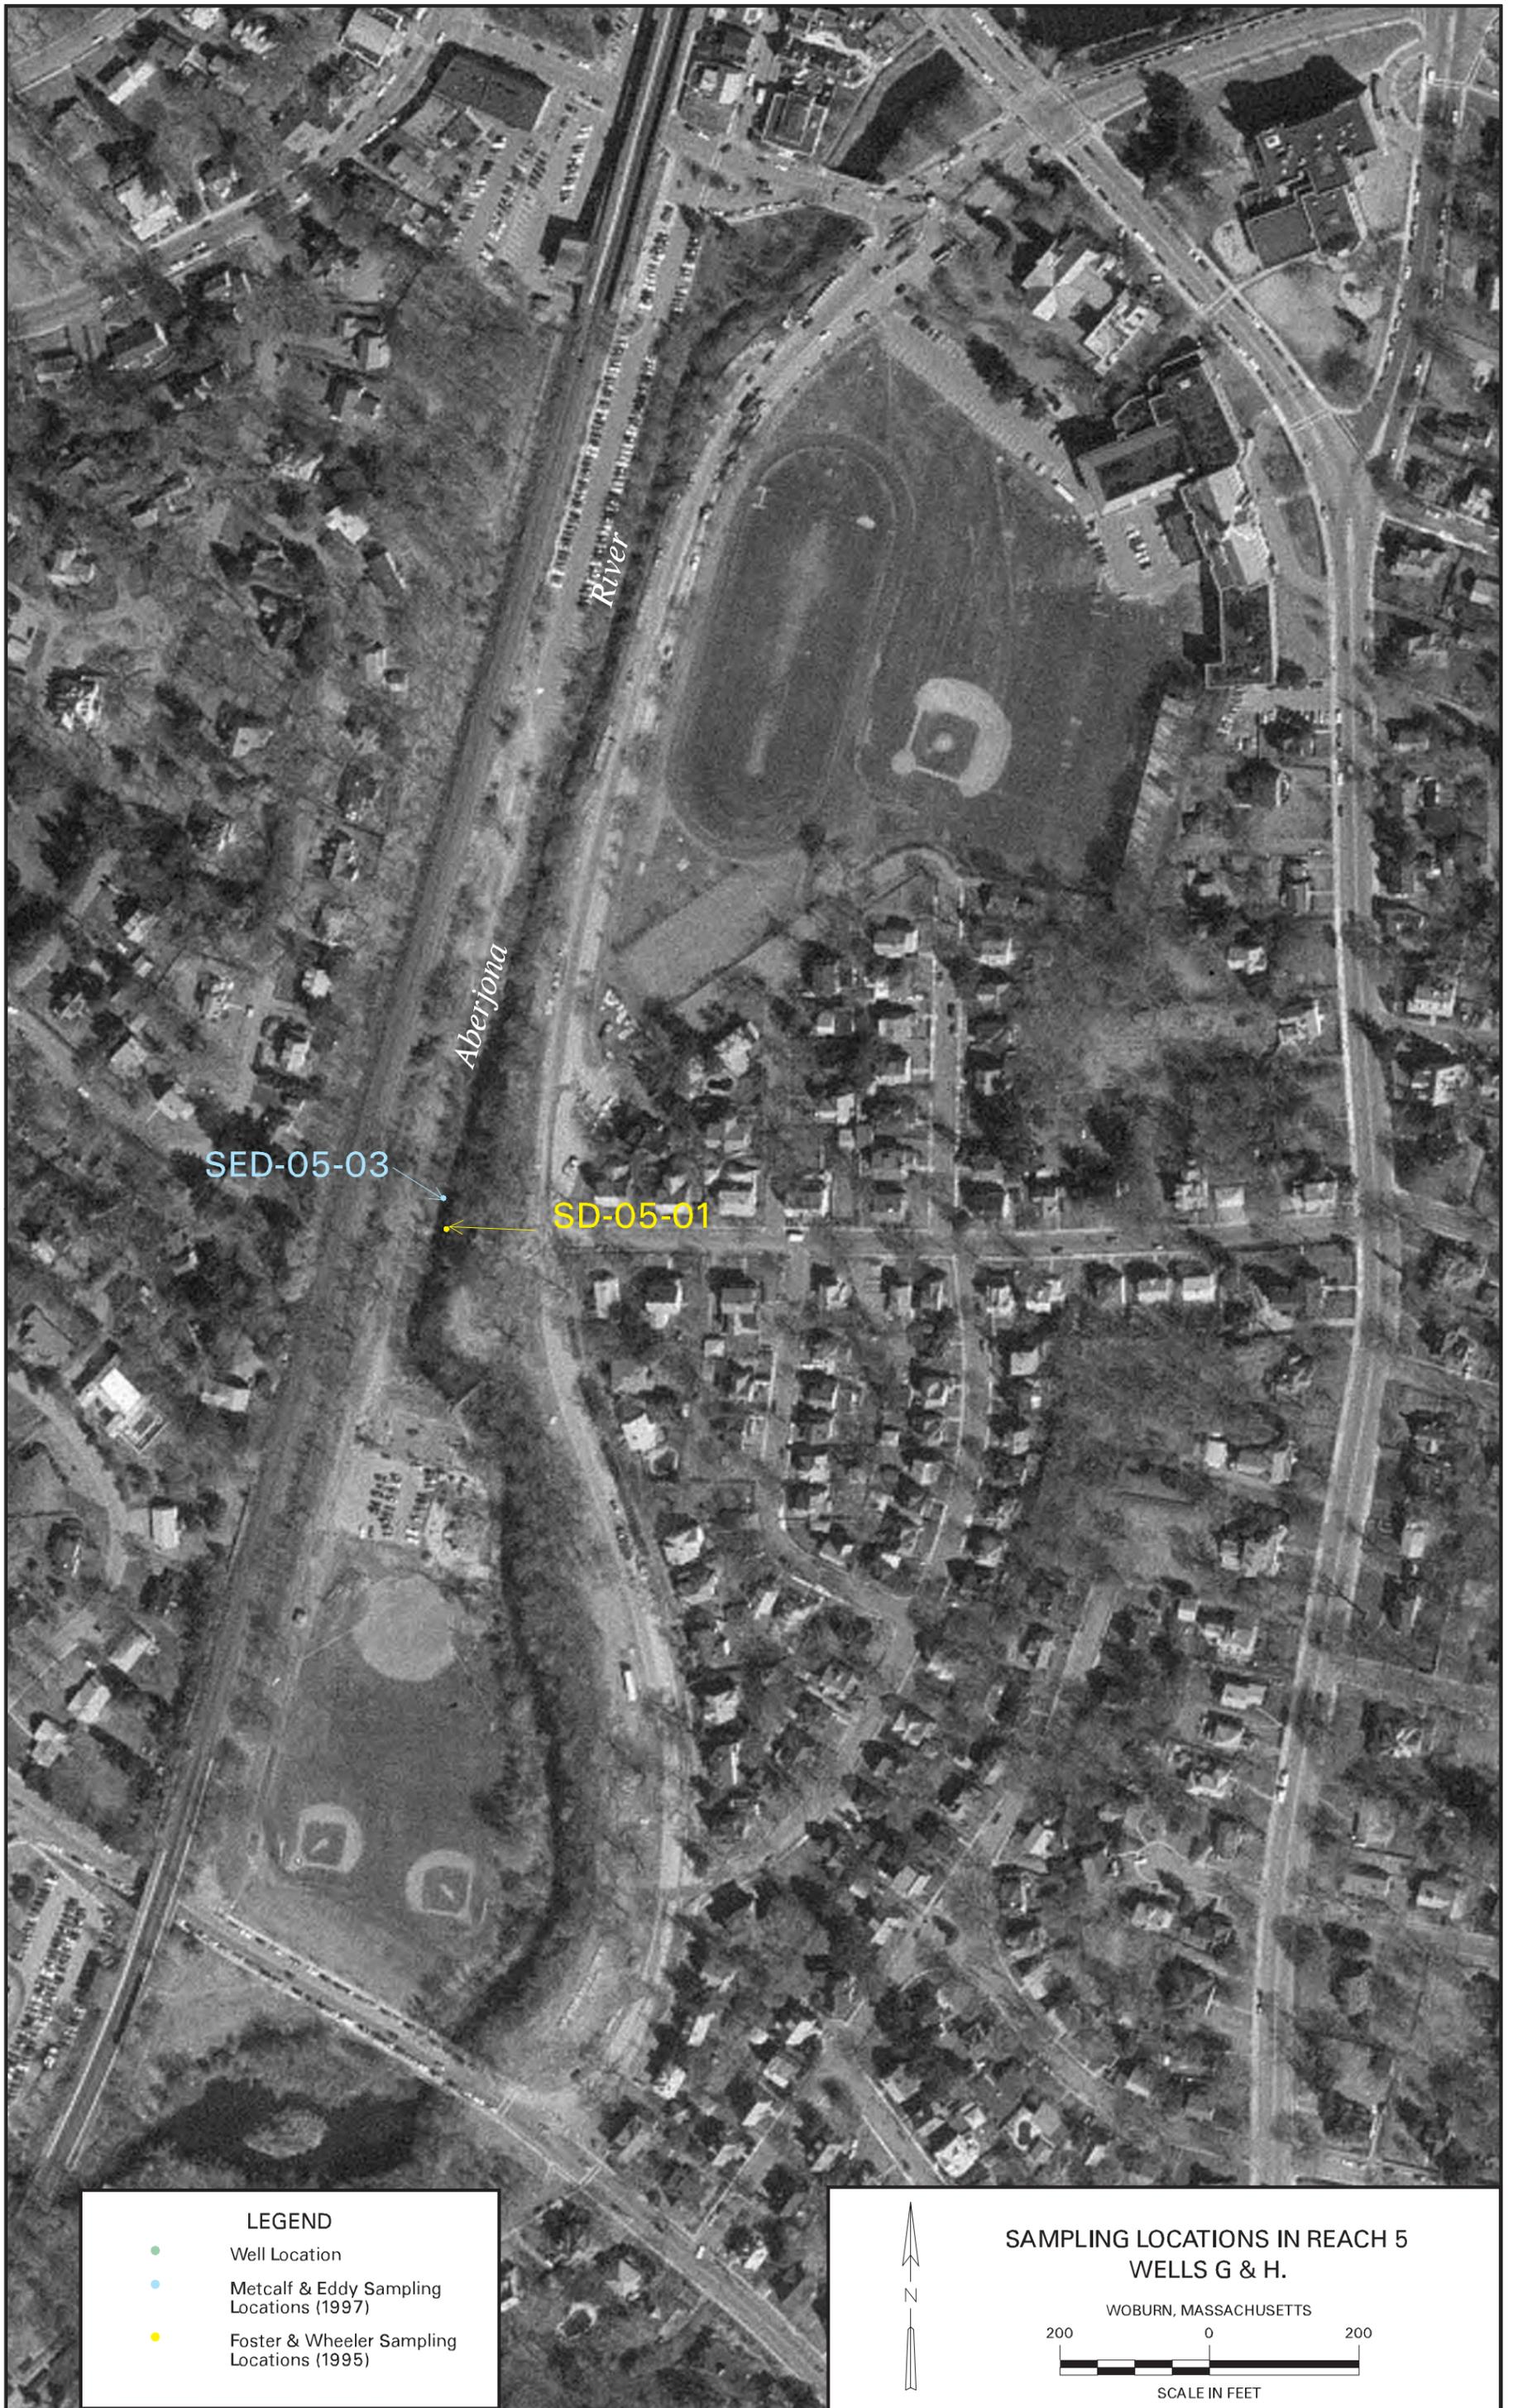
**SAMPLING LOCATIONS IN REACH 5
WELLS G & H.**

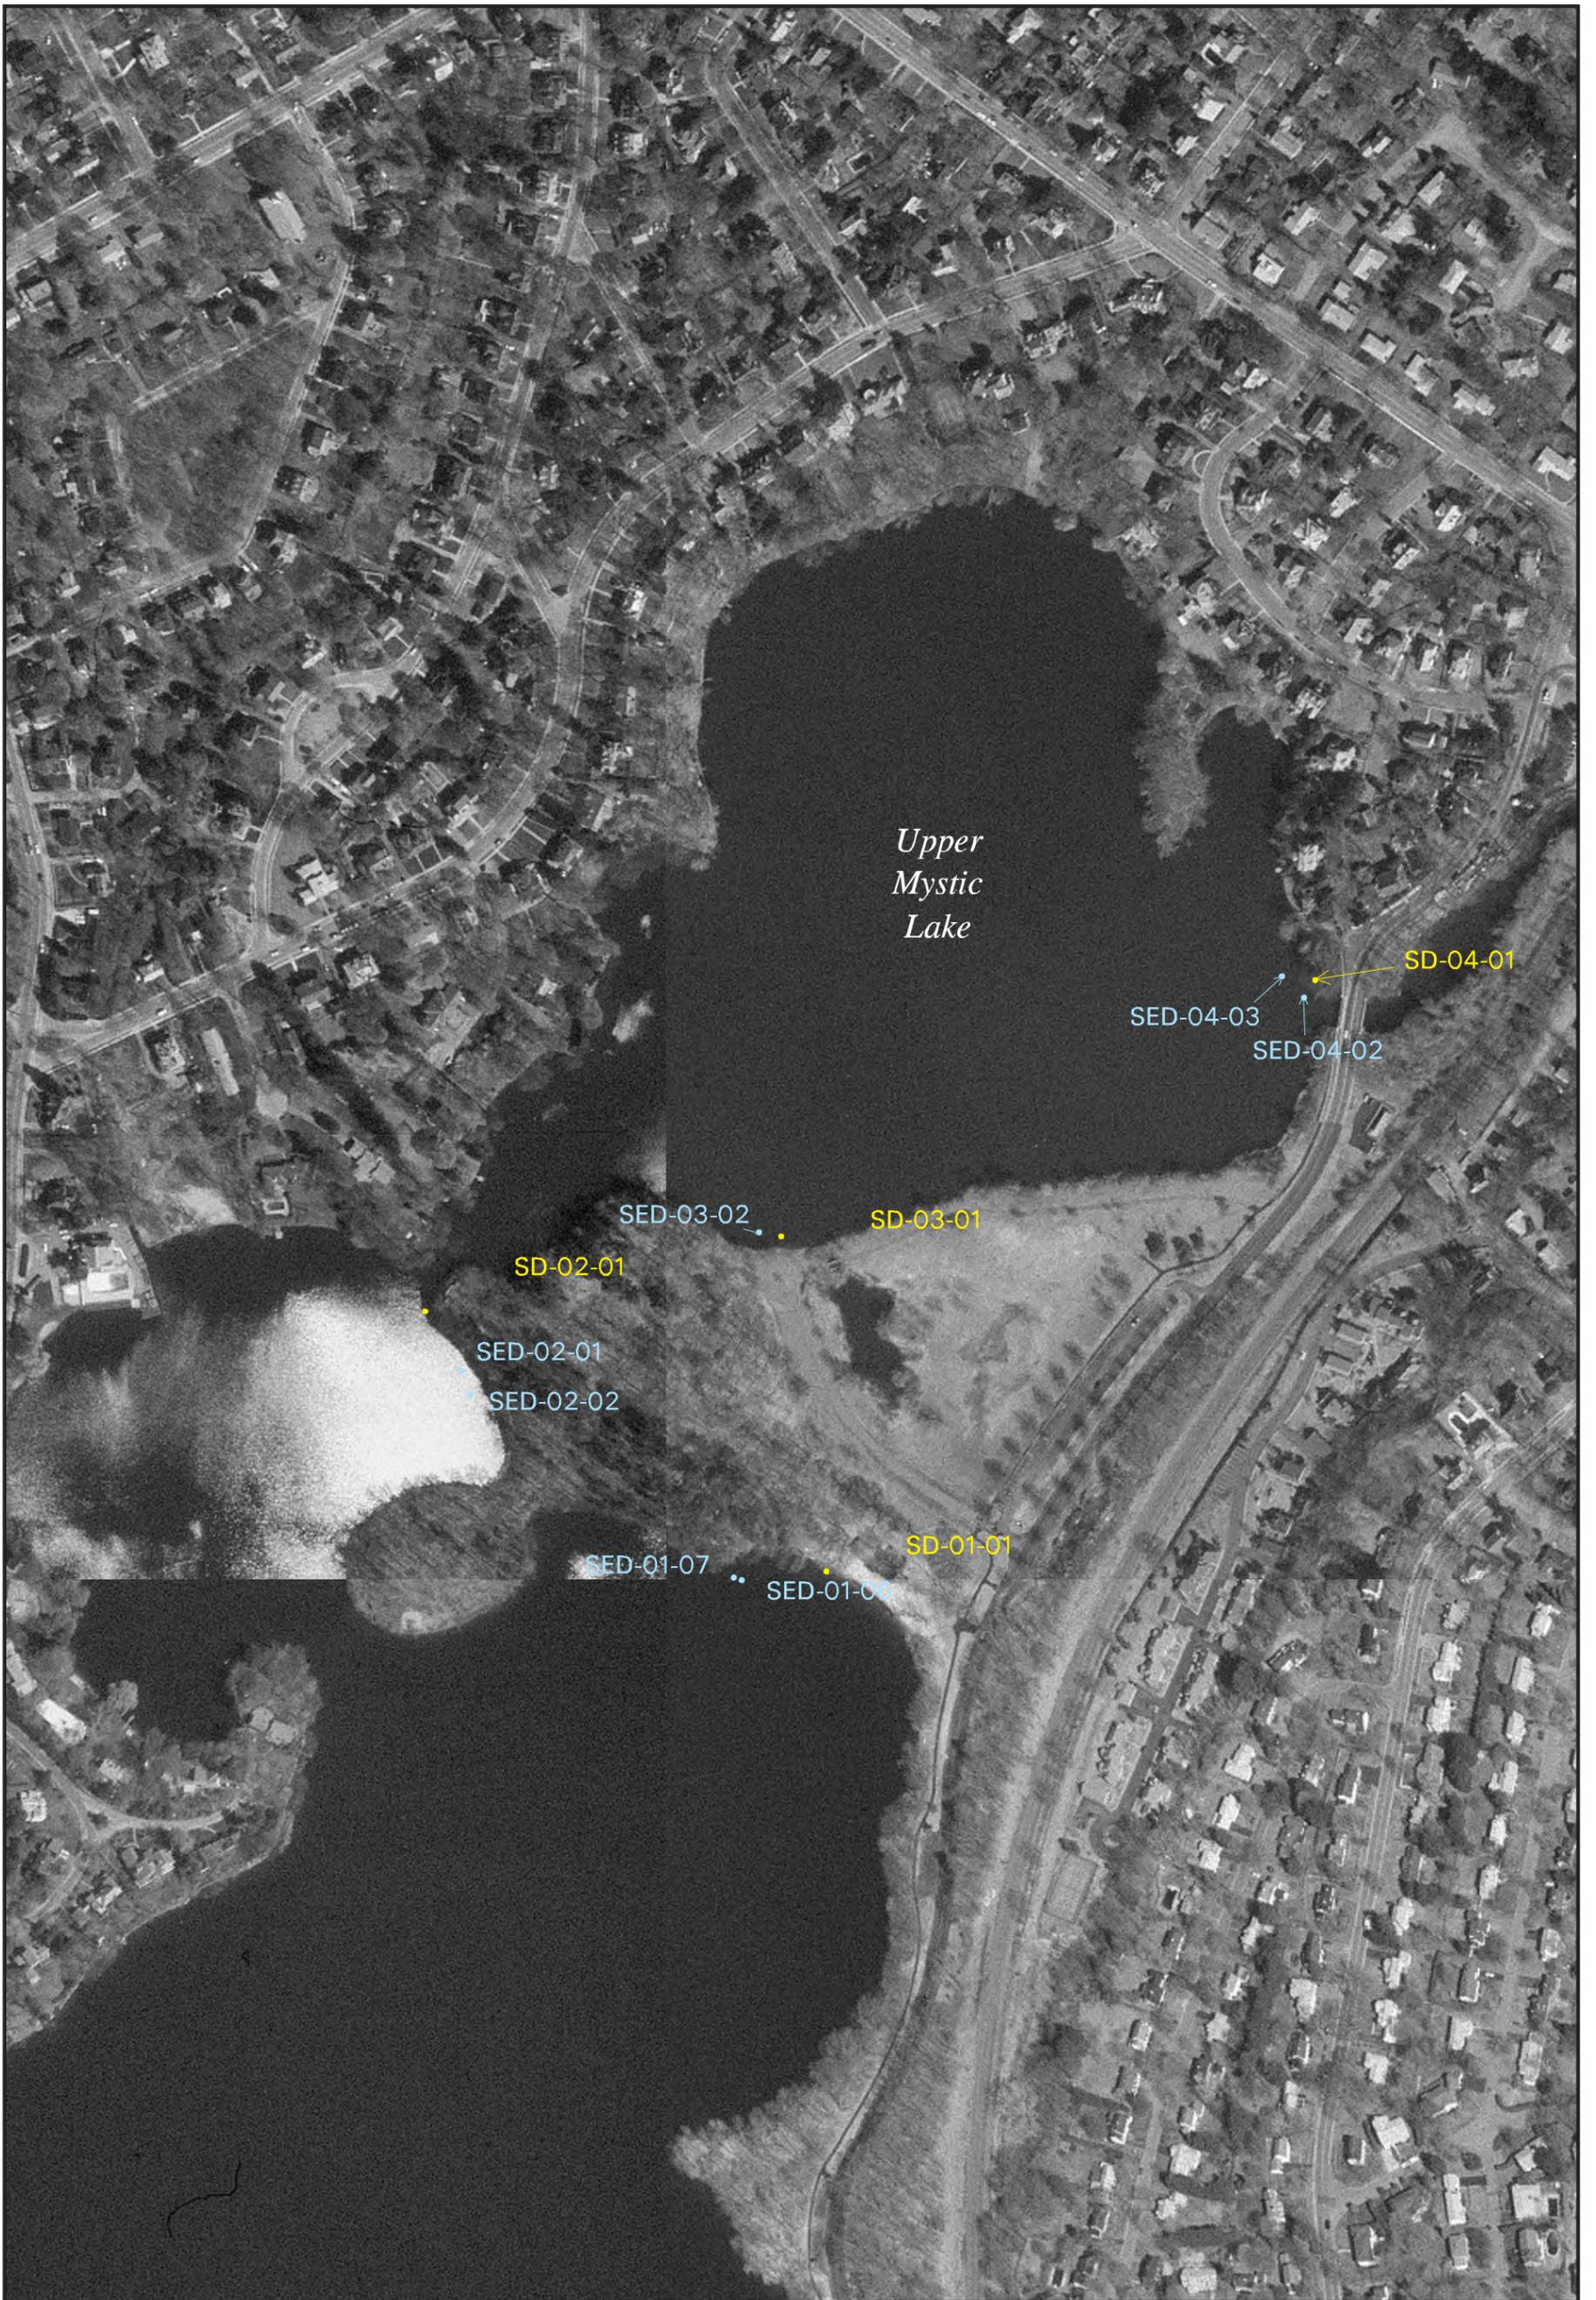
**SAMPLING LOCATIONS IN REACH 6
WELLS G & H.**
