**FIGURE 3-1. TOPOGRAPHIC MAP**  
REMEDIAL INVESTIGATION REPORT  
NORTH BELMONT PCE SUPERFUND SITE  
NORTH BELMONT, GASTON COUNTY, NORTH CAROLINA  
SESD PROJECT No. 96S-058, JUNE 1997

FIGURE 3-3  
CROSS-SECTION BASE MAP, AUGUST 1996  
REMEDIAL INVESTIGATION REPORT  
NORTH BELMONT PCE SUPERFUND SITE  
NORTH BELMONT, GASTON COUNTY, NC  
SESD PROJECT No. 96S-058, JUNE 1997

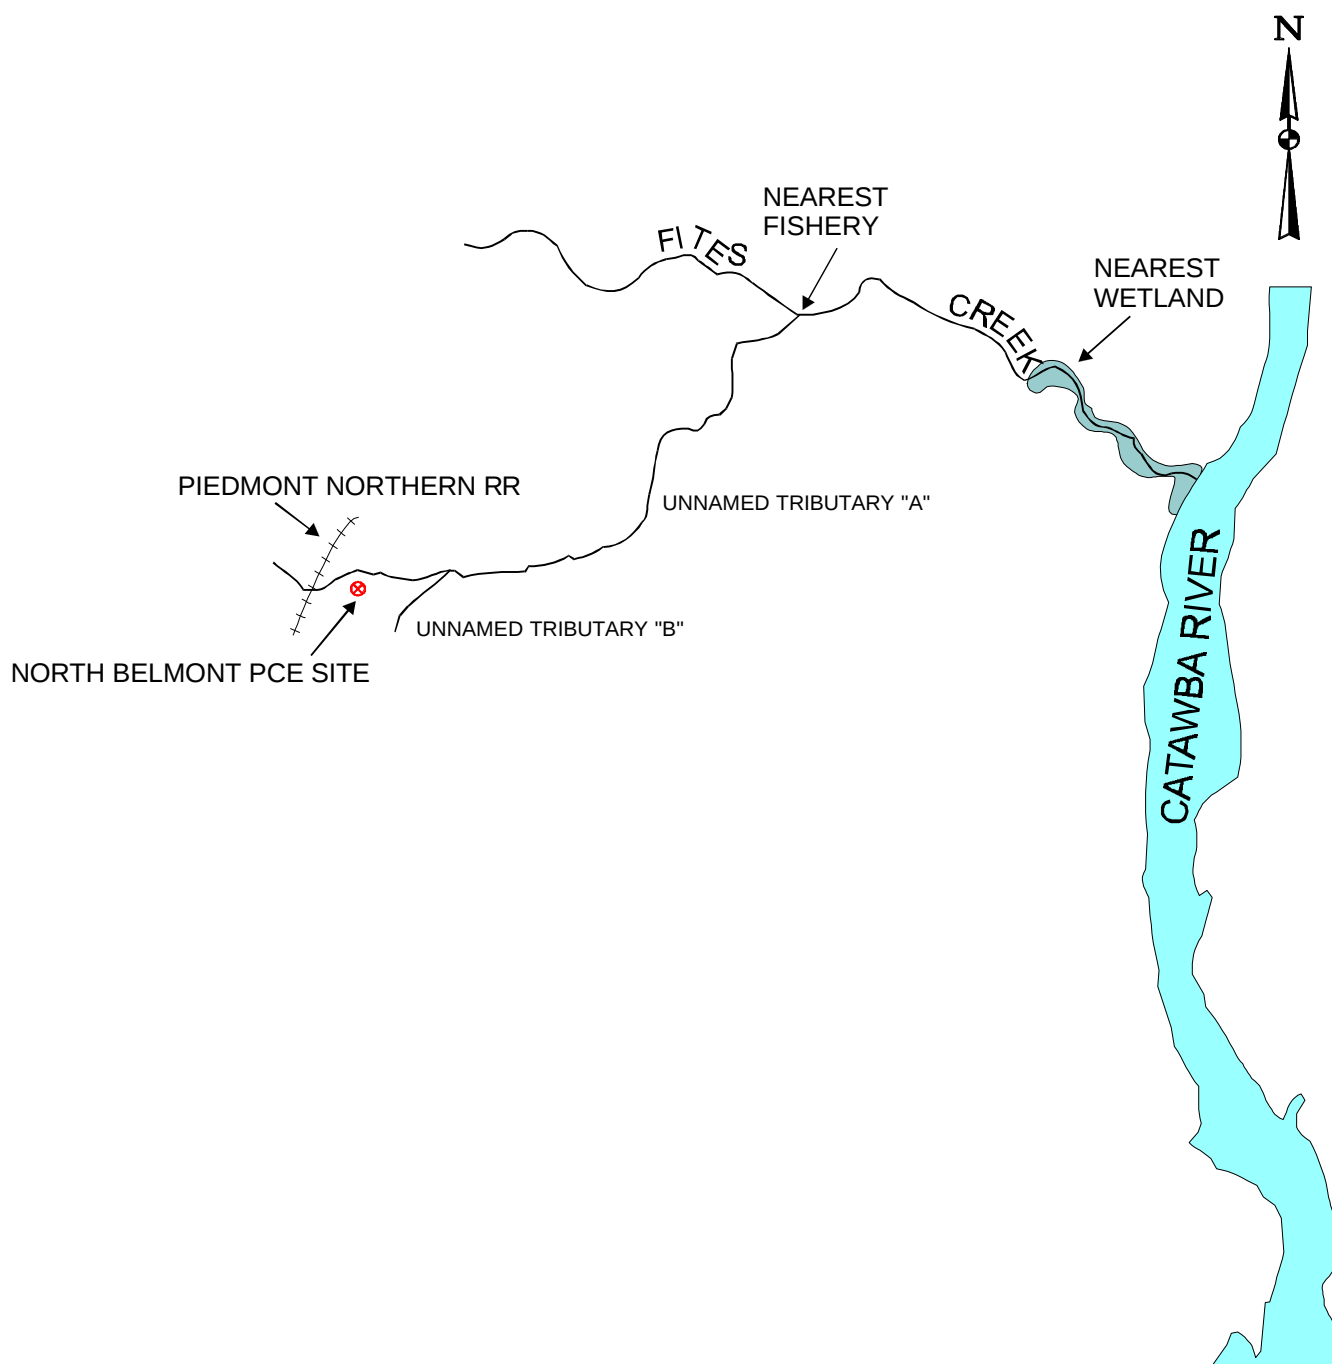
**FIGURE 3-2 SURFACE WATER PATHWAY**  
 REMEDIAL INVESTIGATION REPORT  
 NORTH BELMONT PCE SUPERFUND SITE  
 NORTH BELMONT, GASTON COUNTY, NC  
 SESD PROJECT No. 96S-058, JUNE 1997

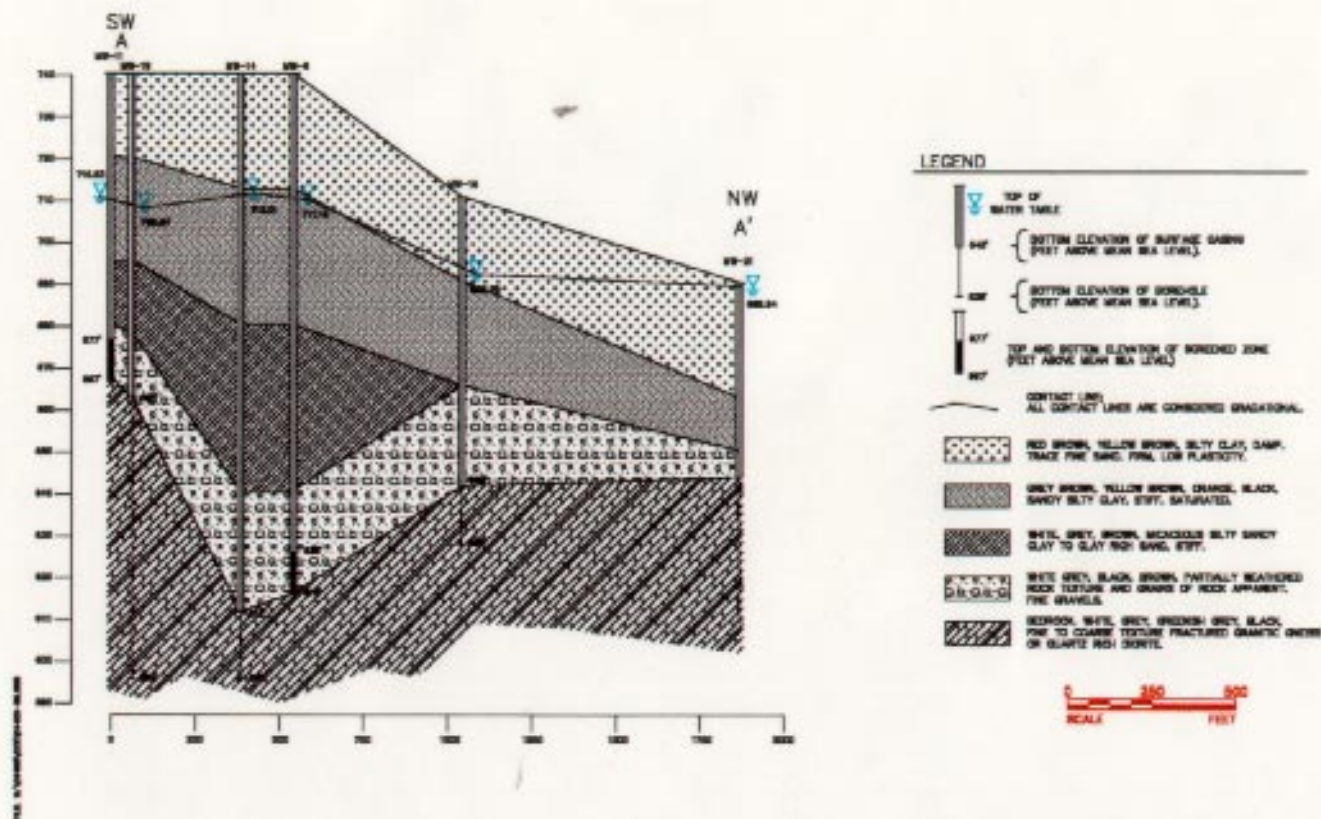
FIGURE 3-4  
GEOLOGIC CROSS-SECTION A-A', AUG 1996  
REMEDIAL INVESTIGATION REPORT  
NORTH BELMONT PCE SUPERFUND SITE  
NORTH BELMONT, GASTON COUNTY, NC  
SESD PROJECT No. 96S-058, JUNE 1997

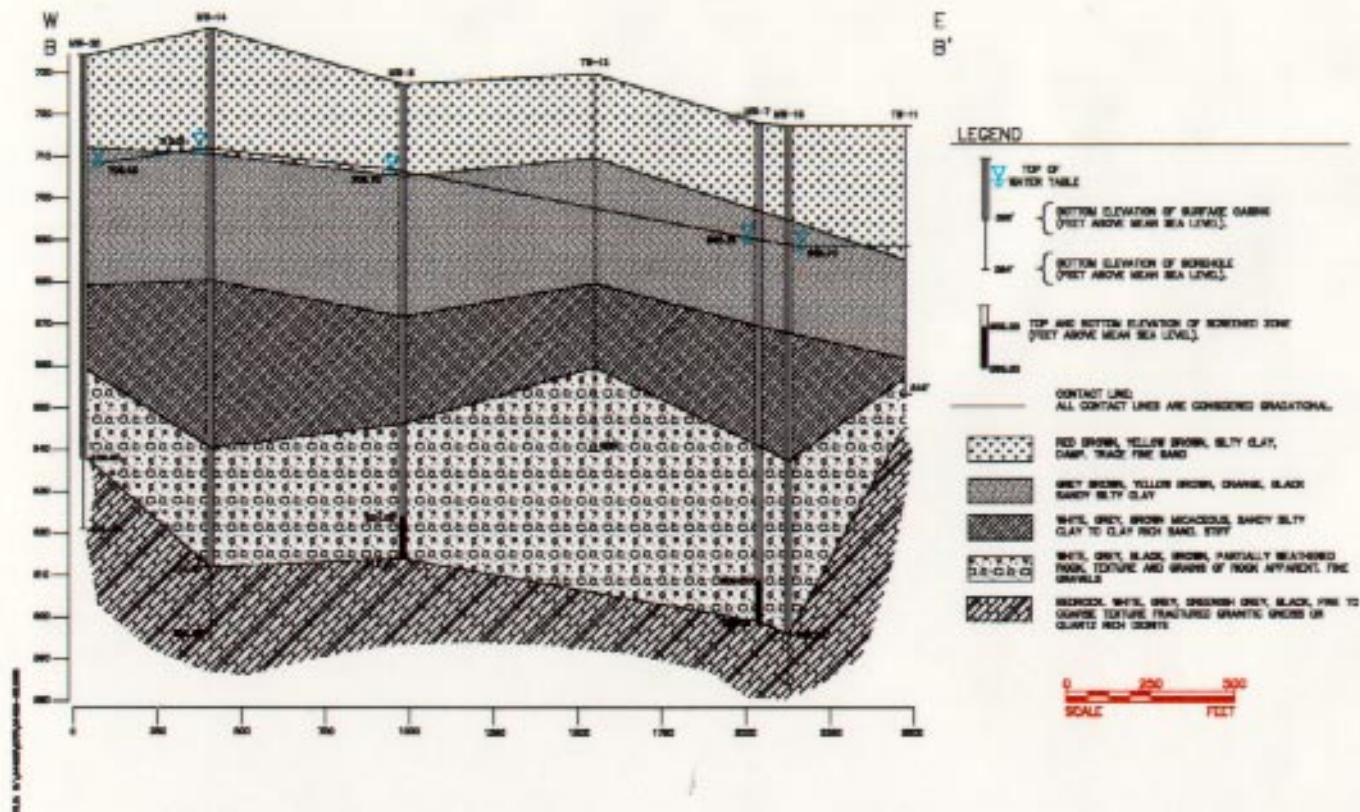
FIGURE 3-5  
GEOLOGIC CROSS-SECTION B-B', AUG 1996  
REMEDIAL INVESTIGATION REPORT  
NORTH BELMONT PCE SUPERFUND SITE  
NORTH BELMONT, GASTON COUNTY, NC  
SESD PROJECT No. 96S-058, JUNE 1997
