**U.S. ENVIRONMENTAL PROTECTION AGENCY, REGION V  
POLLUTION/SITUATION REPORT #164**

**KALAMAZOO RIVER/ENBRIDGE SPILL – REMOVAL  
SITE # Z5JS  
MARSHALL, MICHIGAN  
LATITUDE: 42.2395273; LONGITUDE: -84.9662018**

**Date:** 10/17/2012

**Reporting/Operational Period:** 0700 hours 10/4/2012 through 0700 hours 10/11/2012

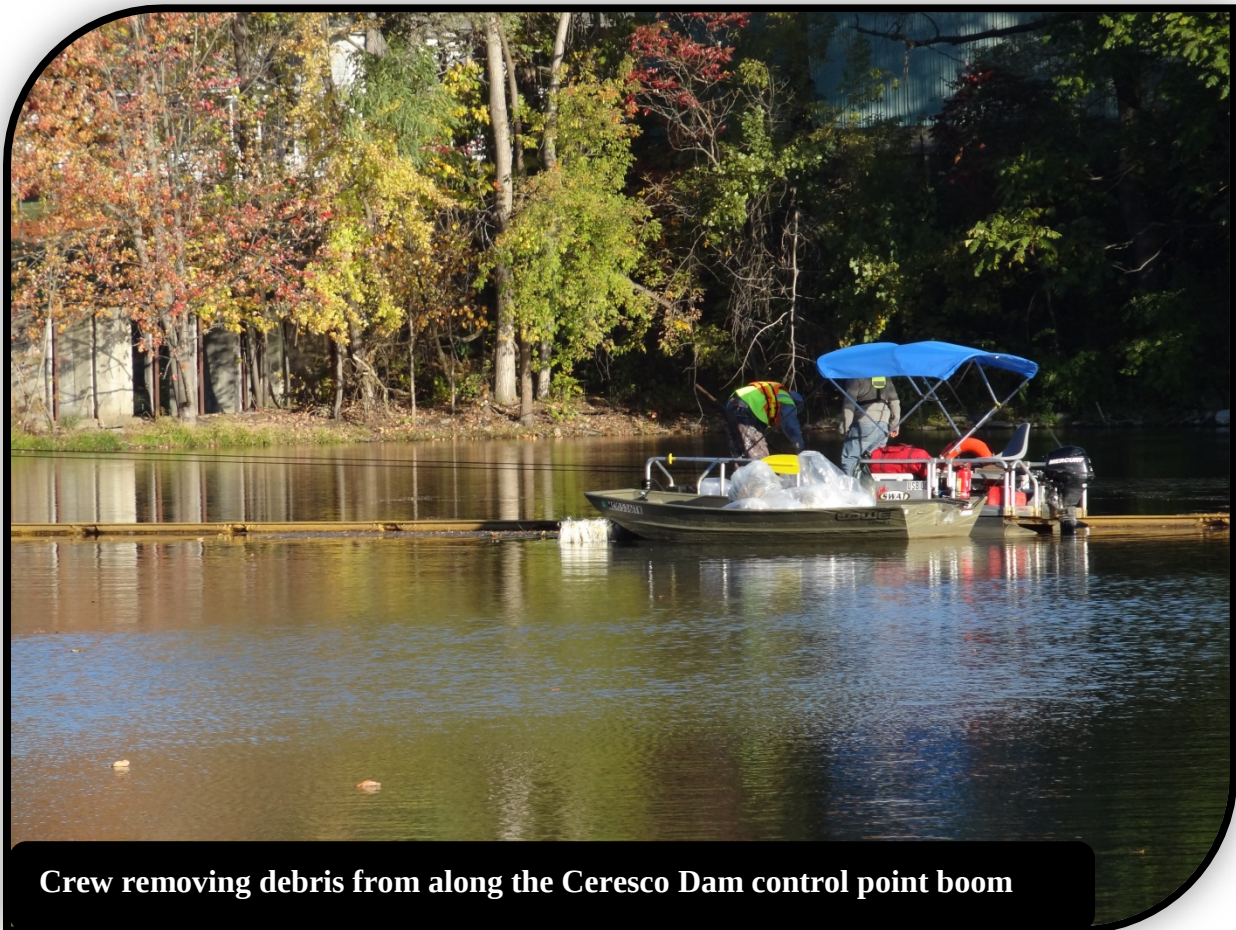
**Crew removing debris from along the Ceresco Dam control point boom**

- As of October 11, 2012, a total of 800 feet of surface hard boom is deployed at the Ceresco Control Point. Additionally, a total of 8,400 feet of surface hard boom and 5,350 feet of subsurface half curtain have been deployed at the E4 Containment system boom locations. Teams removed debris accumulated within the boomed areas and continued to monitor the E4 system half-curtain locations using an underwater camera. Adjustments to various half-curtains were made as necessary.
