U.S. ENVIRONMENTAL PROTECTION AGENCY
POLLUTION/SITUATION REPORT
Kalamazoo River/Enbridge Spill - Removal POLREP-SITREP

Subject: SITREP # 45
Kalamazoo River/Enbridge Spill
Z5JS
Marshall, MI
Latitude: 42.2395273 Longitude: -84.9662018

Date: 9/8/10

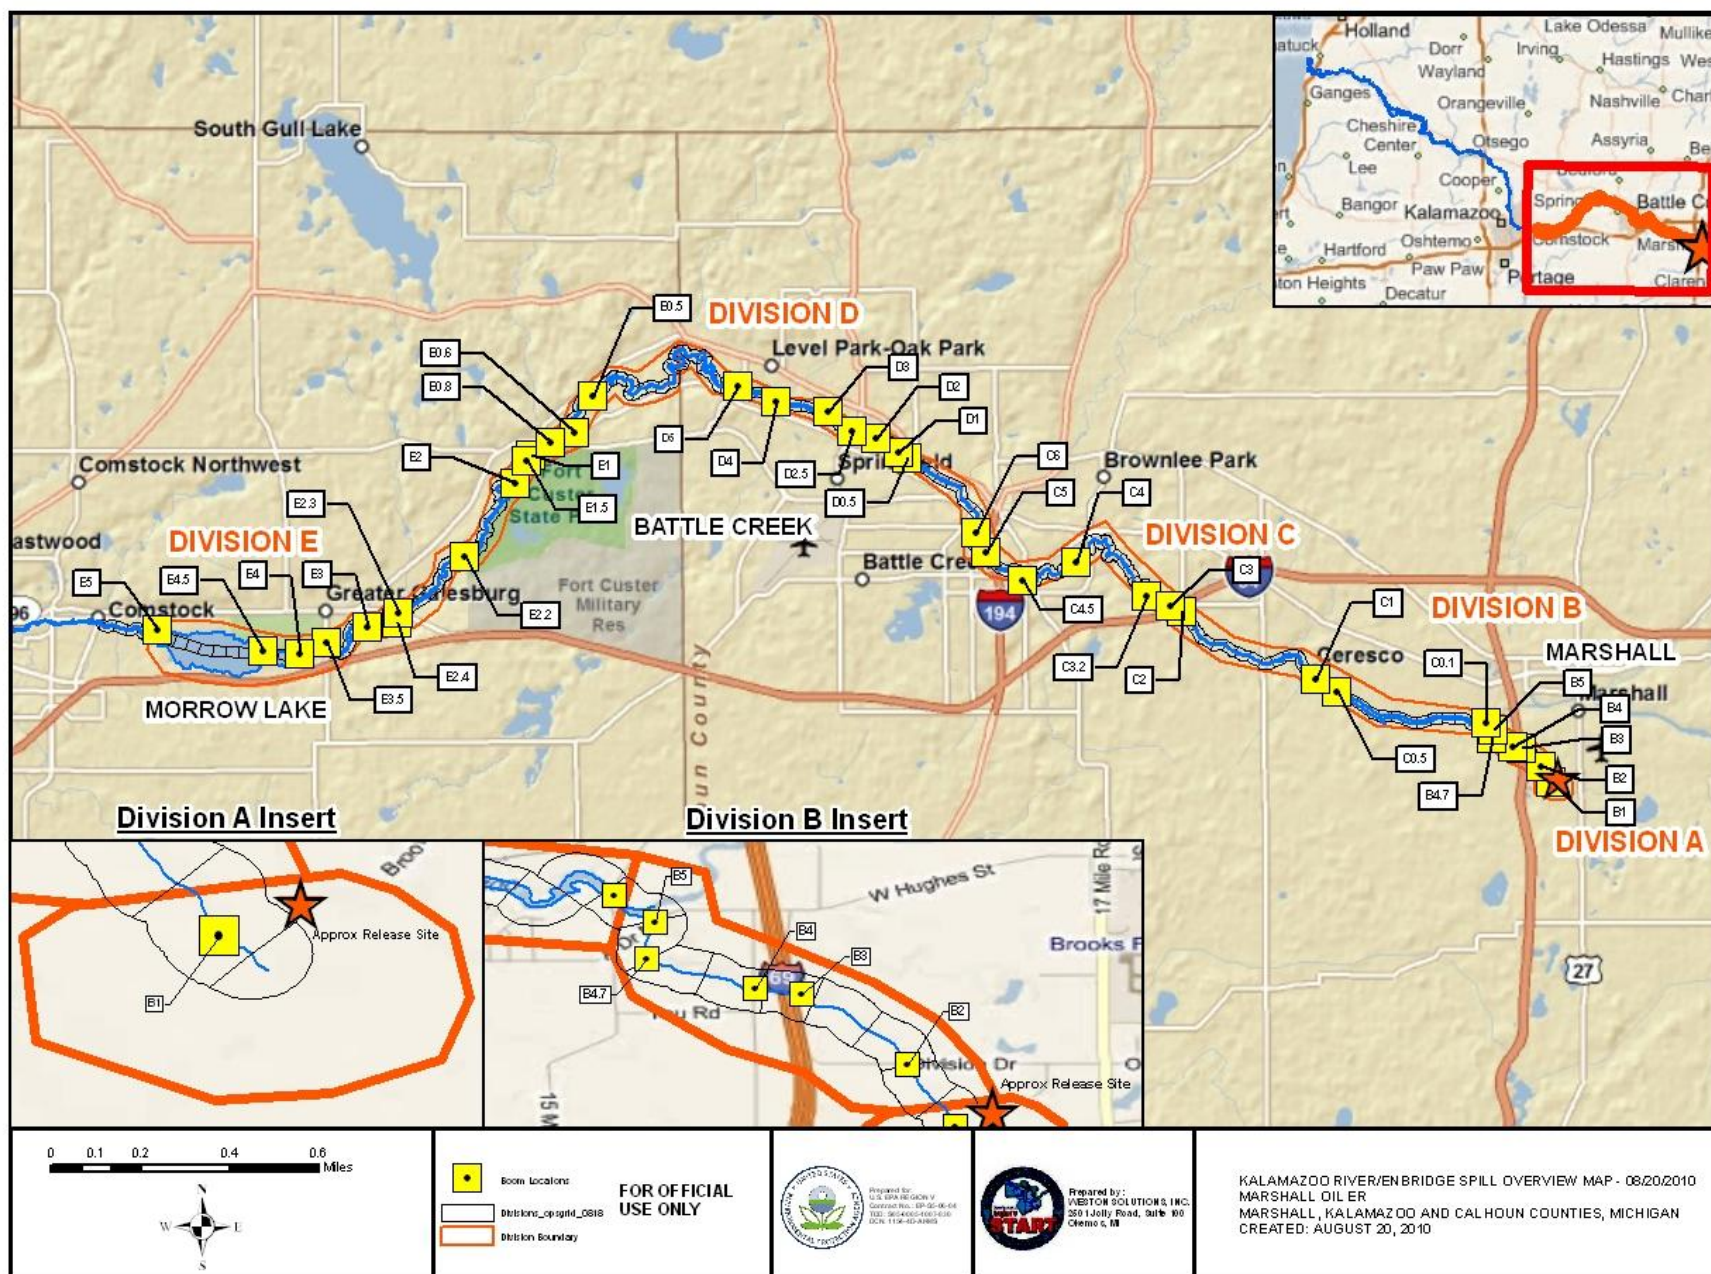
See attached Map, entitled “Kalamazoo River/Enbridge Spill Overview Map,” for more information.

A 30-inch pipeline ruptured, releasing crude oil (NRC report of 19,500 barrels) into a culvert leading to Talmadge Creek. Talmadge Creek is a tributary to the Kalamazoo River. The response site is along Talmadge Creek and the Kalamazoo River running from Marshall, Michigan, to downstream of Battle Creek, Michigan. The Kalamazoo River is bordered by marshland and developed properties for the approximate 30-mile stretch of the response site.

Approximately 30 miles of the Kalamazoo River have been impacted. The Kalamazoo River experienced flooding before and after the spill. The river levels later fell and stranded oil in some backwaters, wetlands and floodplains. Talmadge Creek was boomed off at the confluence to the Kalamazoo River. Containment and absorbent boom were deployed along the Kalamazoo River and Talmadge Creek. Containment and absorbent boom also were deployed in Morrow Lake.
