U.S. ENVIRONMENTAL PROTECTION AGENCY  
POLLUTION/SITUATION REPORT  
Kalamazoo River/Enbridge Spill - Removal POLREP-SITREP

**Subject: SITREP # 83  
Kalamazoo River/Enbridge Spill  
Z5JS  
Marshall, MI  
Latitude: 42.2395273 Longitude: -84.9662018**

**Date:** 01/25/2011

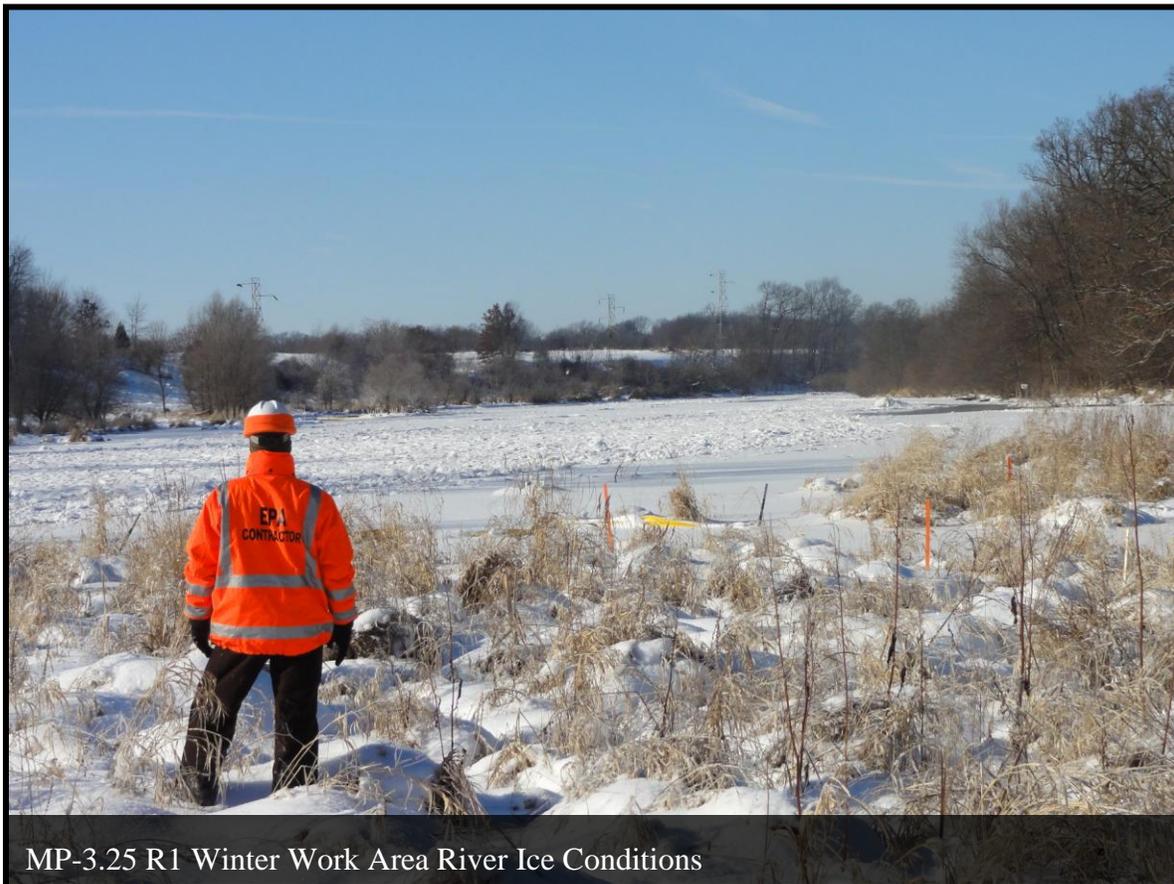
MP-3.25 R1 Winter Work Area River Ice Conditions

The excavation at 2.50 L1 was expanded beyond the original plan due to the presence of oil and/or oil saturated soils after the planned excavation was complete. Excavations and or/dewatering operations at 3.25 R1 and 10.5 L2 were suspended due to river water and ice intrusion into the excavation areas. Ice road building and clearing operations resumed at 3.25 R1.
