U.S. ENVIRONMENTAL PROTECTION AGENCY, REGION V
POLLUTION/SITUATION REPORT #86

**KALAMAZOO RIVER/ENBRIDGE SPILL – REMOVAL
SITE # Z5JS
MARSHALL, MICHIGAN
LATITUDE: 42.2395273 LONGITUDE: -84.9662018**

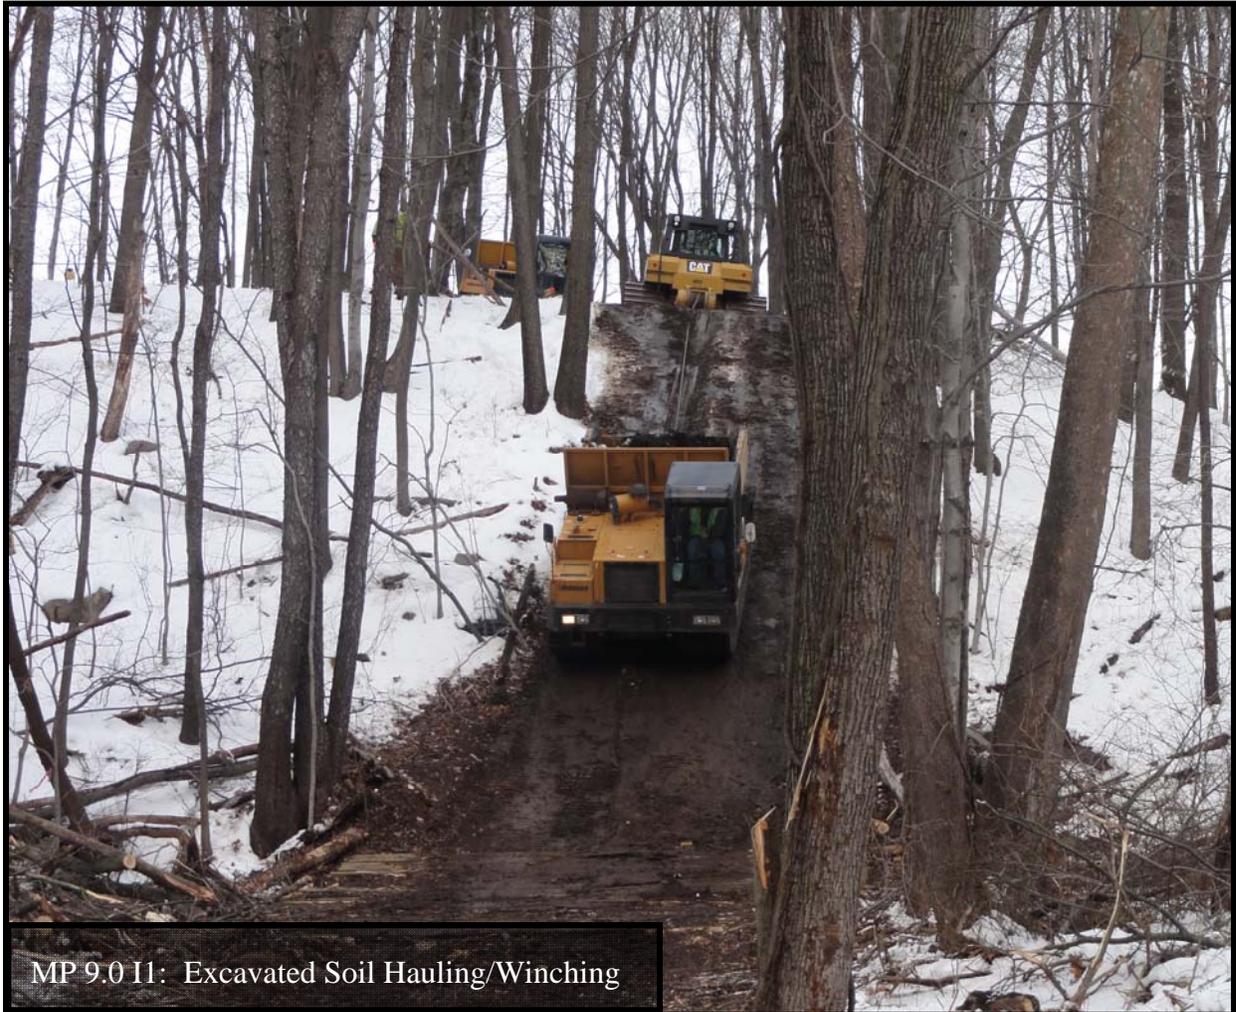
MP 9.0 11: Excavated Soil Hauling/Winching

There was a near-miss incident at the excavation site located at MP-9.0 I1, where excavated soils are transported to a staging area by winching a loaded Morooka Crawler up and down the side of a steep embankment. On February 12, one of the tow straps used to winch the crawler broke while the crawler was being winched on the hill. The crawler slid down the hill in an uncontrolled manner. No one was injured. Safety personnel continue to investigate the near-miss and make appropriate recommendations.
