U.S. ENVIRONMENTAL PROTECTION AGENCY, REGION V
POLLUTION/SITUATION REPORT #106

KALAMAZOO RIVER/ENBRIDGE SPILL – REMOVAL
SITE # Z5JS
MARSHALL, MICHIGAN
LATITUDE: 42.2395273; LONGITUDE: -84.9662018

Reporting Period: 0700 hours 6/27/2011 through 0700 hours 7/4/2011

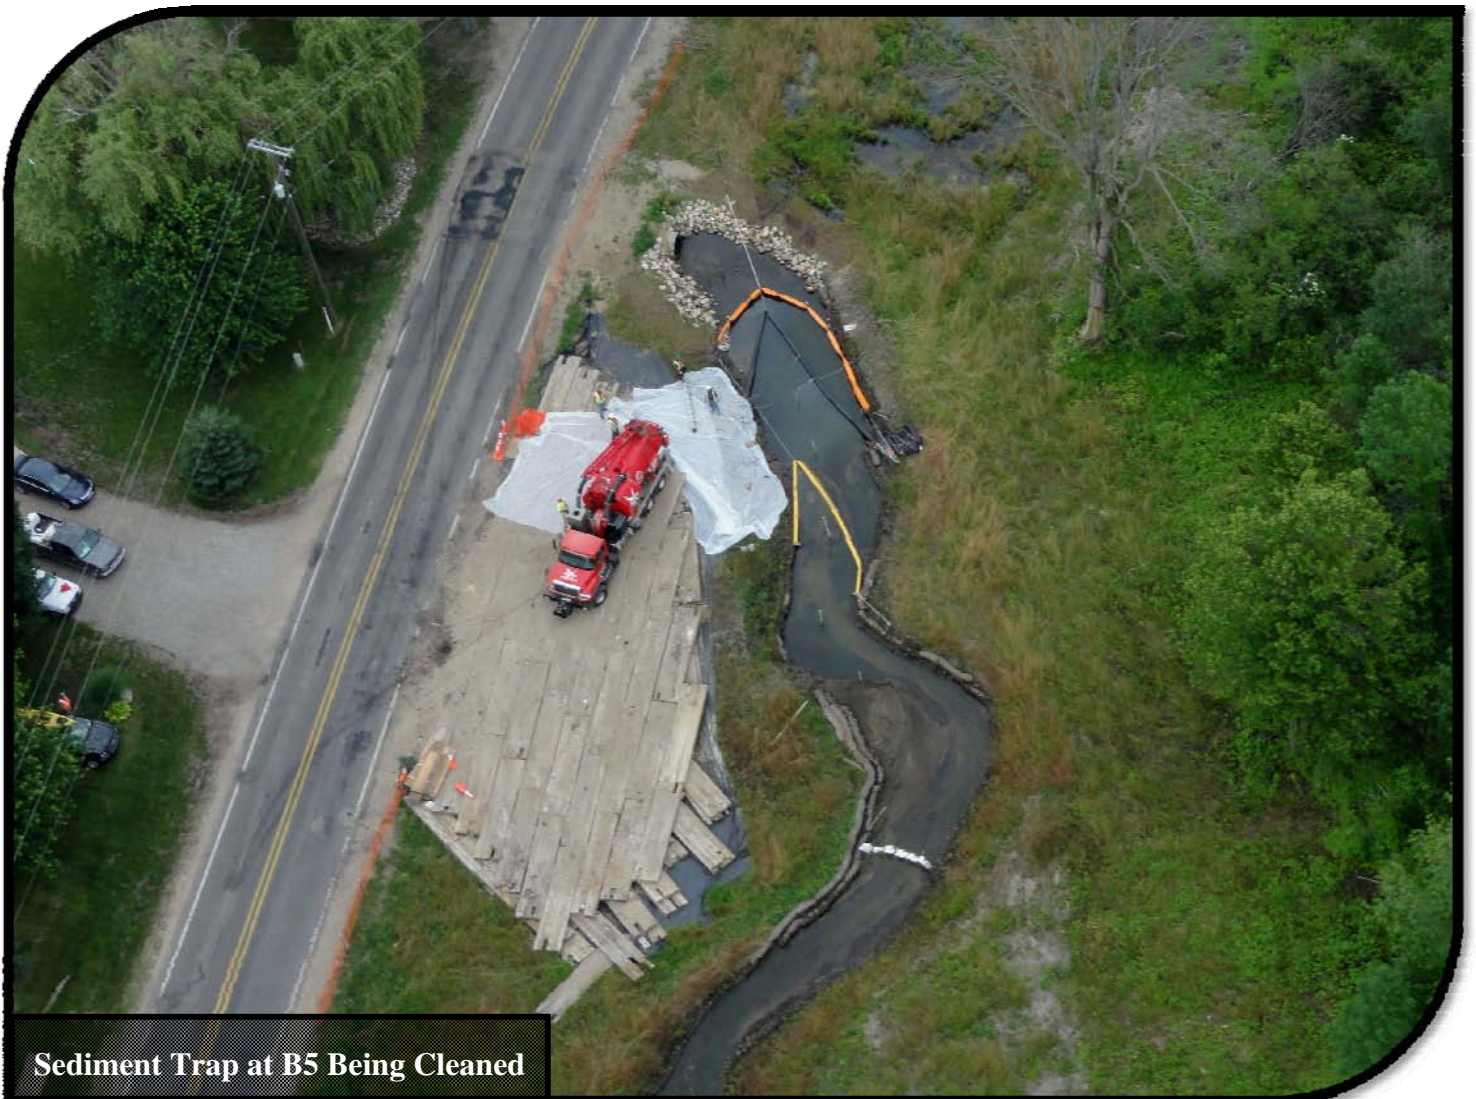
Sediment Trap at B5 Being Cleaned

- On June 29 and July 1, 2011, teams cleaned the B5 Sediment Trap. The removed sediment was transported and staged in a cell at Frac Tank City for sampling and final disposal. Enbridge will begin to clean the B5 Sediment Trap weekly and install downstream turbidity monitors to ensure that the containment is effective.
