**U.S. ENVIRONMENTAL PROTECTION AGENCY, REGION V
POLLUTION/SITUATION REPORT #107**

**KALAMAZOO RIVER/ENBRIDGE SPILL – REMOVAL
SITE # Z5JS
MARSHALL, MICHIGAN
LATITUDE: 42.2395273; LONGITUDE: -84.9662018**

Reporting Period: 0700 hours 7/4/2011 through 0700 hours 7/11/2011

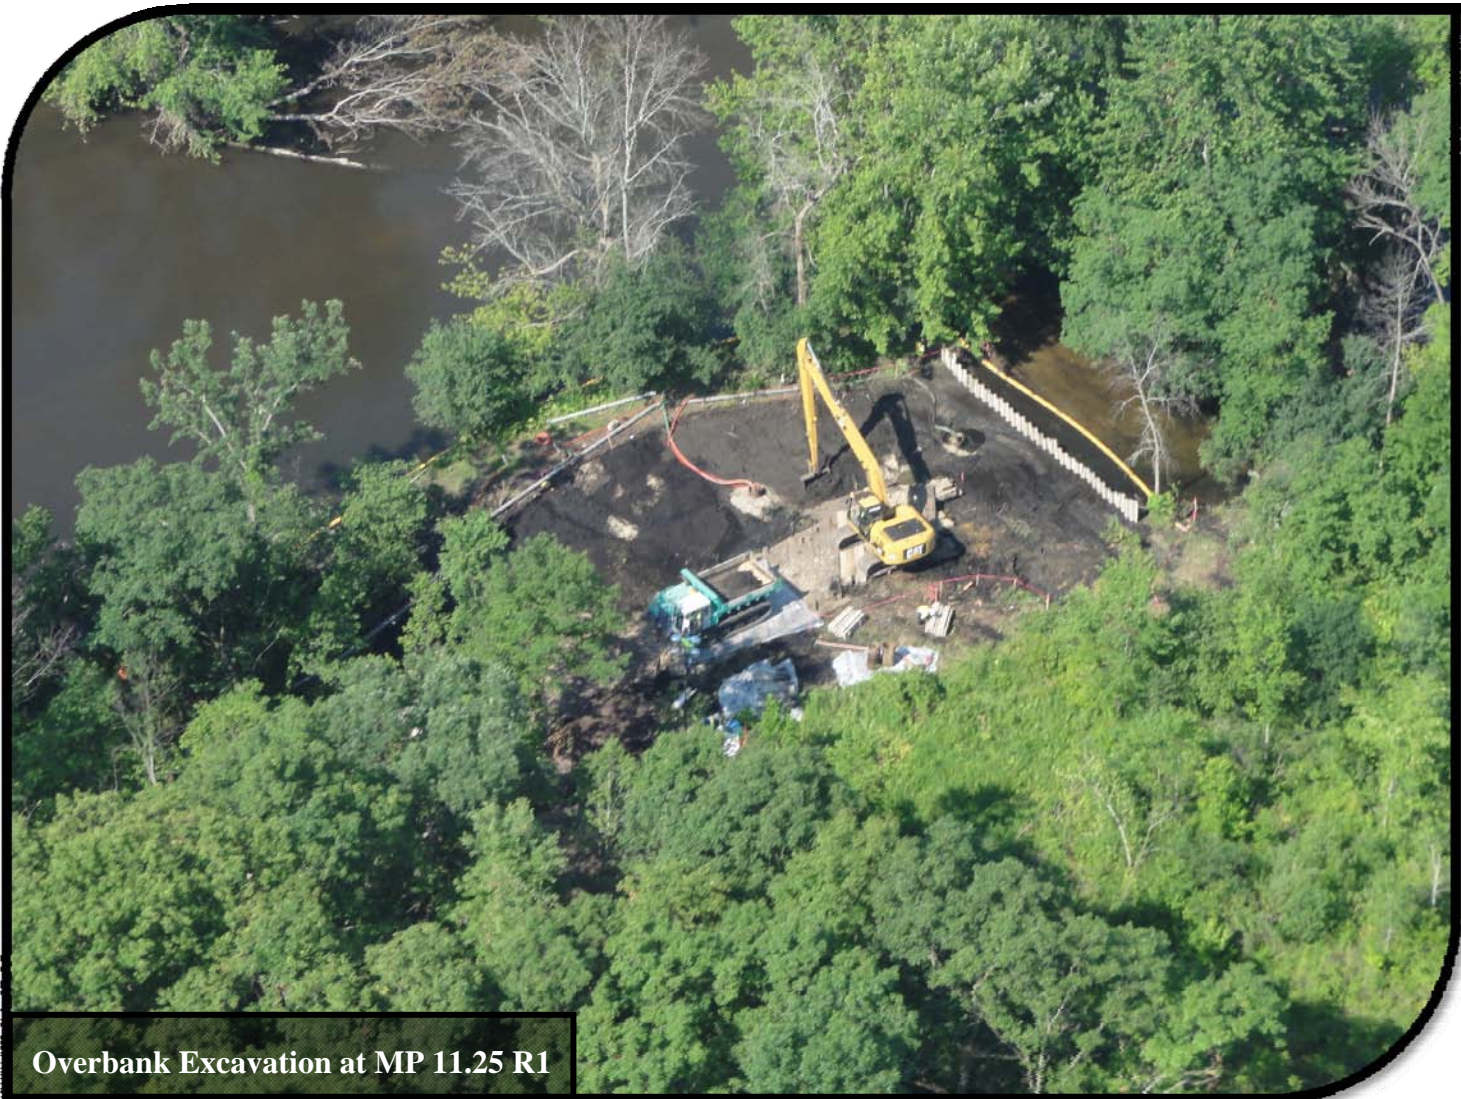
Overbank Excavation at MP 11.25 R1

- EPA continued oversight of waste characterization, transportation, and disposal activities.
- During this operational period, Enbridge began live-loading operations at the 11.25 R1 excavation sites. Impacted soils and sediment were solidified with sawdust in a rock box. Enbridge performed paint filter tests and collected aliquots for O&G/recovered oil analysis. The solidified material was transported to the landfill for disposal. Aliquots from each truck were taken to the ICP for homogenization and samples were collected from the homogenized material.

- During this operational period, teams completed excavation and backfill activities at MP 11.25 R1; performed site preparation and began excavation at MP 11.25 R2; and conducted site evaluation, hydro-excavation, and restoration at the Winding Way site. Teams also began to mobilize mats from site A to MP 9.5 Island near Historic Bridge Park to prepare for excavation during the next operational period.
