**U.S. ENVIRONMENTAL PROTECTION AGENCY, REGION V  
POLLUTION/SITUATION REPORT #108**

**KALAMAZOO RIVER/ENBRIDGE SPILL – REMOVAL  
SITE # Z5JS  
MARSHALL, MICHIGAN  
LATITUDE: 42.2395273; LONGITUDE: -84.9662018**

**Date:** 7/19/2011

**Reporting Period:** 0700 hours 7/11/2011 through 0700 hours 7/18/2011

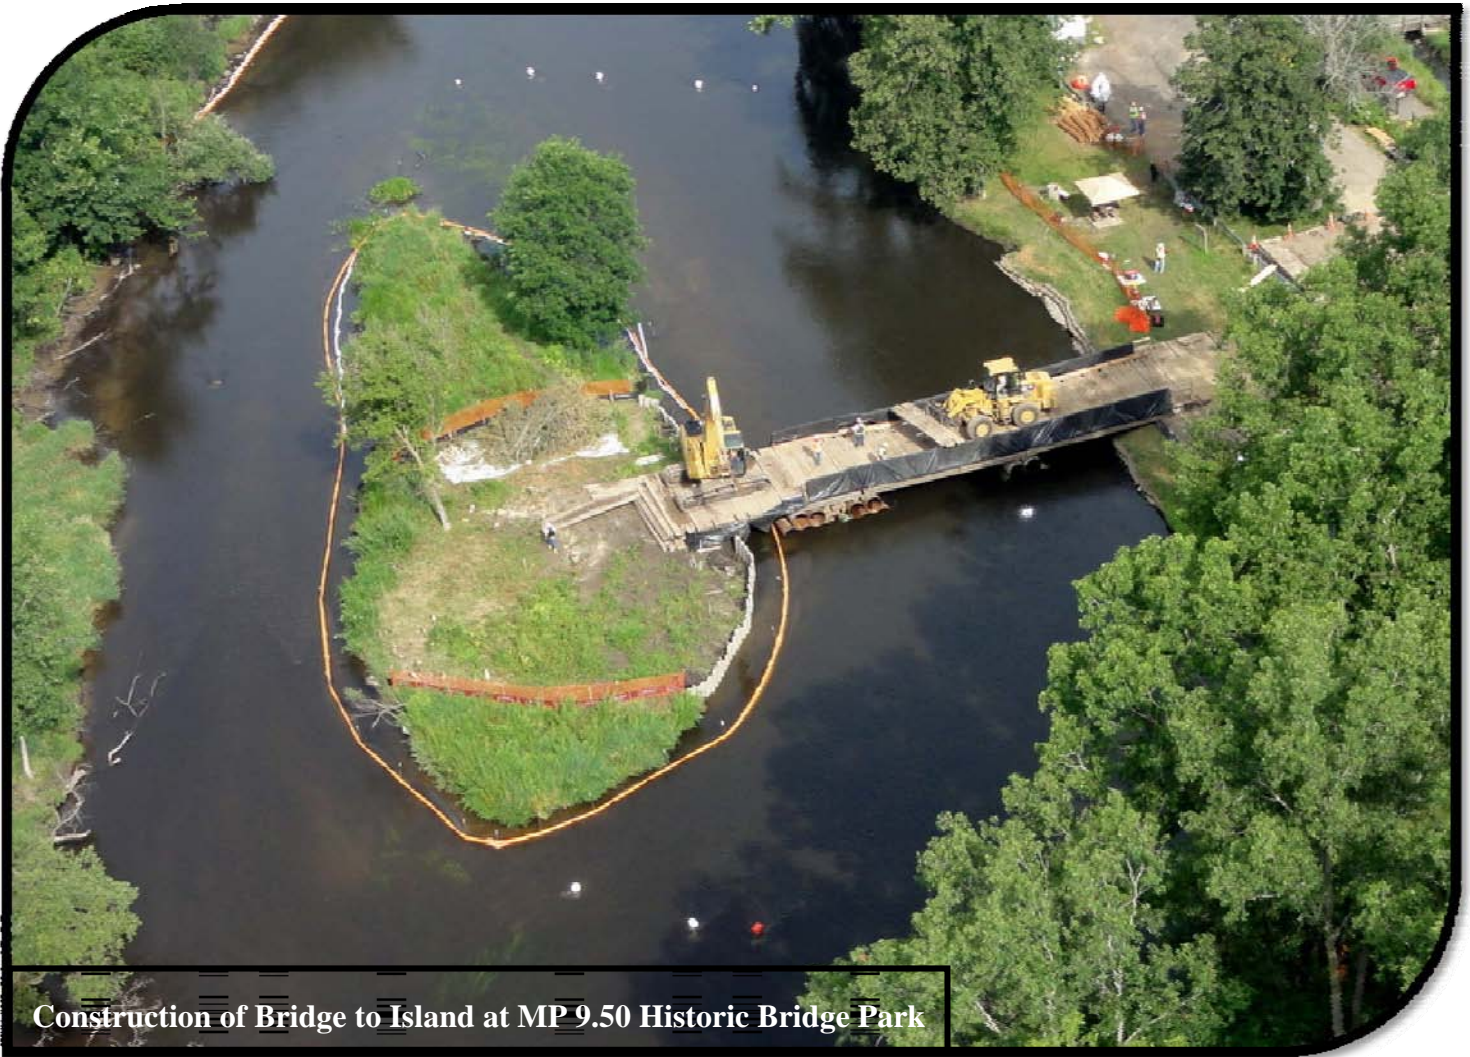
Construction of Bridge to Island at MP 9.50 Historic Bridge Park

- During these two operational periods, teams continued excavating impacted soil and maintaining temporary restoration at 11.25 R1 and R2, mobilized mats into Historic Bridge Park at MP 9.5, and constructed a bridge from Historic Bridge Park for access to the island at MP 9.5 in preparation of impacted soil excavation.
