U.S. ENVIRONMENTAL PROTECTION AGENCY, REGION V  
POLLUTION/SITUATION REPORT #113

**KALAMAZOO RIVER/ENBRIDGE SPILL – REMOVAL**  
**SITE # Z5JS**  
**MARSHALL, MICHIGAN**  
**LATITUDE: 42.2395273; LONGITUDE: -84.9662018**

**Date:** 8/24/2011

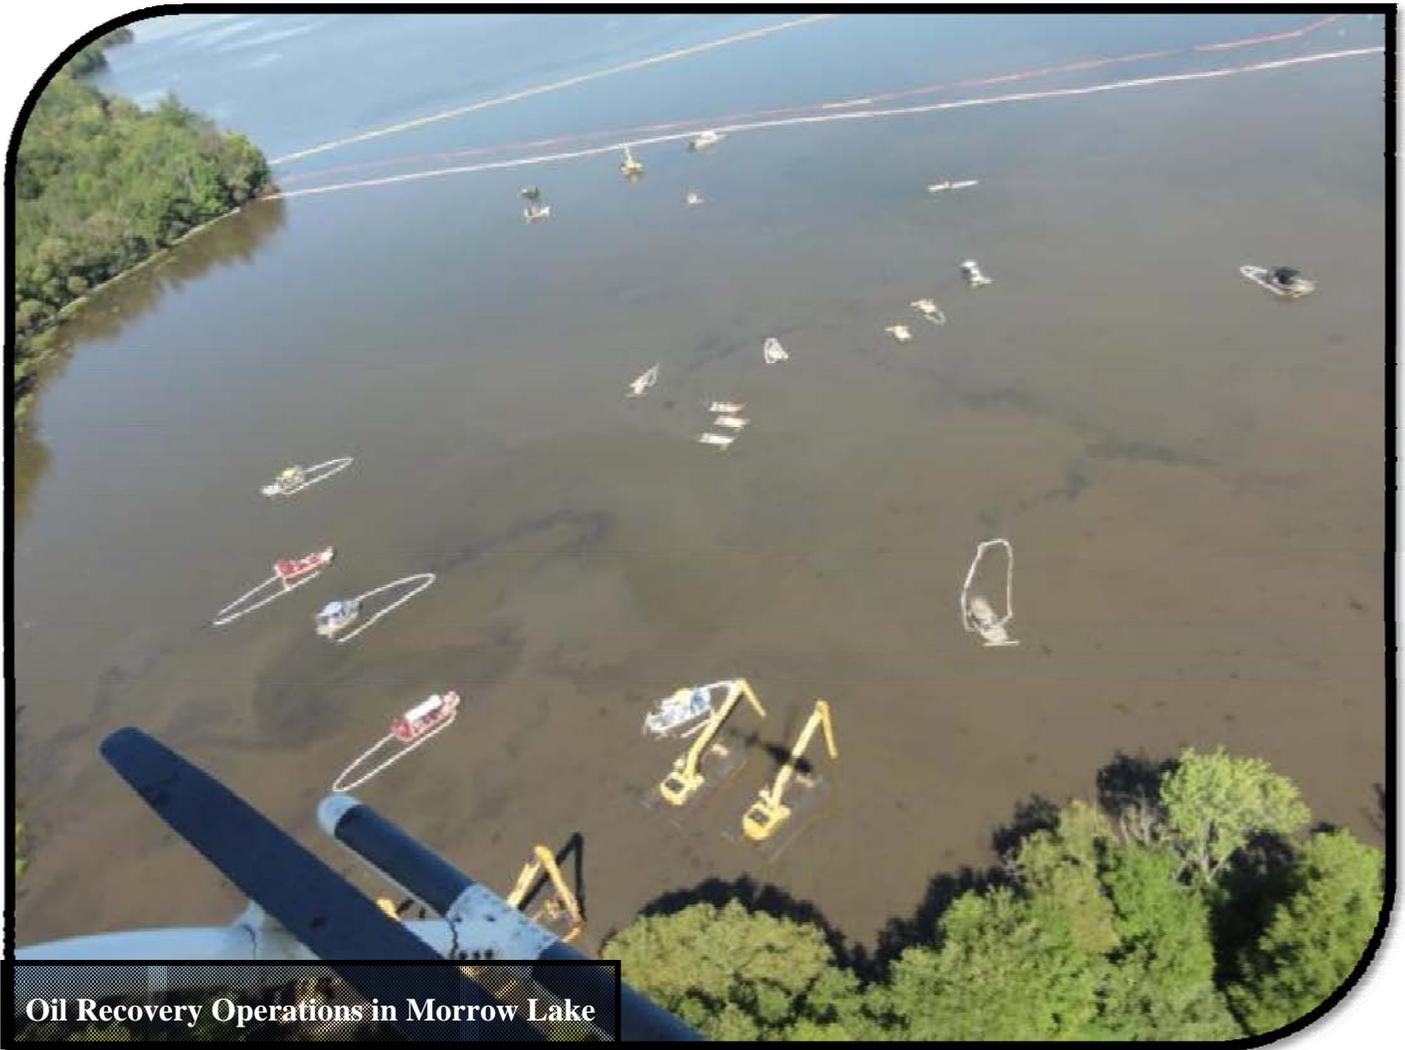
Oil Recovery Operations in Morrow Lake

- Woody debris removal and submerged oil recovery work continued at the Morrow Lake Delta and the fan of Morrow Lake. Enbridge continued using large pontoon mounted excavators for work in the area. Throughout the operational period, sediment was observed breaching containment and slight sheen was noted along the boom at E5 and E6.
