**U.S. ENVIRONMENTAL PROTECTION AGENCY, REGION V
POLLUTION/SITUATION REPORT #112**

**KALAMAZOO RIVER/ENBRIDGE SPILL – REMOVAL
SITE # Z5JS
MARSHALL, MICHIGAN
LATITUDE: 42.2395273; LONGITUDE: -84.9662018**

Date: 8/18/2011

Reporting Period: 0700 hours 8/8/2011 through 0700 hours 8/15/2011

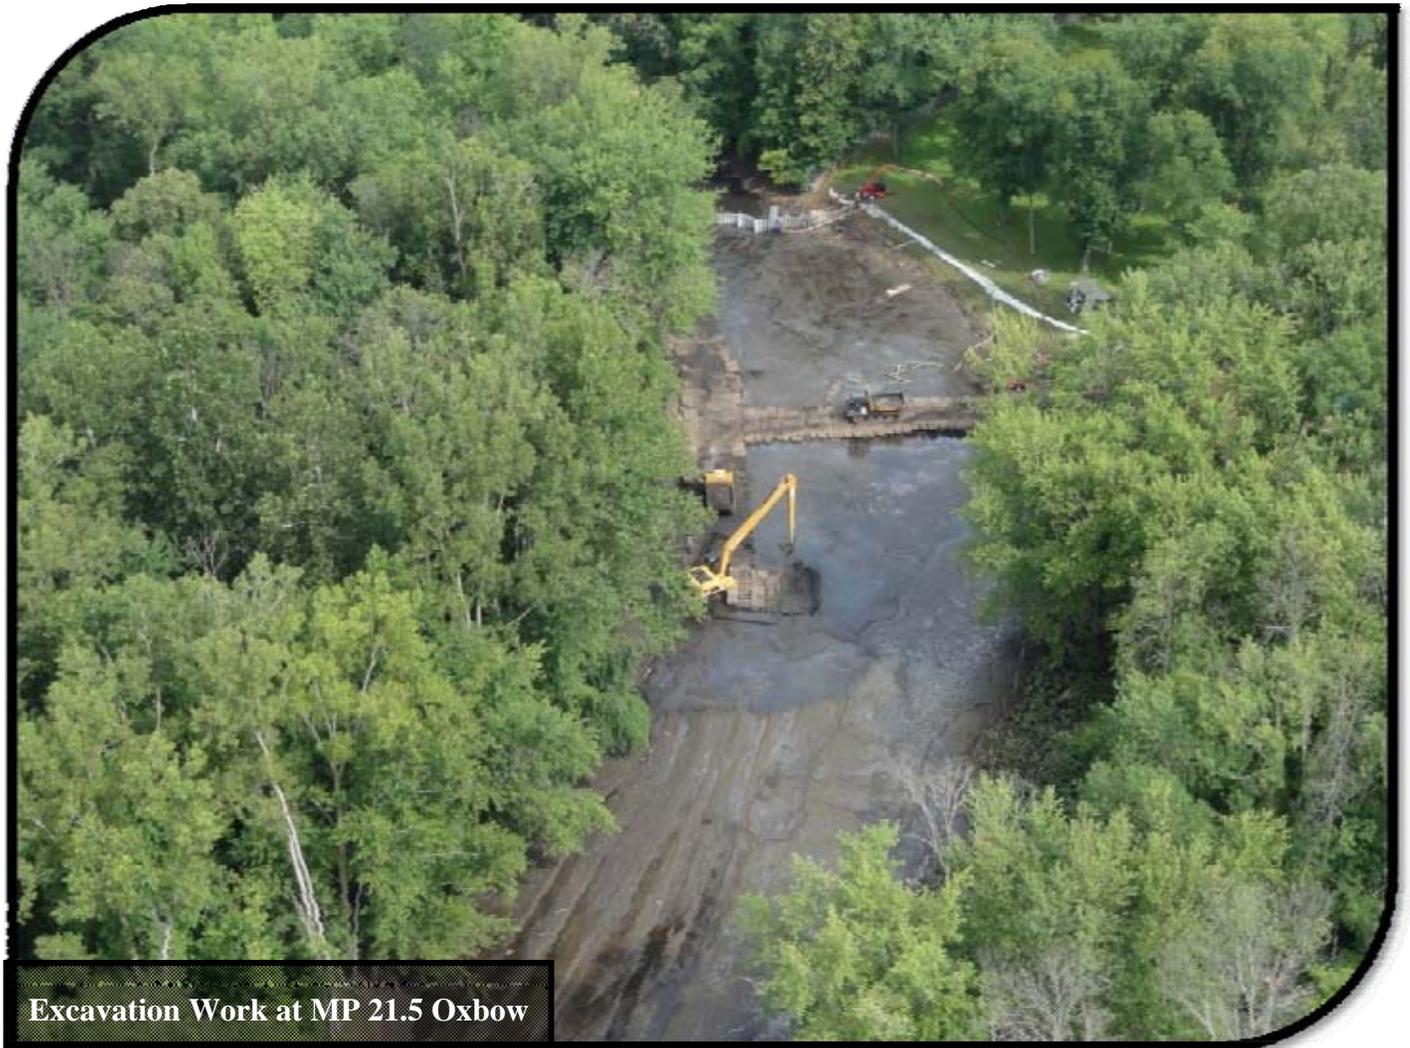
Excavation Work at MP 21.5 Oxbow

- During the operational periods, teams continued excavation, dewatering, and maintained erosion control and stabilization at 4.50 L1 and 21.50 Oxbow.

- Enbridge continued dewatering and excavation work at MP 4.5 and MP 21.25 Oxbow. Sheen and sediment were intermittently noted breaching the sheet piling containment.
